New Water Main
at
Ffordd Penrhwydfa, Prestatyn,
Denbighshire.

An
Archaeological Evaluation

Earthworks
Archaeological Services
(Project No. E261)

June 1998

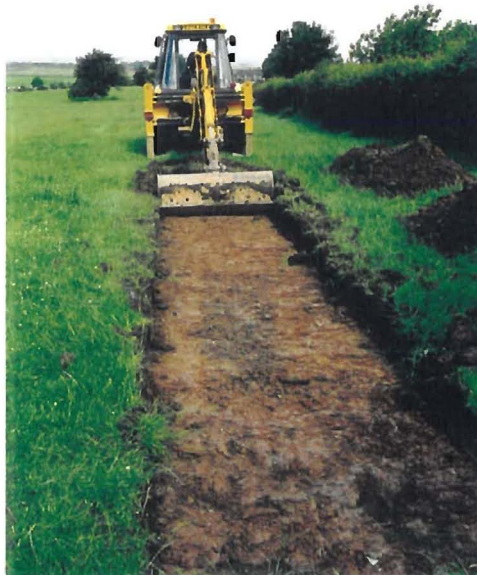
Plate 1: South end of trench 1 at the commencement of machining. Context (1), the rectangular 'stain', is visible; this was initially thought, together with other similar features, to be a possible grave; further investigation showed clearly that it is a relatively modern feature.

4.1.2 At the north end of trench 1 the natural, undisturbed firm mid-brown clay subsoil (see below) lay at a depth of only c.80mm beneath the humic grey topsoil context (37). Confined within the first 50m length of trench 1, up to eight linear cuts were exposed, either fully or partially (contexts 1, 2, 3, 5, 7, 9, 13 & 15; see *Fig. 3*), each measuring c.1.80m (max.) x 400mm/500mm. Context (1) is clearly visible in *Plate 1*.

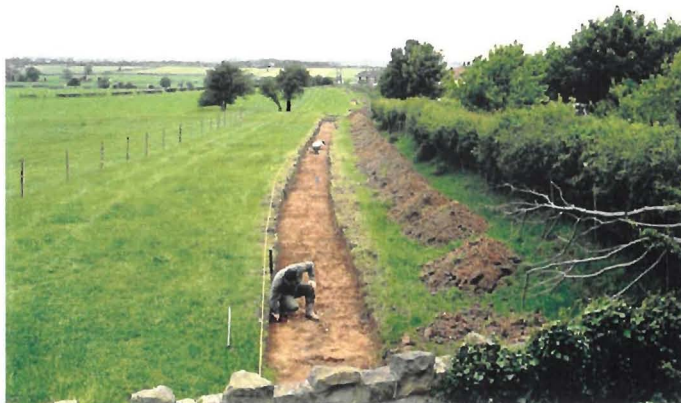
Plate 2: General view of area of evaluation, looking north from Ffordd Talargoch.

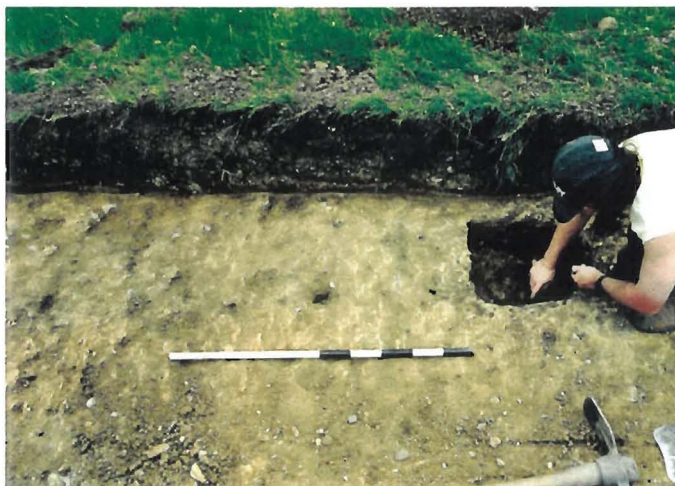
Plate 3: Detailed investigation by Leigh Dodd of context (3), a sub-rectangular cut similar to context (1). Part of a clay tobacco pipe stem recovered from its fill indicated a nineteenth century date for the feature. 1m scale.

4.1.3 Although grave-like in character (see particularly *Plate 3*), partial excavation of contexts (4) and (11), the clay and clay loam fills of respective cuts (1) and (3), yielded a fragment of brick and part of a clay tobacco pipe stem datable to the nineteenth century. The depths of the features appeared to vary; *Figures 4 & 5* contrast contexts (1) and (3).

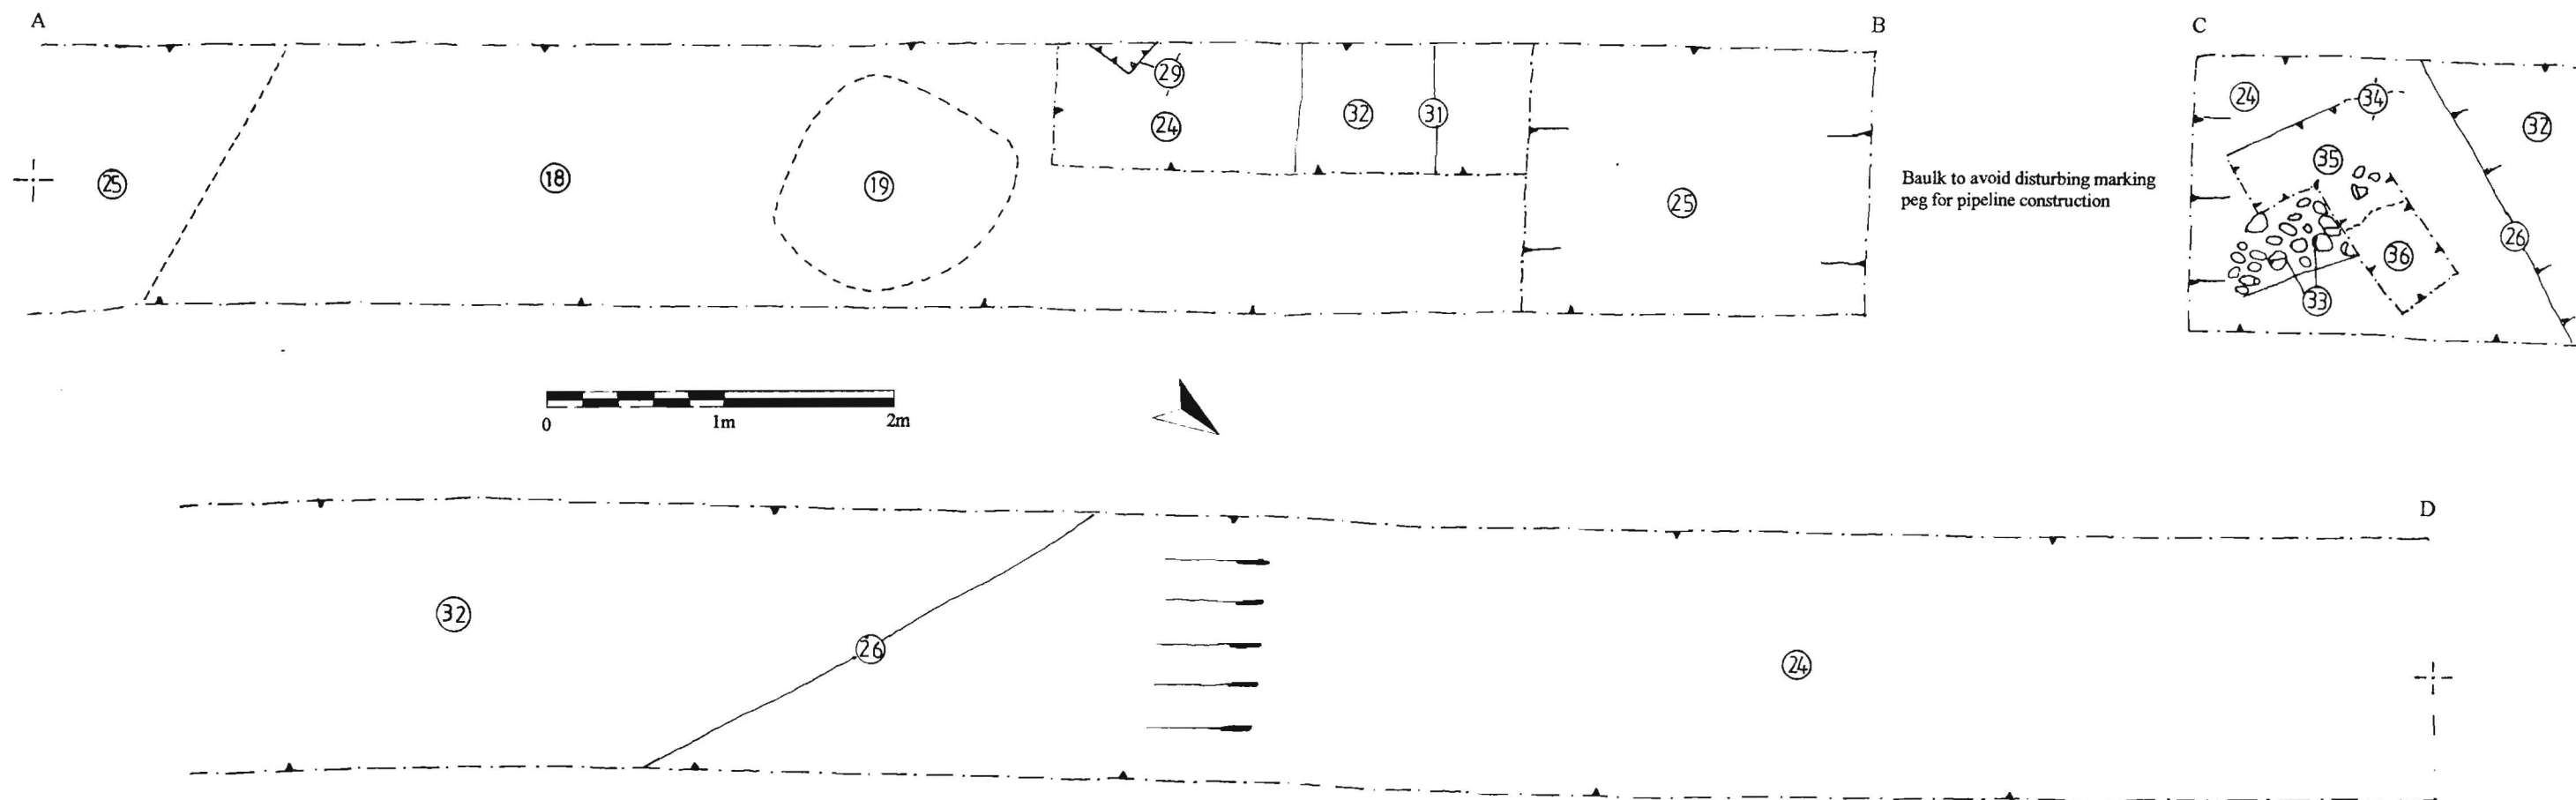
Figure 6: Plan view of features close to Engine Issa (Frost, 1997, Site 1). Scale 1: 40. This plan (for location see Fig. 3) is in the area of that part of trench 1 which cuts obliquely across the bank leading eastwards from the site of the engine (again see Frost, 1997, particularly Plate 1 & Figs. 3, 7 & 9). The bank is visible on Plate 4.

4.1.5.3 A small slot was excavated up against the west section (see *Figs. 6 & 7*). The possible remains of surface metalling on the bank consisted of a thin (10mm-20mm thick) layer of light yellow sandy gravel (23) (see *Fig. 7* and *Plate 6*) and a spread of limestone fragments (19), although the latter may have been the result of more modern deposition. A thin layer (c.15mm) of trampled material,

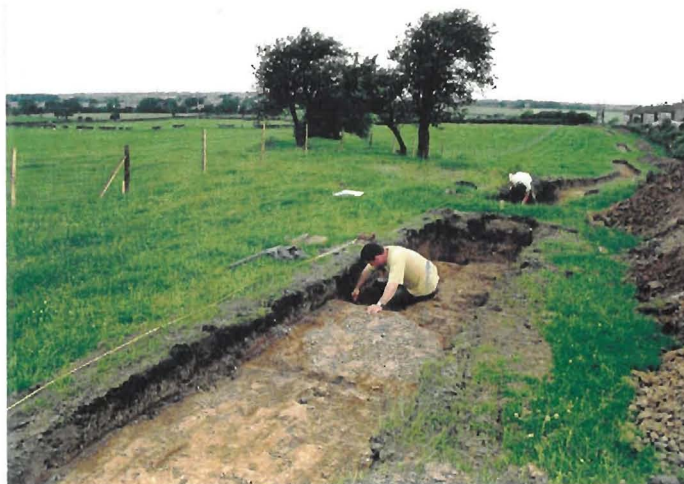
Plate 4: Investigating the area of trench 1 close to Engine Issa (see Frost, 1997, *Figs. 3 & 9*). The trench cuts obliquely through a wide bank, clearly visible, leading from the former engine, in the area of the trees.

large, modern sub-circular rubbish pit (26) up to 8m wide, containing all manner of refuse: crisp packets, cans, asbestos, barbed wire, glass etc. The extent of this modern pit is visible as an area of parched ground on Plate 4, between the trees and the farthest archaeologist.

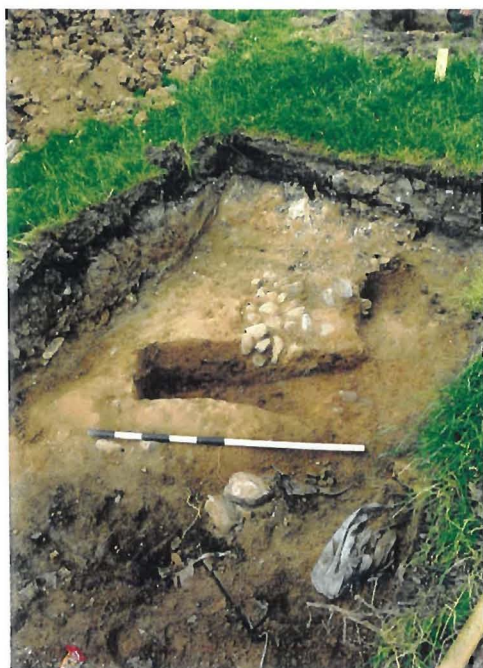
Plate 5: Detail of context (33), a small surviving patch of cobbling seemingly aligned parallel to the bank, but its full extent could not be determined within the confines of the trench. Although no finds were directly associated with the feature, its stratigraphic position indicates a probable nineteenth century date. 1m scale.

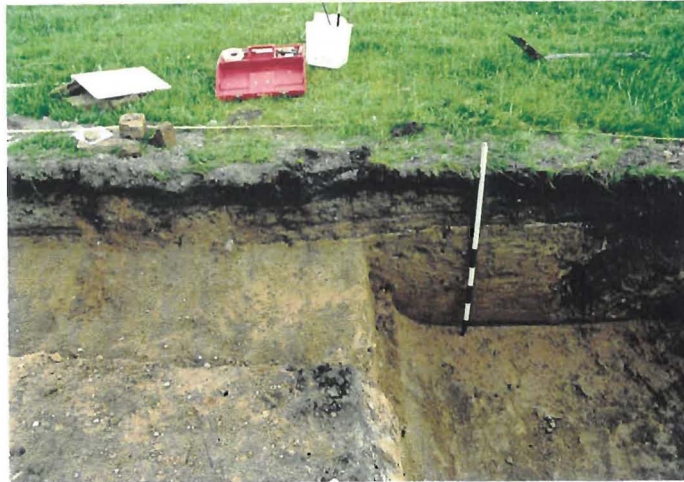
Plate 6: Part of section through bank (see also Fig. 7); the undisturbed clay subsoil starts at a depth of c.600mm below turf level. 1m scale.

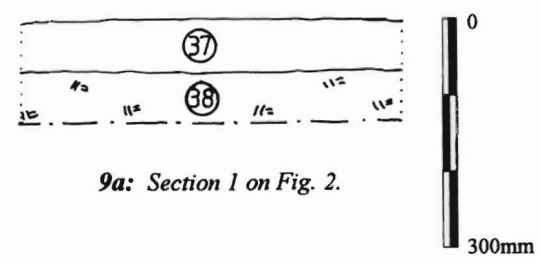
9a: Section 1 on Fig. 2.

- **Section 1** (*Fig. 9a*)
Context (37): soft, grey brown loam topsoil (80mm thick) immediately overlay firm mid-brown clay subsoil (38).
- **Section 2** (*Fig. 9b*)
Context (37): soft, grey brown loam topsoil (90mm thick) immediately overlay firm, friable sandy clay loam (39) containing modern brick fragments and potsherds, a trace of charcoal (>1%), and small angular and sub-rounded stones (5-10%) up to 200mm in size. Natural clay subsoil lay at a depth of 300mm.

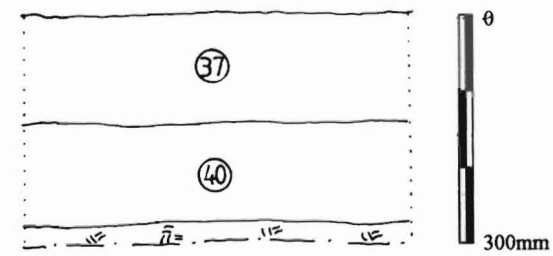
9c: Section 3 on Fig. 2.

- **Section 3** (*Fig. 9c*)
Context (37): soft, grey brown loam topsoil (140mm thick) immediately overlay firm, light to mid grey brown clay loam (40) containing small angular and sub-rounded stones (50%) up to 150mm in size. Natural clay subsoil lay at a depth of 280mm.

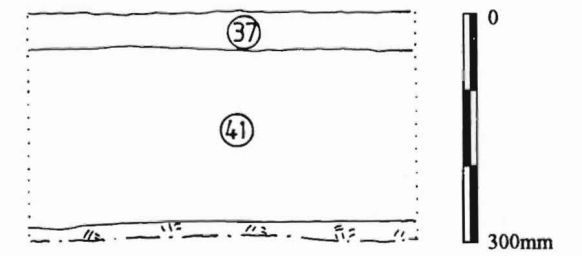
9d: Section 4 on Fig. 2.

- **Section 4** (*Fig. 9d*)
Context (37): soft, grey brown loam topsoil (50mm thick) immediately overlay firm, friable brownish grey loam (41) containing small pebbles (1-2%). Natural clay subsoil lay at a depth of 280mm.

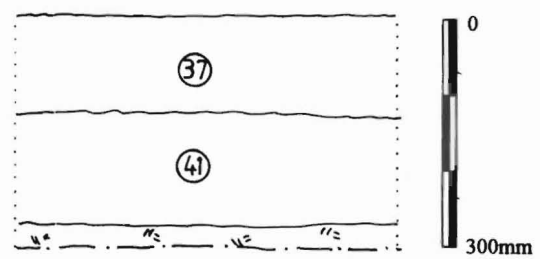
9e: Section 5 on Fig. 2.

4.2.2 Beneath the grey loam topsoil (37), c.120mm thick, lay a brownish grey sandy loam (41) between 100mm and 150mm thick and containing small pebbles and angular stone 1-2% (up to 20mm). The undisturbed sandy clay subsoil lay at a depth of c.270mm. No archaeological features or deposits were observed.

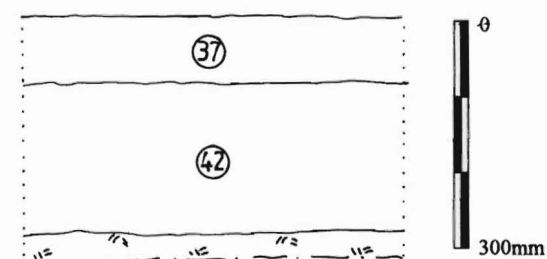
9f: Section 6 on Fig. 2.

4.3.2 Beneath the grey loam topsoil (37), c.90mm thick, lay a light to mid-brown clay loam (42) 200mm thick and containing small angular stone 1-5% (up to 15mm) and traces of brick fragments. The undisturbed firm red brown

clay subsoil, with angular limestone fragments and pebbles, lay at a depth of c.270mm. No archaeological features or deposits were observed.

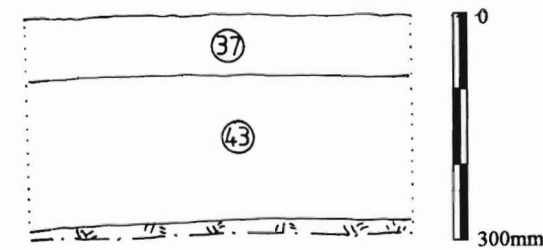
9g: Section 7 on Fig. 2.

4.4.2 Beneath the grey loam topsoil (37), c.80mm thick, lay a loose brown sandy loam (43) 200mm thick and containing rounded stone 1-2% (up to 60mm) and traces of red/orange brick fragments. The undisturbed sandy clay subsoil, with small angular limestone fragments, lay at a depth of c.280mm. No archaeological features or deposits were observed.
