Historic Environment Feature

Management Report

Clwyd-Powys Archaeological Trust

Site name: Ty Newydd

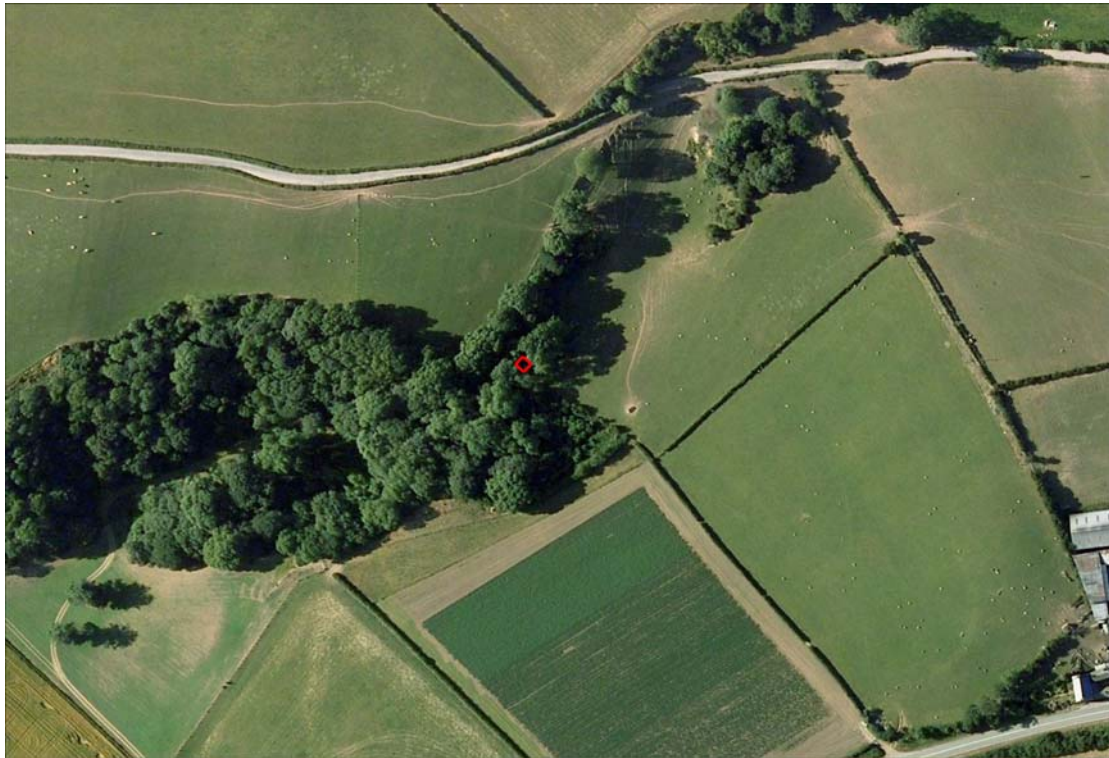
© Next Perspectives. Welsh Assembly Government 2009

The 2009 Next Perspectives Aerial Photography (see above) shows the site of the mine shaft is obscured by trees, many of which appear to be well established. The presence of the trees makes it difficult to tell if there are any other forms of intrusive vegetation on the site that may be potentially damaging to the mine shaft remains.

- Remove any scrub, saplings and intrusive vegetation from the area defined on the map, by hand cutting to ground level, allowing the roots to rot in situ.
- Remove any dead or unstable trees or limbs that may cause damage to historic features by falling limbs or wind throw. Remove by hand cutting to ground level, allowing the roots to rot in situ.
- Remove any young trees or vegetation growing out of the walls by cutting by hand.
- In this woodland setting a canopy of mature trees over the building remains is acceptable, as long as the trees are not causing damage, as this will prevent light entering the ground, inhibiting scrubby vegetation growth.
