Historic Environment Feature Management Report

Site name: Gwestyn Mine

UID: 115061

PRN 5943 Name Gwestyn Mine
Period Multiperiod **Site Type** Mine (copper/lead)
NGR SN89408610

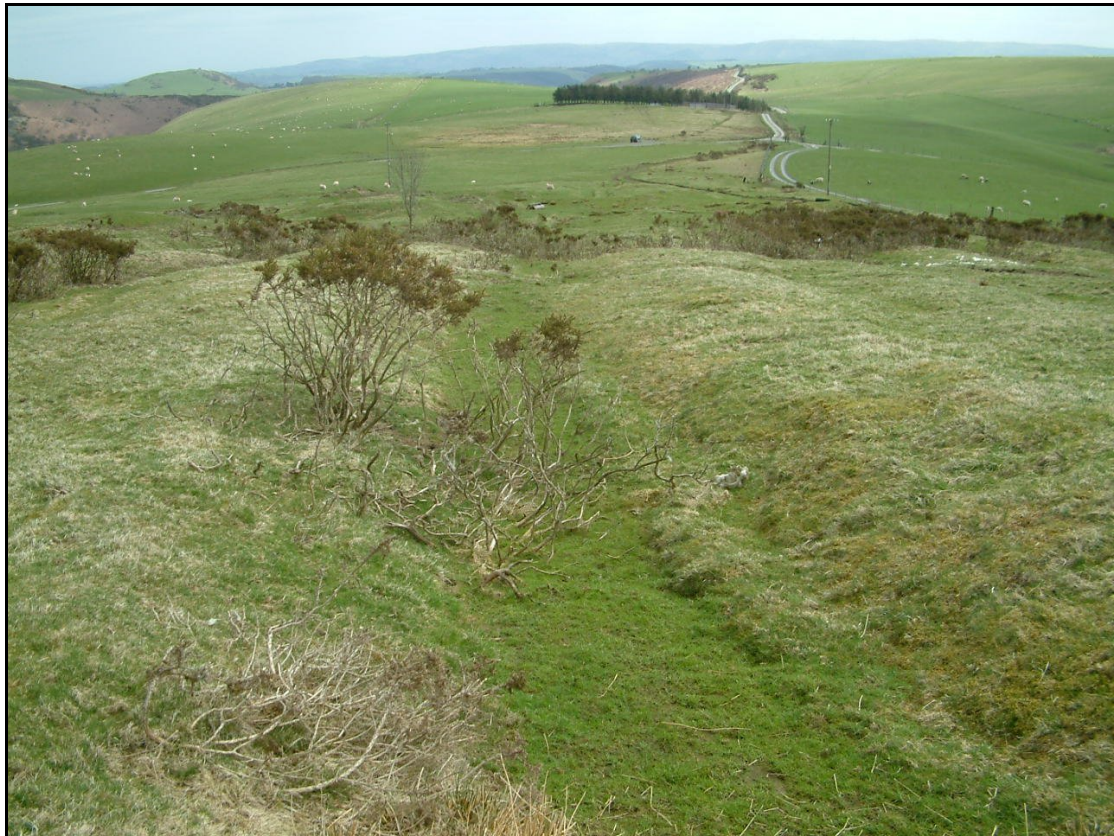
Gwestyn Mine earthworks, Image 2118-0011 © CPAT

Gwestyn Mine was last visited in 2006 and a series of photographs taken at that time showed that on some areas of the site there were gorse bushes growing on the earthworks remains. The roots of gorse and scrub can cause damage to below ground archaeological deposits, and disturb upstanding earthworks. Vegetation can also visually obscure a site and furthermore, offer shelter to livestock and burrowing animals, both of which can cause damage to sensitive archaeological and historic remains.

1. Remove any scrub, saplings and intrusive vegetation from the area defined on the map in order to retain the visibility of the earthwork remains. Remove by hand cutting to ground level, allowing the roots to rot in situ, managing any subsequent woody growth if required.
 2. Establish a stable grass sward, reseeding if necessary, managing any subsequent woody growth if required.
 3. Remove any rubbish that has been tipped within the Historic Environment Feature.
-

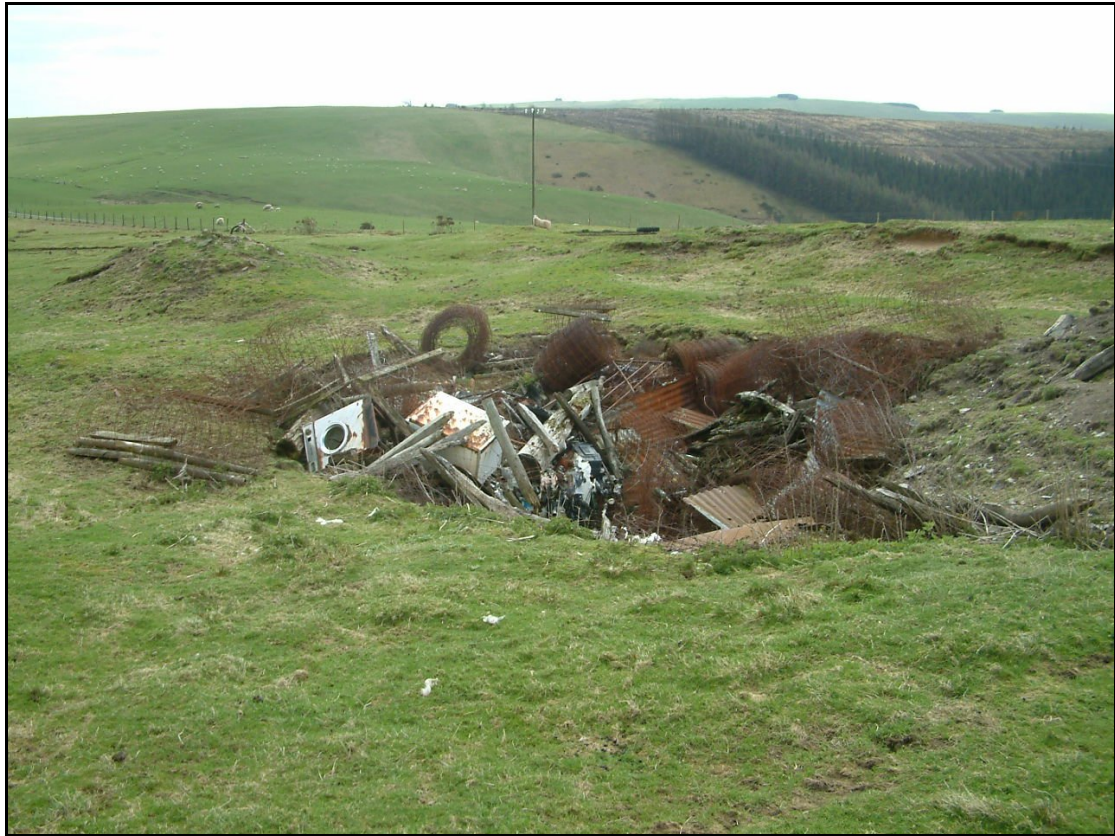
Rubbish at Gwestyn Mine, Image 2118-0017 © CPAT

One of the photographs (see below) also shows that rubbish had been tipped on the site, possibly into one of the former reservoirs. This is inappropriate use of an historical feature and unsightly.
