**CPAT Report No. 1891**

# **Trelogan Mine, Flintshire**

Heritage Impact Assessment

Client name: The Coal Authority  
 CPAT Project No: 2644  
 Project Name: Trelogan Mine  
 Grid Reference: SJ 12148 80479  
 County/LPA: Flintshire  
 Planning Application: Forthcoming  
 CPAT Report No: 1891  
 HER Enquiry No: E6761  
 Event PRN: 214624  
 Report status: Final

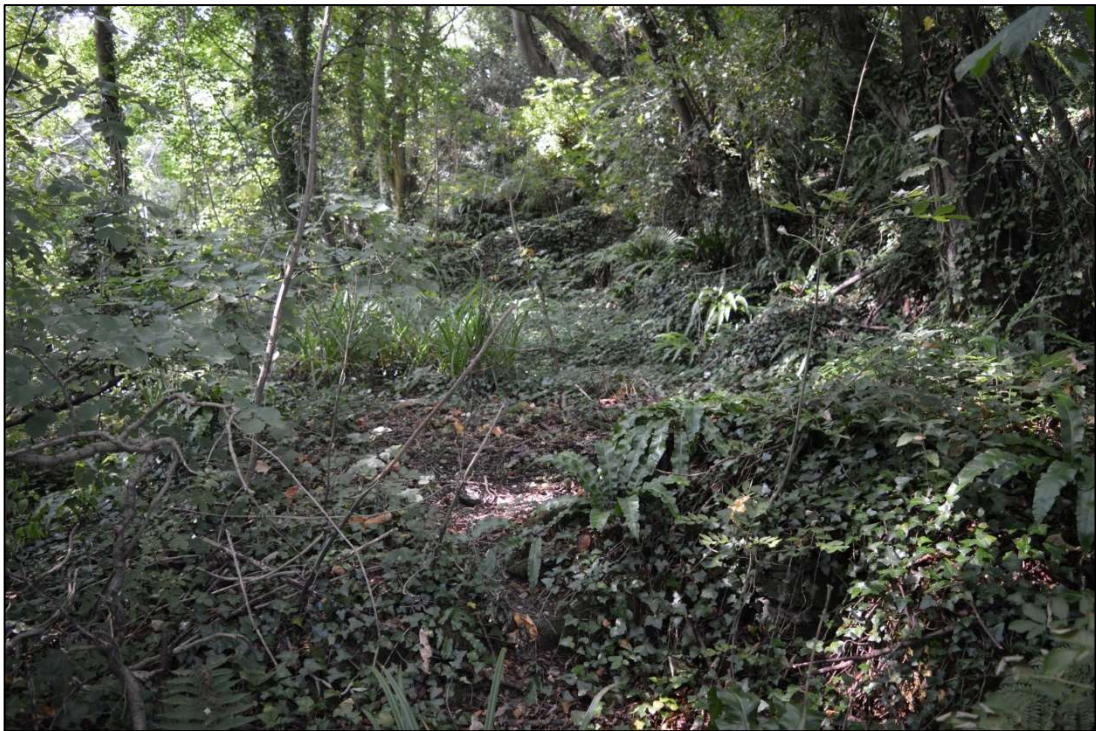
- 3.6. Other farmsteads, such as Trelogan Uchaf, have been recorded in the locality but the only dwelling in the study area is the ruinous Caeau-Isaf (PRN 126867) on the north side of the Afon y Garth.

*Fig. 2: The site of Caeau-Isaf house. CPAT 5007-0001*

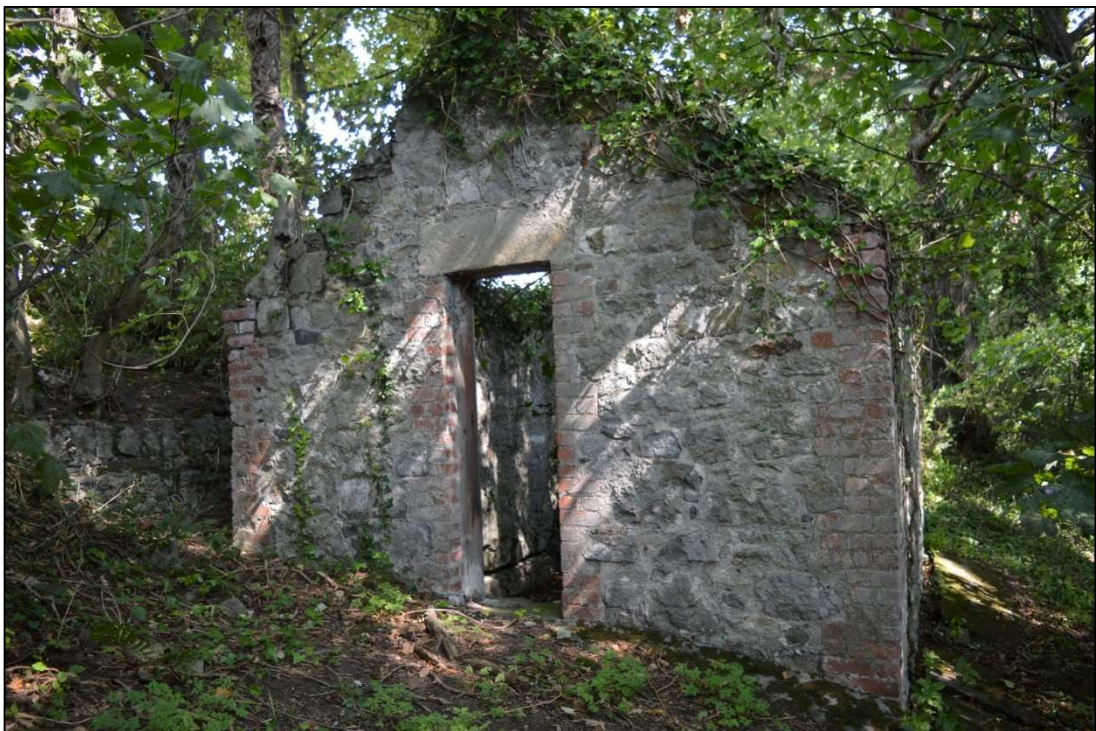
*Fig. 3: Saunders Dingle building. CPAT 5007-0018*

- 3.7. A building (PRN 93633) has also been recorded in Saunders Dingle, which is described as a house site in the records, though this is incompatible with the remains. It has a door but no windows so it seems more probable that it was some form of store.

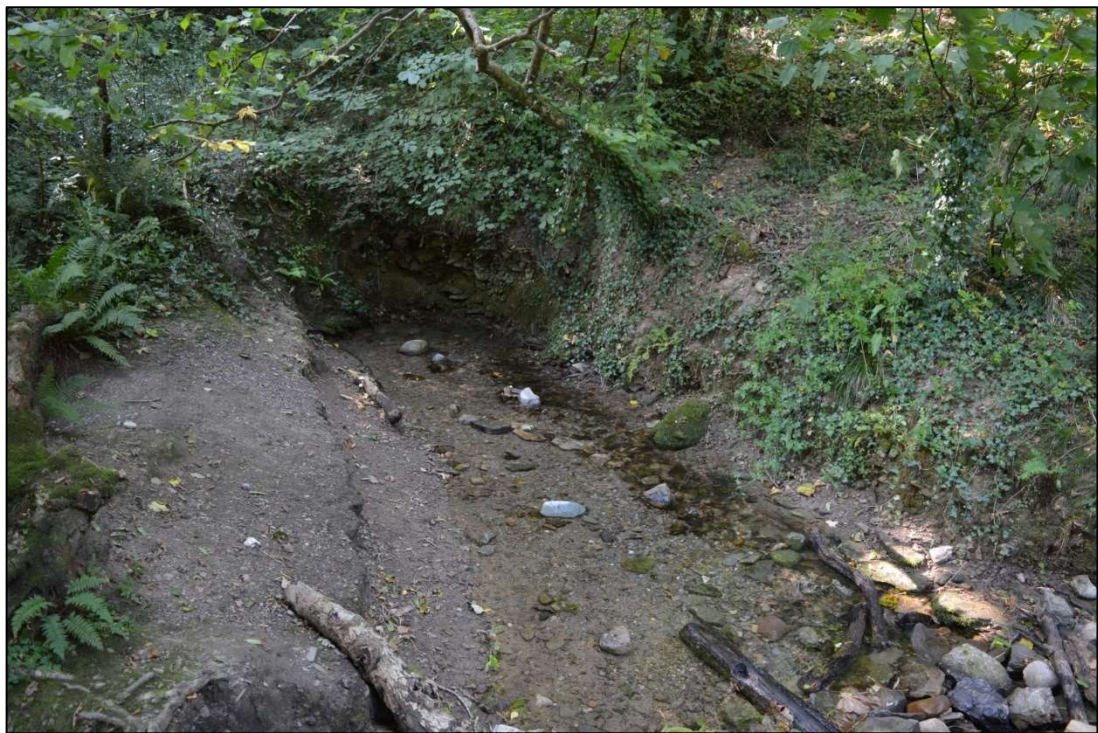
- 3.9. At some point, a deep adit (PRN 213944) was driven from the lower end of Saunders Dingle (see Fig. 4) towards the mine site and this provided an efficient means of draining the workings, though the long period of time that the mine was in operation makes it probable that the workings continued below adit level and additional pumping was required. The mine continued through the 19<sup>th</sup> century under the ownership of the Trelogan Mining Company and was worked by Brunner Mond, from 1897 to the mine's eventual closure in 1911.

*Fig. 4: The outfall of the Trelogan Mine drainage adit. CPAT 5007-0016*

- 5.9. The two locations where temporary flow monitoring structures are proposed are not particularly sensitive. At the Trelogan Mine drainage adit, local information indicates that the end of the adit collapsed in the past 20 years or so and this is corroborated by the visible remains (Fig. 4) which show it to be blocked by rubble, through which water flows. As a result of the damage it is unlikely that the installation will have a marked additional impact; any potential here could be mitigated by a watching brief during construction of the monitoring structure, which may provide a positive benefit by revealing the current condition of the asset.

- 6.2. The portal of the drainage adit appears to have already been damaged by collapse. If works are required in this area, as seems likely, then a watching brief would provide an opportunity to assess the nature of the past damage and record any features of interest that might remain.

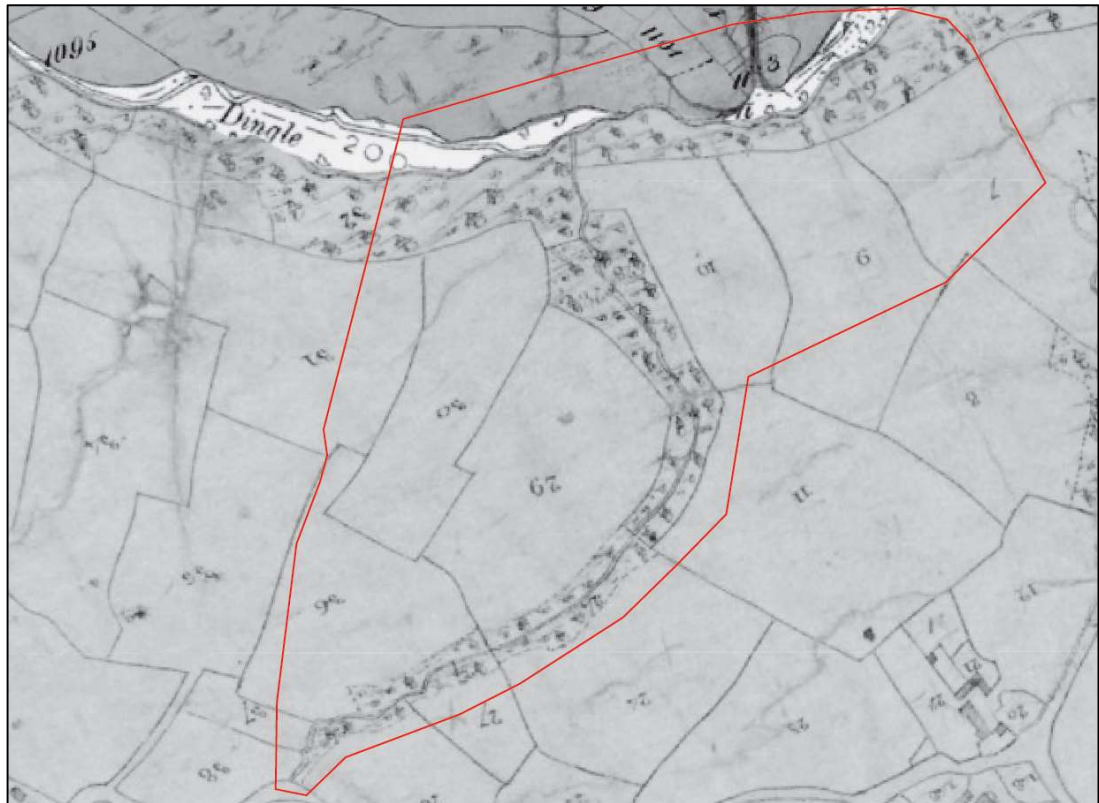
*Fig. 5: Llanasa Tithe map of 1839*

- 3.10. The main sources used to identify heritage assets were the tithe survey mapping of 1839 and the series of large-scale Ordnance Survey maps published in the late 19<sup>th</sup> and early 20<sup>th</sup> centuries; these are shown below with the study area marked on them in red.

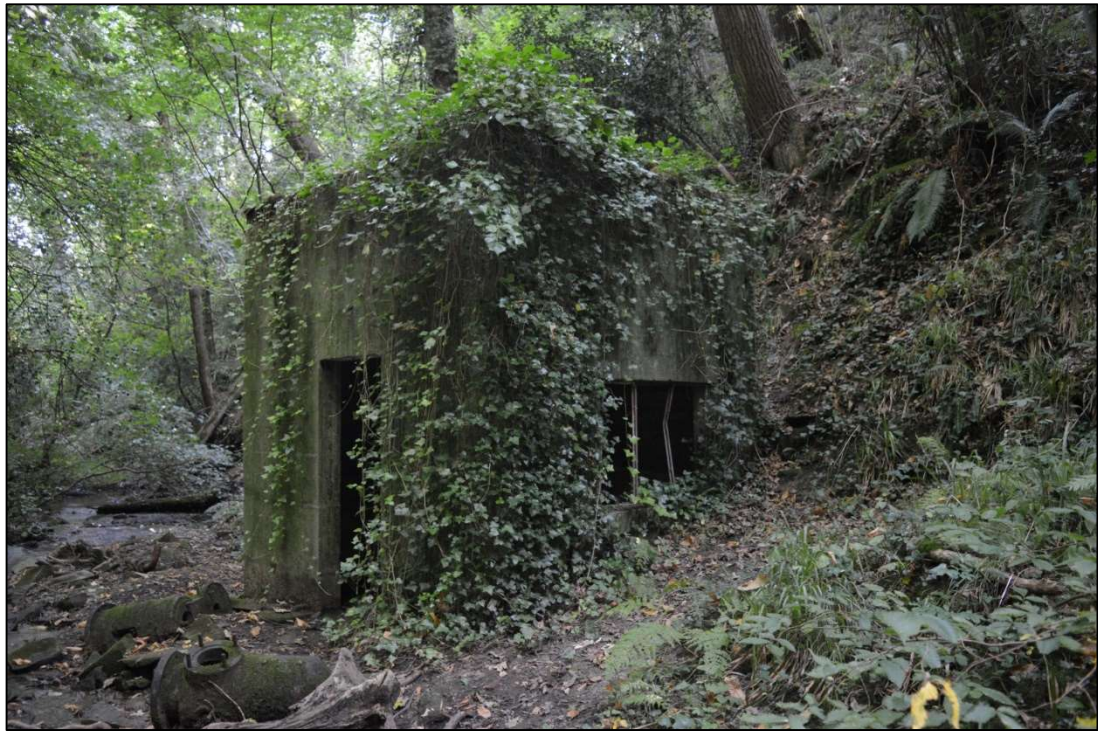
- 3.11. Broadly contemporary with the closure of the mine the Holywell Rural District Council seems to have commenced the provision of water supplies to local villages, the earliest evidence for this being the 'hydraulic pump' apparently drawing water from a well in Mc. Walters Dingle on the 1912 OS map (Fig. 8). A series of wells are depicted in this area on the map and it seems that the council expanded the scheme in the 1930s by building a hydraulic ram installation (Fig. 9; PRN 213950) further east along the Afon y Garth which used water from the mine drainage adit to pump clean water, presumably from the wells, to heights of between 182 and 292 feet.

*Fig. 9: Hydraulic ram installation building, with ram remains nearby. CPAT 5007-0012*

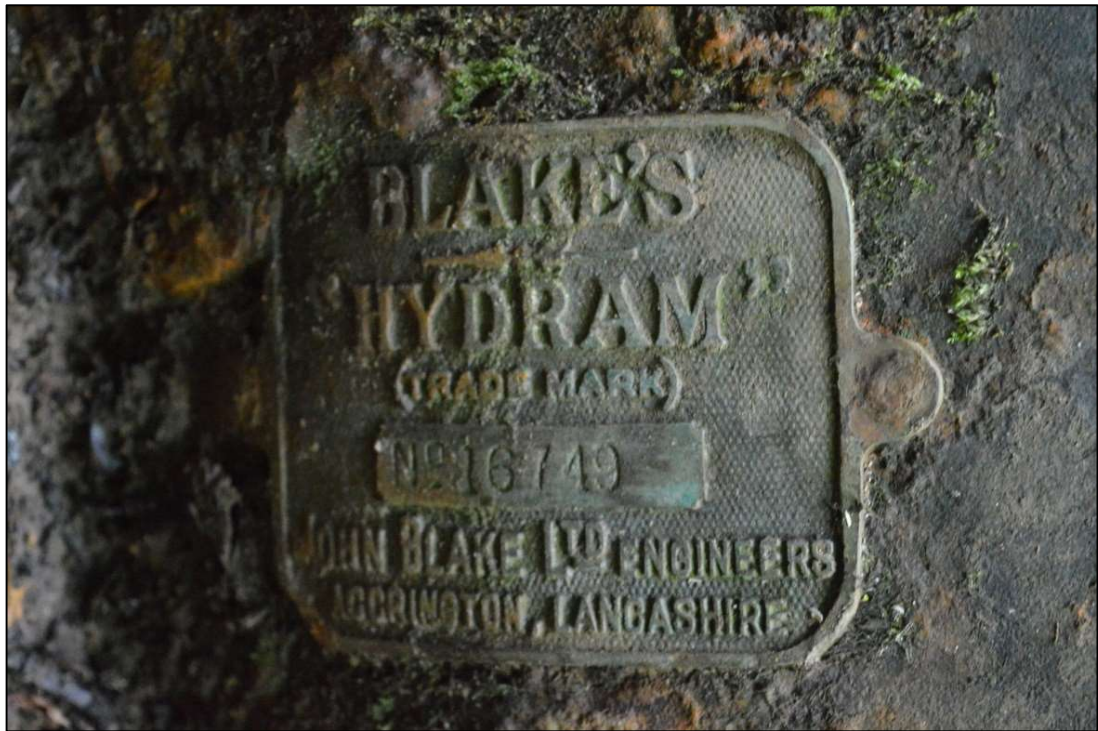
- 3.12. Information on the installation was provided by Green and Carter of Somerset, who hold the records for Blake's Hydram (see Fig. 10), and these indicate that it was constructed in 1933, with the installation last serviced in 1953, sometime after which the supply was presumably superseded by mains water. The installation took water from the drainage adit, via what seems to have been a control building (PRN 213945), and channelled it through a pipeline (PRN 213946) to a concrete building containing hydraulic rams, alongside the Afon y Garth (Fig. 9). Just upstream of the building the pipeline passes through a manhole chamber from which water is overflowing down the side of the valley (Fig. 12), presumably as the pipe below is blocked. The line of the clean water pipe, a 3 inch rising main, is not known but a stop tap (PRN 213952) a short distance further downstream appears to indicate some of the route.

*Fig. 10: Hydraulic Ram identification plate. CPAT 5007-0011*

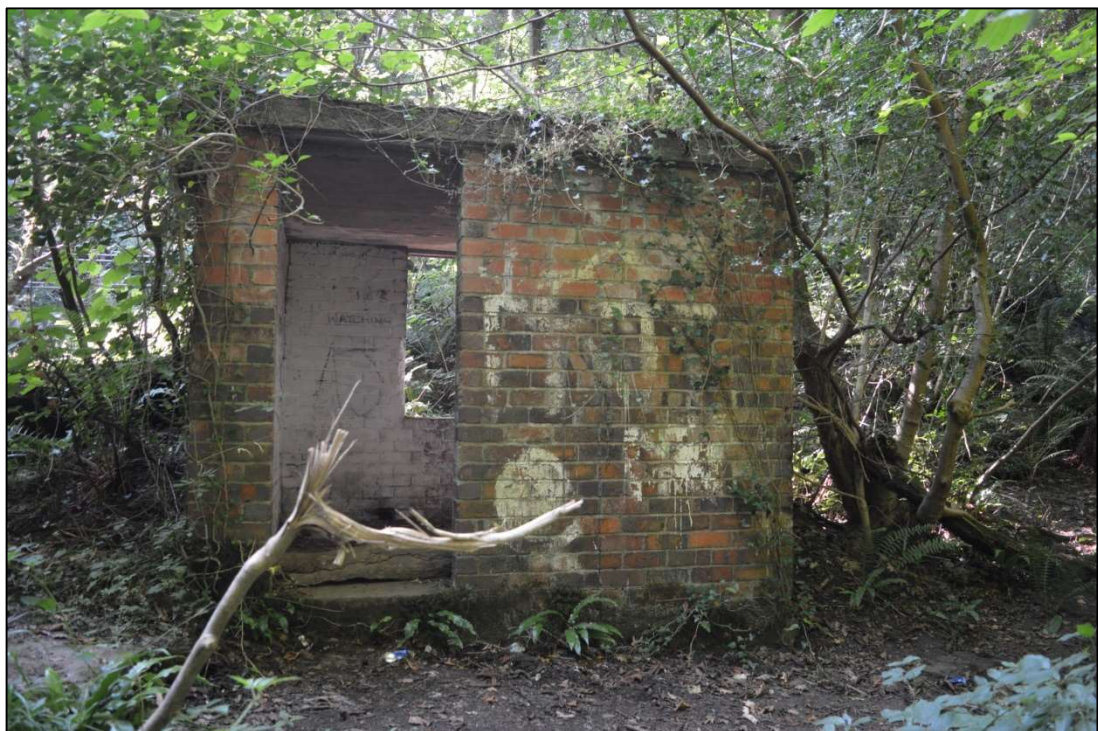
*Fig. 11: Probable control building, near the Trelogan Mine drainage adit, for the hydraulic ram installation. CPAT 5007-0015*

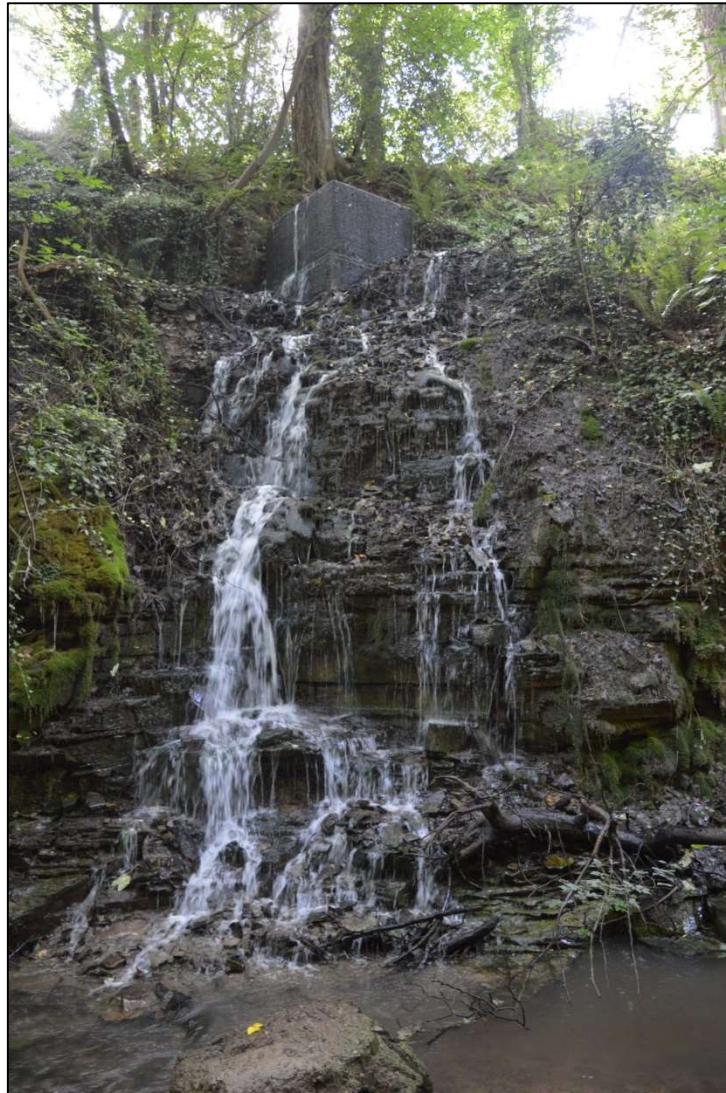
*Fig. 12: Overflowing manhole chamber on the course of the pipeline from the drainage adit, just upstream from the hydraulic ram building. CPAT 5007-13*

- 5.10. At the second location (Fig. 12) water flows down the side of the valley from a manhole along the route of the 1933 hydraulic ram pipeline, very probably supplied from the drainage adit. In theory it would be possible to unblock the original outlet of the pipeline in or near the hydraulic ram building to measure the flow in the pipeline, but this would almost certainly have an effect on that installation unless it was carefully planned in advance.

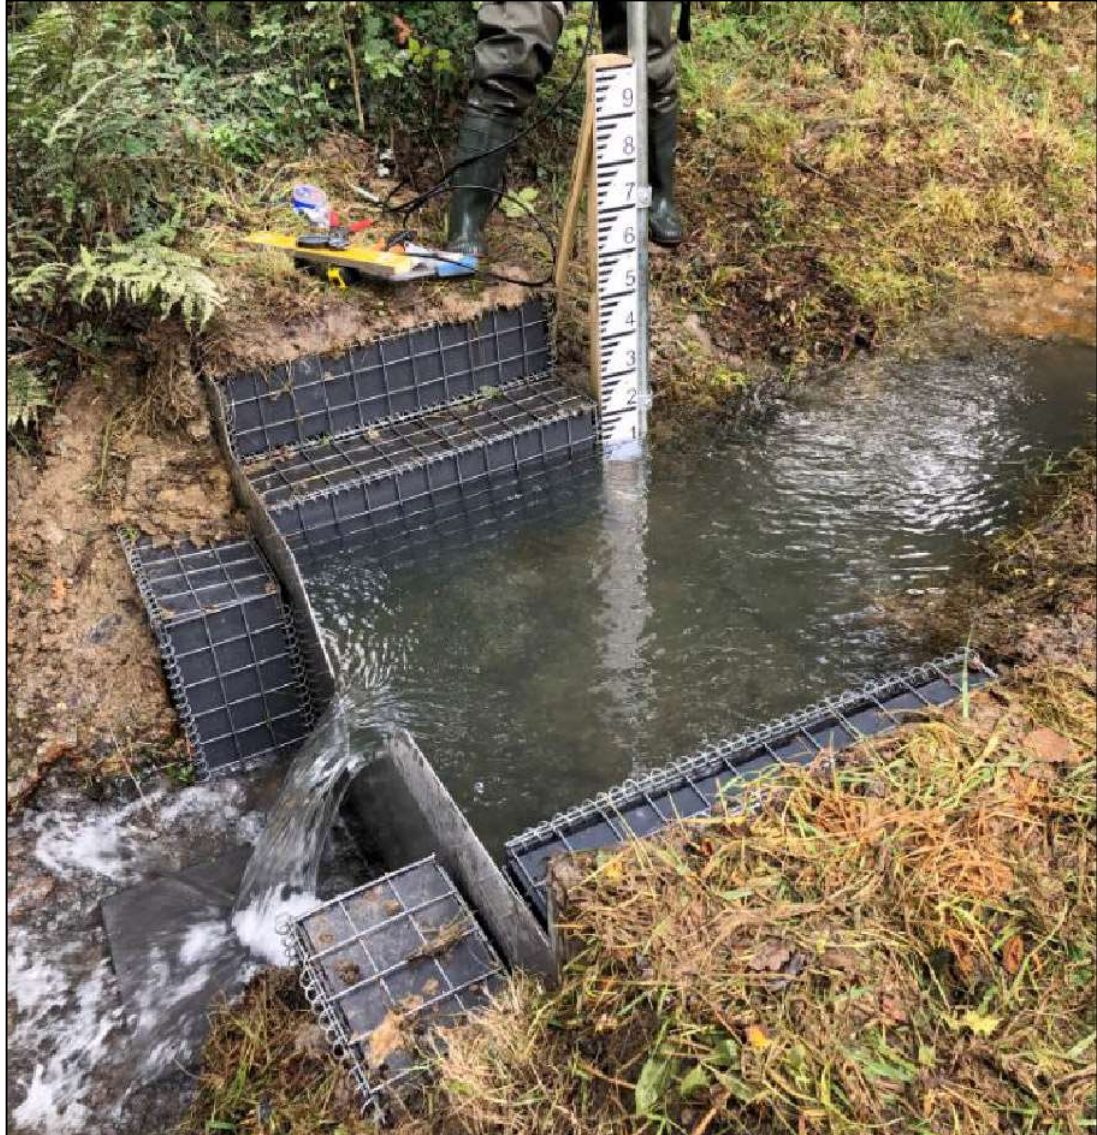
*Fig. 15: An example of a typical temporary flow monitoring structure*
