REPORT ON THE SIXTH SEASON OF THE  
TRE'R CEIRI CONSERVATION PROJECT  
JUNE TO OCTOBER 1994

REPORT NO. 143

prepared for Cyngor Dosbarth Dwyfor

by D. Hopewell

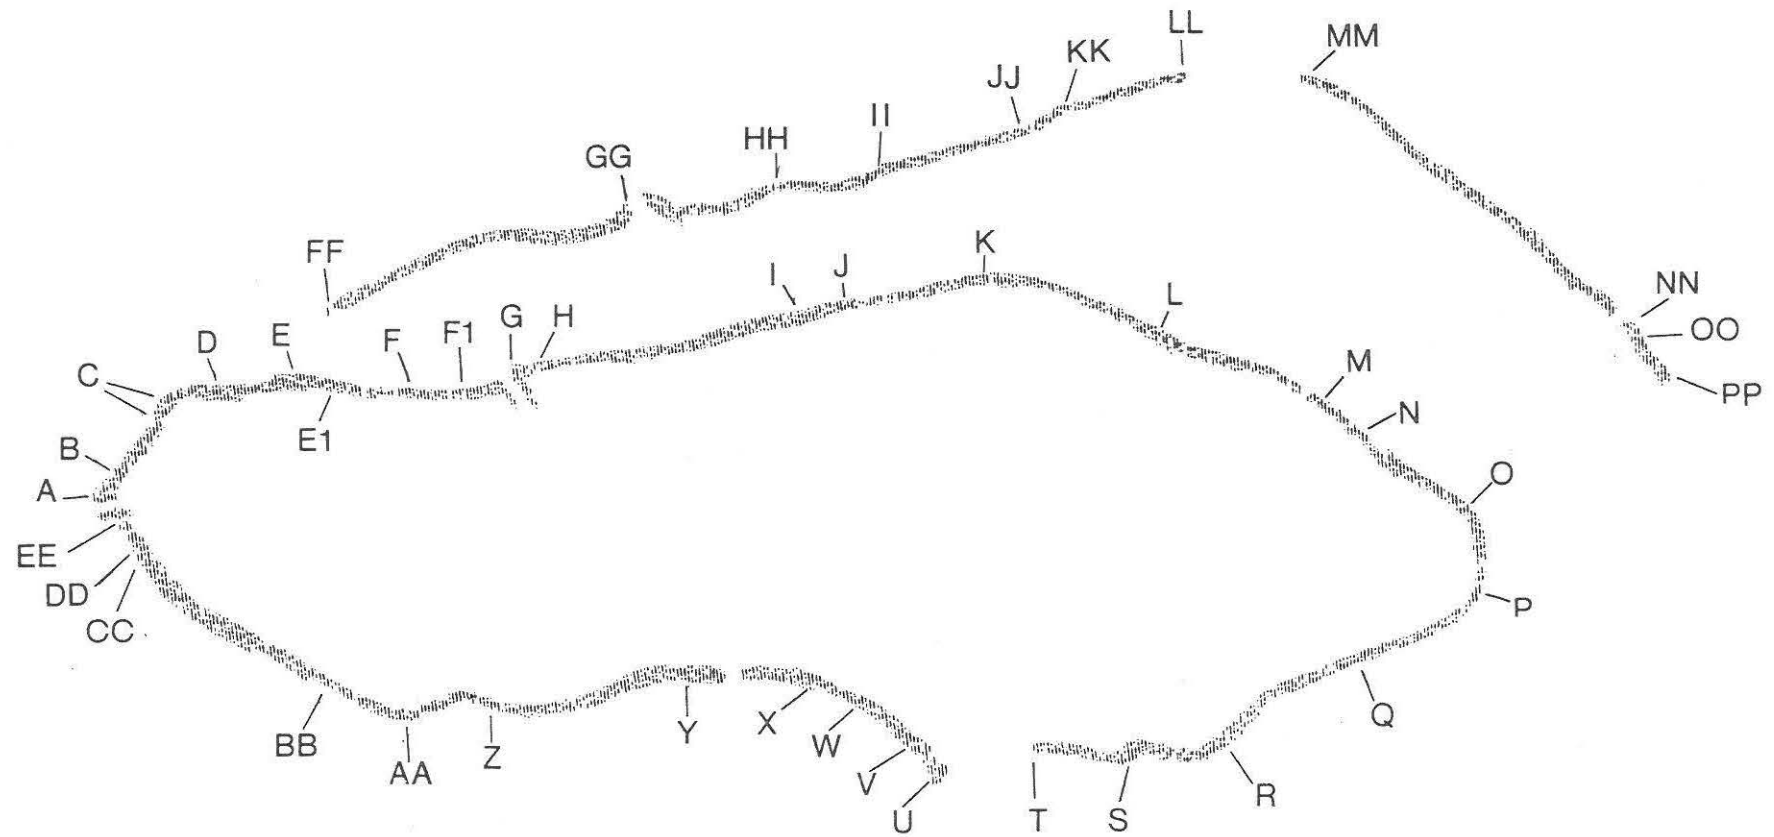
Fig. 2. The Ramparts: points of collapse (after Dallimore, 1978).

During the sixth season work continued on the rampart at the north-east end of the site. A 90m stretch of wall was conserved, running from modern field wall O to outcrop S (see Fig. 2). In addition works were carried out on four of the eleven huts below the cairn and the material excavated from the cairn in 1993 was reinstated. The start of the season was later than usual as the funding had to be arranged in the spring. Several days work on site were lost due to the deterioration of the weather during October.
