Barmouth Viaduct, Abermaw, Gwynedd

Desk Based Assessment and Site Visit

Report No. 1903

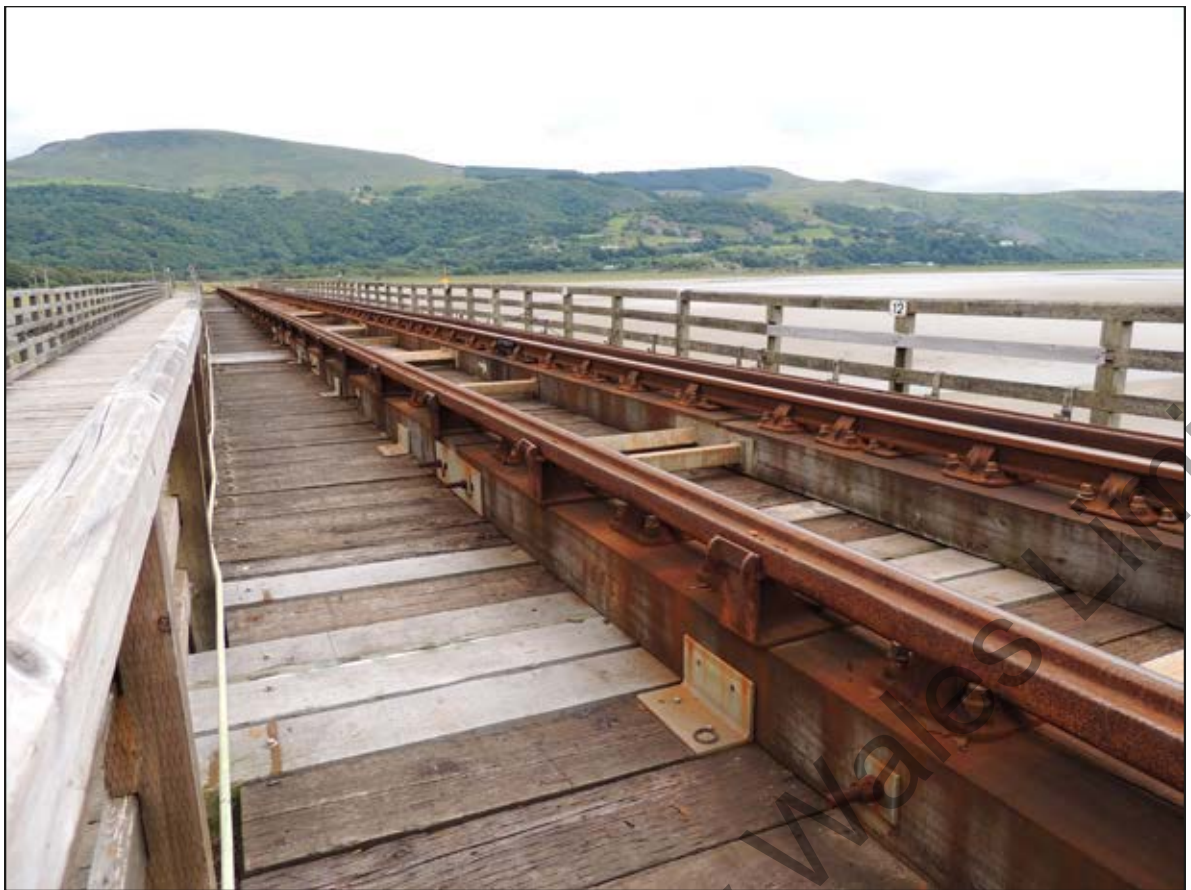
Plate 14. SW facing shot of replacement longitudinal outer beam and metal strap with metal plate reinforcements inbetween trestle 12 and 13.

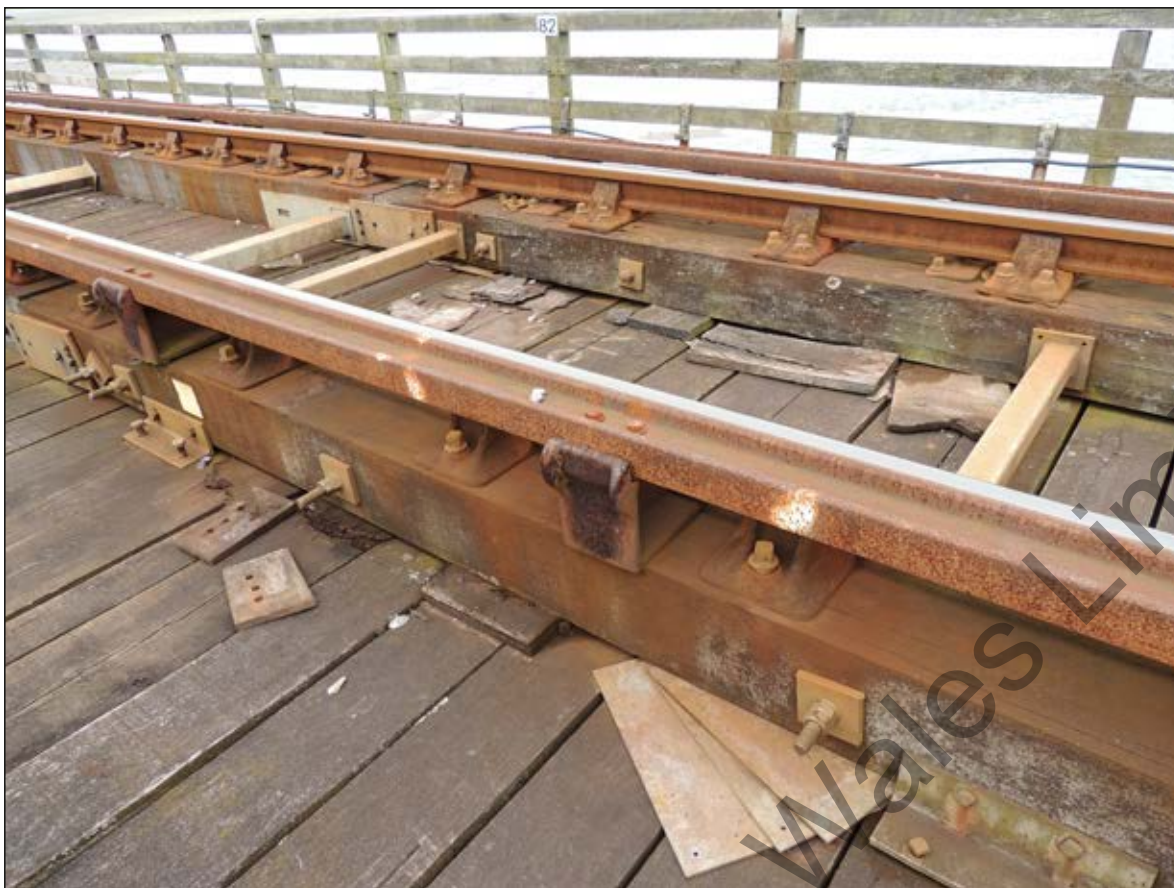
- 7.3.5. Other notable areas that were observed on the railway track were the transverse deck planks at trestle 81 and 82, where a number of planks that the track lies upon are sagging. It appears measures have been taken to prop up the track with metal plates and timber boards to keep the track level. The sagging of these deck planks are most probably due to the horizontal beam atop of the trestle beneath being weakened over time (See plates 24 and 25).

Plate 24. SW facing shot of metal plates supporting the track due to slumping of the transverse deck planks at trestle 81 and 82.

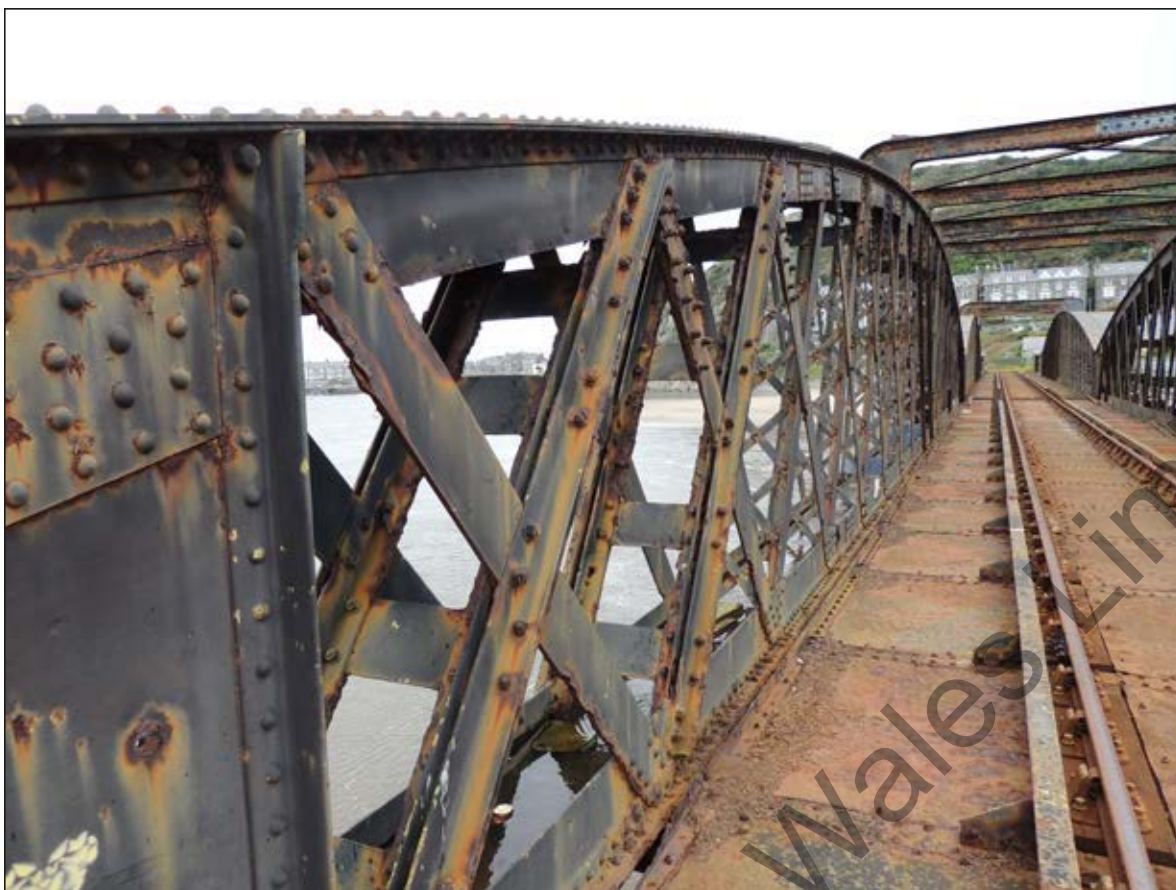
Plate 28. N facing shot of replacement metalwork on the hogback lattice trusses on the span of the viaduct.

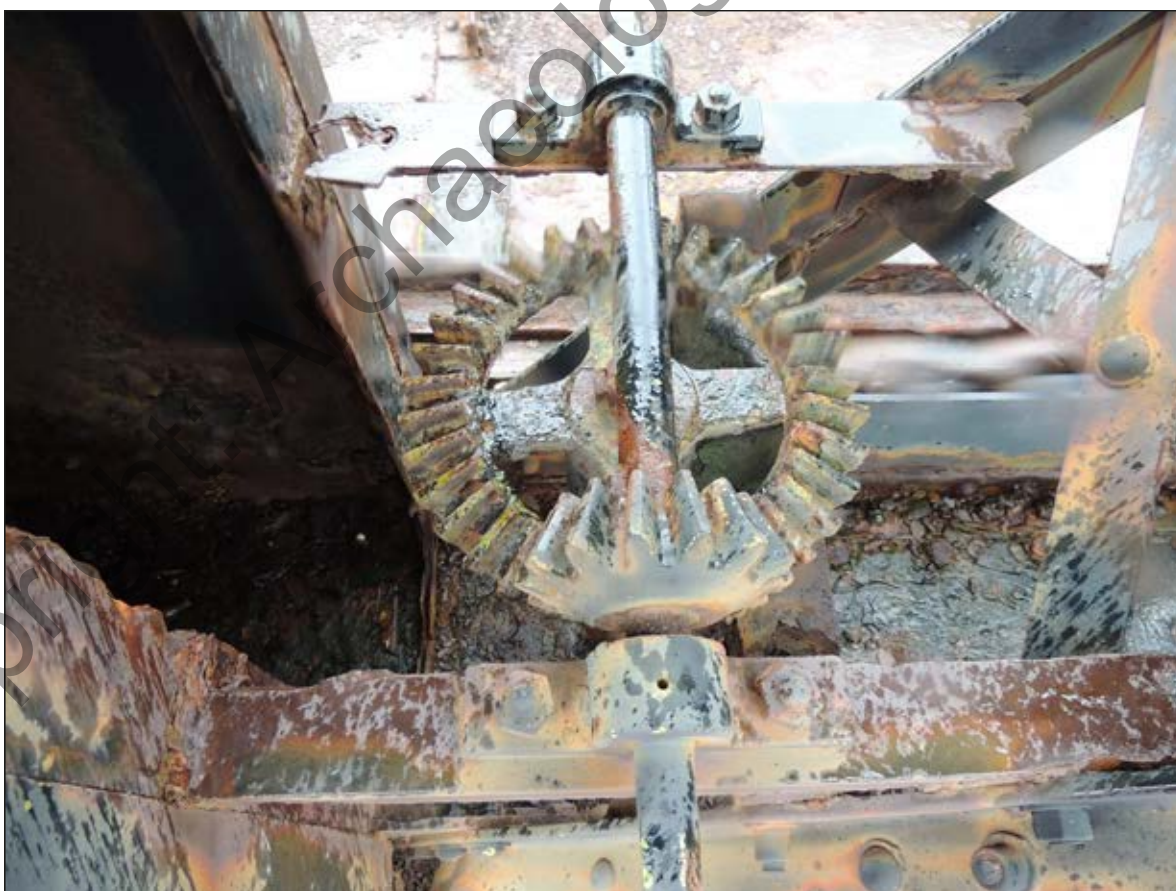
as part of the mechanism to pivot the bridge into position (See plates 37 - 38). The hand crank appeared to be in a good state of preservation and is an original feature of the swing bridge.

Plate 37. SW facing shot of hand crank mechanism of the swing bridge on NE elevation of hogback lattice trusses on the spans of the viaduct.

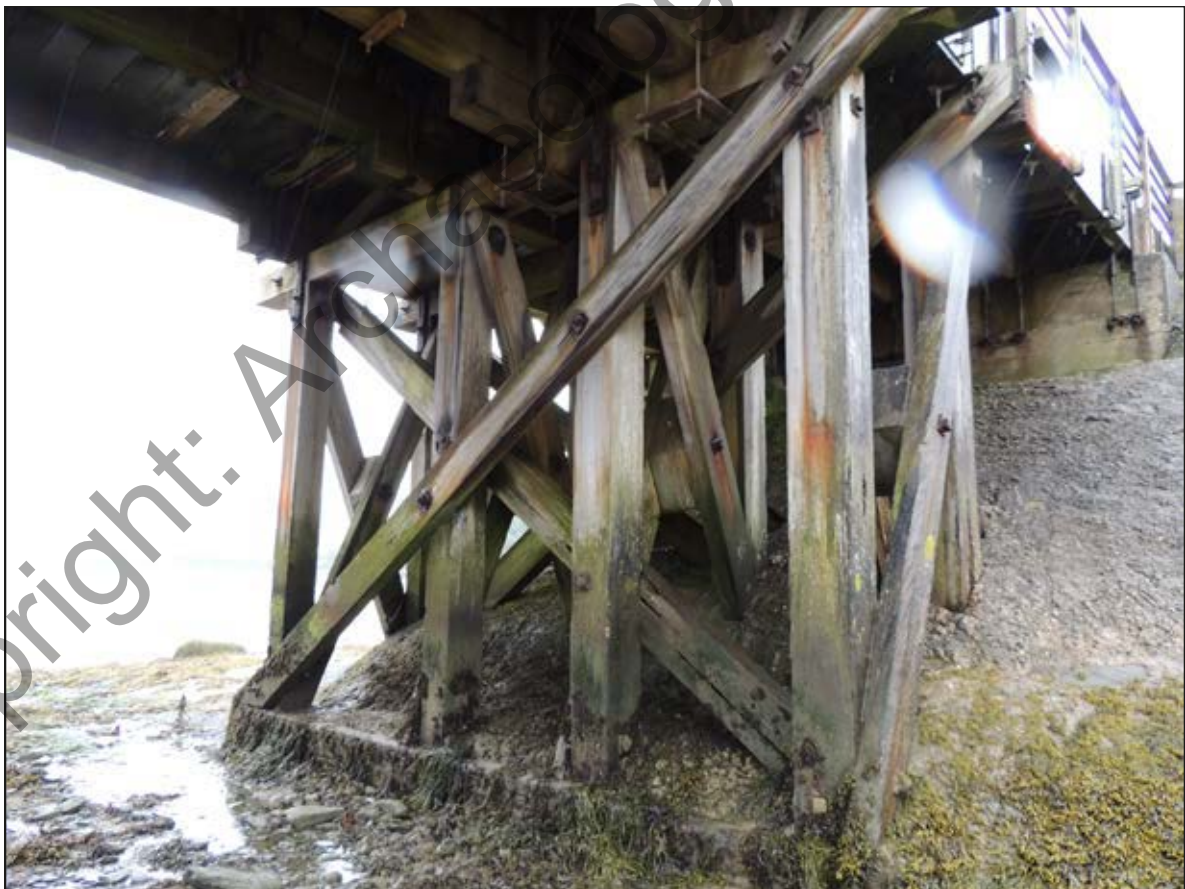
- 7.4.2. The first notable alterations to the underside of the viaduct were on trestle 2, where the metal straps that brace the cross-head beams to the central beam on the underside section of the railway track have been replaced. The replacement straps are made from galvanised steel with a square frame attached via nuts and bolts to hold the beams firmly together (See plates 43 – 44 and 48). The galvanised steel straps are quite noticeable compared to other metallic fittings observed on trestle 2, as all other fittings appeared older in date and had signs of corrosion. According to the engineer who was in attendance during the visit, noted that the galvanised steel straps were probably added during the 1990s, however engineering plans detailing the straps are not available. All other metallic fittings on trestle 2 correspond to engineering plans from the 1980s.

Plate 43. Shot of steel galvanised straps attached to support beams for transverse deck planks at trestle 2.

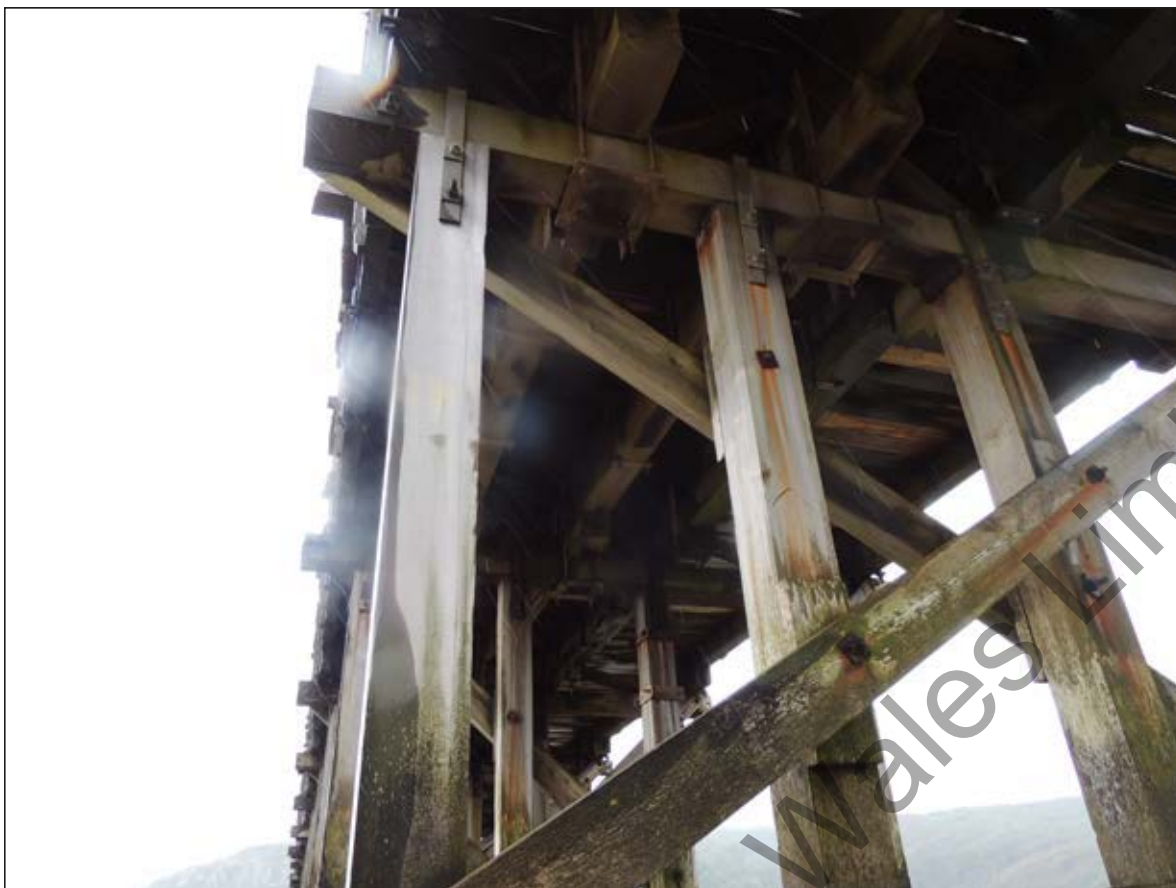
Plate 48. Shot of earlier steel straps attached to support beams for transverse deck planks, trestle 22.

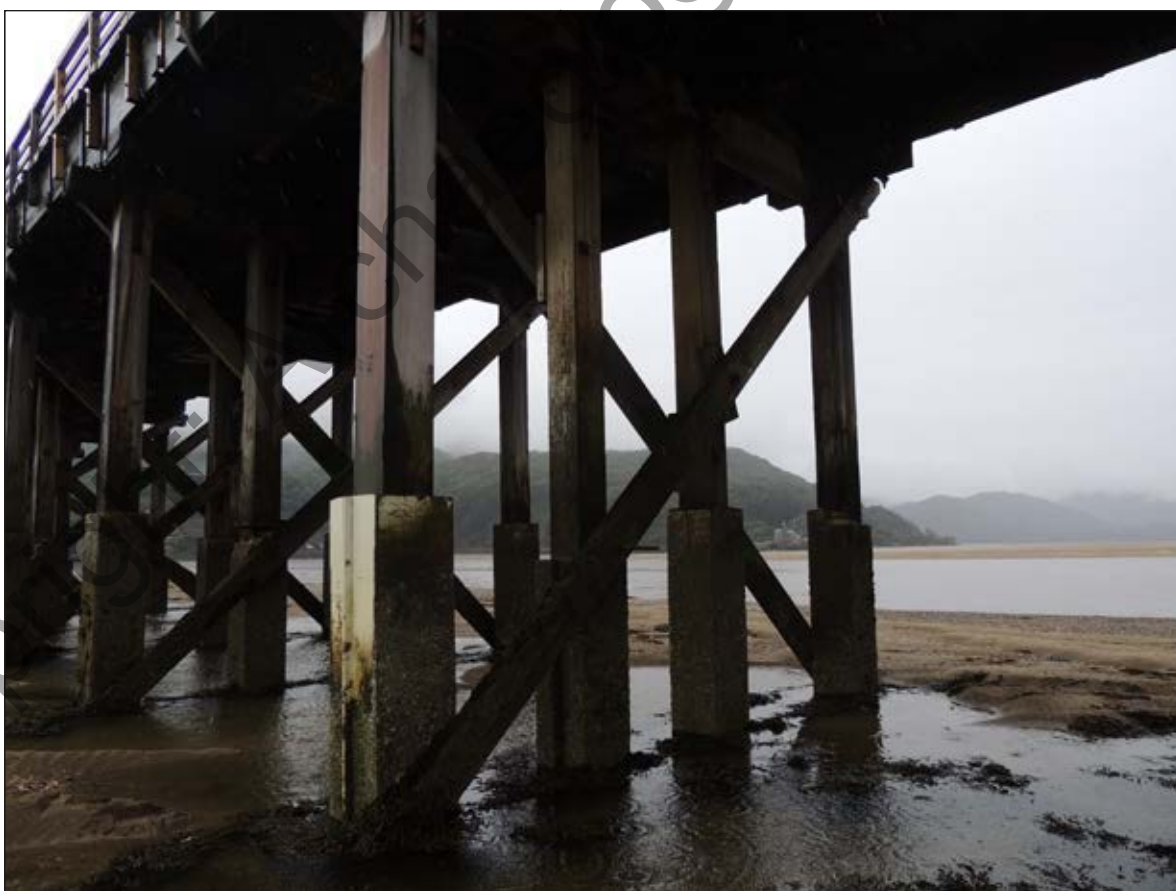
Plate 49. Shot of trestle 26 with replacement verticle piles and galvanised steel straps attached to support beams for transverse deck planks.

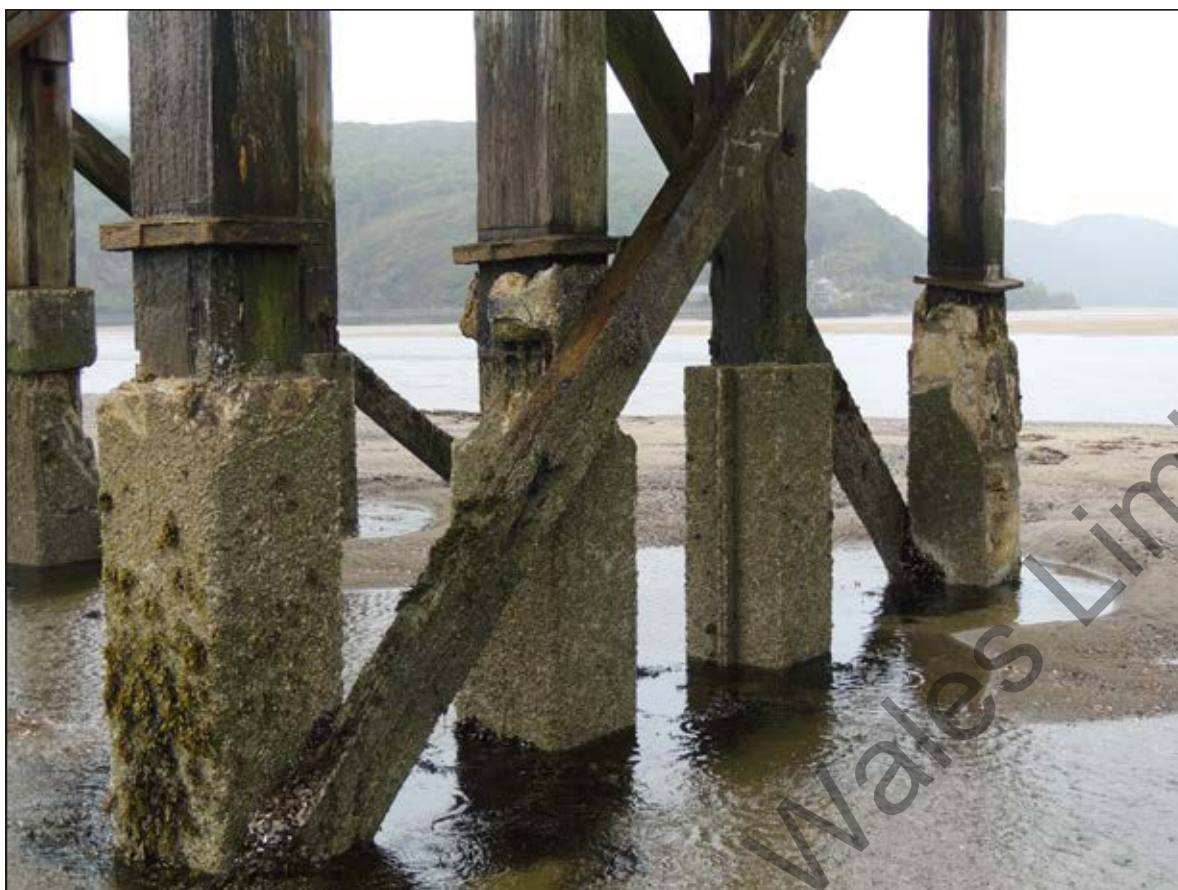
- 7.4.4. Reinforced concrete casings were observed on a majority of piles on the viaduct and were added as part of the alterations of the 1980s. The casings were added to protect the timber piles at the foot of the trestles from *Teredo Navalis*. However, water erosion has caused significant damage to the concrete casings and stripped them down to the rebar beneath (See plate 46). The worst affected by the water erosion are the piles on the seaward side of the viaduct. Observed on trestle 14 and 32 are what appears to be white plastic PVC coverings clipped together on two sides by metal fixings (See plates 47 and 50). Again, engineering plans could not be obtained to determine the date of when these were added, however the engineer who was present noted that they were probably from the 1990s.

Plate 50. N facing shot of trestle 32 verticle pile with a protective covering over concrete pile casing.

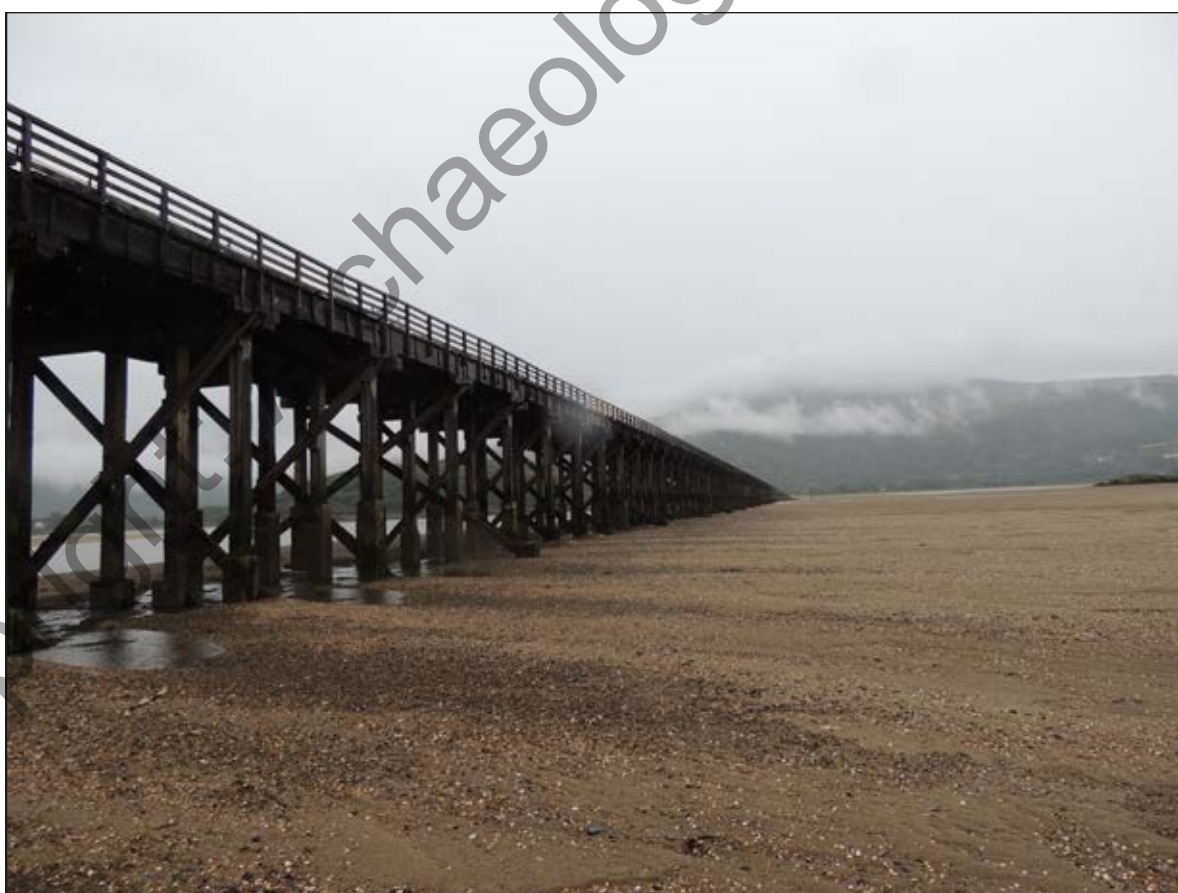
Plate 51. N facing shot of trestle 39 showing erosion of verticle piles and concrete pile casing.

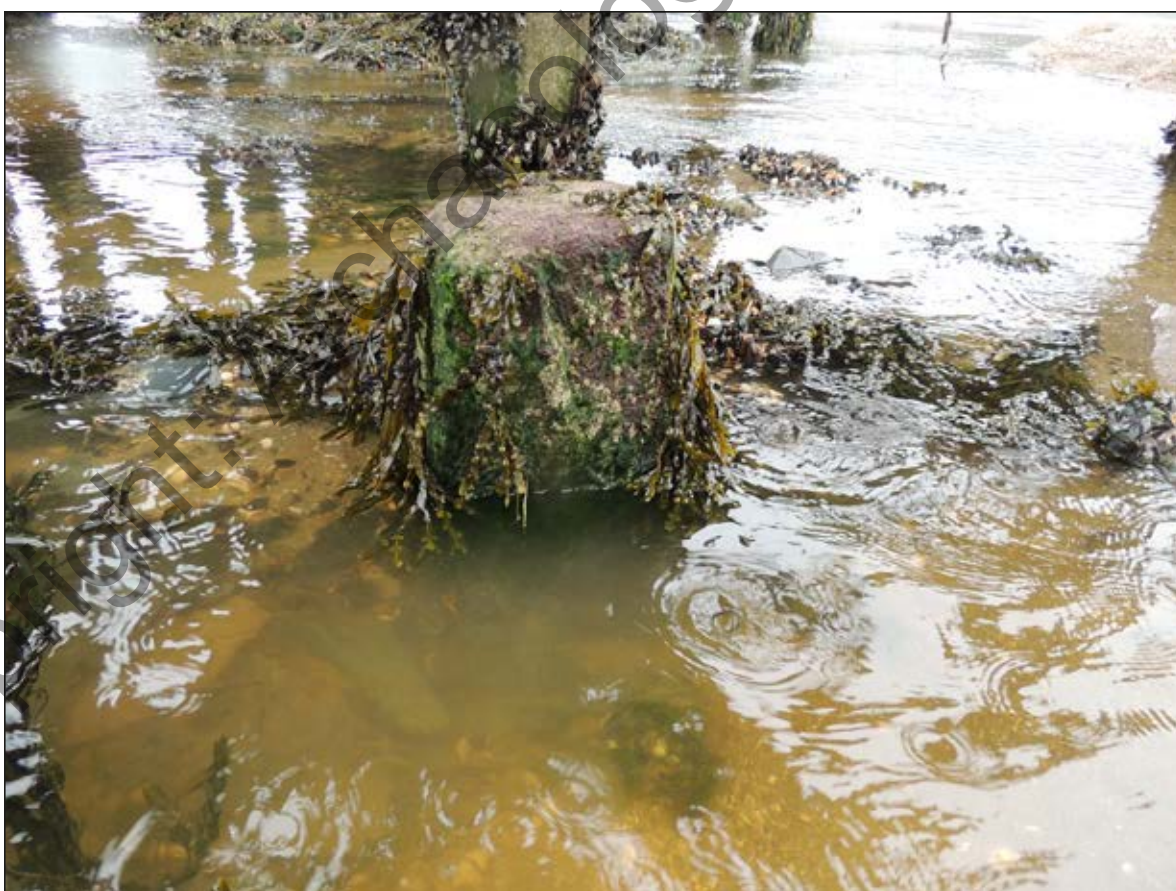
not be ascertained if they were of timber or concrete, as access to them was impeded by fairly deep water in these areas (See plates 53, 54, 56 and 57). The stumps at trestle 55 were in the best state of preservation and were approximately 1m in front of the dividing trestle of 55 and 56 and aligned perfectly with the functioning piles behind. The stumps of the suspected older piles under trestle 55, 86, 87 and 88 are at a section of the viaduct where there is no reno mattress on the estuary bed and appears the reno mattress ceases at trestle 54 (See plate 55). The reno mattress at trestle 54 is approximately 0.50m thick and has a heavy covering of seaweed. It is unclear if the reno mattress in the sections of the viaduct where the pile stumps are located has been removed, or if there was ever any laid on the estuary bed at these sections of the viaduct. Notwithstanding, the 1980s renovation plans included the placement of reno mattresses in pier 55, and indicated the existence of older mattresses in 86, 87 and 88. The absence of these structural elements may suggest alterations postdating the 1980s.

Plate 53. NNE facing shot of remains of verticle pile stumps under trestle 55.

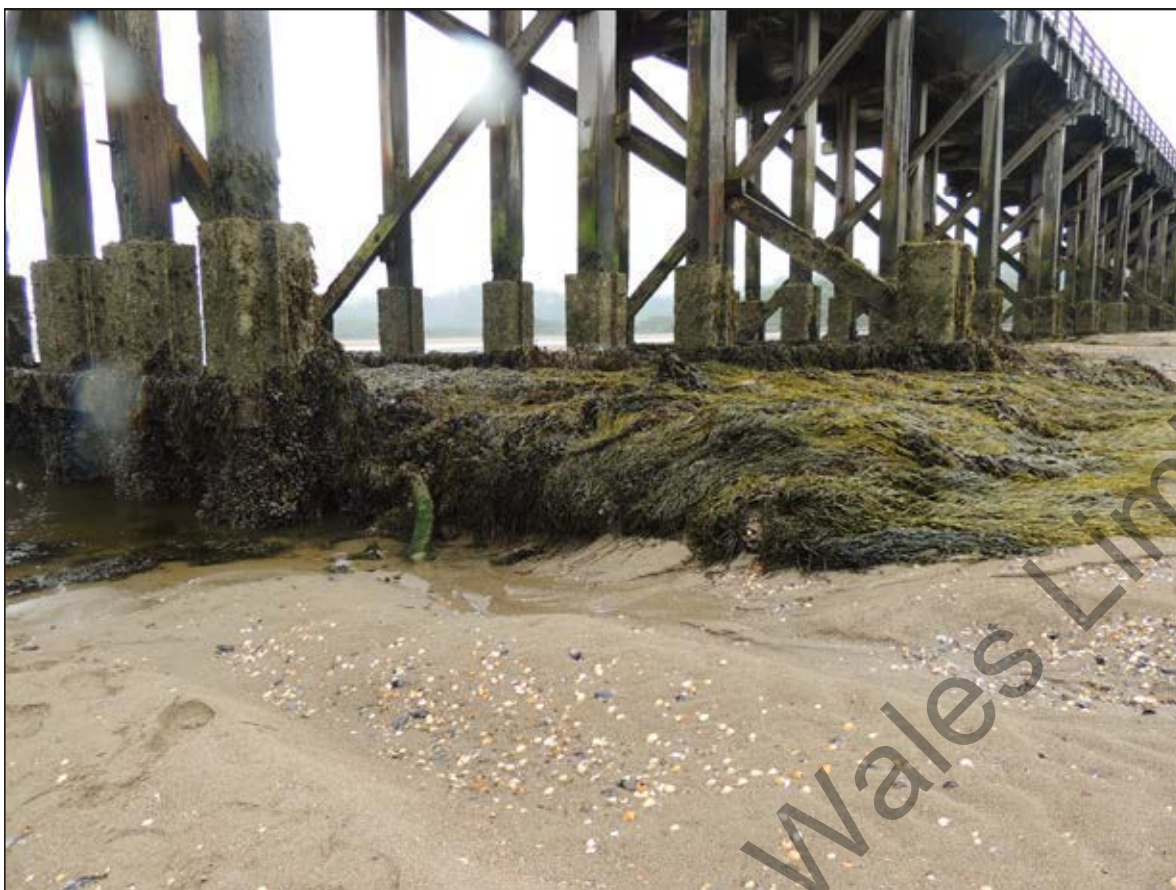
Plate 54. Close up NW facing shot showing remains of central verticle pile stump of trestle 55.

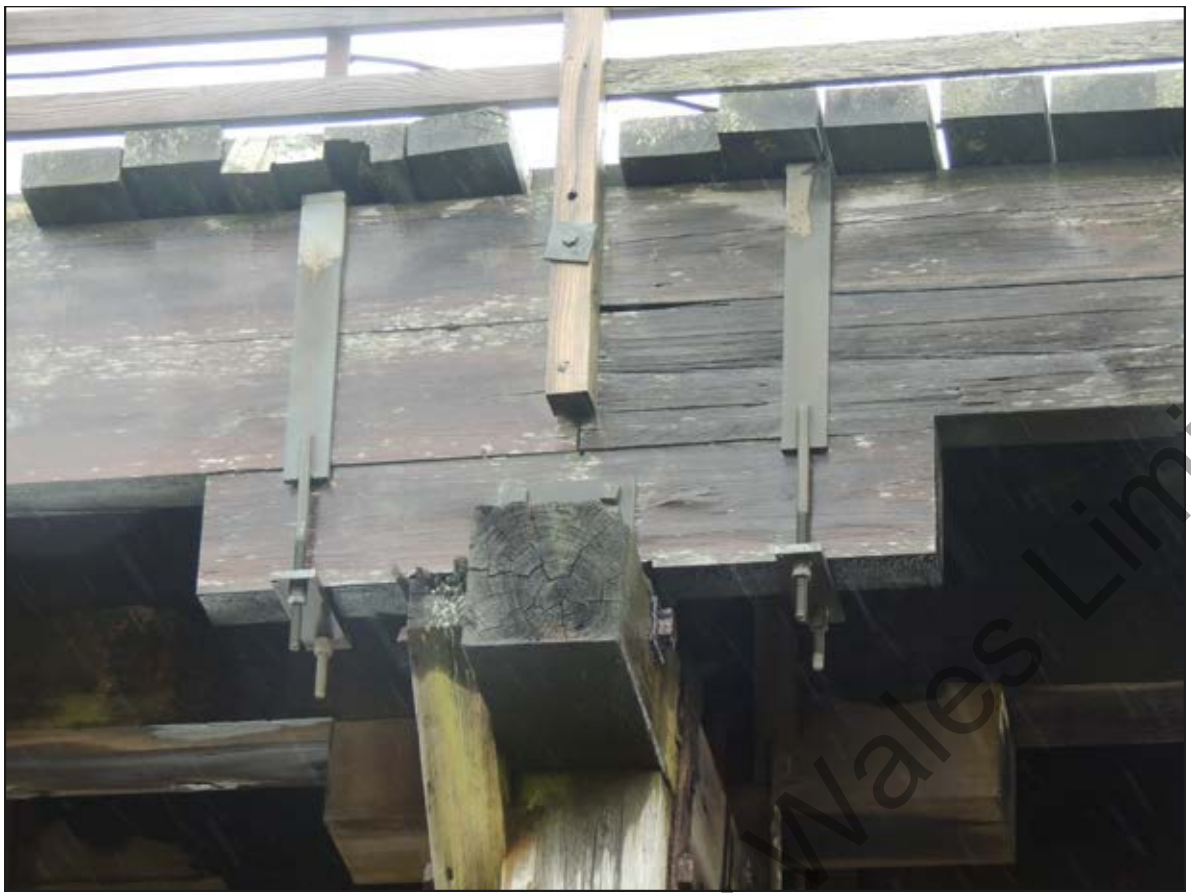
Plate 58. Shot of older steel straps attached to longitudinal outer beam above trestle 86.
