**PONTCYSYLLTE AQUEDUCT  
REFURBISHMENT**

**APPLICATION FOR SCHEDULED  
MONUMENT CONSENT:  
SUPPORTING INFORMATION**

Appendix 2  
General items relevant to the  
refurbishment of the Pontcysyllte  
Aqueduct

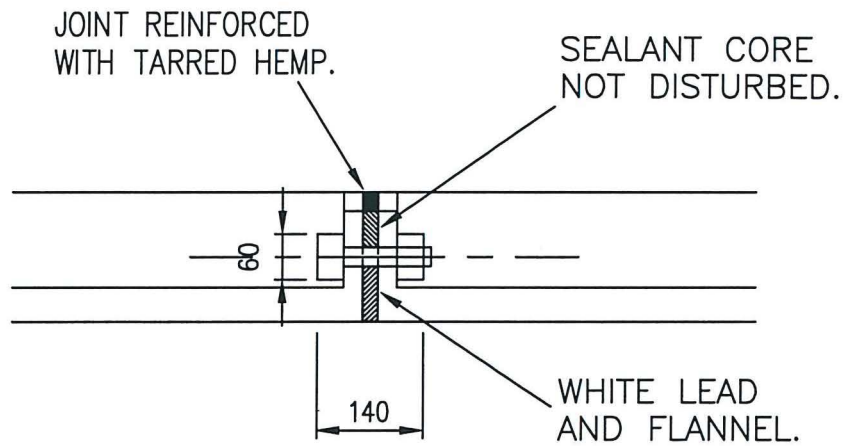
PROPOSED JOINT DETAIL

TYPICAL BOLTED CONNECTION TO  
CAST IRON SEGMENTS

- 2.12 The critical dimensions of the removed bolts and nuts will be measured. If the bolted connection is in a better condition than the visual inspection suggested the bolted connection will be re-installed. The original tar/hemp washer will be replaced, if in a satisfactory condition. If necessary the joint will be reinforced with more tar/hemp sealant. A typical detail is included in Appendix B.

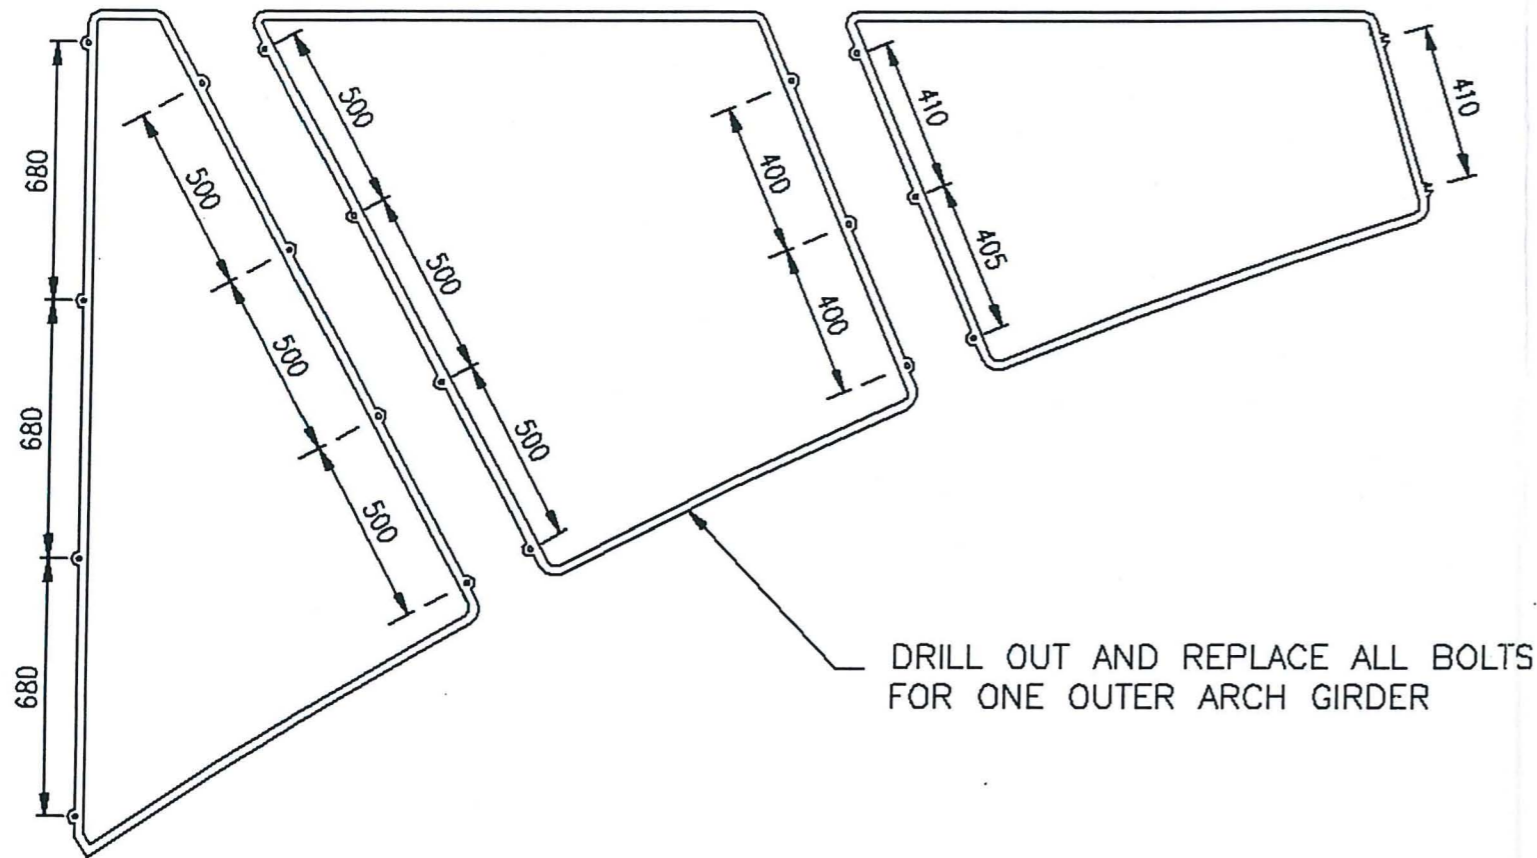
ELEVATION ON FASCIA PANELS  
TO OUTER ARCH GIRDER.

- 2.14 The bolt inspection and grading approach will extend to cover the fascia panel fixings.
- 2.15 The bolted connections of the fascia panels are known to be in very poor condition and in need of replacement.
- 2.16 Following the inspection survey, the relevant fascia panel bolted connections will be carefully removed and inspected. As with the trough bolts the fascia panel bolts will be re-installed if they are in a satisfactory condition. Otherwise replacement replica bolts will be used as replacements.
