# THE YORKSHIRE IMPERIAL METALS SITE, SWANSEA

## A SITE APPRAISAL

## ARCHAEOLOGICAL, CONDITION, AND HEALTH AND SAFETY APPRAISALS BUDGET COSTS

NOVEMBER 2002  
REPORT No. 2002/100

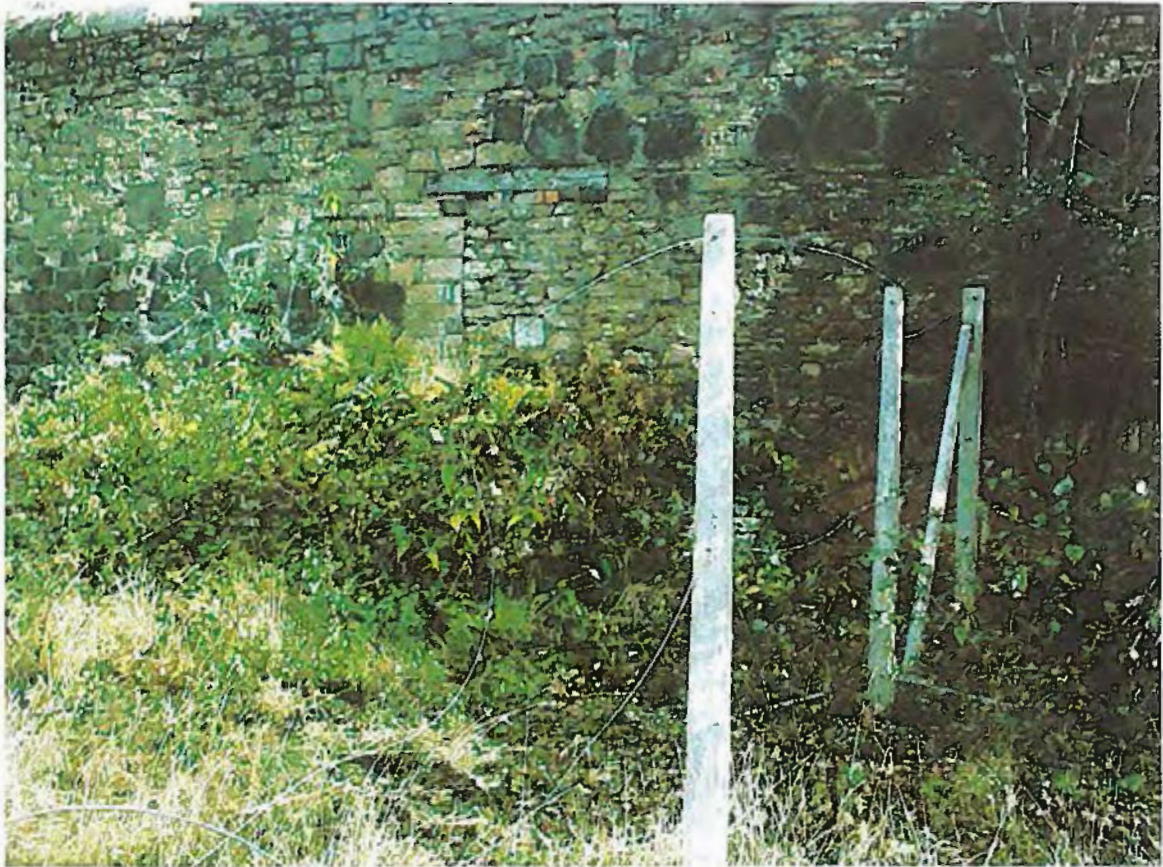
*Photo 4b - Building 3.0 (canal wall) from the west showing blocked archway and doorway to canal basin YIM 12, and towpath YIM 33*

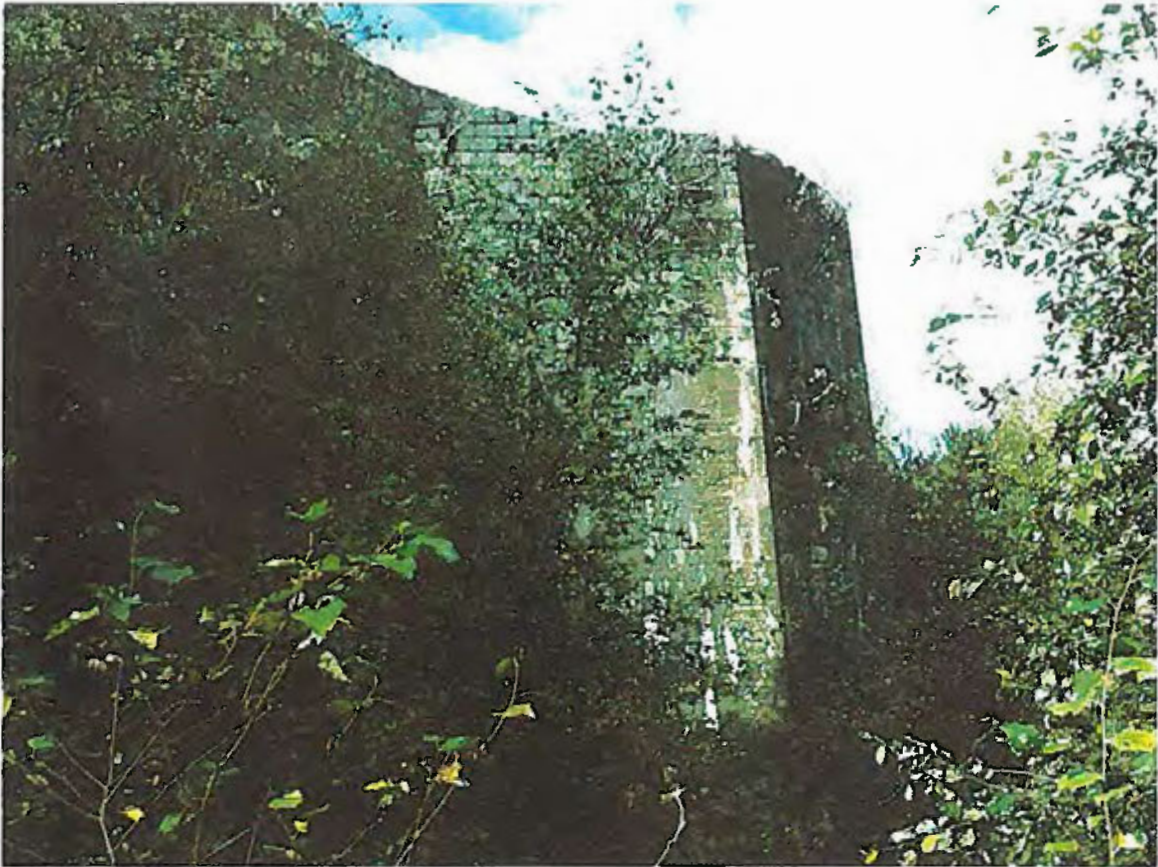
4.0	Hafod Copper Slag Abutment: the abutment formed the western support of the tram road from the former Hafod Copperworks over the Swansea Canal. Probably the most impressive surviving example of copper slag block construction in Wales.	Grade II listed, mid C19 Condition: fair

Photo 5 - Building 4.0 (Hafod copper slag abutment) from the SE

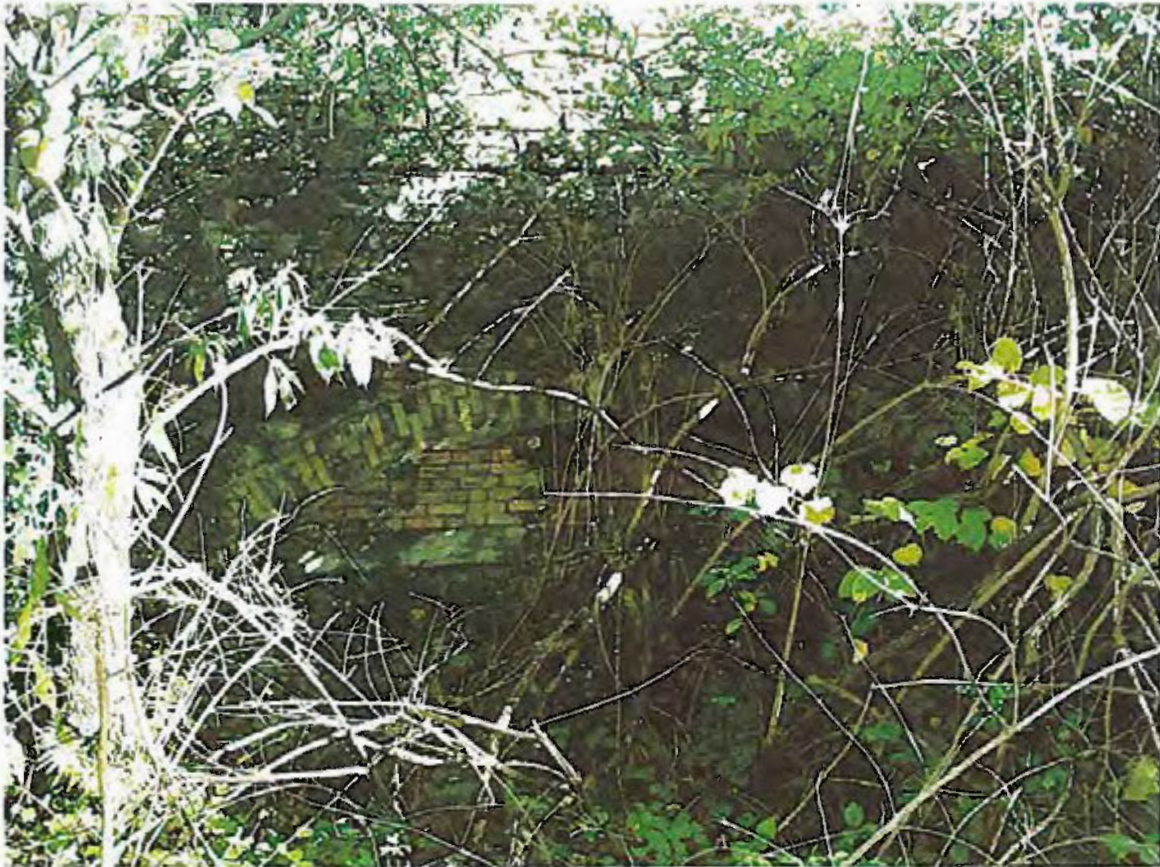
*Photo 7 - Building 6.0 (Hafod canal boundary wall) from the west, showing blocked archway to canal basin YIM 20*

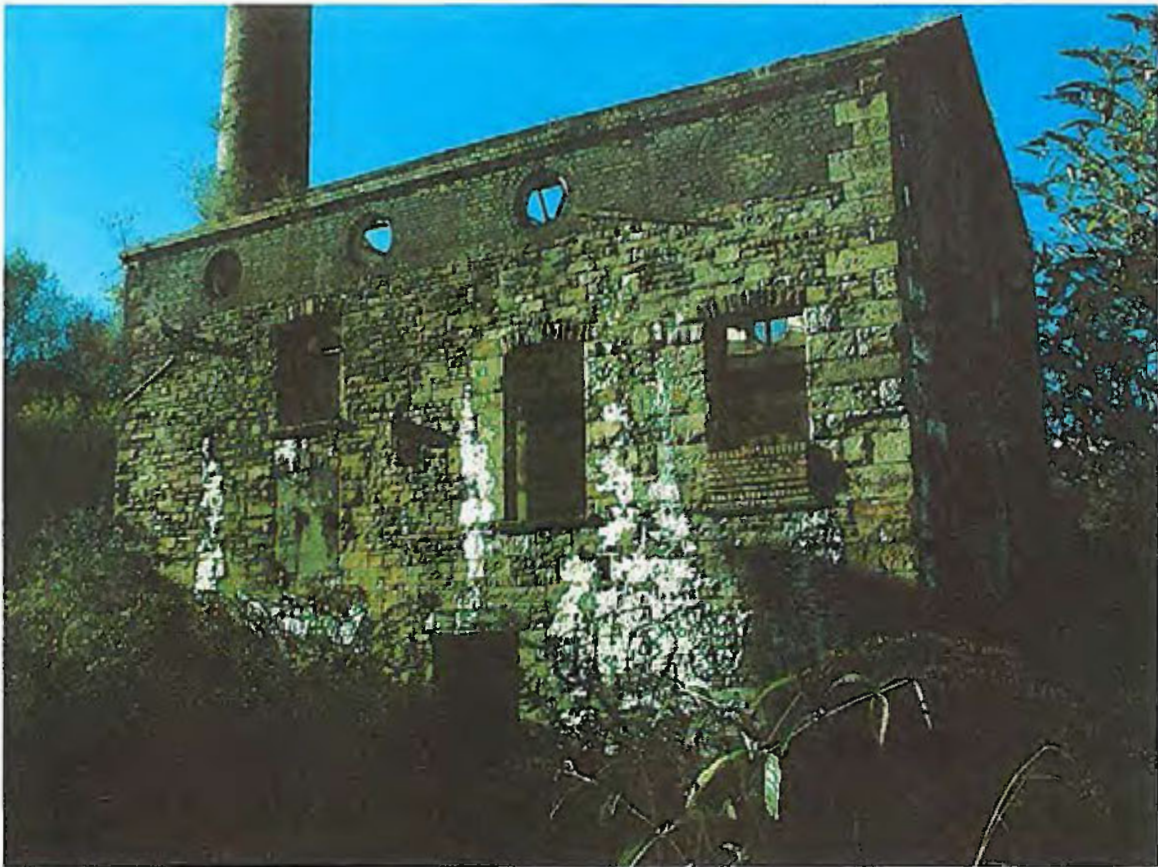
8.0	Vivian Engine House: Housed a steam engine to power copper rolling mills at the former Hafod Copperworks.	Grade II listed, 1860-62 Condition: derelict

Photo 9 - Building 8.0 (Hafod Vivian engine house) from the south

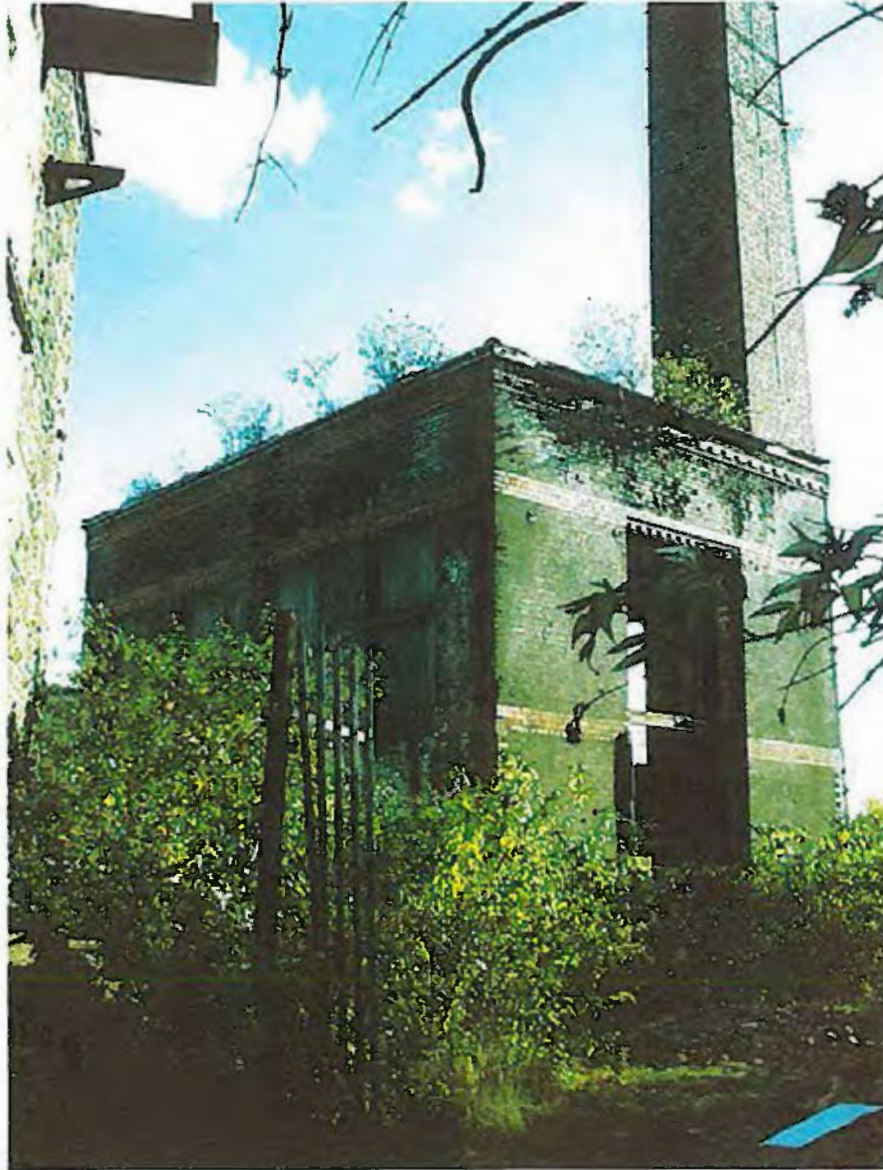
9.0	Musgrave Engine House: Houses an extant uniflow type steam engine at the former Hafod Copperworks.	Grade II* listed and SAM, Built 1910 Condition: derelict

*Photo 10 - Building 9.0 (Hafod Musgrave engine house) from the north*

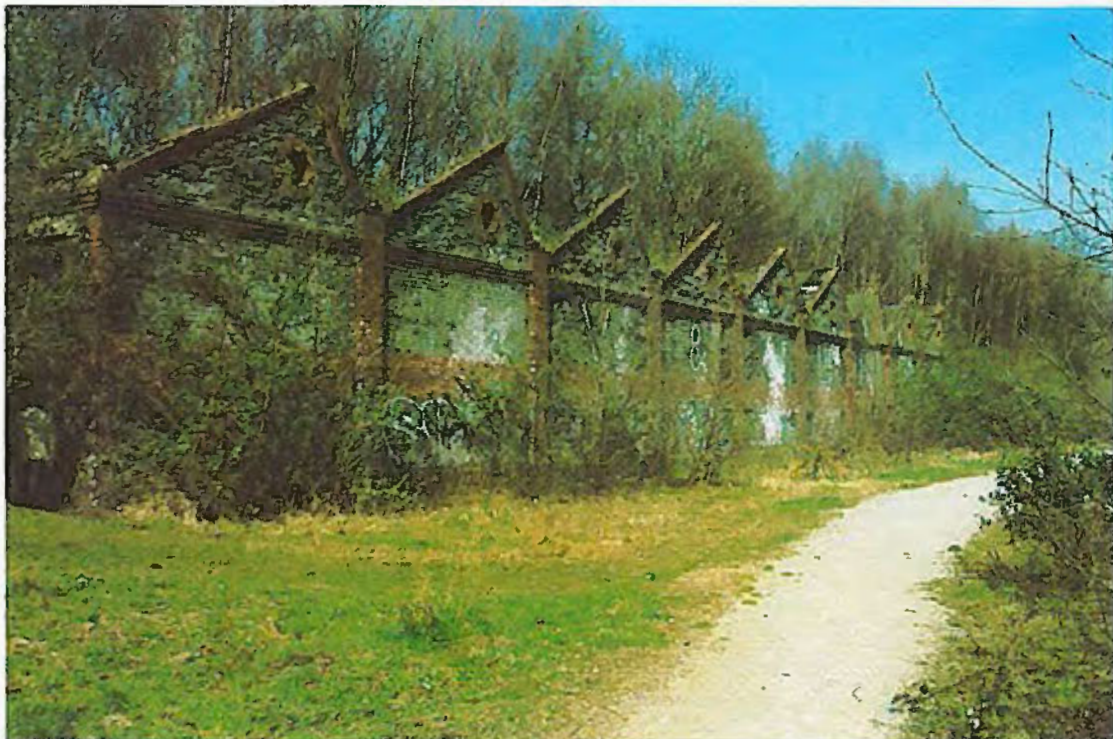
*Photo 11a - Building 11.0 (Vivian Locomotive Shed) from the southeast*

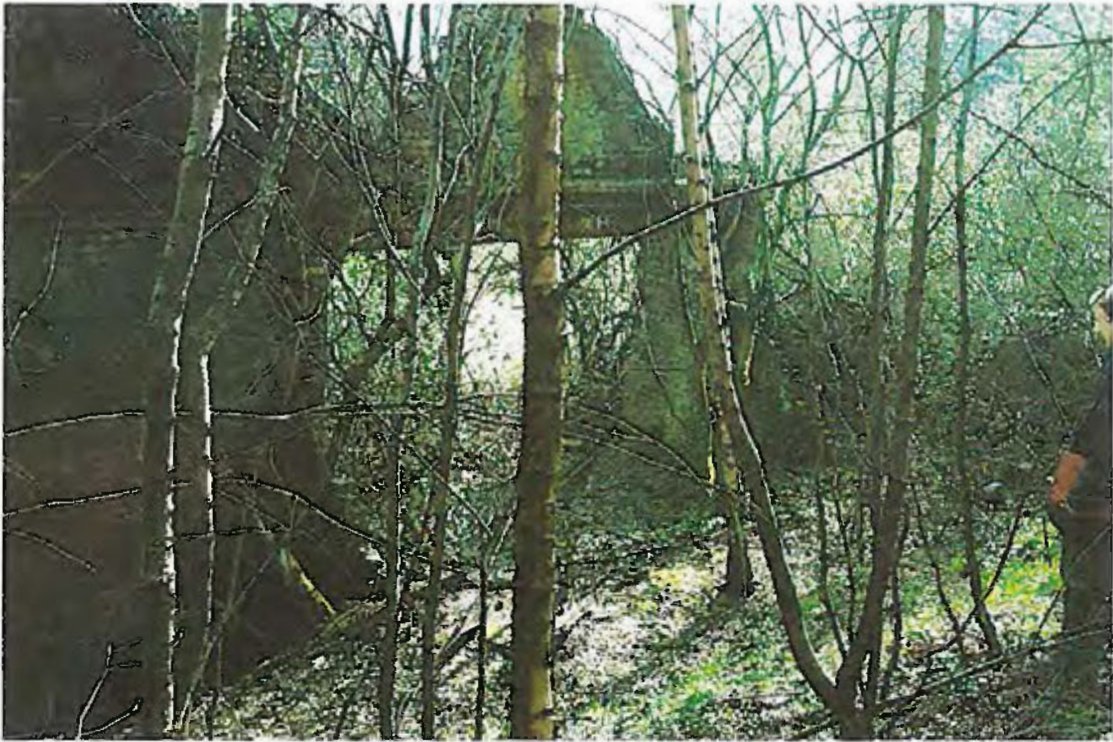
*Photo 11b — The south end of Building 11.0 (Vivian Locomotive Shed) from the northwest, showing annexe*

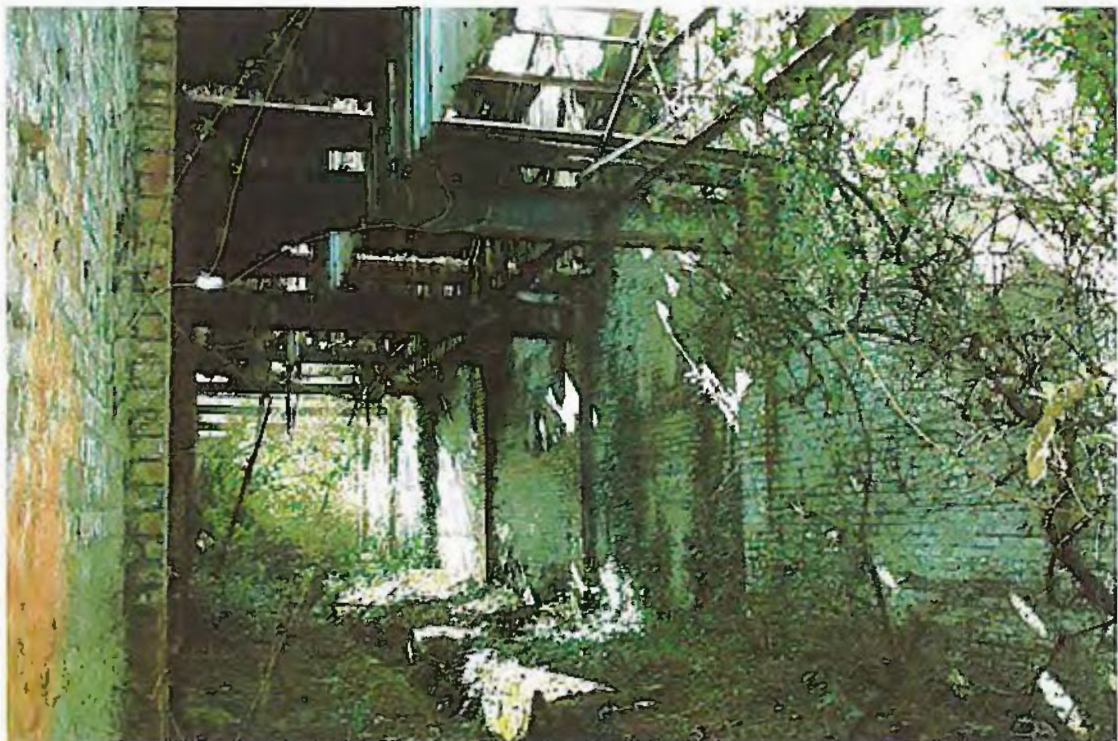
*Photo 11c — The interior of Building 11.0 (Vivian Locomotive Shed) from the northeast*

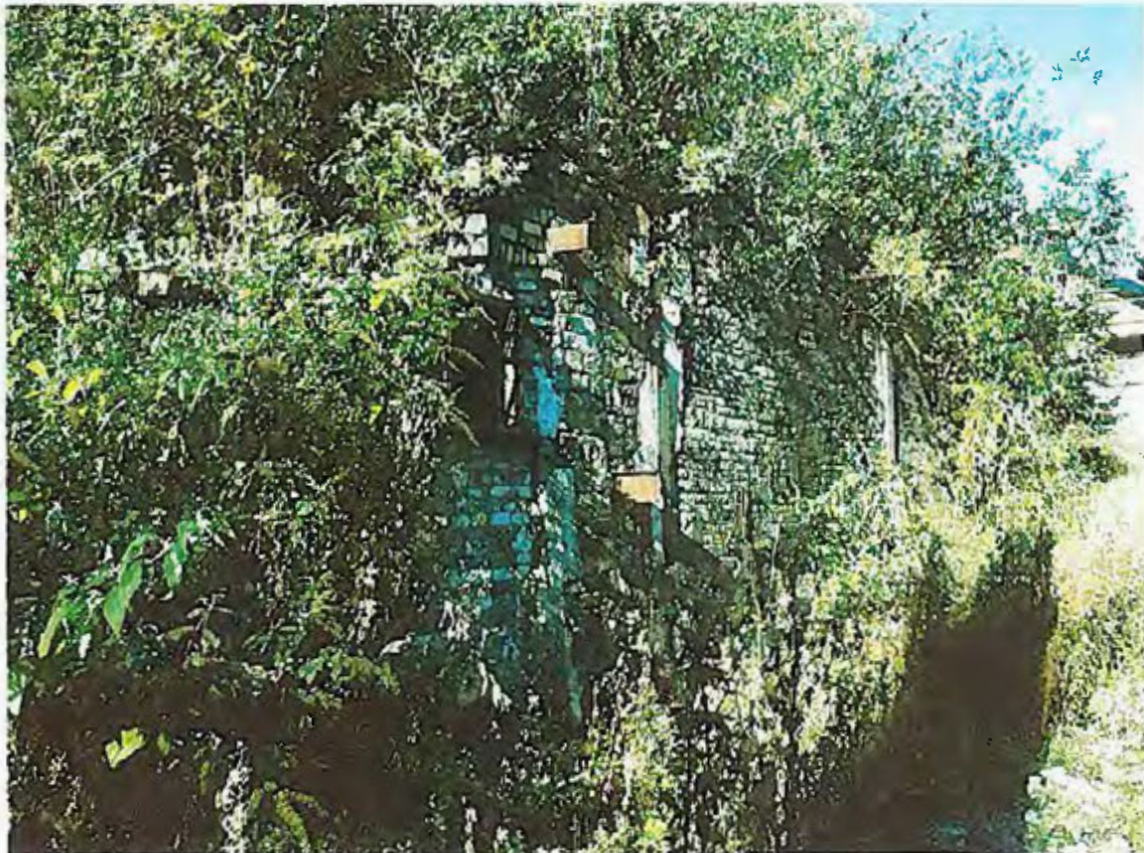
*Photo 11c - Area 1E, west wall of YIM 10 (silverworks/cast house), showing flues, from the SE*

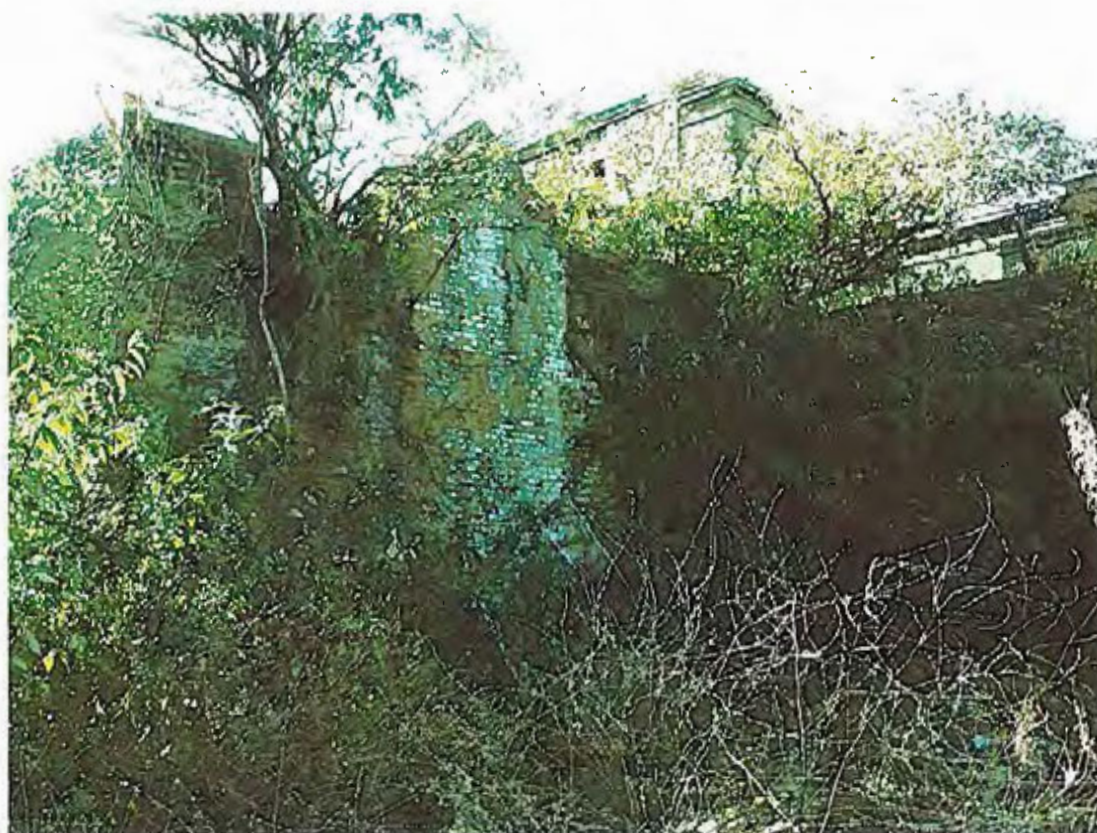
*Photo 11d - Area 1E, south wall of YIM 28 and revetment wall YIM 8 from the NE*

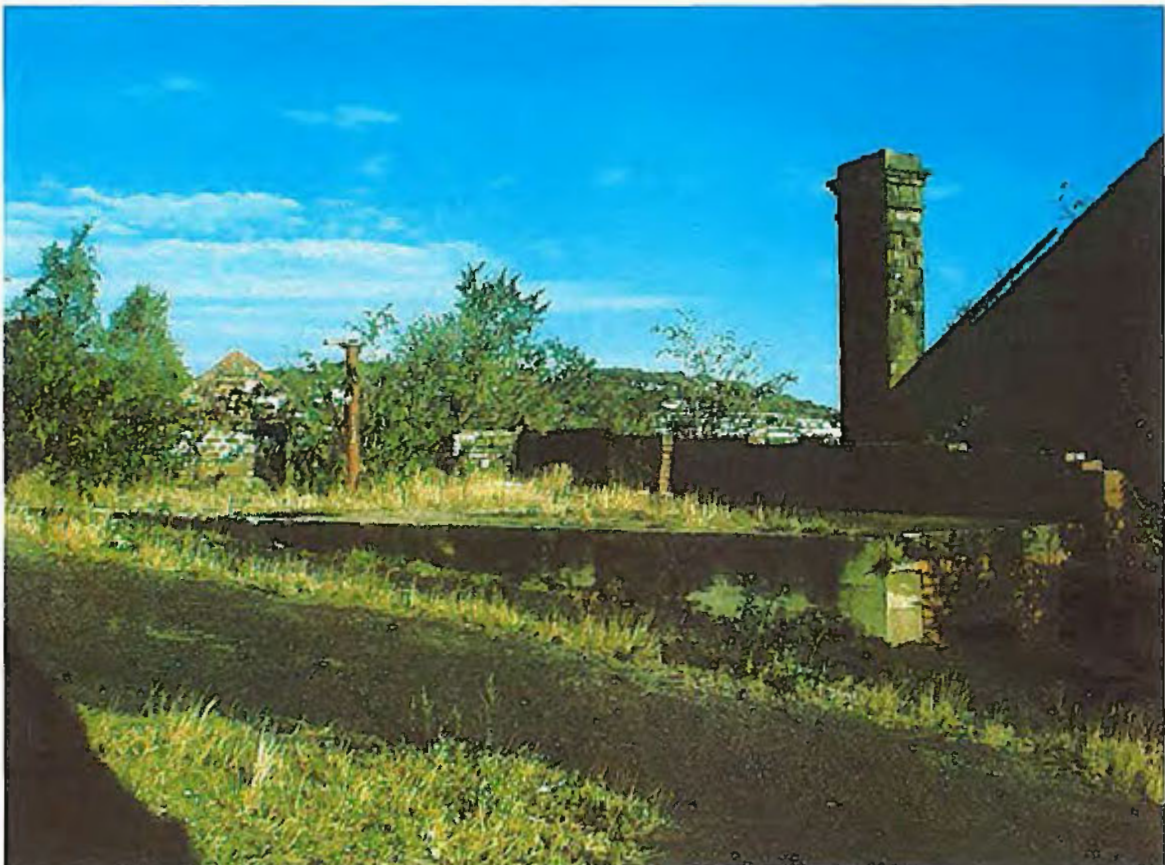
Photo 12 - Area 2, later 20th century tank YIM 37 from the south

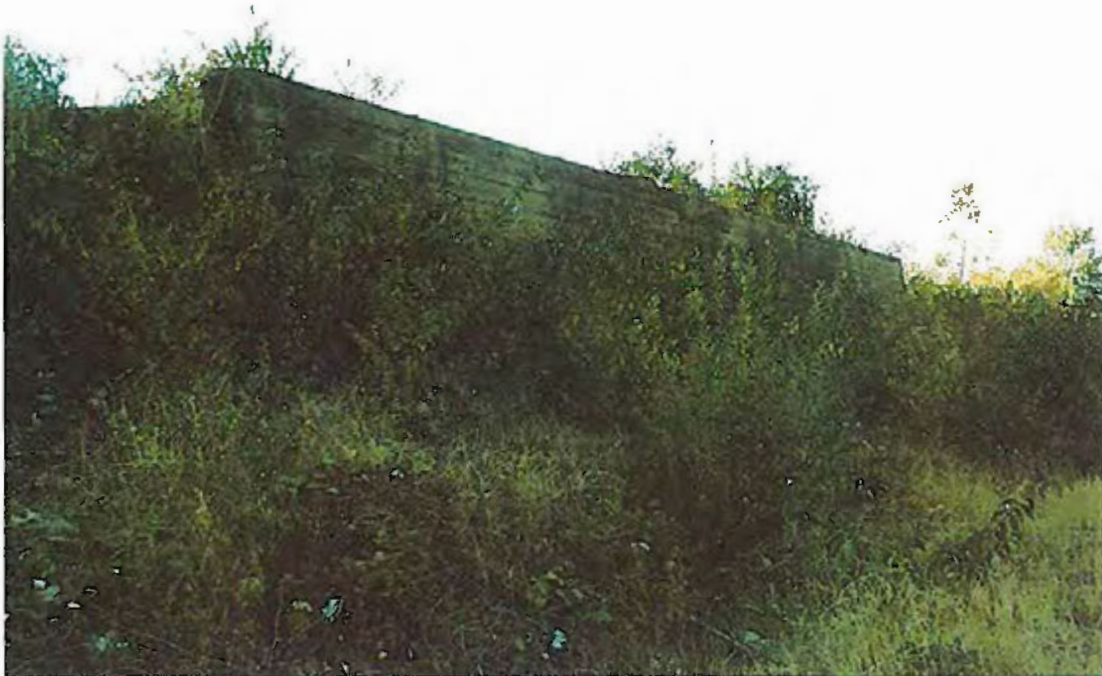
*Photo 14c - Area 4, the remains of revetment wall YIM 42 from the south*

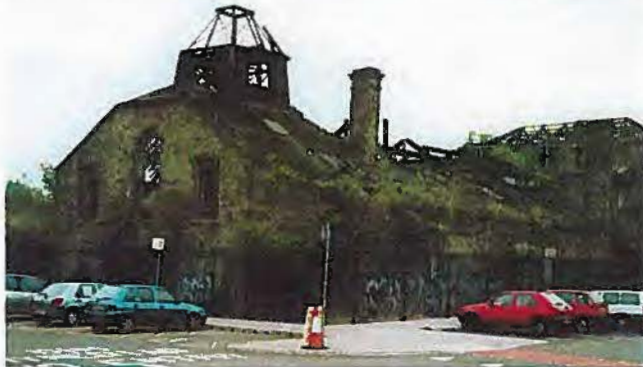
**Right upper:** a modern steel frame has been inserted at first floor level to support the clock tower structure.

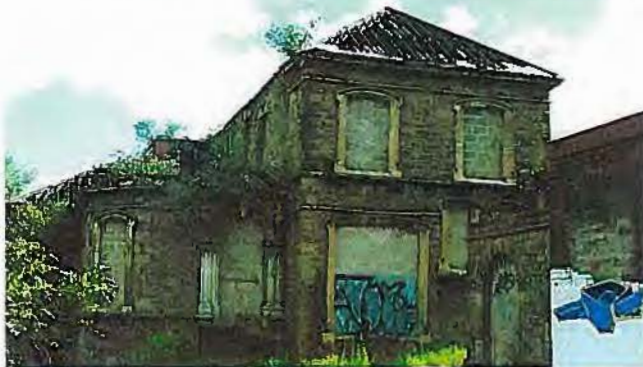
**Right upper:**  
east elevation, the centre portion has subsided towards its north corner causing cracking and distortion of stonework, most pronounced in the sills and lintols of window openings.

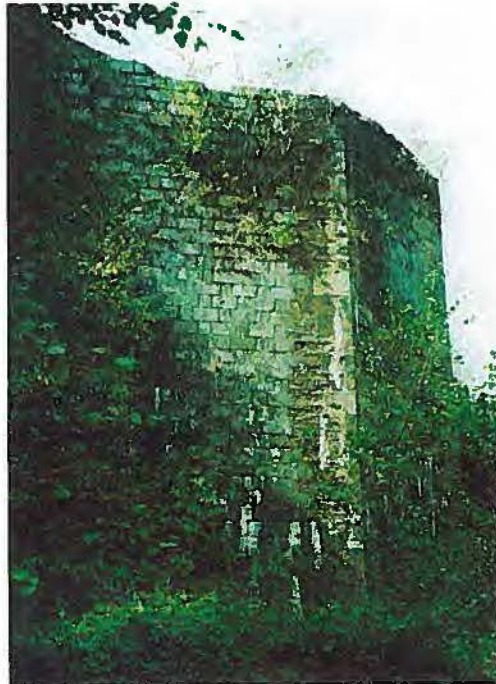
**4.0 Copper Slag Abutment to former waste tip tramroad**

**Above:** view from south looking up the bed of the former Swansea Canal. The tall, substantial projecting abutment, trapezoidal in plan, is flanked either side by battered walls. Constructed in large copper slag blocks with dressed stone quoins. The abutment formed the western support of the tramroad over the canal.

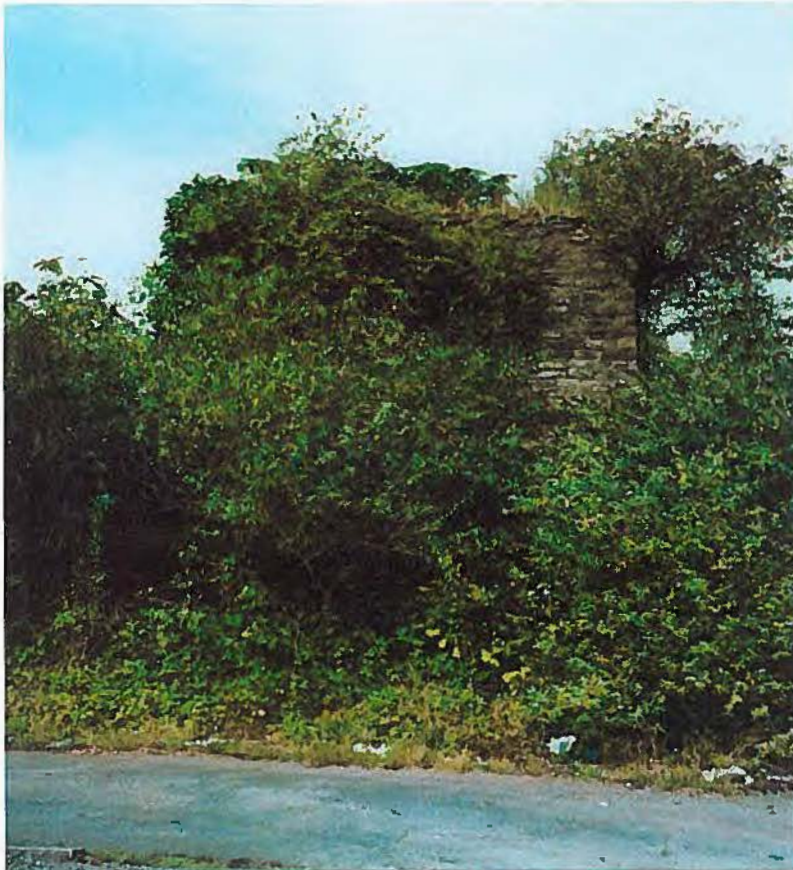
**Above:**  
South face of the lime kiln viewed from the adjoining car park. The kiln is constructed of random rubble masonry and is heavily overgrown, in particular on the north face.

5.0 Lime Kiln	Risk of falling masonry. P26	Cap and consolidate tops of walls (As condition appraisal)
6.0 Former Copperworks boundary wall.	Risk of falling masonry.	Reconstruct unstable sections of wall, repair locally and rake out and repoint generally. (As condition appraisal)

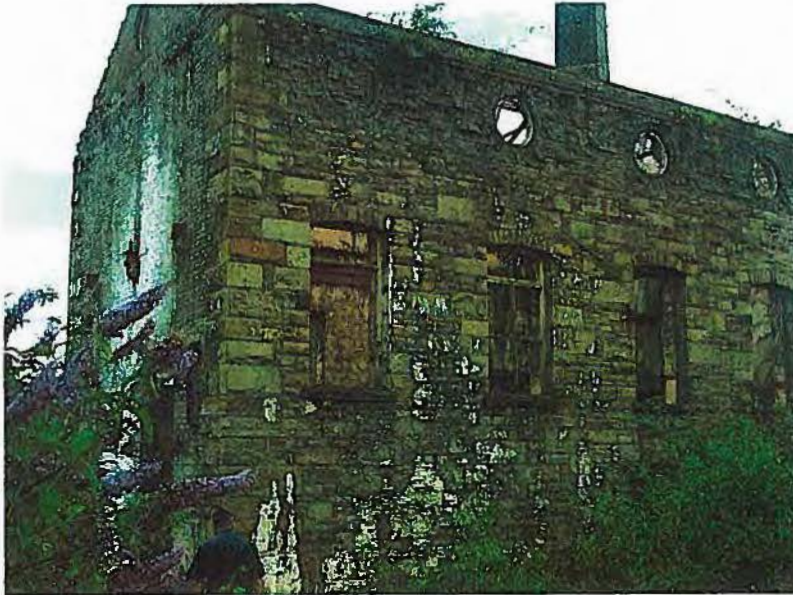
**Left upper:**  
north elevation of the Vivian engine house, the upper portion is built in copper slag bricks.

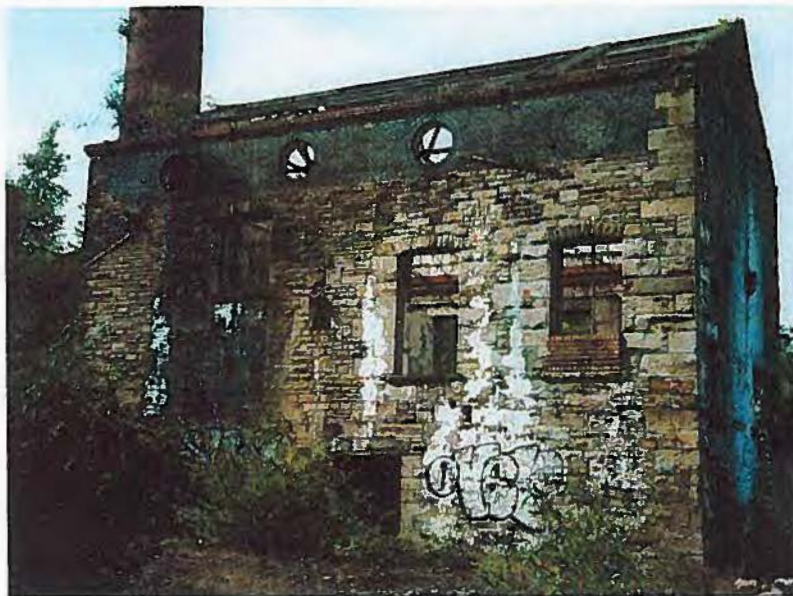
**Left lower:**  
south elevation of the engine house.

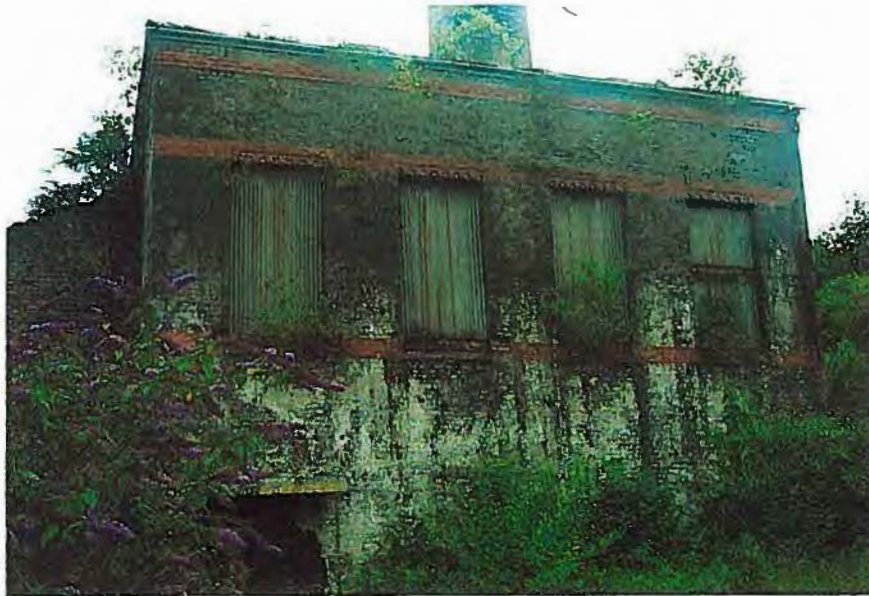
**Left upper:**  
north elevation, the large rectangular windows to the upper ground floor of the engine house have been boarded over.

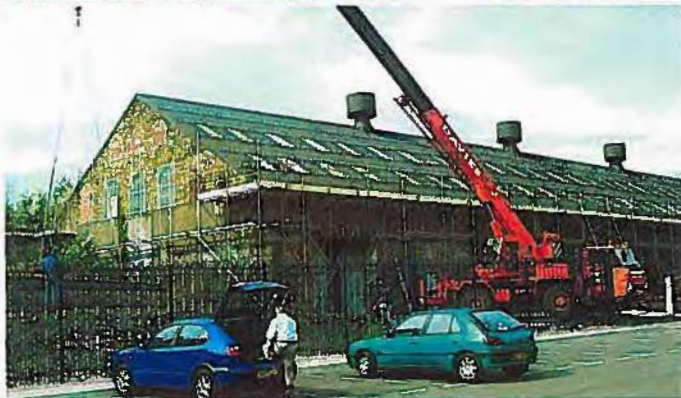
**Left centre:**  
view of east elevation with over-cladding  
of the roof in progress.

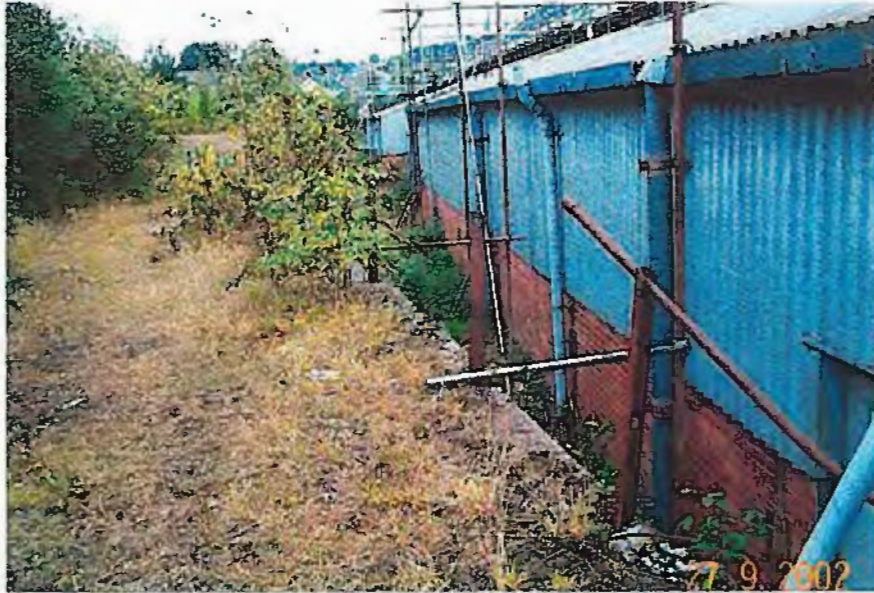
**P1:** Unprotected drop at structure 10.

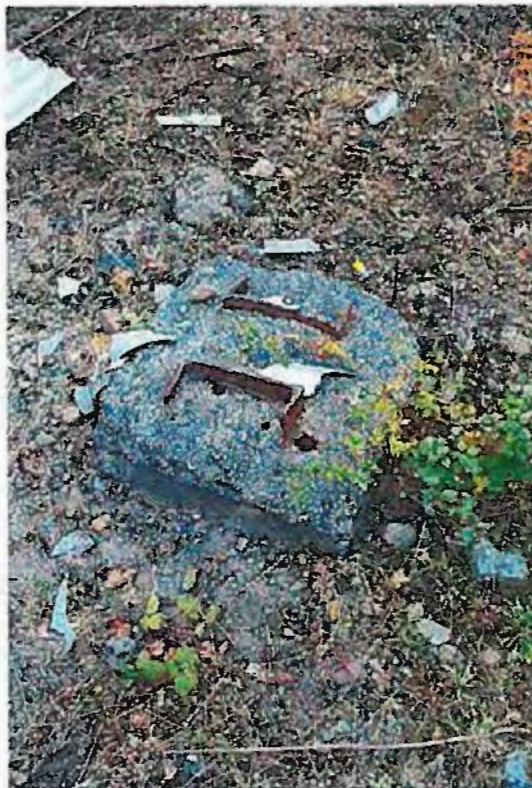
**P2:** Protruding column at structure 10.

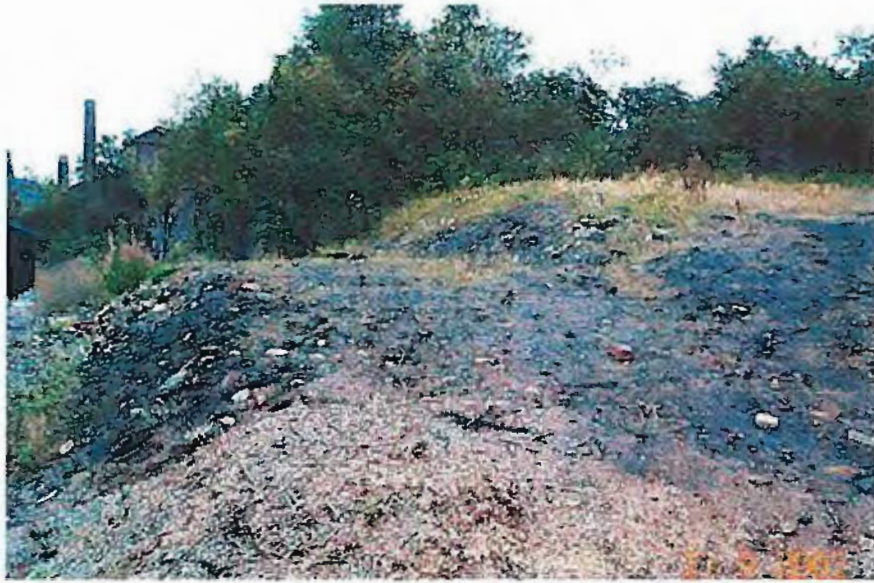
**P3: Uneven ground adjacent structure 10.**

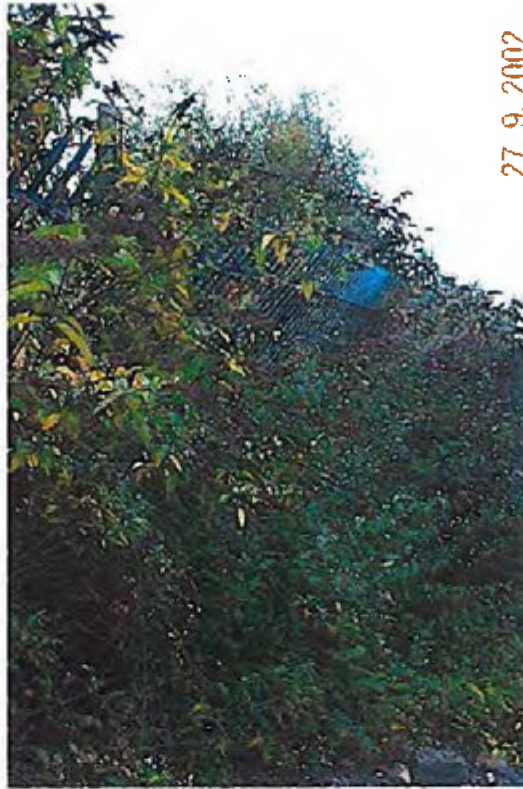
**P5:** Fence adjacent to structure 10 (north end).

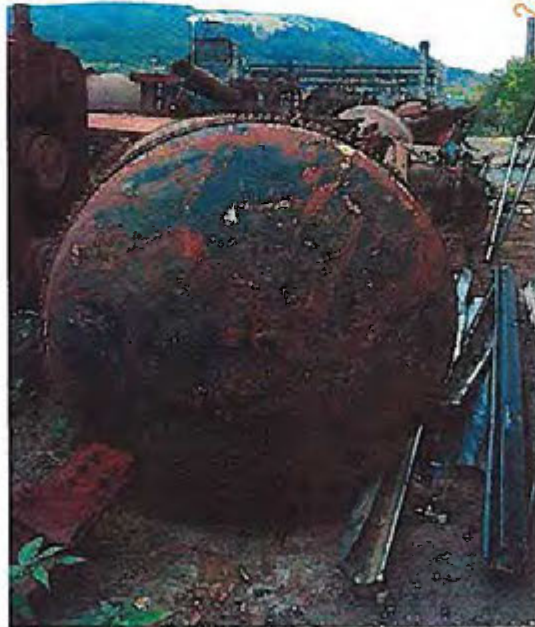
**P6:** Stored material adjacent structure 10.

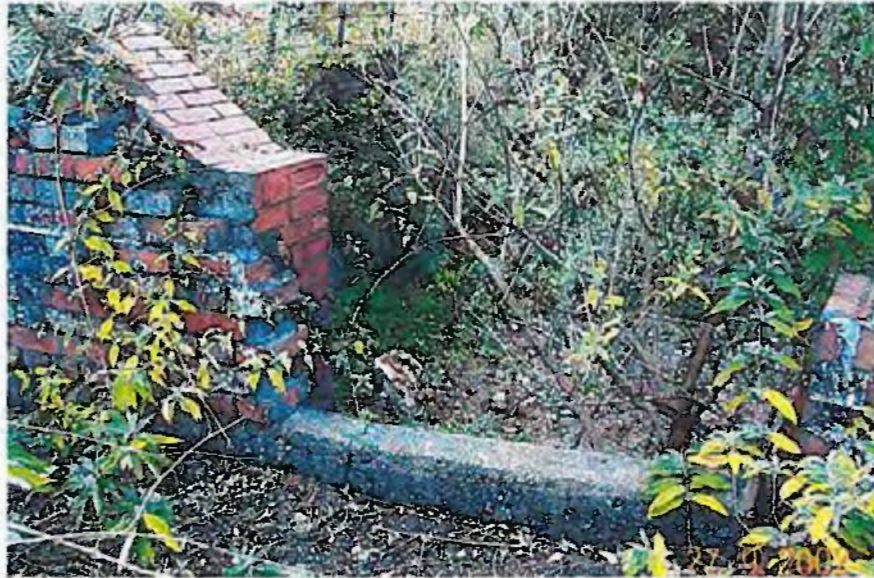
**P7: Unprotected drop to west of structure 1.**

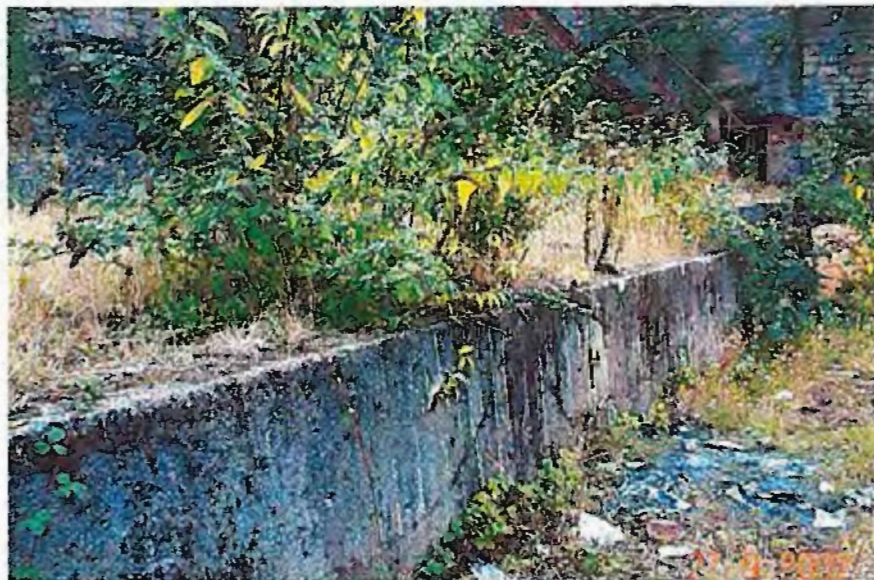
**P8: Unprotected drop to south of structure 2.**

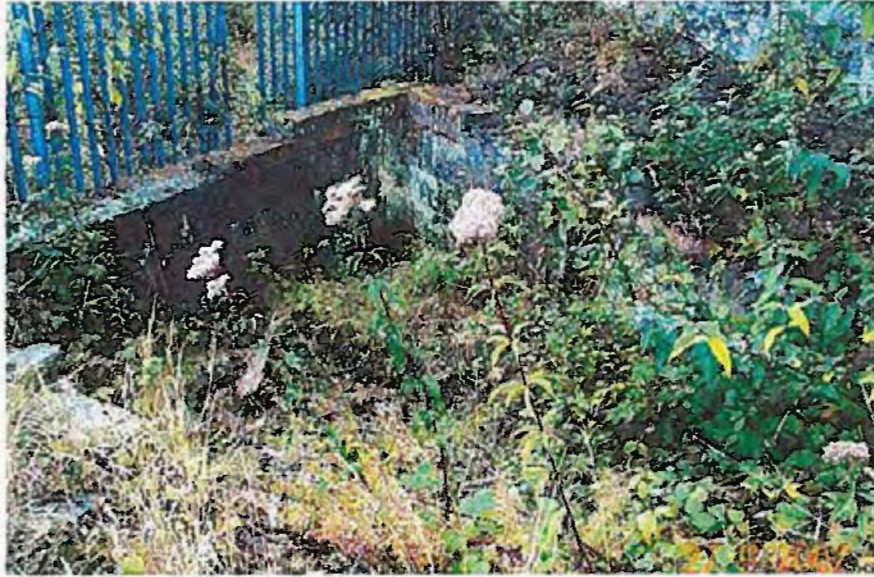
**P9:** Unprotected drop (pit) to south of structure 2.

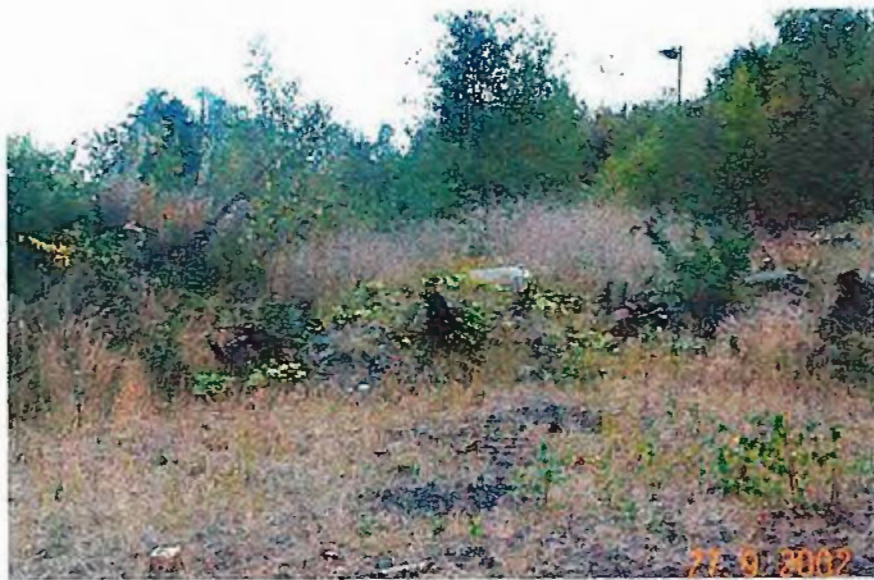
**P10:** Area 3, view south.

SITE AREAS APPRAISAL Refer to drawing No. HS 1, HS2 and HS3 for site areas, and photographs as referenced under 'P' numbers.	Perceived Risk	Mitigating Action
<b>Area 3</b>	Unprotected drop P19 (from top of abutment)  Trip Hazards: P10 <ul style="list-style-type: none"> <li>• Uneven ground</li> <li>• Tree stumps</li> </ul> Uncovered inspection chamber to pipe culvert P11  Felled trees P12	Provide secure barrier  Provide secure fence around perimeter of site.  Provide permanent cover.  Clear site.
<b>Area 4</b>	Trip Hazards: <ul style="list-style-type: none"> <li>• Uneven ground</li> <li>• Demolition rubble</li> <li>• Trees/undergrowth.</li> </ul>	Provide secure fence around perimeter of site. Clear site of rubble.
<b>Area 5</b>	Unprotected drops from retaining walls. P13, P14  Unprotected drops to River Tawe. P15  Access to air raid shelter built into retaining wall P16  Trip Hazards: P17, P18 <ul style="list-style-type: none"> <li>• Uneven ground</li> <li>• Trees/undergrowth</li> </ul>	Provide secure barriers.  Provide secure fence around perimeter of site.  Seal off entrance.  Provide secure fence around perimeter of site.

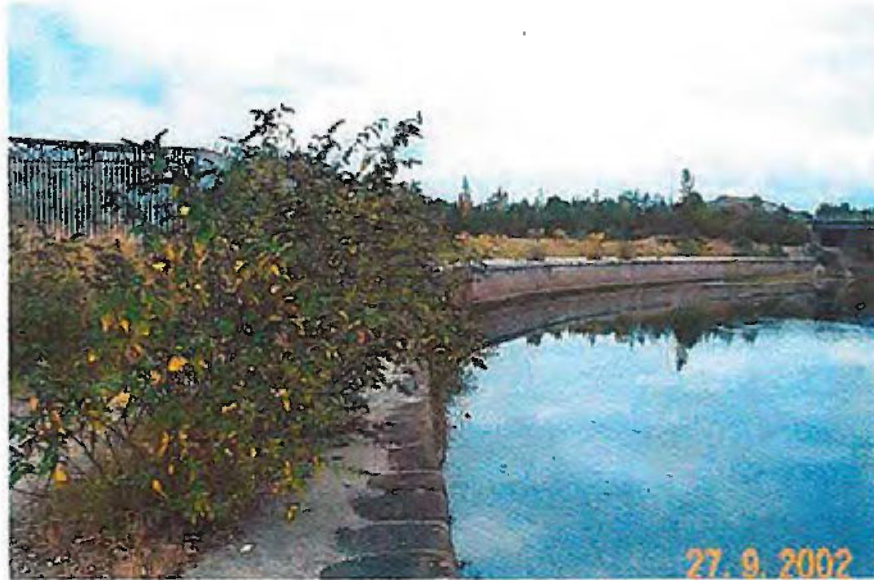
**P15: Unprotected drop to River Tawe.**

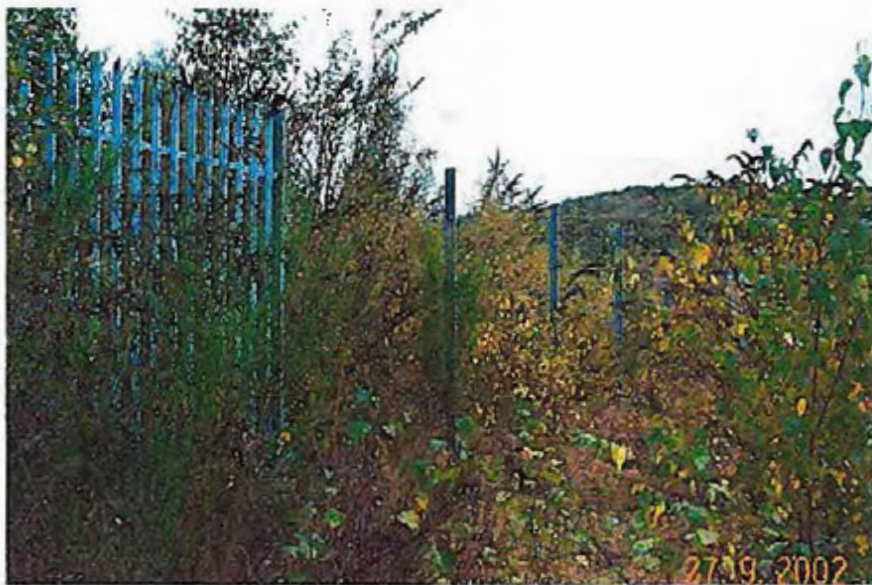
**P18:** Fence south of structure 9.

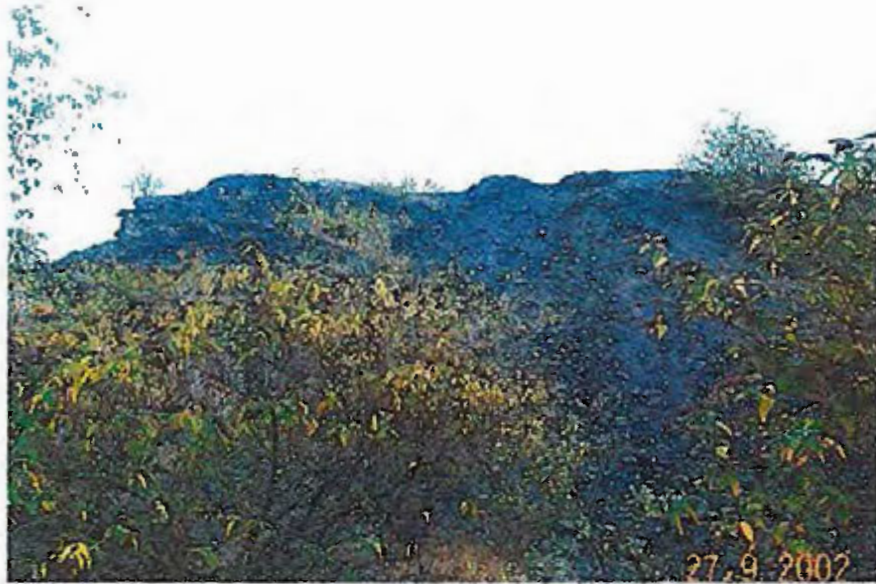
**P19:** Rear of structure 4 (access to unprotected drop).

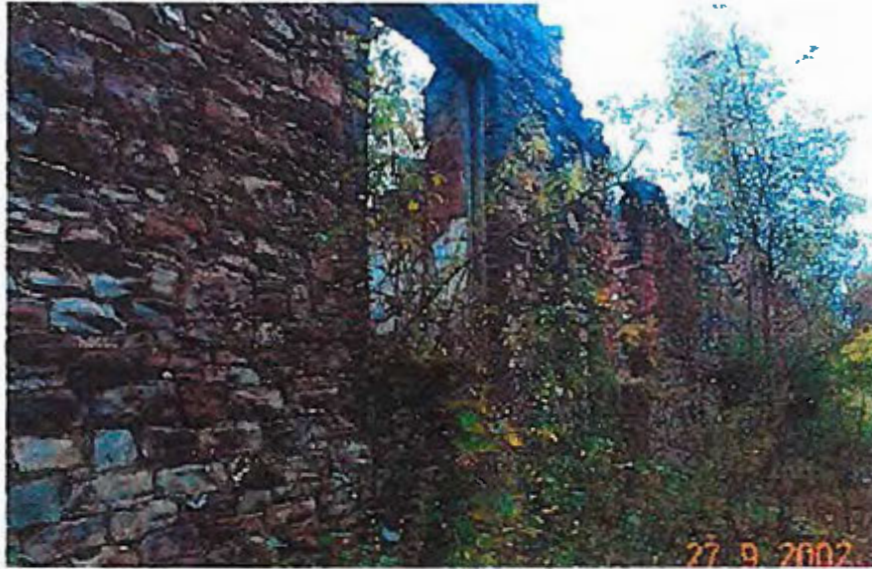
<b>3.0 Former Pier</b>	Risk of falling masonry. P24	Cap and consolidate tops of walls (As condition appraisal)
Wall to south of former pier (Former external wall of building)	Unstable masonry Risk of collapse. P20 & P21	Reduce wall to 2m height.

**P21:** Former Copperworks boundary wall. Risk of falling masonry.

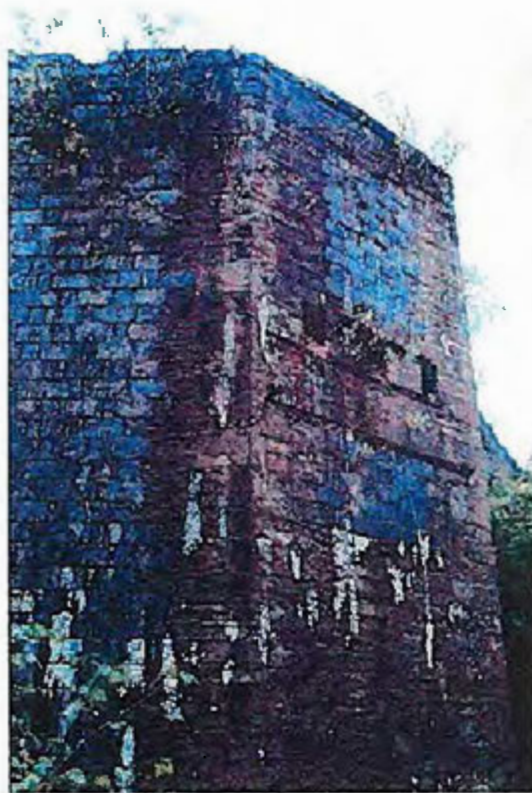
SITE STRUCTURES APPRAISAL	Perceived risk	Mitigating Action
4.0 Copper slag abutment and adjacent walls.	Unprotected drop from top of wall. P25  Risk of falling masonry.	Provide secure barriers and signage.  Cap and consolidate tops of walls. (As condition appraisal)

**P25:** Copper slag abutment and adjacent walls. Unprotected drop from the wall, risk of falling masonry.

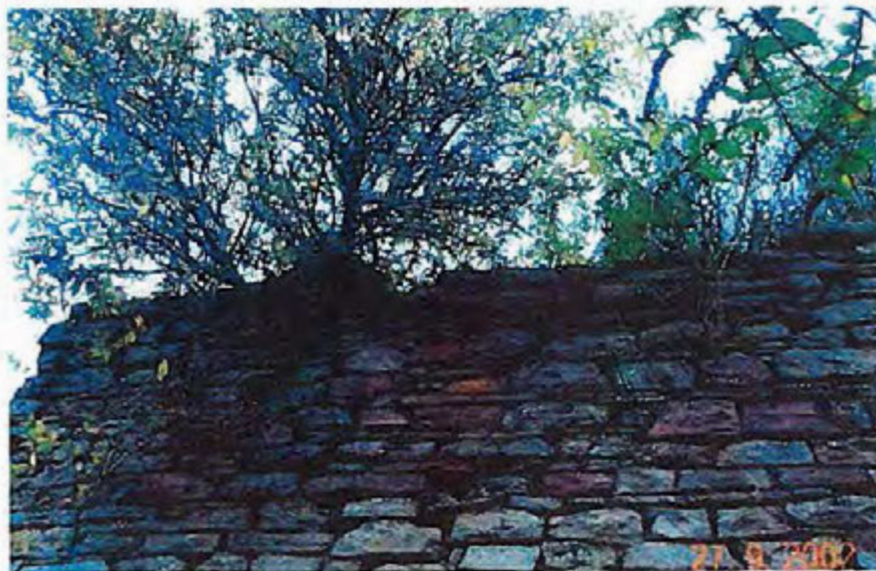
**P26:** Lime Kiln. Risk of falling masonry.
