# THE YORKSHIRE IMPERIAL METALS SITE, SWANSEA

## A SITE APPRAISAL

## ARCHAEOLOGICAL, CONDITION, AND HEALTH AND SAFETY APPRAISALS BUDGET COSTS

NOVEMBER 2002  
REPORT No. 2002/100

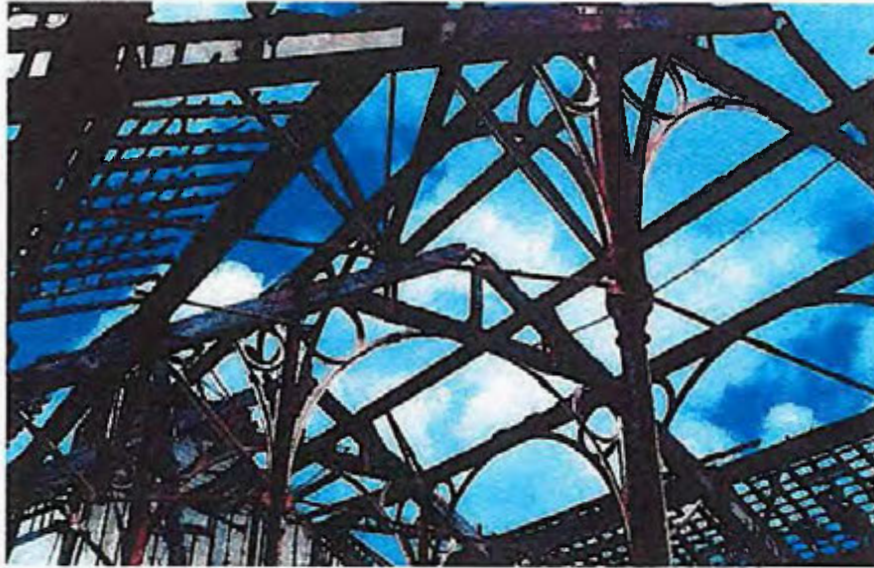
SITE STRUCTURES APPRAISAL	Perceived risk	Mitigating Action
<b>1.0 Former Canteen Building</b>	Risk of falling structure internally. P27	Remove loose/insecure structural elements. (Roof timbers and high level masonry)
	Unprotected drops <ul style="list-style-type: none"> <li>• Staircase and landings</li> <li>• Window openings at first floor level</li> <li>• Changes in level at ground floor</li> </ul>	Provide restraint to remaining frame elements (as condition appraisal)
		Provide secure barriers.
		Secure building to prevent entry.
<b>2.0 Laboratory Building</b>	Building open to intrusion. P22 Risk of falling structure internally. Risk of dropping through insecure structure internally.	Secure building to prevent entry.
	Corroded steel external access stair to 1 <sup>st</sup> floor. Risk of injury through partial collapse of stairs.	Either:- (i) Remove staircase (ii) Repair staircase
Flat roofed brick building adjacent to laboratory building.	Unauthorised entry. P23 Building debris – trip hazard.	Secure building to prevent entry.

**P27:** Former Canteen Building. Risk of falling structure.

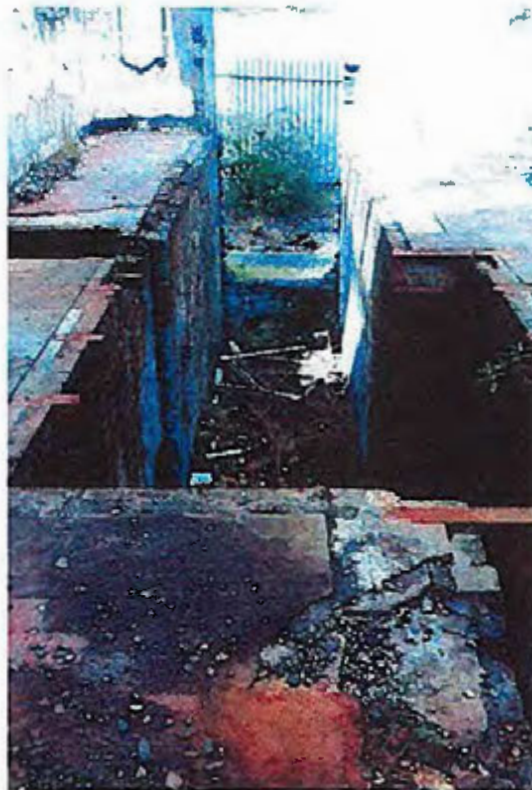
7.0 Chimney west of Vivian Engine House	Assessed to be in fair condition.	No action advised in relation to safety issues.
8.0 Vivian Engine House	Unprotected drops, pits etc. inside engine house. P28  Risk of falling structure internally (roof boarding)  Main west door entry. Insecure arch stones. Risk of falling masonry.	Secure building to prevent entry.  Remove loose boarding. Secure building to prevent entry.  Brick up entry to support arch. (As condition appraisal)

**P28:** Vivian Engine House. Unprotected drops, risk of falling structure.

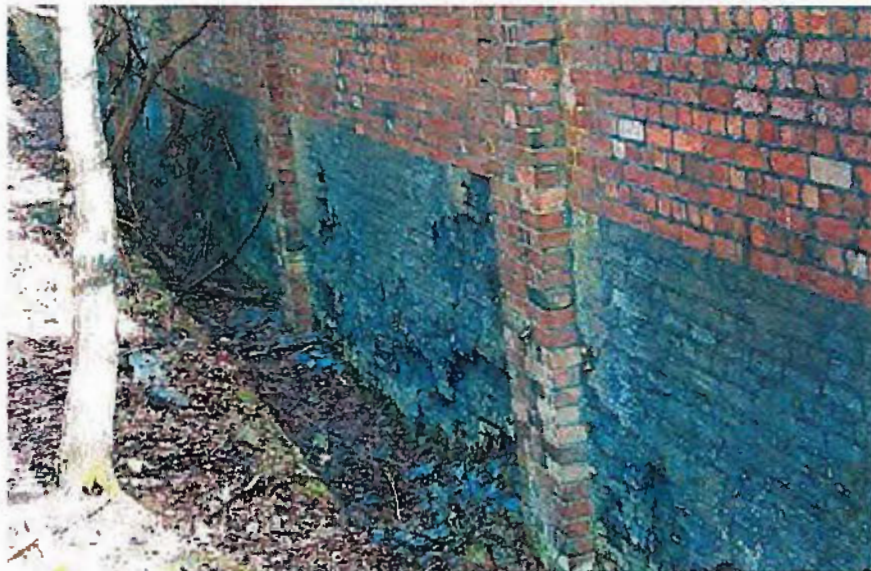
**P30:** Unprotected drop to rear of Locomotive Shed

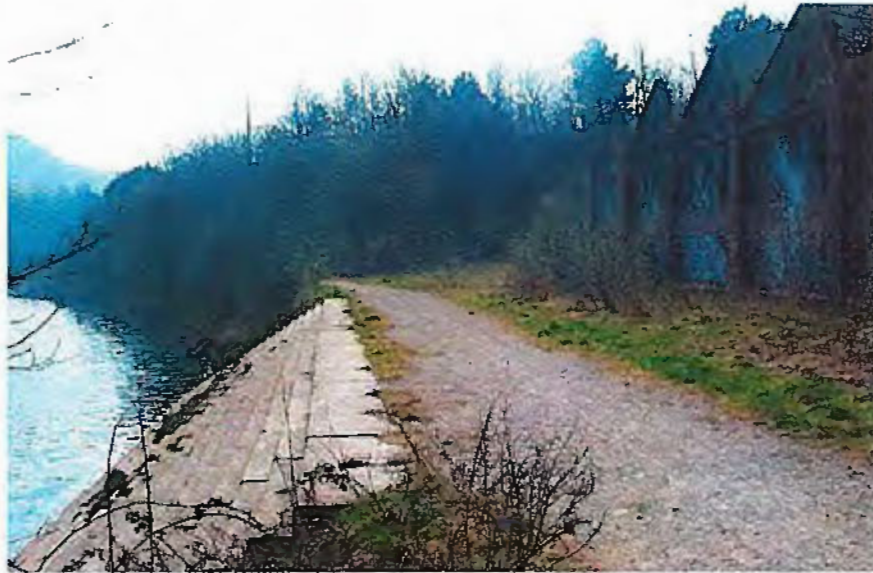
**P31: Unprotected edge to River Tawe**

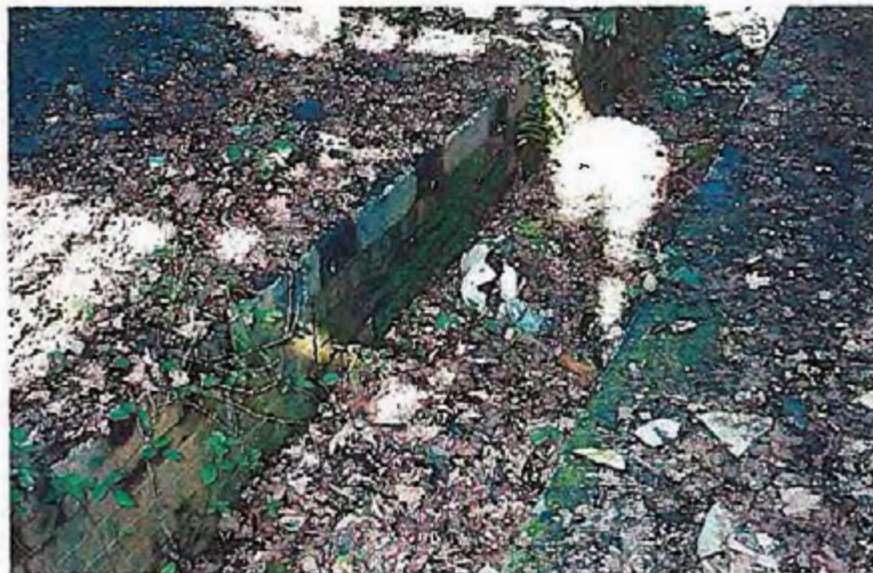
**P32: Unprotected drop to pit in Locomotive Shed**
