# YNYSLAS HULKS, YNYSLAS, CEREDIGION: ARCHAEOLOGICAL INVESTIGATIONS 2014 INTERIM REPORT

Prepared by Dyfed Archaeological Trust  
For Cadw

RHIF YR ADRODDIAD / REPORT NO. 2014/39  
RHIF Y DIGWYLLIAD / PROJECT RECORD NO. 107509  
Cadw Project No. DAT 135

Mawrth 2015  
March 2015

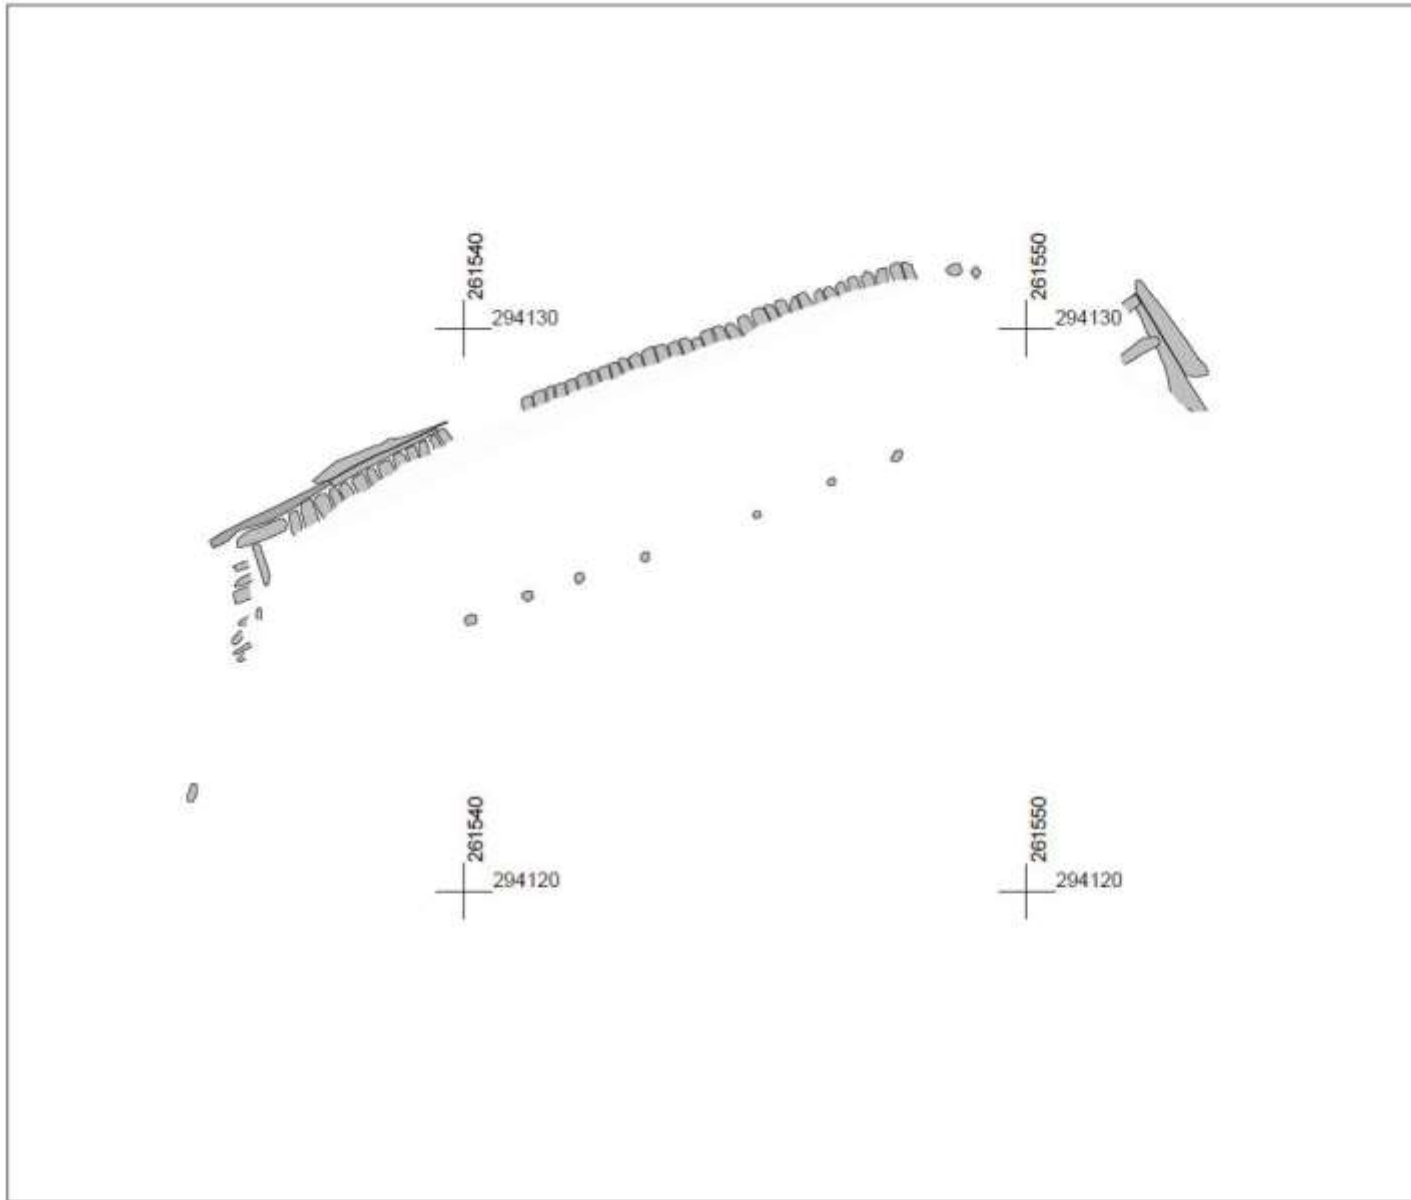
**Figure 2:** Schematic plan of exposed timbers of Wreck 1, with Ordnance Survey grid locations

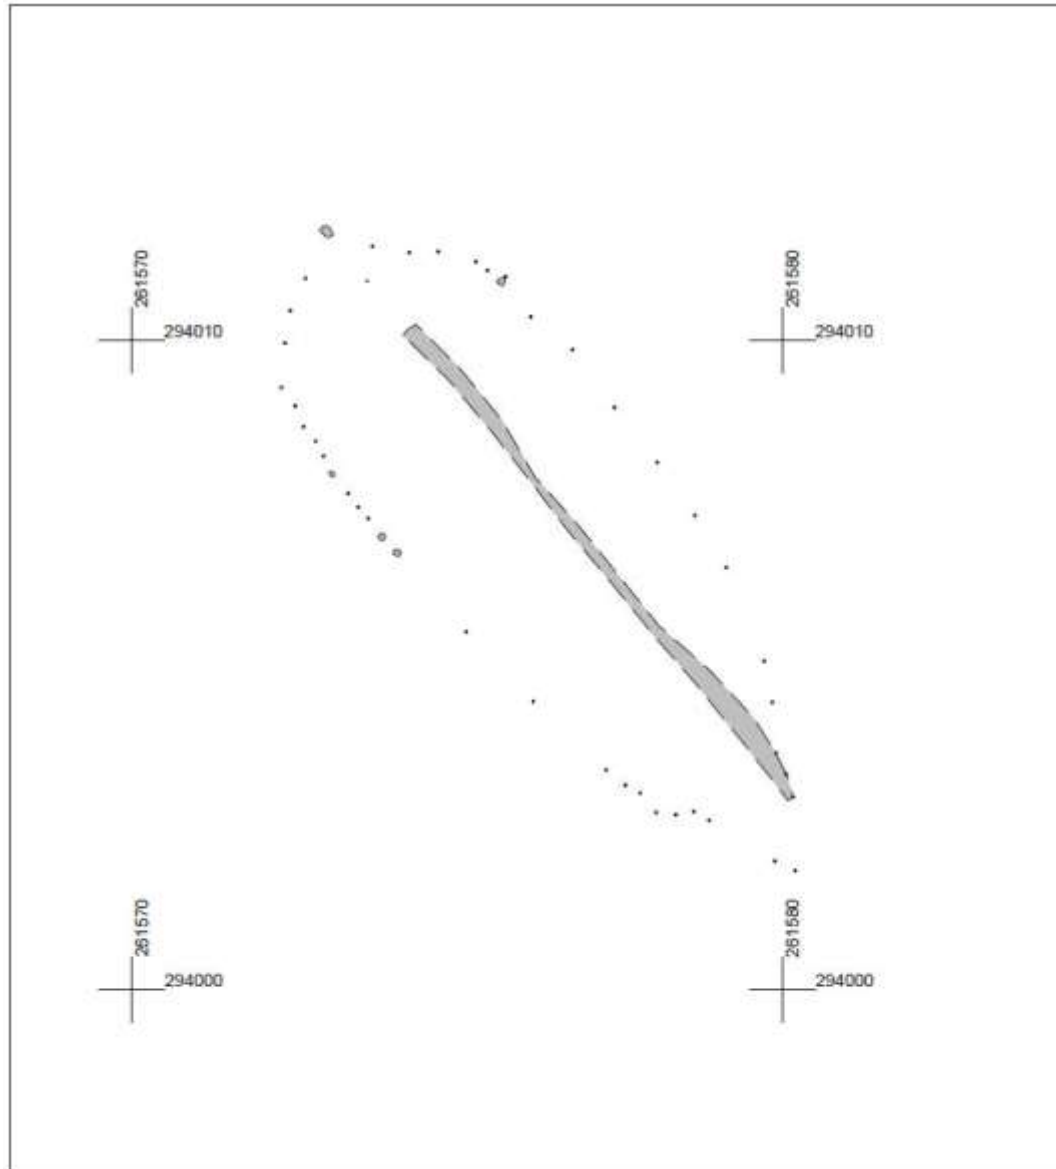
**Figure 3:** Schematic plan of exposed timbers of Wreck 2, with Ordnance Survey grid locations  
Black dots represent extents of vessel as determined by MADU/NAS and possible central timber/mast using probing techniques

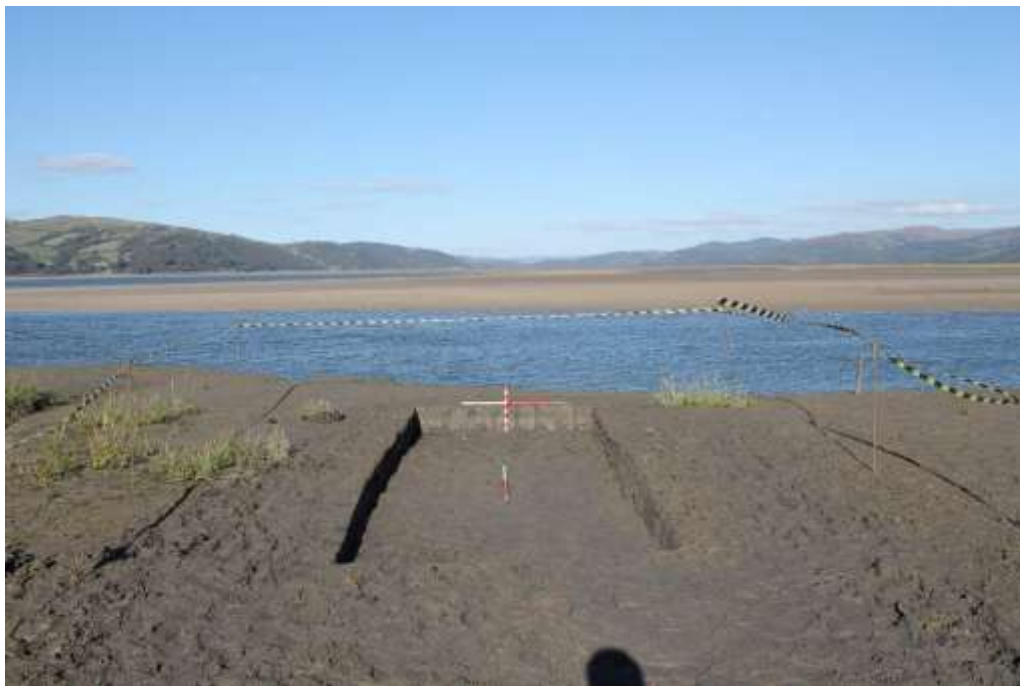
Two hand excavated trial trenches were dug at the western end of Wreck 3. The first trench (Photo 5) had assumed the vessel was of similar length to the northern wreck site (Wreck 1), but it soon became clear that this wreck was smaller. It was excavated on Day 1, measuring some 4.8m northeast to southwest by c.1.9m in width. It was excavated to a depth of between 0.5m to 0.6m.

Photo 5: Excavation of Trench 1 at end of first day

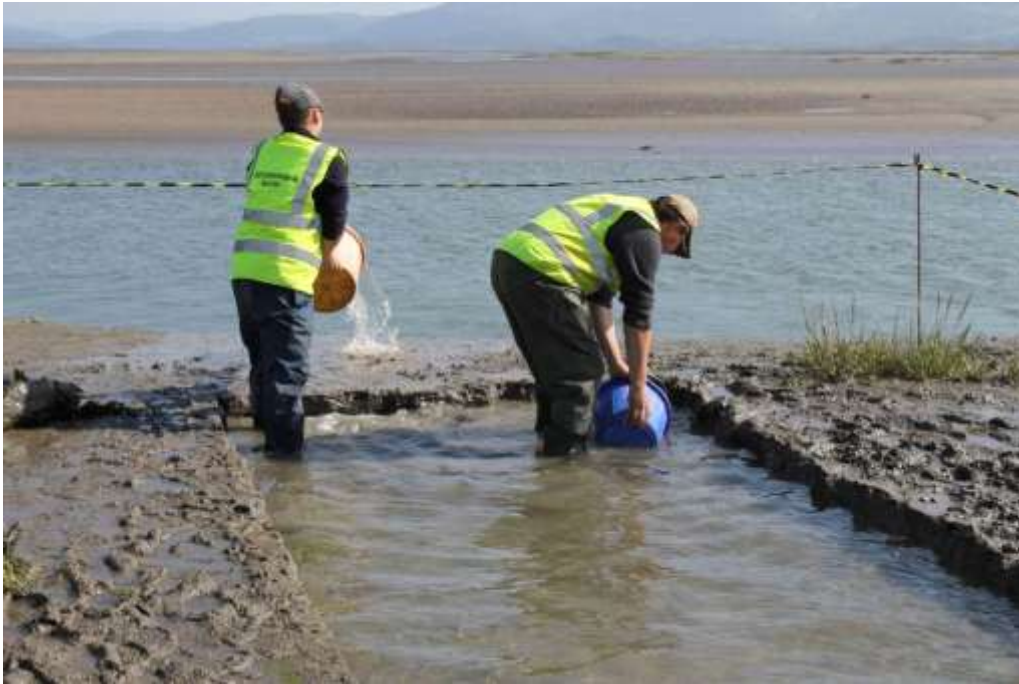
Photo 6: Bailing out of Trench 1 at start of Day 2

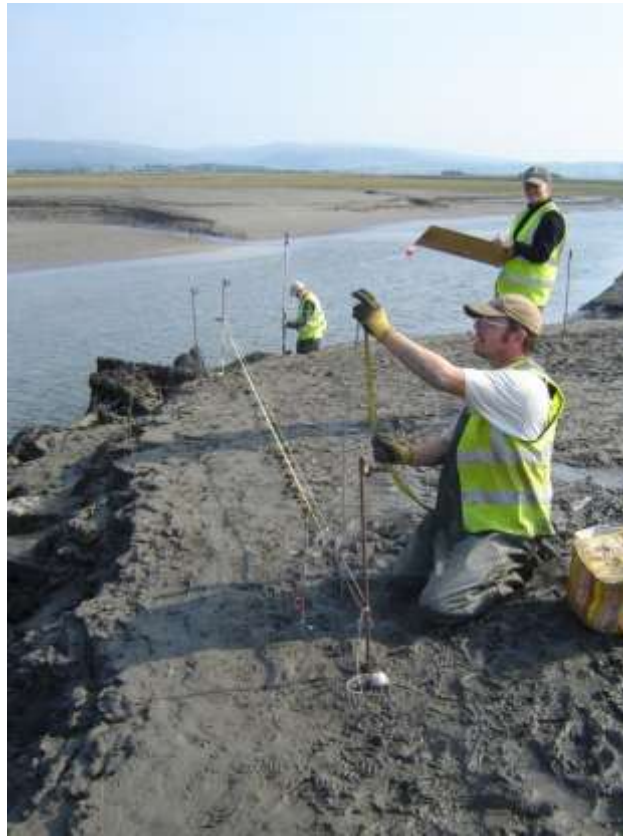
Profile 1 (Figure 6) indicates that timber elements to survive to the northwest of the stempost, possibly associated with the collapsed bow itself, at depths of around 1.40m. The top of the stempost was not exactly crossed by the profile, but adjacent timbers were noted surviving at around 0.5m below the top of the silts. The profile indicates that timber elements survive as high as 0.3m below the top of the silts, but mostly average out at around 0.8m to the northwest to

0.6m to the southeast, as the silts drop down toward the bank of the river. Presumably the profile identifies the hold and objects or collapsed timbers on top of it.

Photo 8: Recording Profile 1 looking southeast along the centre line of the wreck  
(Photo: MADU)

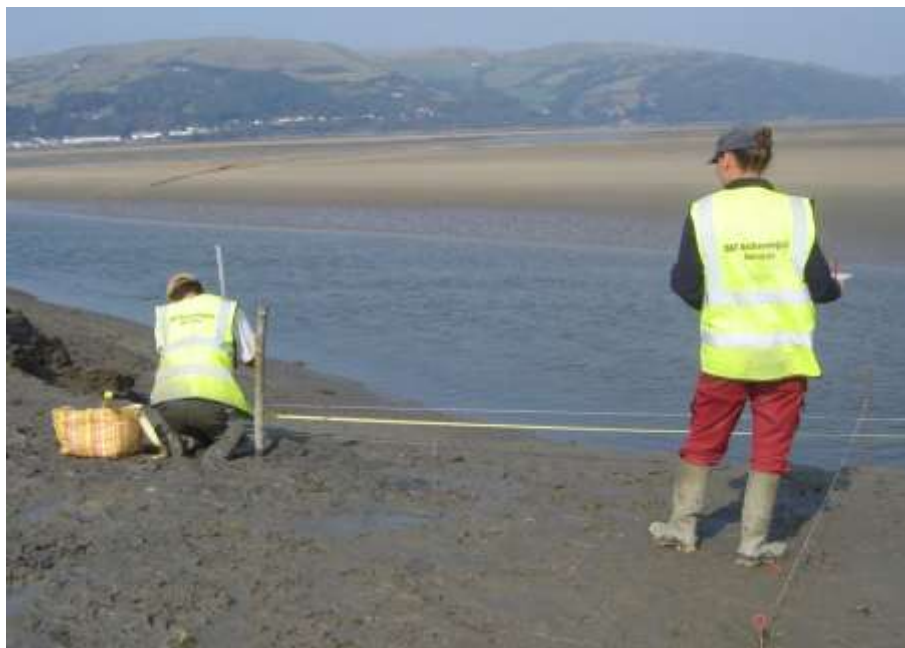
Photo 9: Recording Profile 1 viewing northeast towards Aberdyfi (Photo: MADU)
