YNYSLAS HULKS, YNYSLAS, CEREDIGION: ARCHAEOLOGICAL INVESTIGATIONS 2015 - 2016 INTERIM REPORT

RHIF YR ADRODDIAD / REPORT NO. 2016/15
RHIF Y DIGWYLLIAD / PROJECT RECORD NO. 107509
Cadw Project No. DAT 135

Mawrth 2016
March 2016

James Meek MCIfA

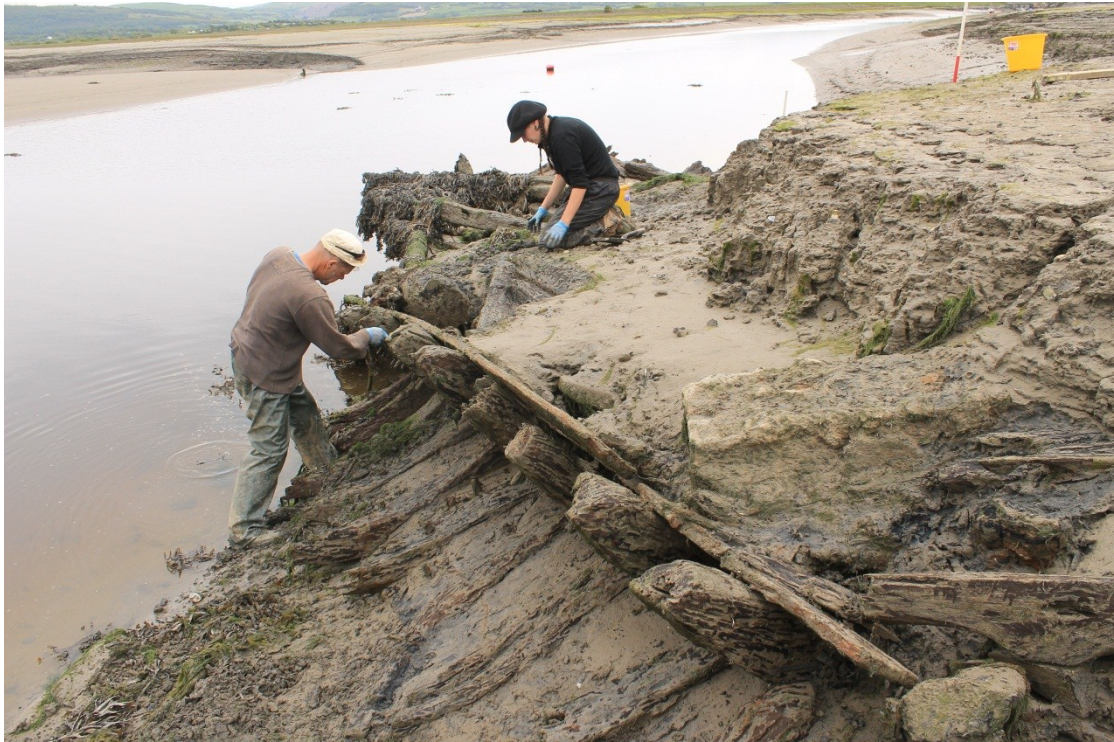
Photo 1: Removal of seaweed, algae and silts from the wreck prior to recording (June 2015)

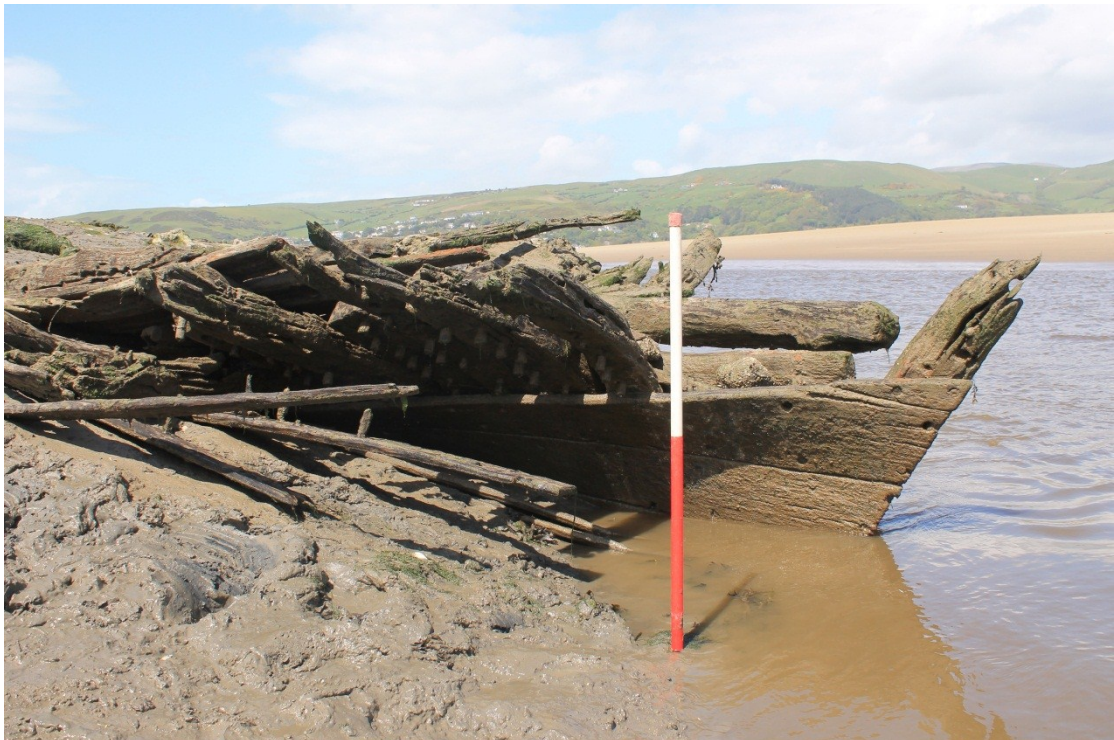
Photo 2: View of port side of stern following clean (June 2015)

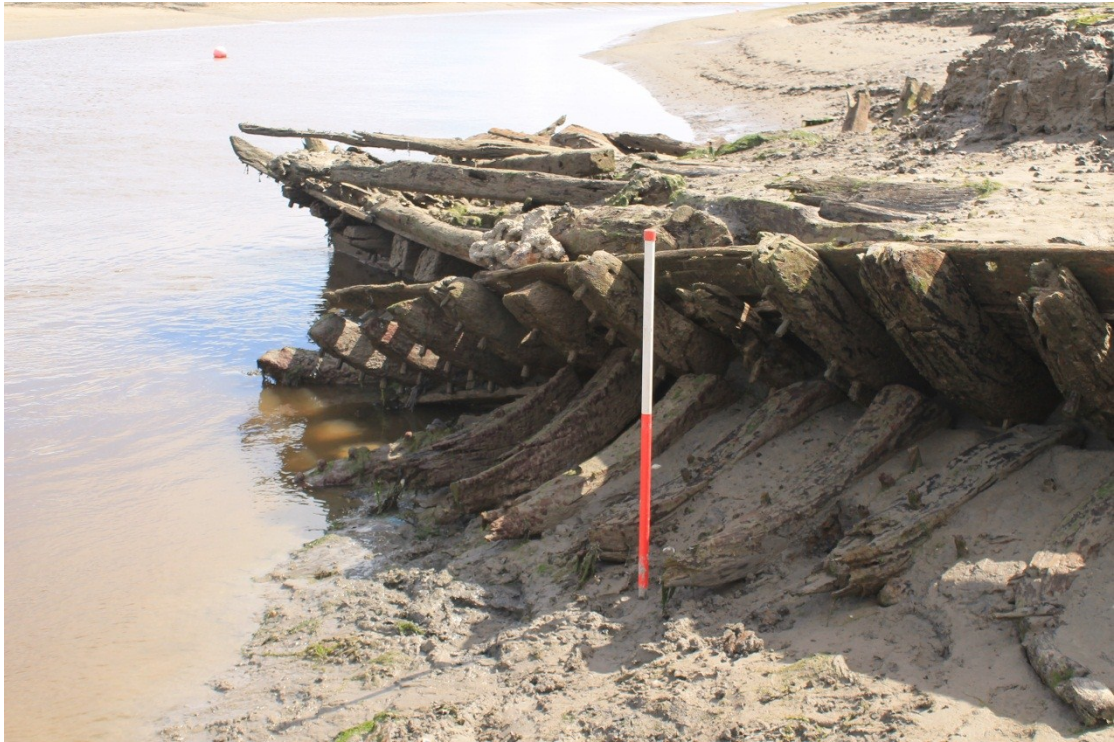
Photo 3: View of starboard side of the wreck following clean (June 2015)

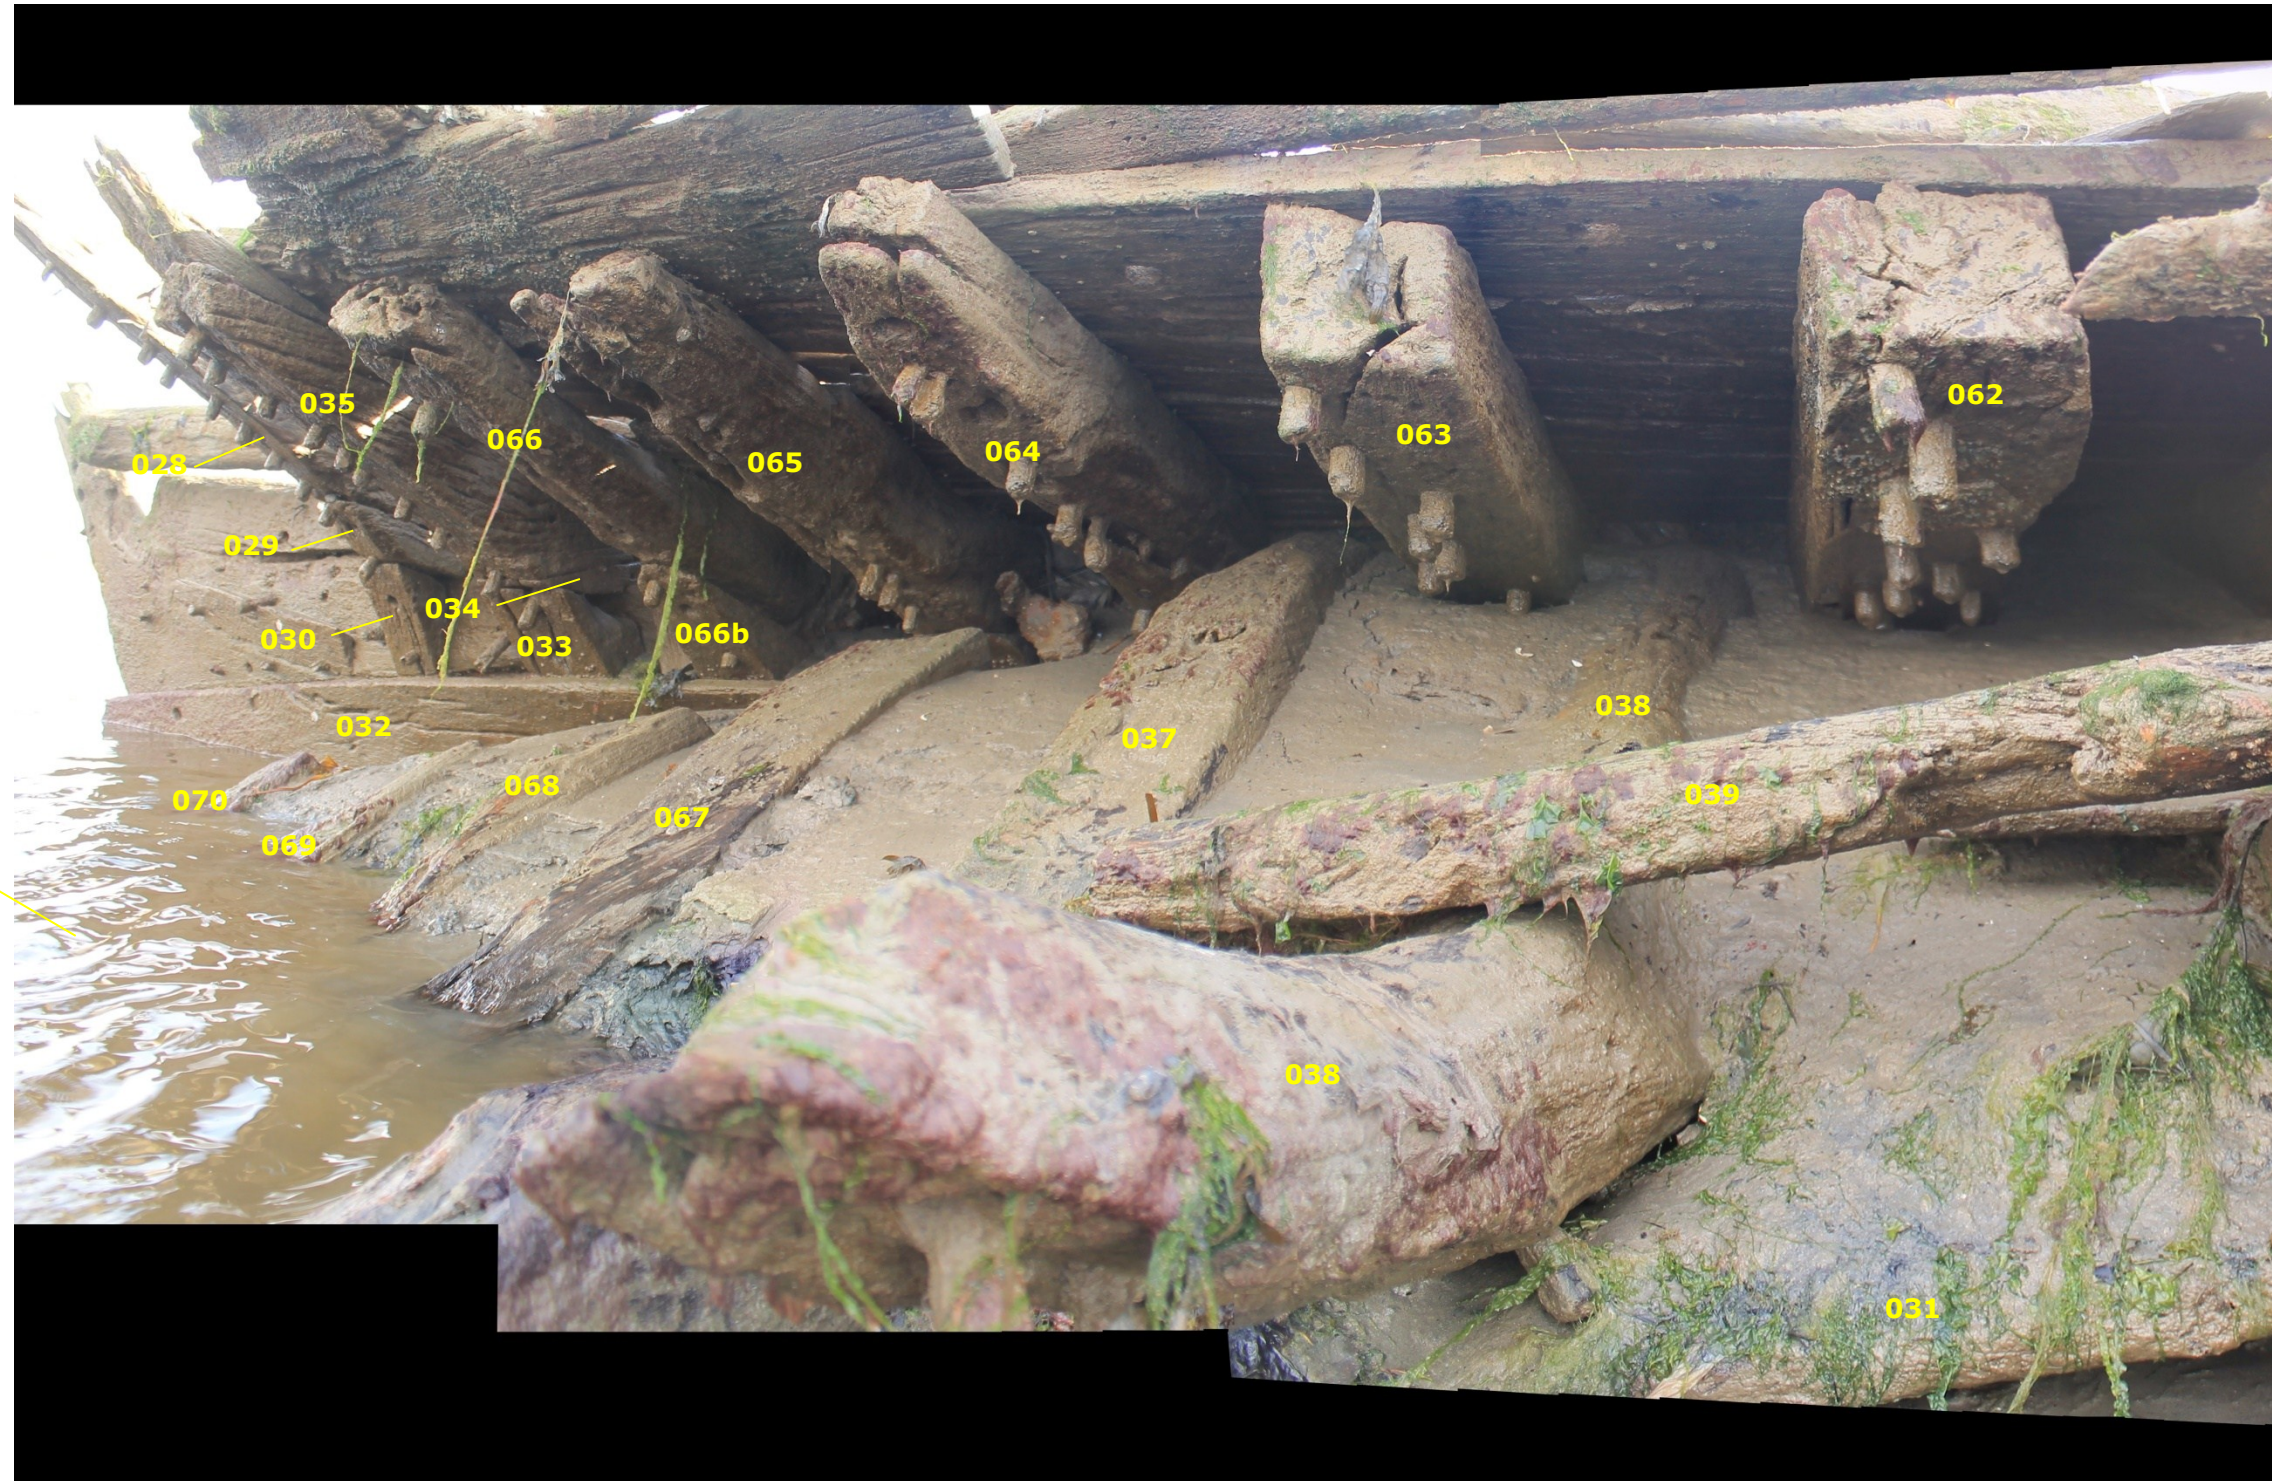
to the floor frames. Filler frames between are still presently roughly in-situ, being held against the inner planking and the bases of the frames still held in the silt, although it will not be long before these too collapse outwards. At this point much of the upper part of the wreck and the objects on top are likely to fall also. This will include the possible oven recorded in 2014. A number of loose timbers and iron work had moved to the edge of the wreck as noted during a visit in March 2016.

Photo 10: Frames on the starboard side (between Photo 11 and stern, Photo 9)
(merged photographs from June 2015)

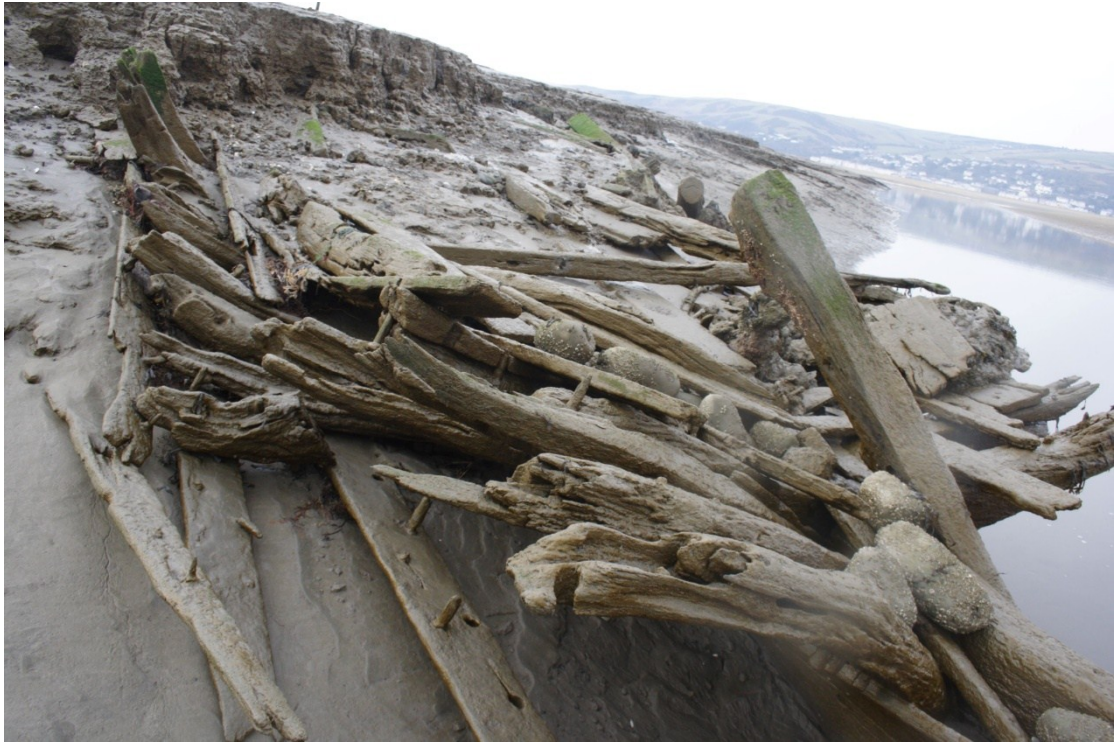
Photo 13: View along the port side of the wreck from the stern, showing the longer surviving frames still roughly in situ towards the river edge

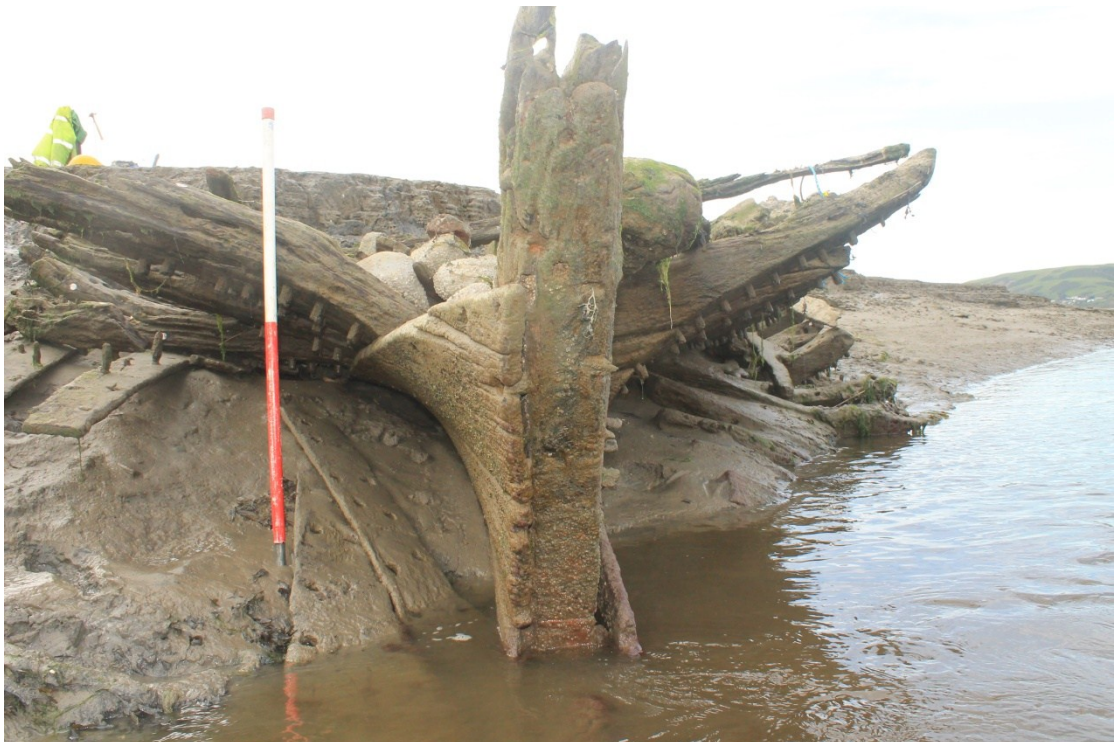
Photo 14: View of stern showing shaped outer planking on port side

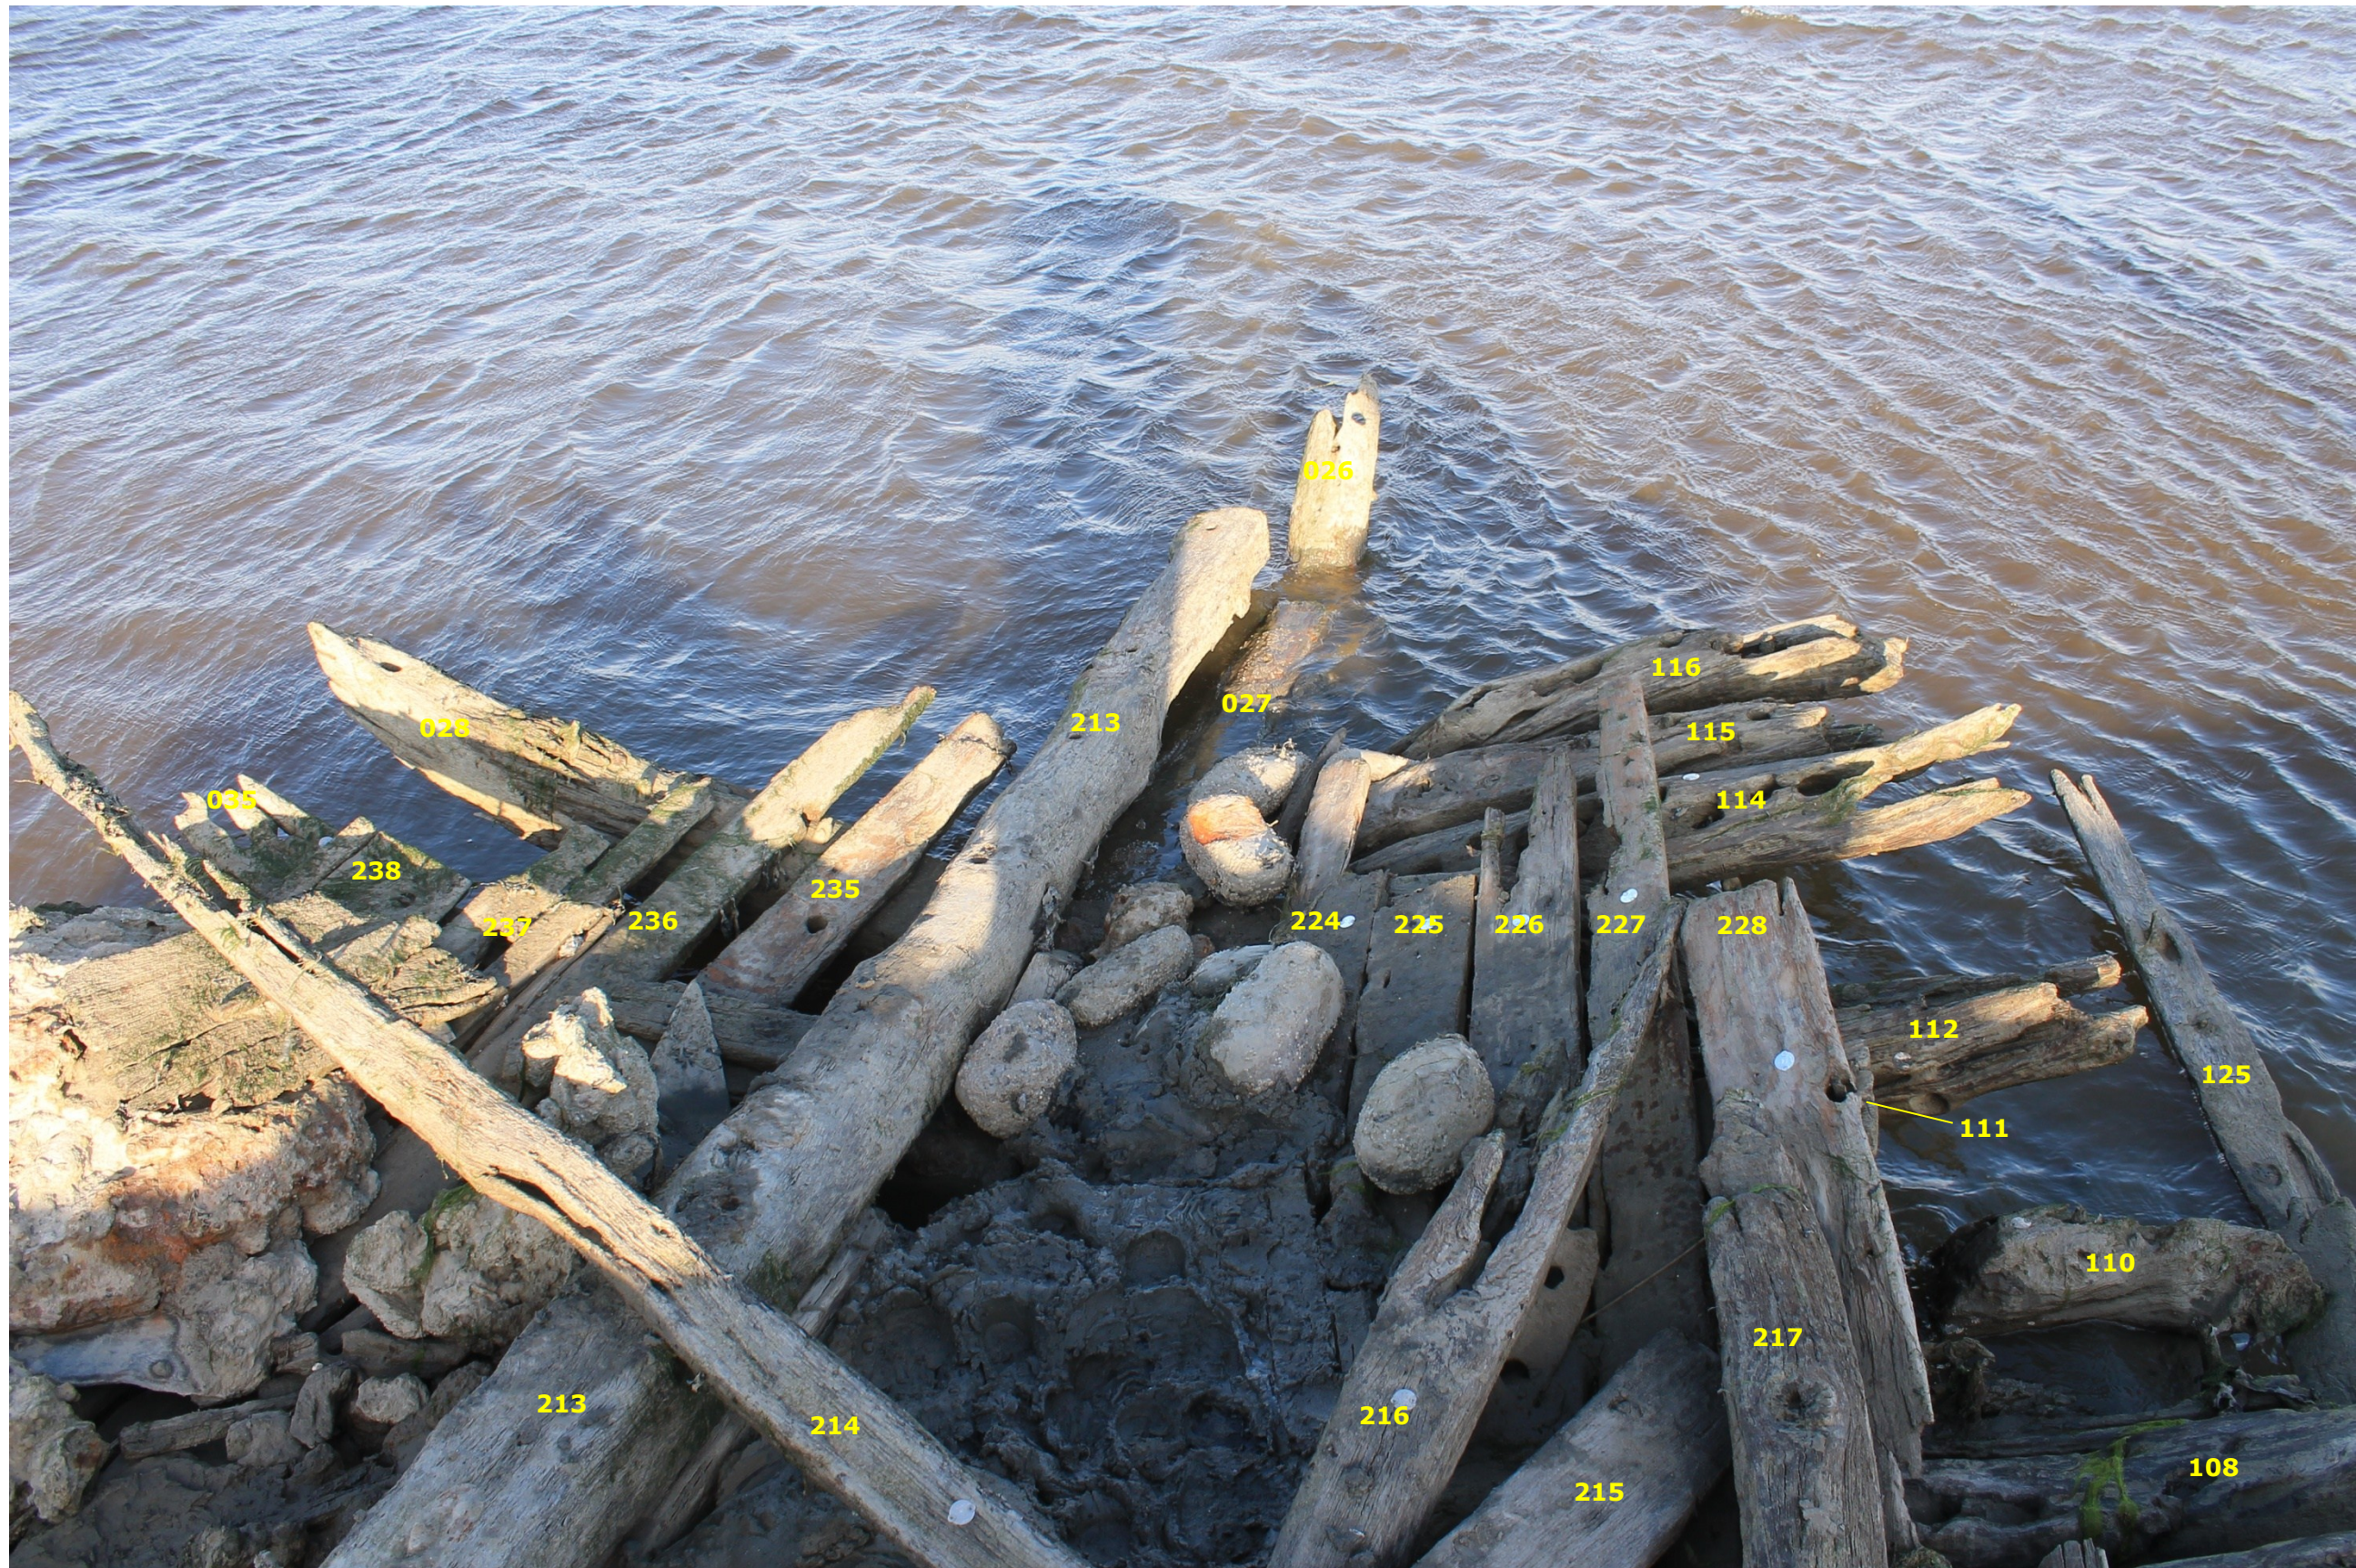
This photo also includes loose timber elements such as 213, which could possibly be a former boom from its shape. It has been seen lying almost directly on top of and parallel with elements of the keel (deadwood 212) since 2010, but has become looser with more and more erosion. It was still in-situ during the work in 2014 and 2015, but could be seen to move slightly as the water rose back into the Afon Leri channel and its movement was exacerbated when boats using the channel passed and their wake hit the wreck. In March 2016 timber 213 had moved and now lies at an angle over the starboard side with its end sticking into the silts of the river channel. It is possible that the timber was deliberately moved rather than it being caused by tidal movement of wakes from motor boats.

Inner planking of the hold includes timbers 225, 226, 227 and 228 on the starboard side and timbers 235, 236, 237 and 238 on the port side. Timbers 214, 215 and 216 appear to be collapsed elements from the former structure above. A number of large rounded pebbles remain in the hold and represent ballast. A large coil of corroded iron chain is still present on the starboard side. Within the corrosion of the chain are fragments of broken roofing slate, presumably former cargo, and also smaller pieces of timber which may include the lid a small wooden box, part of which was recovered in 2014. A number of small copper or brass pipes are also present the function of which is uncertain. These were visible in September 2014 when the Royal Navy Bomb Disposal Squad looked over the wreck to check for ordnance, so it is assumed they are associated with the wreck (although have not been removed).

Photo 16: Stern end of exposed hold showing inner planking and other main surface timbers (September 2015)

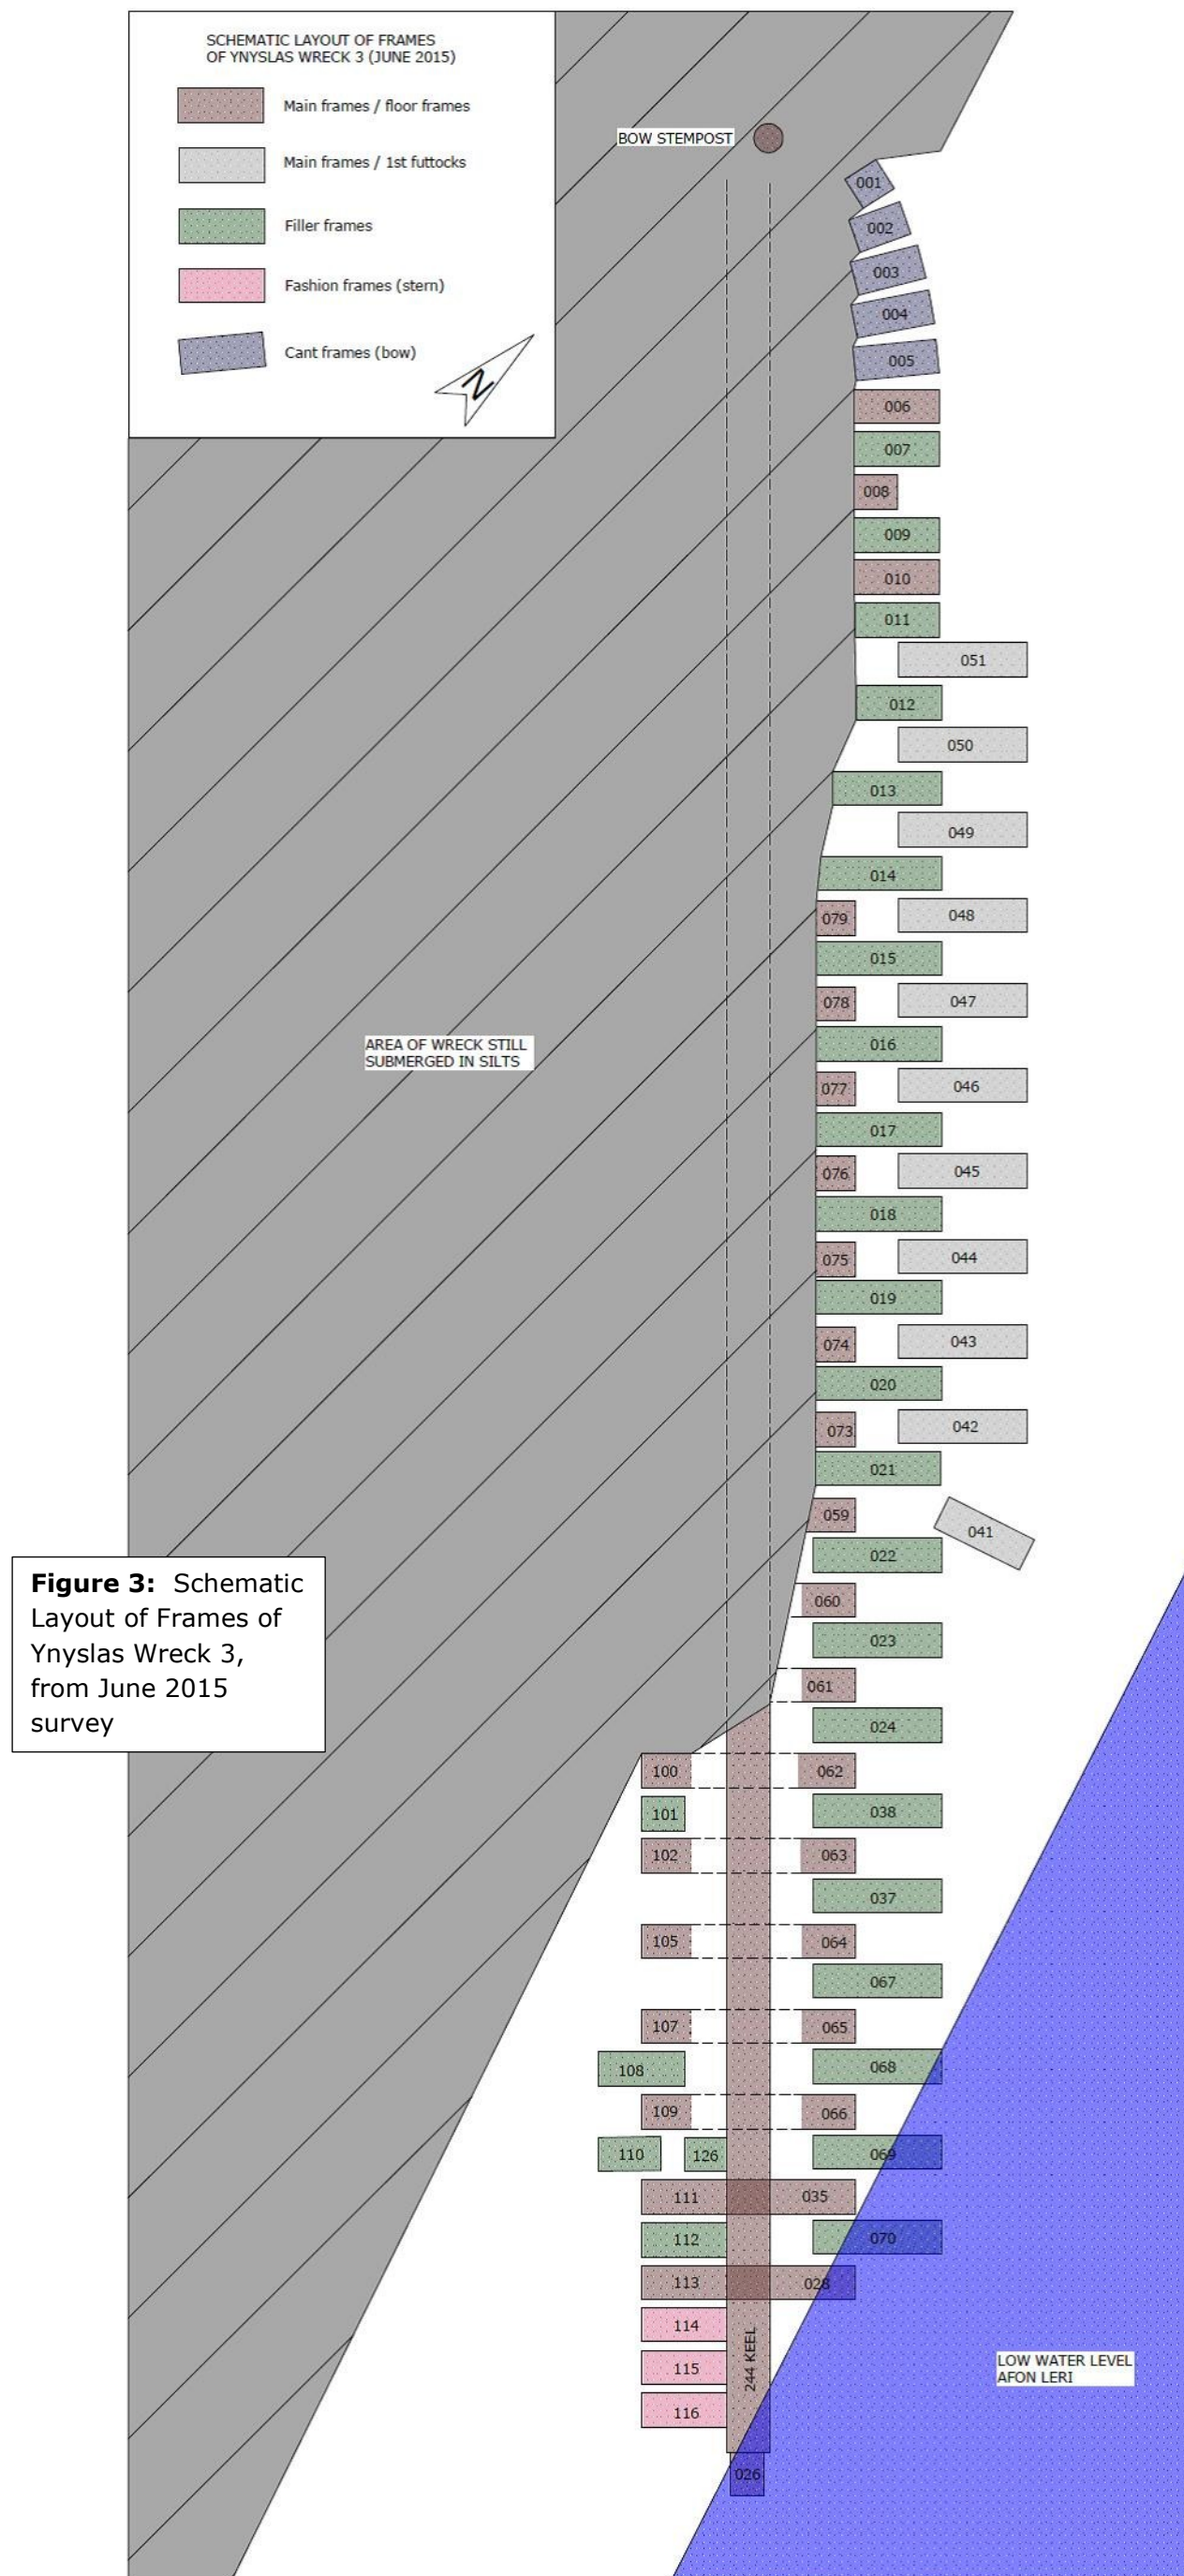
The Stern

The stern post juts out into the Afon Leri channel and would appear to be exposed almost to the base of the wreck. During the low tide in September 2015 following the removal of detritus which had stuck to the base of the stern, it was possible to see an additional timber projecting into the channel beyond the stern post with a rectangular hole within it, surrounded by an iron deposit (Photo 17). This is likely to represent the keel, lying mostly buried in silts or hidden by other timbers. The hole could possibly be either a mortice for a lost timber or possibly part of a rudder hinge. If the hole is for a former timber, this may have been for a former stern post which has since become detached and washed away, with the remaining upright, 026, representing an inner sternpost.

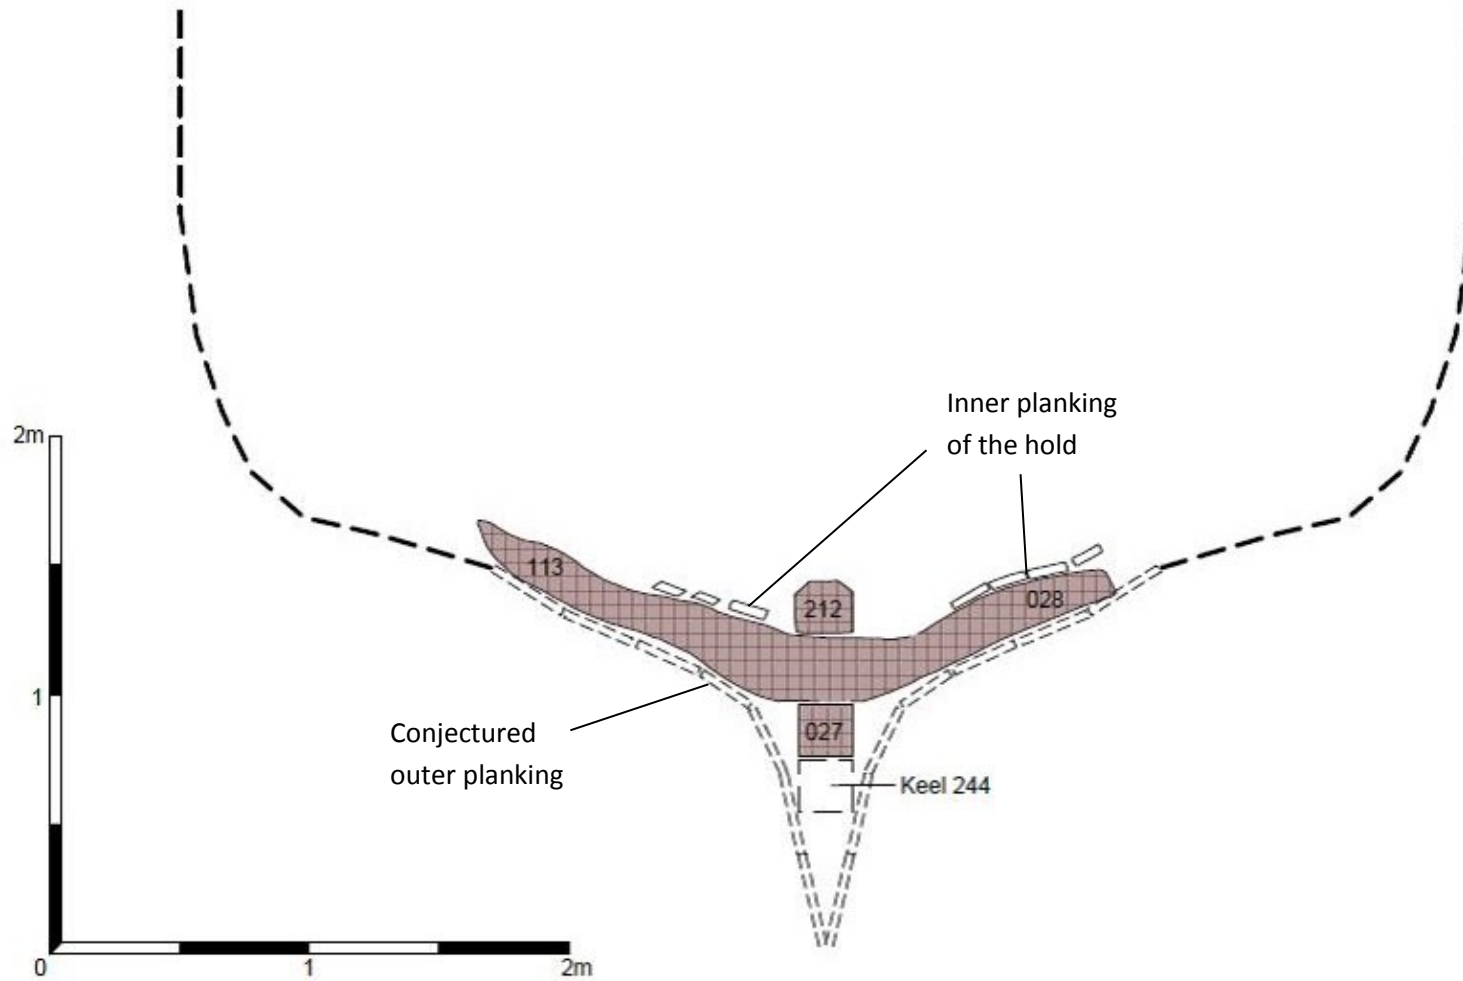
It has been possible to use floor frame 028/113 to provide very simplified conjectural reconstructions of the profile of the wreck (Figure 4). As we have the length of the vessel from recording undertaken in 2015 (12.86m) a simplified side view of the wreck has also been attempted (Figure 5) using similar examples of contemporary ships to provide a potential outline of the wreck. These could indicate that the original length of the wreck at deck height would have been around 16m. The height of the hold and shape is based on similar sized examples of contemporary vessels recorded in a number of sources. These indicate that the height of the hold mid-ships would have been between 6 to 7 foot (c.1.8m to 2.1m) and that the width would have been around 15ft (4.6m). The resultant profiles demonstrate how much of the vessel has probably already been lost and what might still survive buried in the silts.

Figure 4: Conjectured profile through the wreck based on floor frame 113/028 and similar contemporary examples

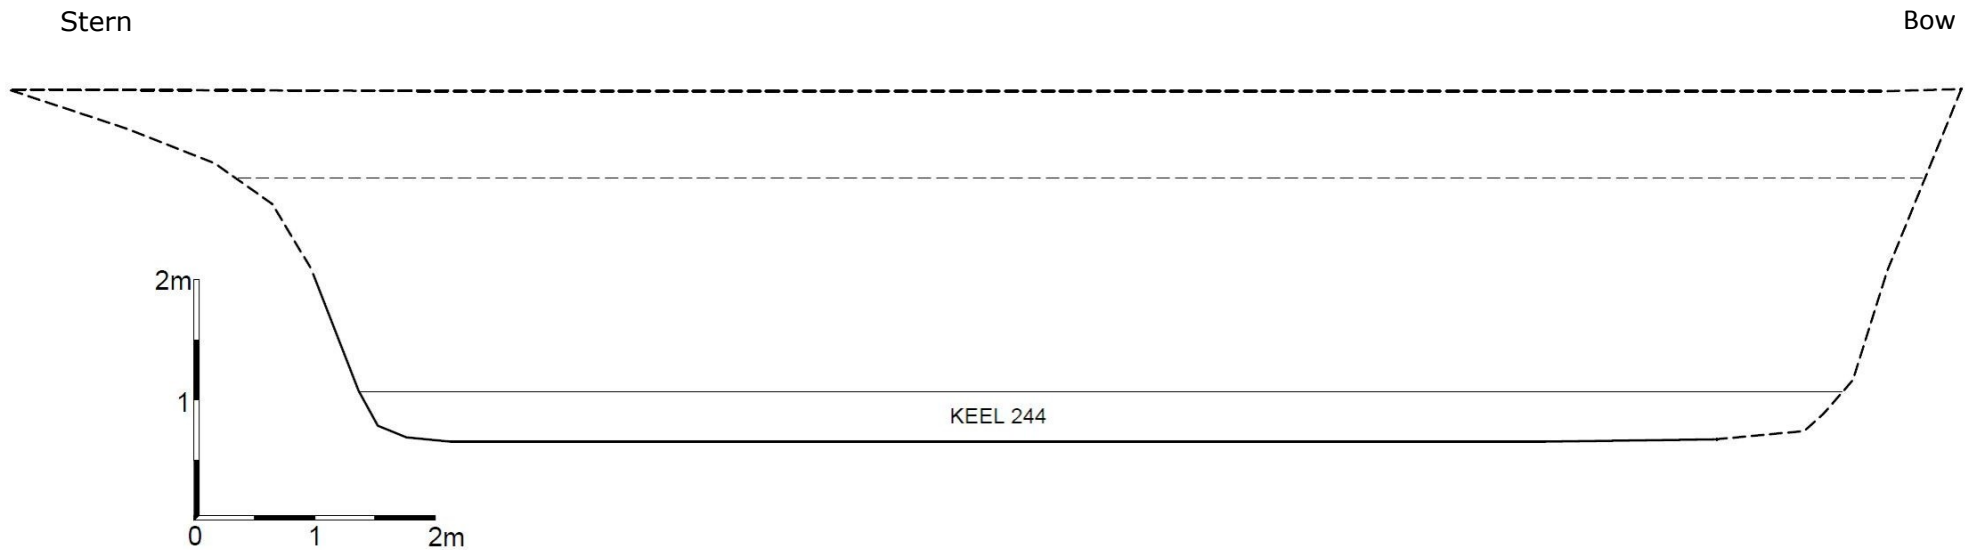
Figure 5: Conjectured profile of potential longitudinal shape of the wreck based on its known length and similar contemporary examples
The solid line represents the known length of the wreck from what is visible and the possible position of the bow is taken from the excavations undertaken in September 2014

Wreck 3 measurements – 12.86m x 4.6m in width based on what survives. (42' 2 " by 15' 1").
The depth of the surviving elements of the wreck from top of stern post to visible depth is around 1m (3' 3")

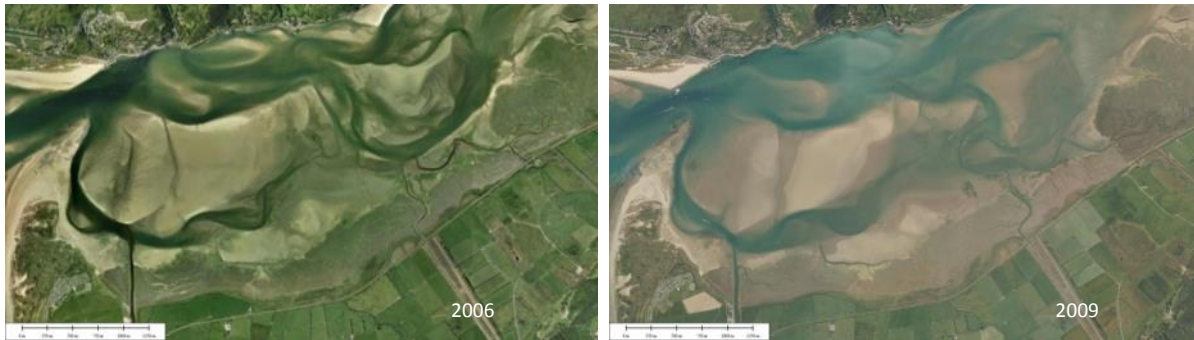
of the flow of the upper section of the southern inner channel. Even though the general width of the section of the southern inner channel is possibly wider in the 2009 image, there is a strong indication that the form of this channel from 2006 through to 2009 has become less dominant (figure 2.4).

Figure 2.4. Air photographs 2006 and 2009.

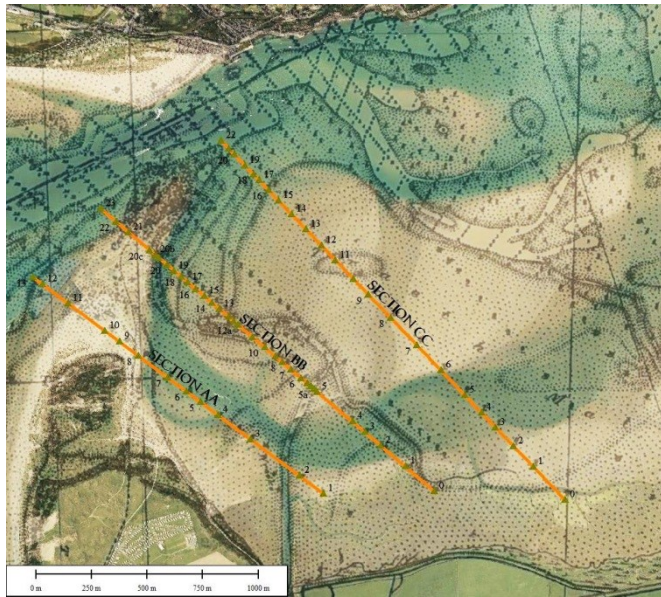
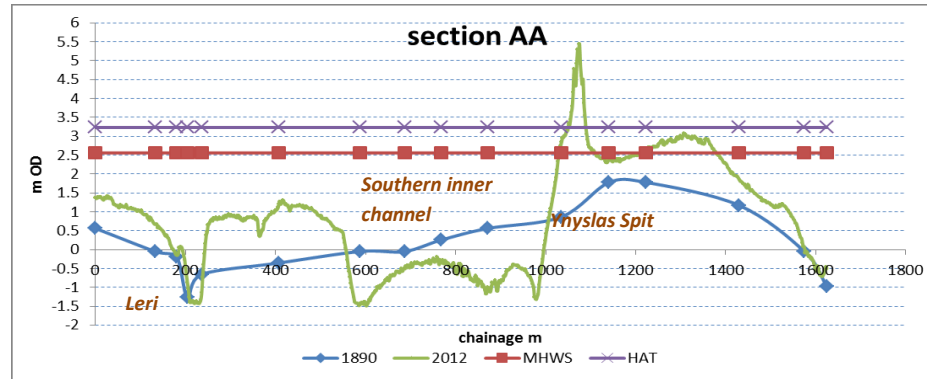
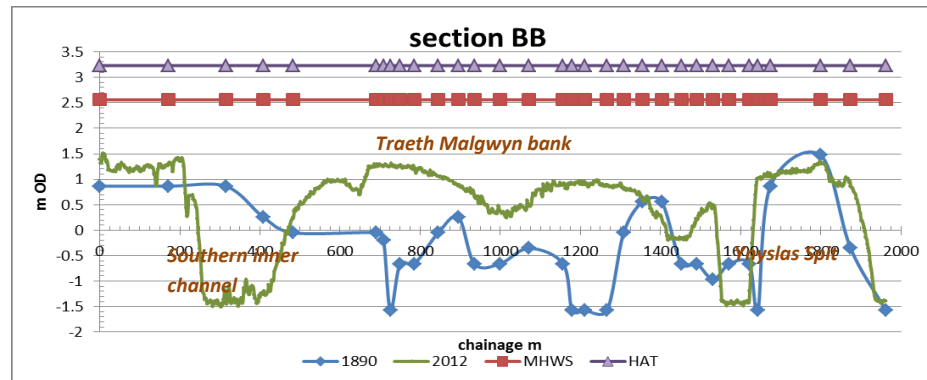
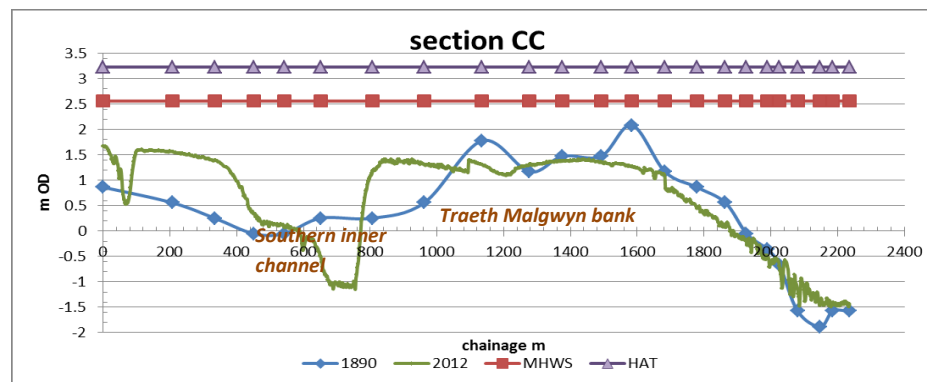
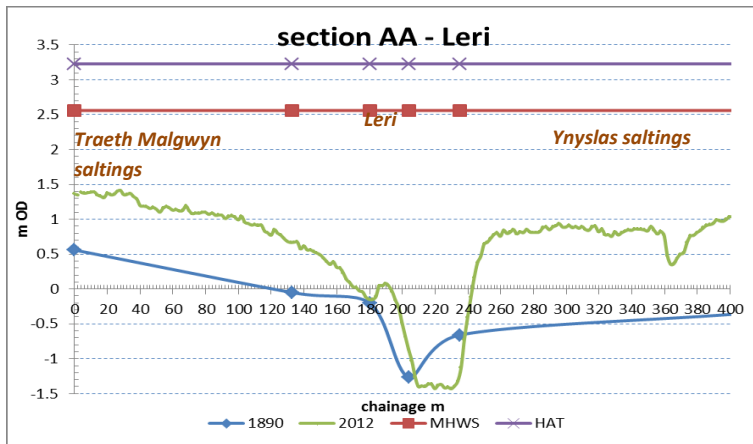
Figure 2.5

An analysis has been undertaken comparing historic change in bed levels, comparing soundings recorded on the 1892 chart (actually surveyed in 1890) with LIDAR data. Three profiles have been considered as shown in Figure 2.5.

The influence of the southern inner channel is quite evident on the present day survey, cutting below the level shown in 1890. Further back along the profile, the growth of the Ynyslas saltings is shown, with present day levels some 1m higher in the area of the wrecks than the historical levels, which might have characterised the area around the time that the wrecks were beached.

With the growth of the Ynyslas saltings and the growth (again in the order of 1m) of the saltings along Traeth Malgwyn (to east of the Leri), it can be seen that the Leri channel cuts deeper relative to the surrounding bed levels. A more detailed cross section, based on section AA across the Leri, is shown on the left of Figure 2.5. While recognising the inherent difficulty of rectifying the old chart soundings to present day, there is still a clear indication that the eastern bank of the Leri channel has moved westward, potentially by some 10m to 20m. The actual depth of the channel may also have deepened but the LIDAR only captures data on land above water levels. The difference in levels between the western bank is consistent with the position or level of the wrecks, assuming that they were beached at a level of the old bed.

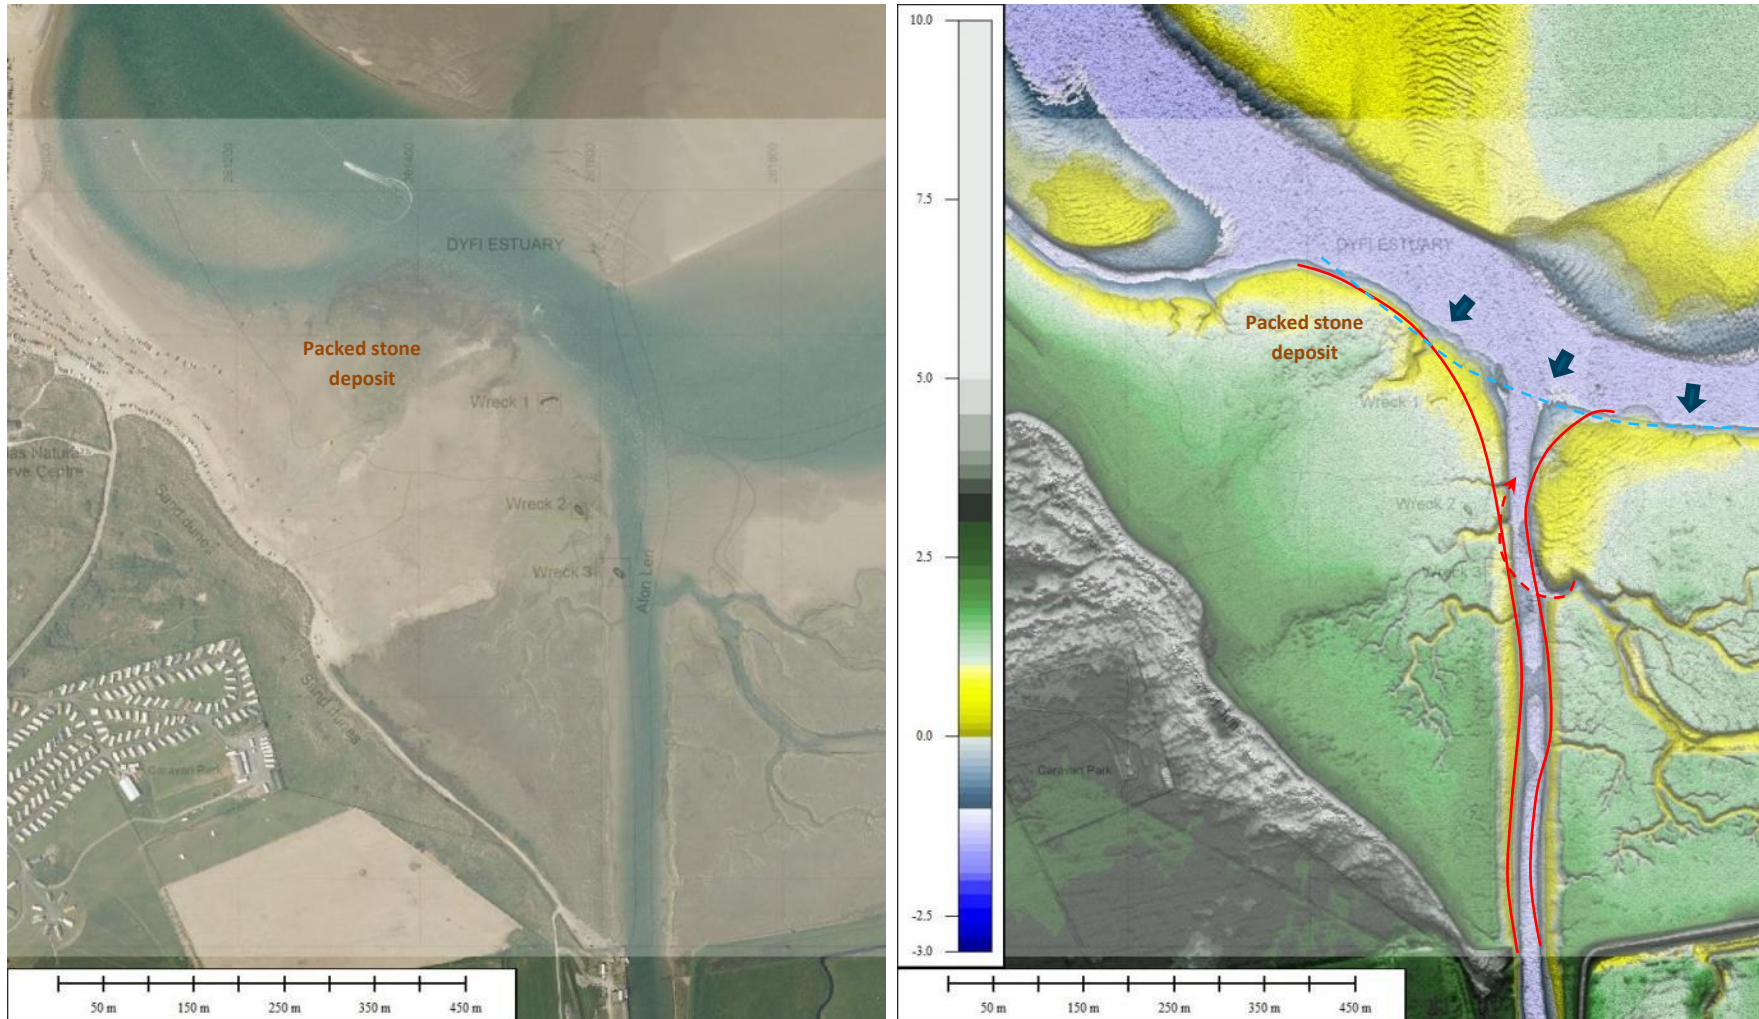
Figure 3.1 shows the local area of the wrecks. The image to the left shows the image of the 2009 air photograph, the image to the right shows the same area but taken as the LIDAR image understood to be from 2012. On the LIDAR image areas shown as blue are below typical mid tide level, with areas shown as yellow being areas between 0m OD and 1m OD. The green areas are progressively less exposed to normal tidal levels and typically less exposed to strong tidal flow.

- Wreck 3, however, is located at a critical inflection point of Leri Channel. Even relatively small changes within this local system have the potential to either increase or, in fact, reduce pressure on the wreck site. A further feature of the system is the deep creek on the eastern side of the Leri channel. Flow from this channel (as shown as a dotted red arrow on Figure 3.1) may also add to the erosion pressure at Wreck 3.

It does seem likely that Wreck 3 will be fully exposed and possibly lost over the next ten years, subject to more extreme conditions.

It seems probable that Wrecks 1 and 2 will be less affected. It would, however, be recommended that this is reassessed against further survey data as this becomes available.
