CPAT Report No. 1259

Brecon Beacons National Park Scheduled Ancient Monument Condition Survey 2014

Archaeological condition survey

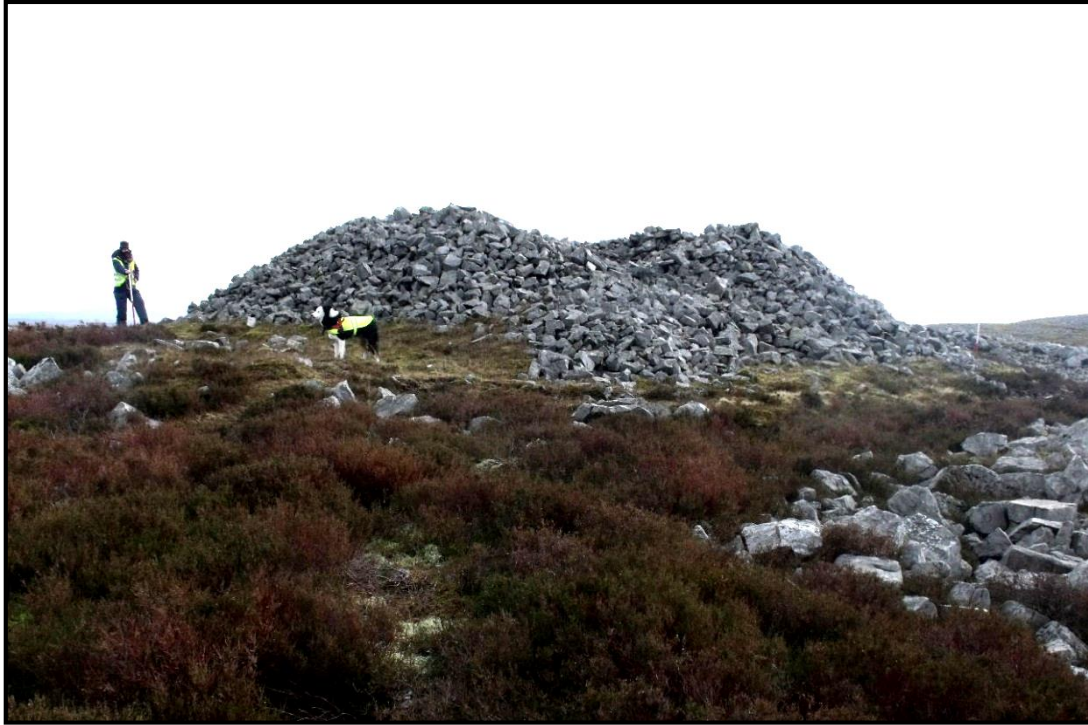
- 4.4 SAM CM255 was designated as a 'High' priority site as there was no information available about the group. There are three cairns in this group (PRNs 4013, 4014 and 4015), and all are approximately 2m in height and around 12m x 15m in plan. Two of the cairns (PRNs 4013 and 4014) had been disturbed in the past; with hollows in the centre of the cairns (Photos 1 - 4). However, there was no evidence to indicate any recent intrusions or disturbance. Of secondary importance, although very minor, was the encroachment of heather around the base of the cairns (Photo 5). The conditions of the cairns at this SAM was generally good, and so in the light of the survey it was re-assessed as a 'Low' risk site.

Photo 1. Photo showing hollow in SAM CM255, Tair Cairn Uchaf Cairn I (PRN 4013), facing south-east CPAT 3764-0060

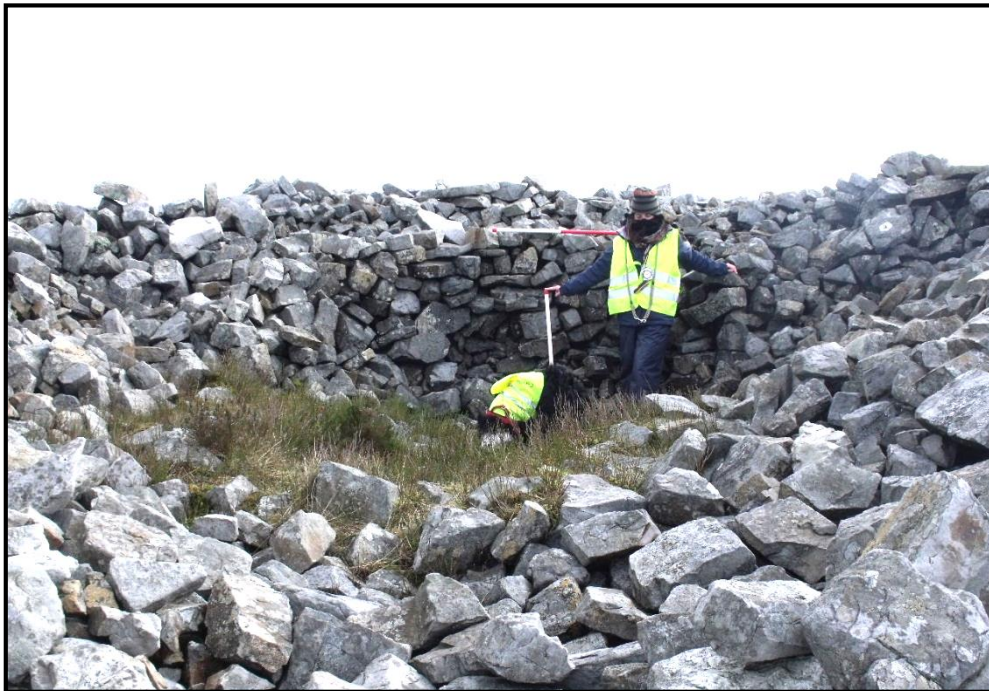
Photo 2. The hollow, presumably a shepherd's shelter in Tair Cairn Uchaf Cairn 1 (PRN 4013)

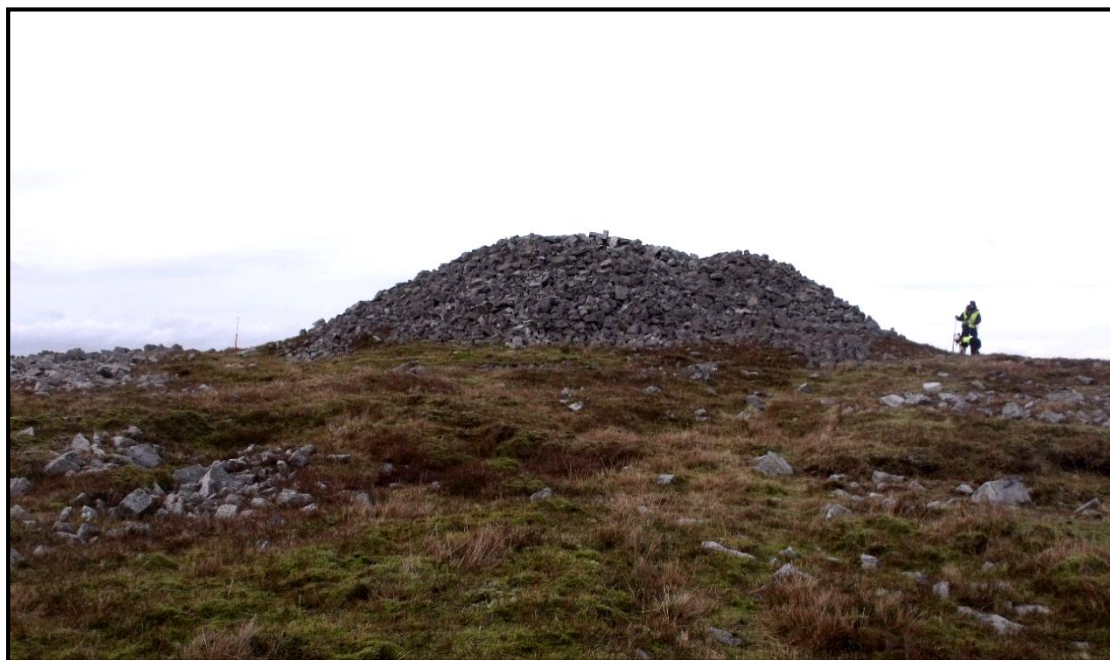
Photo 3. Photo showing hollow in SAM CM255, Tair Cairn Uchaf Carin ii (PRN 4014), facing north
CPAT 3764-0070

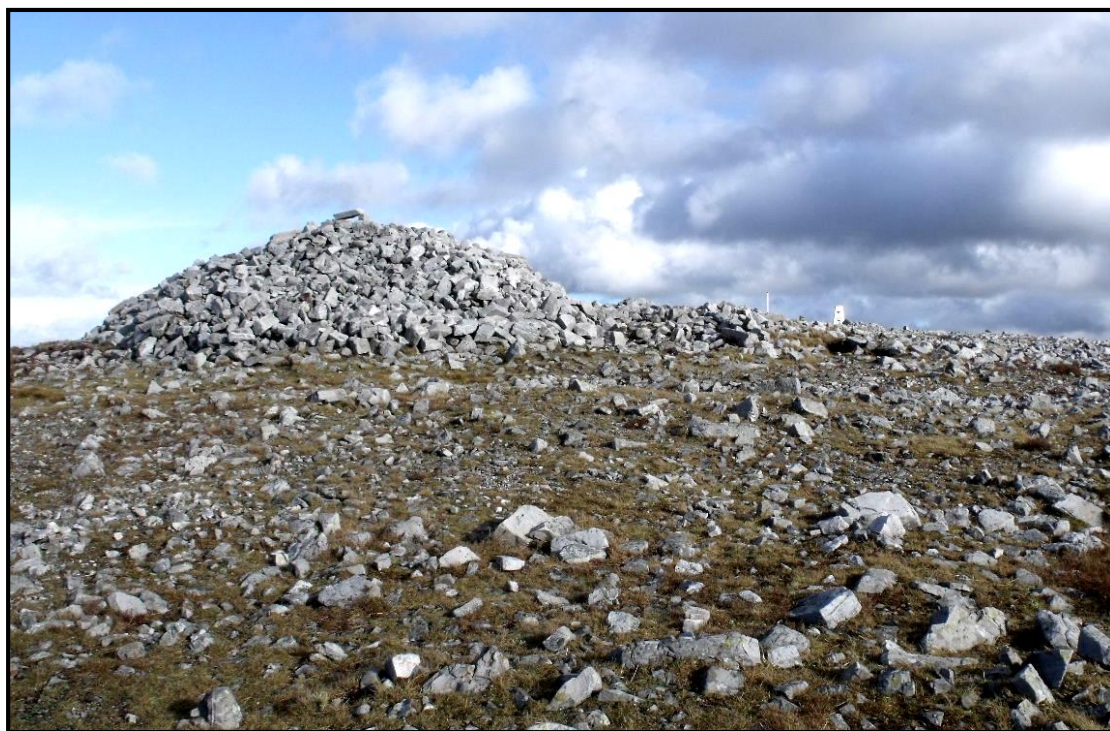
- 4.5 SAMCM256 was designated a 'High' priority SAM owing to known issues regarding frequent disturbance of Cairn ii (PRN 5970) by walkers. Of the four cairns in the group, this is the most prominent, being located at the highest point on the ridge and visible for many miles in all directions. Consequently, an Ordnance Survey triangulation point has been installed next to the cairn and the combination of these two features in the landscape attracts many walkers to the site (Photo 6). The cairn is approximately 2.2m in height and around 8m in diameter with a 2m-wide spread of stones on the eastern side. Cairn ii appears to have been quarried by walkers for cairn building; it has been greatly disturbed by prolonged destruction and construction, and consequently it is difficult to determine the original extent of the cairn. For this reason, it was considered to be in poor condition. At the time of the visit, a small scale 'portal dolmen' like feature had been built into the top of the cairn (Photo 7). This appears to be a reinstated version of damage documented by the BBNPA Heritage Officer in October 2012 (Photo 8). Along with this structural disruption, there was also an area of poaching along the western side of the cairn caused by walkers taking shelter on this side (Photo 9).

Photo 6. Facing northwest showing CM256 Tair Cairn Isaf Cairn ii (PRN 5970) in proximity to trig point CPAT 37664- 0012

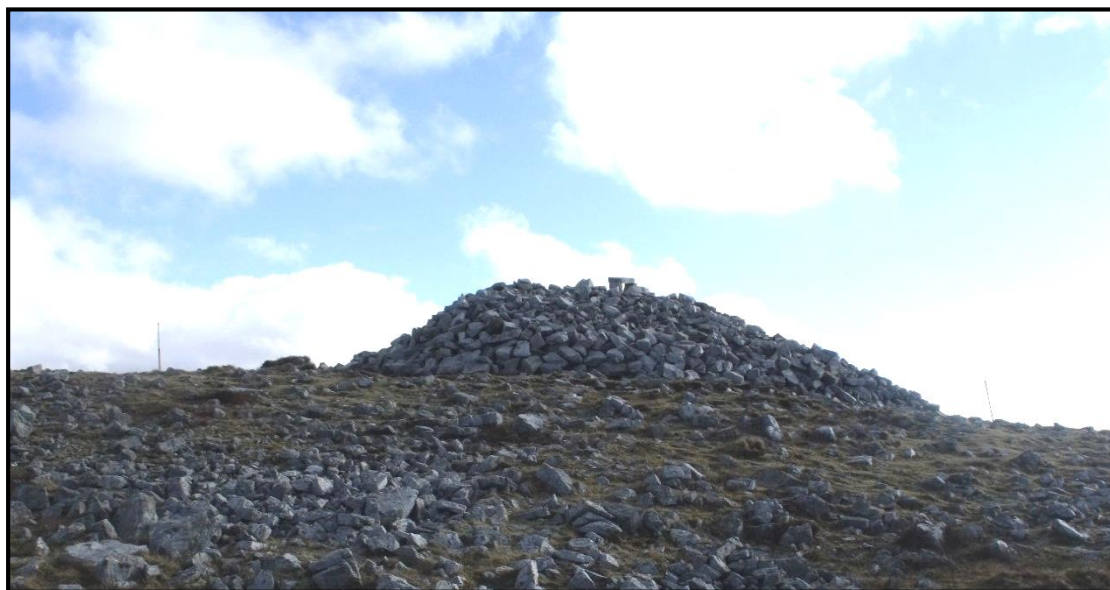
Photo 7. Facing east showing reinstated “portal dolmen” structure on top of CM256 Tair Cairn Isaf Cairn ii (PRN 5970) CPAT 3762-0004

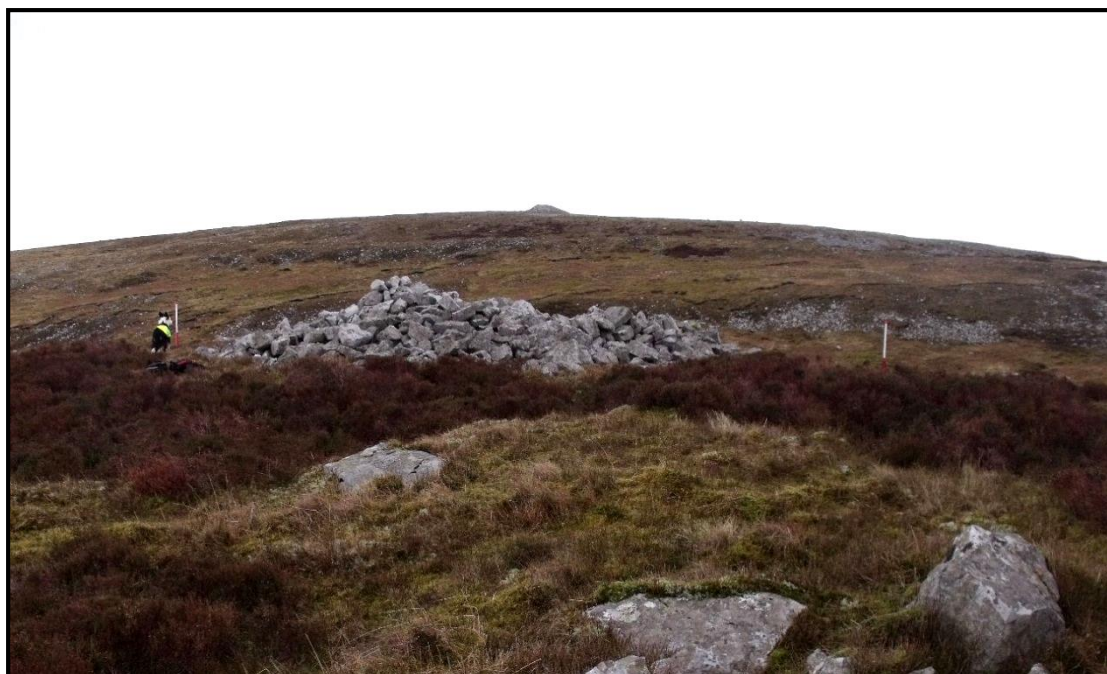
- 4.6 The remaining cairns (PRNs 5969, 5971 and 5972) within the group were assessed as being 'Low' risk sites and were considered to be in good condition (Photos 10, 12,14). All of these cairns had been subject to human intrusions in the past as each one had a hollow in the centre of it (Photos 11,13,15). However, there was no evidence of recent disturbance or any other threats aside from some encroachment by heather that can be considered to be a very minor issue.

Photo 10. Facing east showing CM256 Tair Cairn Isaf Cairn I (PRN 5969) with Tair Cairn Isaf Cairn ii (PRN 5970) in background
CPAT 2764-0085

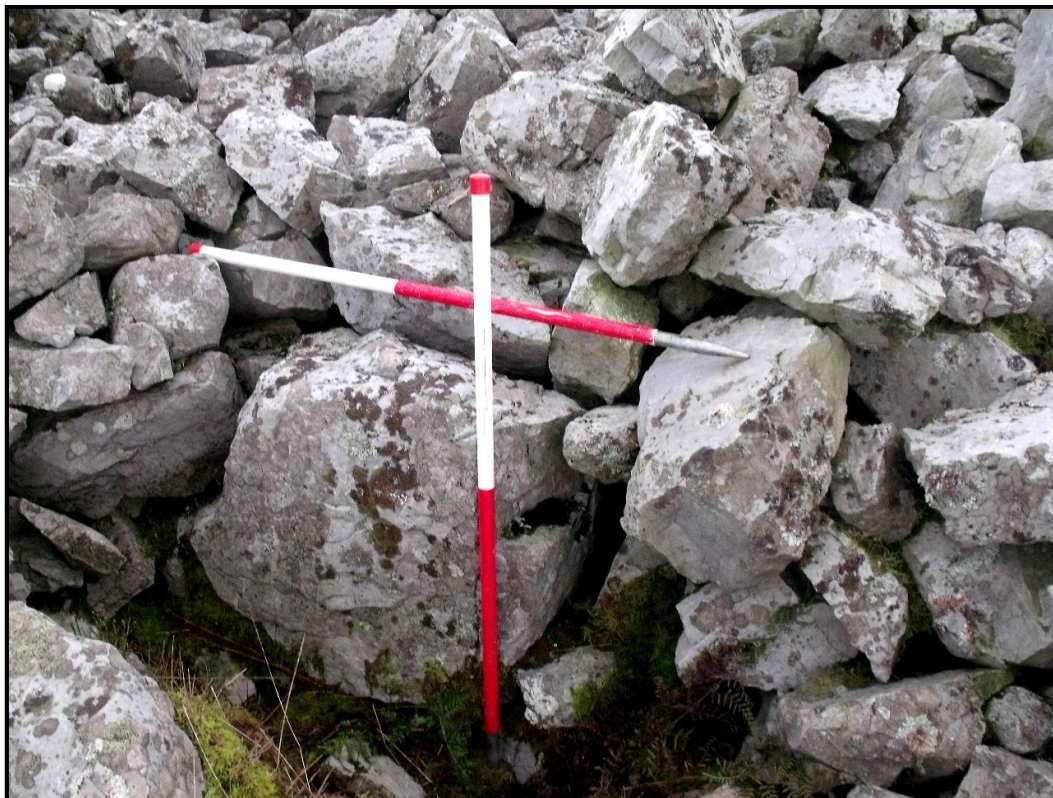
Photo 11. Photo showing hollow inside CM256 Tair Cairn Isaf Cairn I (PRN 5969) CPAT 3764-0087

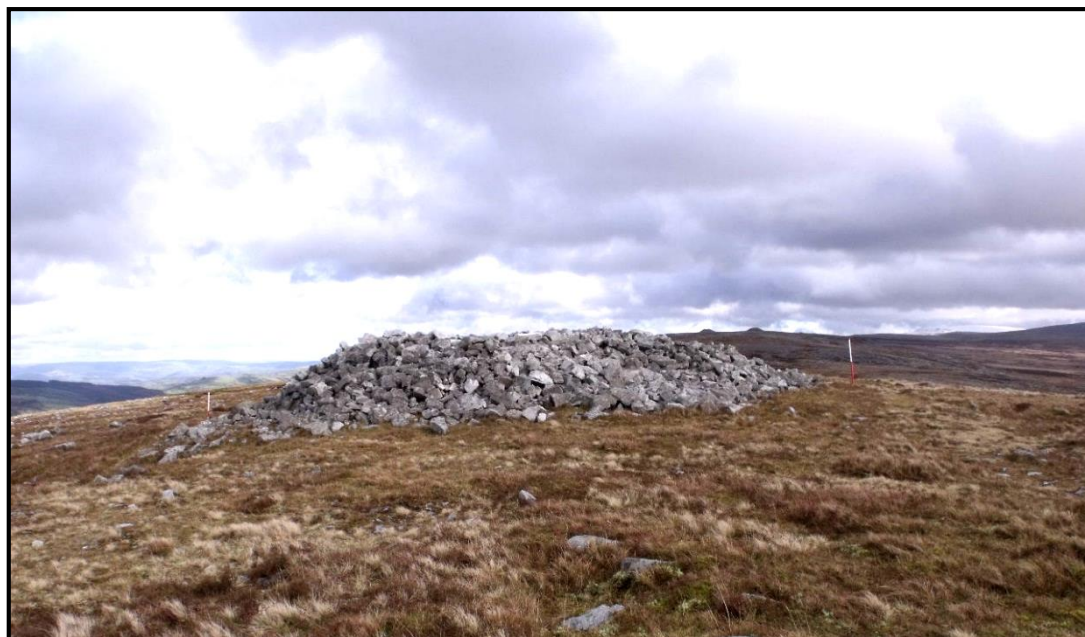
Photo 12. Facing north showing CM256 Tair Cairn Isaf Cairn iii (PRN 5971) with CM255 cairns in background CPAT 3764-0039

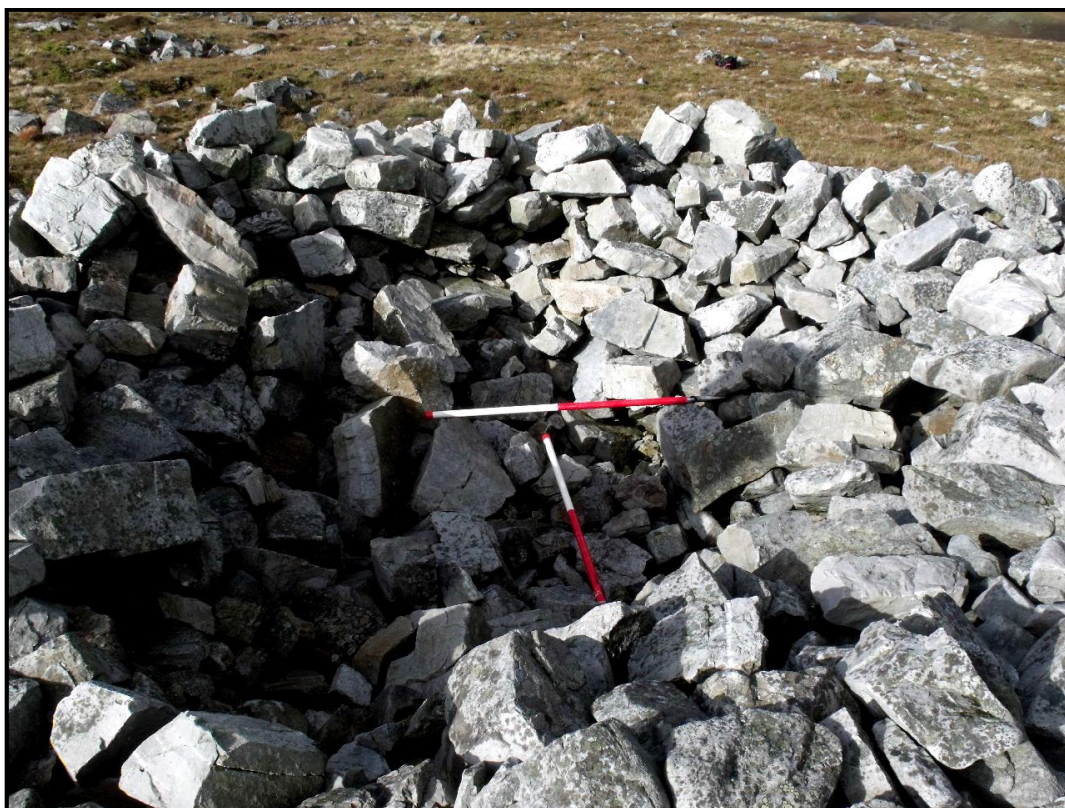
Photo 13. Photo showing hollow in centre of CM256 Tair Cairn Isaf Cairn iii (PRN 5971) CPAT 3764-0043

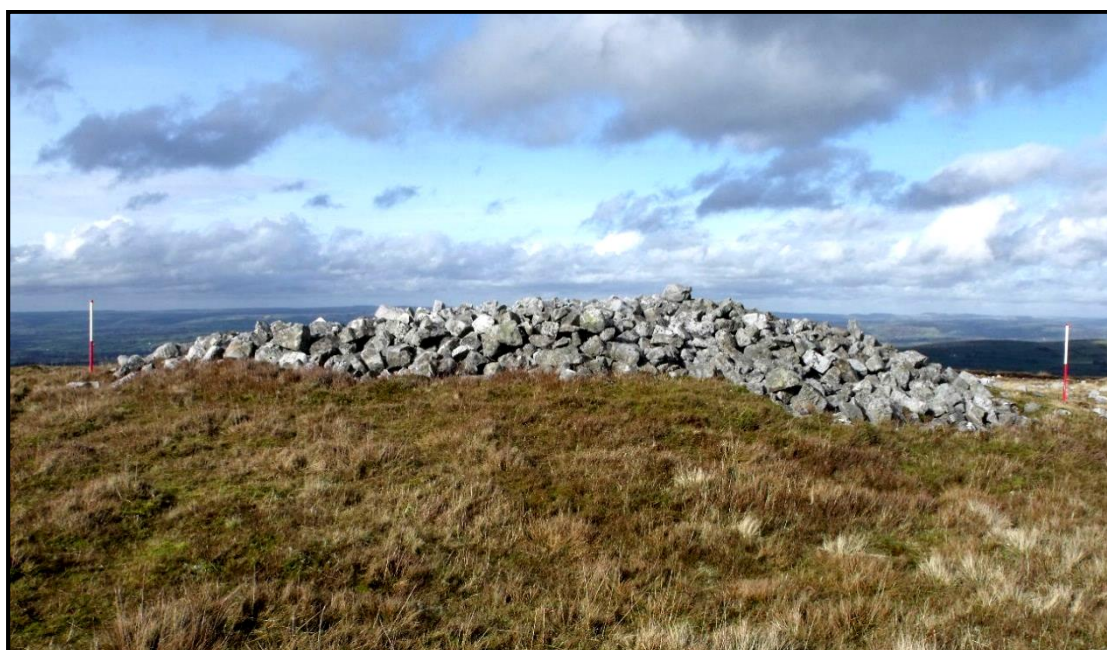
Photo 14. Facing west showing CM256 Tair Cairn Isaf Cairn iv (PRN 5972) CPAT 3764-0047

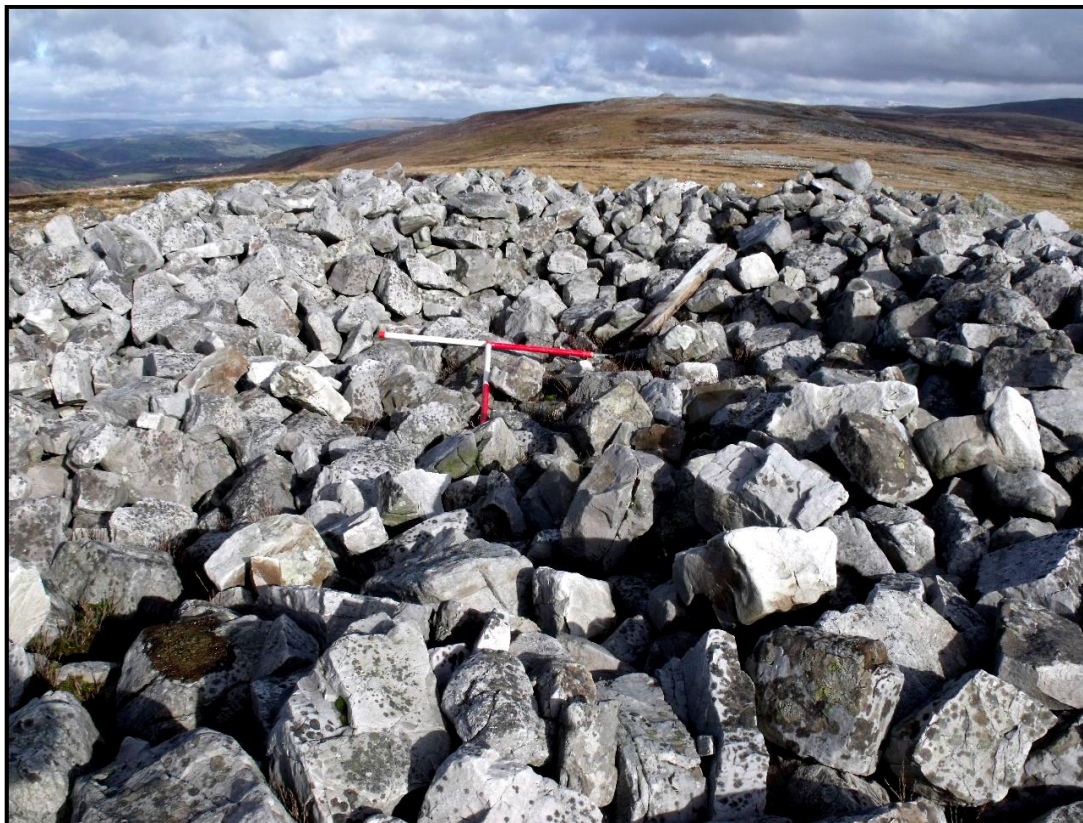
Photo 15. Facing north showing hollow in CM256 Tair Cairn Isaf Cairn iv (PRN 5972) CPAT
3764-0052

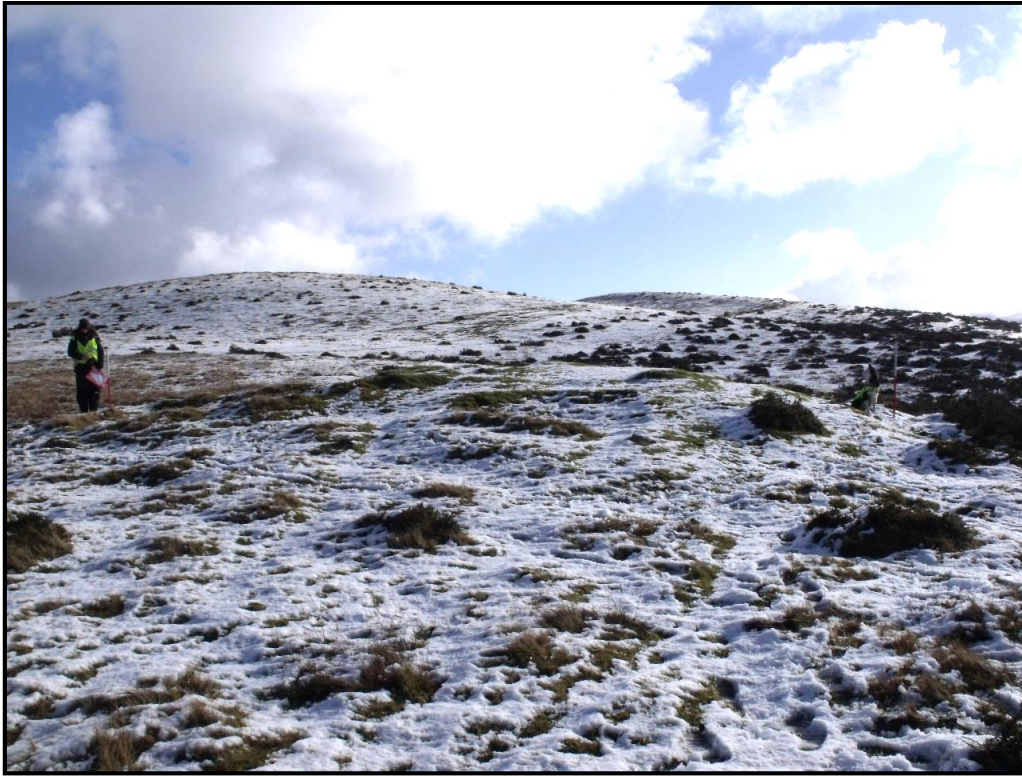
Photo 23. Facing southeast showing CM337 (PRN 14418) Arhosfa Garreg Llwyd Barrow

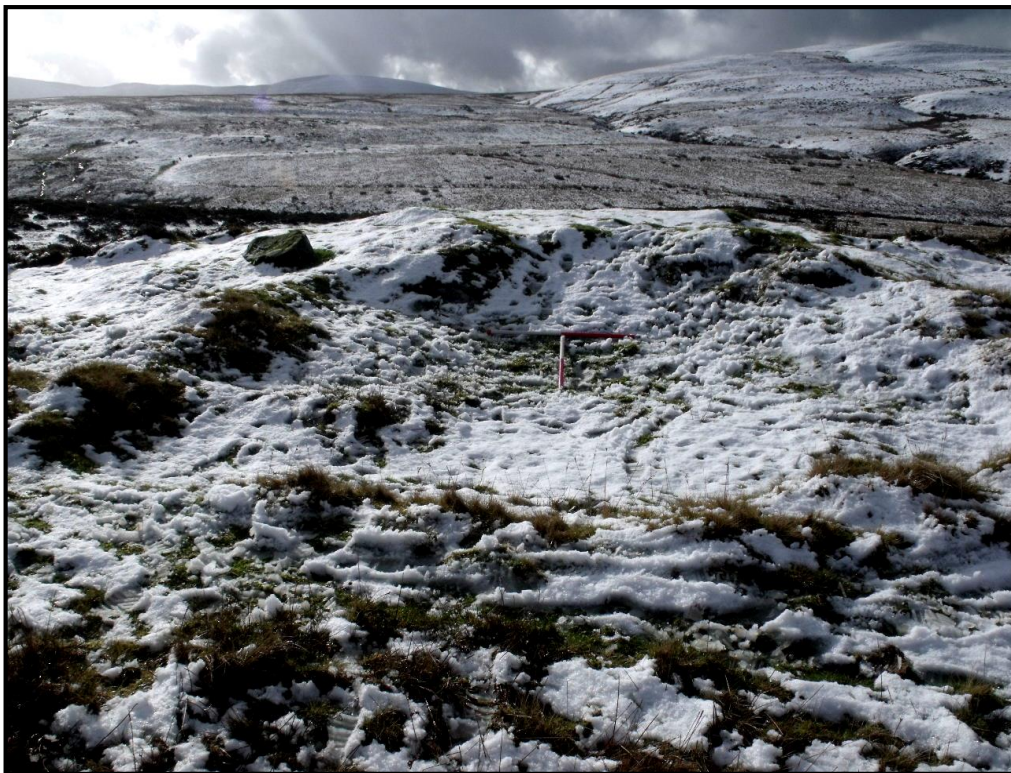
- 4.12 Group 9 was made up SAMs CM174 and CM337, located on Mynydd Llan, Black Mountain in Carmarthenshire (Map 3). These also fall within the Dyfed Archaeological Trust's area. Both of these SAMs were designated as 'High' priority sites due to the lack of information available and since they hadn't been visited in over 10 years.
- 4.13 CM337 (PRN 14418) is Arhosfa Garreg Llwyd Barrow; a low and roughly circular barrow located some 200m west of CM174; it is approximately 11m in diameter and 0.8m in height. This barrow was considered to be in fair condition, and after assessment, was categorised at 'Medium' risk. At the time of the visit, a fine layer of snow blanketed the site (Photo 23). However, it was clear to see that the barrow had been quarried sometime in antiquity and large areas of the barrow

had been removed, particularly in the northwest and southern west areas (Photo 24). From what was visible, there did not appear to be any evidence of recent disturbance. The current issue threatening this site at the moment is the encroachment of gorse. At the time of the visit, there were around ten young gorse bushes concentrated on the eastern side of the barrow and legion of gorse approaching from the East within and beyond, the buffer zone (Photo 25).

Photo 24. Facing southwest showing area of quarrying in northeast side of cairn of CM337 (PRN 14418)

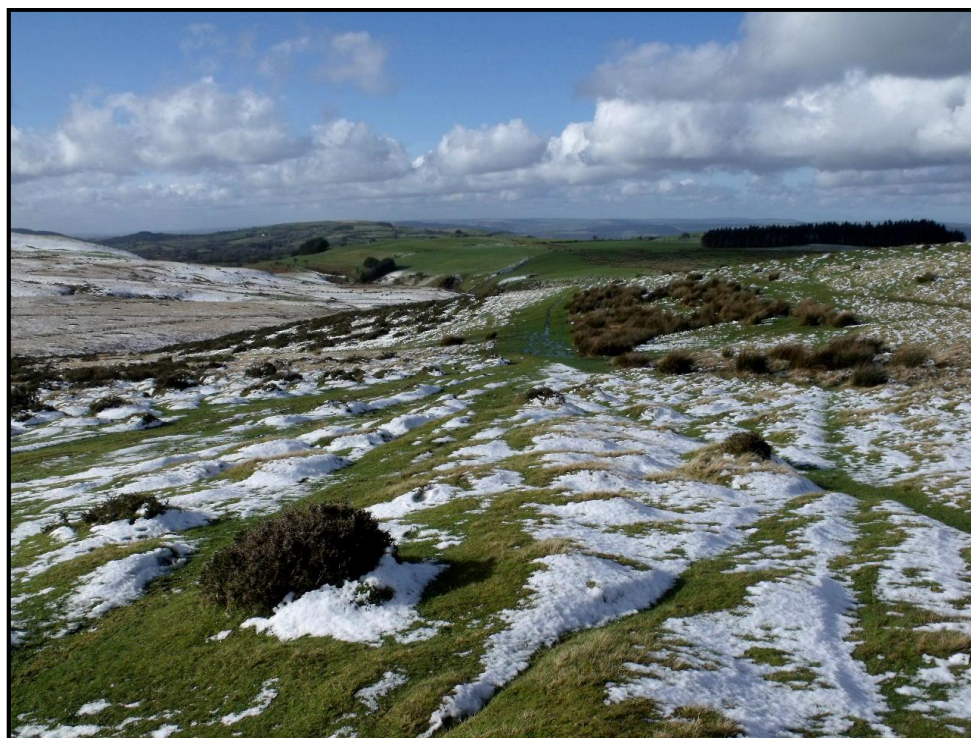
Photo 29. Facing west showing gorse on southwest side of CM174 (PRN 4142) CPAT 3793-0011

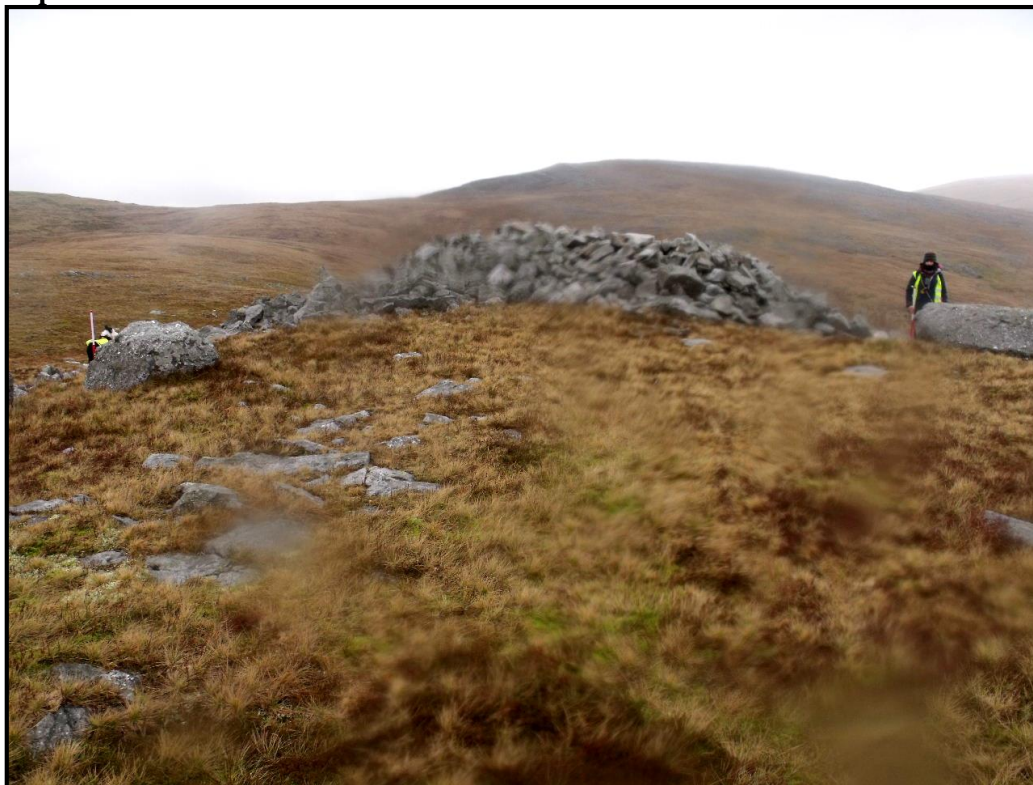
- 4.17 CM356 is Carn Fadog (PRN 4042), a cairn located on a high ridge on the south-eastern side of Cefn Carn Fadog (Photo 31). It is roughly oval in plan measuring approximately 8m x 4m, and 1.1m in height. There is a large hollow in the centre of the cairn. In the HER info for this site this is reportedly a shooting hide (Photo 32). There is some sheep track erosion on the north side of the cairn. There was no evidence of any other active threats or erosion and for this reason the cairn was considered to be in good condition and at 'Low' risk.

Photo 31. Facing north showing Carn Fadog Cairn CM356 (PRN 4042) CPAT 3794-0027

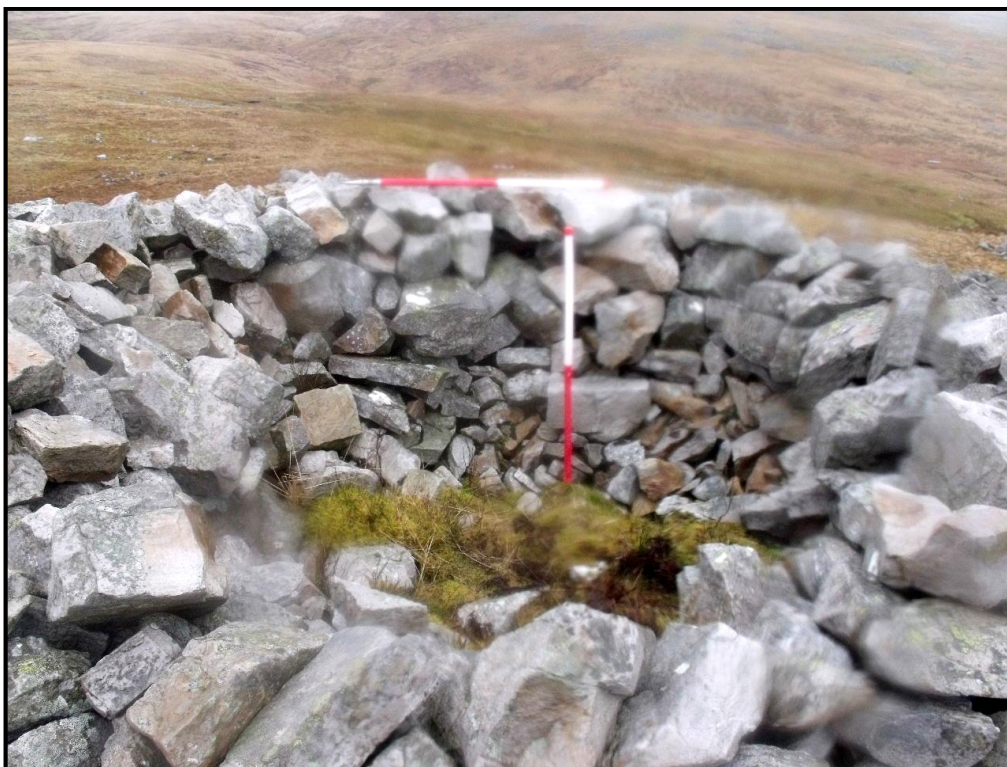
Photo 32. Facing east showing hollow/shooting hide in centre of CM256 (PRN 4042)
CPAT 3794-0028

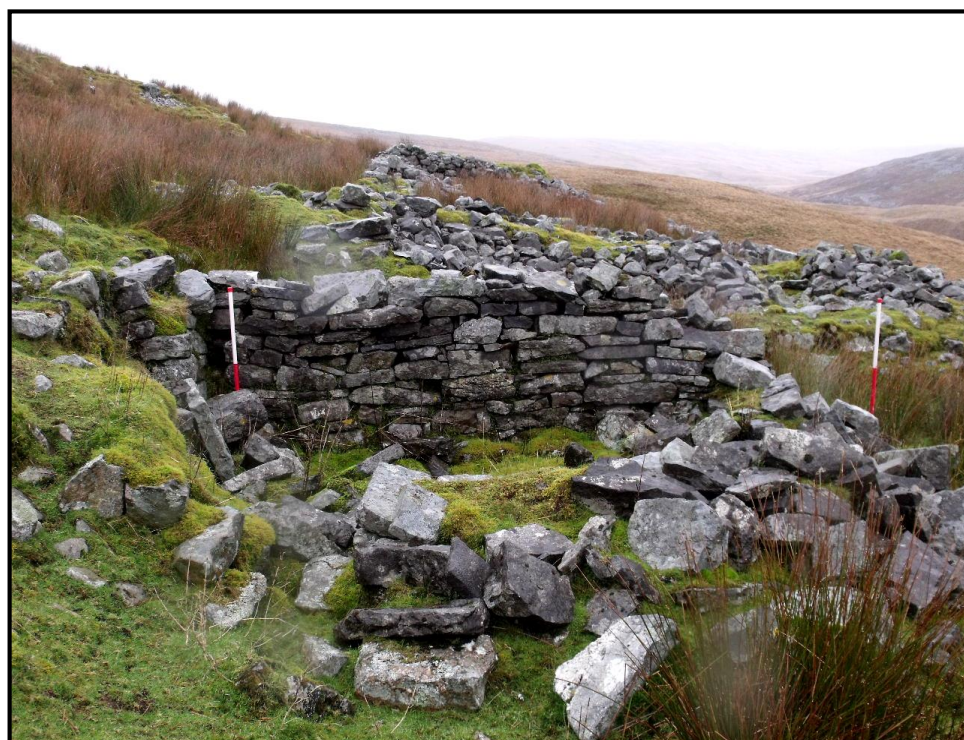
- 4.19 The long hut (PRN 31806) consists of a single-celled building around 3.5m x 2m in plan, with well-constructed walls surviving up to 1m in height on its north side and 0.3m on its south (Photo 33). Aside from collapse, the only active threat identified for this site was the encroachment of lush reeds that almost completely encircle the site (Photo 34). It was considered to be in good condition and at 'Low' risk.

Photo 33. Facing north showing CM355 Longhut (PRN 31806) with CM355 (PRN 31809)
Longhouse in background CPAT 3794-0004

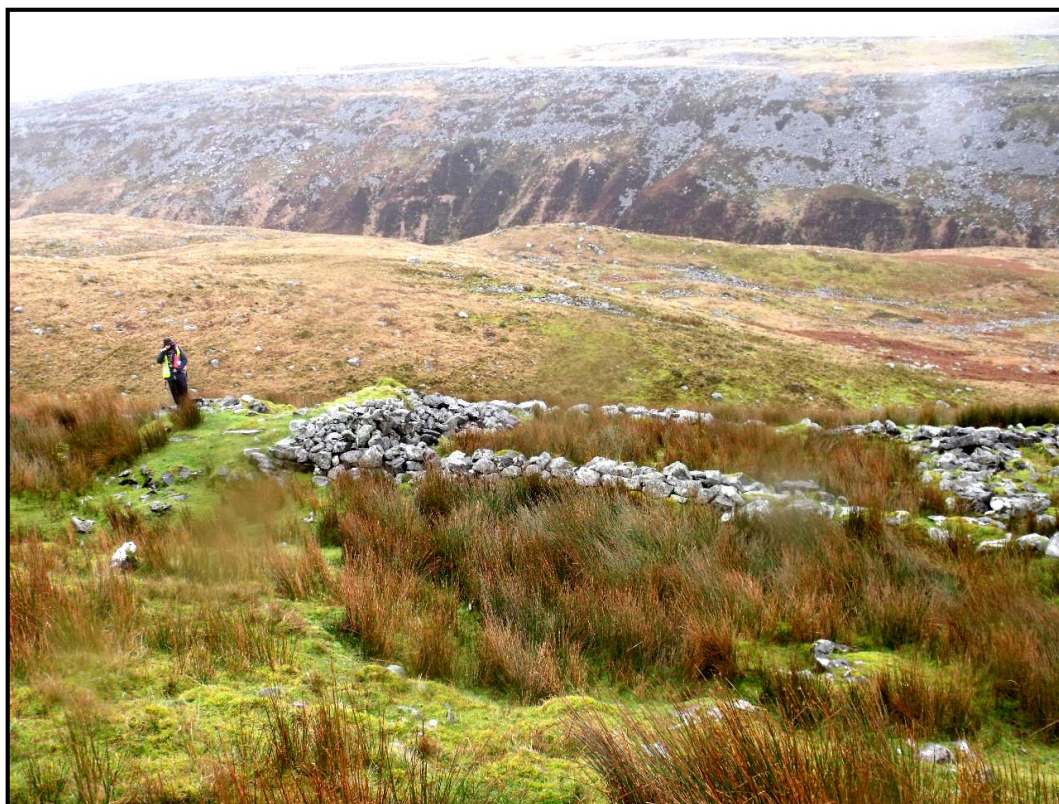
- 4.21 Associated with the longhouse PRN 31809 is a limekiln (Photo 35). This is not mentioned in the HER description of the site, but does form part of the title of the Schedule; it was therefore recorded as an individual component of the SAM. The limekiln is small and is built into the bank at the north end of the longhouse. It has mostly collapsed but has yet to be subsumed by the bank, as so often is the case with particularly antiquated limekilns (Photo 36). It measures around 2m in height and around 2.5m in width and the pot diameter is roughly 1.8m. Its quarry is located on a terrace above it, to the west of the site. It is fair condition and other than its structural collapse, the other threats appeared to be encroachment of reeds and some minor stock erosion on top of the kiln.

Photo 35. Facing east. The author is standing on the top of the limekiln located at the north end of CM355 (PRN 31809) Longhouse CPAT 3794-0011

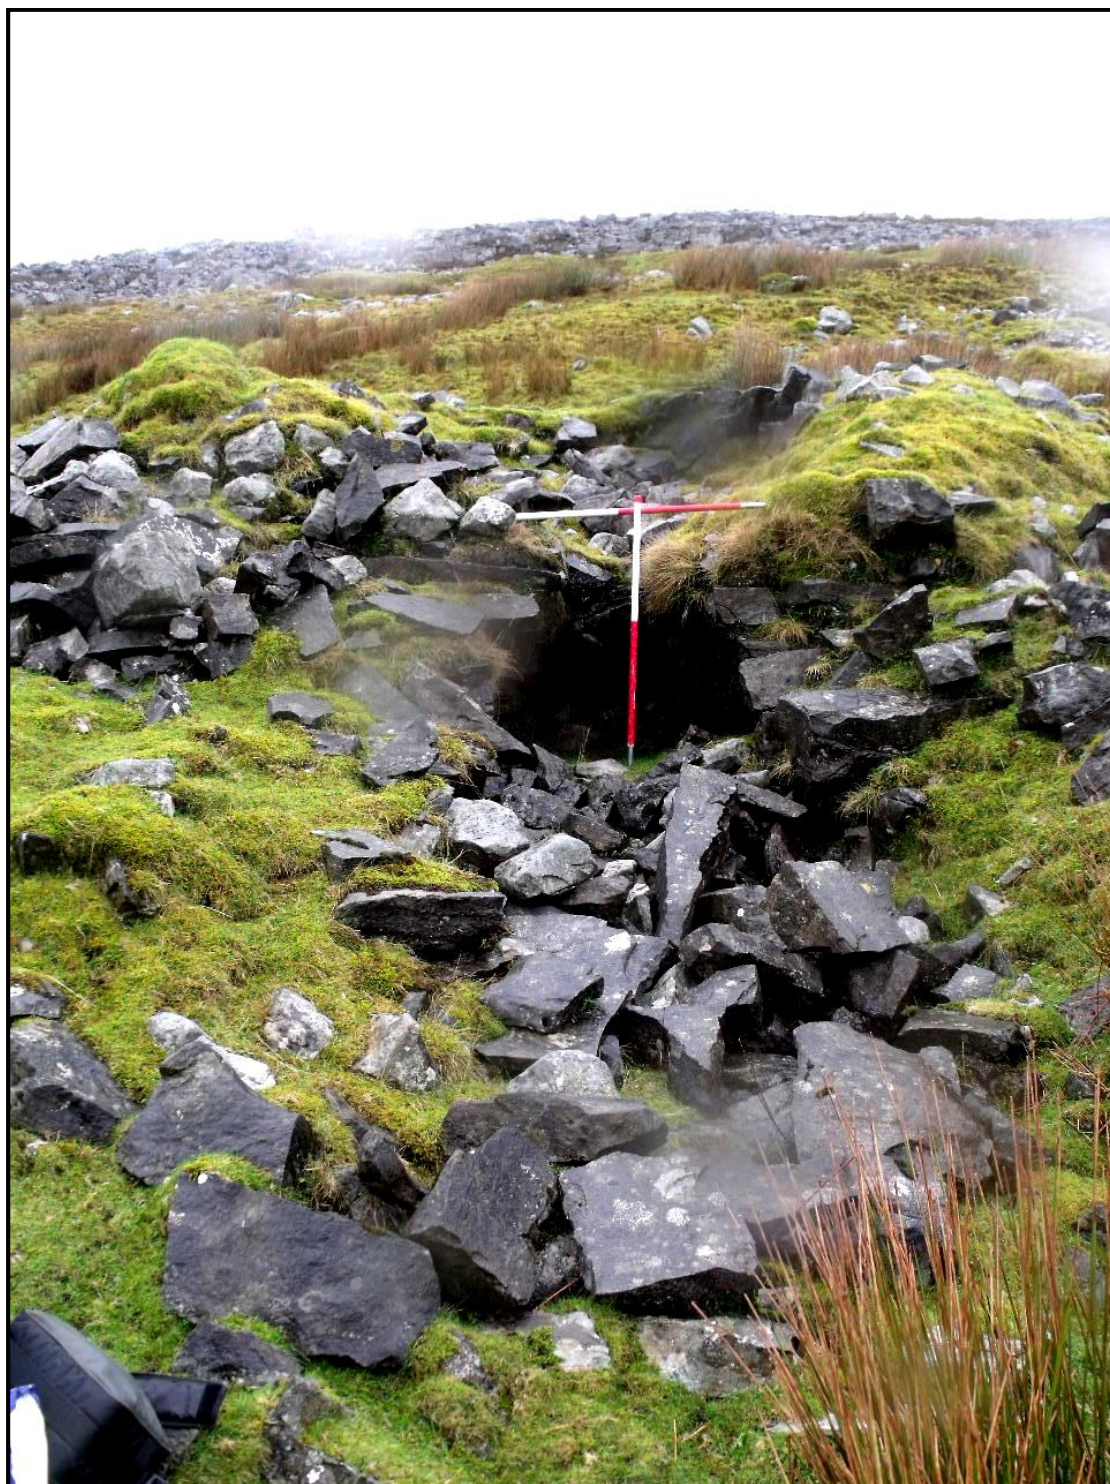
Photo 36. The front of the limekiln located at the north end of CM355 (PRN 31809)

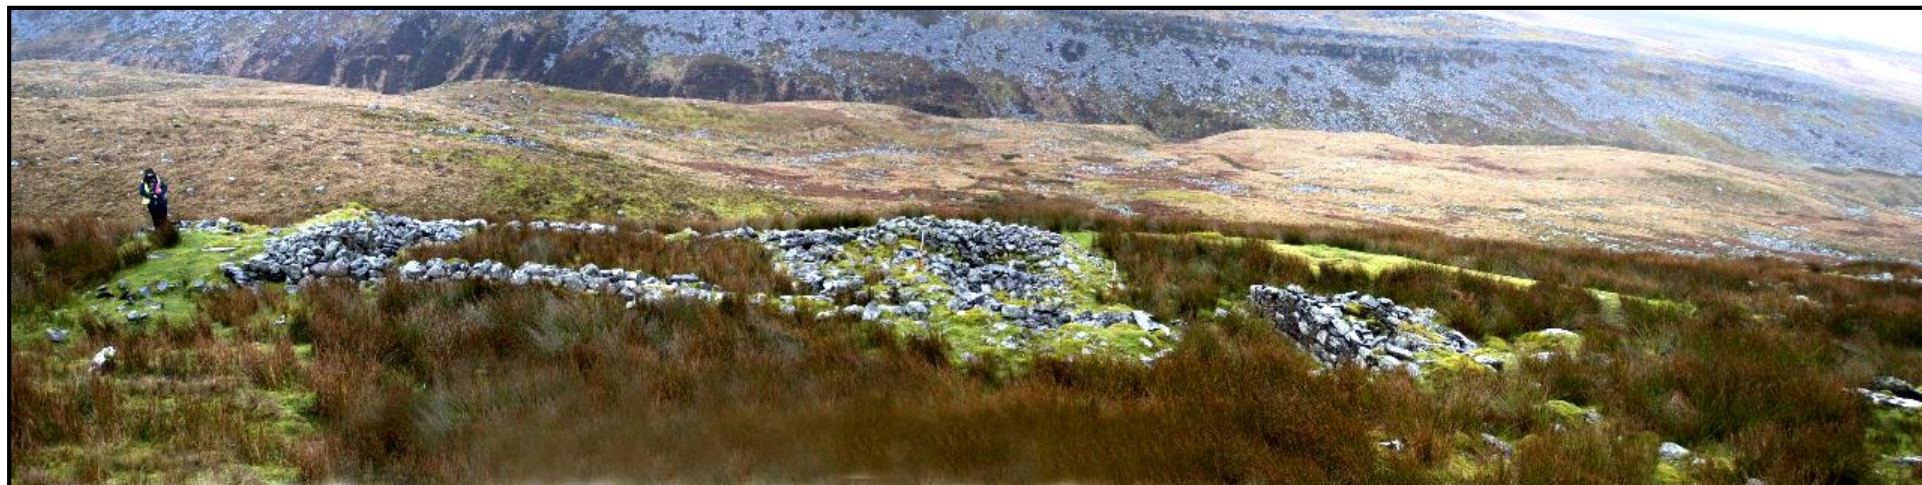
- 4.22 Overall this SAM was assessed as being at 'Low' risk and is generally in good condition (Photo 37).

Photo 37. Facing east; a stitched photo showing (L:R) CM355 Limekiln, CM355 (PRN 31809) Longhouse and CM355 (PRN 31806) Longhut CPAT 3794-0031

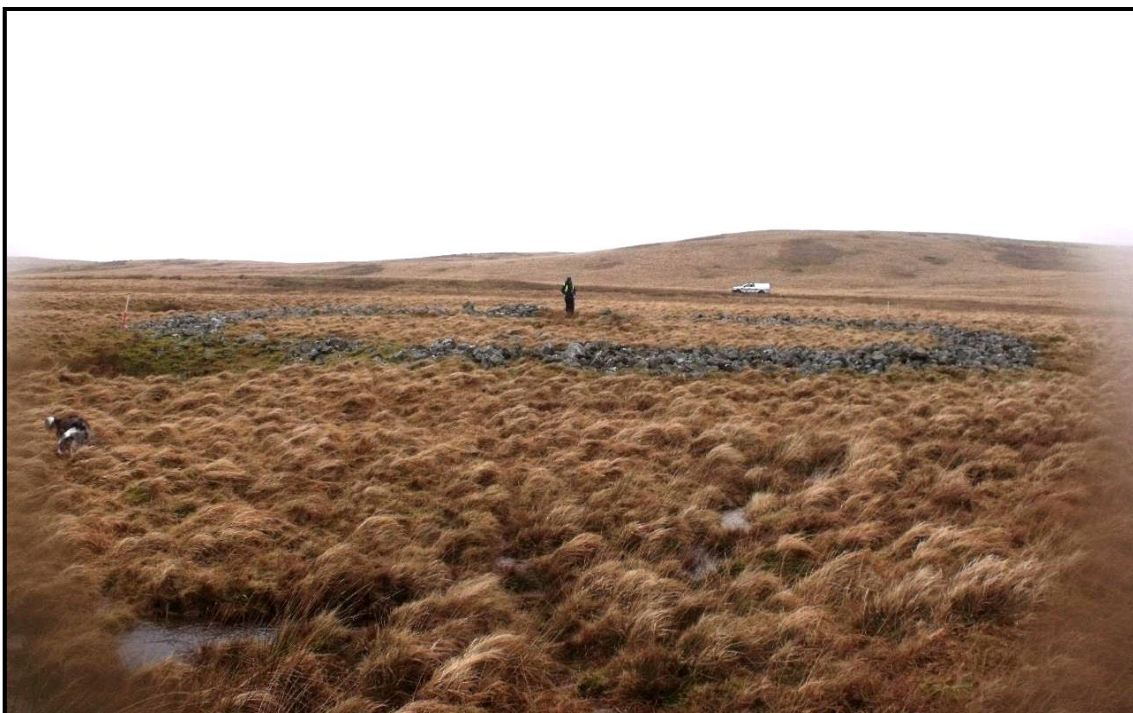
- 4.27 Cairn ii is in fact; a well-preserved and impressive ring cairn located around 150m South of the road. The stone bank is on average 1.5m wide and up to 0.5m in height and it is around 25m in diameter (Photo 39). There is a small sinkhole at the south-west area of the ring causing subsidence in this area (Photo 40). In the centre of the cairn there are a small number of large, almost upright, Limestone blocks. It is tempting to describe these as possible recumbent standing stones, although that can only be speculation without further investigation. There was no evidence of any recent disturbance or active erosion and no threats were identified. Consequently, this site was considered to be in optimal condition and at low risk.

Photo 39. Facing north; the author is standing in the centre of BR137 Cairn ii (PRN 004491m). Not the proximity to the road running East/West in the background CPAT 3795-0018

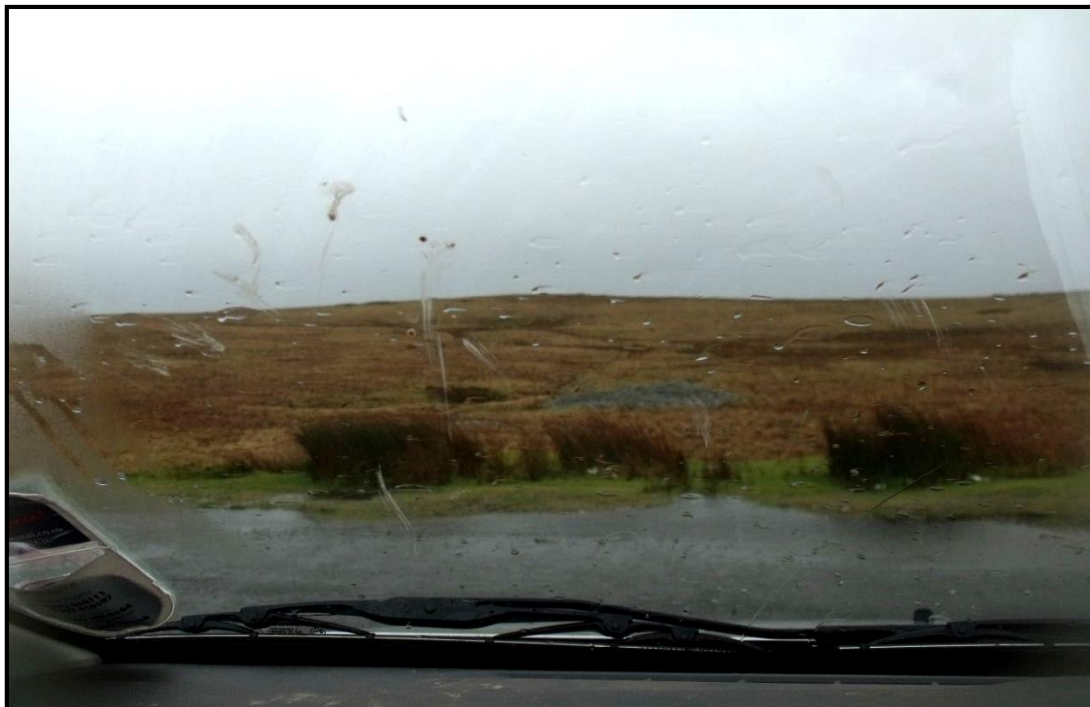
- 4.28 Cairn iii is presumed to be PRN 00768m, although again the grid reference stated by GGAT was incorrect. This is a high, oval-shaped cairn approximately 12m x 14m in plan and 2m in height. It is located some 100m south of the road from which it is clearly evident as a cairn (Photo 41). It is well preserved save for two small hollows in the Eastern and Western ends. Aside from this, there is no evidence for any other active threats or erosion although there is a sheep track to the within the buffer zone to the west of the cairn. The cairn was considered to be in good condition and a 'Low' risk site (Photo 42).

Photo 41. Cairn iii (PRN 00768m) of BR1367 visible from inside the BBNPA Warden's truck parked on the side of the road. Facing south showing cairn in proximity to road and also the challenging weather conditions
CPAT 3795-0008

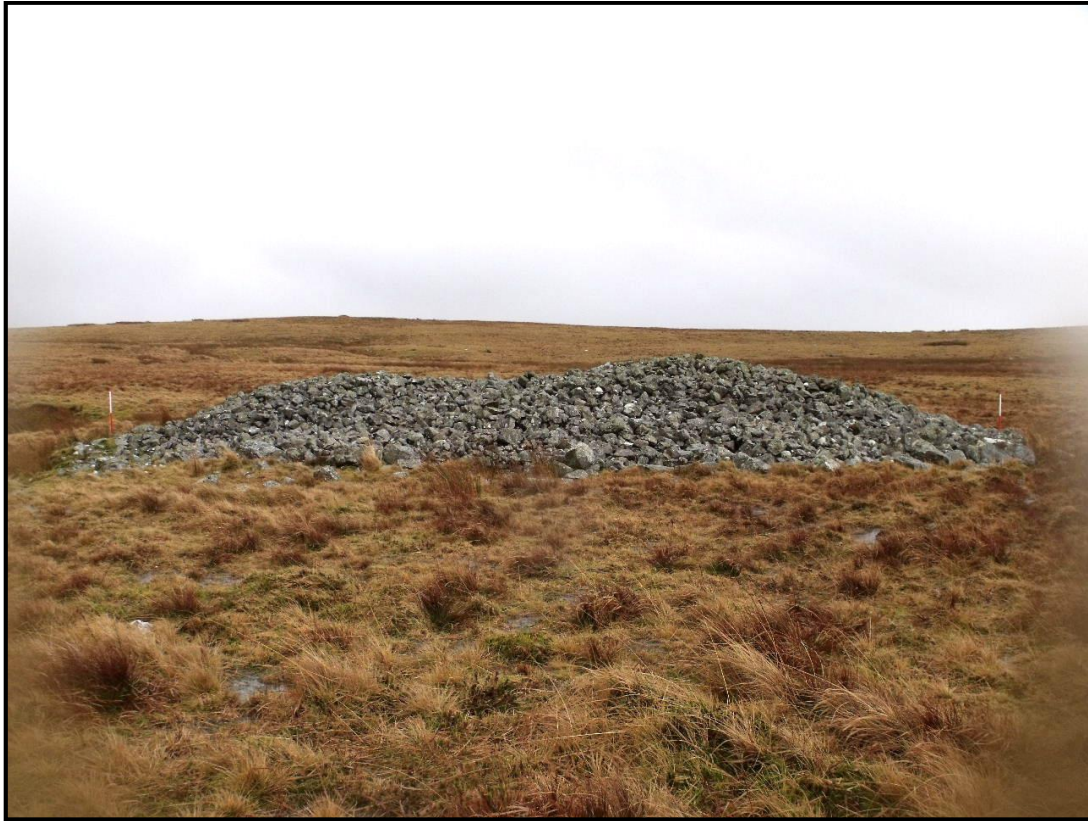
Photo 42. Facing west showing Cairn iii (PRN 00768m) of BR137

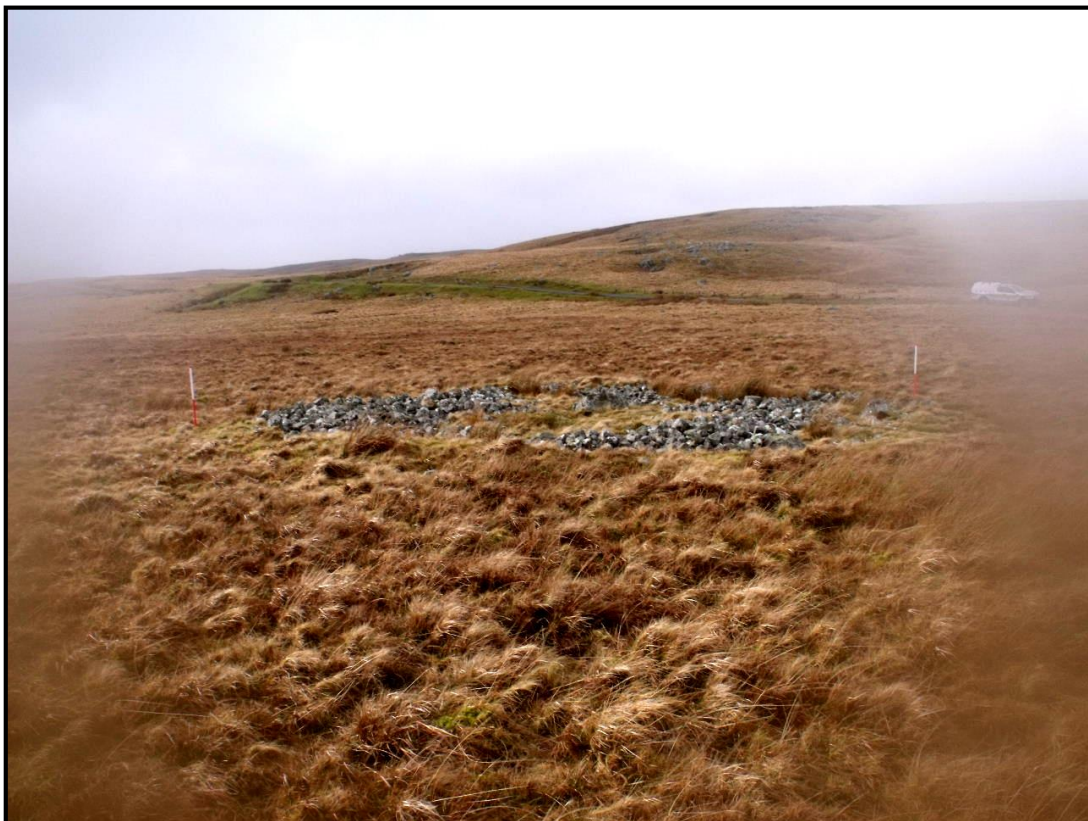
- 4.29 Cairn iv had not been allocated a PRN, but did appear in the scheduling description, though without a grid reference. By process of elimination, the cairn was identified as being the most north-easterly within the group, closest to the road. This appeared to be another ring cairn although it is significantly smaller at around 12m in diameter and 0.2m in height, and is less well preserved than PRN 00491m (Photo 43). However, it does have a very distinct kerb around the outside of the cairn which is approx c.0.3m in width. The interior of the cairn is not well defined as there is a spread of stones in the centre. It seemed most likely that this disruption may actually be due to subsidence of the ground beneath the cairn as it is located in an active karst landscape with numerous sinkholes nearby (Photo44). At the time of the visit, the ground around the cairn was very wet with lots of standing water. There were some reeds located on and around the cairn and there was one sheep track running northeast-southwest through the buffer zone on the west side of the cairn. Unlike the other cairns in this group, there was some evidence of recent disruption as the removal scars of three stones were clearly visible on the eastern side. However, aside from this there were no other active threats or disturbance evident. This cairn was considered to be in good condition and at 'Low' risk.

Photo 43. Facing north showing Cairn iv of BR137 (no PRN). Note proximity to road running east/west in the background
