CPAT Report No. 1259

Brecon Beacons National Park Scheduled Ancient Monument Condition Survey 2014

Archaeological condition survey

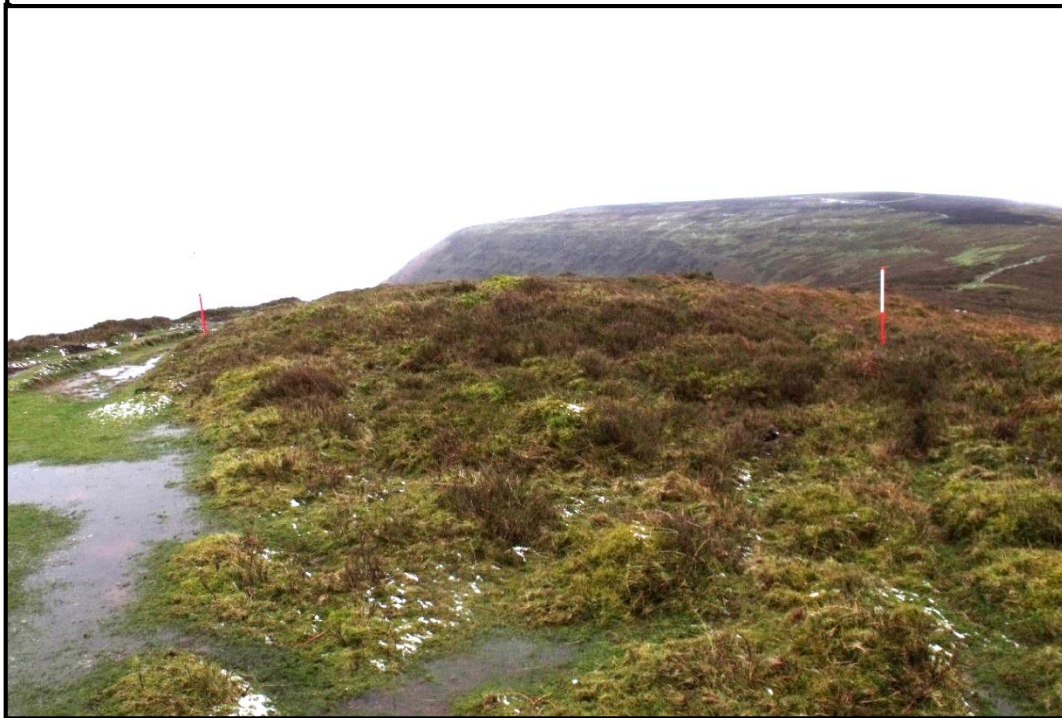
CPAT 3796-0002

Photo 45. Facing south showing MM299 (PRN 08459g) Rhiw Arw Cairn covered by heather

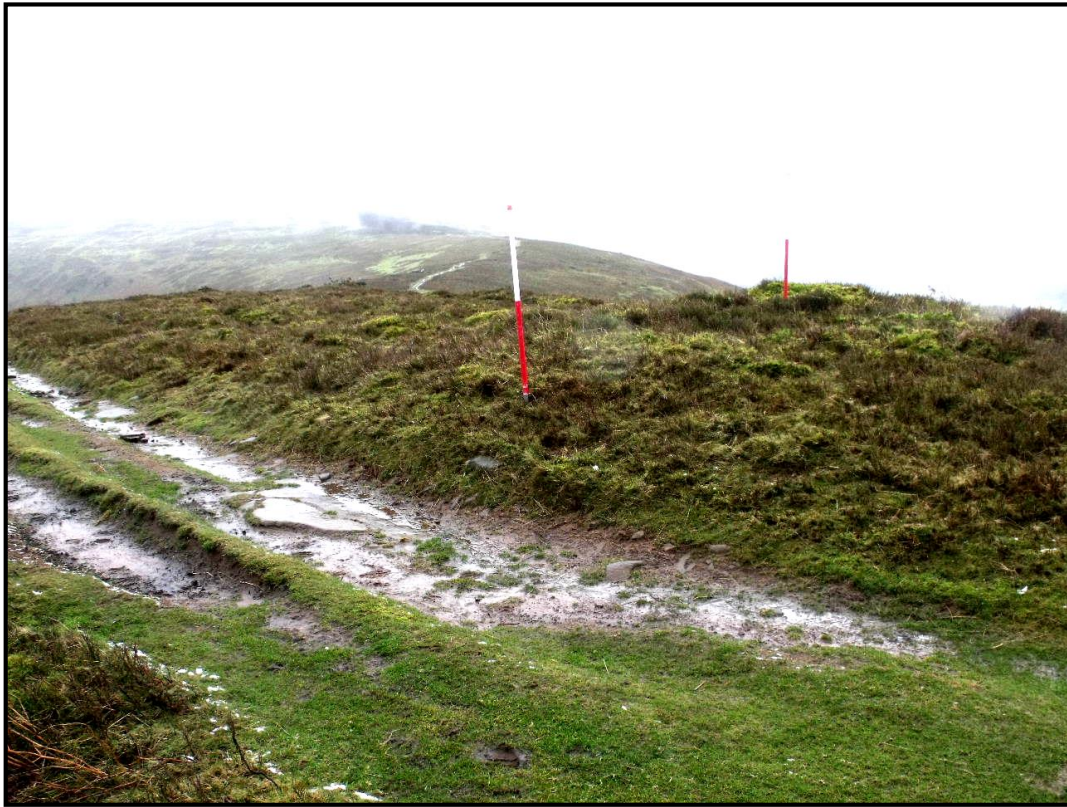
CPAT 3796-0005

Photo 46. Facing southeast showing proximity of MM299 (PRN 08459g) to Offa's Dyke footpath

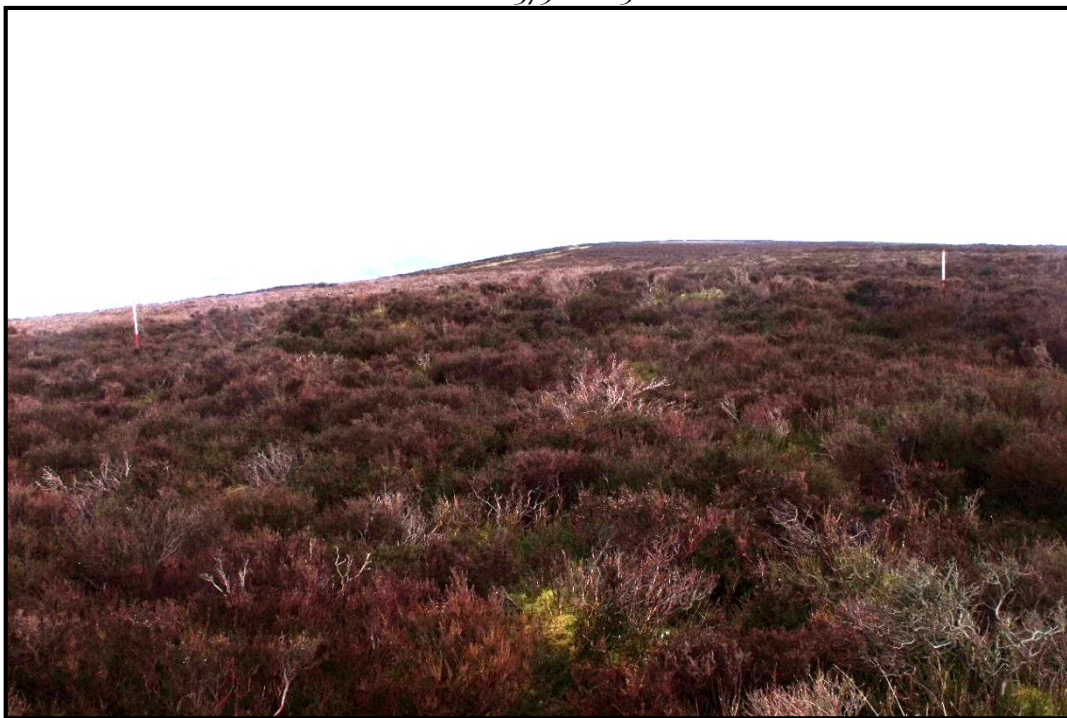
CPAT 3796-0007

Photo 47. Facing east showing MM302 (PRN 8014g) Cairn 1 under thick heather coverage

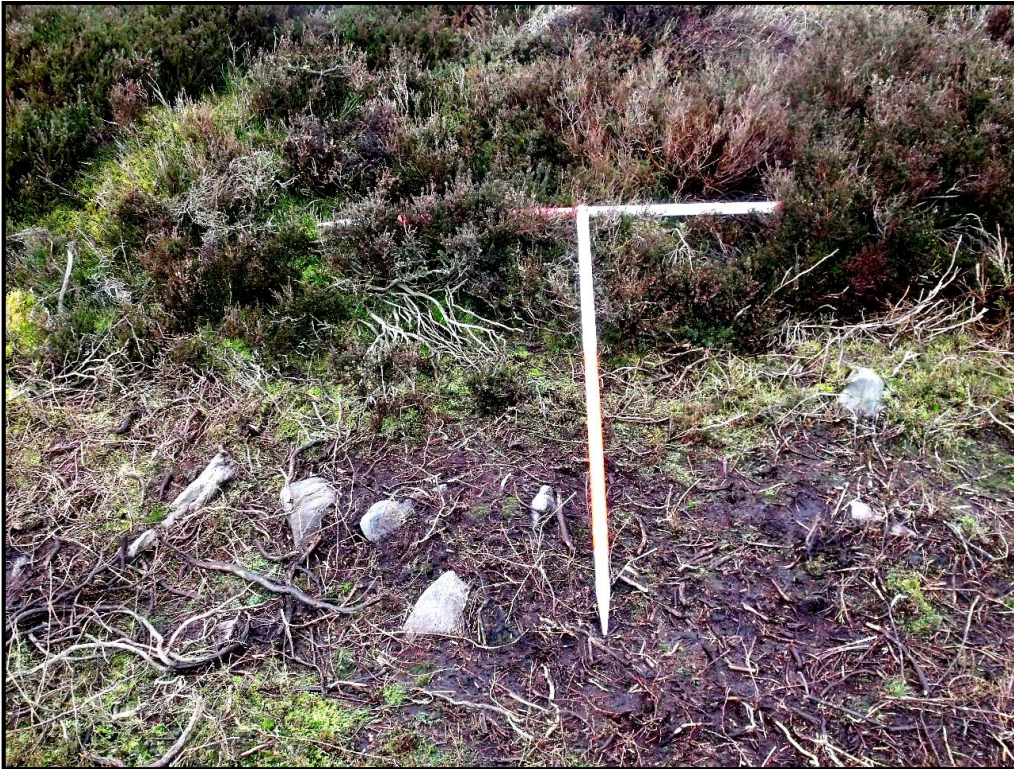
CPAT 3796-0010

Photo 48. Showing spread of stones in south-eastern area of MM302 (PRNo8114g) Cairn i

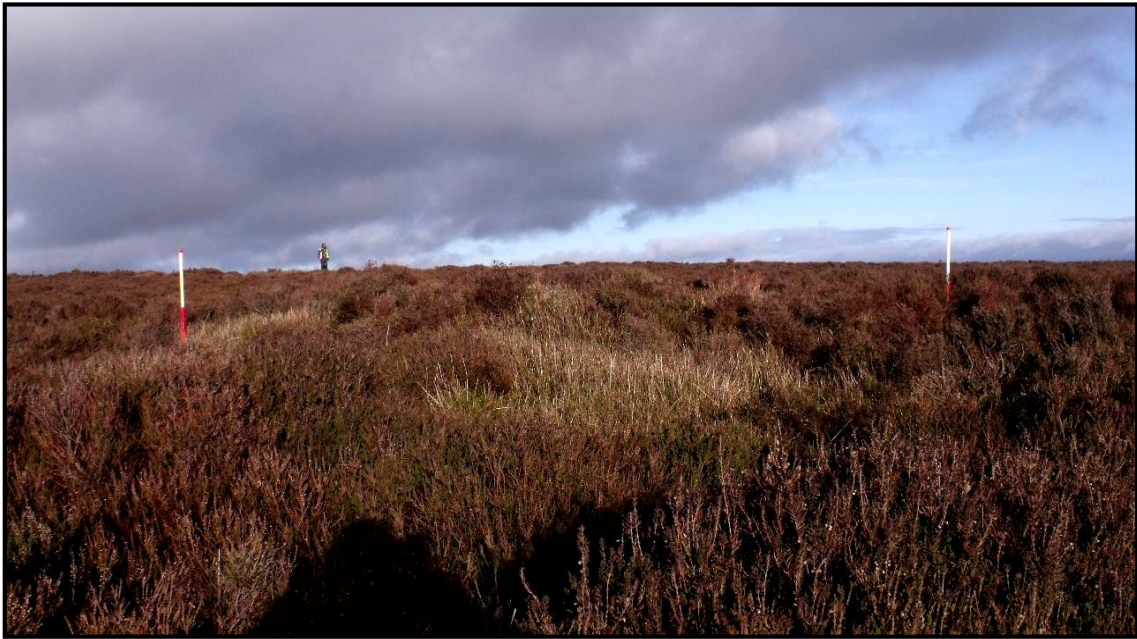
Photo 50. Facing northeast showing MM302 (PRN 08114g) Cairn ii in foreground. The author is standing on MM261 (PRN 1600g) in the background
CPAT 3796-0033

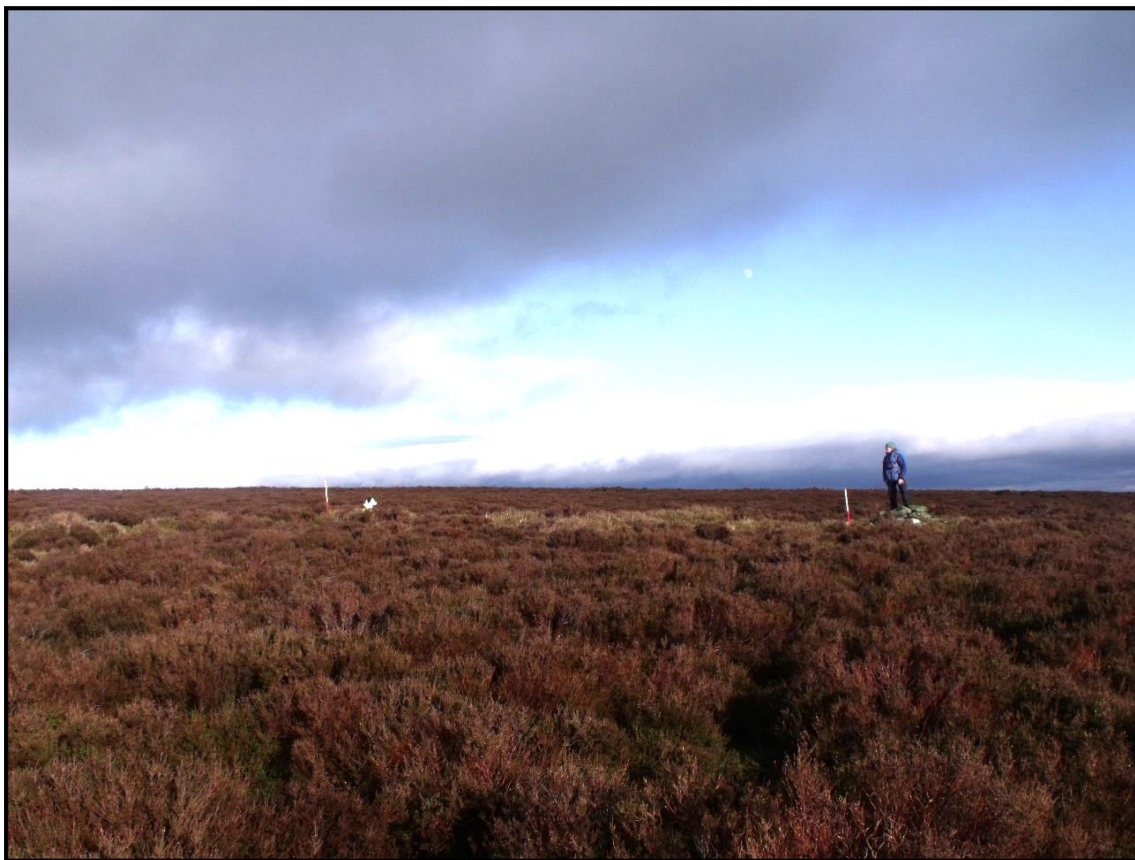
Photo 51. Facing north showing BBNPA Heritage Officer Natalie Ward standing on stone bank of MM261 (PRN1600g) circular enclosure
CPAT 3796-0026

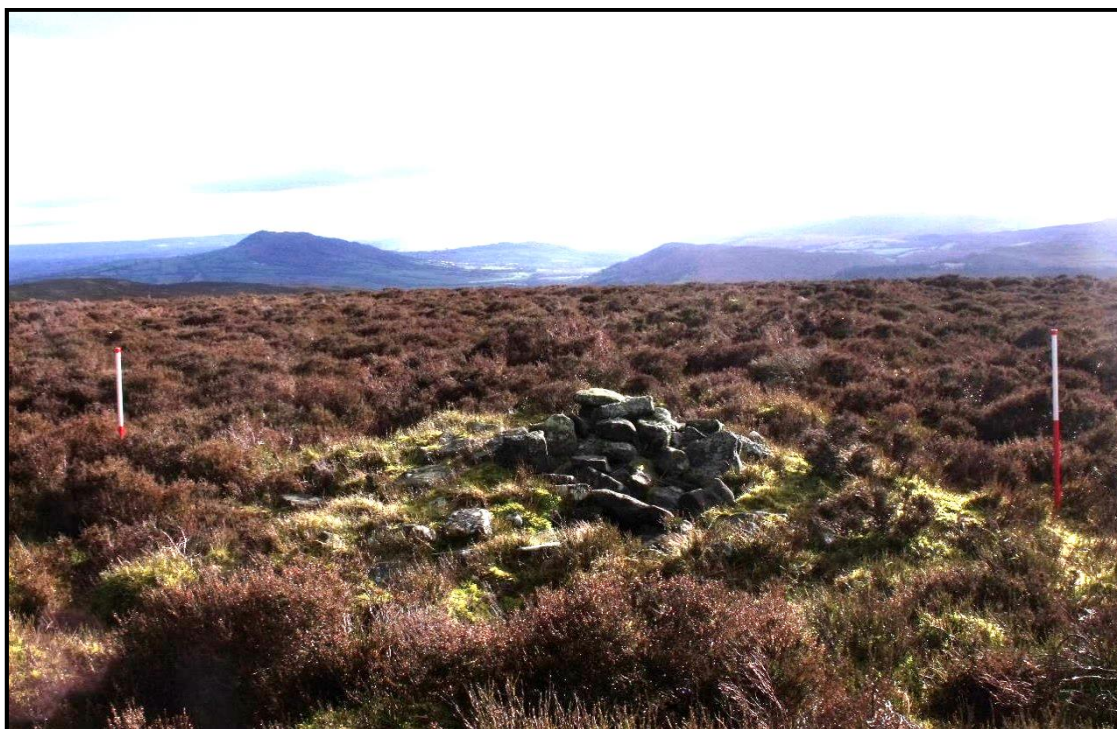
CPAT 3796-0028

Photo 52. Facing south showing cairn like structure at northern end of MM261 (PRN1600g)

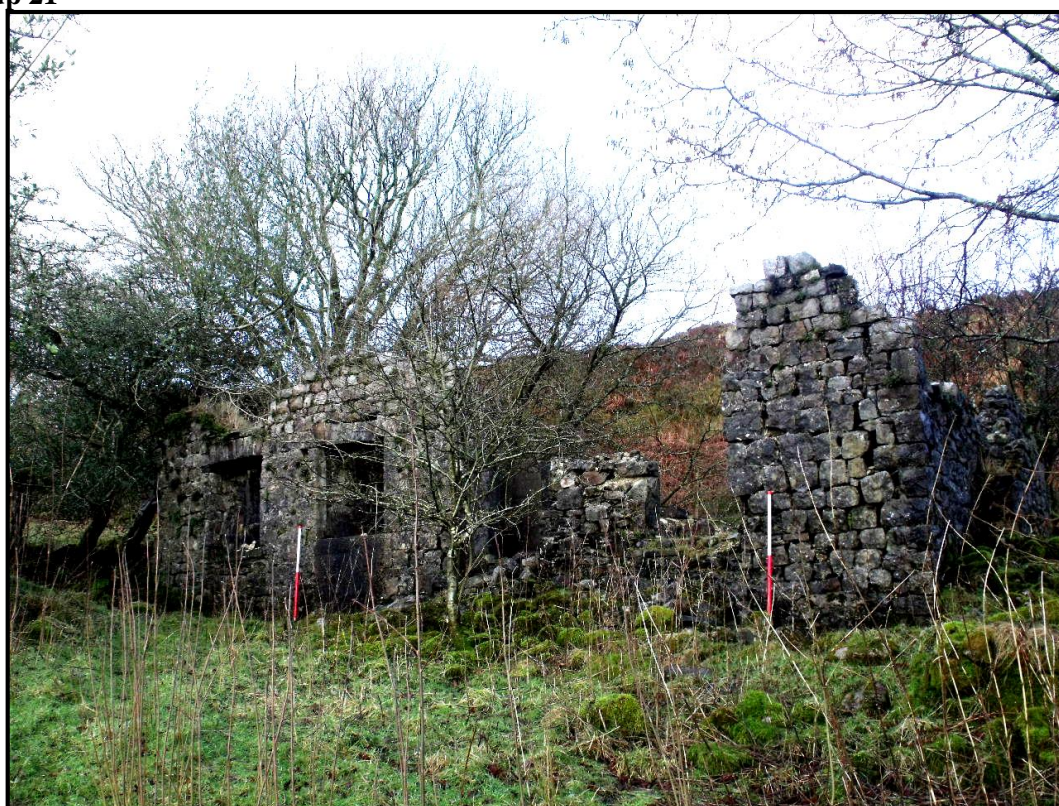
CPAT 3797-0007

Photo 53. Facing north showing ruined buildings at Pen Cribarth at the south-west of the BR237 (PRN 114089) Cribarth quarries

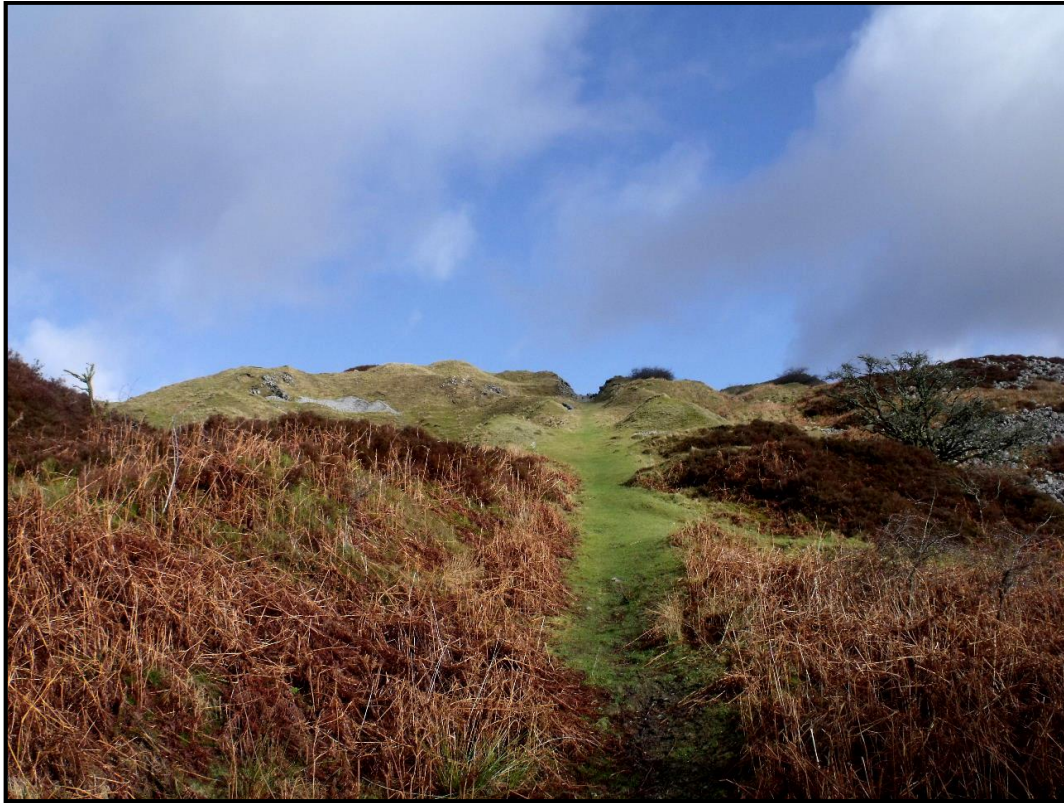
CPAT 3797-0014

Photo 54. Facing north looking up old tram road at south-west end of BR237 (PRN 114089) quarries

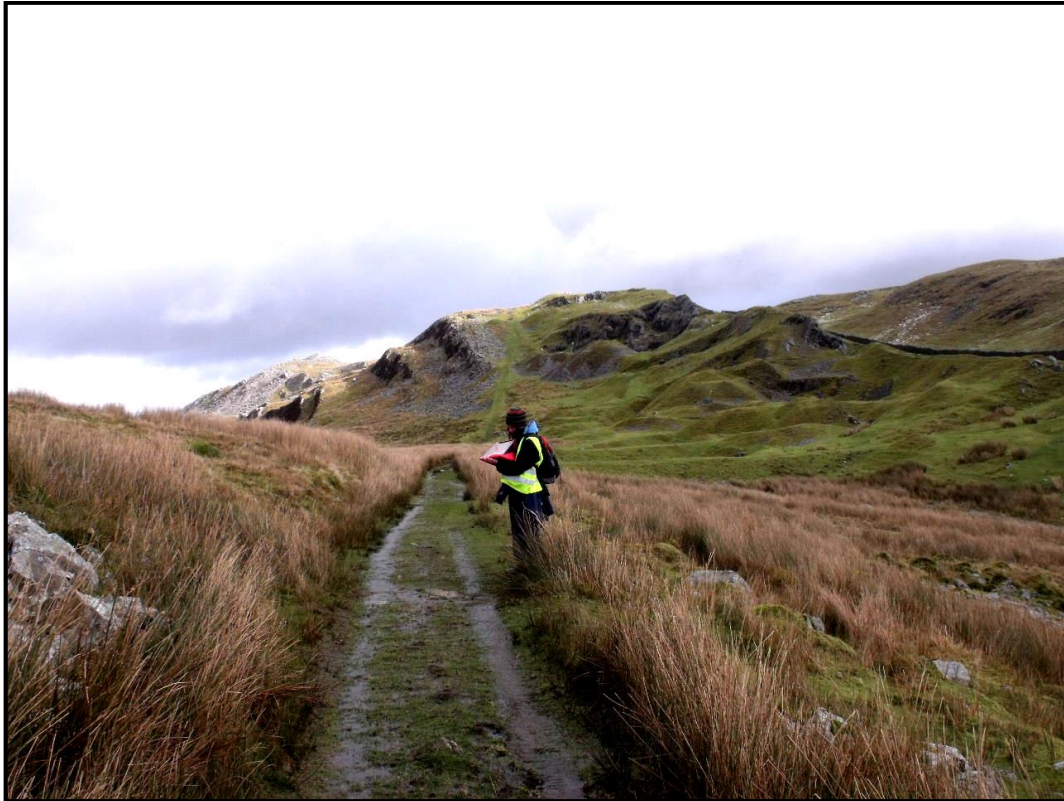
Photo 56. Facing north showing tramroad leading up to area of quarrying of BR237 (PRN 114089)
CPAT 3797-0019

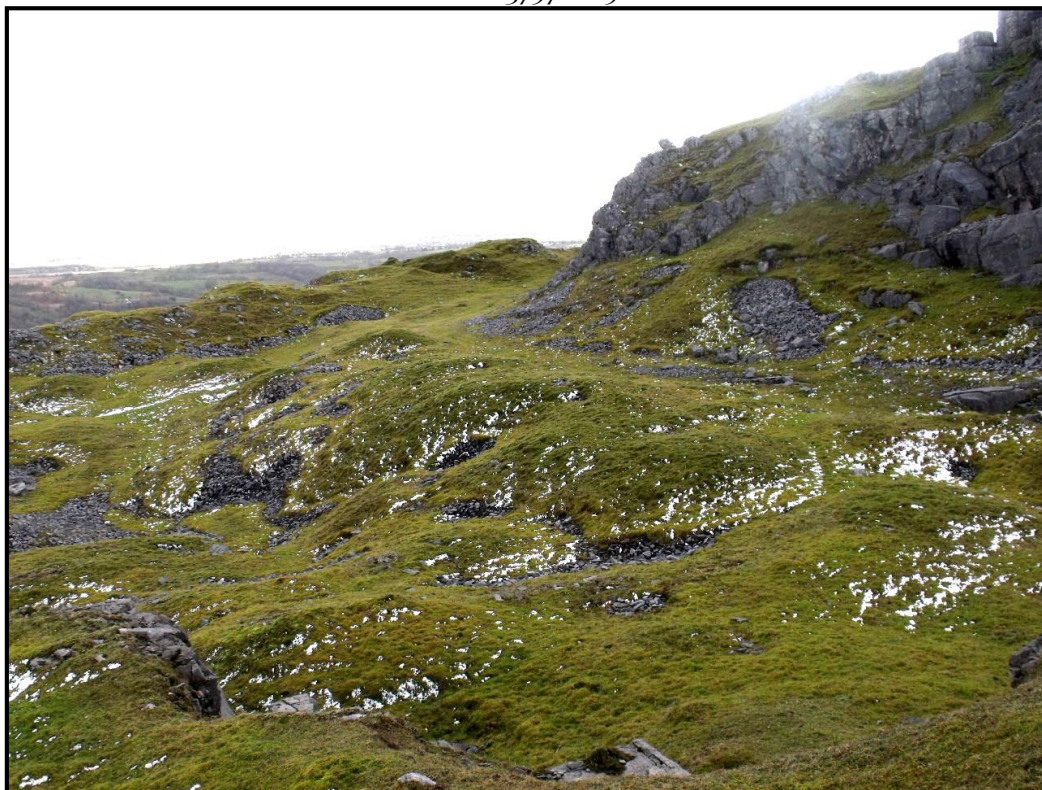
CPAT 3793-0045

Photo 57. Facing southeast showing area of quarrying at northeast end of BR237 (PRN 144089)

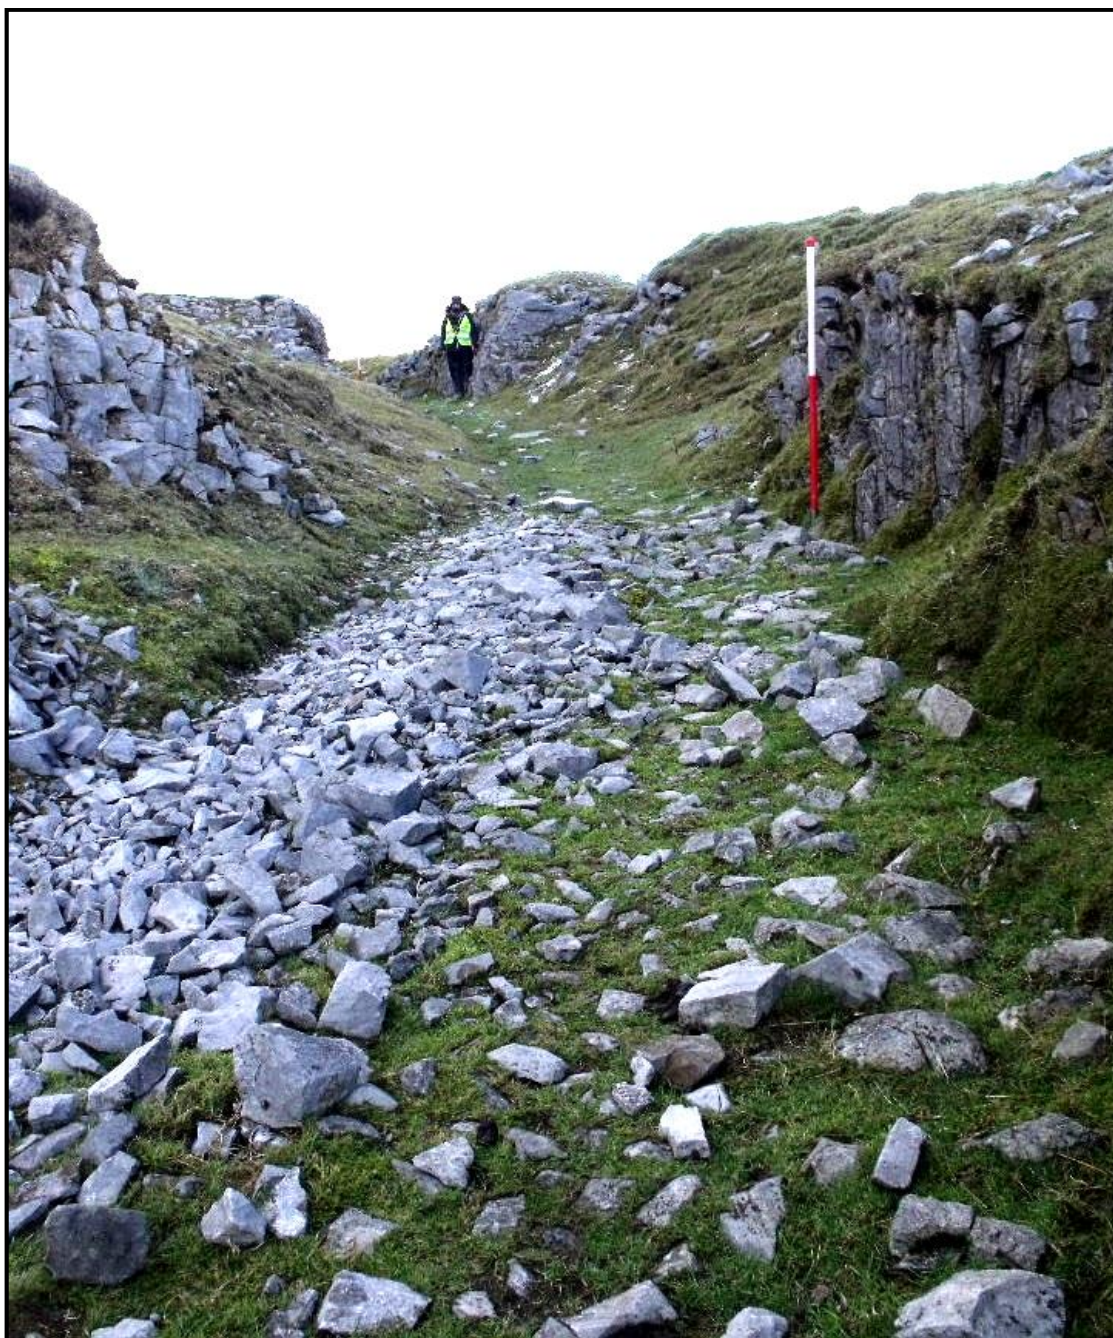
CPAT 3797-0060

Photo 58. Facing east showing rock cut tramroad at BR137 (PRN 114089 quarries

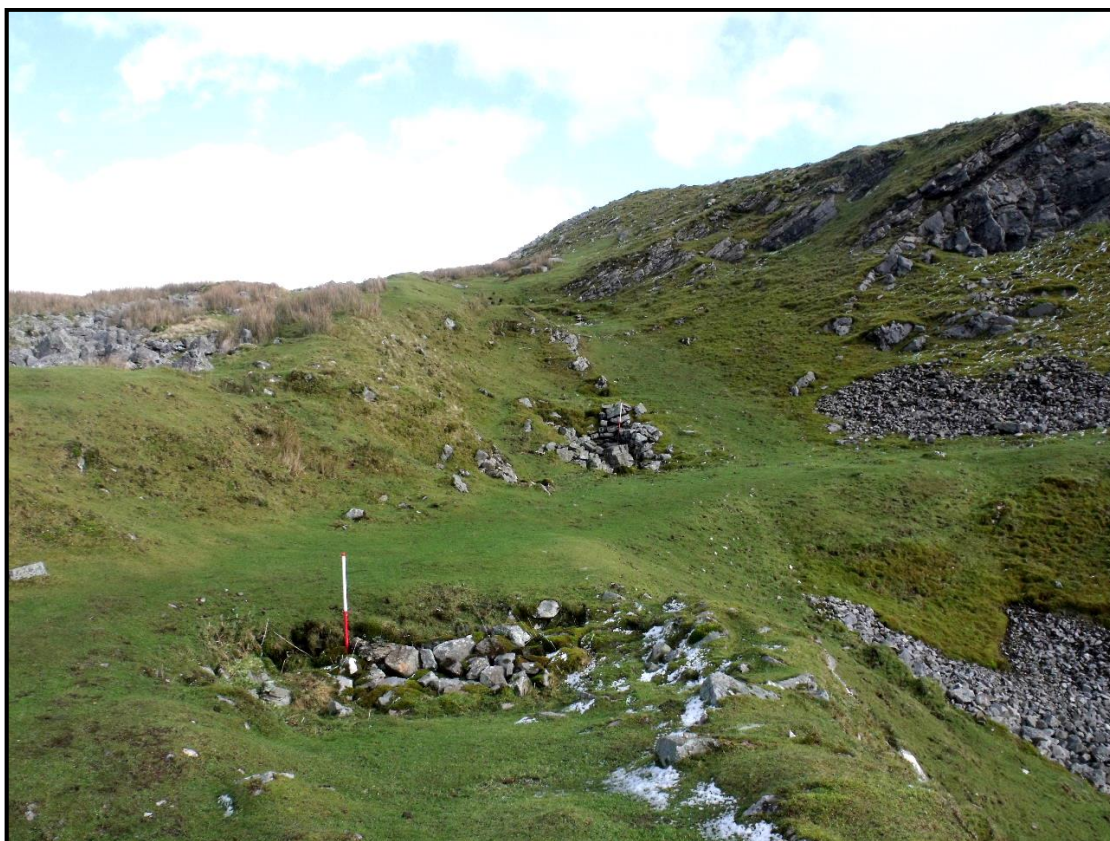
CPAT 3797-0023

Photo 59. Facing north showing built structures at terminus of tramroad on BR137 (prn114089)

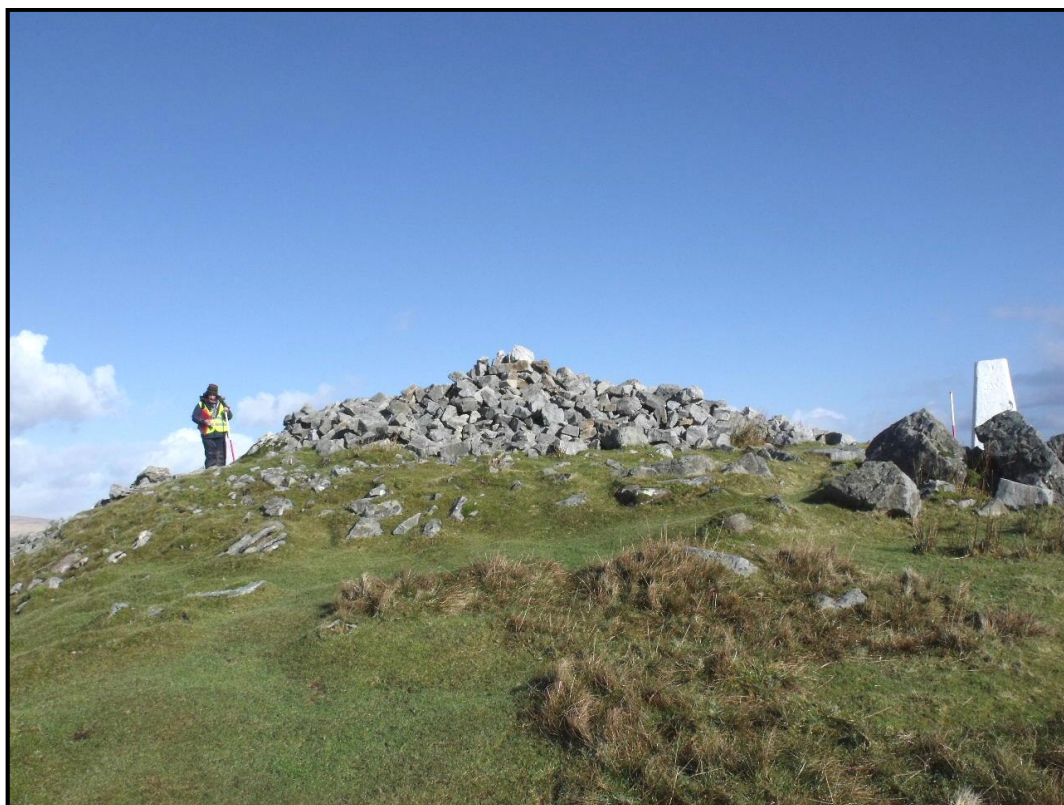
- 4.40 Located next to the triangulation pillar is a well-preserved oval-shaped cairn approximately 6m x 7m in size and up to 1m in height (Photo 63). There was no separate PRN allocated for this cairn. The cairn has a large shallow hollow in the centre, which has most likely been made by walkers as a shelter. For this reason the western side of this hollow is slightly higher than the eastern side (Photo 64). There is a large spread of stones/ tumble from the cairn on the north side of the ridge. Aside from this disturbance, the cairn is in good condition considering its proximity to the triangulation pillar and the former quarrying activity. It was assessed as being at 'Low' risk.

Photo 63. Facing North showing Cairn next to trigpoint at BR137 (PRN 114089) CPAT 3797-0030

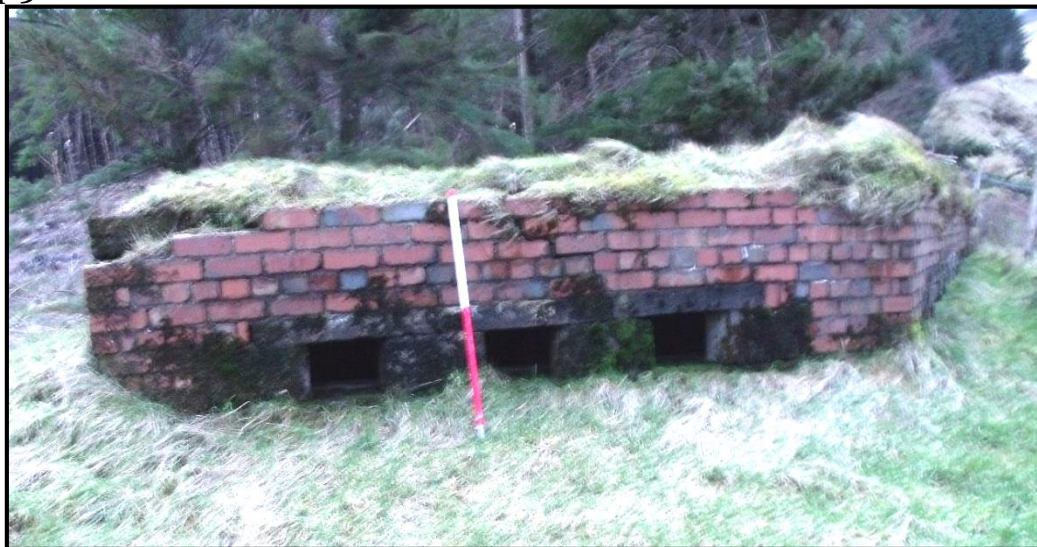
- 4.44 SAM BR337A is a red brick infantry support trench around 13m x 5m in size and 1m height. It is built into the top of a terrace immediately north of the bend in the river Taf Fawr and is aligned east/west. It has eight sides and is broadly V-shape in plan. This site is located next to Pillbox B and is also located right by the main footpath leading up to Pen Y Fan. There has been recent felling of the conifers just north and within the immediate vicinity of the site. This has not of itself caused any damage, but the clearance of the site has enhanced its visibility and so may attract increased attention from walkers. (Photo 65). Aside from these factors no other threats were identified and the site was considered to be in good condition and at 'Low' risk.

Photo 65. Facing northeast showing Infantry Support Trench of BR337A (PRN 110474)
CPAT 3798-0051

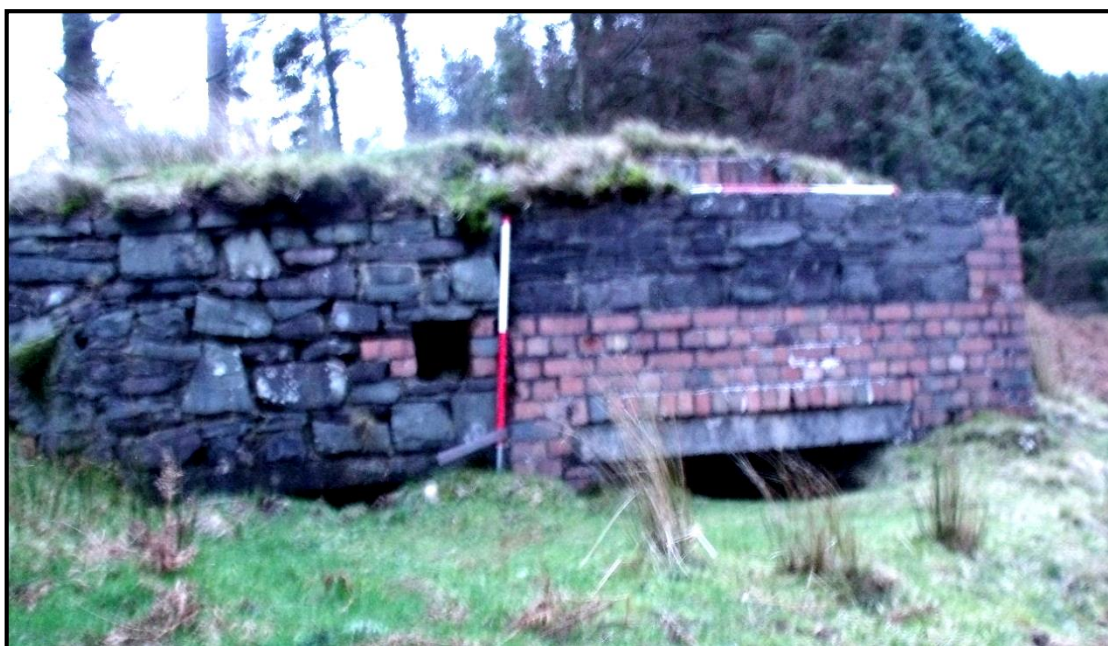
- 4.45 BR337B is a Pillbox is rectangular in shape and is constructed from a combination of red brick and roughly dressed stone. It is located around 20m east of the infantry support trench (BR337A) and is around 8m x 5m in plan, and just over 1m in height. It is built into the slope of the river terrace north of and above, the river Blaen Taf Fawr. The top of the pillbox is turf covered (Photo 66). At the time of the visit the conifers just north of the site were being felled. As with BR337A there was no direct damage but increased visitor attention may result from the tree clearance. The site was considered to be in good condition and at 'Low' risk.

Photo 66. Facing northeast showing Pillbox BR337B (PRN 110474) *CPAT 3798-0054*

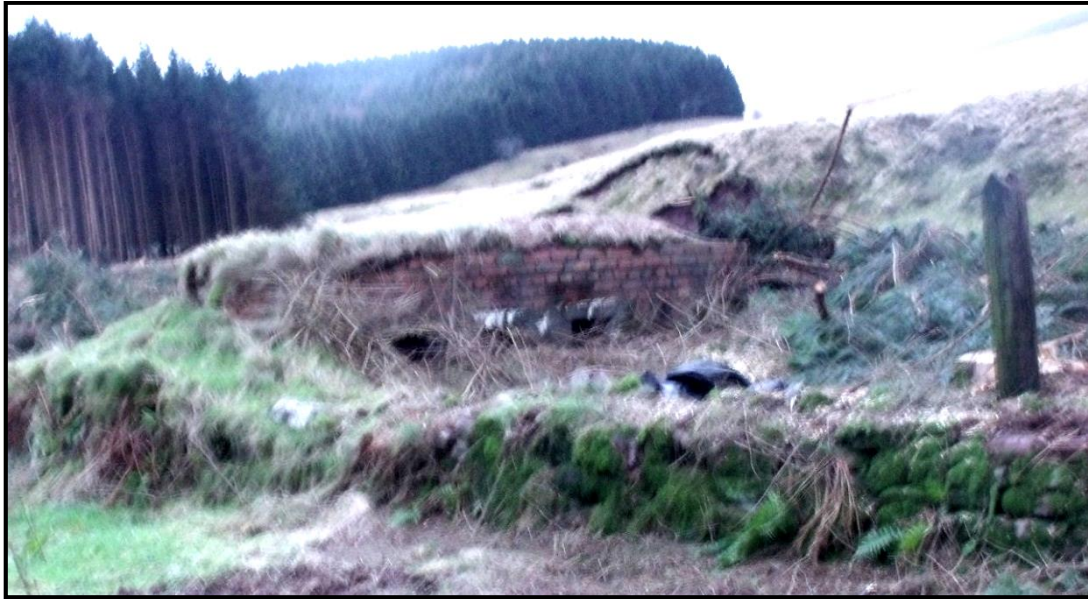
CPAT 3798-0048

- 4.46 BR337C is another red brick pillbox and as Berry describes; it is located in a band of forestry on the east side of the A470. It measures around 4m x 6m in plan, and is 1m in height and is broadly 'L' shaped. At the time of the visit, the band of forestry had been recently felled and felling continued further north of the area. The visit was only brief owing to the failing light conditions and the pillbox was only assessed from the exterior. There was a build up of brash around and against the site but it was not obscuring it (Photos 67& 68). The site seemed to be in good condition; however, because of the proximity of the tree felling, this site was assessed as being of 'Medium' risk and it is recommended that the site be visited as soon as possible to monitor the felling activity.

Photo 67. Facing northeast showing Pillbox BR337C and recent felling activity all round the site

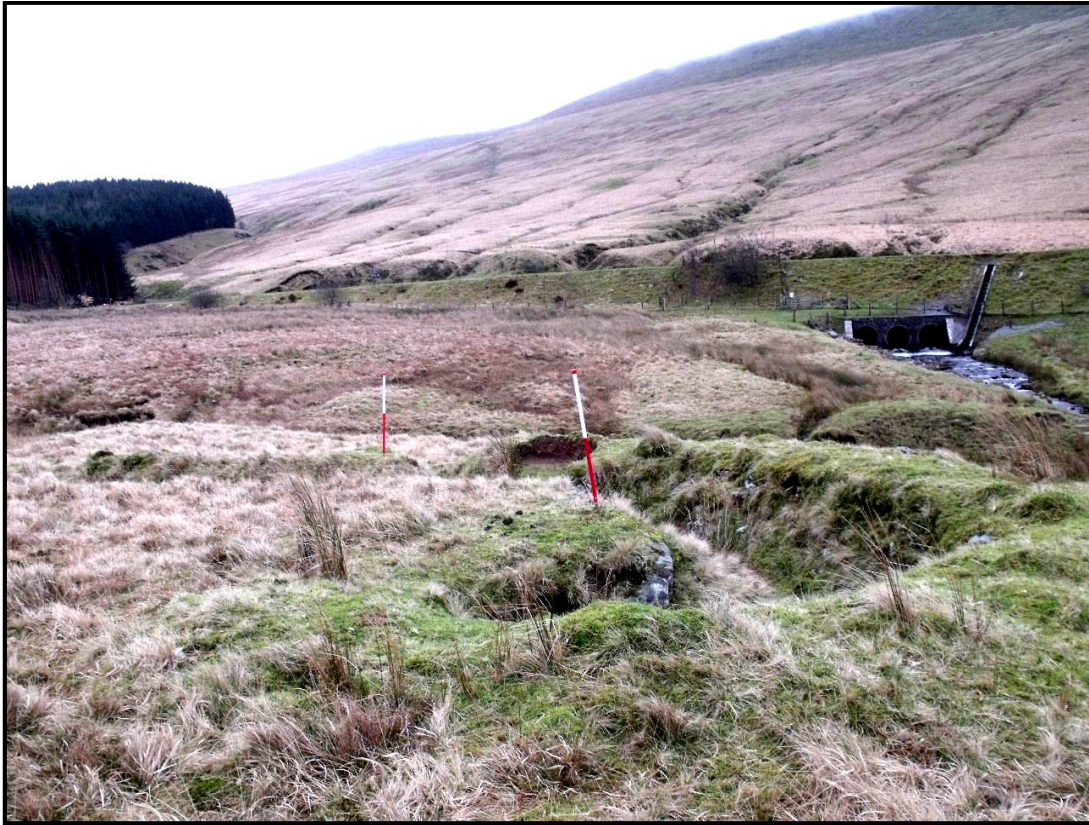
- 4.47 As Berry describes in his report, BR337D is a broadly L-shaped slit trench around 2.5m x 5m in plan and is located on the western side of the A470 (Photo 69). The long axis of the earthwork is orientated north-south. It consists of a ditch measuring c.6.6m long, 0.5m deep and c.1.3 wide, part of which appears to be rock cut. There is a grass covered earth and stone bank measuring 0.3m tall along its entire eastern side. The bank has spread to a width of 1.5m. At the southern end, the ditch continues west for a length of c.4m. The ditch measures 1.3m in width and 0.5m deep. The bank then curves west to follow the south side of the ditch. On the north-eastern end of the trench it divides into two shallower and less well-defined trenches, forming a V-shaped plan, with low stone turf banks c. 0.7m in depth. The banks are constructed of Old Red Sandstone blocks and are turf covered. It seems that the main defensive bank face east. The trench bank is sloping at a medium gradient into a flat-bottomed trench. The trench is very close to the Taff Trail, although there is very little evidence for visitor disturbance. There are two active sheep scrapes, one of which was recorded by Cadw in 2005 (which

- has enlarged in the intervening period) and one which has appeared since (Photo 70). The site has suffered some structural collapse and there are reeds encroaching on the eastern side. Aside from these factors, no other threats were identified. The site was considered to be in fair condition and at 'Medium' risk.

Photo 69. Facing east showing Slit Trench BR337D with the A470 running north/south in the background
CPAT 3798-0013

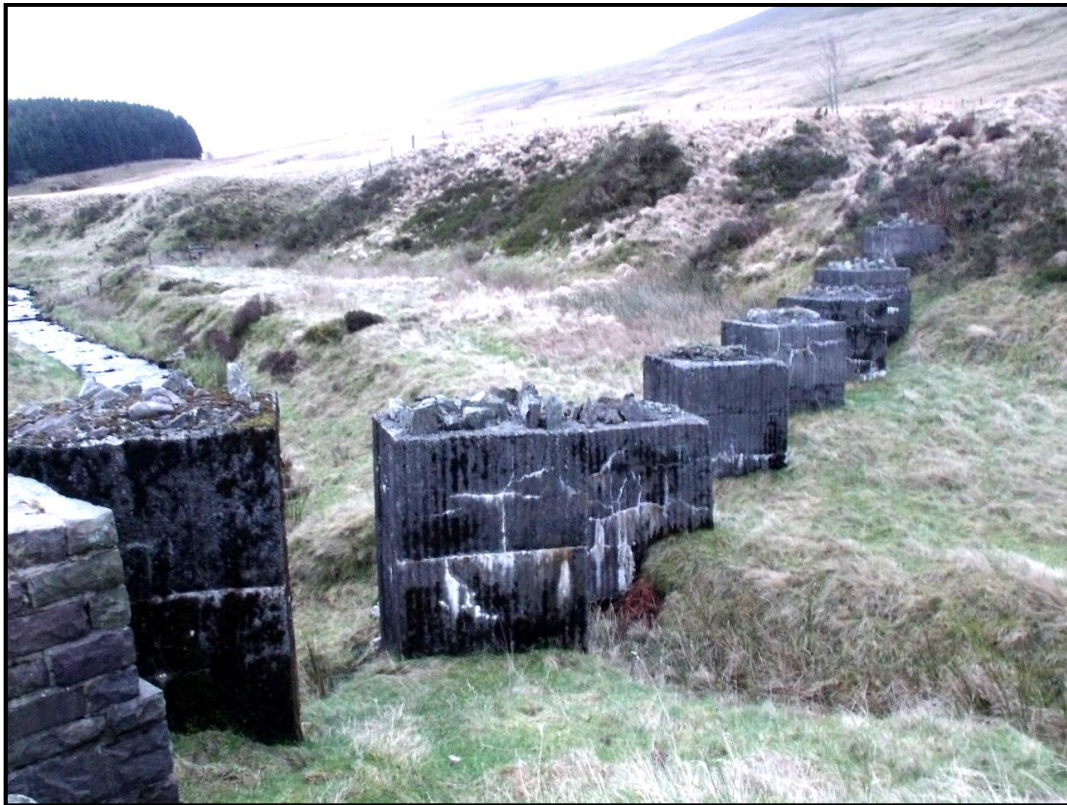
- 4.48 BR337E is the eastern group of Mark 2 anti-tank defences. This group of blocks lies at the bottom of a river valley between the Pont ar Daf bridge and the east side of the A470. They are offset some 3m or 5m below the A470. The defences are 27m long overall, oriented east-west, and consisting of 8 concrete blocks arranged corner to corner at c.3.3m intervals (Photos 71). The construction of the blocks differs from the anti-tank blocks west of the A470, as each block is constructed purely from concrete, with no local facing stones incorporated into the fabric. Each block measures 1.5m wide by 1.5m deep. The heights of the blocks vary, and according to Berry, examples at the southern end of this group are very unusual as they measure up to 2.5m tall. Each block bears the imprints of vertically aligned corrugated steel sheet shuttering used to form the mould. The tops of each block have been finished with stones set on their ends into concrete. Each block retains its original location, spacing and orientation. These blocks were considered to be in optimal condition and at 'Low' risk.

Photo 71. Facing northeast showing BR337E; eastern group of Anti Tank blocks on eastern side of A470
CPAT 3798-0045

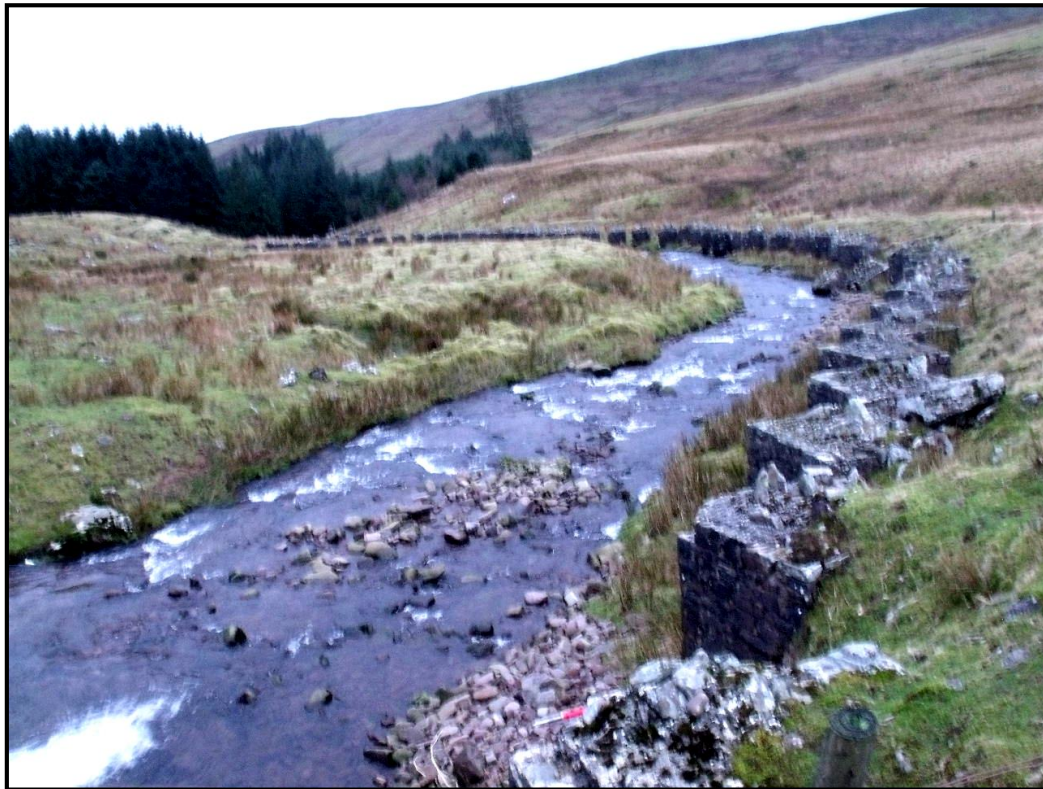
- 4.49 BR337F is the western group of Mark 2 anti tank defences blocks. This group consists of 62 examples running in a curvilinear alignment along the west bank of the gently meandering river Blaen Taf Fawr over a distance of c.200m. The northernmost 14 blocks are aligned east-north-east to west-south-west, and the remainder of the structure is oriented north-south (Photo 72). They are arranged corner to corner at approximately 3.1m intervals. Each block is built from concrete with local stone facing and measures c.1.6m tall, wide and deep. The top of each block features stones set vertically on their ends in a bed of concrete. The northernmost block of the western group is partially buried in the elevated earthen embankment of the new A470 and Berry suggests that it is possible that the alignment survives intact beneath this built up area to the west side of Pont ar Daf. The majority of these blocks are upright and intact although there is a small number of collapsed blocks. There is evidence of structural degrading of the concrete and weathering of the pointing on the upright blocks (Photos 72- 74). Overall, this group was considered to be in good condition and at 'Low' risk.

Photo 72. Facing southwest showing BR337F; western group of Anti Tank blocks on western side of A470
CPAT 3798-0044

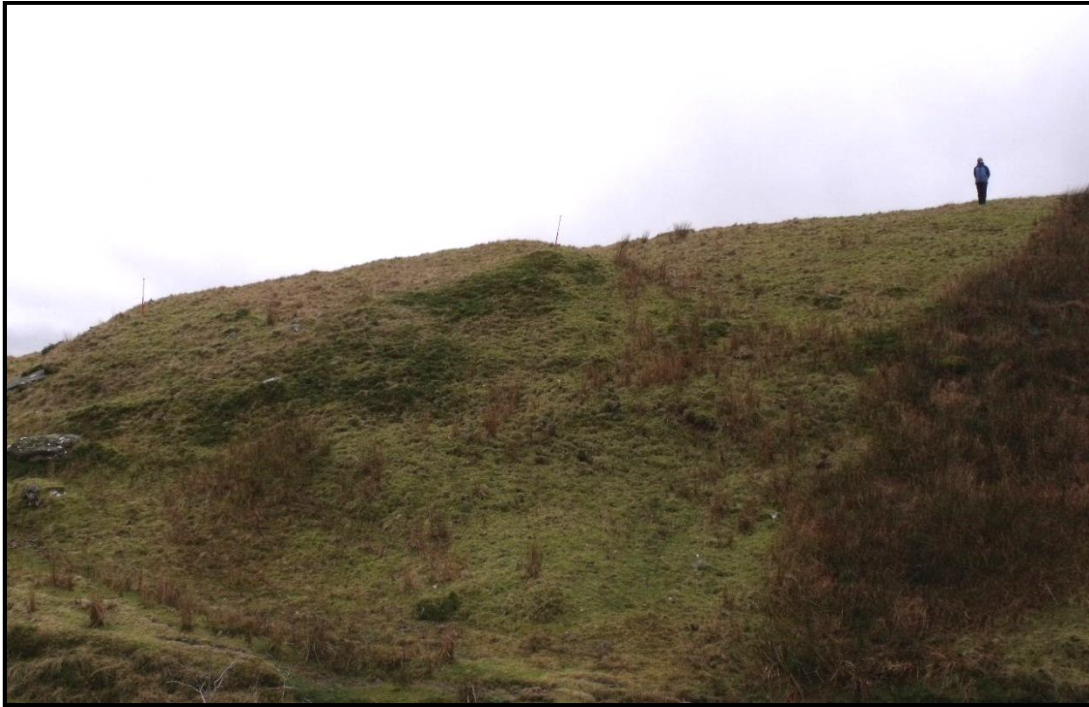
CPAT 3798-0006

- 4.50 BR241 is Rhyd Uchaf Hillfort (PRN 3248) and is located to the south of, and above, the Beacons Reservoir on the western side of the A4059. This site is composed of a series of three low crescent-shaped banks, and is located above a track, which runs on a spur above a stream (Photos 75 & 76). The inner bank is most prominent, reaching a maximum of 0.6m in height. The banks roughly enclose a triangular area c.9m wide from the inner bank. Each bank has a shallow ditch on the western side. The defences are only on the south-western sides. The topography falls steeply on the northeast side. At the time of the visit, there were 17 young gorse plants encroaching on the monument. There is more mature gorse in the buffer zone on the southern side (Photo 77). There is also pony track damage exposing the soil on the steep side of the northern side towards the stream (Photo 78). The gorse is not a problem at present but will become an issue which will need addressing in the near future. No other threats were identified and the site was considered to be in good condition and at 'Low' risk.

Photo 75. Facing southeast showing inner, middle and outer banks of BR241 (PRN 3248)

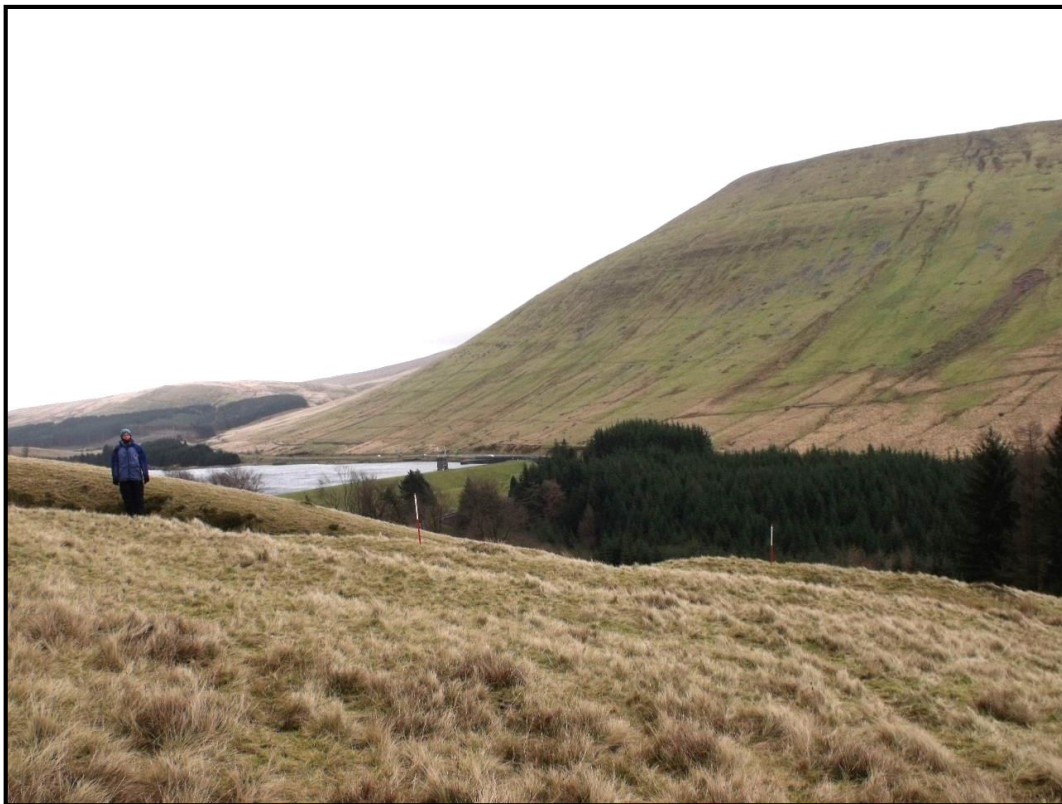
CPAT 3798-0007

Photo 76. Facing north showing crescentic outer, middle and inner banks of BR241 (PRN 3248). BBNPA Heritage Officer Natalie Ward is standing on the outer bank

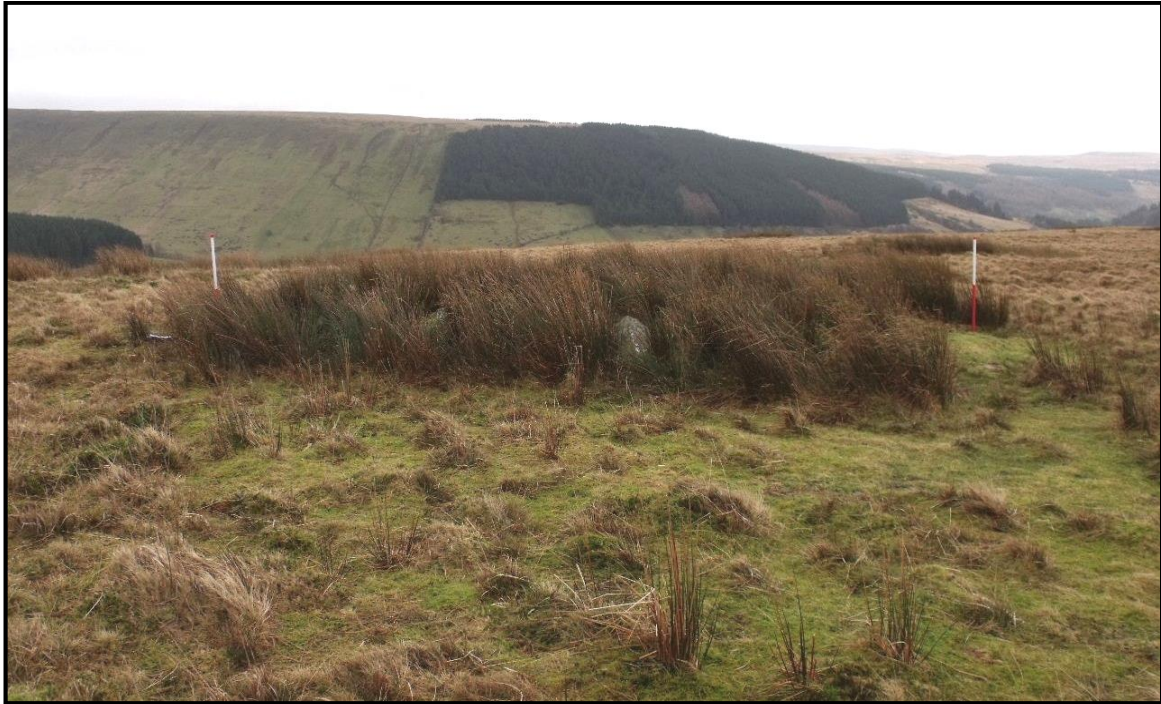
- 4.51 BR276 is Twyn Y Garreg Wen Cairn (PRN 23803) and is located to the west of the A4059 in an area of the Common called Twyn Garreg Wen. It is a roughly circular, flat-topped cairn, which is mostly covered in turf and measuring around 6m in diameter and 0.4m in height. There are a number of large Old Red Sandstone uprights located along a raised edge (kerb?) around the north and eastern side (Photo 79). The cairn is quite heavily masked by juncas grass and reeds which makes it difficult to determine its full extent. The cairn is most visible when approached from the south, and is less well defined on the north-western side where there is an absence of stone uprights (Photo 80). The only threat identified for this site was the encroachment of the reeds and juncas grass. The site was considered to be in good condition and at 'Low' risk.

Photo 79. Facing southeast showing Twyn Y Garreg Wen Cairn BR276 (PRN 23803) surrounded by reeds showing some upright along the edge
CPAT 3798-0002
