CPAT Report No. 1259

Brecon Beacons National Park Scheduled Ancient Monument Condition Survey 2014

Archaeological condition survey

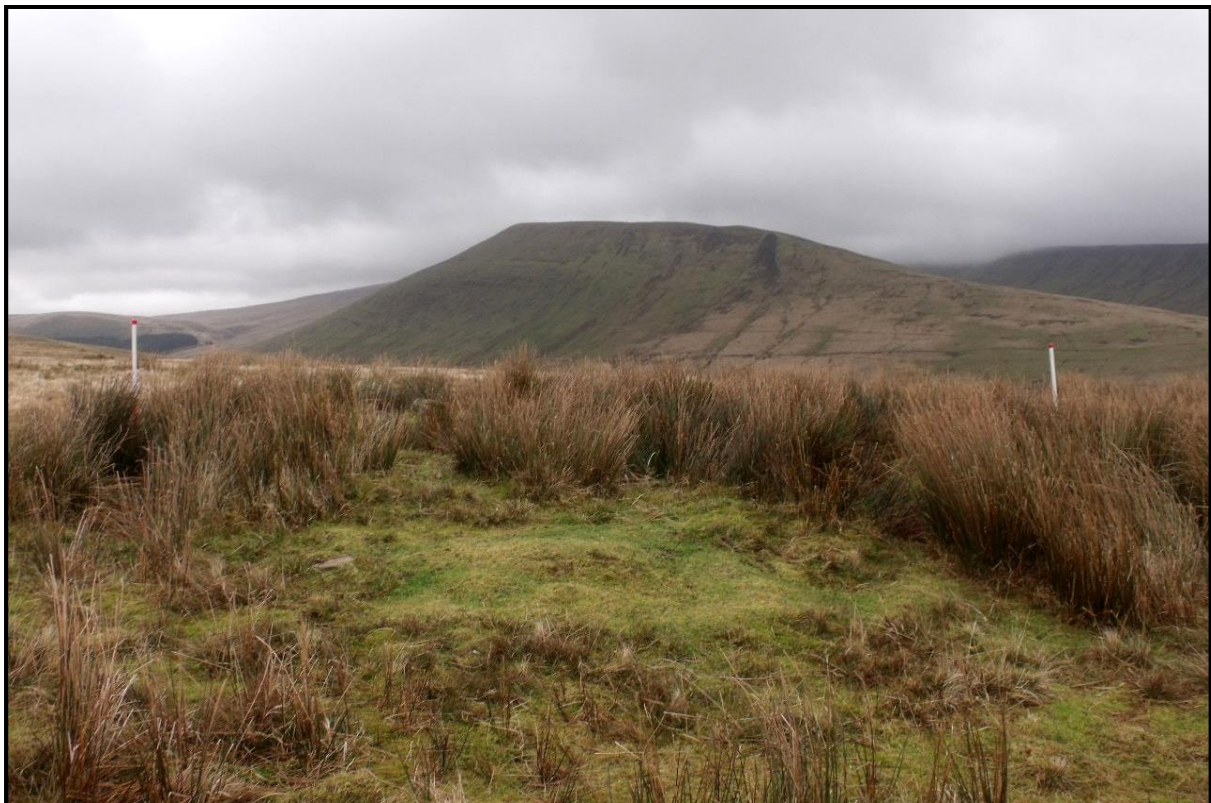
Photo 80. Facing north showing approach from cairn BR276 (PRN 2803) from south *CPAT 3798-0004*
