CPAT Report No. 1739

# Castell Dinas Brân, Llangollen, Denbighshire

Condition Survey

Client name: Denbighshire County Council  
 CPAT Project No: 2457  
 Project Name: Castell Dinas Brân  
 Grid Reference: SJ 2225 4306  
 County/LPA: Denbighshire  
 CPAT Report No: 1739  
 Event PRN: 140340  
 Report status: Final  
 Confidential until: N/A

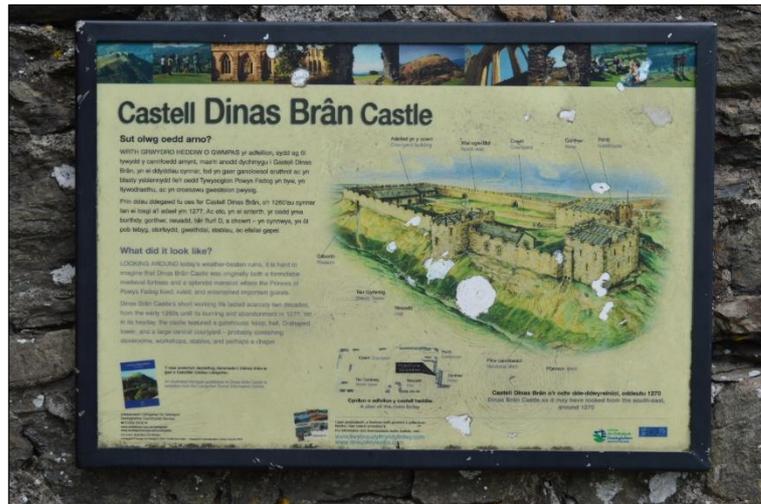
*Fig. 3 Interpretation panel on the west side of the keep*

- 5.8. There are currently two bilingual information panels, one within the masonry castle (Fig. 3) and the other at the start of the western access path (Fig. 4). The former has been in place for a number of years, is damaged and consideration should be given to an updated replacement. There is currently no information associated with the eastern access path.

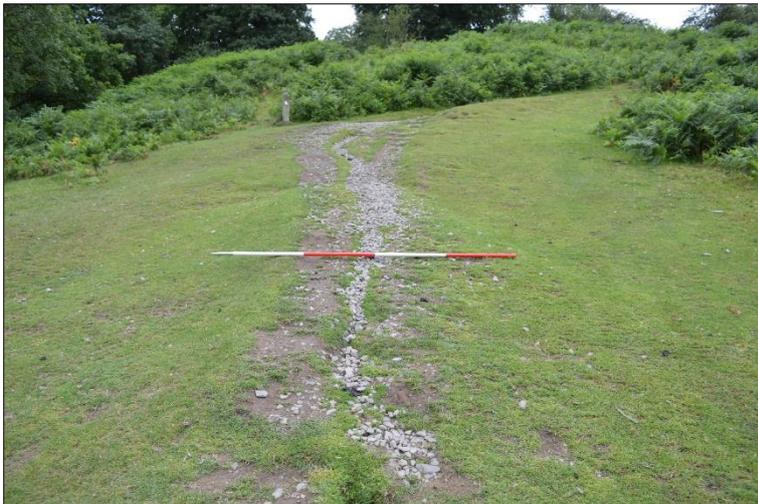
**Description:** section of path above lower access gate. Gradual erosion of turf cover, leading to broadening of path, particularly on the corner. Early stages of water erosion with a narrow gully forming in the centre of the path.

**Recommendations:** Monitor. Possible future need for drains to deflect runoff.

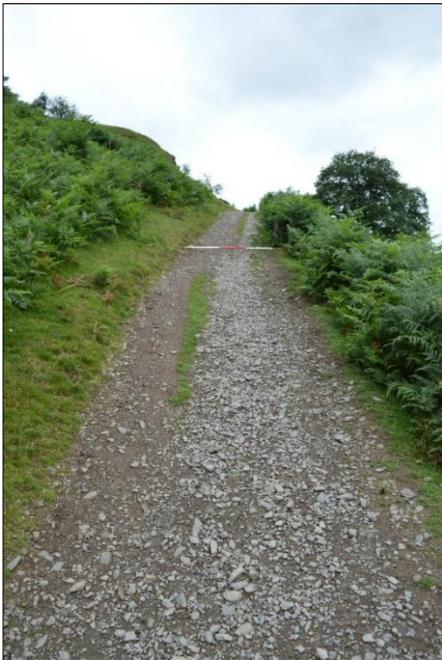
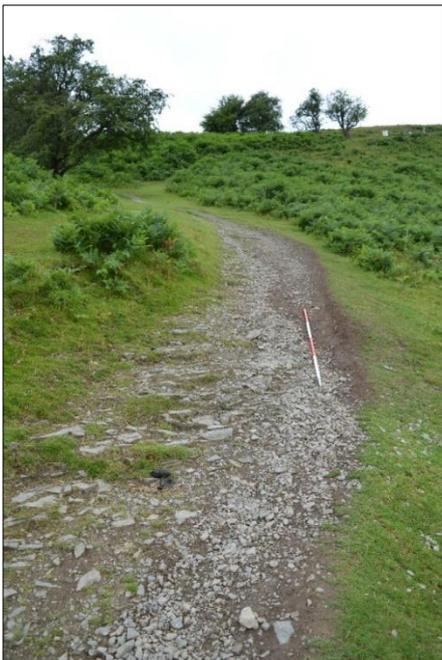
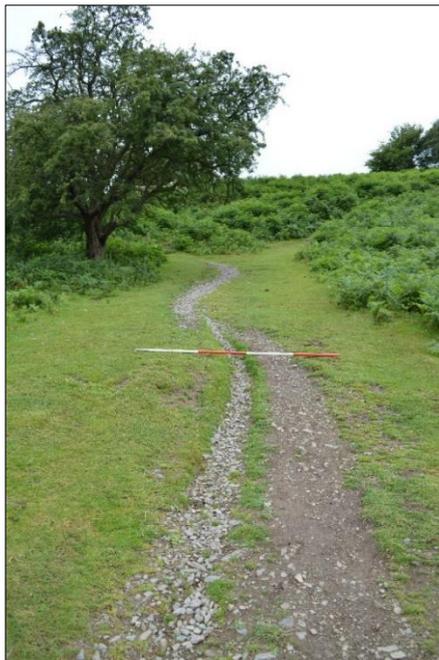
**Description:** Gradual widening of path which is stable where bedrock is exposed, although there are the early stages of water erosion and gullying where turf has been removed to expose soil beneath.

**Recommendations:** Monitor. Possible future need for drains to deflect runoff.

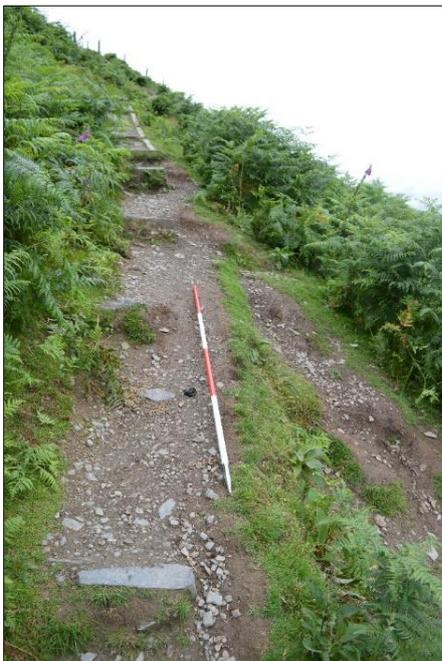
**Issue No: 04**                      **Issue type 1: Visitor****Location:** Eastern access path**Photographic references:** CPAT 4771-0006 to 0007**Stability:** active                      **Impact:** none                      **Priority:** medium**Description:** At the first set of timber and stone steps a new path has developed, cutting the corner and avoiding the steps. Above these steps edge-set slates have been used to form low steps, which are being bypassed by visitors. Potential for future issues with water erosion.**Recommendations:** Monitor. Extend timber and stone steps to replace edge-set slate. Install post and rail fence to prevent shortcut on corner.

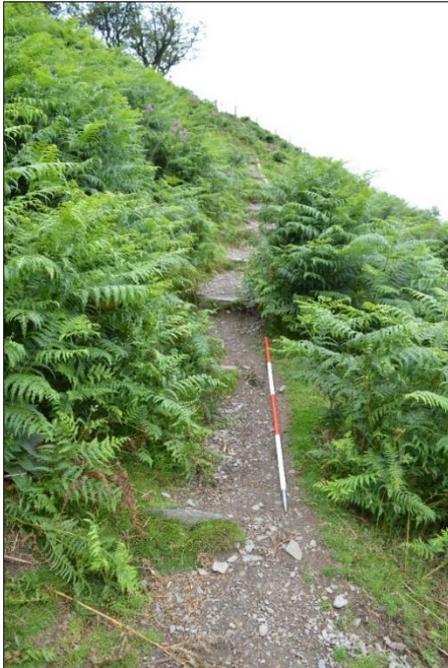
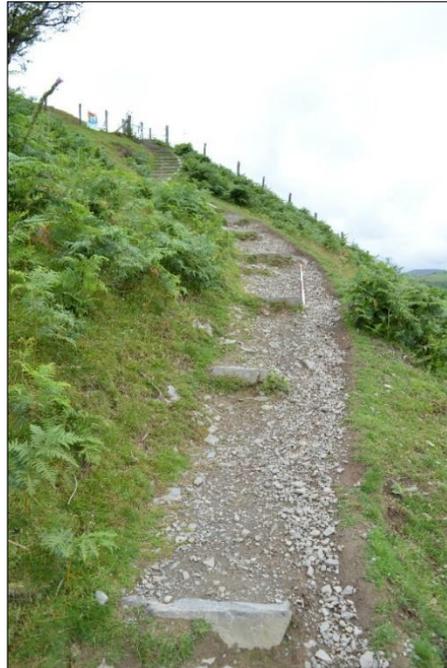
**Description:** Avoidance of edge-set slat steps, broadening path with potential for future water erosion.

**Recommendations:** Monitor. Replace existing steps with timber and stone.

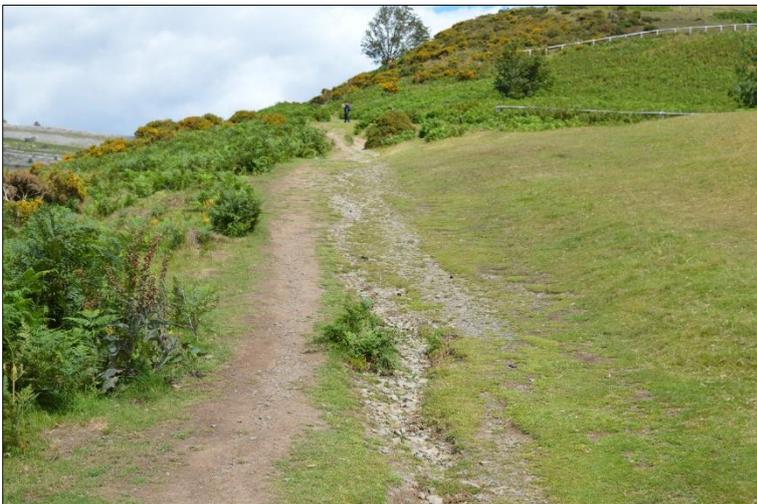
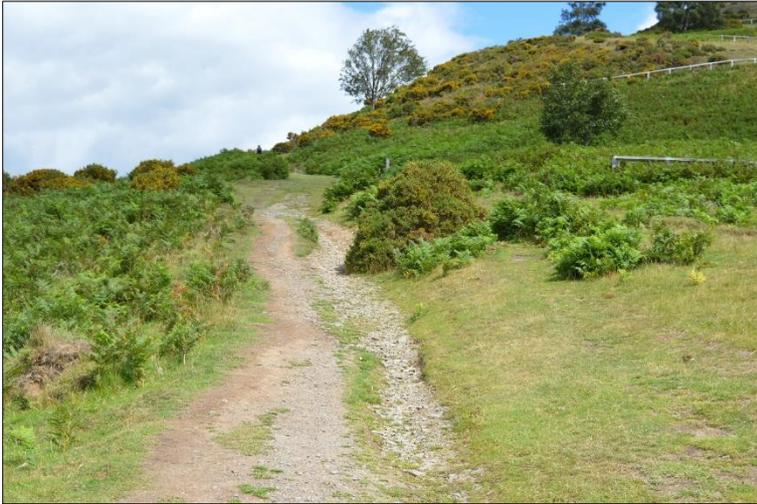
**Description:** The lower section of the western access path is becoming braided, mostly as a result of visitors avoiding the main path, which is often wet and muddy and can be slippery on the decent.

**Recommendations:** Monitor. Install drains to deflect runoff.

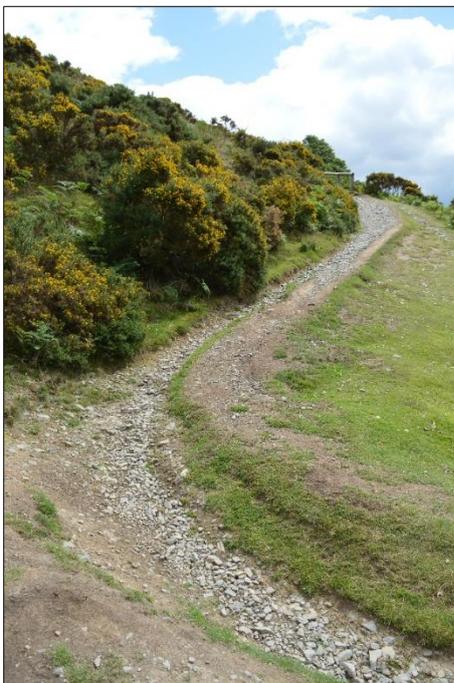
**Description:** On the lower hairpin the path has become a narrow gully eroded further by water, while visitors are cutting the corner, leading to the loss of turf cover.

**Recommendations:** Monitor

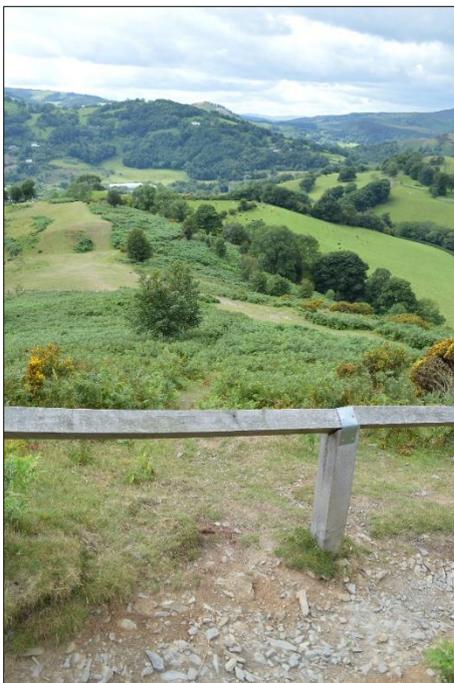
**Description:** A narrow path avoids the lower hairpin, although this was not well used at the time of the survey.

**Recommendations:** Monitor

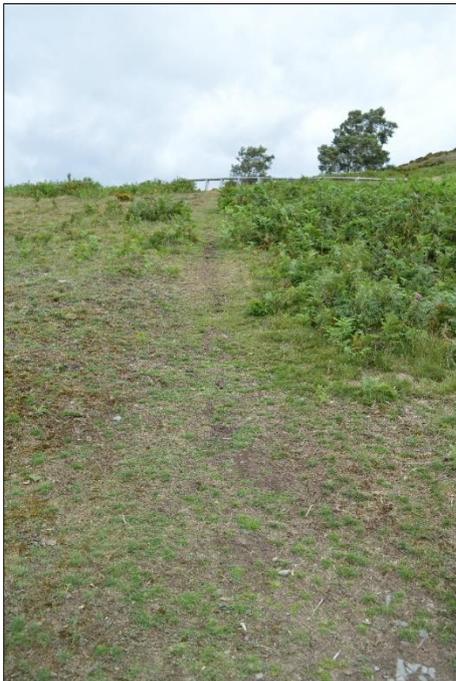
**Description:** Visitors are avoiding the second hairpin and have created a direct line of ascent/descent.

**Recommendations:** Monitor. Consideration should be given to introducing a mid-rail in the existing fence.

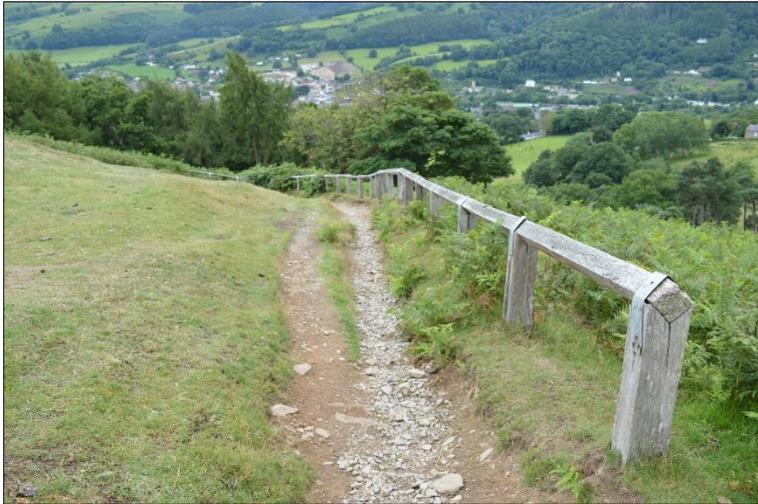
**Description:** Between the second and third hairpins the path is becoming braided.

**Recommendations:** Monitor

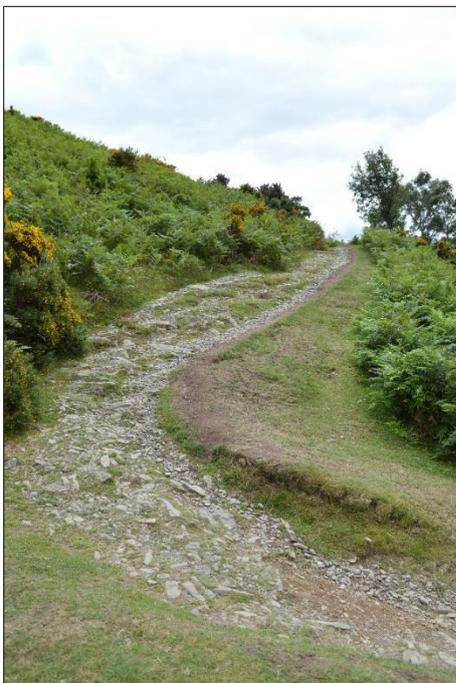
**Description:** The path around the third hairpin has widened, resulting in the loss of turf and potential for water erosion.

**Recommendations:** Monitor

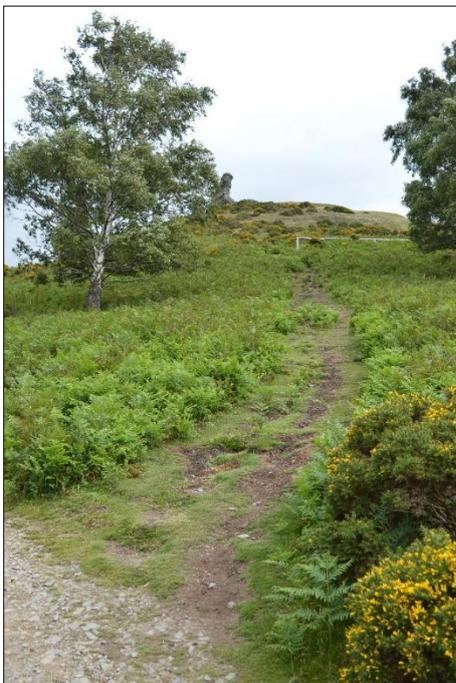
**Issue No: 13****Issue type 1: Visitor****Location:** Western access path**Photographic references:** CPAT 4771-0045 to 0046, 0049 and 0126**Stability:** active      **Impact:** none      **Priority:** low**Description:** Visitors are avoiding the third hairpin and have created a direct line of ascent/descent.**Recommendations:** Monitor. Install fencing across the lower end of the new path and extend fencing at the upper end to deflect visitors.

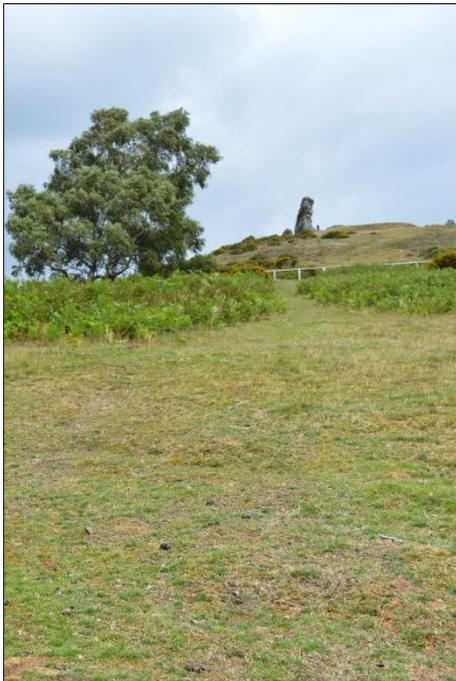
**Description:** Visitors are avoiding the third hairpin and have created a direct line of ascent/descent.

**Recommendations:** Monitor. Consideration should be given to introducing a mid-rail in the existing fence.

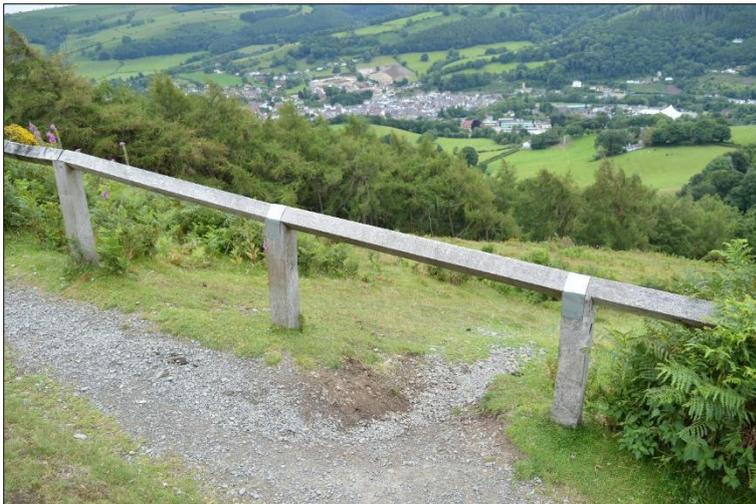
**Description:** An old path rising from the second hairpin avoids the third hairpin and is now eroding at the upper end as a result of runoff from the main path.

**Recommendations:** Monitor. Install drain on main path to deflect runoff. Consideration should be given to introducing a mid-rail in the existing fence.

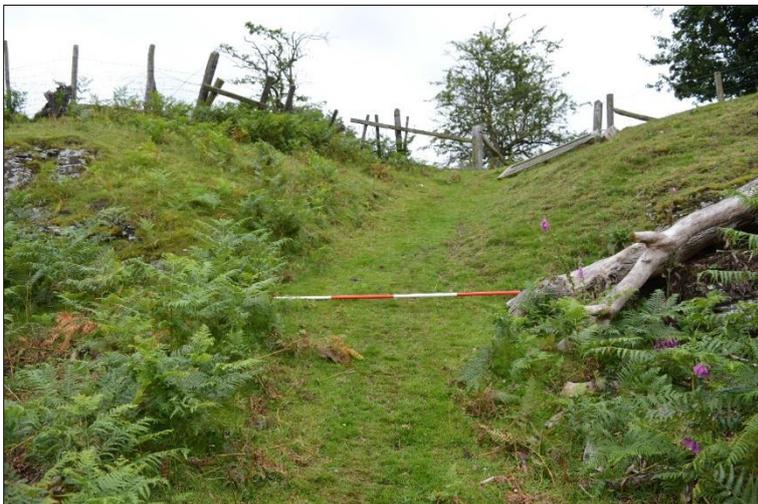
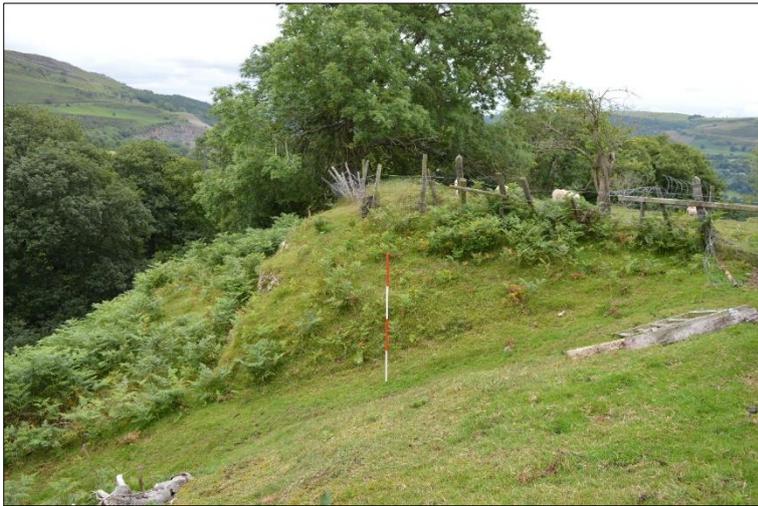
**Description:** An old trackway rises through what appears to be an original entrance to the outer enclosure. The track is used for farm access by vehicles and for driving livestock.

**Recommendations:** Monitor

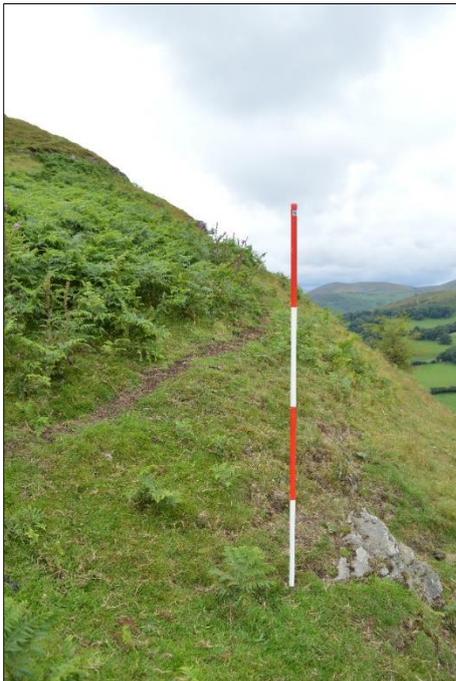
**Description:** A narrow sheep track rises onto the outer enclosure bank adjacent to the second gate of the eastern access path.

**Recommendations:** Monitor

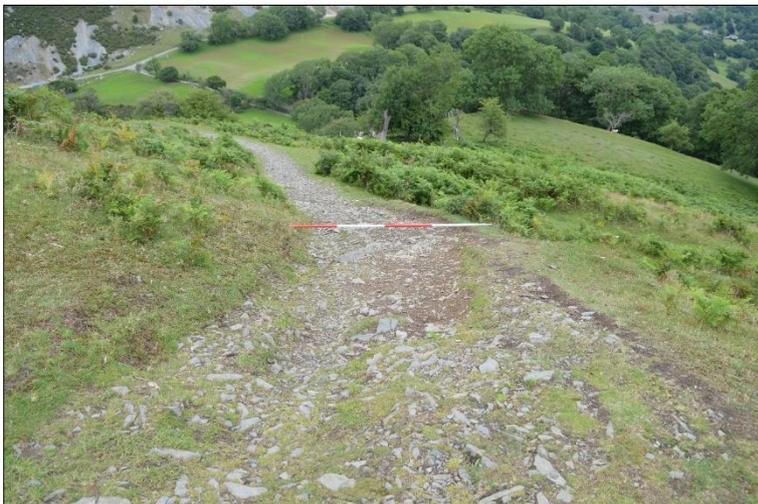
**Description:** The eastern access path crosses the eastern rampart of the hillfort. The stony nature of the rampart has limited the degree of erosion.

**Recommendations:** Monitor

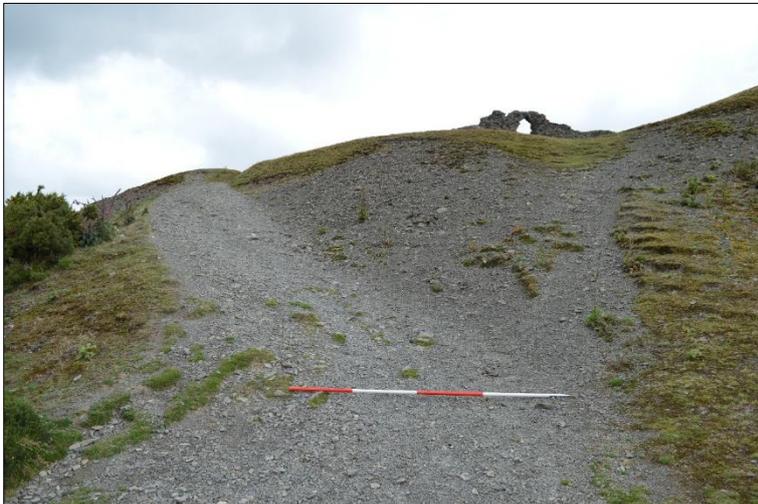
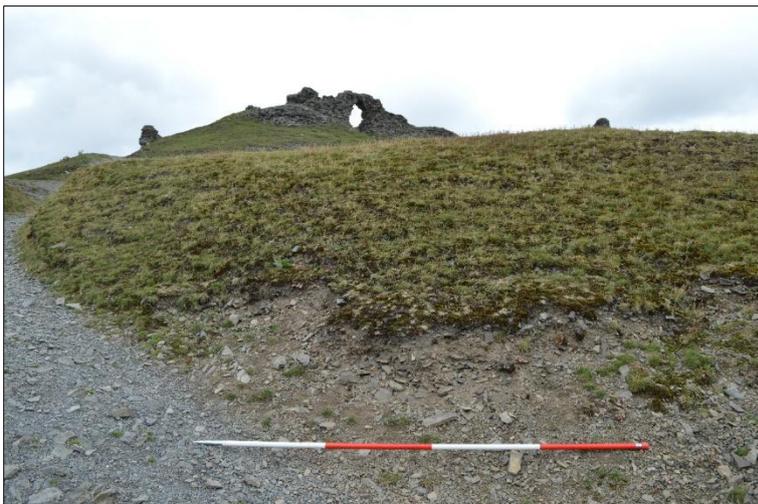
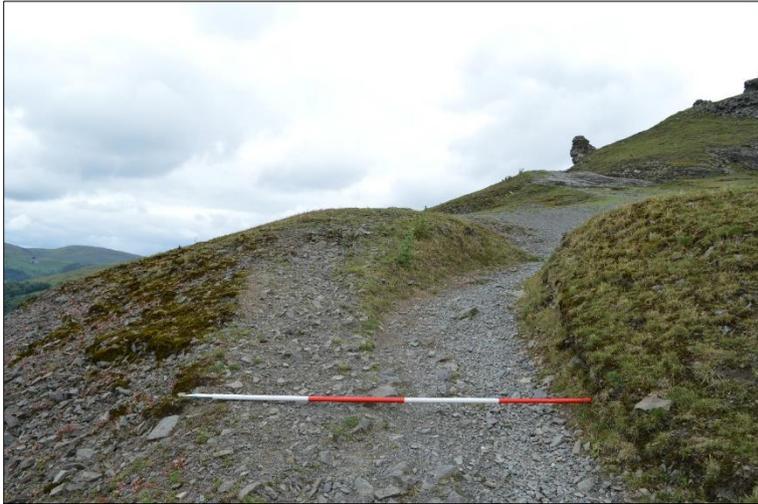
**Description:** The western access path cuts through the hillfort rampart above the fourth hairpin. The turf cover has been lost and the path widened by use, although for the most part this has not affected any in situ archaeology. However, where the path cuts through the crest of the rampart there is an active erosion scar on the west side of the path, while on the interior of the rampart the turf has been lost over a wide area, exposing loose scree which is vulnerable to erosion and could expose buried archaeological deposits.

**Recommendations:** Monitor. Consolidate and stabilise erosion scar and rampart interior.

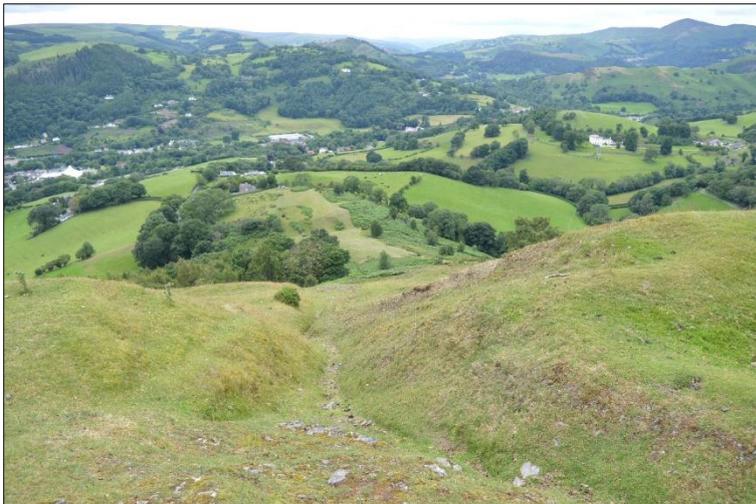
**Description:** A sinuous gully descends from the western side of the castle, cutting through the hillfort rampart and the outer enclosure bank. At the time of the survey the gully retained its turf cover and appeared stable.

**Recommendations:** Monitor

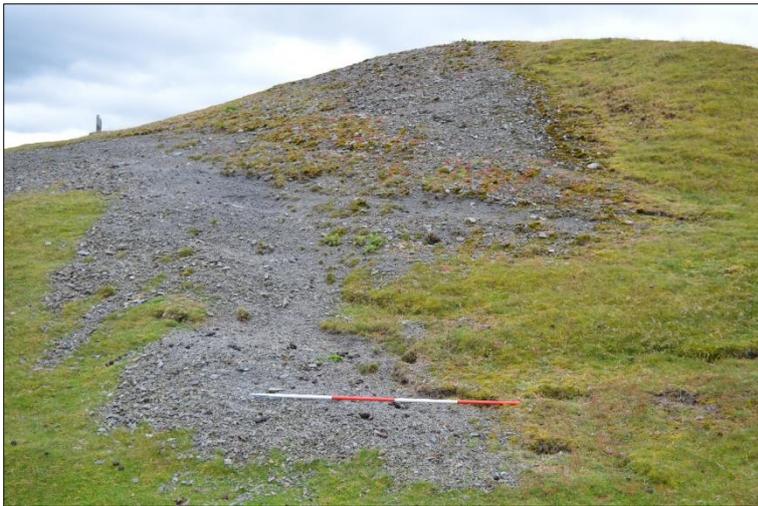
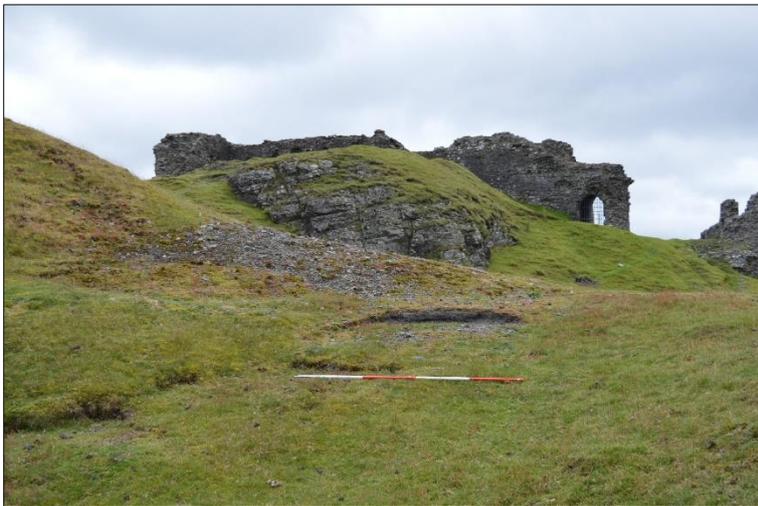
**Description:** The scree slope to the east of castle quarry ditch and counterscarp is affected by active sheep scrapes, as well as rabbit burrowing, although this does not appear to affect any archaeological deposits.

**Recommendations:** Monitor

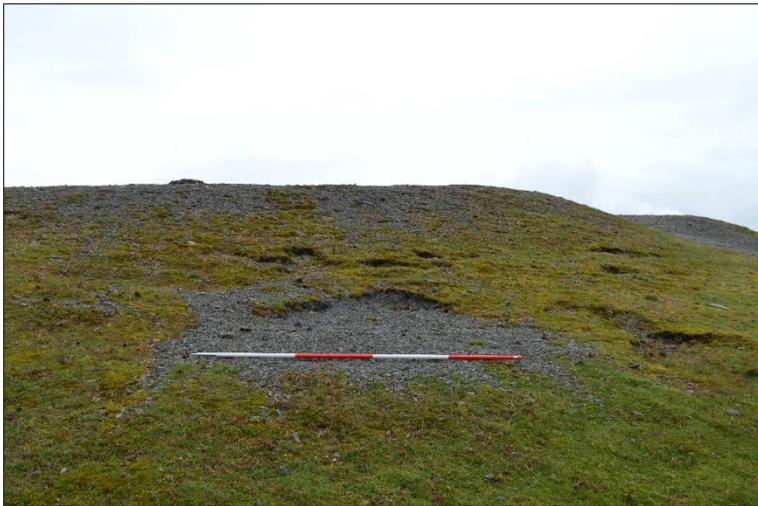
**Description:** The scree slope to the east of castle quarry ditch and counterscarp is affected by active sheep scrapes, as well as rabbit burrowing, although this does not appear to affect any archaeological deposits.

**Recommendations:** Monitor

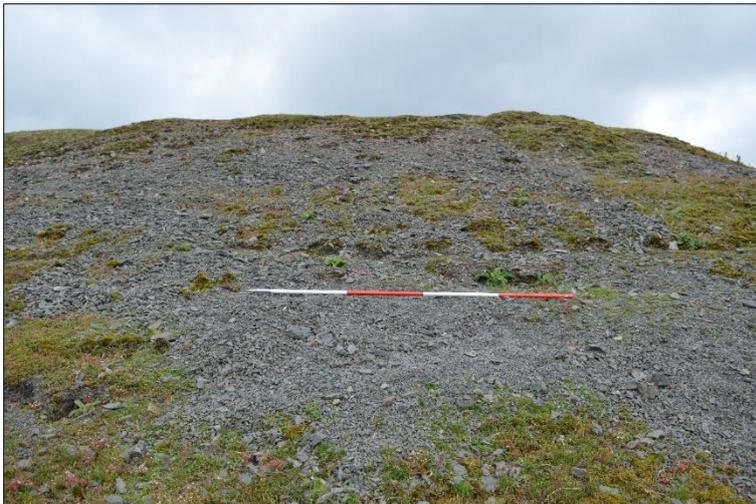
**Description:** The scree slope to the south of castle quarry ditch and counterscarp is affected by active sheep scrapes, as well as rabbit burrowing, although this does not appear to affect any archaeological deposits.

**Recommendations:** Monitor

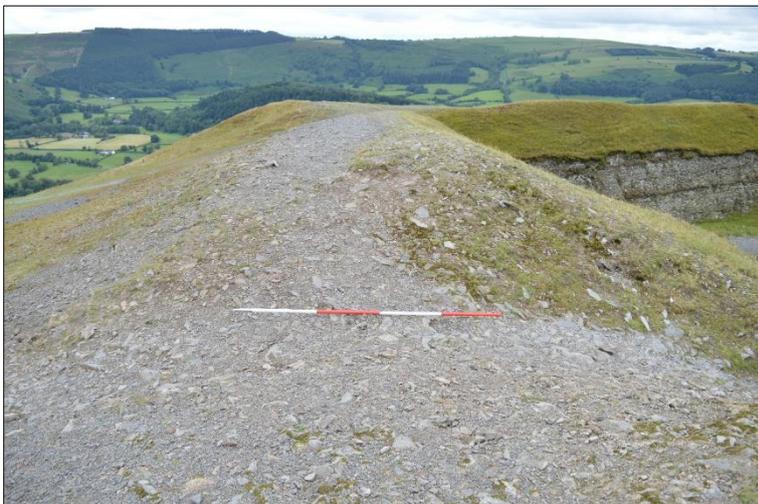
**Description:** The eastern visitor access cuts through the bank/counterscarp on the east side of the quarry ditch. Stone steps descend into the ditch and here the path is stable. Where the path cuts through the bank, the stone makeup is exposed, but stable, while on the outer side of the bank there is a broad area of stone where the turf has been removed, although this also appears stable.

**Recommendations:** Monitor

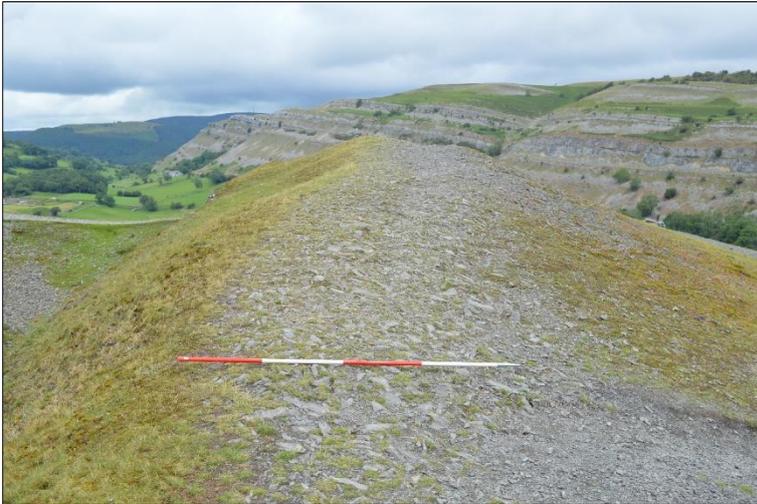
**Description:** The crest of the bank/counterscarp to the south of the steps into the quarry ditch has exposed stone, but appears stable.

**Recommendations:** Monitor

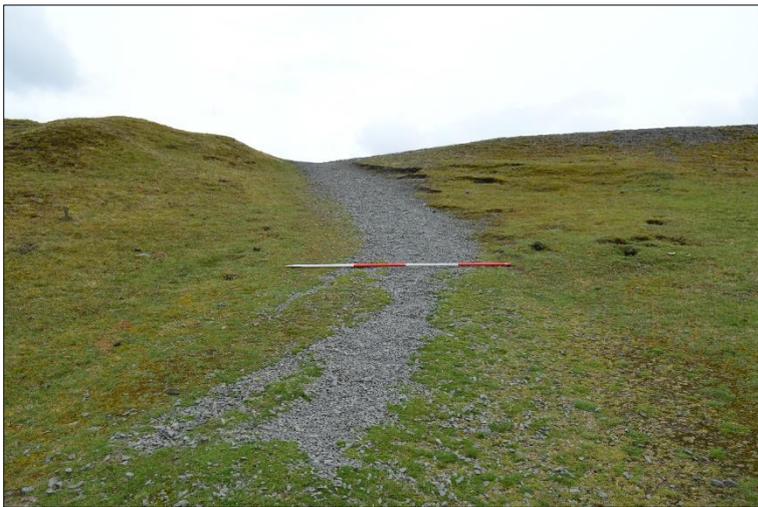
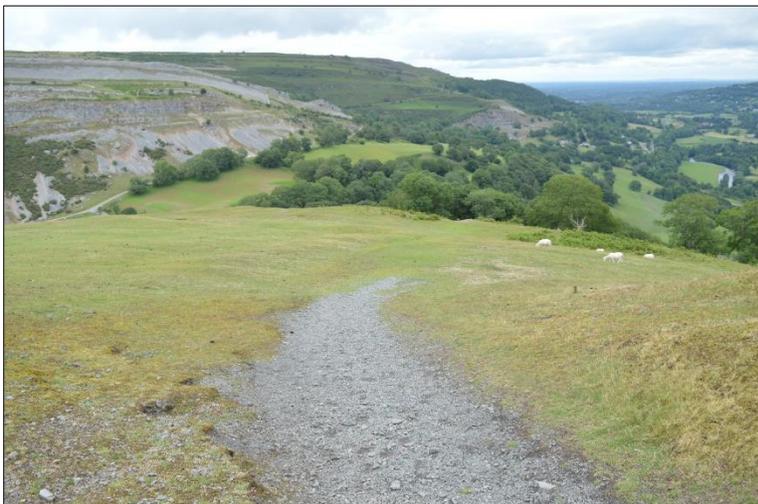
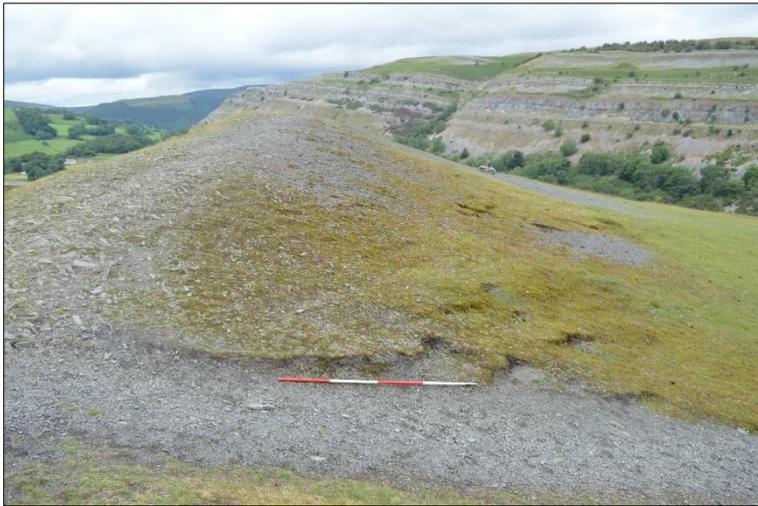
**Description:** The main eastern access path leads to the south-east corner of the bank/counterscarp outside the quarry ditch of the castle. On the final approach visitor erosion has removed the turf cover, although the path appears stable. to the south of the steps into the quarry ditch has exposed stone, but appears stable. As it rises onto the bank there is a slight scarp on the north side of the path.

**Recommendations:** Monitor

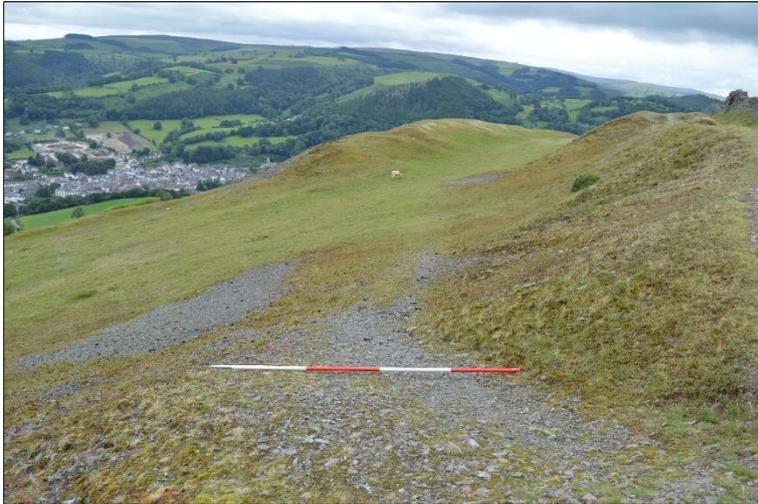
**Description:** A slanting path descends from the crest of the bank/counterscarp outside the quarry ditch, near the south-east corner.

**Recommendations:** Monitor

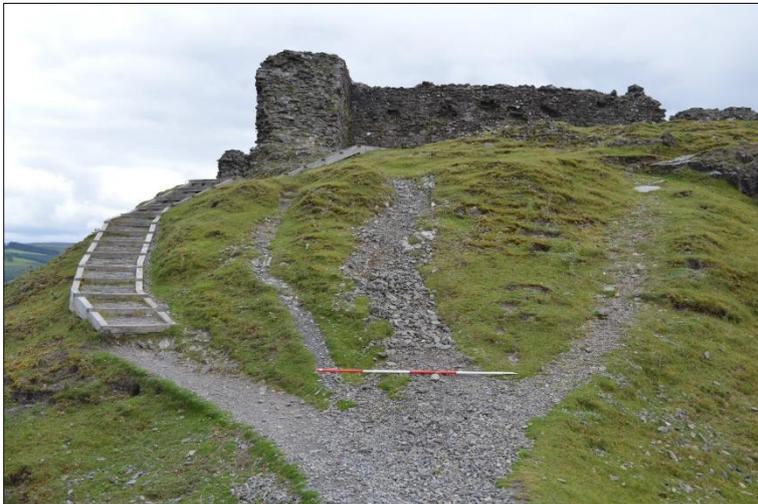
**Description:** From the base of the quarry ditch the eastern access path rises to the castle remains. There are four paths currently in use, of which the main, southern path, comprises a set of timber and pitched-stone steps. The central path of the remaining three is a shallow eroded gully with loose stone in the base. Geotextile membrane has evidently been used here in the past, but is now being exposed as the stone cover is eroded away. The other two paths are both minor and appear stable.

**Recommendations:** Monitor. Infill upper end of eroding path, protect with geotextile and re-establish turf cover.

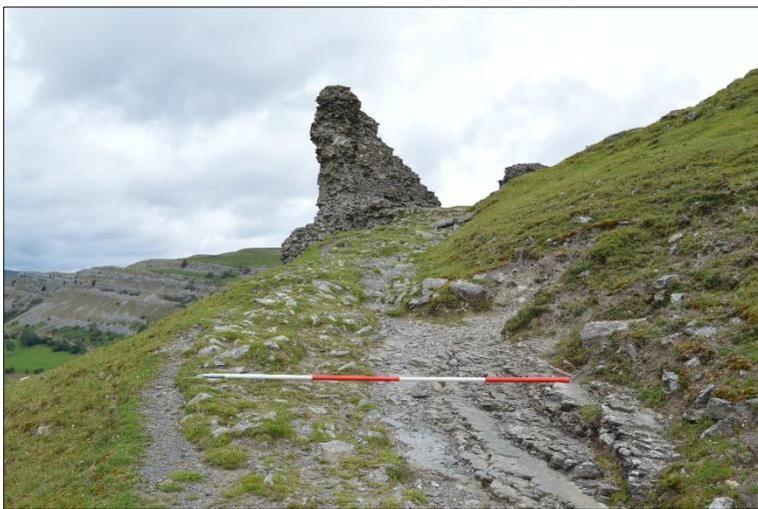
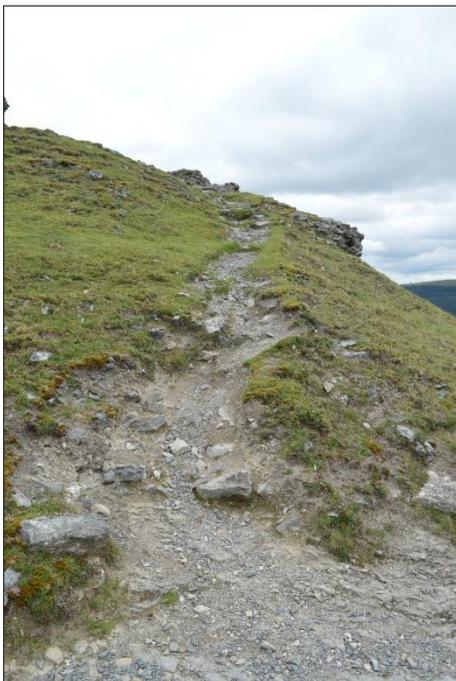
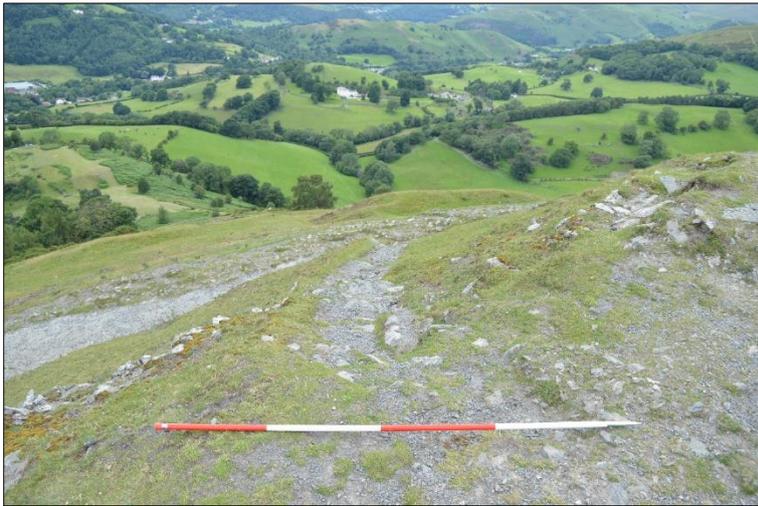
**Issue No: 40****Issue type 1:** Visitor**Location:** south-west corner tower**Photographic references:** CPAT 4771-0069 to 0070 and 0075**Stability:** active**Impact:** low**Priority:** medium

**Description:** Beneath the western side of the castle a path leads from the main western access path directly to the site of the south-west corner tower. The path has become more evident in recent years and is actively eroding with the potential to impact on buried archaeological remains.

**Recommendations:** Monitor. Install fencing along the eastern side of the western access path to discourage visitors from using the eroding path. Protect with geotextile and re-establish turf cover.

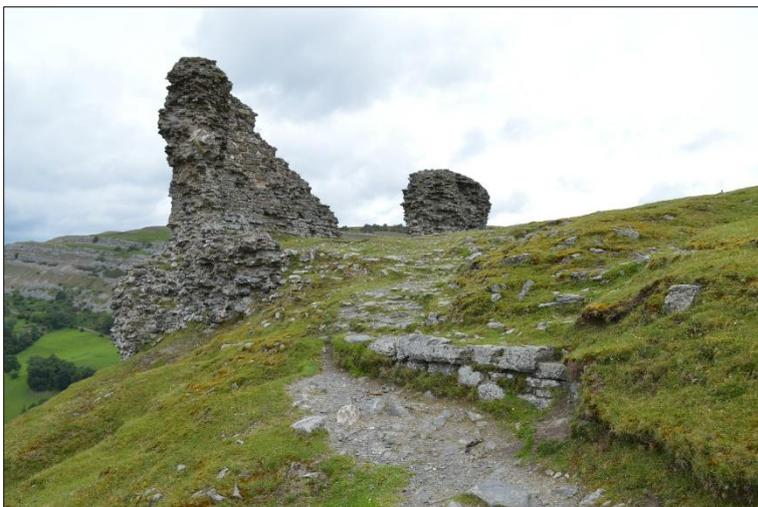
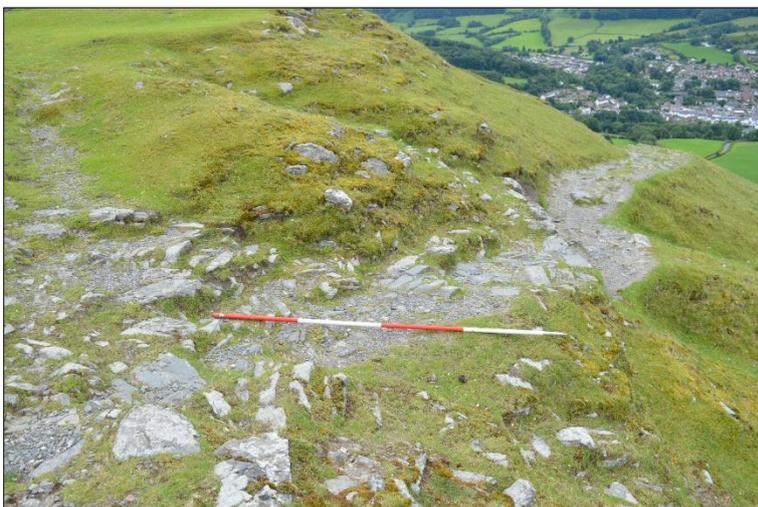
**Description:** The western access path enters the castle via a step up onto the exposed base of the curtain wall. However, although the turf cover has been eroded to expose in situ masonry and the rubble core of the wall the area appears to be stable.

**Recommendations:** Monitor

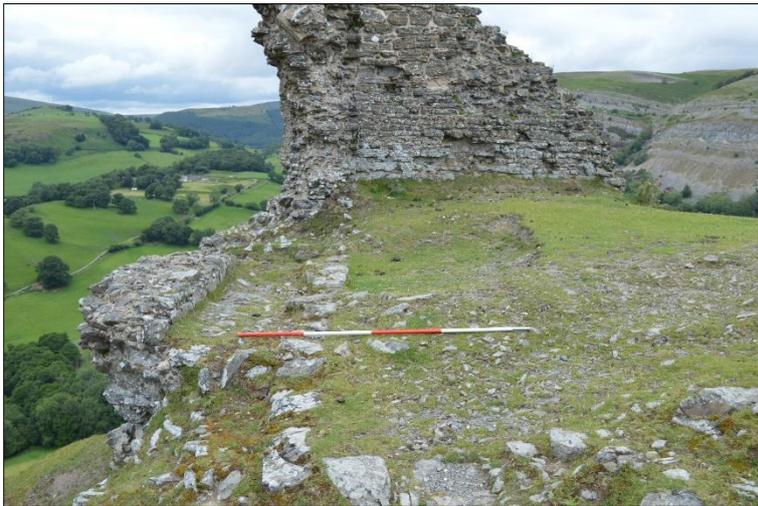
**Issue No: 42**

**Description:** A minor erosion scar has developed in the north-east corner of the castle which has the potential to expose buried archaeological deposits should it develop further.

**Recommendations:** Monitor.

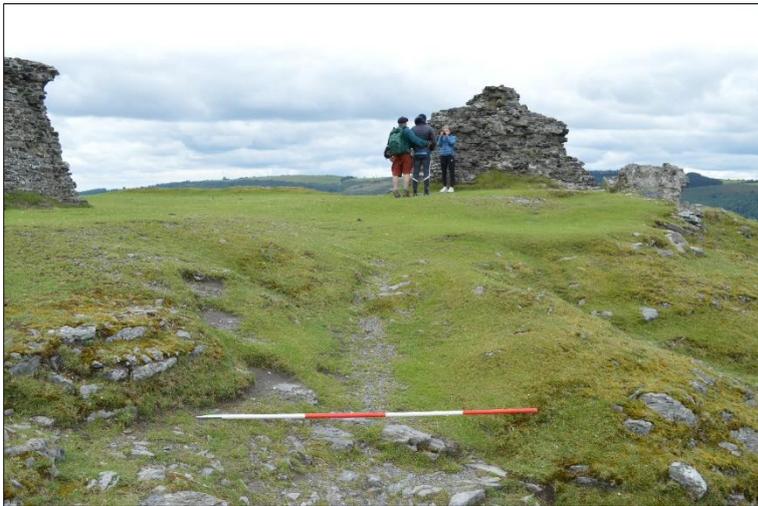
**Issue No: 43**

**Description:** A narrow path leads south-east from the point at which the western access path enters the castle. Minor loss of turf cover.

**Recommendations:** Monitor

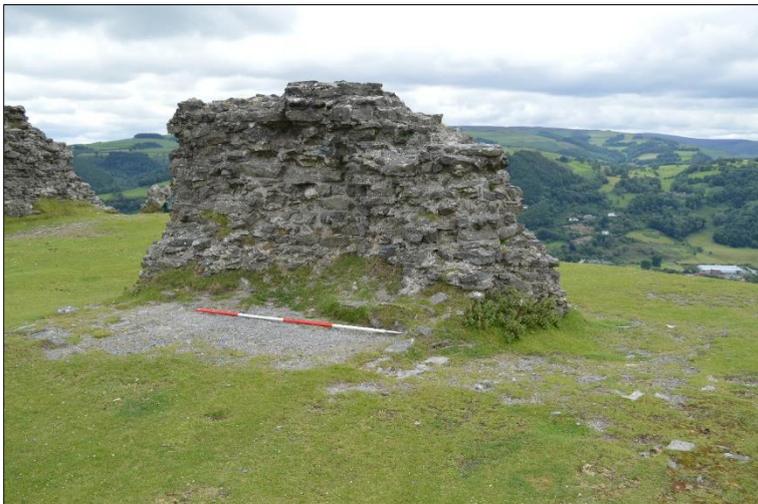
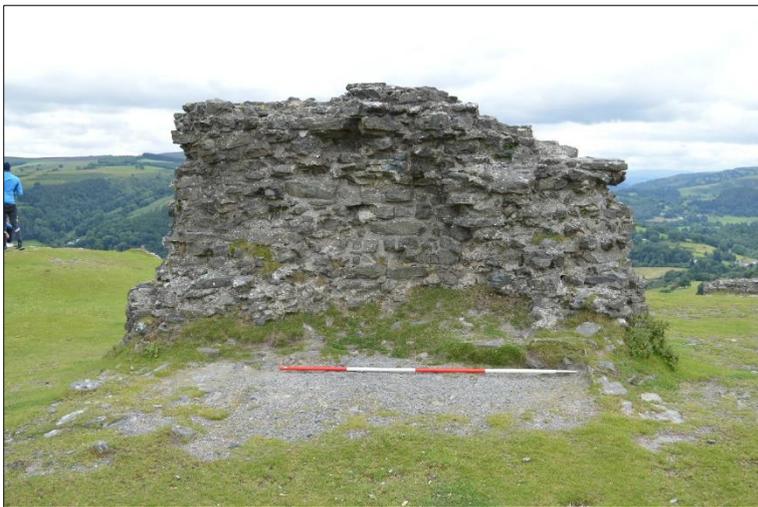
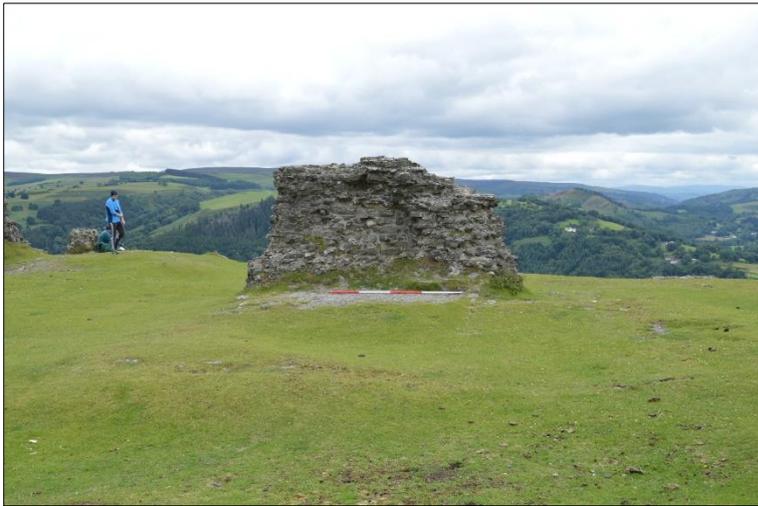
**Description:** Visitor erosion has removed the turf cover from the eastern side of an upstanding section of medieval masonry which later formed the west end of a small cottage. The wall provides visitors with some shelter from the wind.

**Recommendations:** Monitor

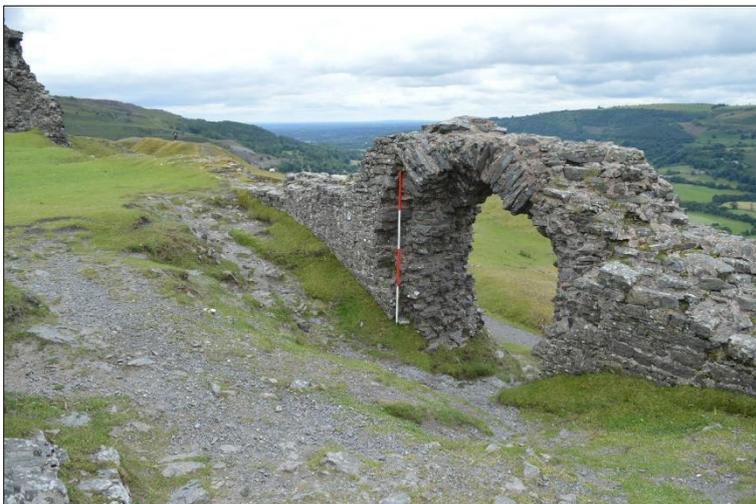
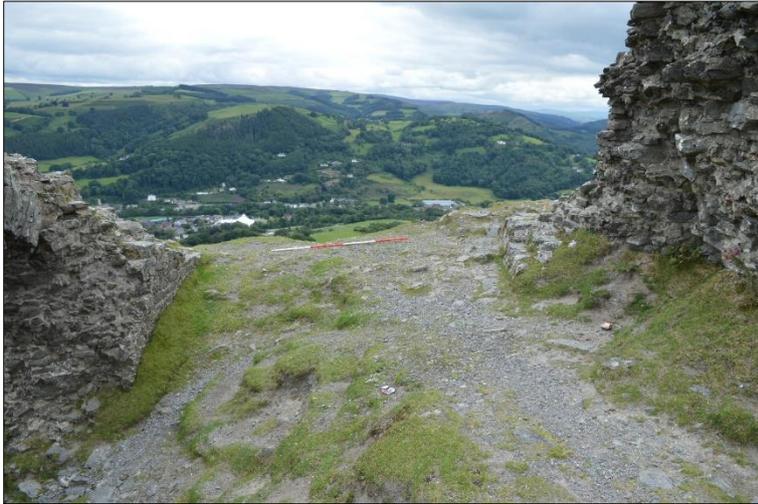
**Issue No: 45****Issue type 1:** Visitor**Location:** south-west corner of castle**Photographic references:** CPAT 4771-0076 to 0077 and 0079**Stability:** stable**Impact:** negligible**Priority:** low

**Description:** The south-west corner of the castle is a popular viewpoint and the turf has been eroded over much of the area between the postern gate and upstanding walling to the north, as well as the area formerly occupied by a camera obscura. However, despite the lack of turf the area appears to be relatively stable.

**Recommendations:** Monitor

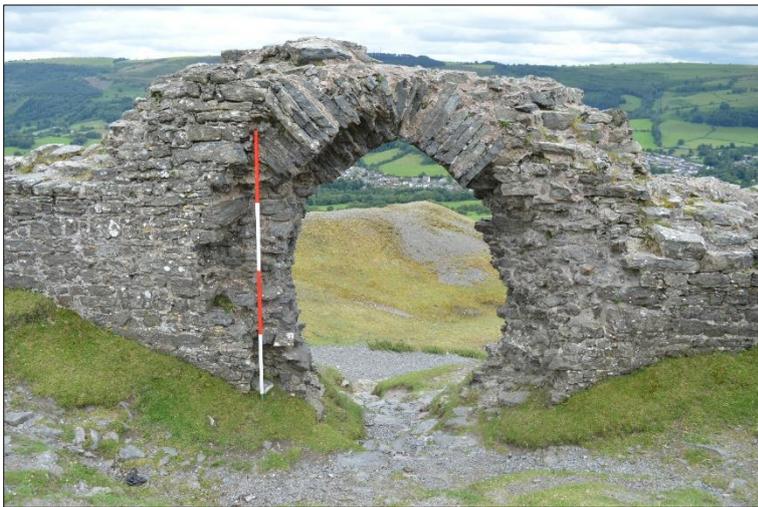
**Issue No: 46****Issue type 1:** Visitor**Location:** postern gate**Photographic references:** CPAT 4771-0078**Stability:** active**Impact:** negligible**Priority:** low

**Description:** The upstanding masonry of the postern gate attracts the attention of most visitors to the castle, resulting in the loss of turf cover on the narrow paths inside and outside the curtain wall. However, despite the visitor numbers the underlying rock and rubble are stable, with no apparent impact on archaeological deposits.

**Recommendations:** Monitor

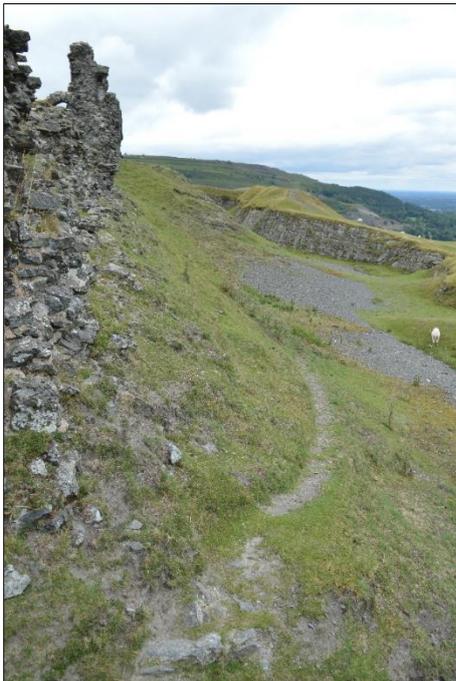
**Description:** A narrow path traverses the slope below the postern gate. It is little used and is relatively stable.

**Recommendations:** Monitor

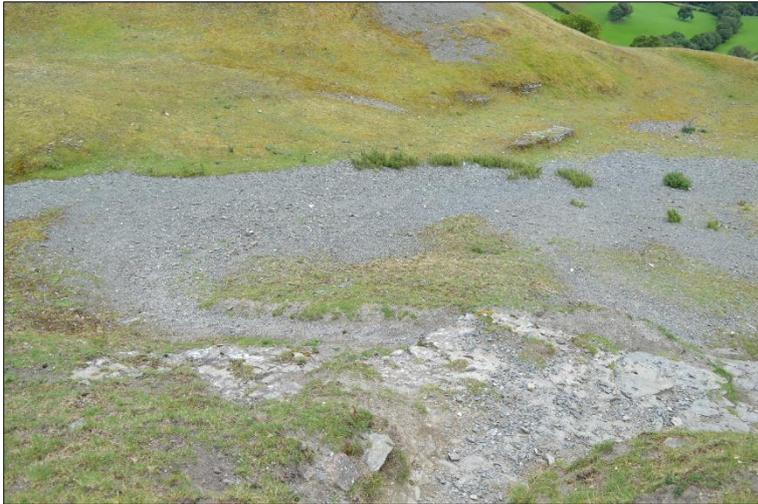
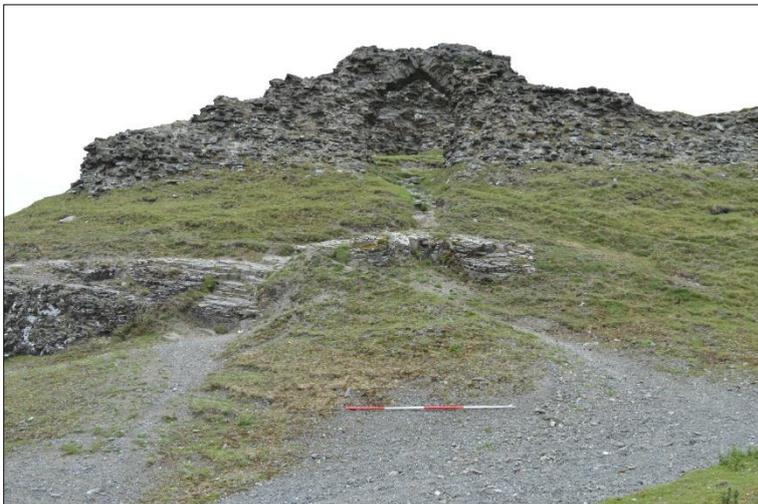
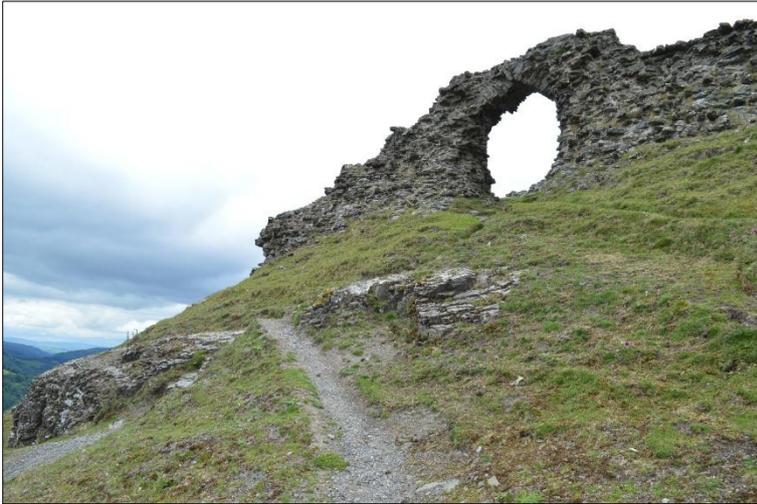
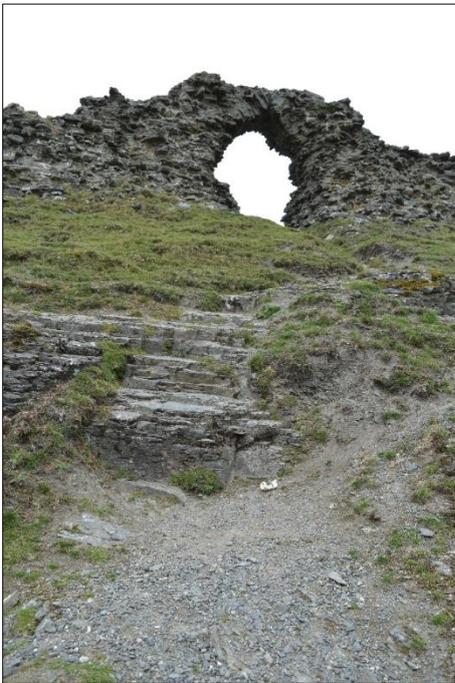
**Issue No: 48****Issue type 1:** Visitor**Location:** exterior of postern gate**Photographic references:** CPAT 4771-0081 to 0084**Stability:** active**Impact:** none**Priority:** low

**Description:** Below the postern gate a short, steep path descends before dividing. The south-western branch crosses a rock outcrop, while the south-eastern branch descends more gradually. Both paths are in regular use and are actively eroding, but are not a serious issue.

**Recommendations:** Monitor
