CPAT Report No. 1739

# Castell Dinas Brân, Llangollen, Denbighshire

Condition Survey

Client name: Denbighshire County Council  
 CPAT Project No: 2457  
 Project Name: Castell Dinas Brân  
 Grid Reference: SJ 2225 4306  
 County/LPA: Denbighshire  
 CPAT Report No: 1739  
 Event PRN: 140340  
 Report status: Final  
 Confidential until: N/A

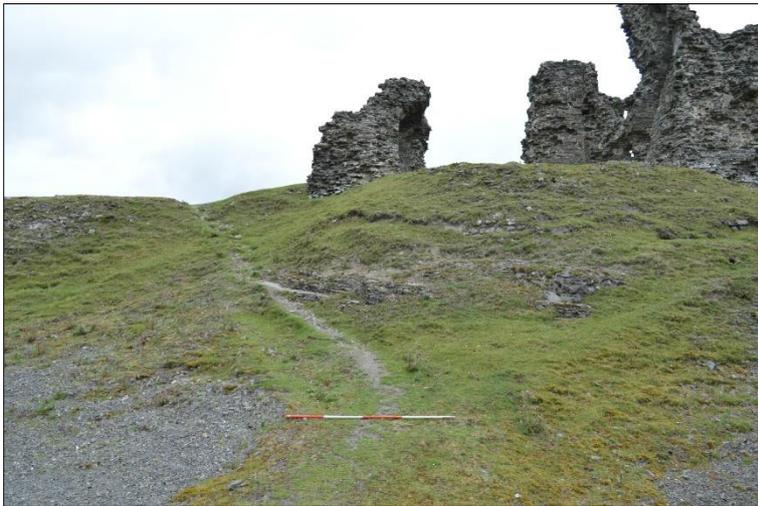
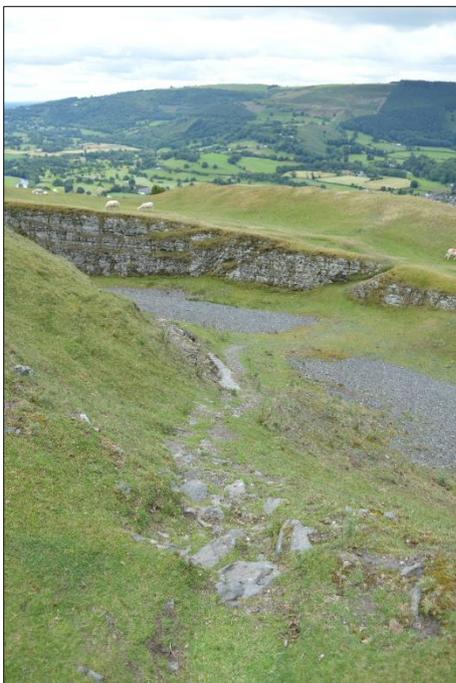
**Description:** A narrow path has developed on the slope to the west of the D-shaped tower, exposing some of the corework for the curtain wall, although this is not actively eroding.

**Recommendations:** Monitor

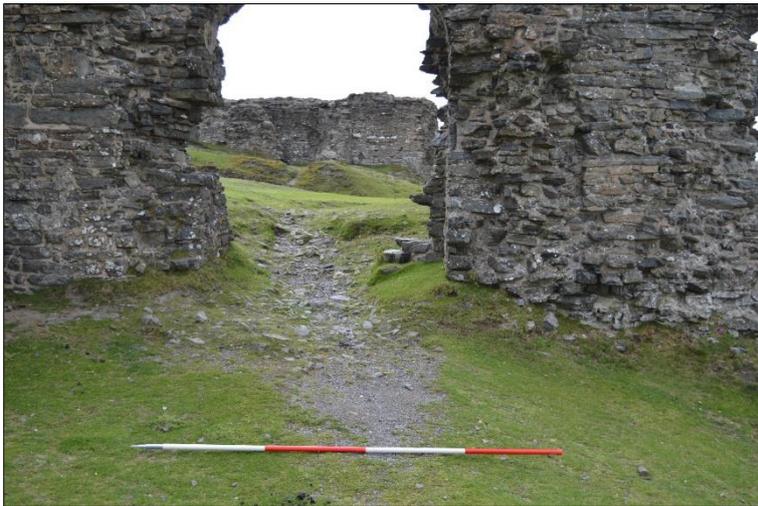
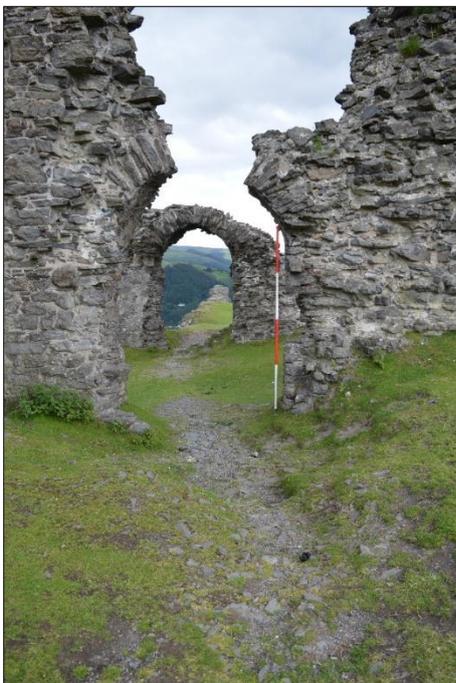
**Issue No: 51**                      **Issue type 1: Visitor****Location:** D-shaped tower**Photographic references:** CPAT 4771-0089 to 0090**Stability:** active                      **Impact:** negligible                      **Priority:** low**Description:** Passage through the eastern arch of the tower has eroded the turf cover internally and externally, although the underlying rubble is stable.**Recommendations:** Monitor.

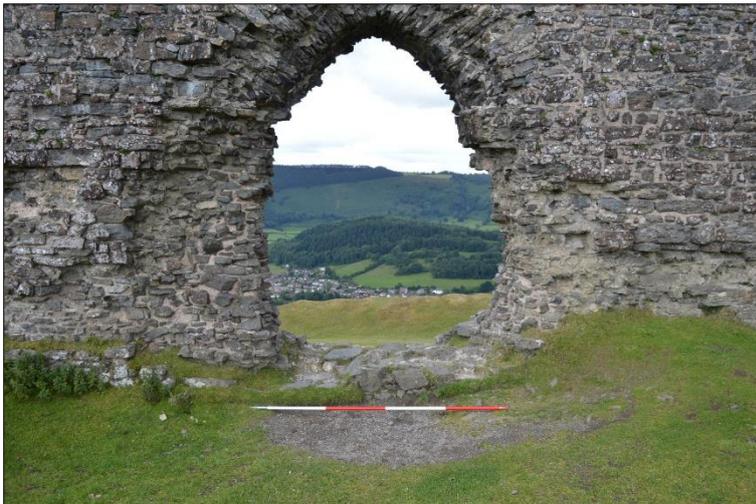
**Description:** The western window of the hall, to the east of the D-shaped tower, is a focus for visitor activity which has resulted in the loss of turf cover over a small area inside the castle, although with no obvious impact on archaeological deposits.

**Recommendations:** Monitor

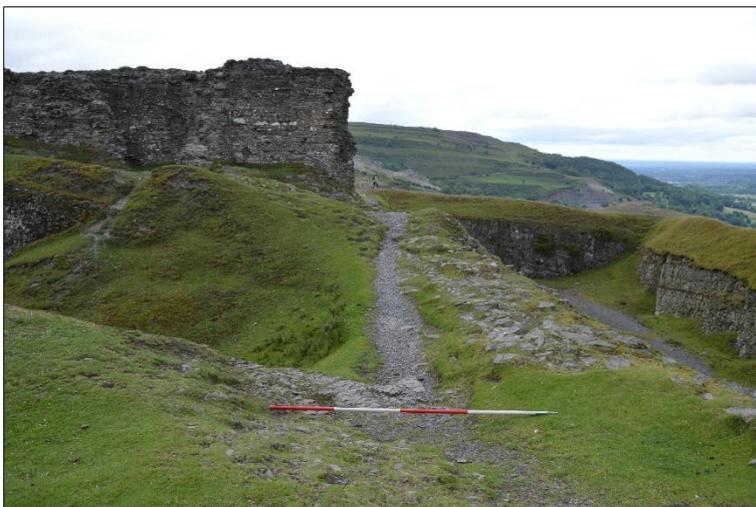
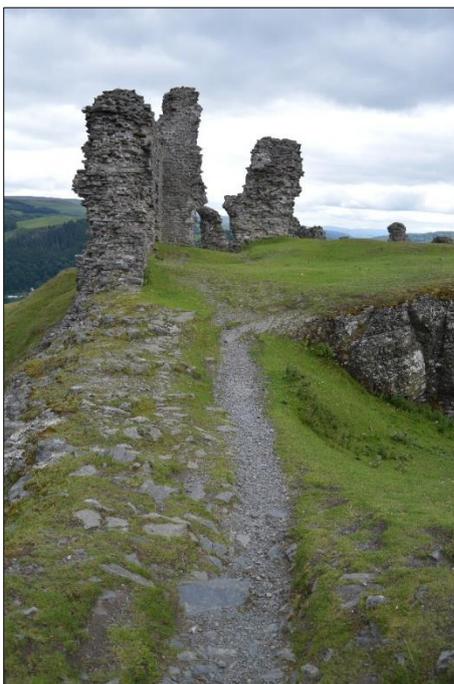
**Issue No: 53****Issue type 1:** Visitor**Location:** curtain wall south-west of keep**Photographic references:** CPAT 4771-0092 to 0093**Stability:** stable**Impact:** negligible**Priority:** low

**Description:** A narrow path provides access for visitor between the southern side of the keep and the rest of the castle. The path crosses the line of the curtain wall and has exposed some corework, although with little archaeological impact.

**Recommendations:** Monitor

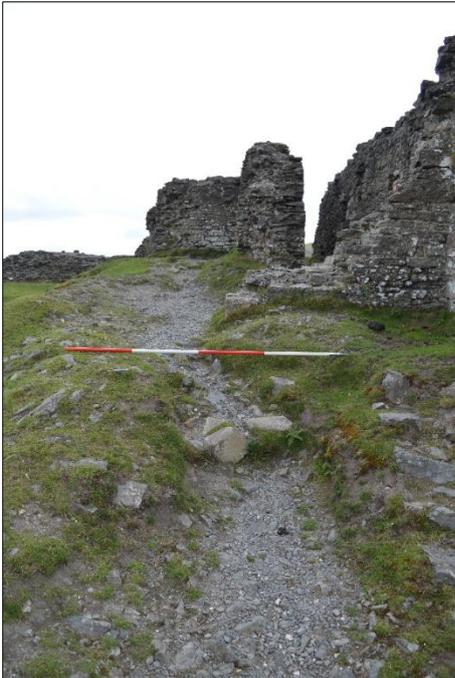
**Issue No: 54****Issue type 1:** Visitor**Location:** west side of keep**Photographic references:** CPAT 4771-0094 to 0095**Stability:** stable      **Impact:** none      **Priority:** low

**Description:** A path runs along the western side of the keep, crossing a short length of exposed masonry, leading to the site of the interpretation panel, where the loss of turf cover is more extensive. The area is, however, fairly stable.

**Recommendations:** Monitor

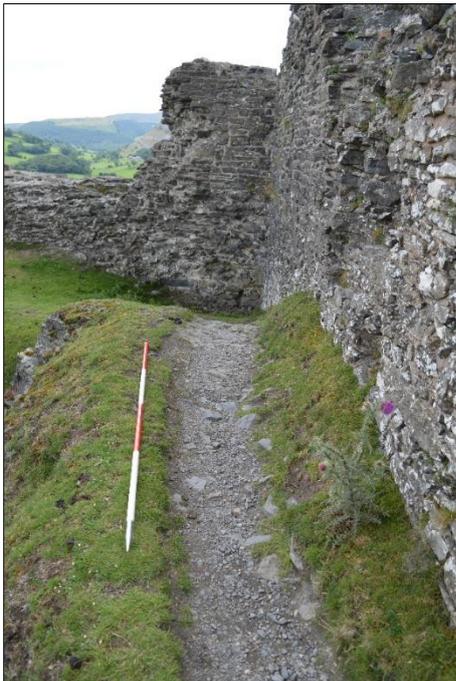
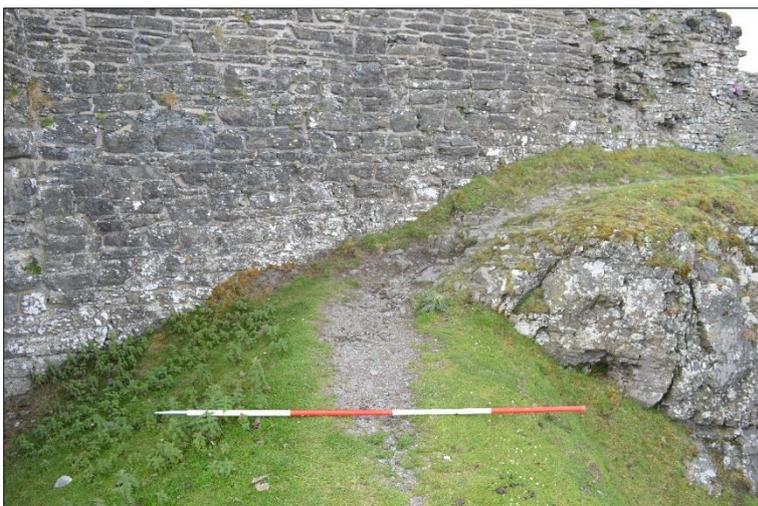
**Description:** A narrow path follows the edge of the inner ditch northwards from the interpretation panel.

**Recommendations:** Monitor

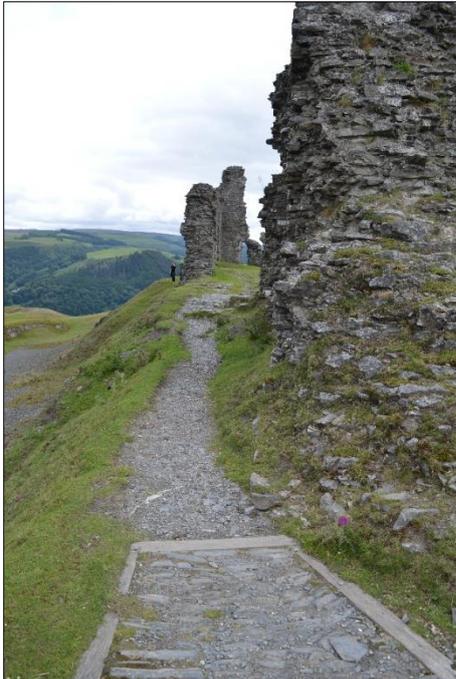
**Description:** The path from the top of the access steps follows along the south side of the keep.

**Recommendations:** Monitor

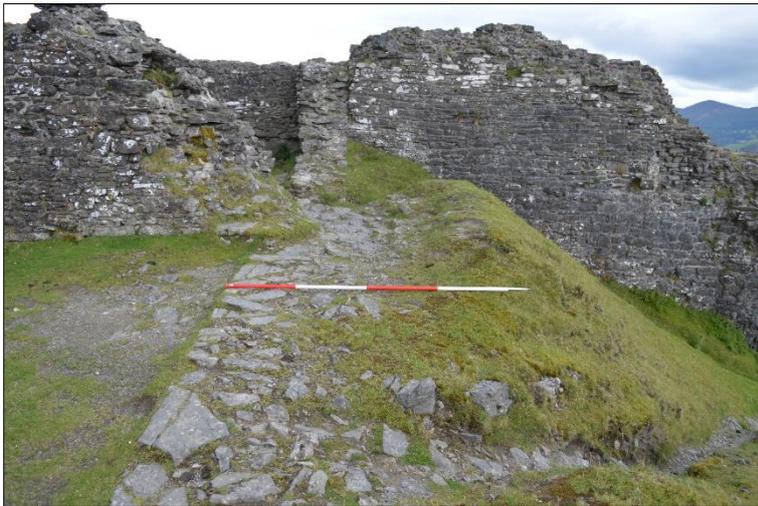
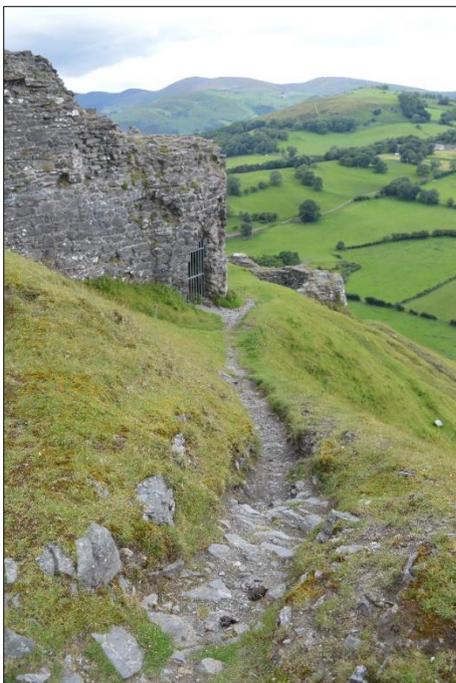
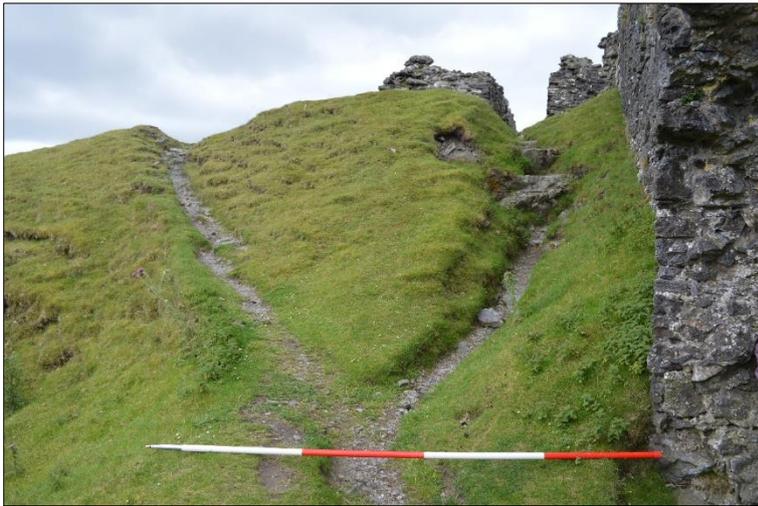
**Description:** Two paths, one steep and the other slanting, connect the keep with the outside of the gatehouse.

**Recommendations:** Monitor
