St Trillo's Church, Llandrillo-yn-Rhos,  
Conwy  
ARCHAEOLOGICAL RECORDING

CPAT Report No 403

**R J Silvester**  
November 2000

Report for Robin Wolley, Esq

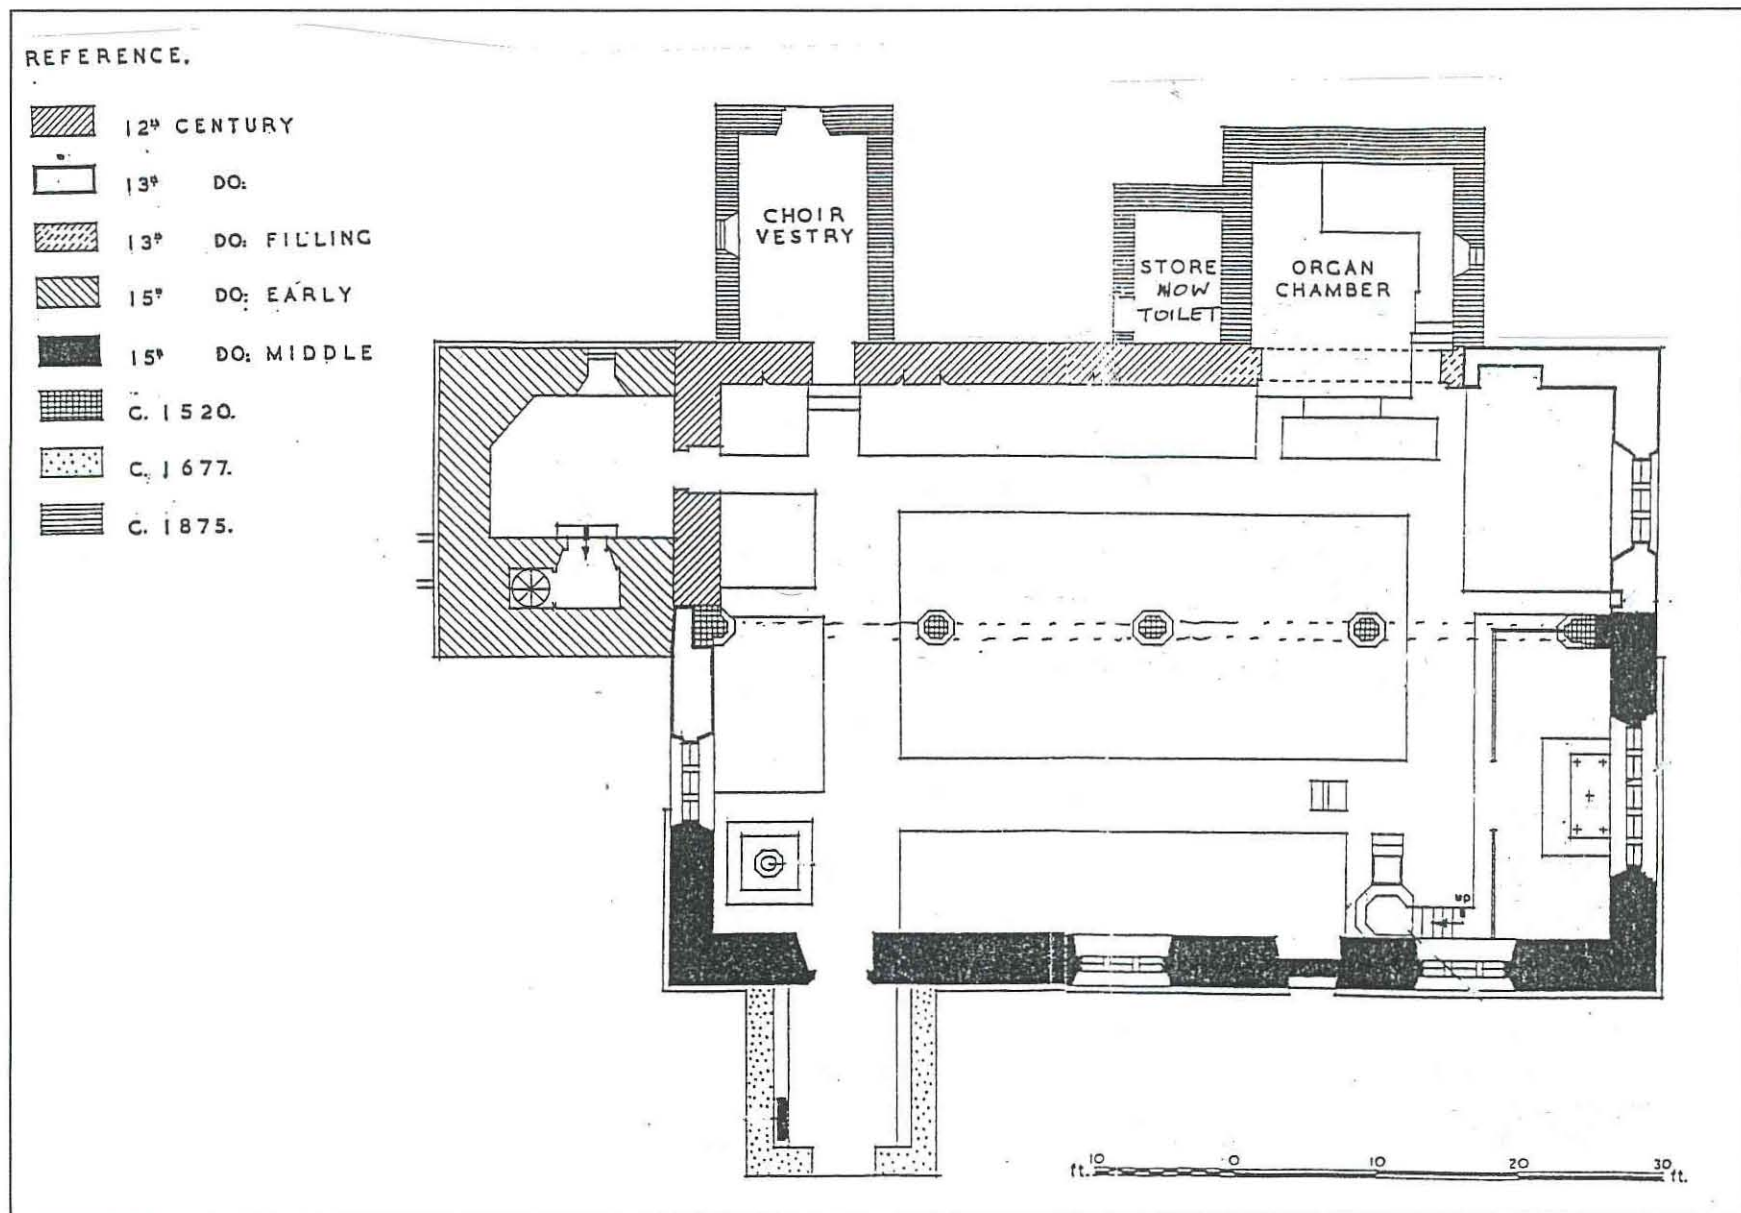
Fig 1: Llandrillo-yn-Rhos church: possible sequence of development based on Radford 1939 and taken from the church guide

10.1 As a result of the recording work, a sequence can be suggested which shows some revisions and simplifications to that proposed by Radford which was used, perhaps rather uncritically, in the preparation of the church plan (Fig. 1). Certainly Radford's views on the 15th-century origin of the tower and south nave cannot be substantiated.

10.6 The south nave with its chancel were added in the earlier 16th century. Hubbard implied that the south nave was extended to create a new chancel as a result of Conway's will in 1540, but it is clear from the fabric analysis that the south nave is all of one build. It can thus be assumed that the south nave was erected in the earlier 16th century, and the central arcade, which would have been an integral feature and was dated by Radford to c.1520, suggests a date for the whole enlargement. There is no need to suggest as Radford did (and as is indicated in Fig. 1) that the arcade was rebuilt at this time.
