Lower Lea Farm, Lydham, Shropshire

ARCHAEOLOGICAL ASSESSMENT

N W Jones
August 2009

Report for McCartneys, on behalf of Mr R Hughes

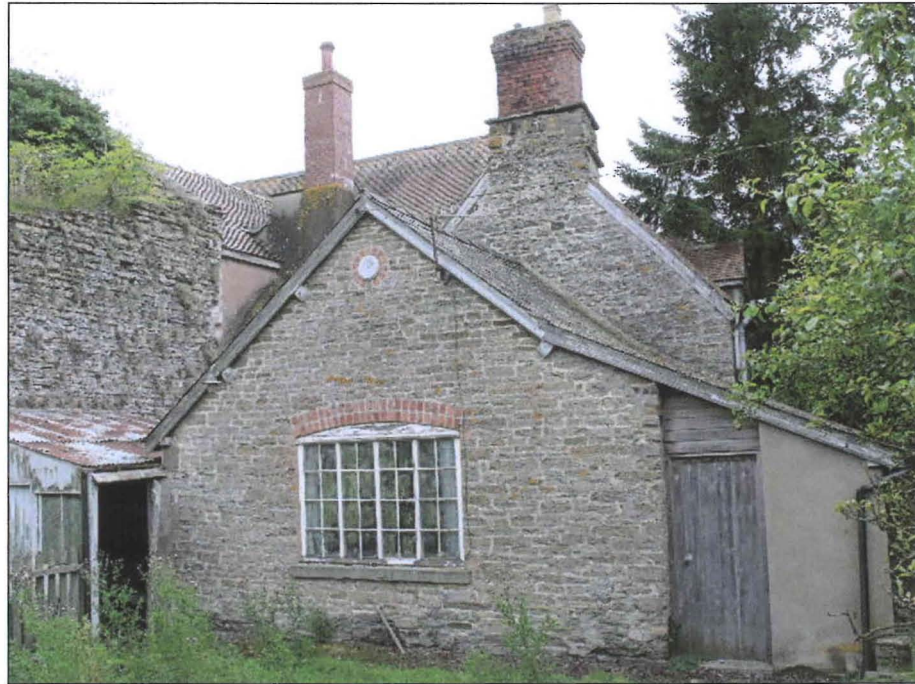
Fig. 11 The western range of the farmhouse (Phase 2)

- 4.9 The earliest visible structure (Phase 2a) is the western range which dates from the mid 19th century, and is built of coursed limestone rubble with red-brick dressings and a tiled roof (Fig. 11). This has a dormered upper storey and a massive stack incorporated into the northern gable. The position of the wing is curious and may suggest that it was built to replace part of the earlier building while the remainder was still standing, although this is entirely speculative. A single-storey, slated extension was later added to the northern end to form the farmhouse kitchen (Phase 2b), from which there is a stair ladder leading to what has been described as the 'mens' room' (Moran 2003).

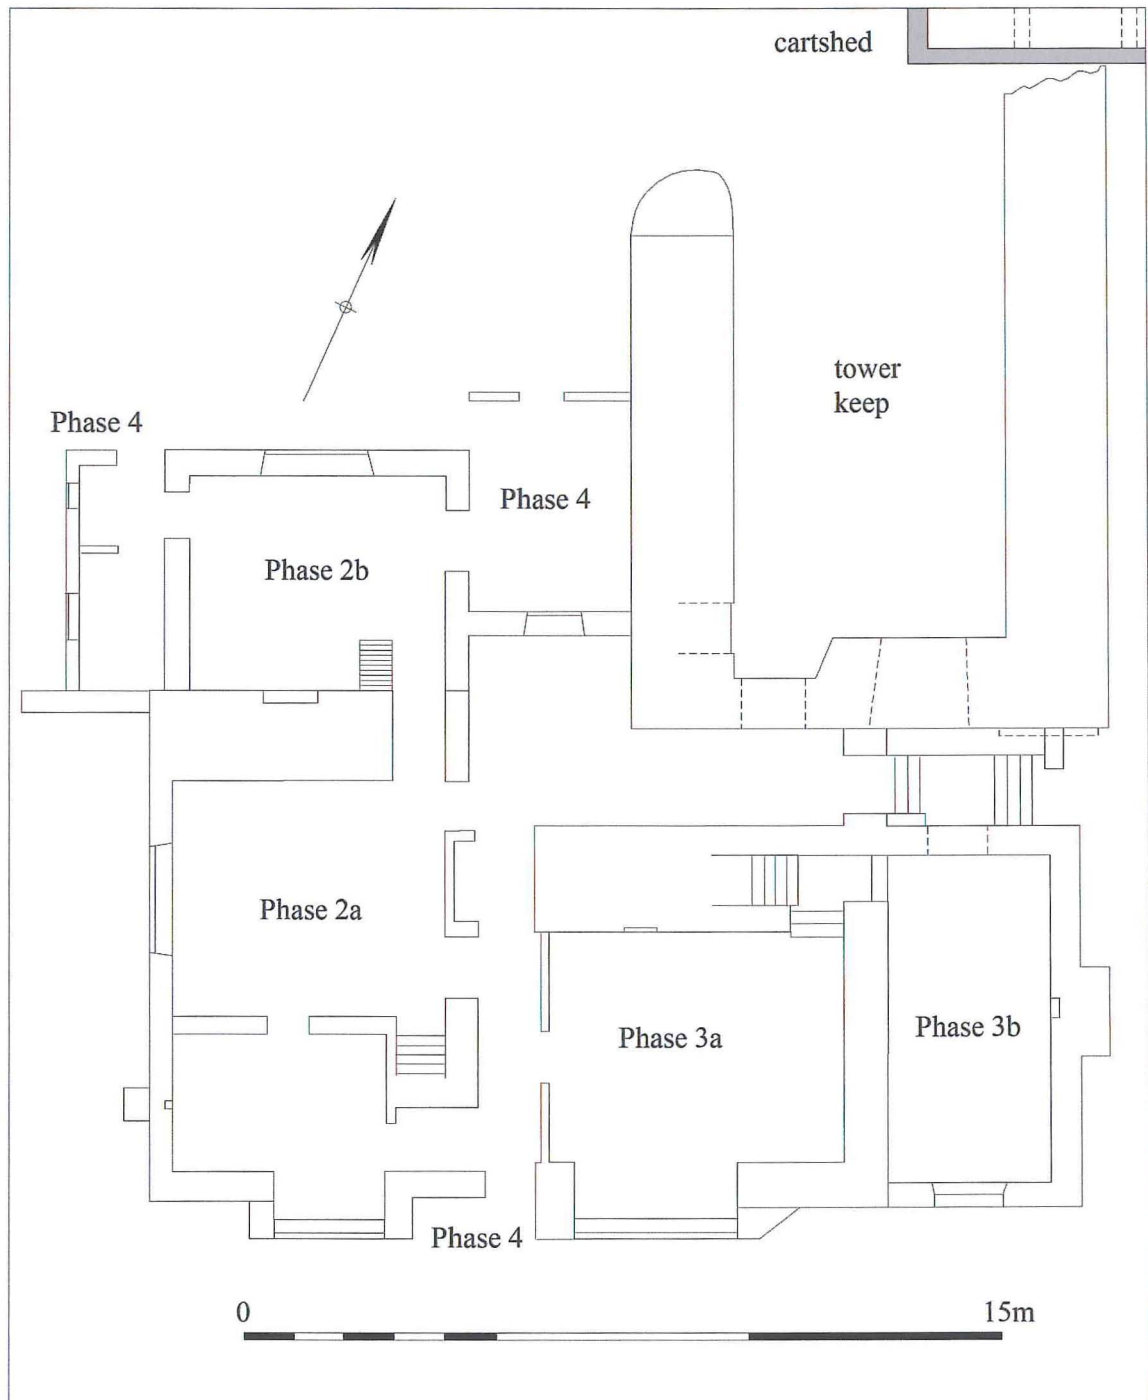
Fig. 12 Ground floor plan of Lower Lea Farmhouse and Tower Keep

approximately 9.5m east to west by 13m north to south, with walls about 2m thick (see Fig. 12). The northern end of the east wall has been incorporated into a mid 19th-century cartshed which is itself in a somewhat precarious state with significant recent collapse. Although it has been suggested that the tithe map of 1844 (Fig. 3) shows the outline of the tower keep prior to the demolition of the northern part of the building, the present study, through rectification of the map, has demonstrated that the tower is not actually depicted. The map does, however, depict what must be the farmhouse to the south, along with a number of boundaries, some of which respect the position of the tower keep.

- 4.8 The visible structure is largely 19th-century, with several phases evident (see Figs 12-13), although a predecessor is suggested by the Tithe Survey of 1844, which depicts a rectangular building against the southern end of the tower keep with a projection on the south side (Phase 1). A date plaque of AD 1560 has been set into the outside of the modern porch and it is tempting to suggest that it was derived from this building. Externally, there is now no trace of

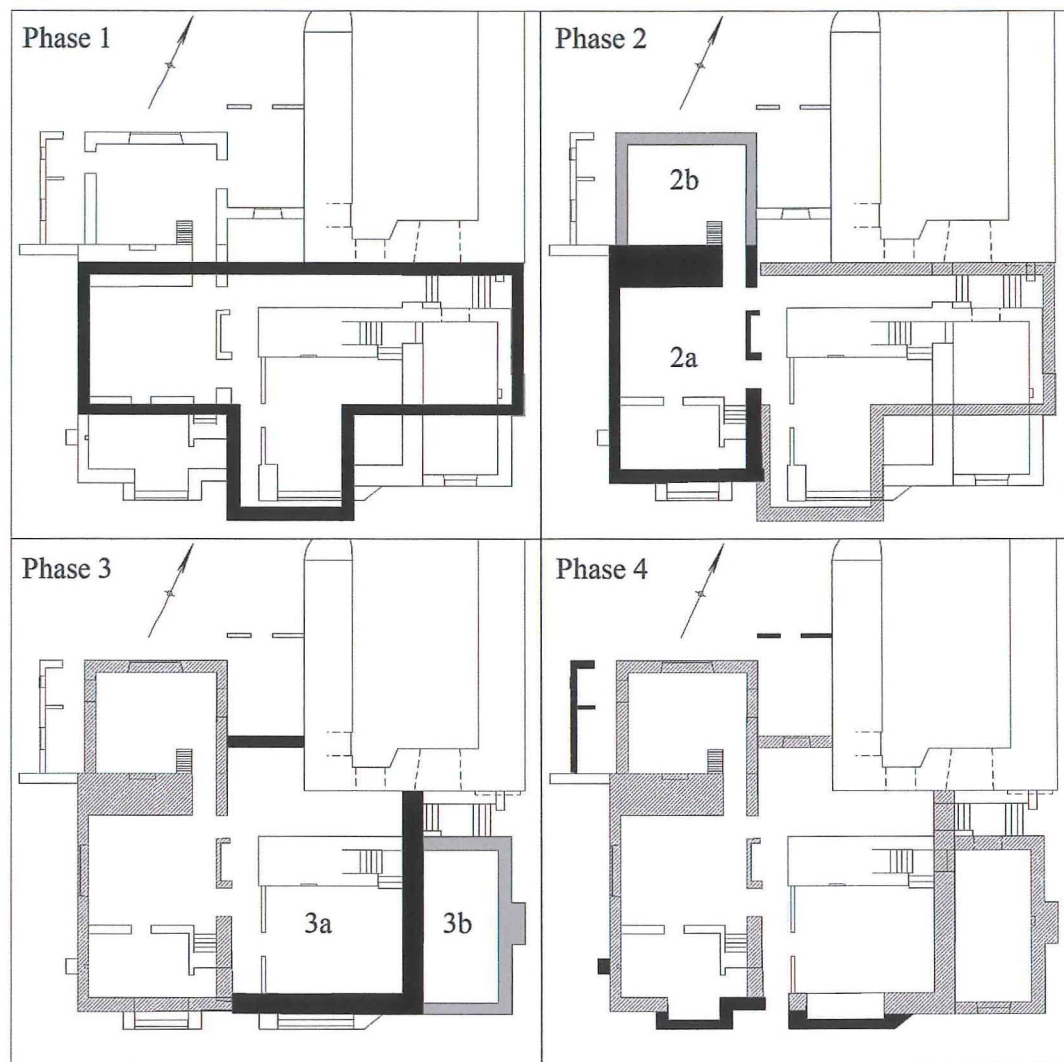
Fig. 13 Conjectural phasing of Lower Lea Farmhouse

- 4.10 A substantial two-storeyed extension was added on the east side (Phase 3a), which is also of coursed limestone rubble with red-brick dressings. The roof is of plain tile, with a partial catslide over an outshut at the rear, between the earlier phase and the west side of the tower keep. This phase incorporates a large stack on the northern side, which has an obvious butt joint in the masonry, visible in the roof space above the outshut. Possibly not long after its construction, and certainly before 1883, a further two-storeyed extension with an external end stack was added to the east (Phase 3b). The floor levels in this part of the building are raised several steps above the main house, due to the presence of a basement.

- 4.11 The final phase (Phase 4) probably dates from the second half of the 20th century and comprises a gabled red-brick extension to the front, south side, and the addition of a utility room and bathroom on the western side of the kitchen.

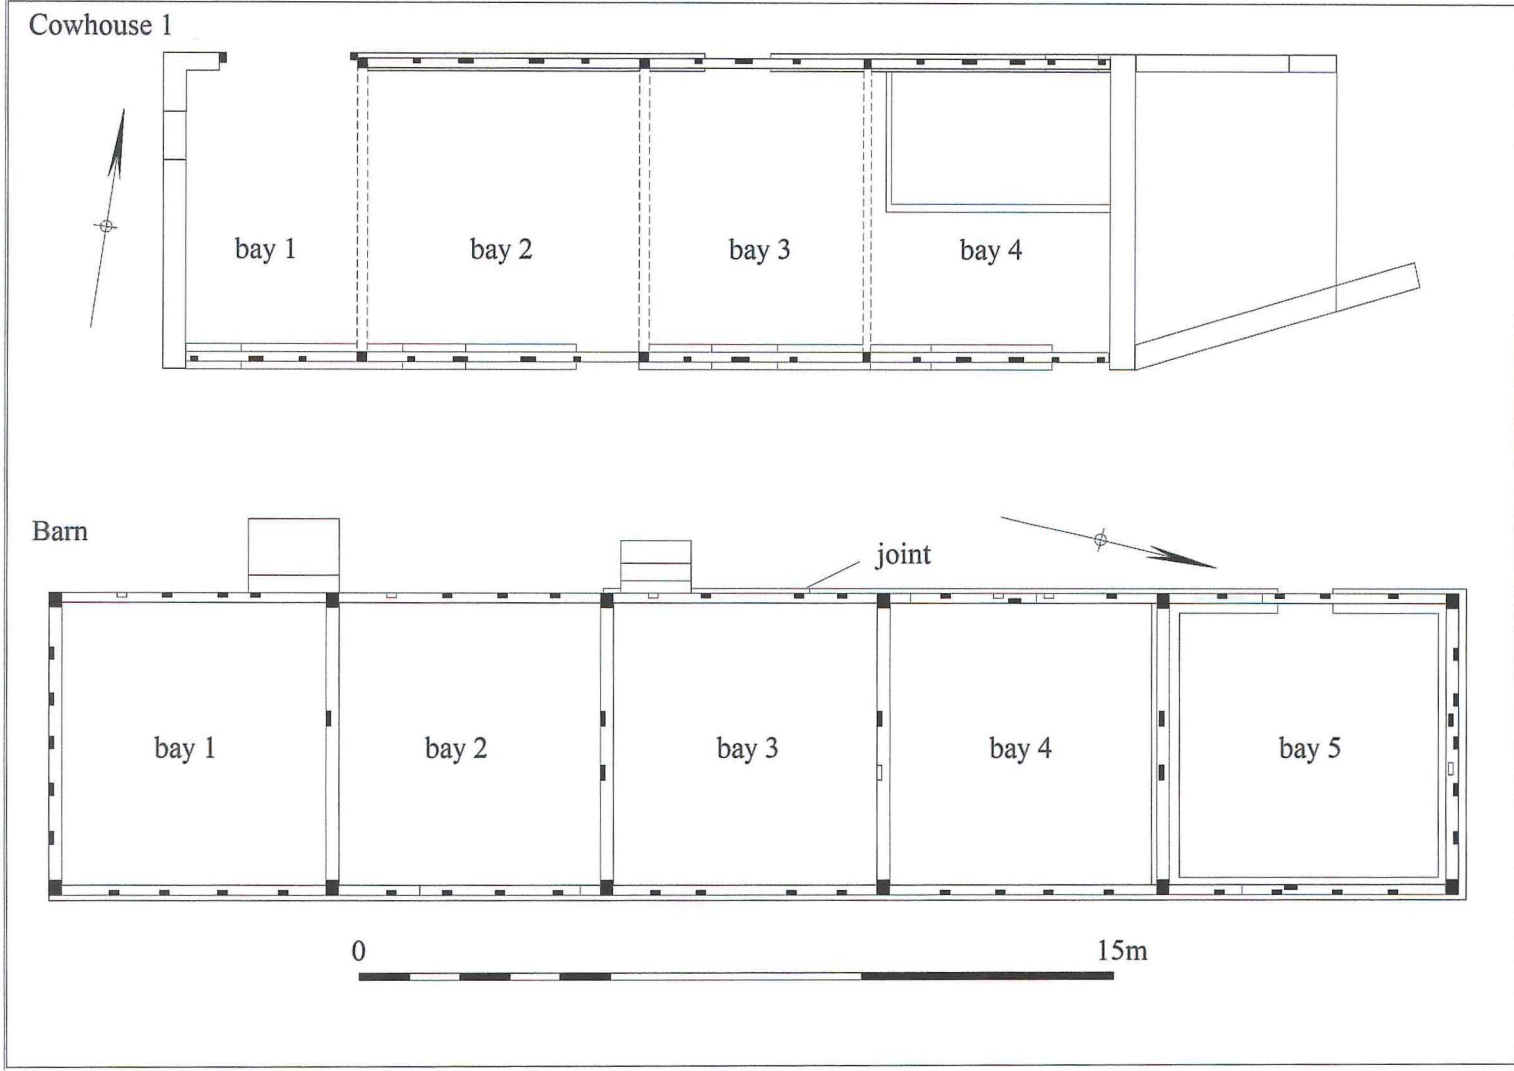
Fig. 17 Ground floor plans of the Barn and Cowshed 1

- 4.17 The trusses are in good condition, as is most of the framing, with the exception of the western side where the weatherboard is missing and significant rotting has occurred. The plinth has bowed considerably on the western side, with movement of up to 150mm.

- 6.8 The barn is now redundant and in a poor state of repair, although the main structure itself is in good condition. As noted above, the long term future of the building is dependant on an alternative use being found as the barn does not suit modern agricultural needs. The timber framing is in need of urgent repair and the movement of the frame will need to be corrected. The level of survey undertaken by the present study is considered sufficient unless there are proposals to convert the building to residential use, in which case further recording may be considered appropriate.

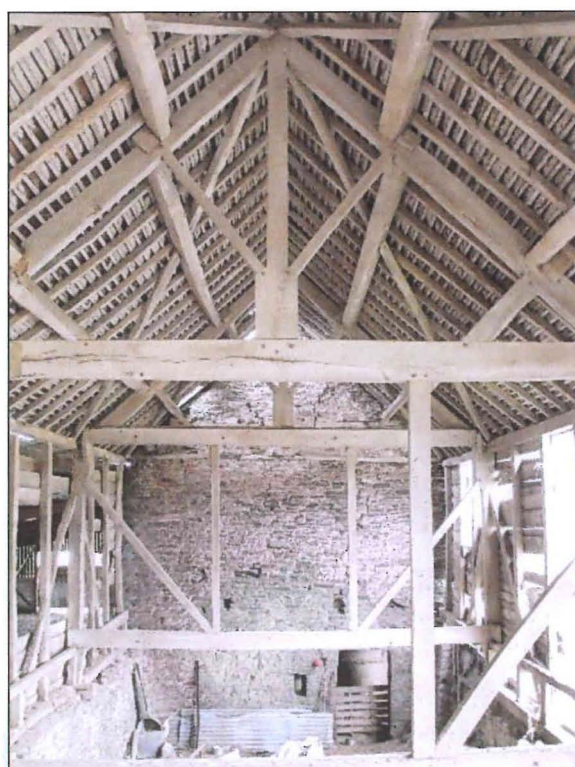
Fig. 19 Interior of Cowhouse 1

- 4.20 The roof has staggered double purlins supported on machine-cut king post trusses with slanted struts and jowled posts, and is clad in plain tiles. The roof is in generally good condition, although there are some missing tiles in the south-western corner. The overall structure appears sound, although there are several visible cracks in the western gable wall.

- 6.9 The 19th-century cowhouse is generally in good condition, with only minor repairs required to the roof. The present form of the building would allow it to continue in use as an agricultural building and this would be the preferred option to ensure its survival.

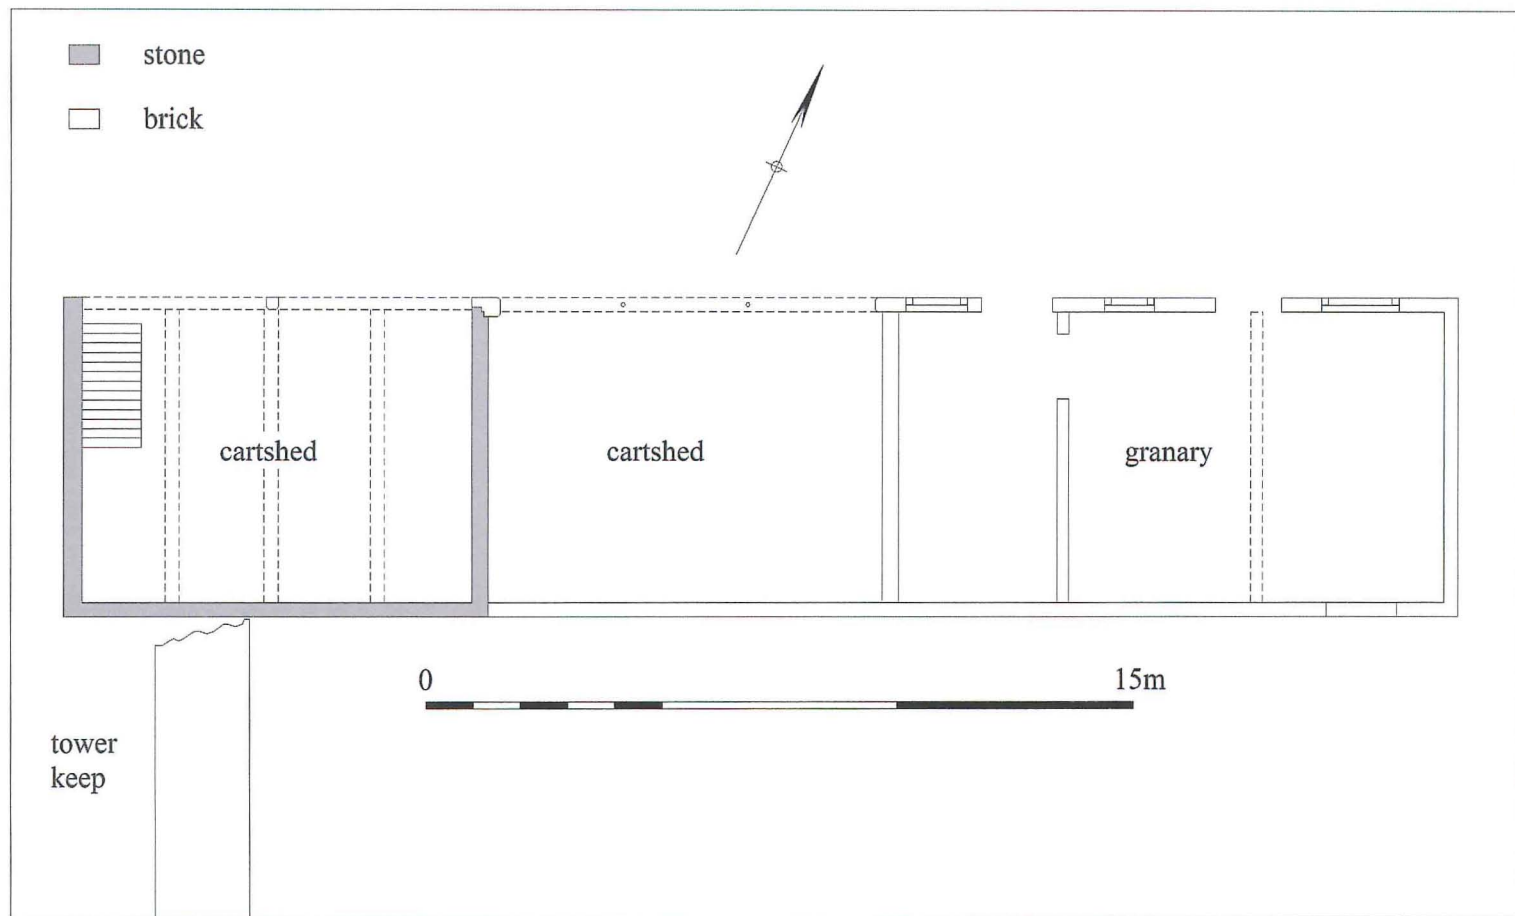
Fig. 24 Cartshed and Granary Range

- 4.21 The cartshed and granary range immediately to the north of the tower keep is protected as a grade II listed building (no. 257071). The earliest part of the range is a cartshed at the western end which was built sometime between 1844 and 1883. This is of rubble stone construction, measuring 9m by 6.75m, open on the ground floor on the northern side, with a timber frame and weatherboarding above. This structure was built directly onto the northern end of the east wall of the tower keep (Fig. 24).

- 6.10 As has already been mentioned, the condition of the earlier cartshed is a cause for considerable concern. The western gable wall has seen recent collapse and the whole structure is now under threat if remedial works are not undertaken immediately. Stabilisation of the wall is of vital importance to the management not only of the cartshed, but also of the tower keep.
- 6.11 The remainder of the range is in good condition and the first floor is still in use as a grain store. The long-term future, however, may depend on an alternative use being found.

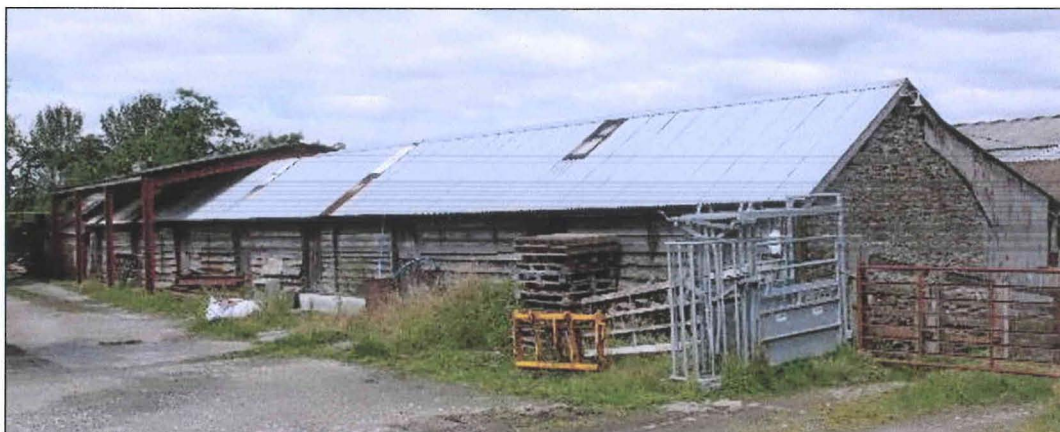
Fig. 25 The single-storey cowshed viewed from the south-east

- 4.26 The single-storey cowshed which occupies a central position in the farm complex appears to have been built between 1844 and 1883 and is currently not listed. The purpose-built cowshed, which measures 30.5m by 4.65m, has random rubble walling on the northern side and gable ends, with weatherboarded timber framing along the southern side. The simple king-post roof trusses have principal rafters which are often formed from reused timbers, supporting single purlins. The roof is now of corrugated iron and the western end of the building has been partly enclosed beneath a modern, steel-framed barn which has only been partially erected.

- 6.12 The single-storey, 19th-century cowhouse is a good example of its type, which has remained relatively unaltered. It is not, however, subject to any statutory protection. The building has been disused for some time and is not suited to modern agricultural needs. The western end lies beneath a modern steel-framed cover barn which was never completed, the intention having been to replace the whole structure. It is to be presumed that the cover barn will eventually be completed and the cowhouse is likely to be demolished. The present study has conducted a survey of the building which is considered to include sufficient detail for provision of an appropriate record and no further recording is proposed.

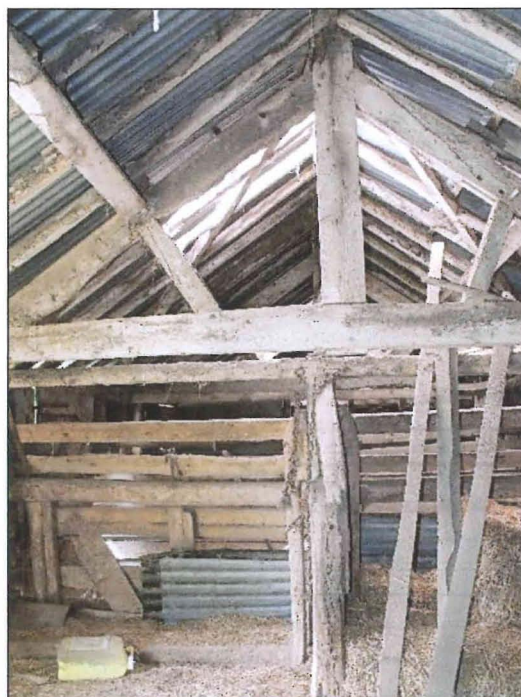
Fig. 26 Interior view of the single-storey cowshed

- 4.27 The internal layout remains largely intact and preserves original features such as feeder troughs, stalls and hay racks. Eight doorways on the southern side provide access to the feeding passages and stalls. The original floor was of stone, or possibly cobbles.
- 4.28 There is a small extension on the western end with rubble walling on the south and west, and a weatherboarded timber frame on the north side. There is a single king-post truss and the interior has a feeding trough and hay rack on the southern wall.
