# Llanddwyn Church Newborough, Anglesey

Archaeological report to aid digital reconstruction and interpretation

## St Dwynwen's church, Llanddwyn

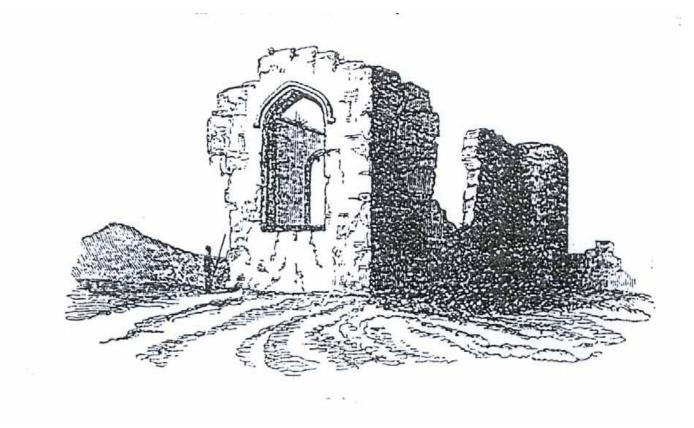
Fig 4. View of church in 1844 from north-east (Archaeologia Cambrensis 1846, 126). The north chancel window dressings have been removed. The four-centred hood mould is clearly represented over the east window.

A view of the church drawn in 1844, and reproduced in Archaelogia Cambrensis 1846, is from the north-east. The north window of the chancel has fallen, and the top of the chancel wall has partly fallen. The west end and the transepts

appear to be ruinous. The east window of the chancel is drawn with a hood mould with upturned ends.

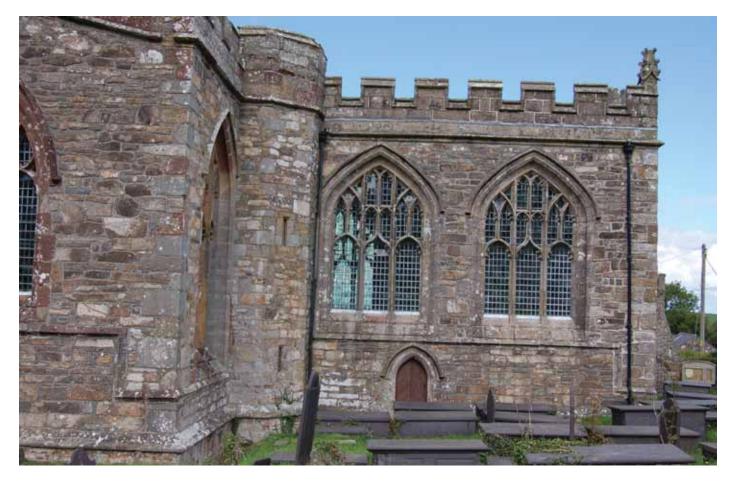
Fig 10. Clynnog church showing chancel from north. Cusped tracery in four-centred arch with crenelated parapet and stair tower in angle with south transept.

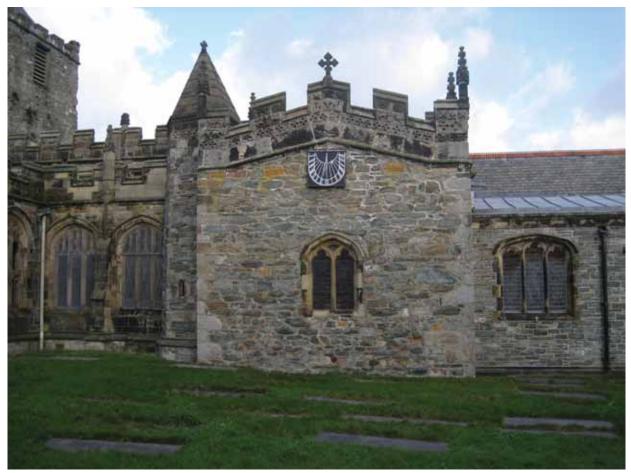
Fig 12. Holyhead church showing south transept with trefoil headed lights under four-centred arch. The three-light window on the right is re-set. The heads on all are 19th century - compare with Buck print below. Note the decorated frieze on the parapet and the stair tower to west.
