FLINT MB

Flint Castle

Site No: F 3 Site Name: Flint Castle.

**CADW Scheduled Ancient Monument Record
SAM Information Section 1 (General Information)**

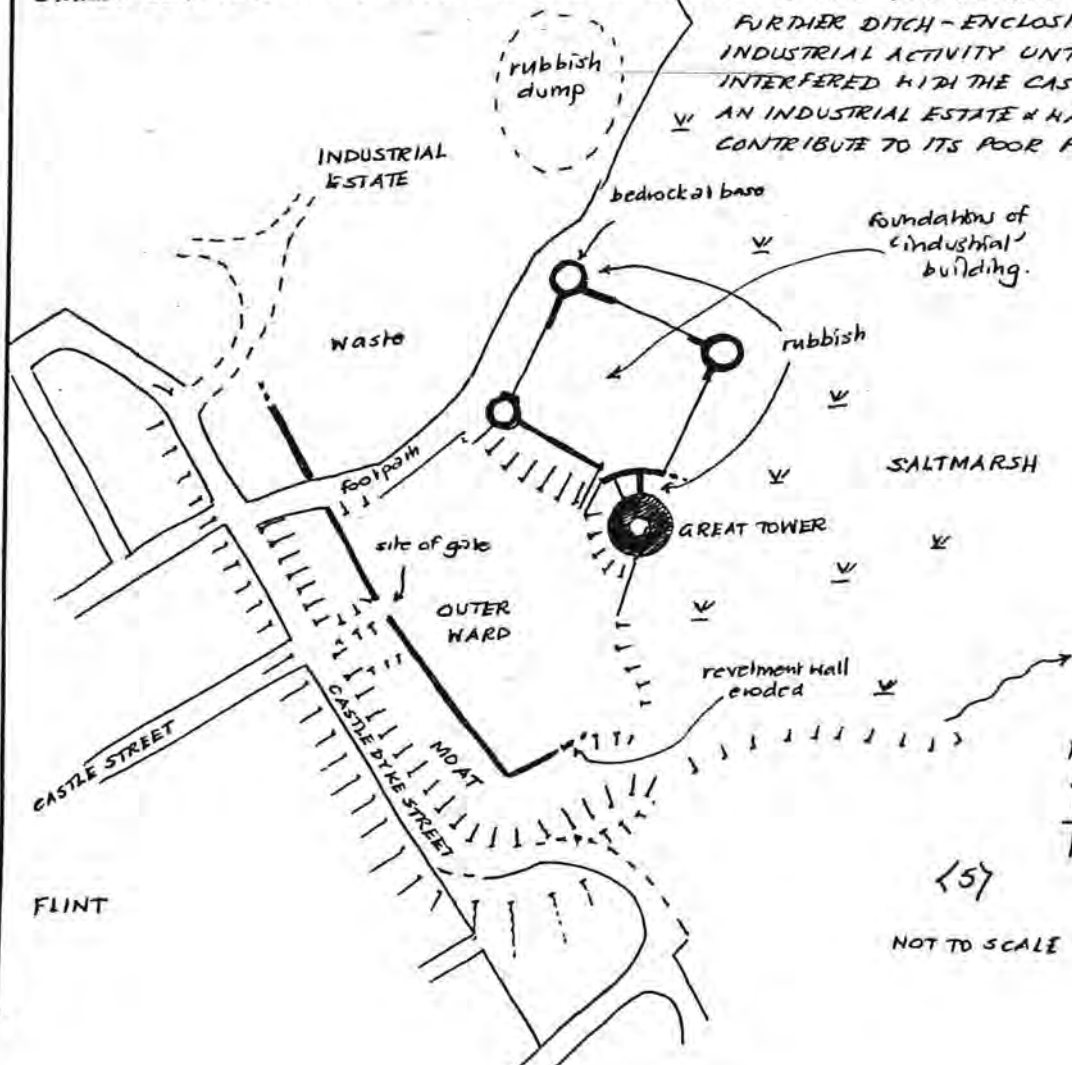
(5)

FLINT CASTLE IS BUILT ON A LOW PROMONTORY OF SANDSTONE ROCK AMONG THE MARSHES BORDERING THE SHORES OF THE DEE. THE APPROACH FROM THE TOWN IS BY A STONE-WALLED CAUSEWAY LEADING OVER WHAT WAS ONCE MARSHLAND INTO THE OUTER BAILEY OF THE CASTLE. THE WALL ON THE FURTHER SIDE ... HAS PROBABLY THE BASE OF A CURTAIN WALL SURROUNDING THE OUTER BAILEY, WHILE THE SMALL REMAINS OF ANCIENT MASONRY ... ARE FRAGMENTS OF THE OUTER GATEWAY TO THE CASTLE. THE RED SANDSTONE BUILDING UNTIL RECENTLY [1976] OCCUPYING MOST OF THE OUTER BAILEY A ... WAS BUILT IN 1785 AS A GAOL. THE ENTRANCE TO THE INNER BAILEY ... IS ON THE OTHER SIDE OF THE MODERN WOODEN BRIDGE ACROSS THE INNER MOAT ... LITTLE IS LEFT [OF THE GATEHOUSE], ALTHOUGH ... UNDER THE BRIDGE 2 DEEP CHASES FOR THE COUNTERPOISES OF THE DRAWBRIDGE [CAN BE SEEN]. BEYOND .. IS THE INNER BAILEY ... COMPLETELY [OR WAS] ENCLOSED BY THE CURTAIN WALL. THIS IS FAIRLY WELL PRESERVED ONLY ON THE S SIDE. TO THE RIGHT .. IS A WOODEN BRIDGE LEADING ACROSS THE MOAT INTO THE DONJON.

RUINED STRUCTURE OF EDWARDIAN CASTLE ENCLOSING APPROX. SQUARE INNER BAILEY, WITH MASSIVE DETACHED DONJON TOWER. AN OUTER WARD, OCCUPIED UNTIL c 1970 BY MILITARY BUILDINGS, LIES BETWEEN THE CASTLE AND THE BASTIDE TOWN OF FLINT. THIS BAILEY IS DEFINED BY MOST OF A BROAD OUTER DITCH, ITS INNER FACE REVETTED WITH STONE. CASTLE DYKE STREET BEYOND IS CAUSEWAYED - A FALL OF BETWEEN 3 AND 9 M PERHAPS INDICATING A

FURTHER DITCH - ENCLOSED THE TOWN. INDUSTRIAL ACTIVITY UNTIL RECENTLY HAS INTERFERED WITH THE CASTLE - AND ITS LEGACY. AN INDUSTRIAL ESTATE & WASTE GROUND CONTRIBUTE TO ITS POOR PRESENTATION. (2)

The approach from the town is by a stone-walled causeway leading over what was once marshland into the outer bailey of the castle. The wall on the further side...was probably the base of a curtain wall surrounding the outer bailey, while the small remains of ancient masonry ...are fragments of the outer gateway to the castle. The red sandstone building until recently (1976) occupying most of the outer bailey...was built in 1785 as a gaol.

Source: Desc. Text / AM107 / Morgan, T. / 1987 / F3 / Sect. 12 / <3.> : Ruined structure of Edwardian Castle enclosing approximately square inner bailey, with massive detached Donjon Tower. An outer ward, occupied until c.1970 by military buildings, lies between the Castle and the bastide town of Flint. This bailey is defined by most of a broad outer ditch, its inner face revetted with stone. Castle dyke street beyond is causewayed- a fall of between 3 and 9 M. perhaps indicating a former ditch-enclosing the town. Industrial activity until recently has interfered with the Castle-and its legacy, an industrial estate & waste ground contribute to its poor presentation. <3.>
