St Andrew's Church, Minera

**AN ARCHAEOLOGICAL ASSESSMENT
IN ADVANCE OF REDUNDANCY**

CPAT Report No 988

R J Silvester
April 2009

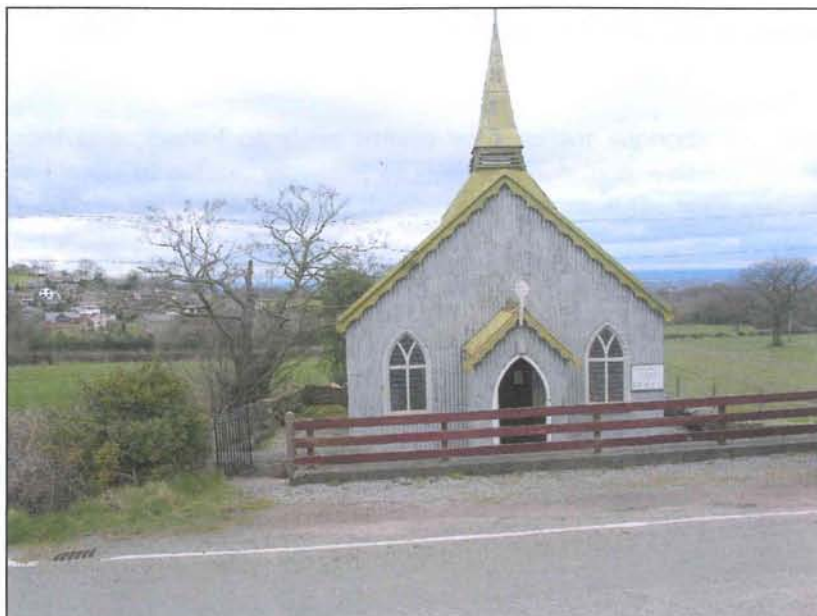
St Andrew's is a late 19th-century mission church which was constructed for the district of Esclusham Above which included New Brighton in 1892, and was designed to accommodate 150 according to Archdeacon Thomas. It is of a type known as a tin tabernacle, a reflection of the corrugated-iron cladding on a timber frame. This is the primary reason why the church has been listed, the citation stating that it is 'a particularly unaltered example of the corrugated-iron mission churches built in relatively large numbers in the period 1890-1914 but now becoming rare'.

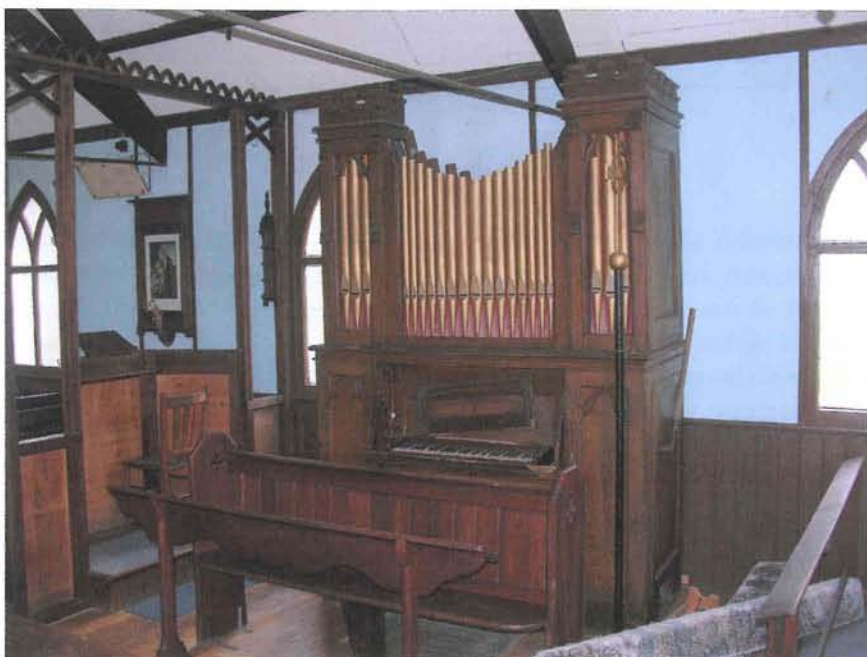
Internally, the roof is supported on three trusses with scissor supports and there is a panelled wooden floor, and walls of painted plyboard or similar. Each long wall has four two-light timber windows with Y-tracery and transoms, and there are two more at the west end, and a further one high up in the east wall.
