# ROUNDHOUSE FARM, NANTYGLO

ARCHAEOLOGICAL SURVEYS

CPAT Report No 715

Report for Blaenau Gwent County Borough Council

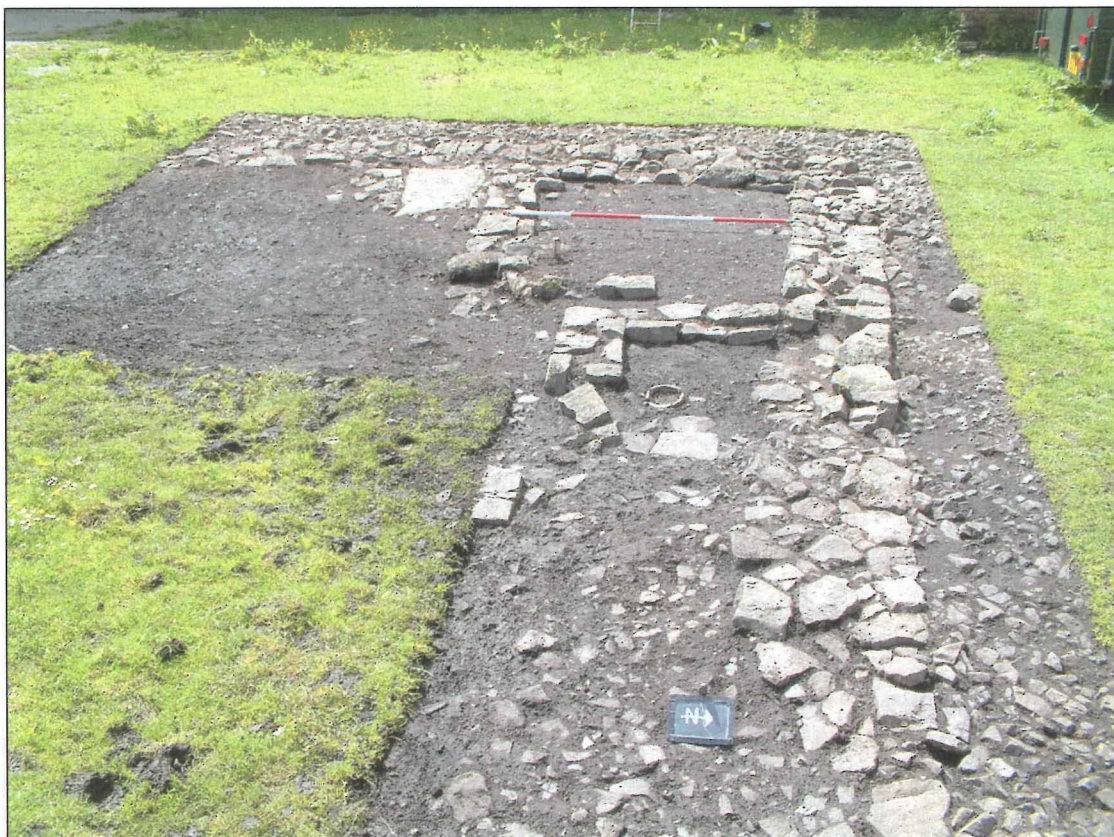
Plate 1 North-west corner of the midden enclosure. Photo CPAT 1929-16

- 4.3 The structure had evidently been terraced into the slightly sloping ground, so that the interior of the west wall was 0.5m below the external yard surface, the internal wall facing being slightly battered. The ground surface inside the structure consisted of clay (13), with no indication of a metallised surface. In the north-west corner a drain (12) was identified cutting into the clay, with a culvert within the walling alongside. It would seem likely that this carried rain water from a downpipe in the corner of the barn complex.

- 4.4 The position and nature of the structure suggest that it was built as a midden enclosure in the centre of the farmyard. Manure from the stables and animal pens would have been barrowed into the enclosure for temporary storage. Evidence from the excavations, together with the Ordnance Survey mapping, suggest that the enclosure was around 17.5m long north to south, and tapered from 12.25m wide at the northern end to 10.5m at the southern end. It would appear that by 1900 the southern half of the enclosure had been removed and by 1920 the structure seems to have been levelled.

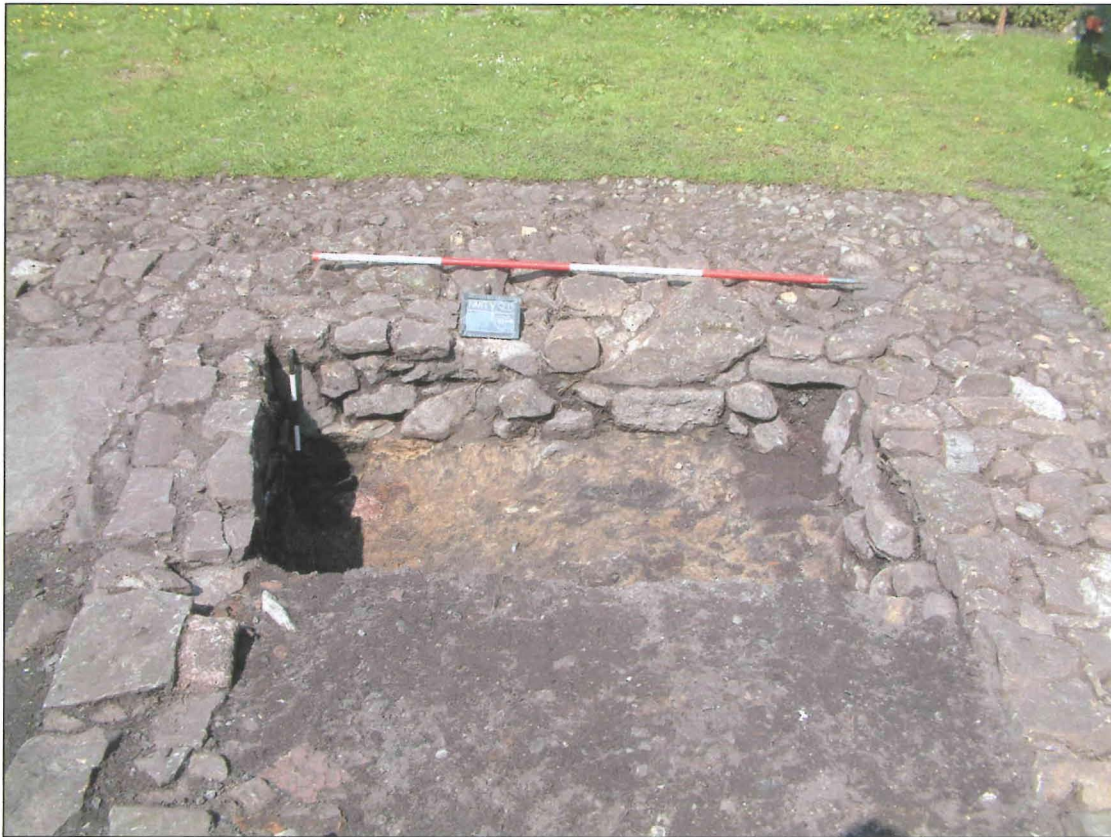
Plate 2 North-west corner of the midden enclosure after excavation showing the ash pit (08) and drain (12)

- 4.5 A small structure had been added in the north-west corner of the enclosure, measuring 2.87 x 1.32m externally, and constructed of stone walling (08) 0.37m thick, butting against the enclosure wall. The nature of the infill and the recollection of the present owner suggest that this was used to collect ash from the domestic quarters in Barn 4 and it is likely to be the small structure depicted by the Ordnance Survey in 1920. To the south of this structure was a large slab (10) surrounded by an area of rough cobbling just below the present ground level, the function of which is uncertain.

- 4.6 Alongside the ash pit was another small stone structure (09), measuring 1.6 x 1.3m, which also butted against the enclosure wall. The function of the structure remains uncertain, although there was a salt-glazed downpipe *in situ* in the south-east corner.

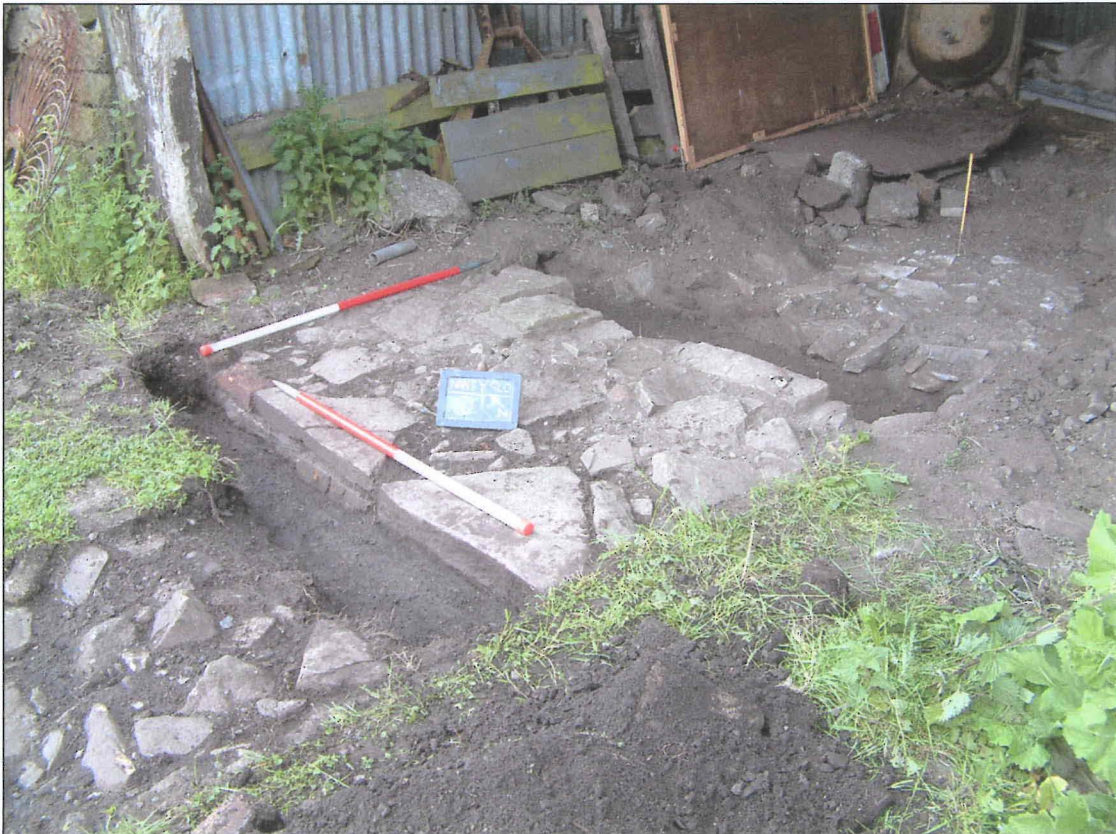
Plate 3 Stone structure (16)

- 4.8 The second trench was excavated across the front of the shed along the eastern side of the farmyard. Stone visible at ground level suggested that some structure might survive which related to the tramway depicted by the Ordnance Survey in 1881. The removal of the topsoil revealed the upper part of a stone wall (16) 1.2m wide with modern levelling material (15) butting against either side. This was removed along either wall face to reveal up to two courses of masonry standing to 0.2m in height.

- 4.9 The function of the walling remains uncertain, although its position and alignment suggest that it may have been related to the tramway, of which no structural evidence was revealed during the excavation.

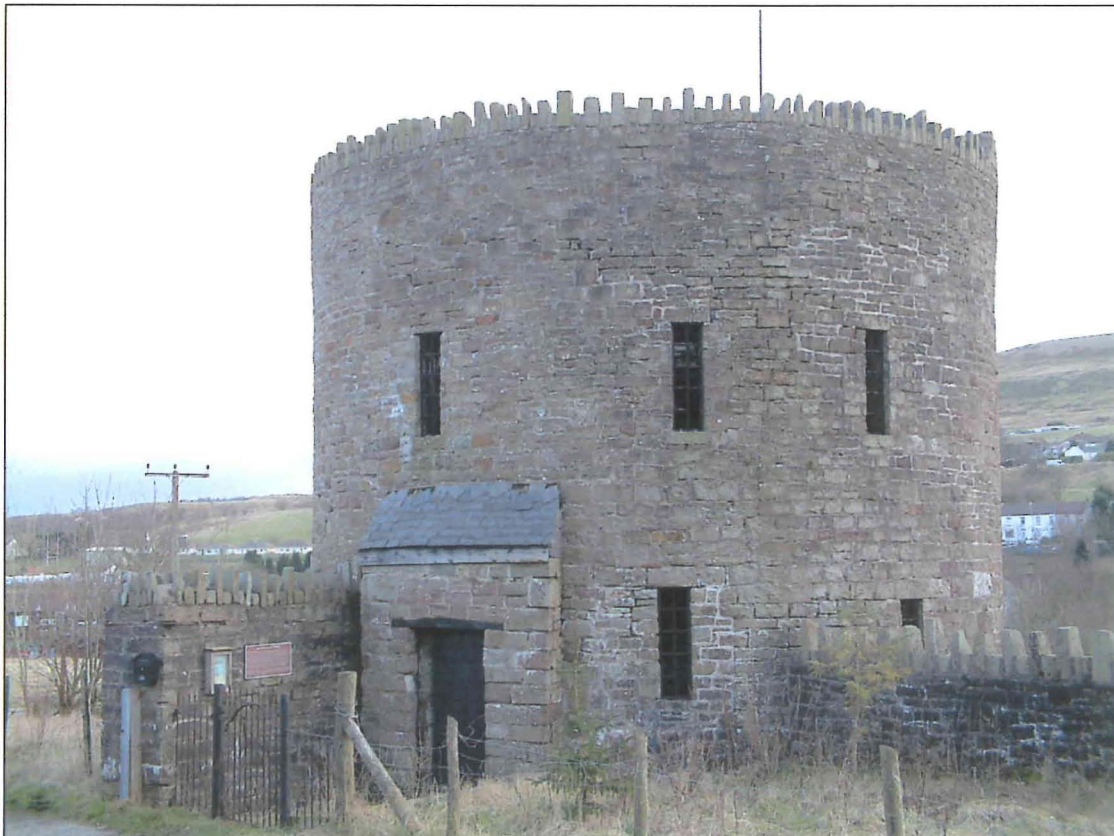
Plate 4 North-east tower

- 5.2.1 The tower is of rubble stone construction with dressed stone around the openings, cast iron internal beams and joists, and a cast iron and brick roof. It is interesting to note that, as with other early cast iron structures, the joists are joined to the beams using carpentry-style dove-tail joints. The beams are T-sectioned, 22m thick and 115mm wide, tapering from 230mm deep in the centre to 165mm at either end. There are seven pairs of dove-tail joints set approximately 0.9m apart. The joists have an inverted L-shaped section, 22mm thick, 70mm wide and 135mm deep, with peg holes 12mm square set approximately 275mm apart.

- 5.2.2 The tower is approximately 9.5m in diameter at ground floor level, the base of the walls splaying as the ground level falls to the east, with walls approximately 1.1m thick at ground level, reducing to around 1.0-1.05m at first-floor level. The tower walls are surmounted by small crenellations.

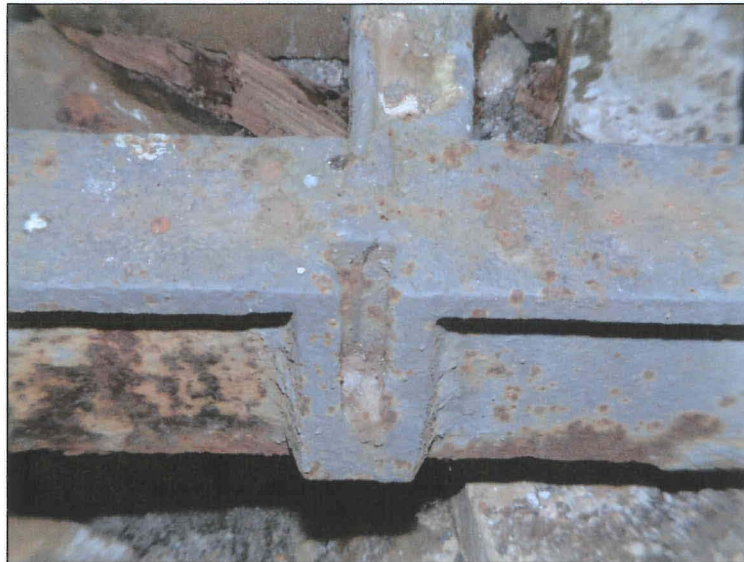
Plate 5 Detail of cast iron dove-tail joint

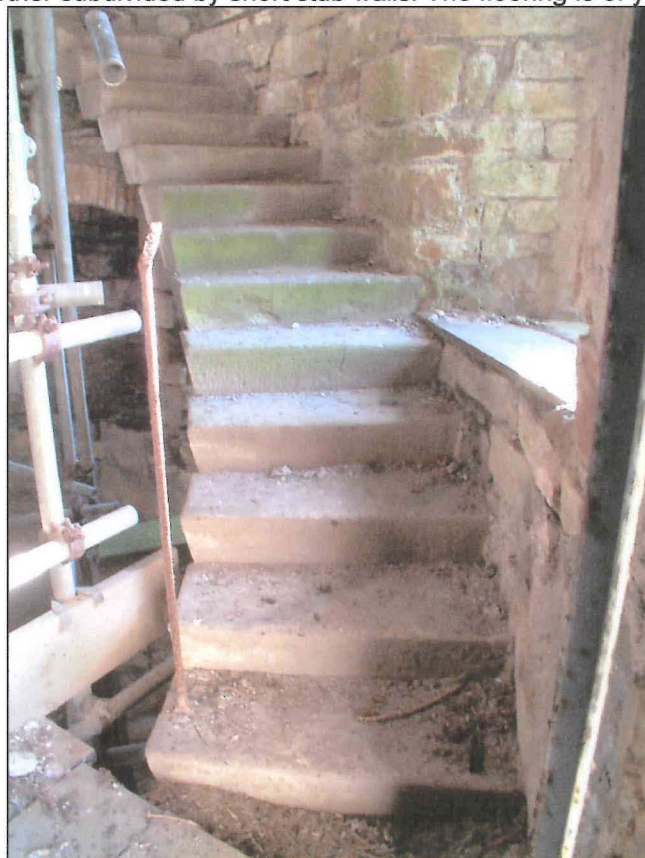
Plate 6 North-east tower, stairs to first floor

- 5.2.5 The dressed stone, cantilever staircase rising to the first floor survives intact, with 19 steps, each of which has a socket for an iron spindle which would have supported a wooden balustrade. There are five lancet windows, all of which retain their iron window frames. The walling above each of the windows is supported on three cast iron plates, sloping down towards the outside of the windows. A mains water pipe enters the tower at the base of the north-west window.

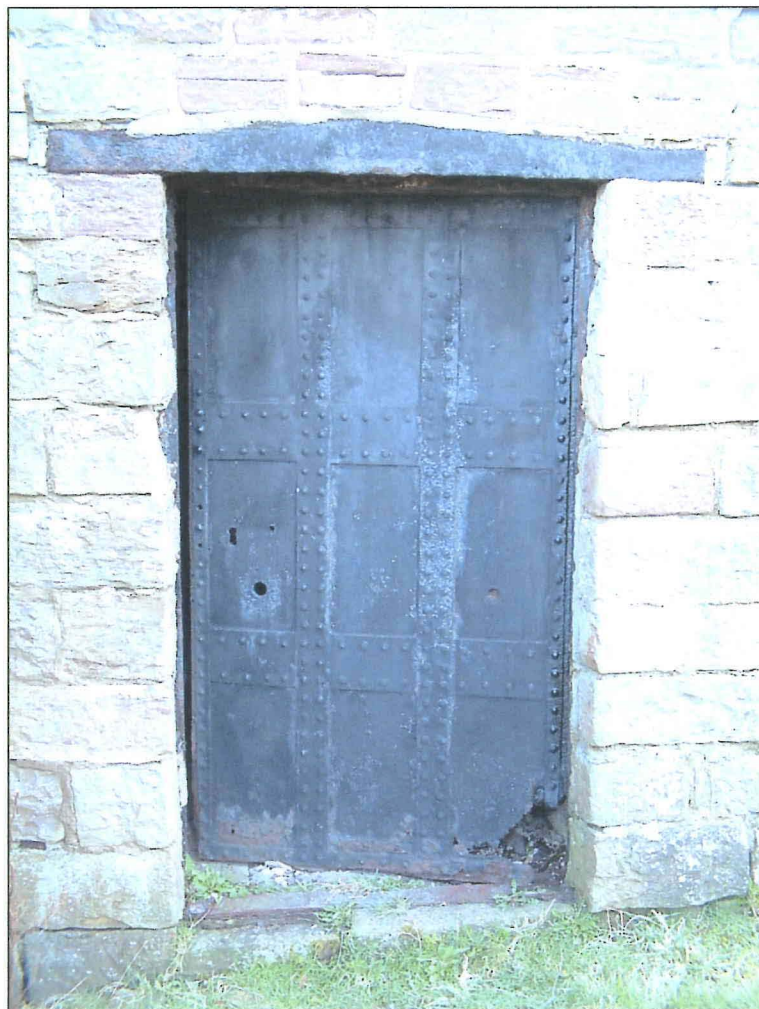
Plate 7 North-east tower entrance

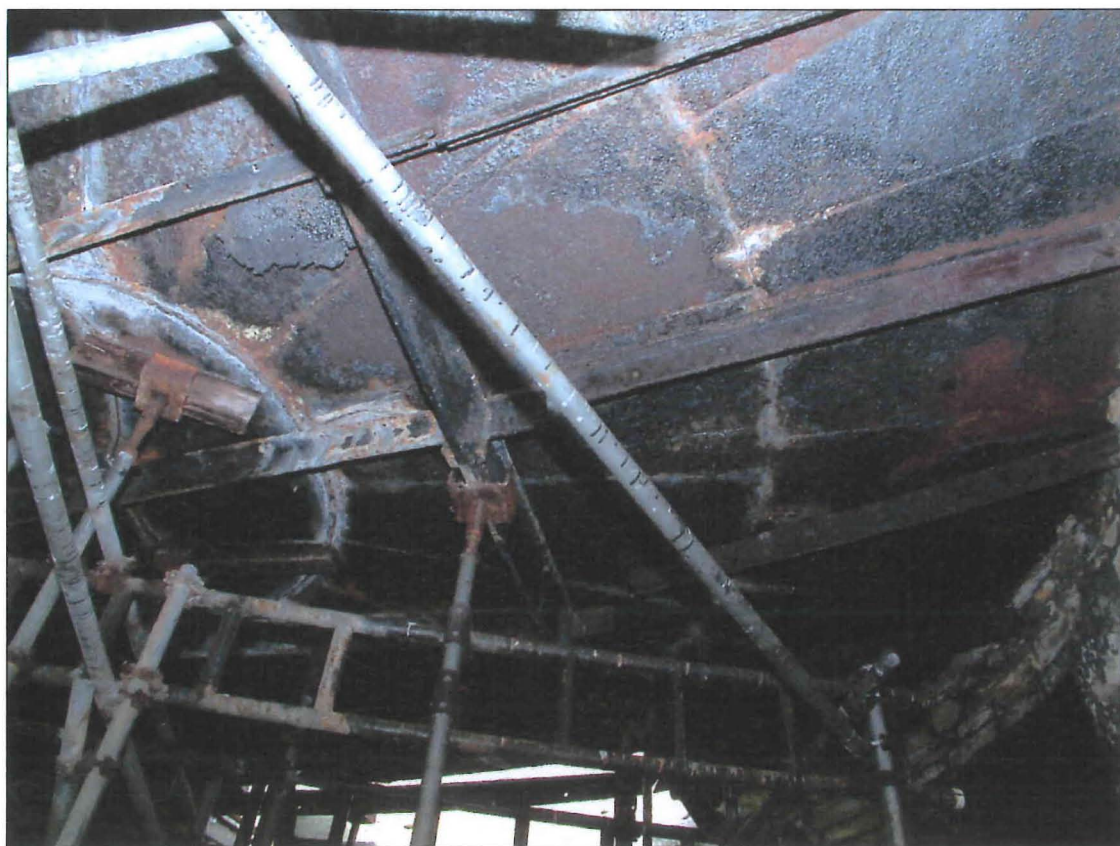
Plate 8 North-east tower, cast iron roof plates

- 5.2.8 The roof has an unusual construction, comprising a series of cast iron segments supported on the same arrangement of cast iron beams and joists as the ground and first floors. The centre of the roof is formed by a circular cast iron plate c. 1.8m in diameter with a small central hole. A ring of 20 segments surrounds this, with an outer diameter of c. 5.1m. There appears to have been a problem in the casting of these segments, with insufficient tolerance allowed for shrinkage as the metal cooled, so that three iron fillets were required to fill gaps in the circuit. The outer ring has an external diameter of c. 7.5m and comprises 31 complete segments, with different cast iron plates surrounding the roof hatch. The outer plates rested on a composite cast iron ring beam laid in segments on the inner wall capping. A layer of bricks was laid on top of the cast iron segments, originally sealed by a layer of pitch. Over the years the weight of the roof has led to the structural failure of the supporting beams and joists, with the result that the roof has dropped in the centre by perhaps 0.2m, also cracking several of the roof segments. The whole has been supported by scaffolding since the 1980s, the safety of which is uncertain.

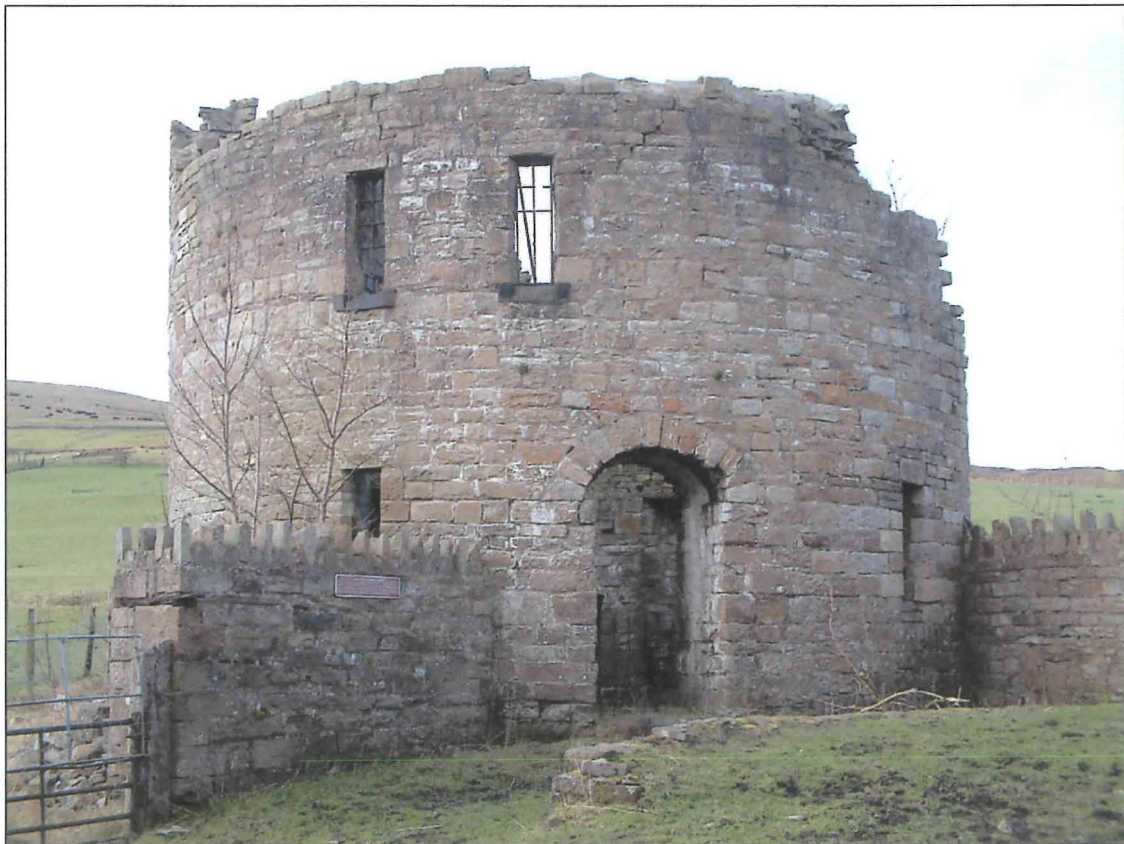
Plate 9 South-west tower

- 5.3.1 The south-west tower was substantially damaged during the 1940s when it was partly demolished in order to remove the majority of the cast iron structure. Although originally a three-storey building, little masonry now survives of the second floor, and the western part of the first floor has also been largely removed. Significant structure detail does survive, however, sufficient to determine that although the tower is superficially of the same design as the north-east tower, there are a number of differences. Apart from the addition of an extra floor, the main differences are the inclusion of a second door on the south-east side, opening outside the defended farm yard, and the use of iron window sills, rather than the plain masonry of the other tower.

- 5.3.2 The tower is approximately 9.55m in diameter, of rubble stone construction with dressed stone around the openings. The walls are approximately 1.25-1.3m thick at ground level, reducing with each floor to around 1.1-1.15m at first-floor level and perhaps 0.95m thick in what remains of the second floor.

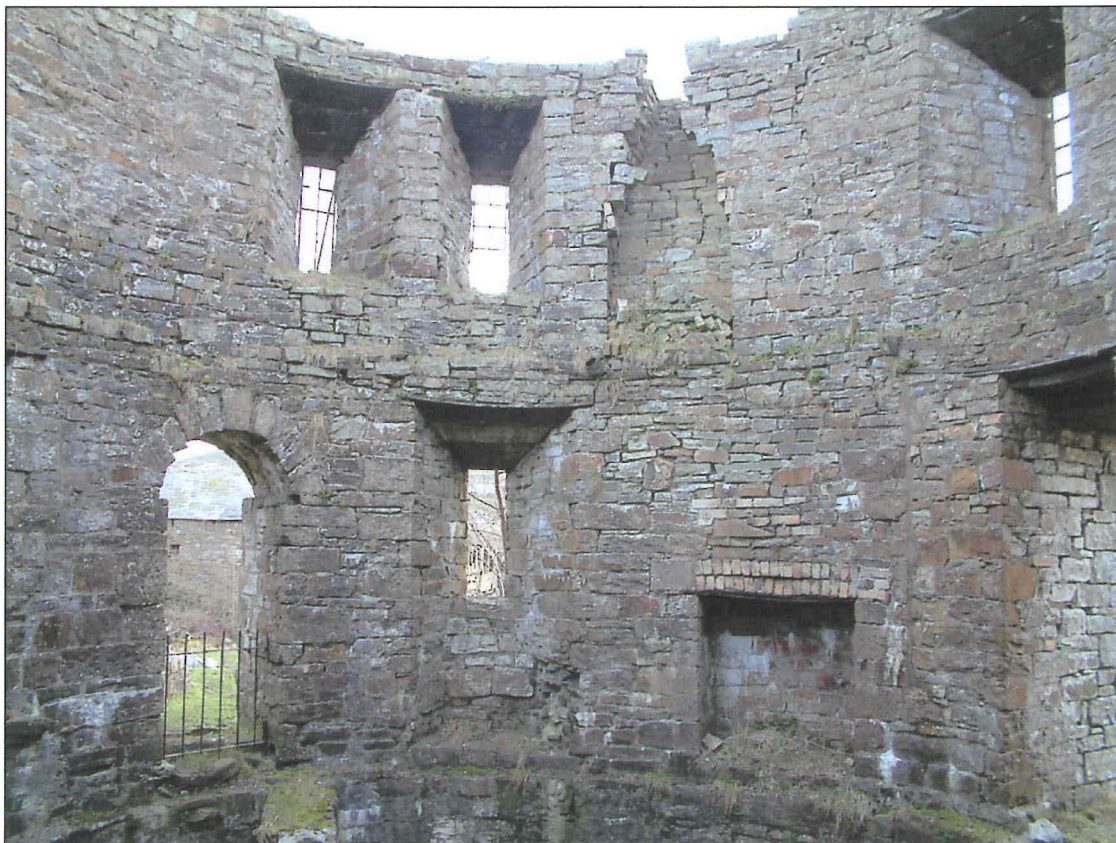
Plate 10 South-west tower interior

- 5.3.4 The ground floor is approximately 7m in diameter internally, with doorways to the north-east and south-east. The former has a segmental arch above, both internally and externally and leads to the farmyard, with a curved step outside. The south-east doorway is plain with simple cast iron lintels, the internal one extending to the north-east of the door to span a straight vertical joint in the masonry 0.8m from the door jamb. The doorhead slopes down towards the outside and is formed from several cast iron beams.

- 5.3.5 The remains of a dressed stone, cantilever staircase rises to the first floor, with seven surviving steps. There are five lancet windows, all but the northern of which retain their iron window sills. The walling above each of the windows is supported on three cast iron plates, sloping down towards the outside of the windows. The windows all extend to floor level internally, with the exception of the northern window, which is above the stairs. The ground floor appears to have been divided into two rooms, each with its own fireplace.

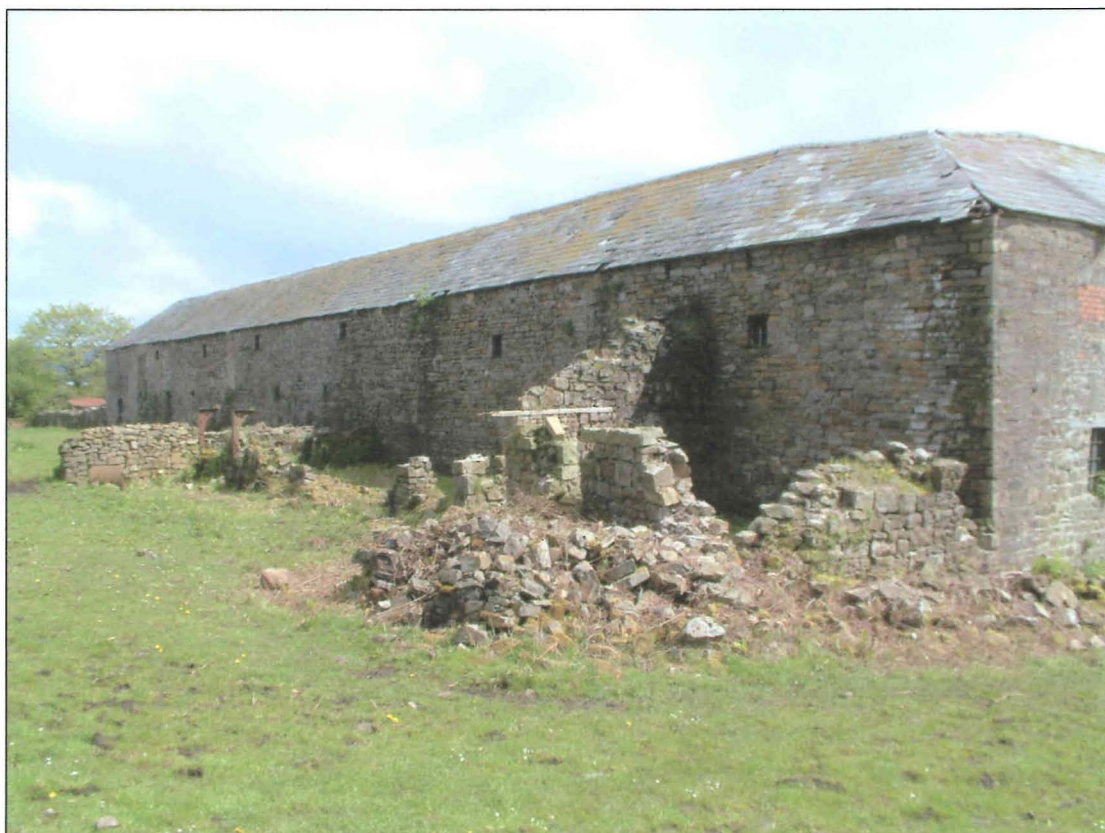
Plate 11 West side of barn complex showing bull house

- 5.4.1 The earliest surviving buildings on the site lie at the southern end of the complex. Barns 1 and 2 form an L-shape c. 6m in width with Barn 2 aligned north to south, 16.8m in length, and Barn 1 aligned east to west, extending 15.7m from Barn 1. Later additions include a bull house and sow house along the west wall of Barn 2.

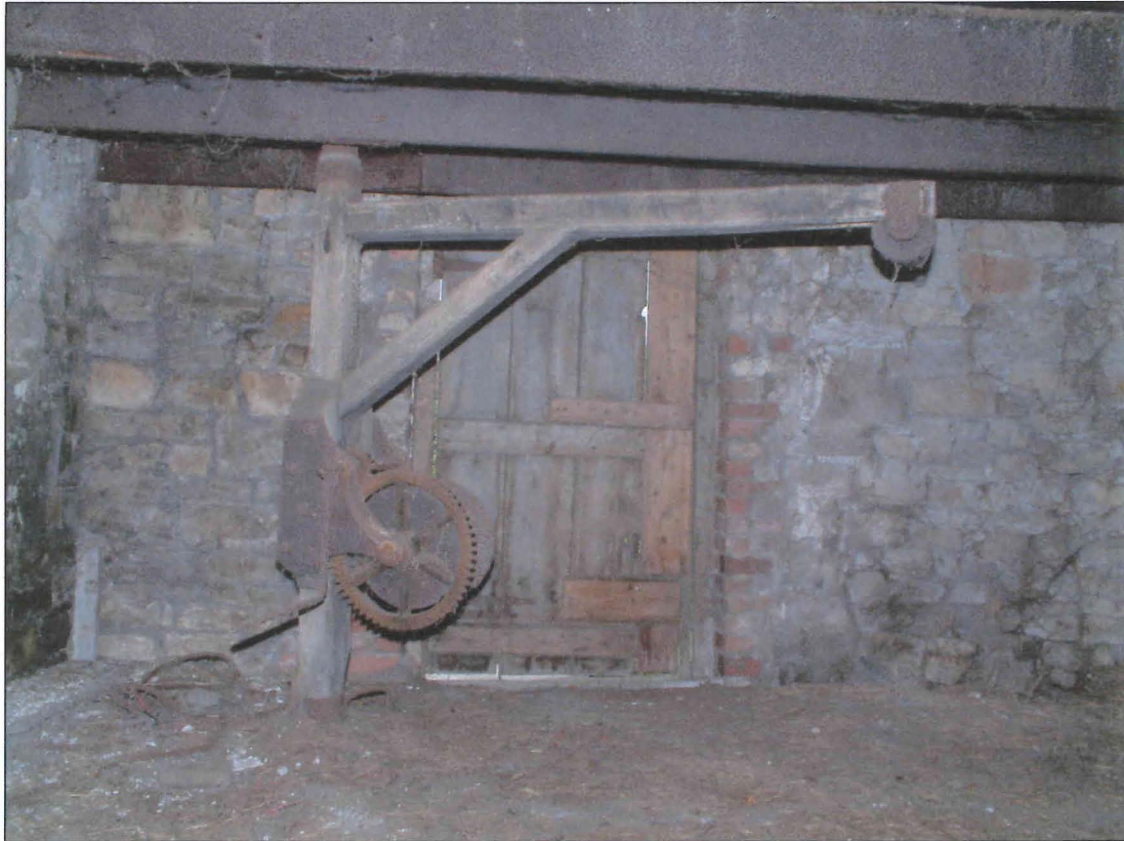
Plate 12 Loading crane, Barn 1 first floor

not readily apparent externally, as well as a blocked ventilation slit east of the central door. There is a loading crane in the north-east corner which originally swung out through the off-centre doorway in the end wall, although this was later reduced in width. The southern wall has three windows and a ventilation slit, all of which have been externally blocked, the western window now showing no obvious external evidence. The second floor loft is supported on cast iron joists with the addition of a timber joist and framing at the western end for a stairway, the scar of which is apparent on the western wall.

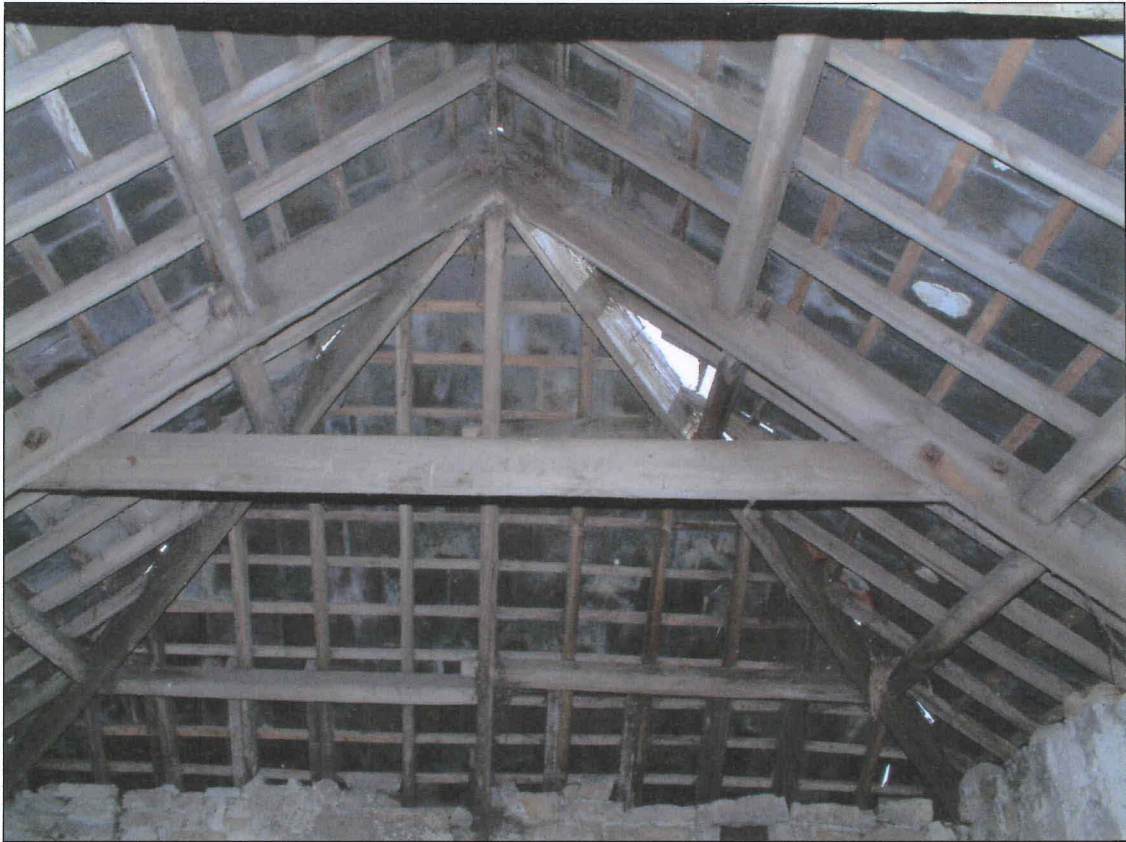
Plate 13 Barn 2 roof showing truss and hipped east end

- 5.4.8 Barns 1 and 2 have the same type of roof trusses, each comprising principal rafters with chiseled assembly marks joined at the apex by a pegged mortise and tenon joint, with a tie beam which is attached by iron bolts, and pairs of through purlins. There is no obvious sign of a wall plate although close inspection was not possible during the survey. The slate roof is hung on lathes supported by four rafters between each truss. At the eastern end of Barn 1 the roof is hipped, while in Barn 2 at the junction of the two roof lines there is a diagonal truss forming a valley on the north-east side.

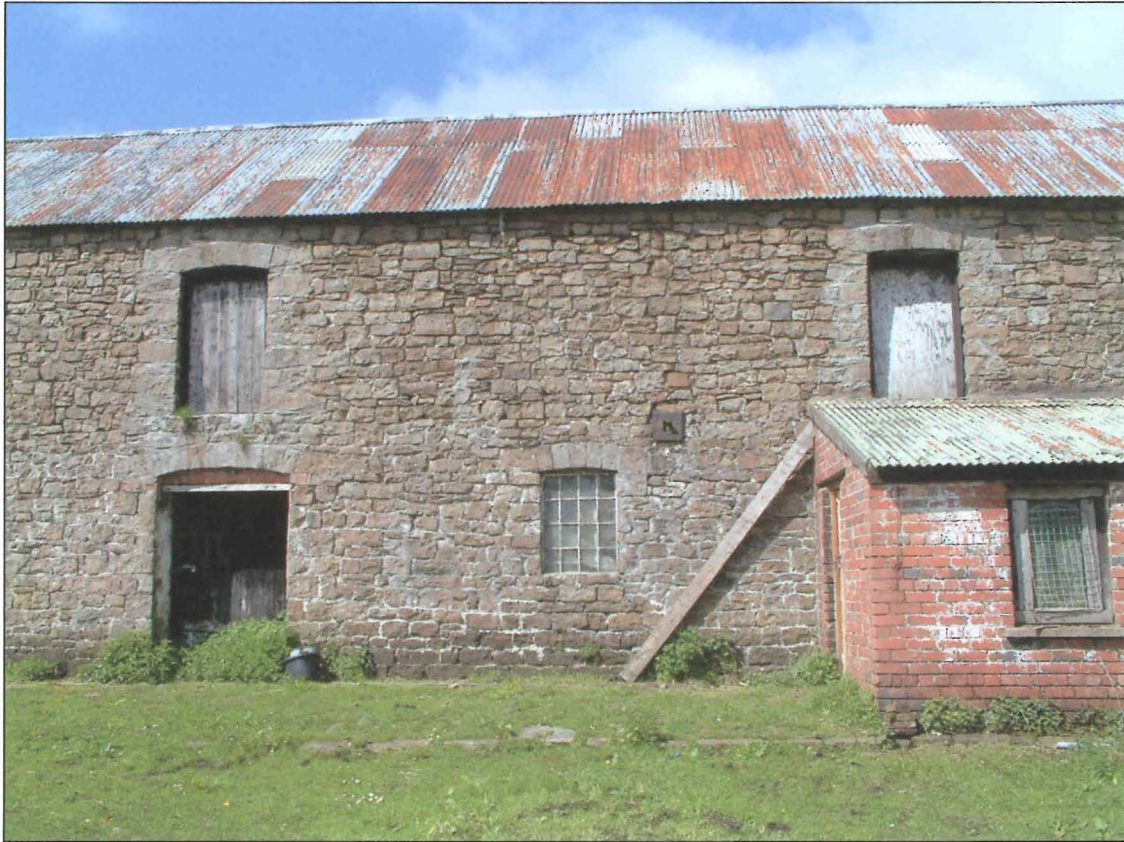
Plate 14 Barn 3 east elevation

- 5.5.2 The ground floor is divided into three units by masonry walls with arched openings, each unit having an external doorway in the east wall, which also has a total of five windows, all with cast iron frames and stone voussoirs. There are four wrought iron tie rods with cast iron face plates held in place by iron pegs, spaced in pairs in the end two units. The flooring is of blue brick stable blocks and there are feeding troughs running the length of the building along the western wall, indicating the former use as a stables.

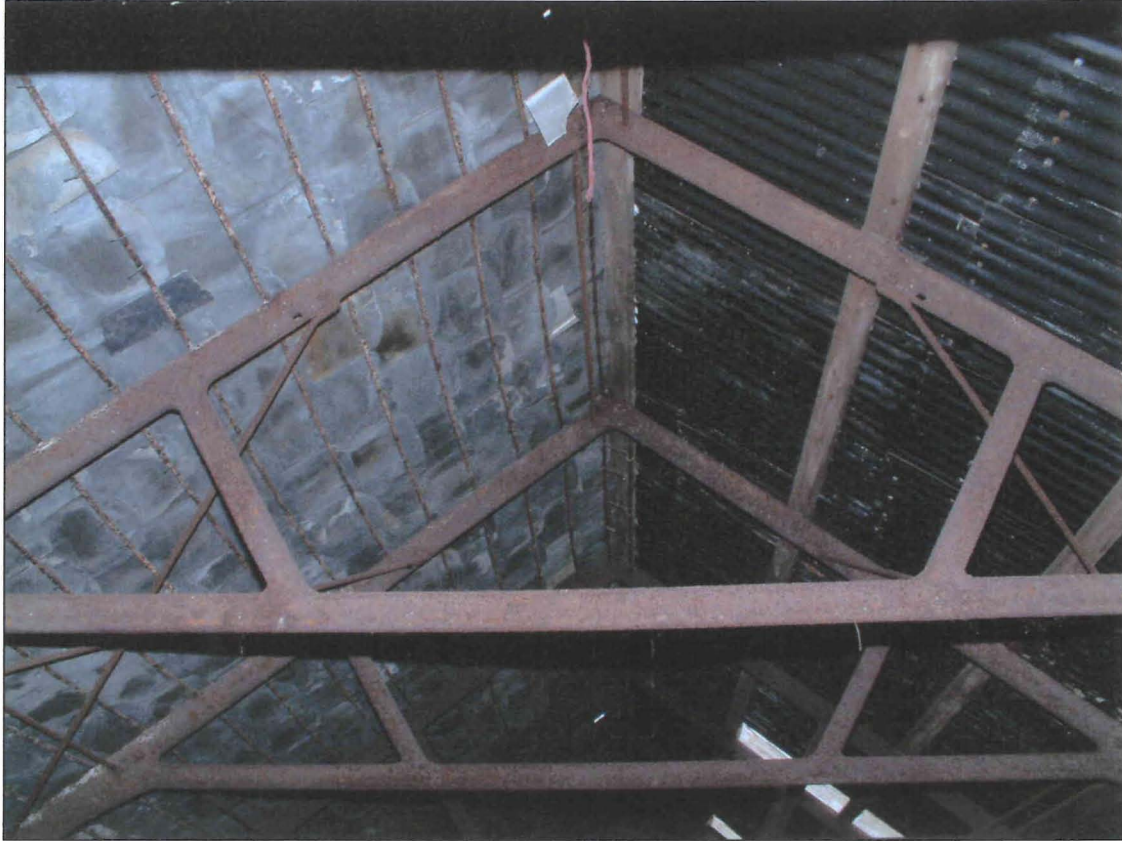
Plate 14 Barn 3 cast iron roof truss

- 5.5.5 The roof structure is the same in Barns 3 and 4, comprising cast iron flanged trusses with obvious air bubbling on one side, indicating that they were cast in open moulds (see section I - J, Fig. 31). The trusses are braced by a series of wrought iron rods which run longitudinally between each truss, with additional cross-bracing at irregular intervals. The slate roof, which is intact on the western side of Barn 2, is hung on a series of horizontal iron rods by means of copper nails or pins.

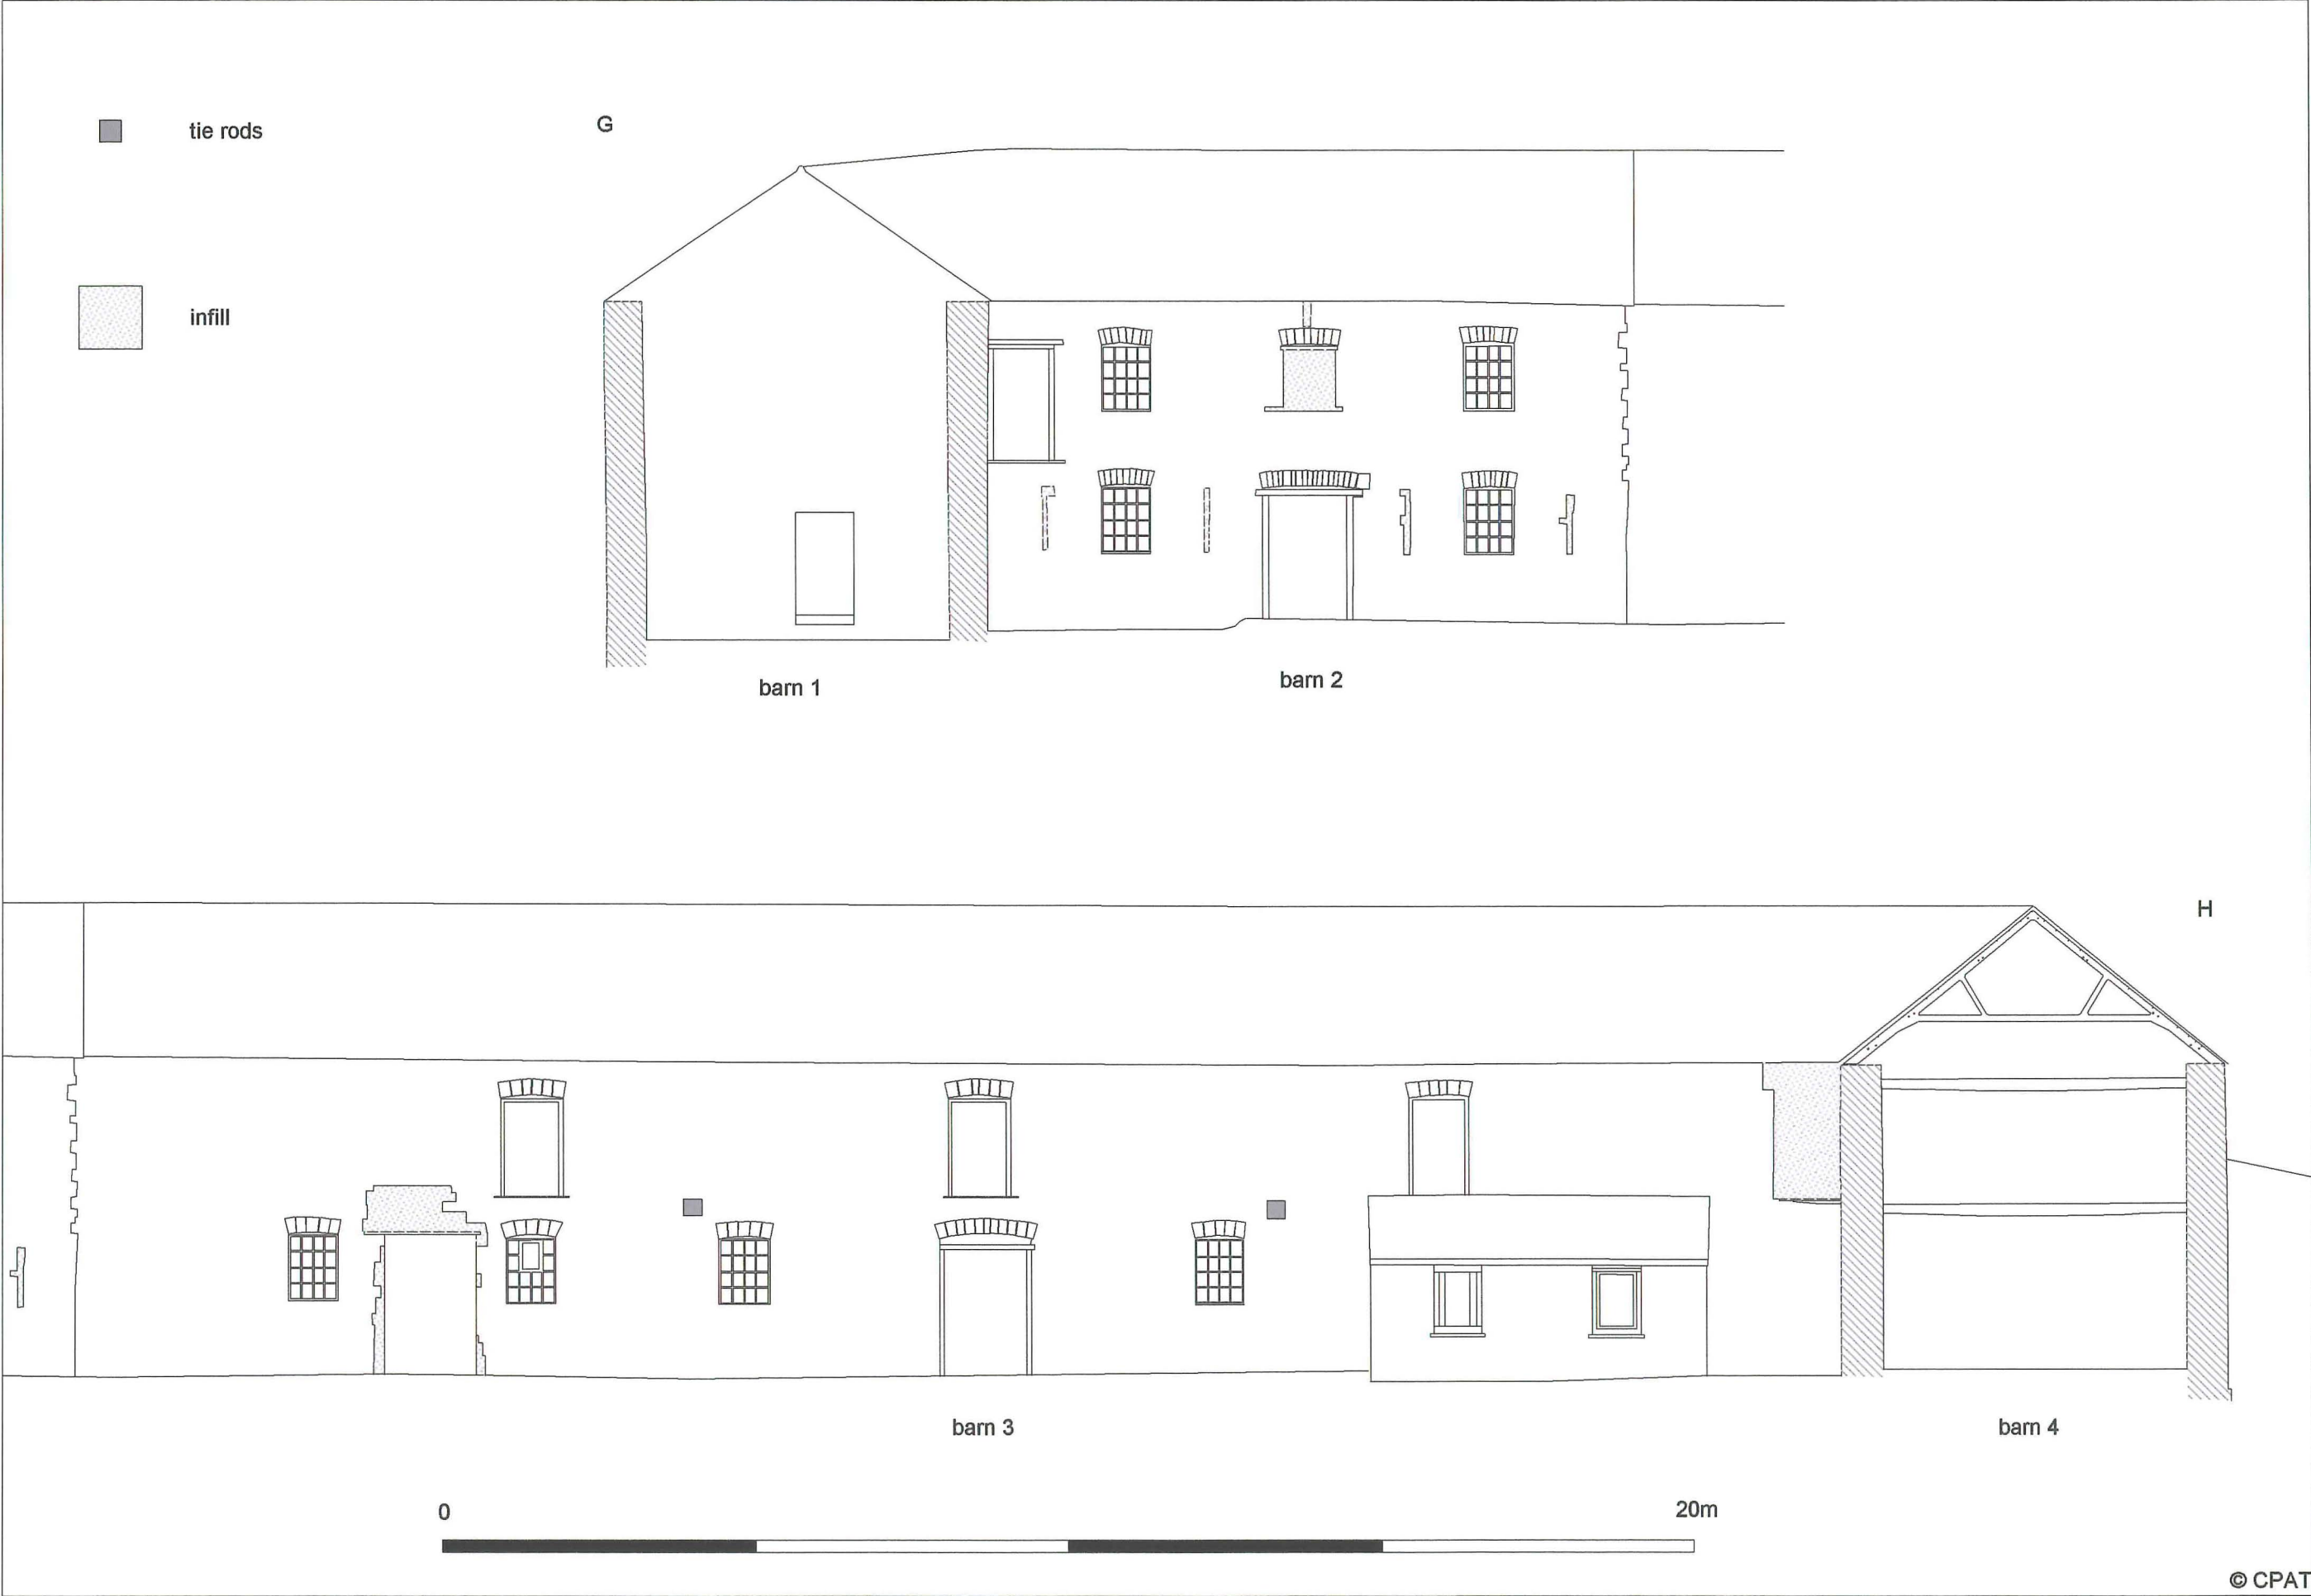
Fig. 28 Roundhouse Farm Bams 2 and 3 east elevation (section G-H)

- 5.5.1 Barns 3 and 4 represent a later addition to the complex, as evidenced by the toothed joint at the northern end of Barn 2 (see Figs 27 and 28). Barn 3 is aligned north to south, 27.5m in length and 6.1m wide.

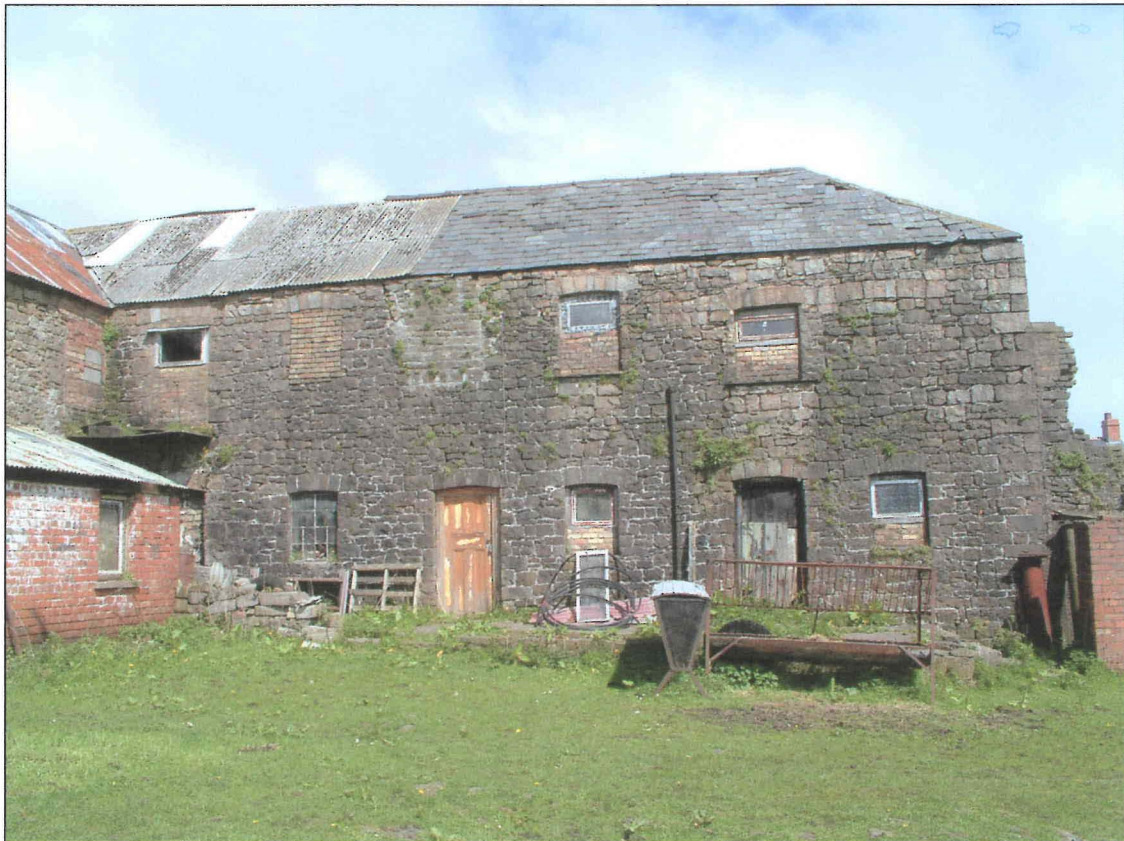
Plate 16 Barn 4 south elevation

- 5.6.1 Barn 4 is aligned west to east, 20.2m in length and 6.1m wide, and was built on a plinth on all but the western end. Later additions include an extension at the east end, now ruinous, but which was once used as a cider house, and a range of lean-to structures along the north wall of Barn 4, of which a single standing wall remains at the east end within one of two recent corrugated iron lean-tos. A more northerly range of buildings depicted on the Tithe Survey of 1841, of which only fragmentary ruins survive, appears to have been a largely independent structure tied into Barn 4 at a single point on the north-west corner.
