TOP YARD BOSTON LODGE, MINFFORDD

Archaeological Excavation

Project No. G2401

Report No. 1235

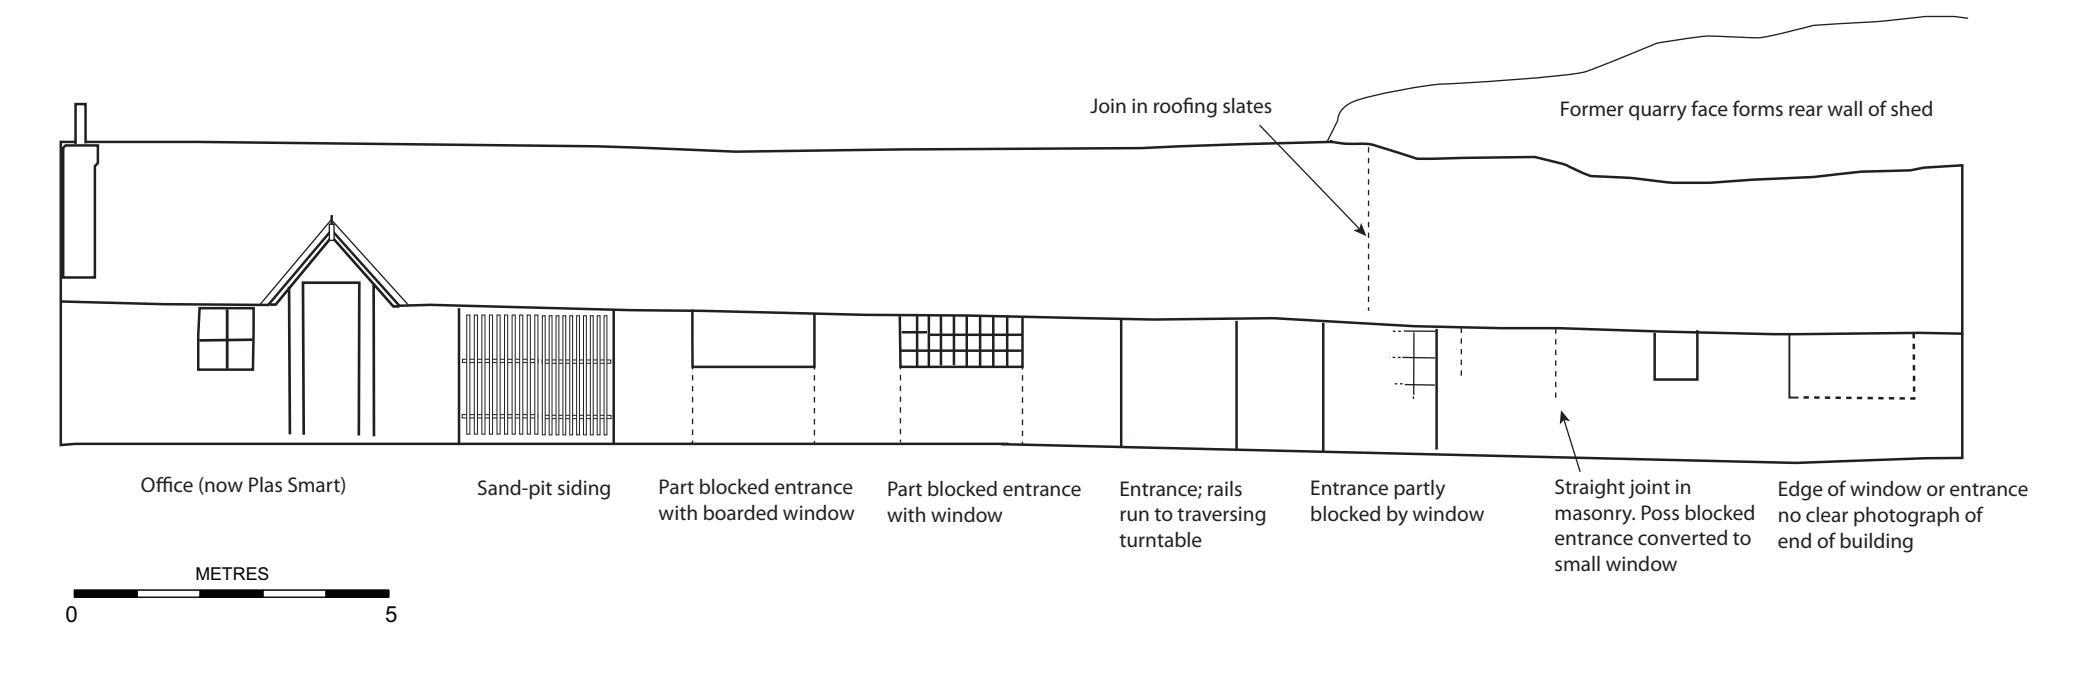
Fig. 12 Diagrammatic south-west facing elevation of the north-eastern wagon shed c.1930

There appeared to be at least two entrances into the front of the shed. Fig. 12 shows a scaled interpretive elevation of the shed, after the alterations of the 1920s, drawn from photographic evidence. The entrance corresponding to the line of the incoming rails (29) is clearly visible, as is the entrance (37) to the south-east of this. The 1920-30s photograph shows a window or door in the latter entrance which had gone by 1956 (photograph 15 Sept 1955 - J Halsall). Probable straight joints in the masonry and in the interior walls indicate that the other two windows to the north-west had formerly been entrances into the building that had been subsequently partially blocked with masonry (Plates 1 and 2 and also see Fig.13). This suggests that the shed in its original form had been largely open-fronted, with sections of wall c.1.3m to 1.5m long alternating with c.1.8 to 1.9m wide openings.

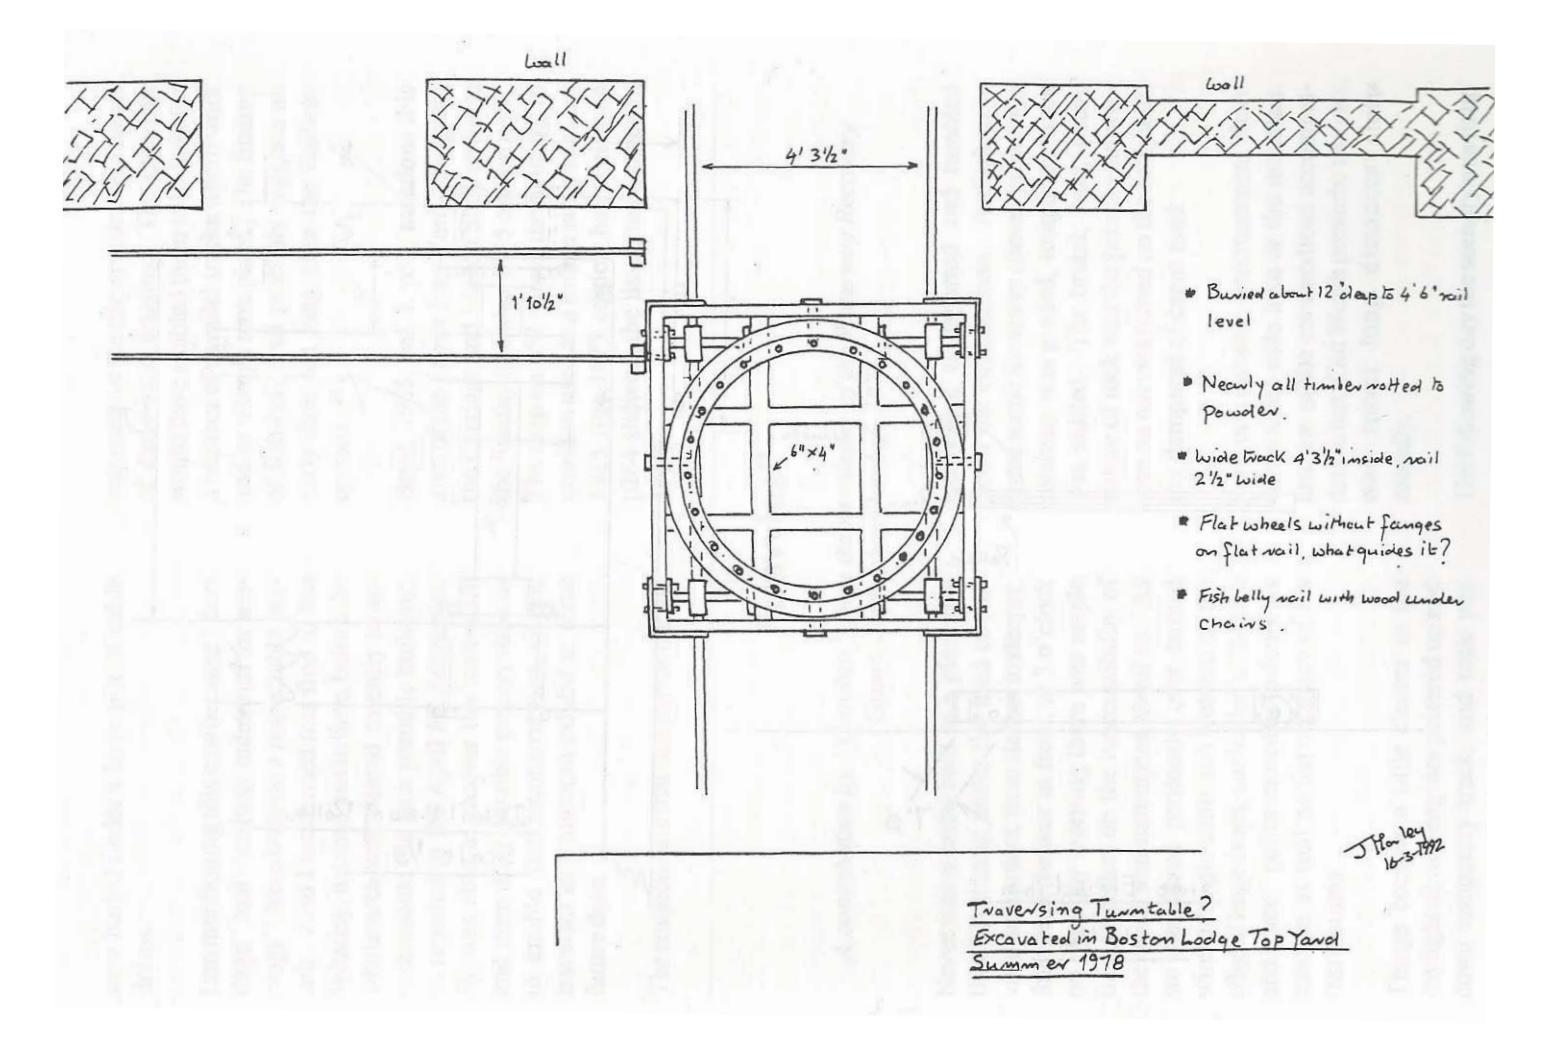
Fig. 13 The traversing turntable (from Waters 1992)

Two *in situ* chairs (29) and a few slate fragments indicate the line of the rails running to the entrance from the turntable in the middle of the yard. Wagons were presumably then transferred to the sliding turntable that ran on 4 ft. 3 ½ in gauge rails set below the level of the floor This is shown on Fig. 13 (from Waters 1992); the entrance to the shed is at the top of the drawing. The building floor was heavily disturbed on this alignment by modern service trenches and presumably as a result of the turntable being removed in 1970 (36). The rails running parallel to the front wall of the shed that are shown on Water's drawing had also been removed, presumably during the installation of the 11kV cable. A stub of mortared masonry on the north-western edge of the excavation crosses the projected line of the rails and may indicate the edge of the turntable pit. The second entrance (37) was identified about 0.13 m to south-east of the entrance containing the rails. This had been partly disturbed by the 11kV cable trench but a brown stain in the sand appeared to mark the position of a wooden door sill.

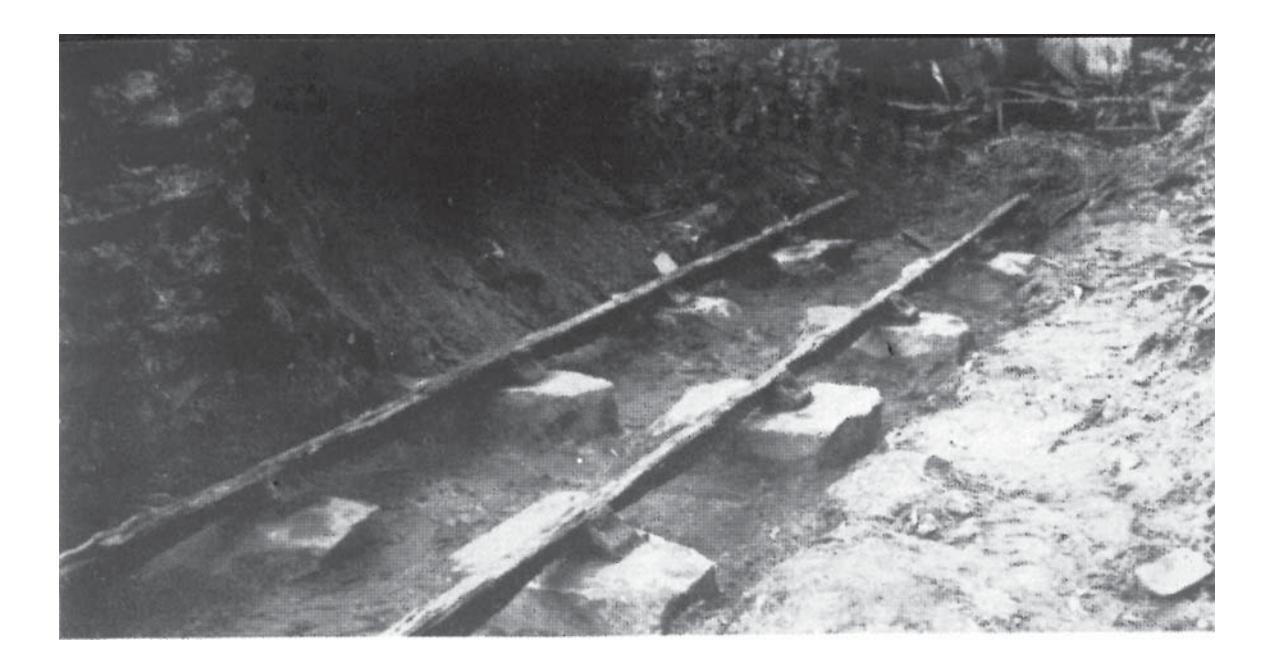
Plate 2 Early fish-bellied track in 1956 (G. E. Baddley in Boyd 1975, Plate1T)

The storage shed is thought to have contained two lines of rails fed by sliding or traversing turntable that was in turn fed by a the turntable in the middle of the yard. Photographs from 1956 show an excavated length of fish-belly rail apparently in the, by this time, derelict shed (Plate 2). The exact location of the rails not recorded but the wooden wall adjacent to the sand-pit siding access is visible in the photographs showing that the length of rail was in the north-western end of the surviving shed. It is thought that the rail was taken up and stored after it was recorded. The derelict shed was unsafe and was eventually demolished, probably in the 1960s. The sliding turntable survived the demolition and clearance of the building. This was excavated and removed in 1970 (Plate 3, see also P9 below and Fig. 13).

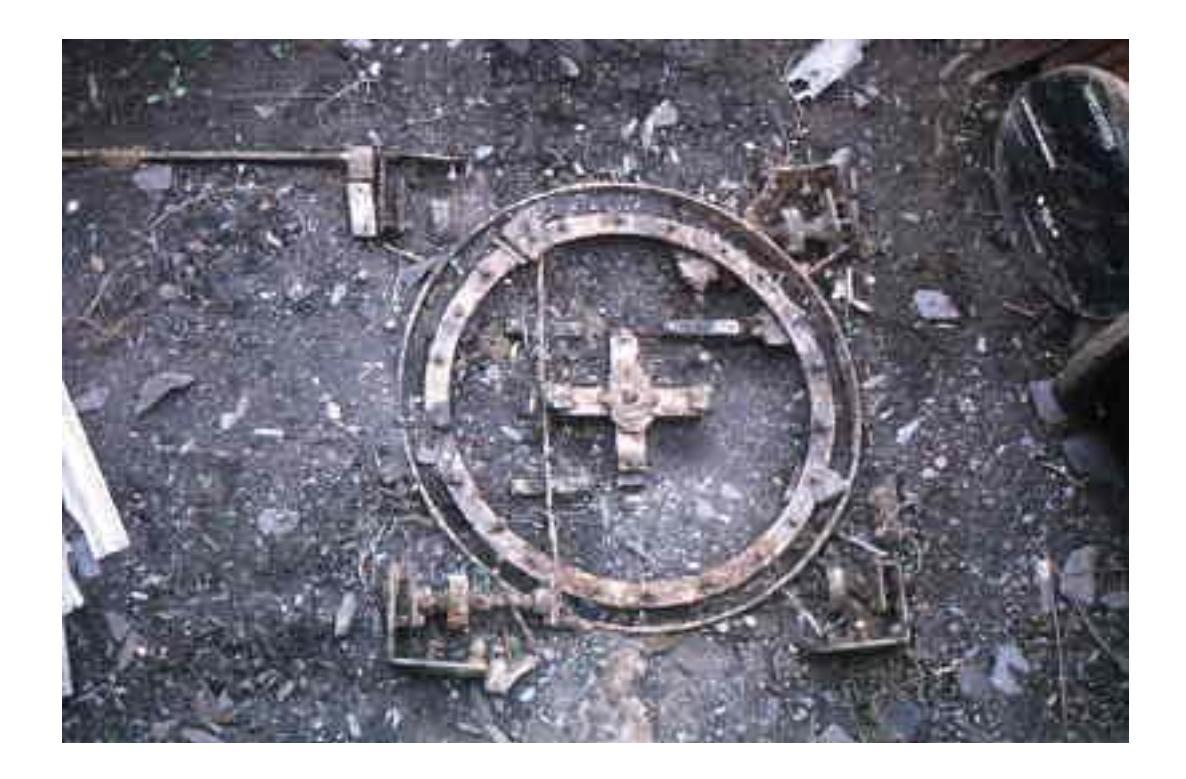
Plate 3 The sliding turntable 17 October 1970 (John Alexander)

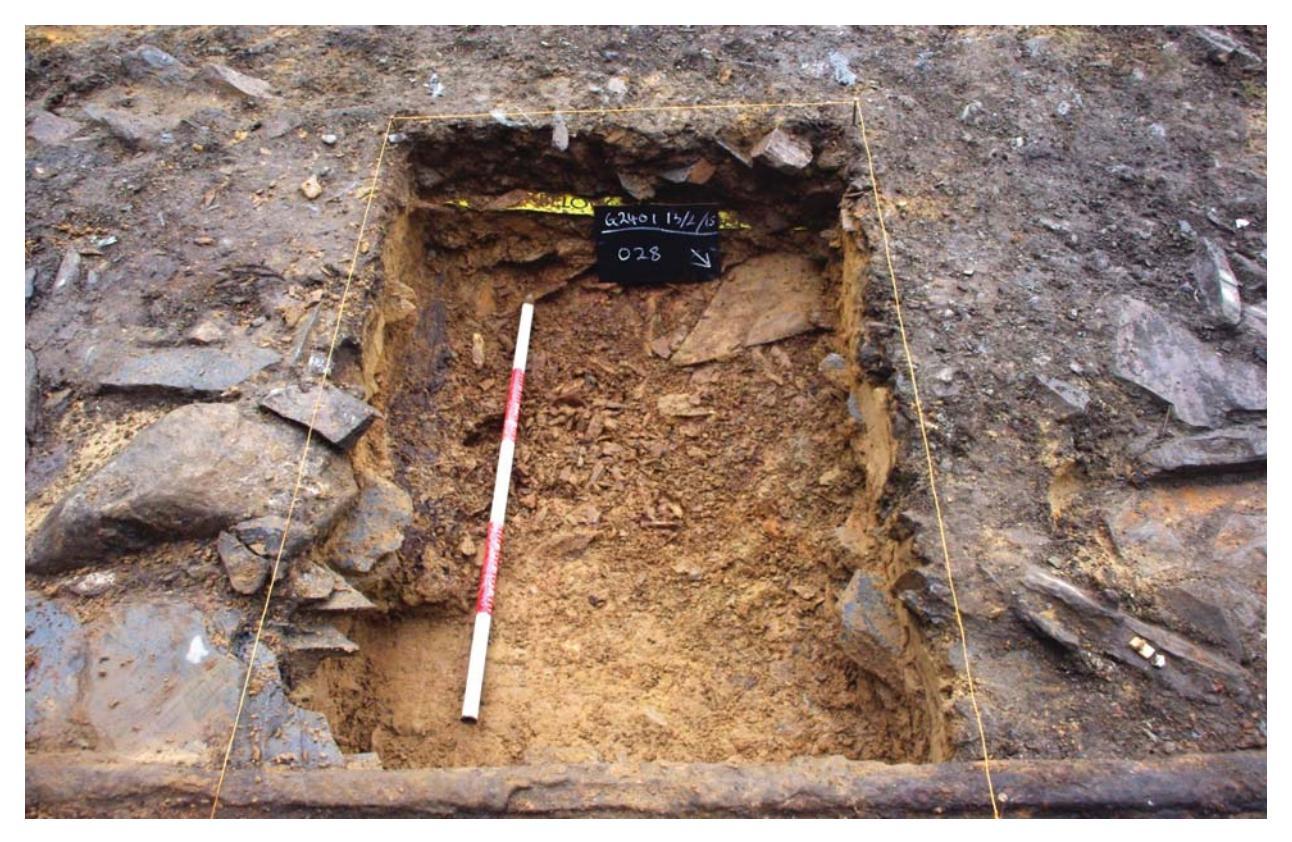
Plate 5 Trench 1 excavated down to quarry floor

The site originated as one of two quarries for the stone used in building the Cob from 1808 to 1811 and probably during repairs to a breach in 1812 to 14. The rock face forming the northwest side of the excavation marked the limit of the quarry in this direction. The level of the quarry floor was unknown but presumed to be close to or above the level of the Cob. Two small sub-trenches in the excavation (Trench 1 and Trench 2 Fig. 9) aimed to investigate the early deposits. Trench 1 identified a layer of compacted shattered stone and larger rocks (28 and Plate 5) at 7.05m OD. This was 0.35m below the level of the floor of the wagon storage sheds. This appeared to be the working level of the quarry although excavation down to bedrock was not possible in the small trench. The lowest excavated level contained fibrous organic matter, probably preserved roots and grass dating from the period between the abandonment of the quarry and the levelling of the site for Boston Lodge works. It was noted that the organic material was sealed by hard infill with no apparent root penetration suggesting that the material was not a product of the development of weeds during the 20th century abandonment; sections are shown on Figs 10 and 11.

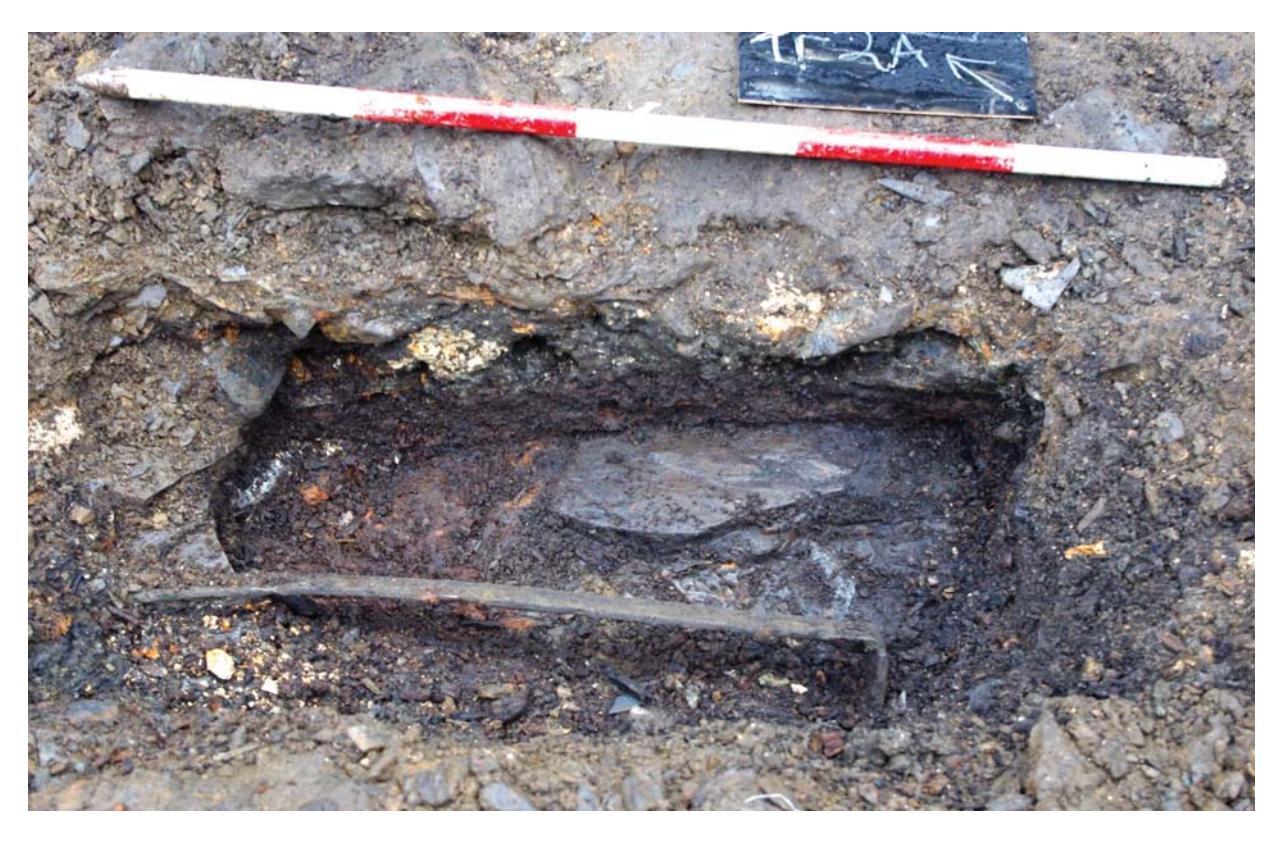
Plate 6 Trench 2A showing buried deposits from carpenter's shop with possible quarry deposits beneath

A layer of compacted stone was identified at the base of trench 2 at a similar depth (Plate 6) but there was not time to further investigate this.

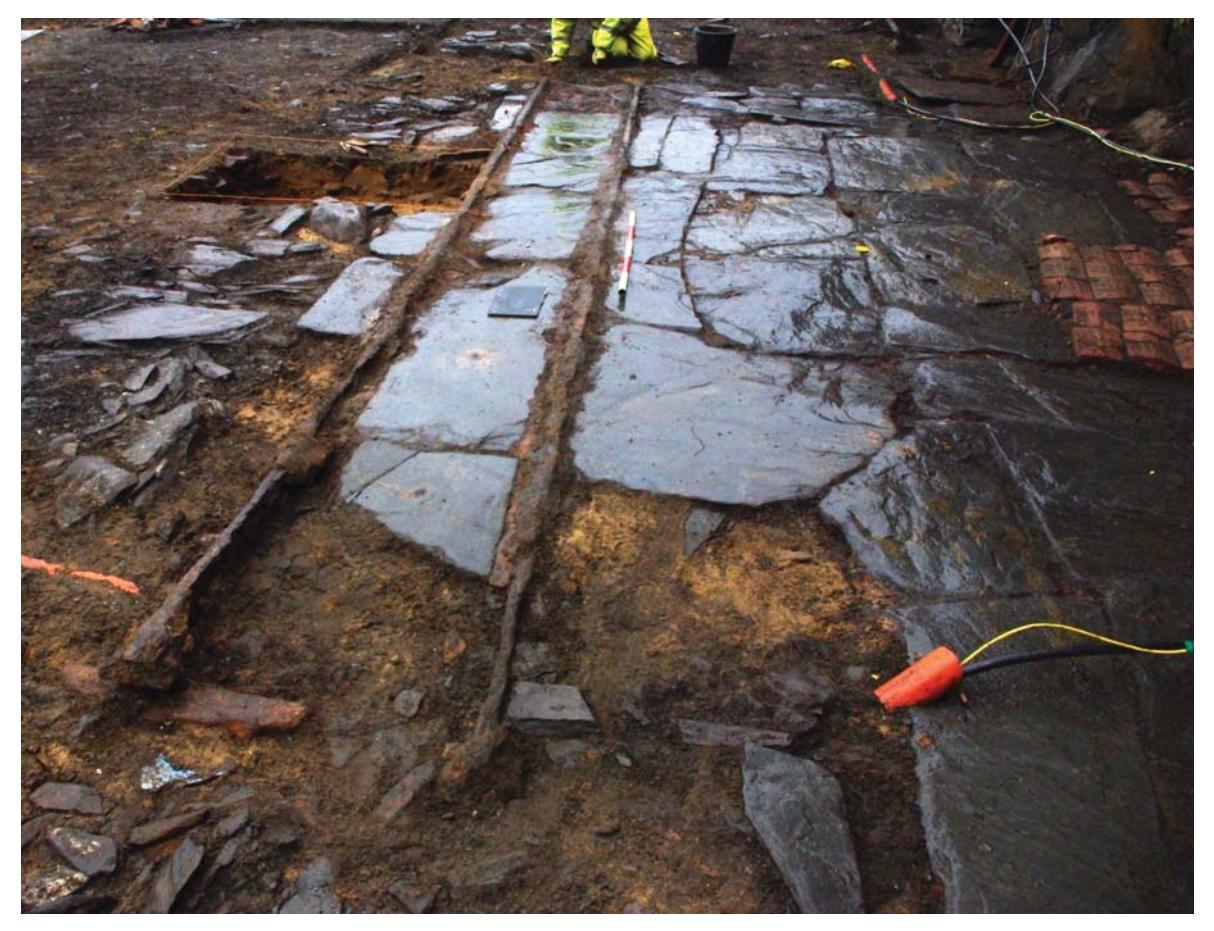
Plate 7 Rails and slate slabs after excavation from the south-east

An area of slate flooring and a length of rails were uncovered immediately beneath the modern overburden (Plate 7). The slab floor was bounded on the south-east (02) and south-west (10) by the somewhat fragmentary remains of the foundations and lower courses of a stone wall. The wall corresponds to the limits of the north-eastern wagon shed as shown on the 1889 25" OS map and 1915 plan. The south-western wall was also, having once been part of the same structure, aligned with the front of Plas Smart. The wall foundations were not investigated in detail.

The slate-slab floor (04) comprised closely fitted, but somewhat irregular, sub-rectangular slabs up to 1.2m in length (Plate 7). Slabs were carefully fitted around and between the rails and in the narrow 0.23m wide gap between the rails and the south-western wall of the shed. At least one of the slabs was sawn, the rest were roughly shaped. The floor did not run up to the rock face at the rear, leaving a 0.6m wide gap in most places perhaps in order to accommodate a drain. The north-west end of the slate flooring (05) consisted of smaller slabs and was somewhat fragmentary. A discrete area of heat affected material (09: mostly sand with some charcoal), filled the gap between the two rails at their north-western end. This was not excavated. Its origin was unclear, it could have been a result of a process carried out in the shed, or could have been imported from another building such as the foundry to infill a hole in the floor.

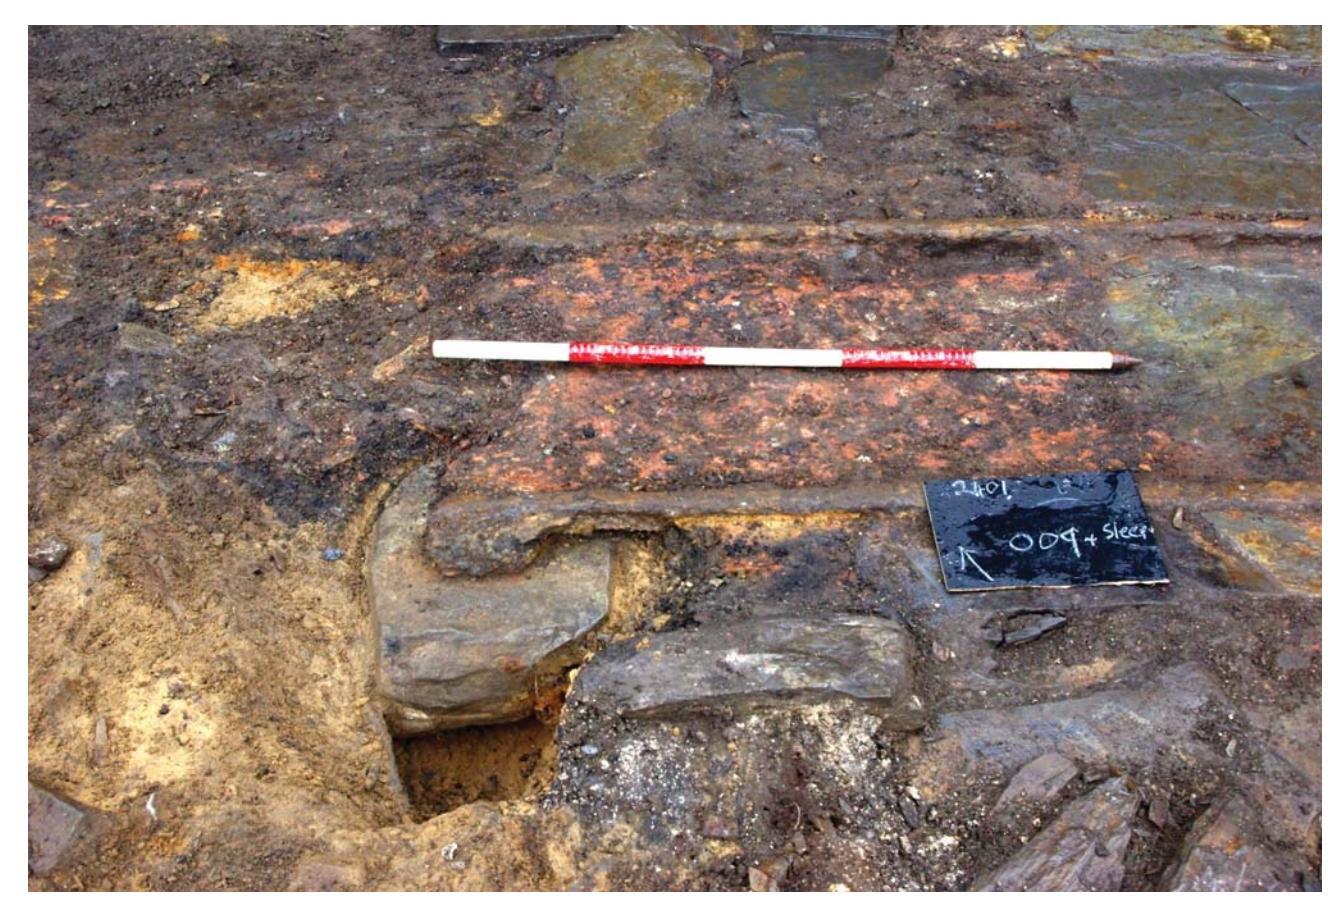
Plate 8 The north-western end of the rails with heat-affected deposit and stone sleeper block
