Moel Findeg, Denbighshire ARCHAEOLOGICAL ASSESSMENT

Report No 325

> NW Jones July 1999 Report for Denbighshire County Council

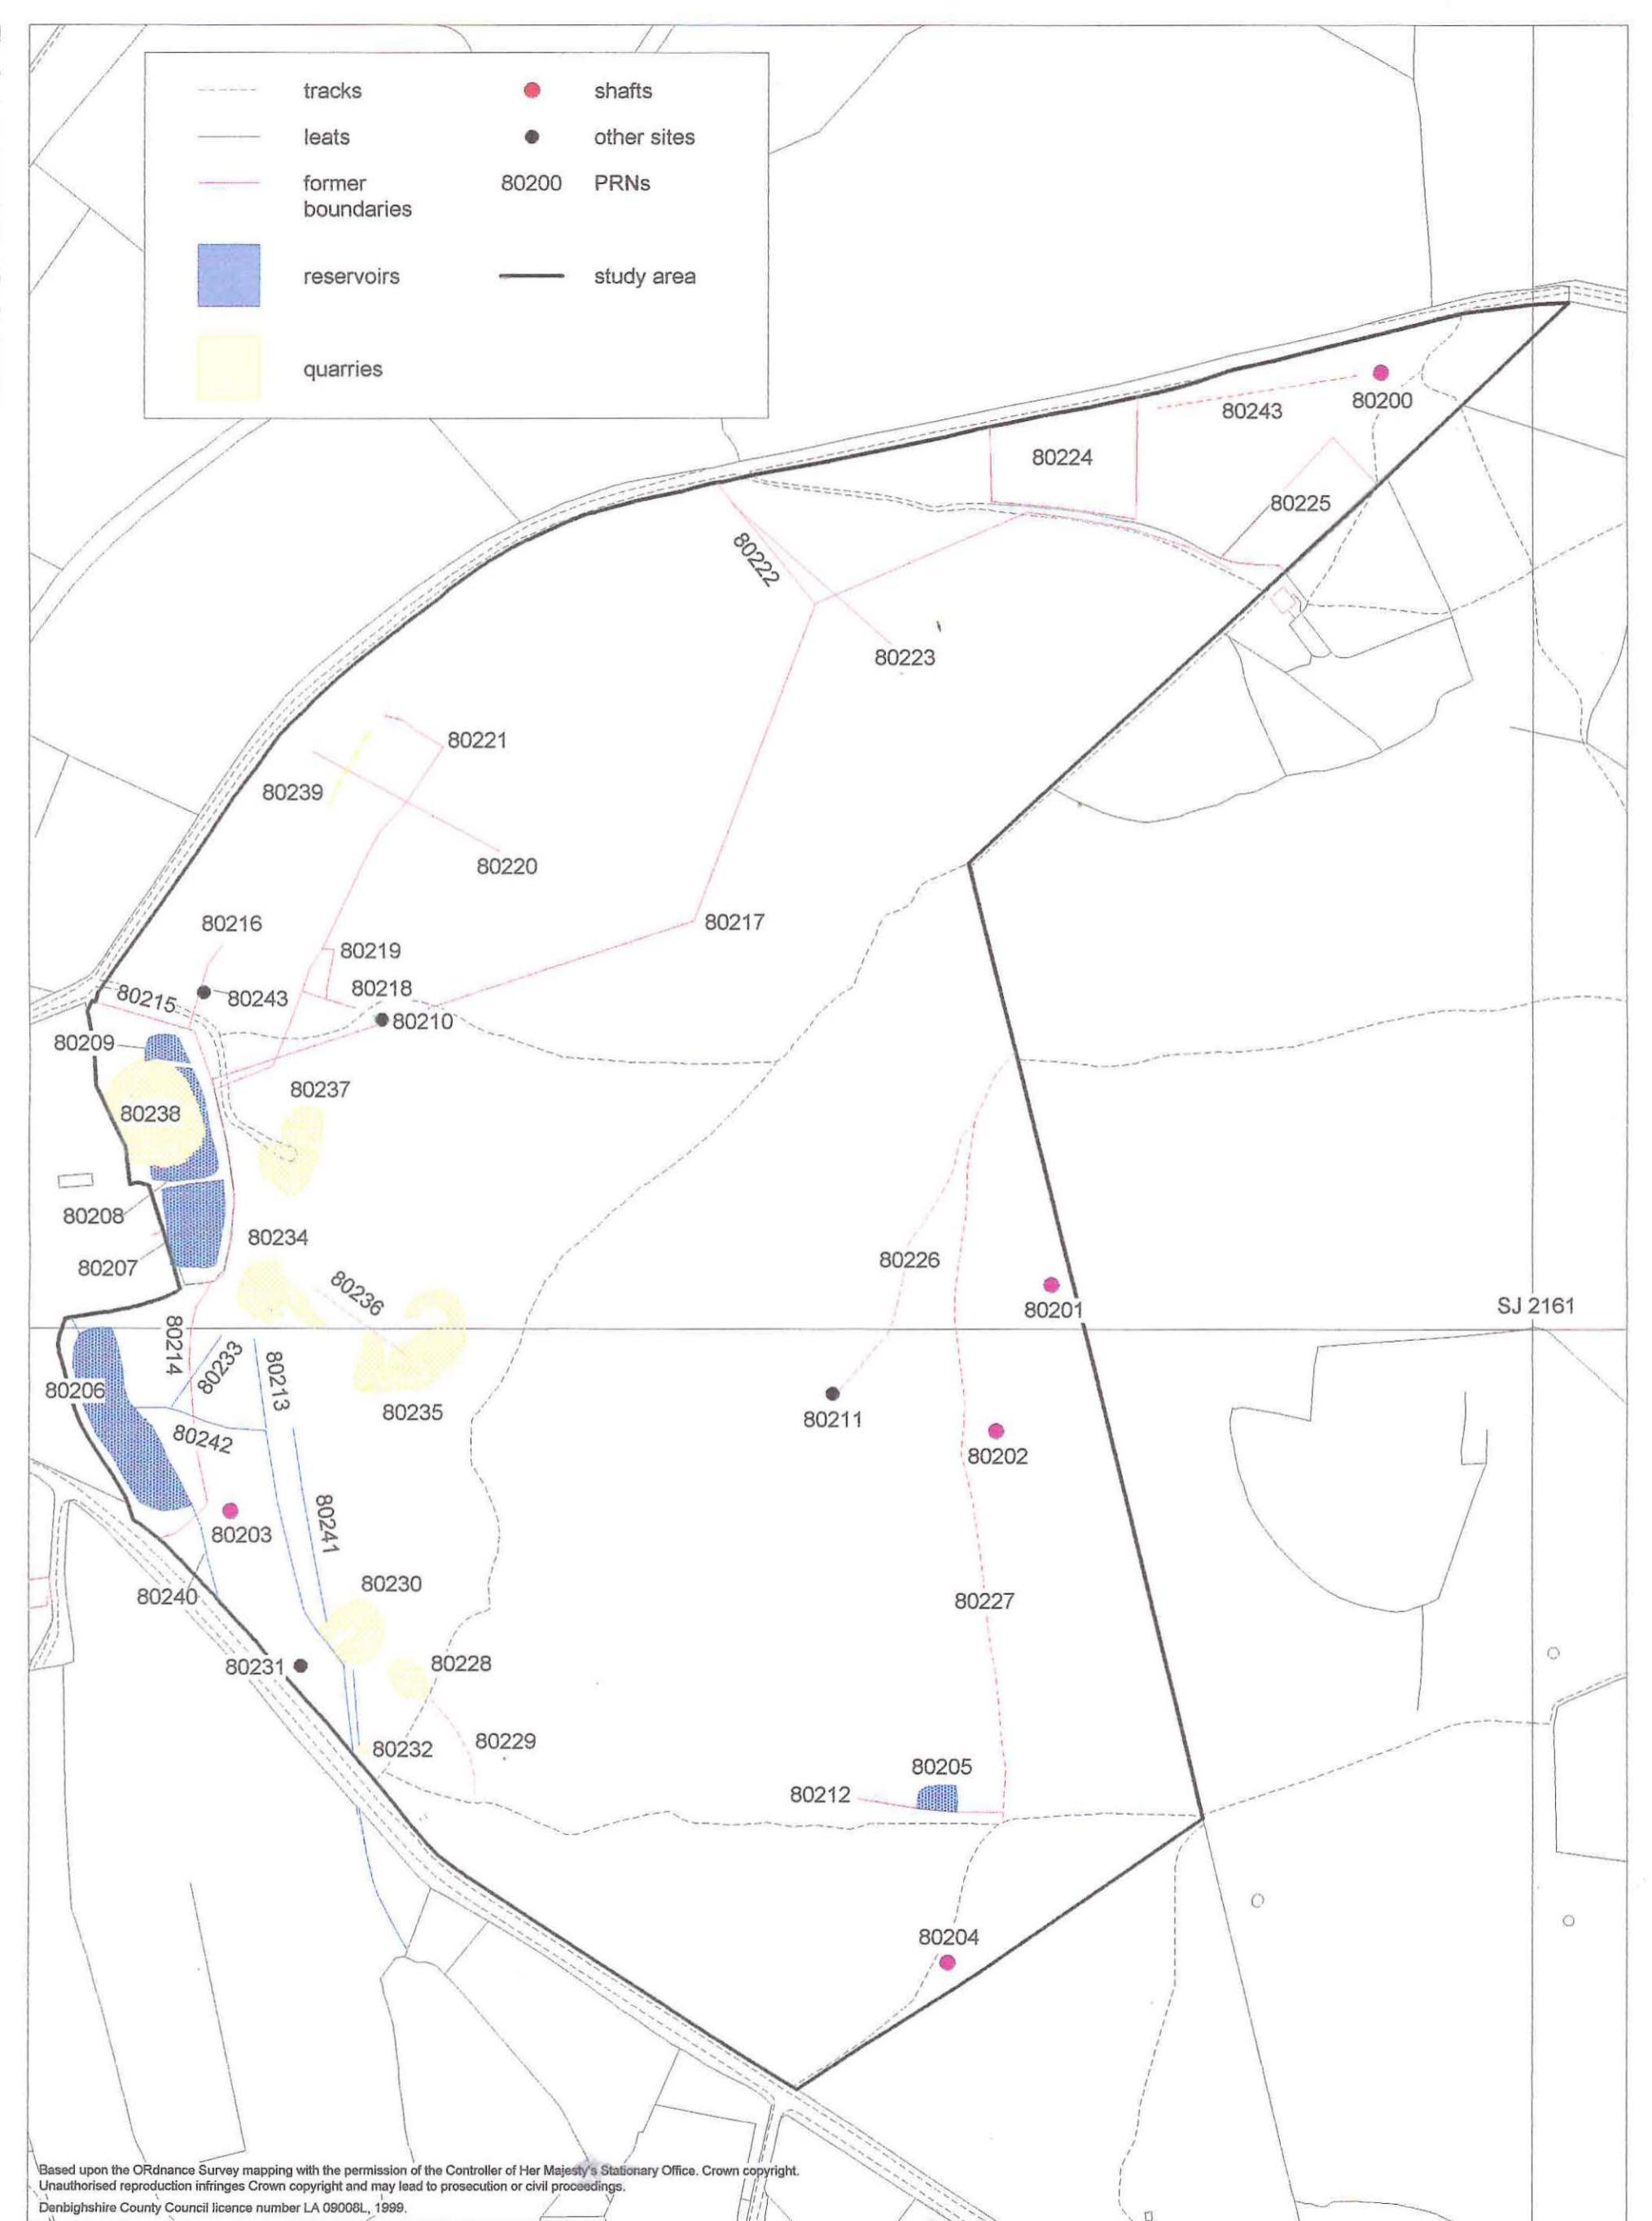
- 3.1 The following section has been derived from a desk-based study which was undertaken using all readily available primary and secondary documentary, cartographic and aerial photographic sources within the following repositories: County Sites and Monuments Record (SMR), Clwyd-Powys Archaeological Trust, Welshpool; Denbighshire Countryside Service; County Records Offices (CRO) atHawarden and Ruthin; National Library of Wales, Aberystwyth; National Monuments Record (NMR), Royal Commission on Ancient and Historical Monuments in Wales (RCAHMW), Aberystwyth. All features identified during the study are shown on fig. 2.

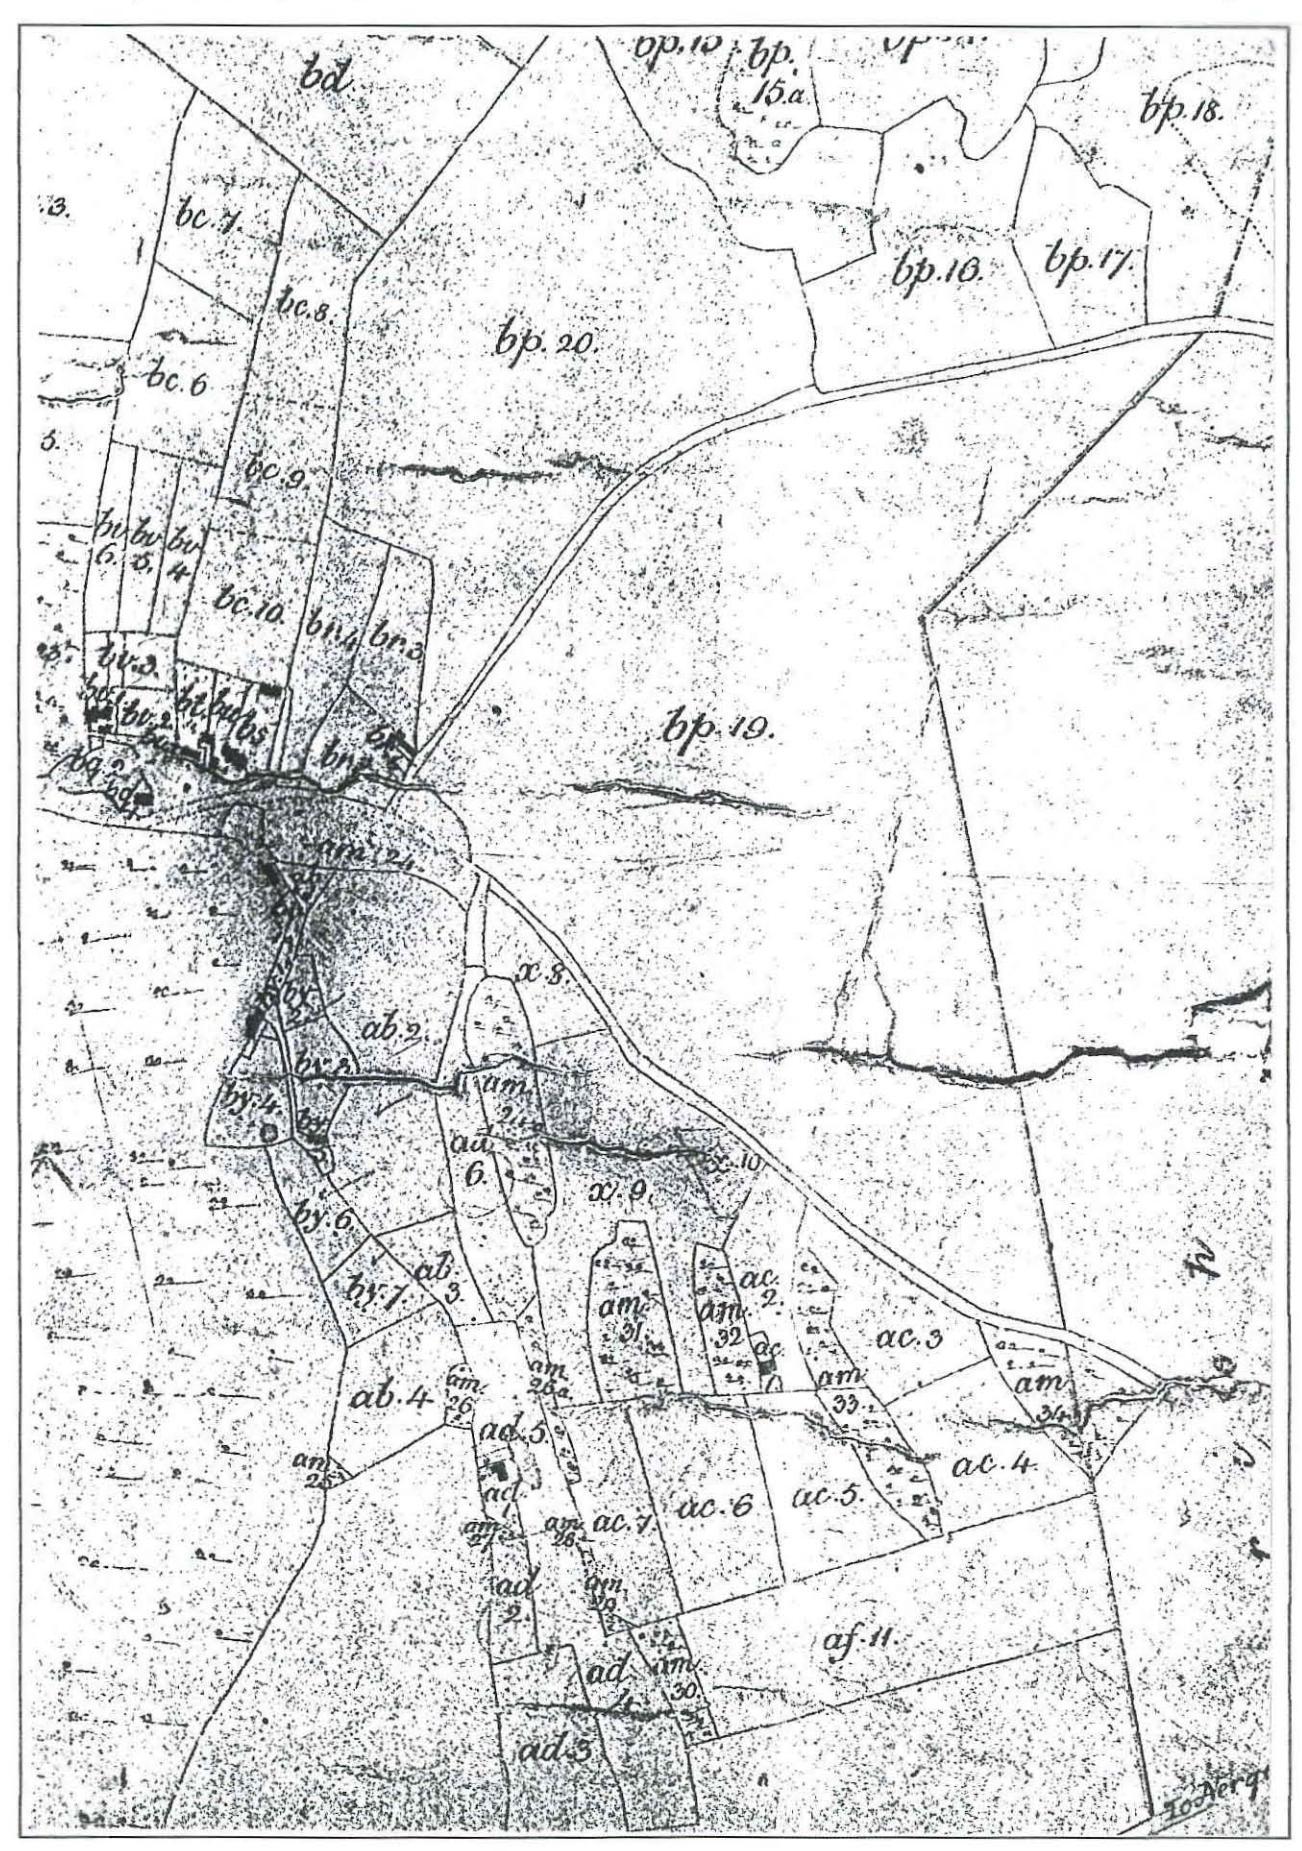
Fig. 3 Tithe Survey of 1838

- 3.6 The Tithe Survey of 1838 (CROR TM/52/1; fig. 3) shows the area as unenclosed land belonging to Richard Garnons and occupied by Evan Davies, covering an area of 59 acres, 2 roods and 11 perches.

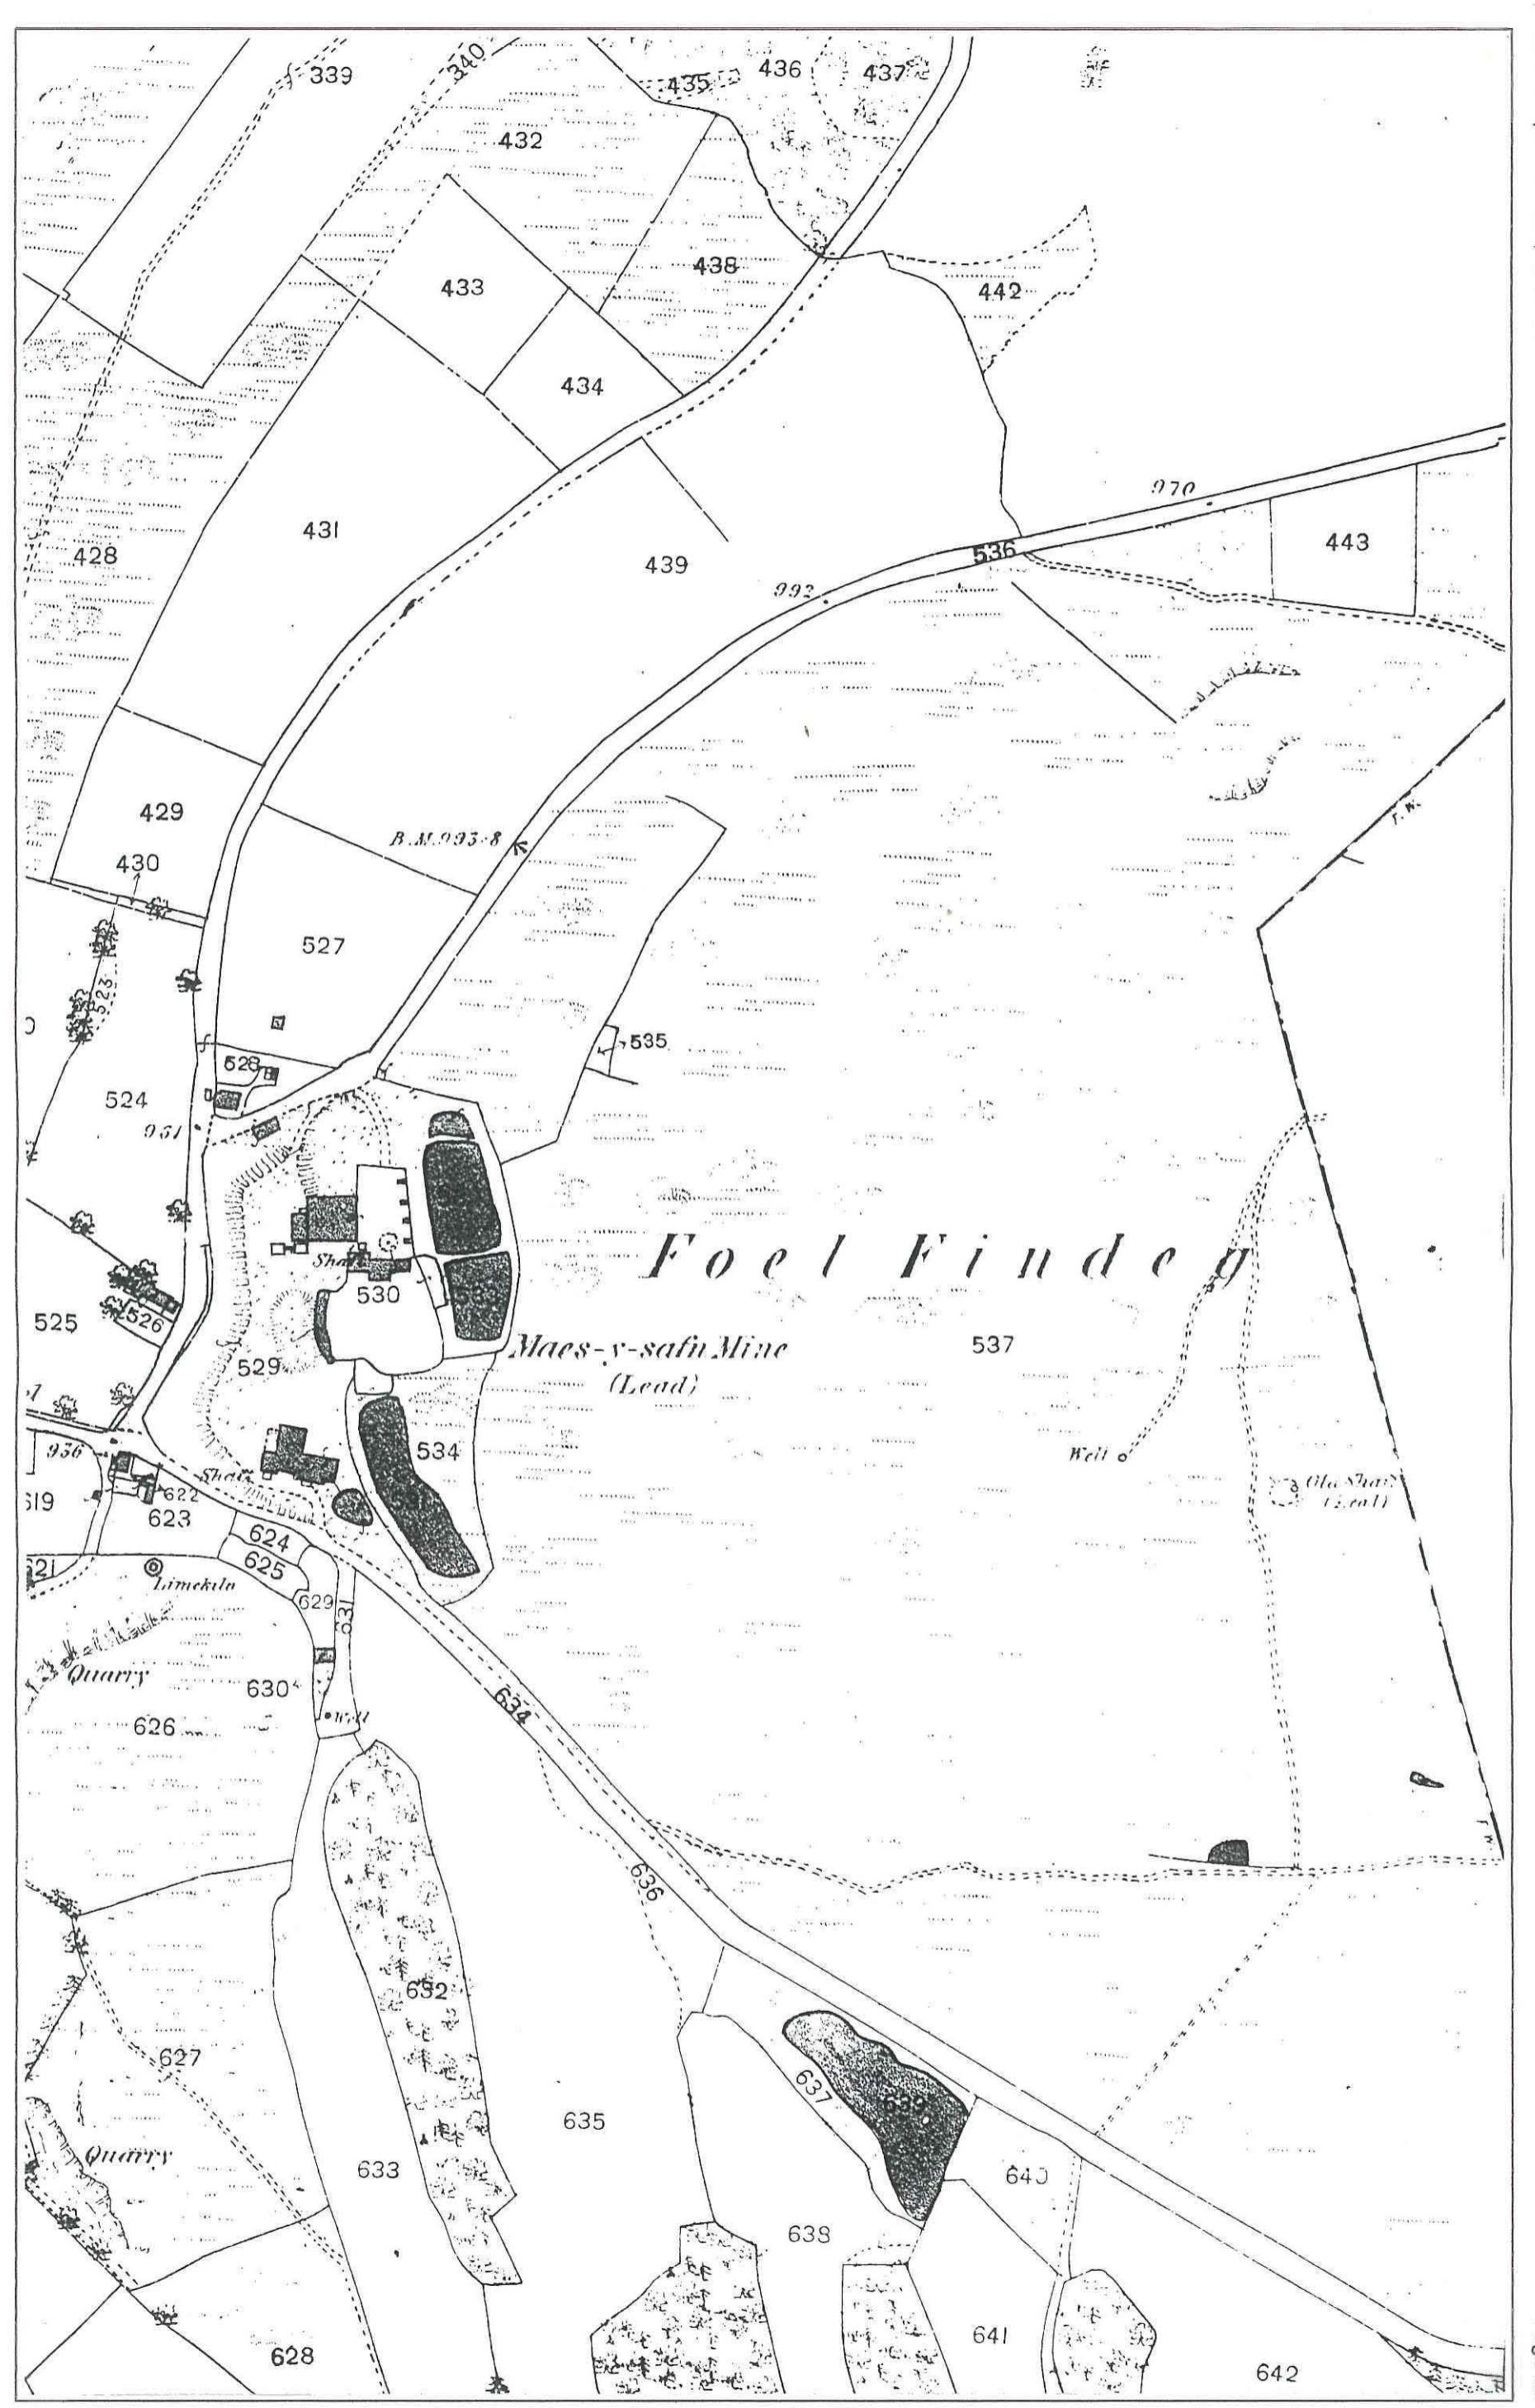
- 3.7 The Ordnance Survey 1st edition at 1:2,500 (Denbighshire 15.14 and 15.15; fig. 4), surveyed in 1870 and published in 1878 provides the earliest accurate cartographic evidence for the area and reveals a considerable amount of information relating mostly to Maeshafn lead mine. Within the study area the map shows three reservoirs to the east of the main (Grosvenor) shaft, together with a fourth to the south, lying within two bounded enclosures. These were presumably to supply water for the boiler of the Cornish engine house and are likely to have been supplied by a system of leats, not shown on the map, as well as by water pumped from the mine. Towards the south-east of the area a small pond or reservoir is shown alongside what may be a short length of boundary. Close to the eastern, county boundary, an old lead shaft is shown, with a well nearby. Elsewhere, a number of tracks are shown crossing the area, together with several field boundaries in the northern part of the area.

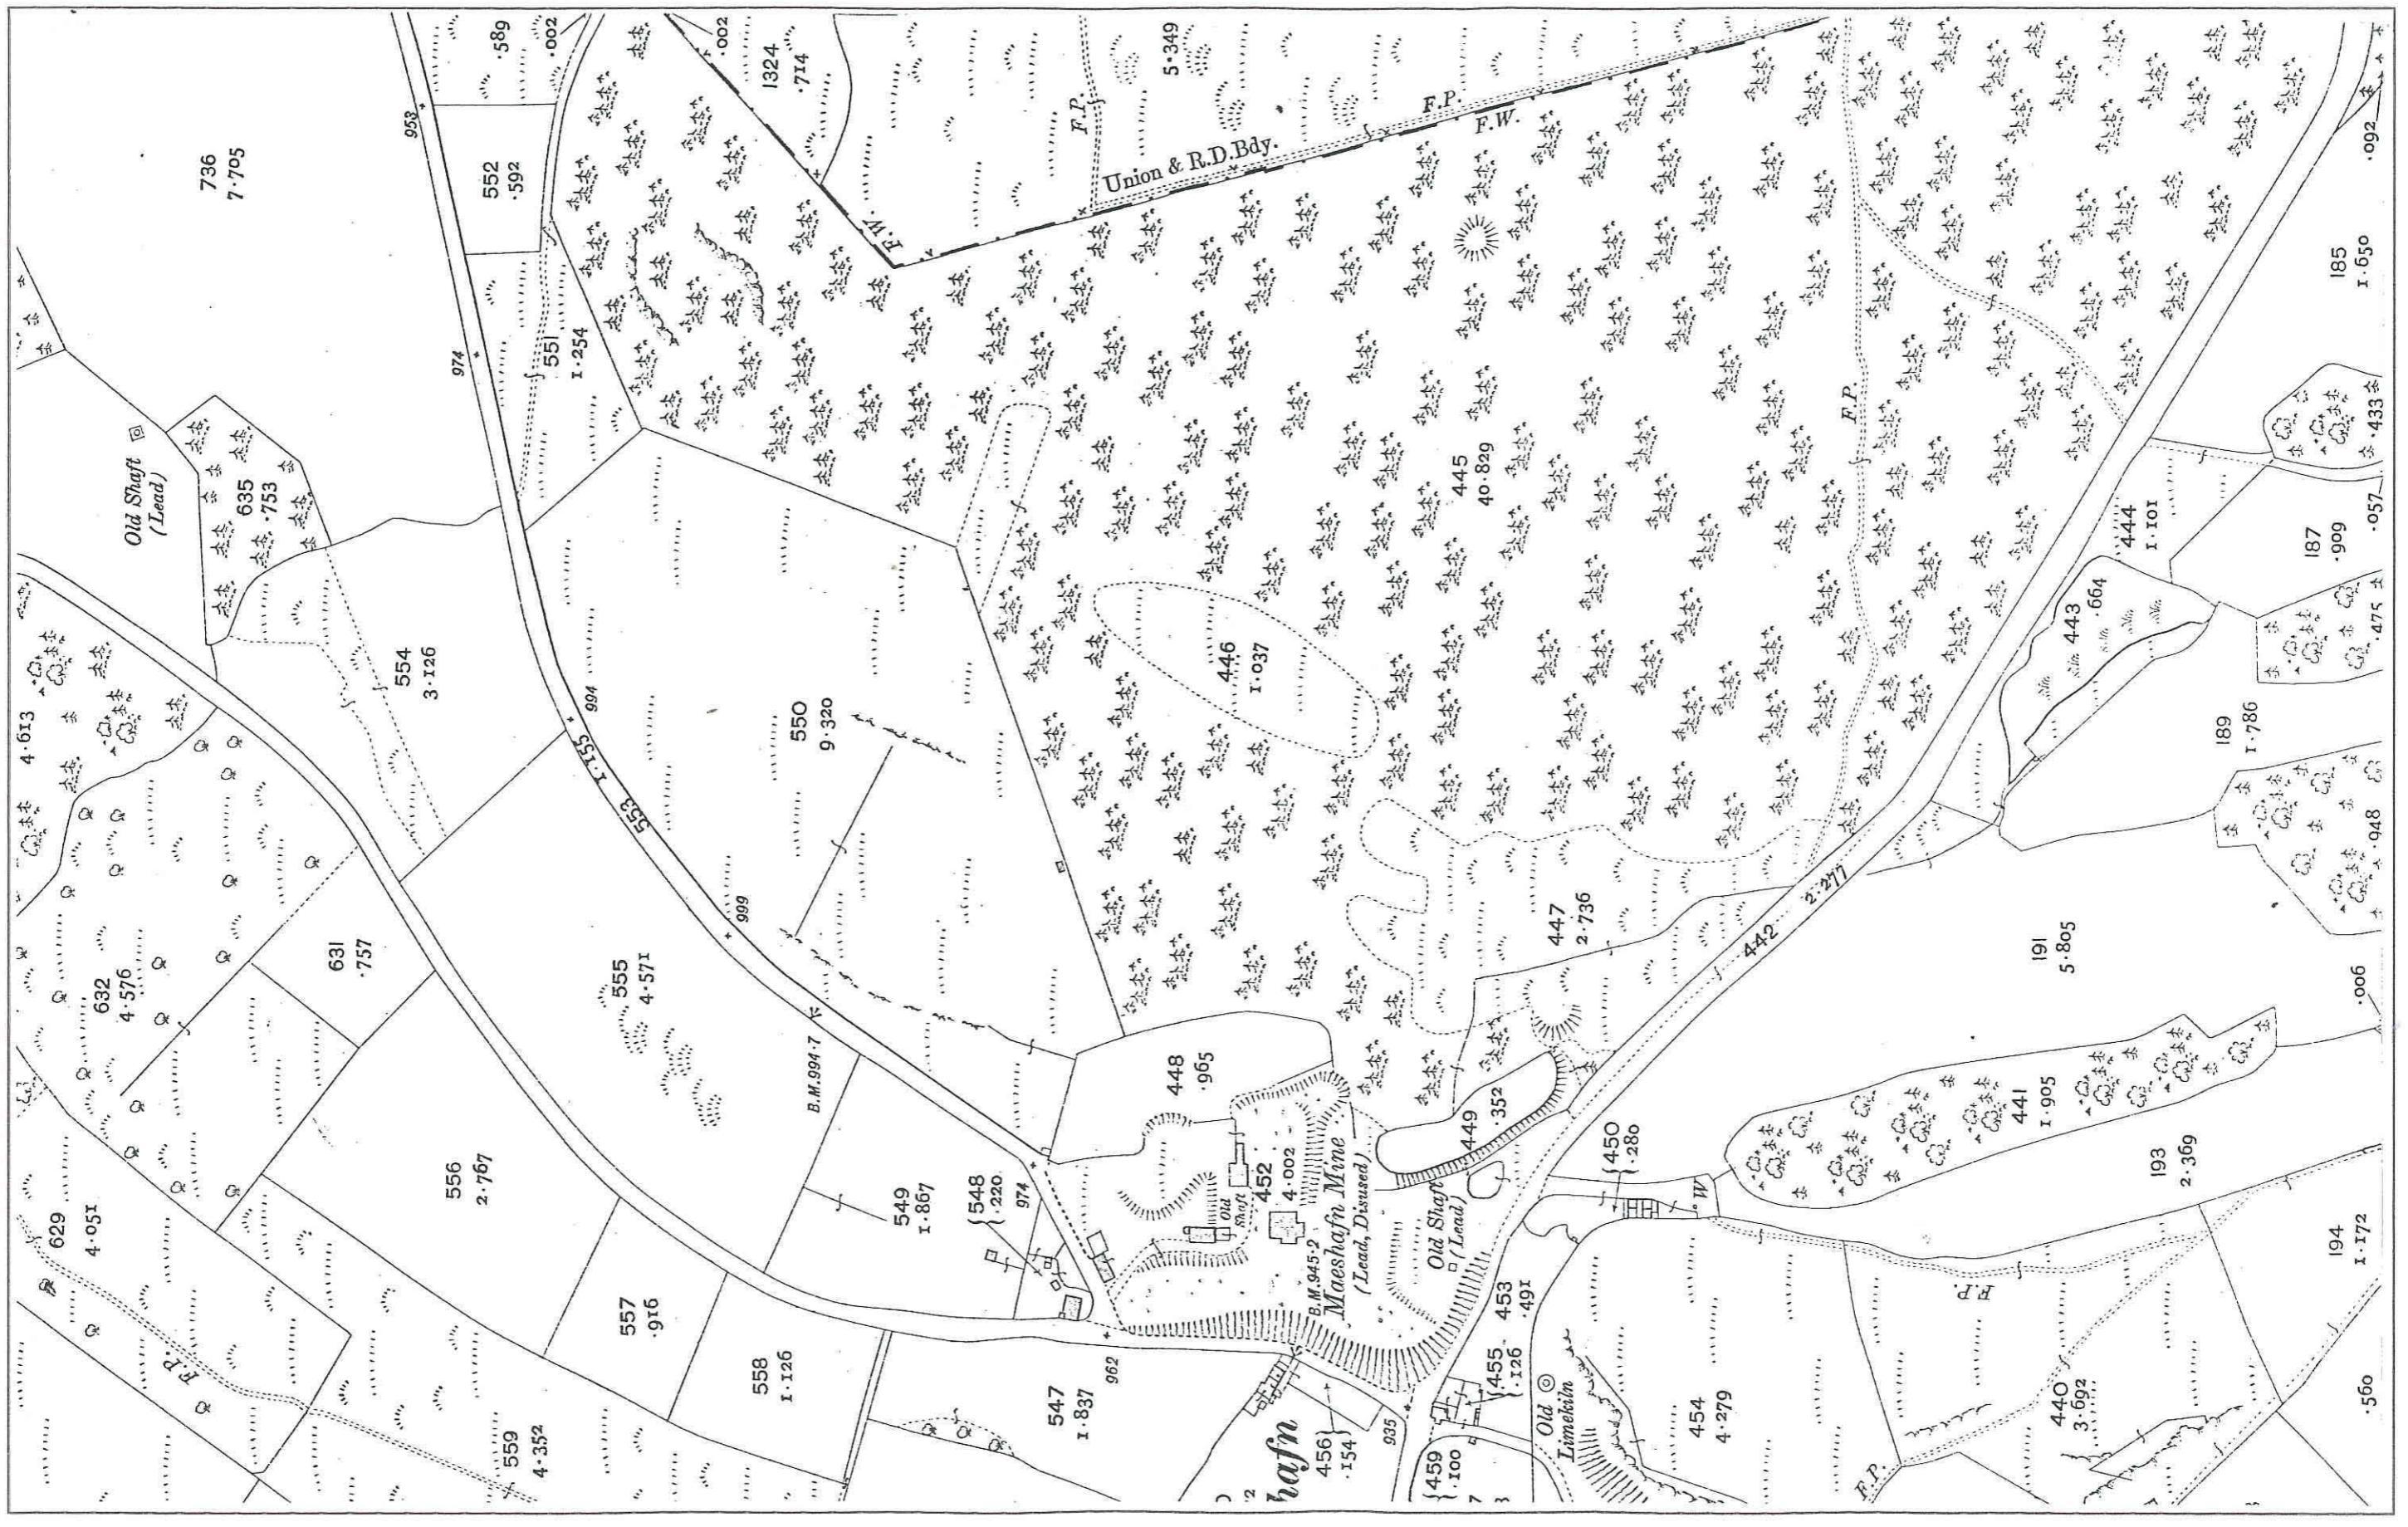
Fig. 5 Ordnance Survey 3rd edition 1:2,500, Denbighshire 15.14, revised 1910.

- 4.11 Two enclosures are shown on the Ordnance Survey 3rd edition in the north-eastern part of the area. There was no visible trace of PRN 80226 in high bracken, although PRN 80225 could be identified, consisting of a derelict stone wall.
