The Old Mill, Pont Faen, Brecon, Powys ARCHAEOLOGICAL BUILDING SURVEY

CPAT Report No 396

N W Jones October 2000

Report for Mr J Parsons

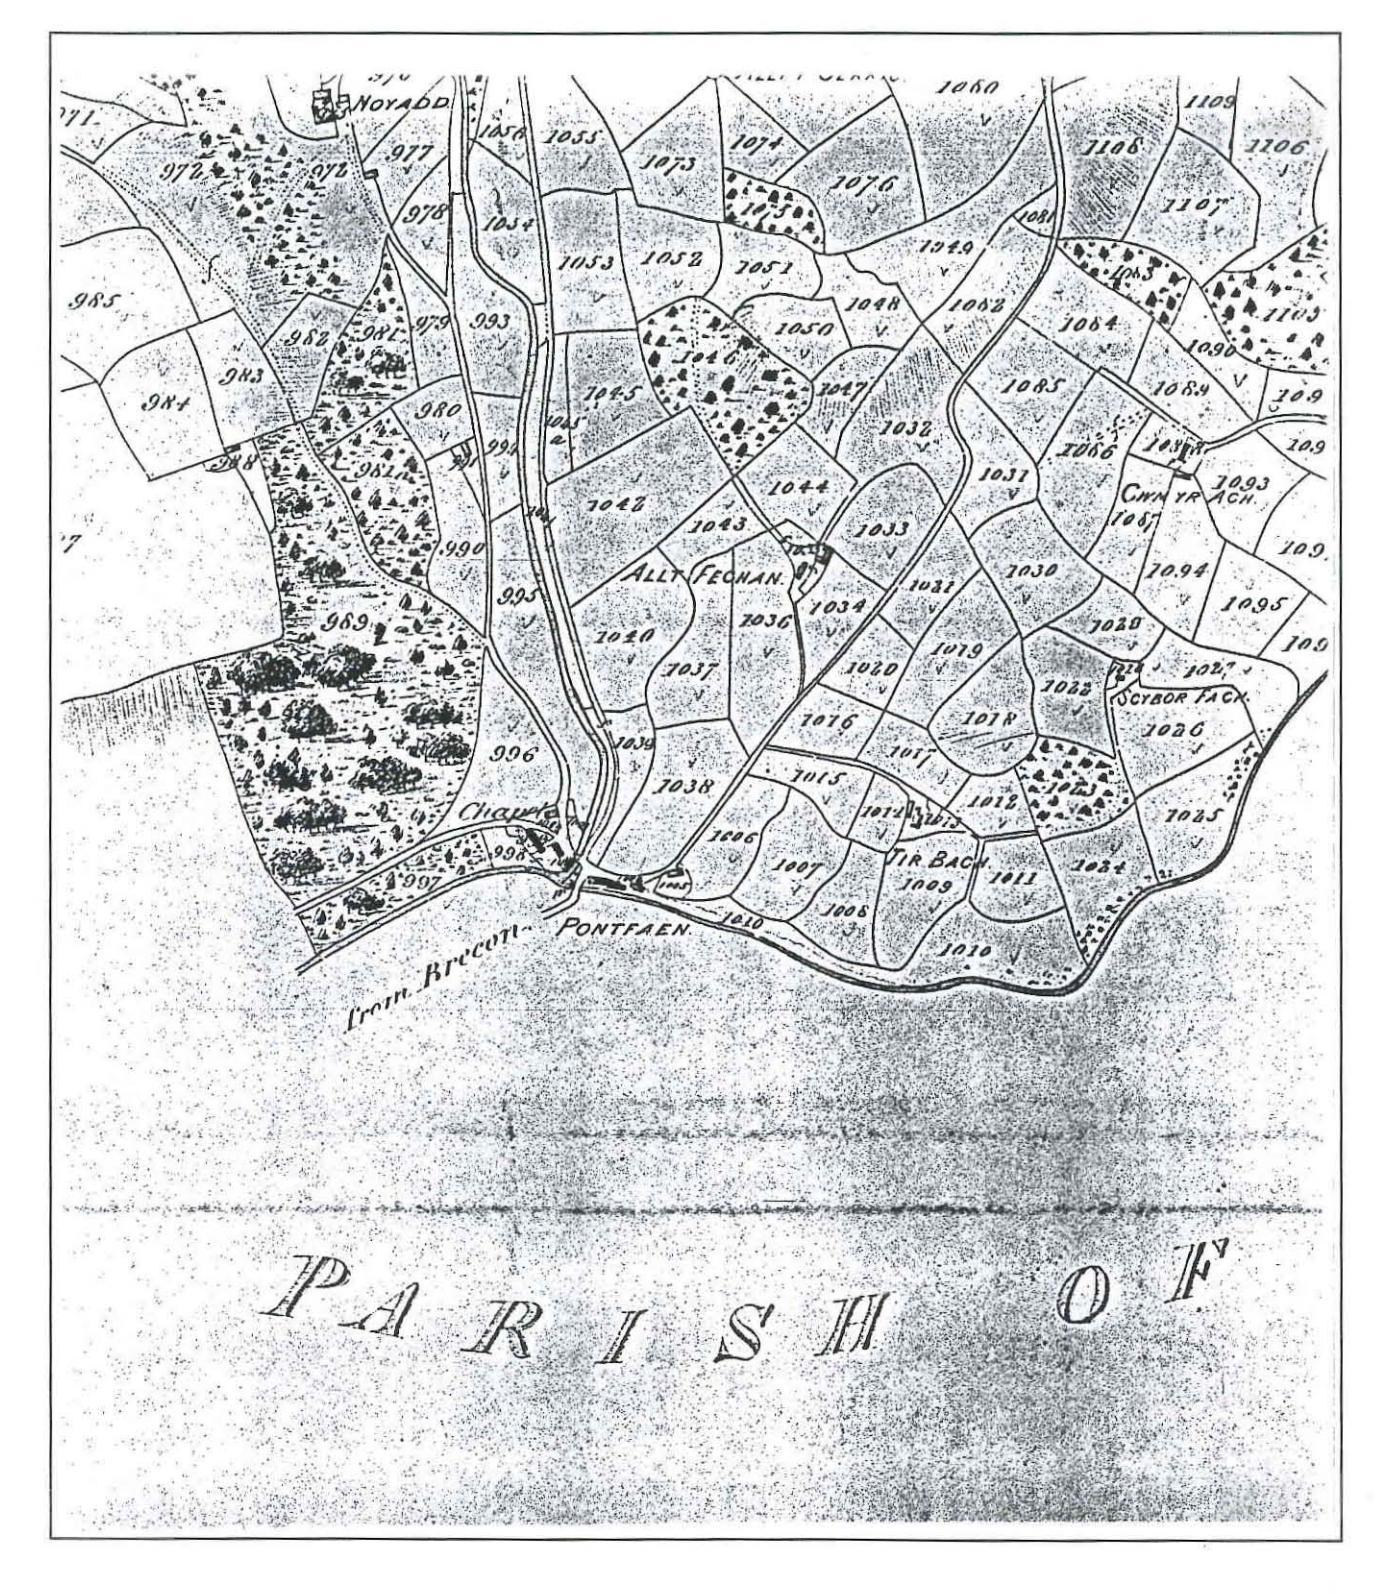
Fig. 2 Tithe Survey of Merthyr Cynog Parish, 1840

- 3.2 The Regional SMR currently has no record for the Old Mill, or any associated features or structures.
- 3.2 The earliest available cartographic evidence for the area is the Tithe Survey of 1840 for Merthyr Cynog parish (Fig. 2). A building is depicted on the site of the present mill and a faint line may indicate the leat feeding from the river to the east. It is not possible to determine whether this is the existing mill, or an earlier structure. At this time the plot (No 1004) is recorded as Mill house and garden, in the ownership of Revd Thomas Vaughan and let to Daniel Watkins.

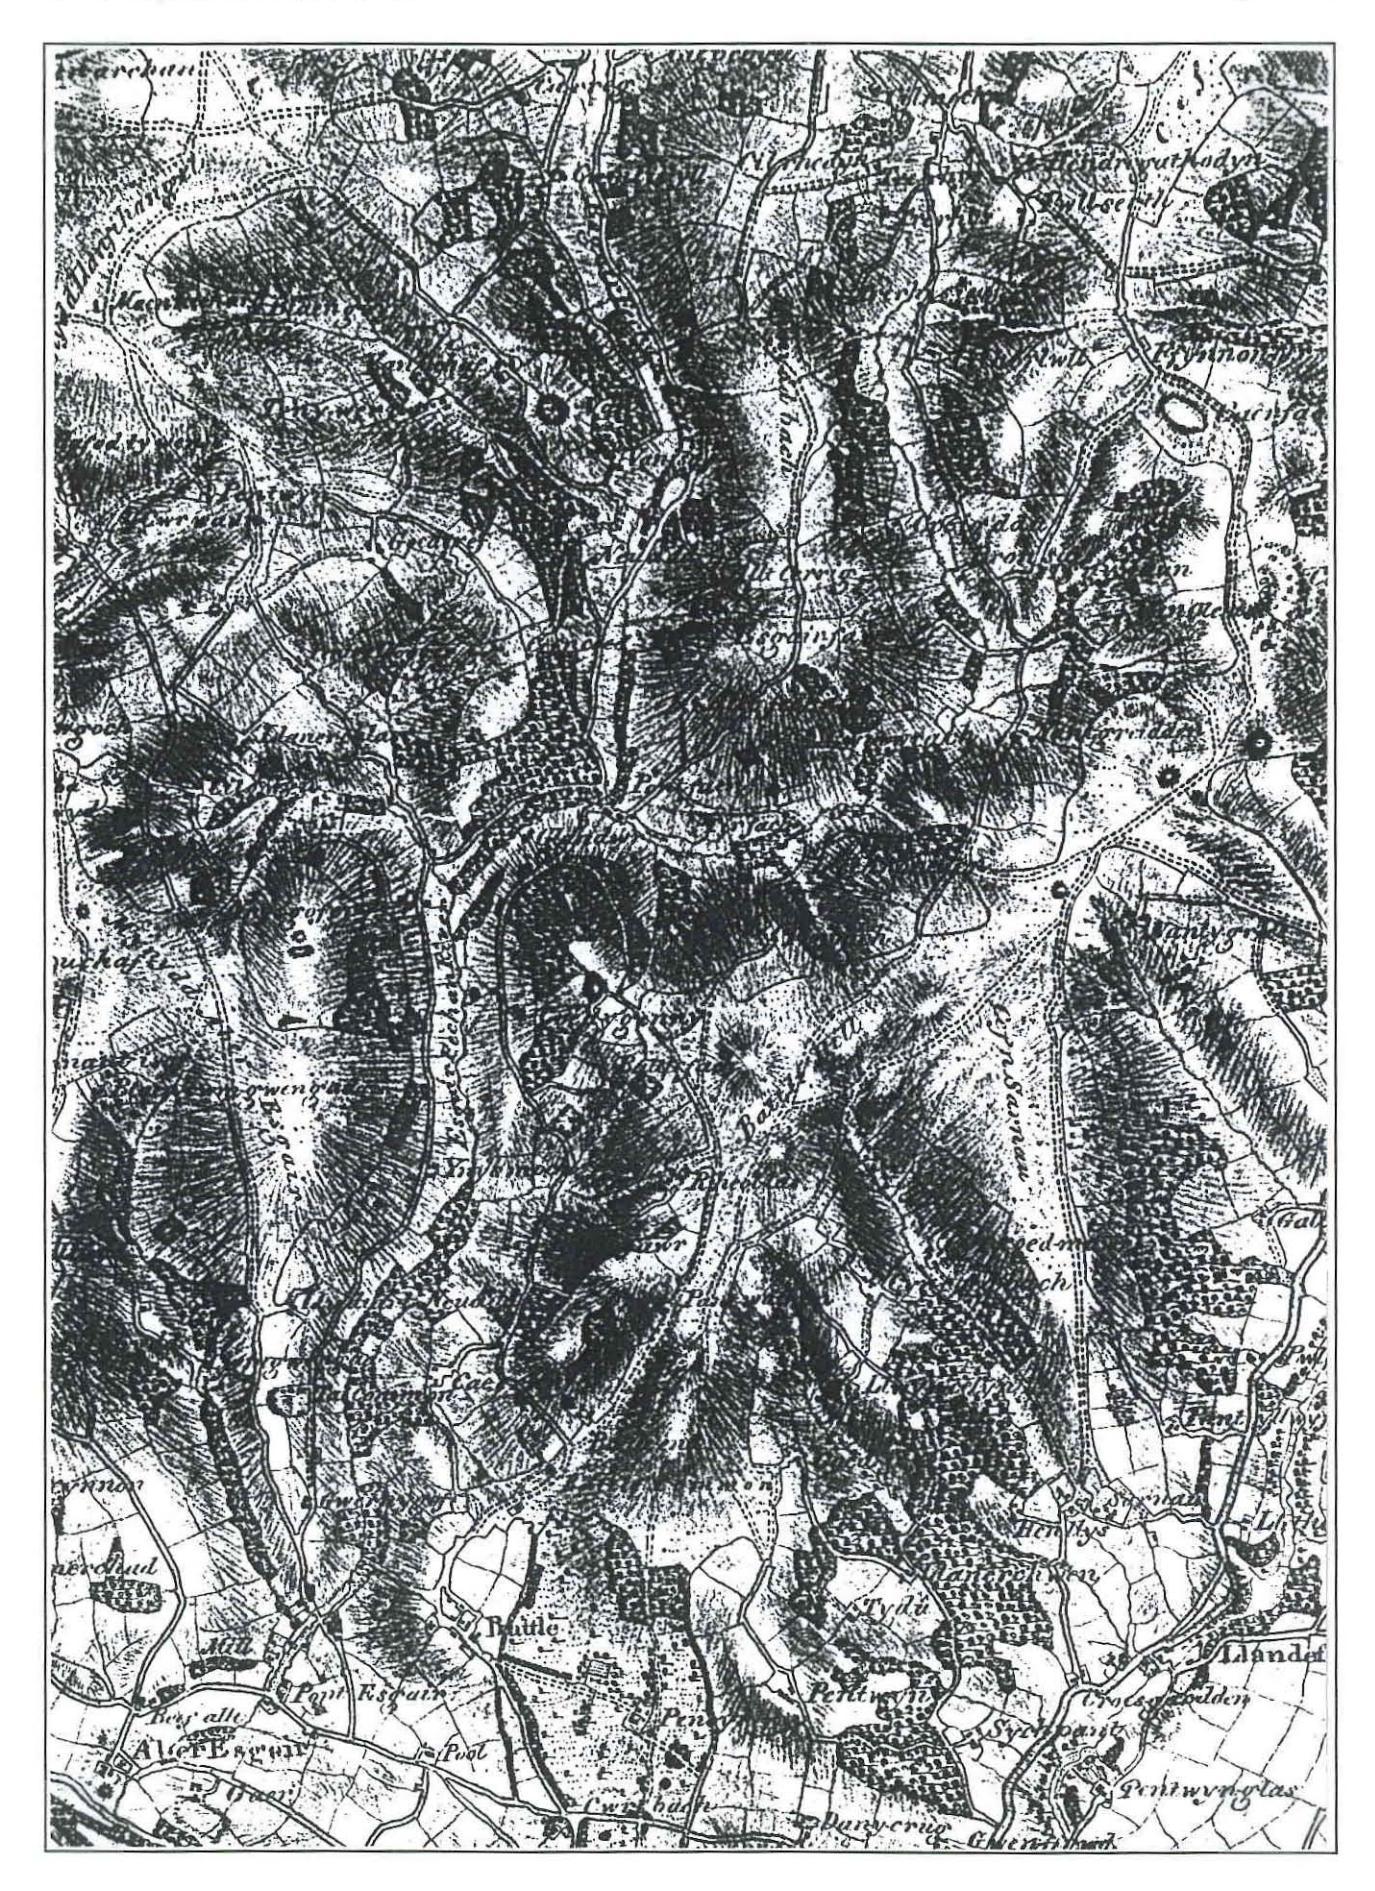
Fig. 3 Ordnance Survey Surveyor's Drawing 1809-36

- 3.3 The Ordnance Survey Surveyors' Drawing of 1809-36 (Fig. 3) shows several buildings in the vicinity of the mill, although it is not possible to determine whether the mill itself is depicted.

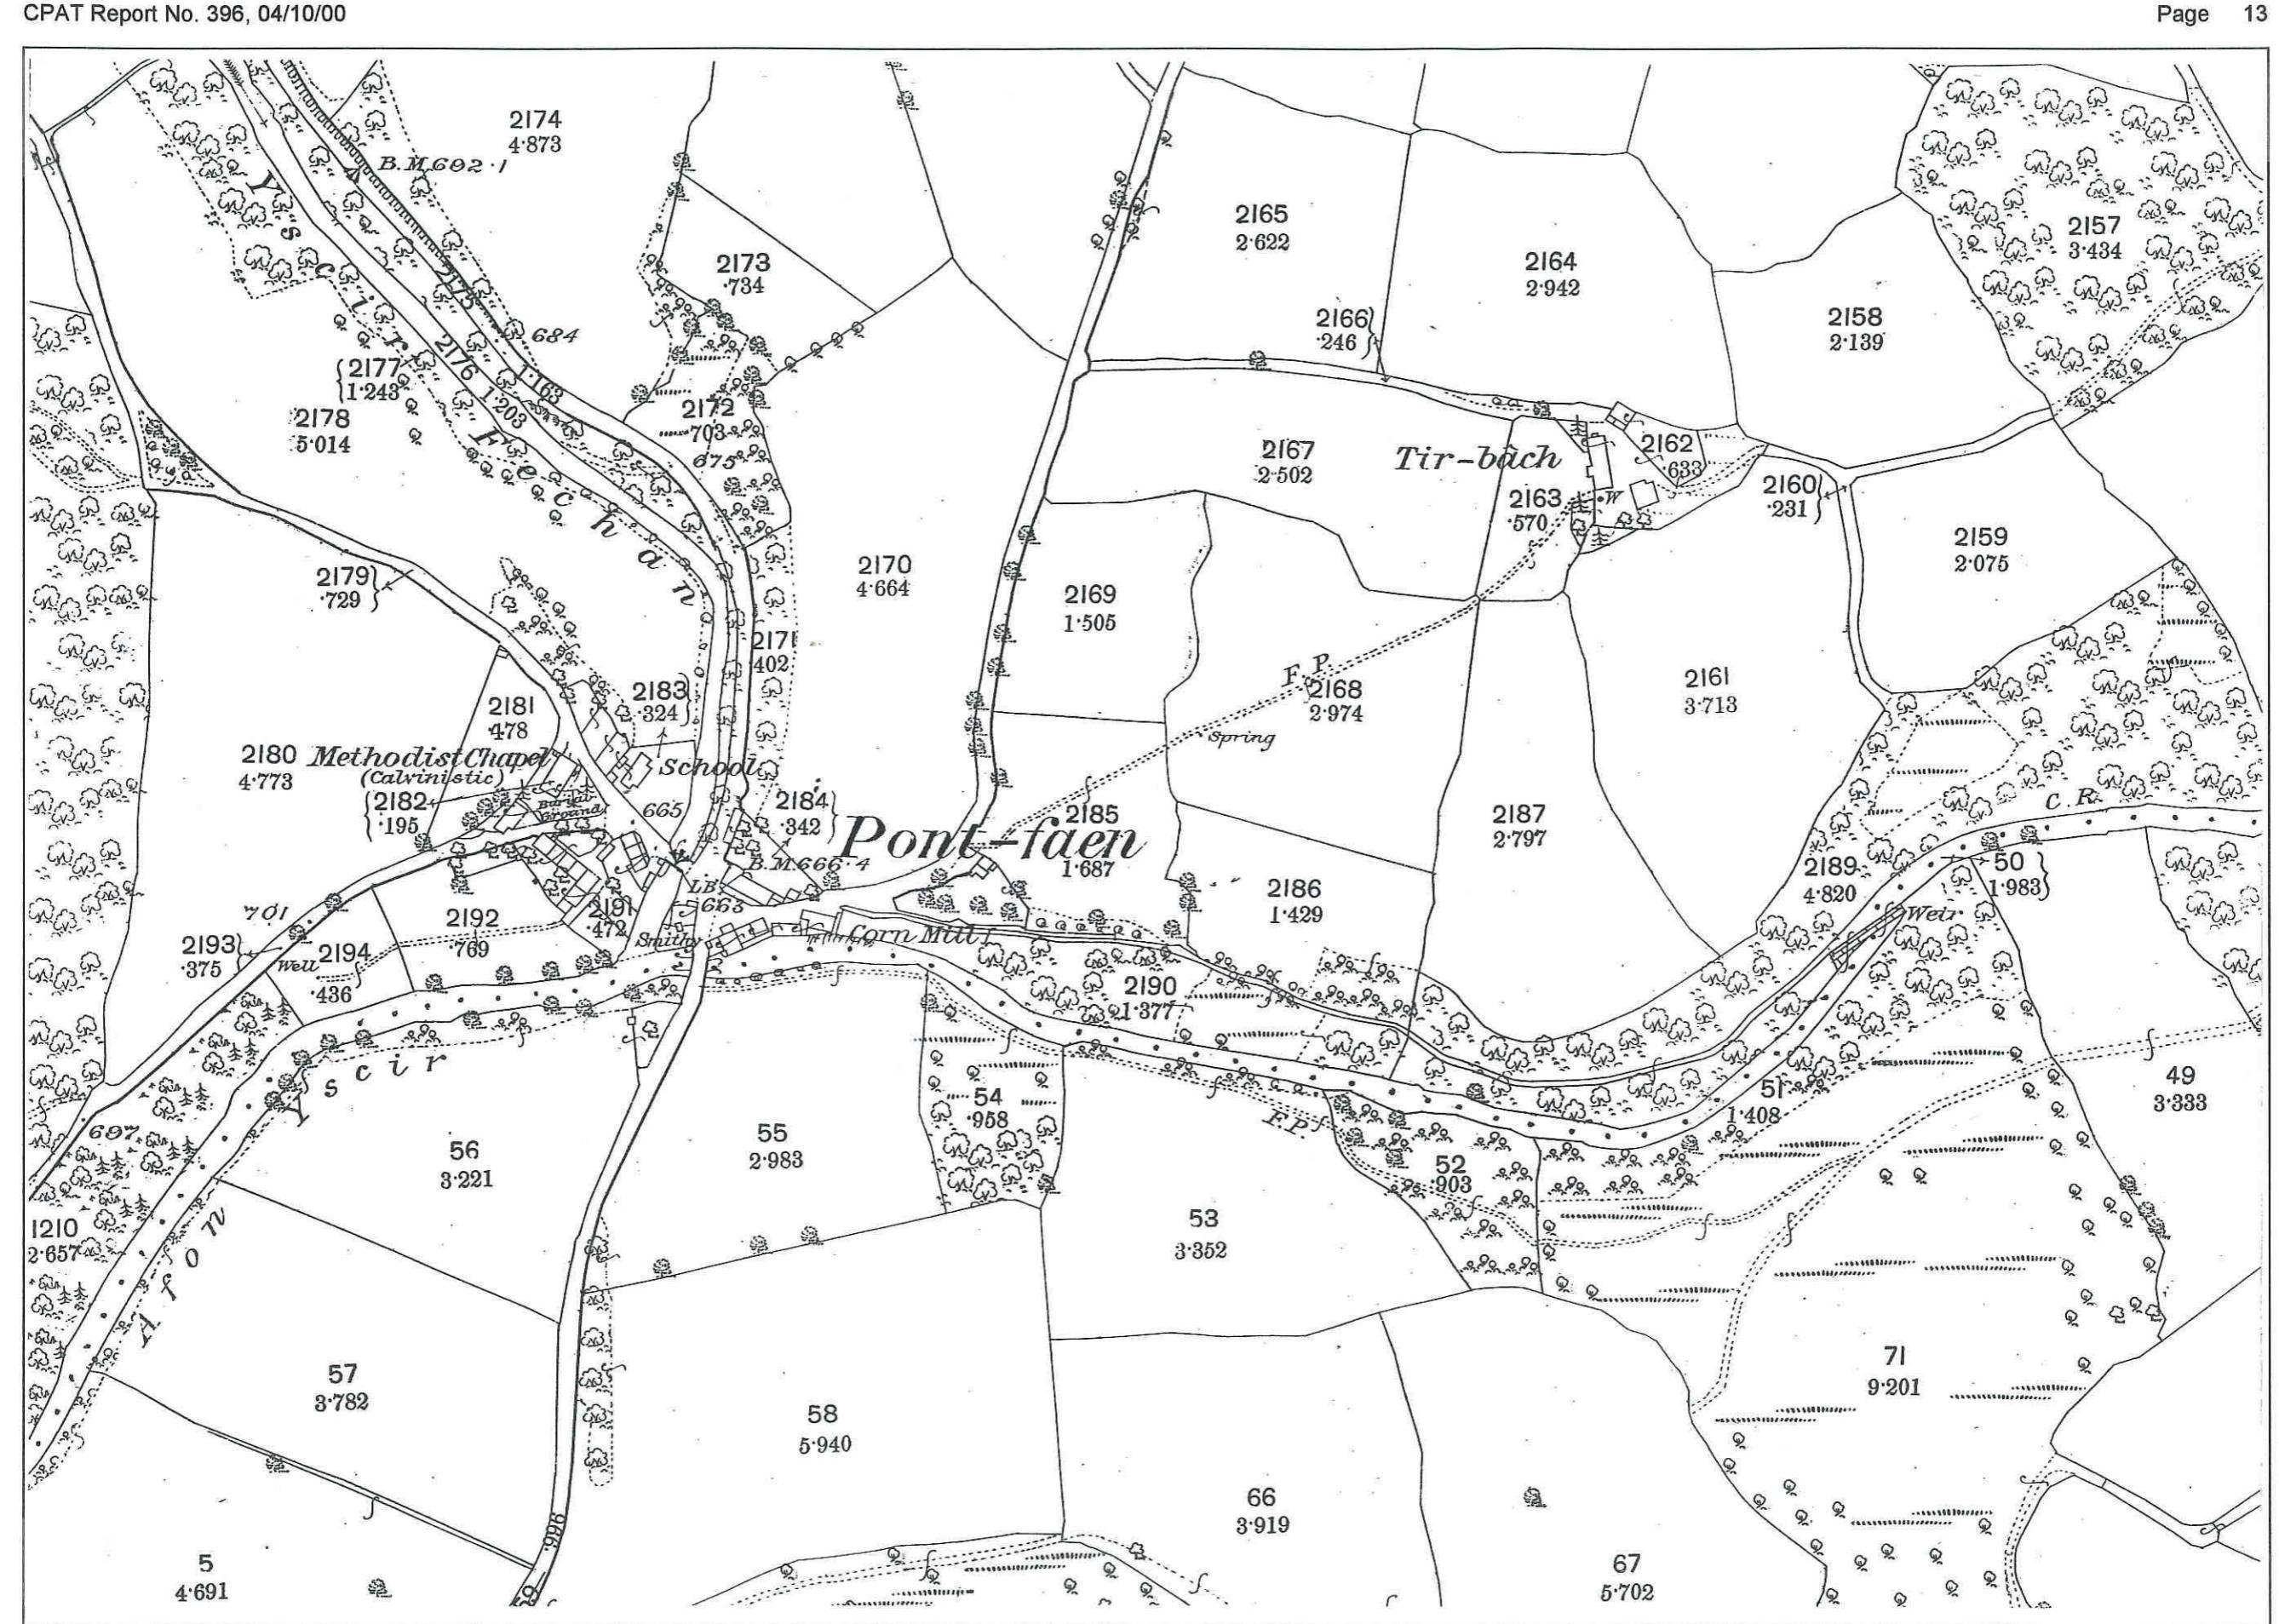
Fig. 4 Ordnance Survey 1st edition 25", 1888

- 3.4 The earliest detailed mapping of the area is provided by the Ordnance Survey 1st edition 25" series (Fig. 4), surveyed in 1886 and published in 1888. This clearly shows the water mill, with the drying kiln at the western end (see below), together with the head race leading off the Ysgir Fawr at a weir c. 400m to the east (SO 00073411). The weir has since been breached although its position can still be identified, while the head race can be traced as an earthwork.

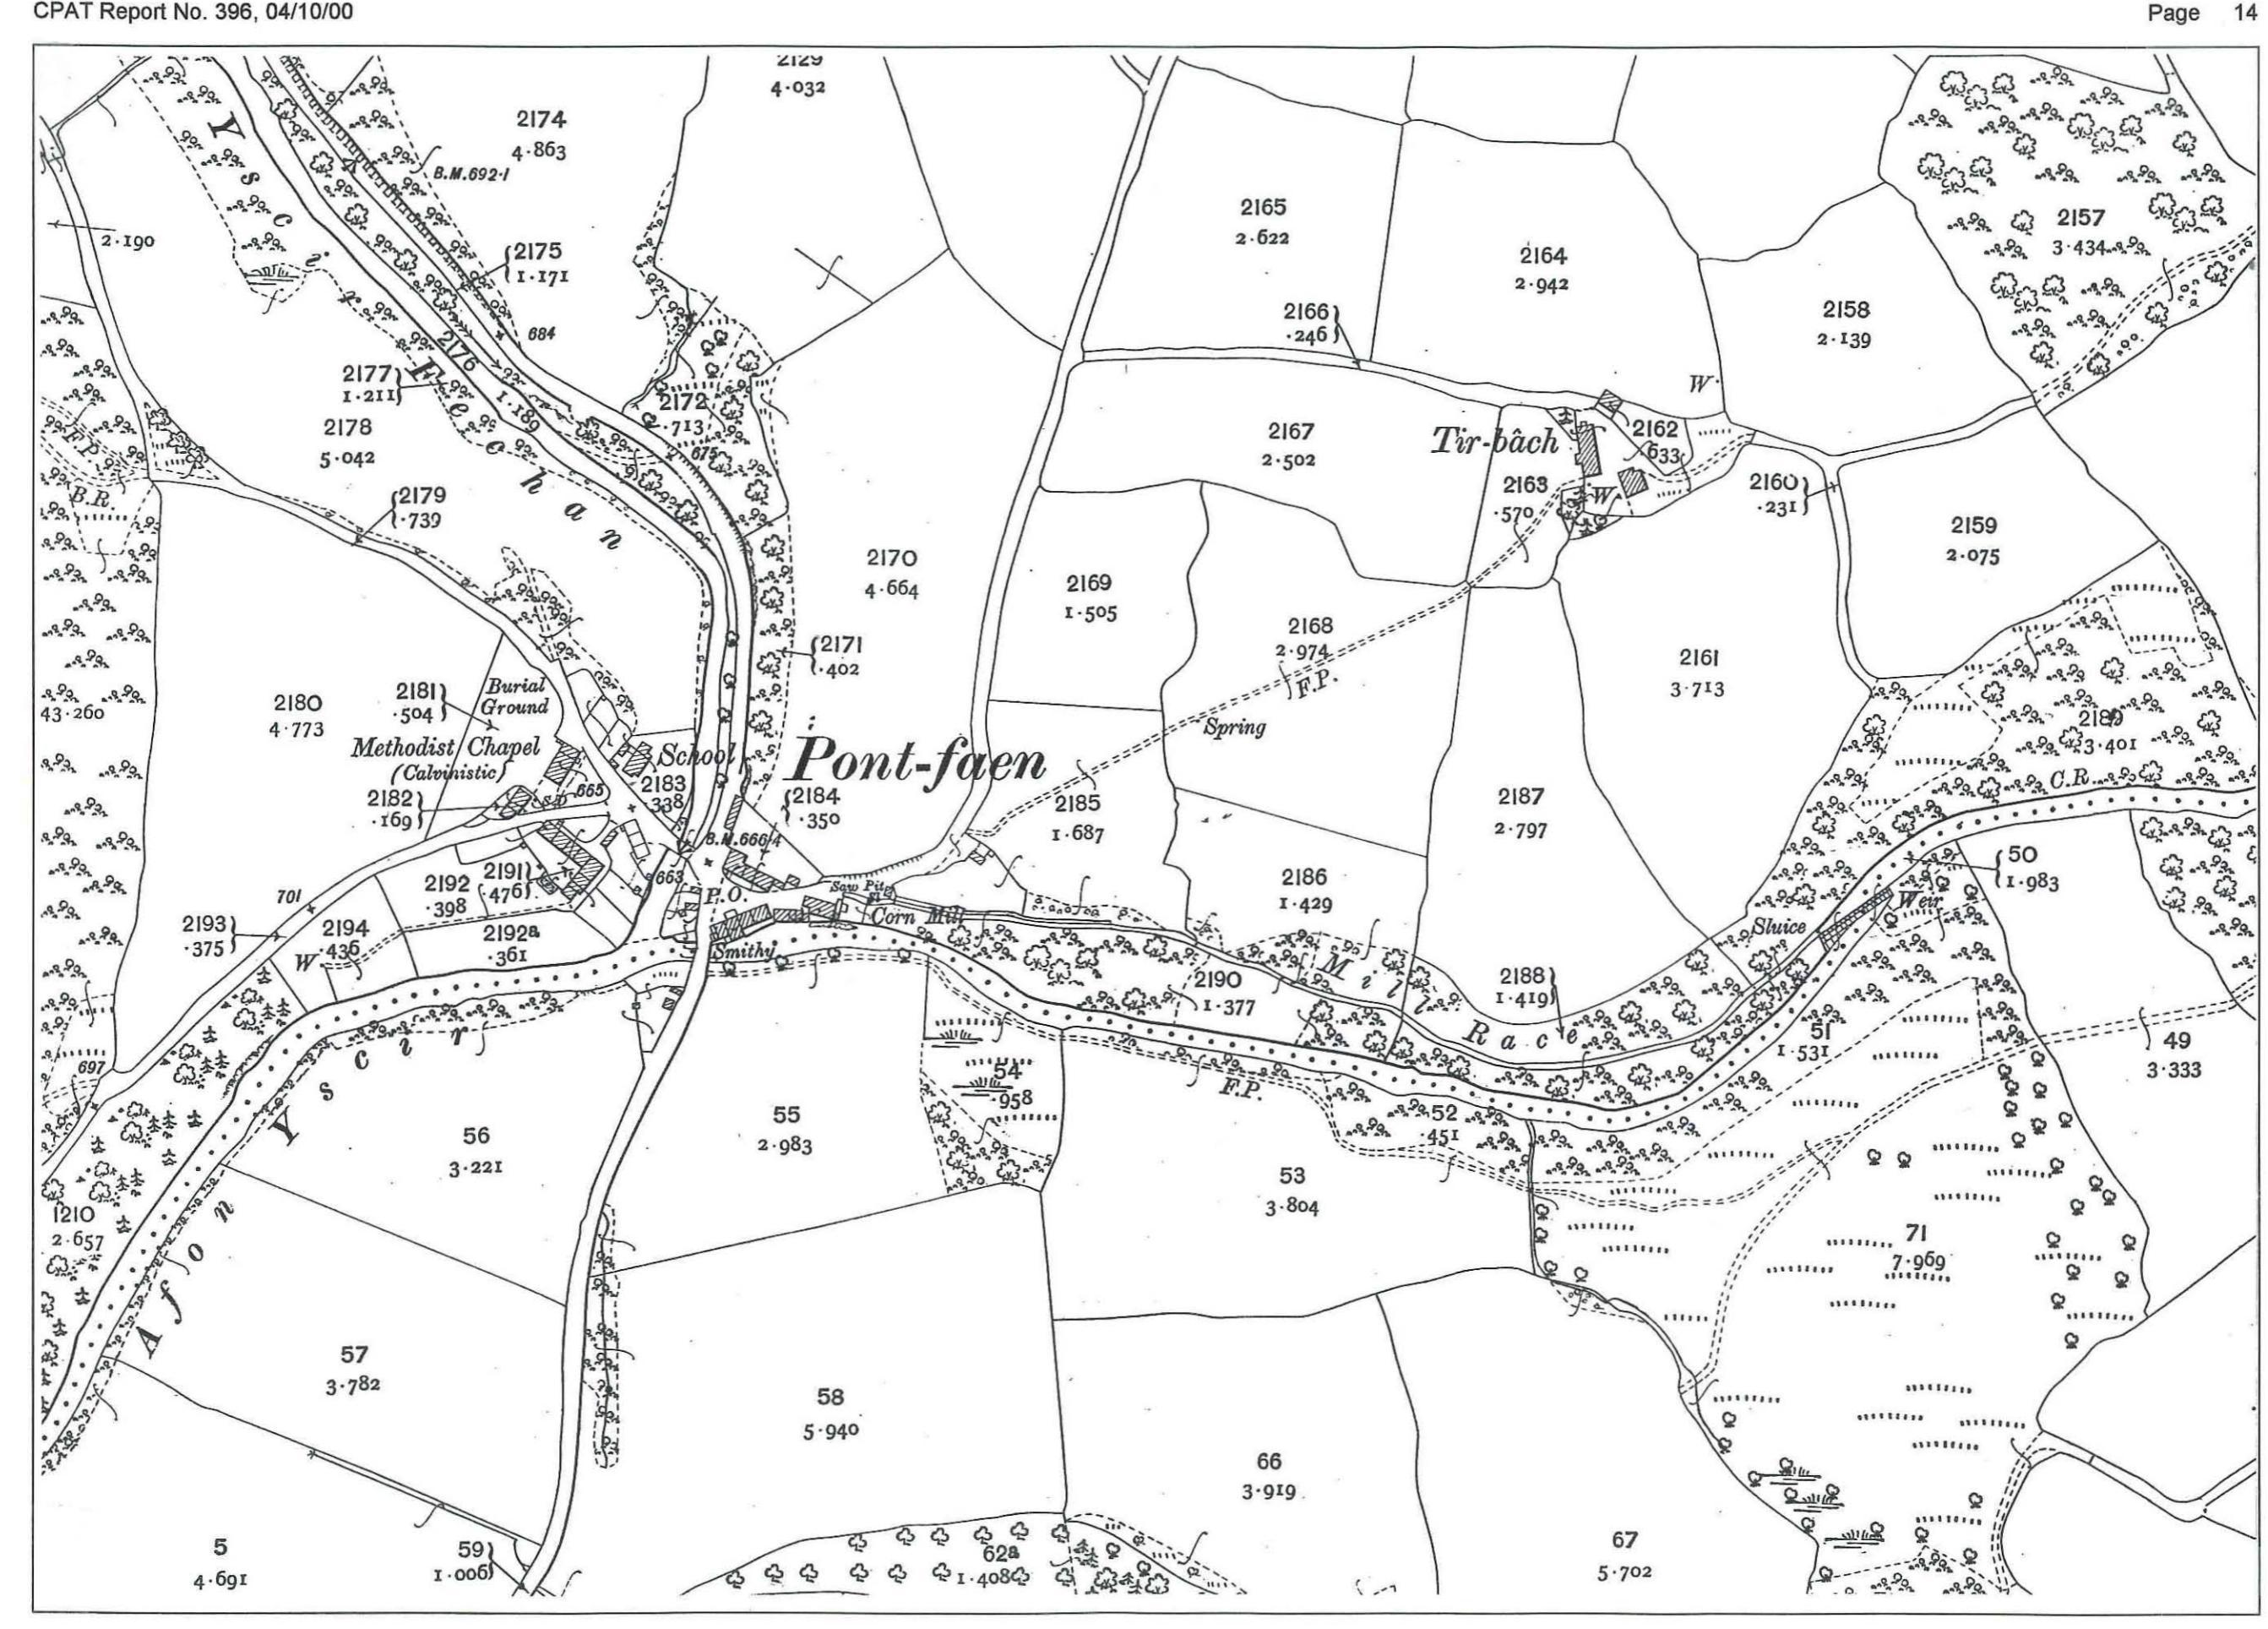
Fig. 5 Ordnance Survey 2nd edition 25", 1904

- 3.5 The Ordnance Survey 2nd edition 25" series (Fig. 5), revised in 1903 and published in 1904 shows the mill building and head race as on the earlier edition, but with the addition of a saw pit adjacent to the leat approximately 20m to the east of the mill.

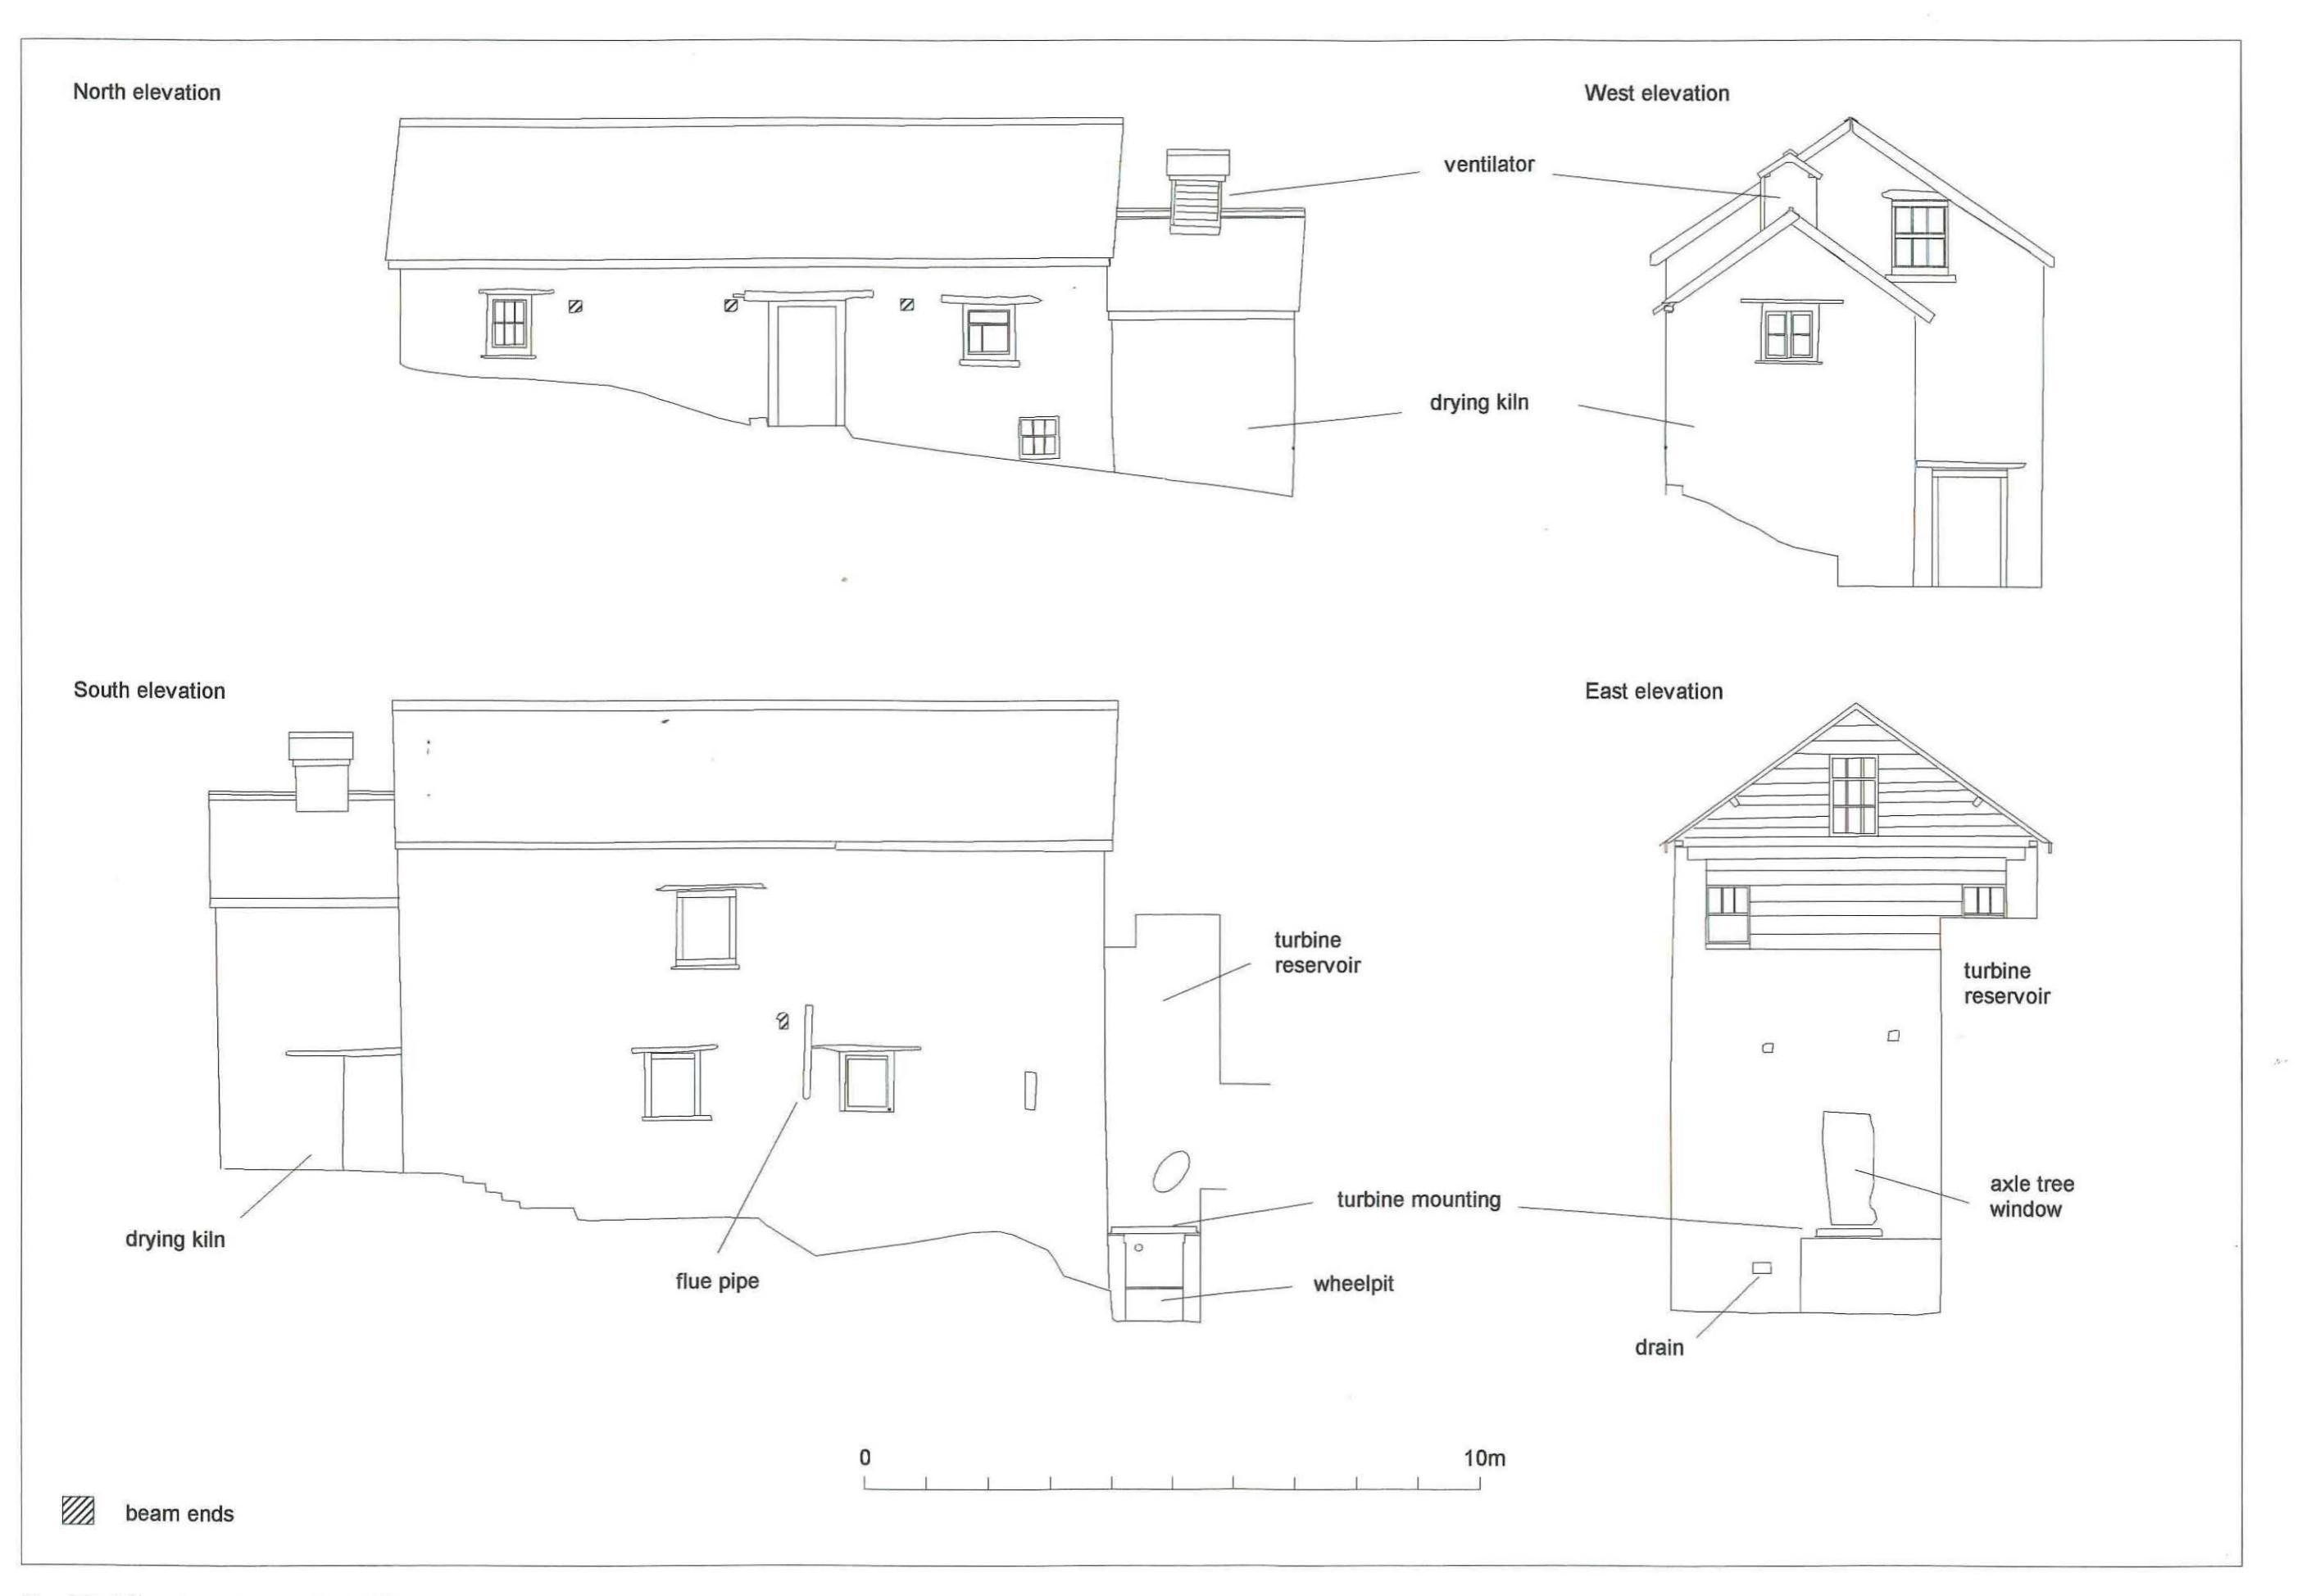
Fig. 6 Building elevations, scale 1:100

4.4.1 The north elevation contains the main entrance, which is a single wooden door with simple frame and timber lintel. There are two windows at first-floor level, both with timber lintels and stone sills, with a ground floor window just above ground level at the east end. The ends of three beams supporting the second floor are visible projecting through the wall. A drying kiln adjoins the west end, also constructed in random stone with a slate roof. A joint in the masonry indicates that this was a separate construction to that of the main building. A ventilator occupies a central position along the ridge of the drying kiln, constructed in timber with timber cladding on the north side, slate on the east and west sides and boarding on the south side.

4.5.1 The west elevation shows the drying kiln with a simple window at first-floor level with a timber lintel and stone sill. The main mill building has an entrance on the ground floor consisting of a simple wooden door and frame with timber lintel. There is a single window at second-floor level, offset slightly to the south, consisting of a wooden frame with timber lintel and stone sill. The offset position of the window reflects the position of the drying kiln, suggesting that either it is a later insert, or that both the window and the kiln were part of the original construction, even though the kiln has clearly been built separately from the main building.

4.6.1 The south elevation shows the entrance to the drying kiln, consisting of a plain timber door and frame with timber lintel. The main mill building has three windows, two on the ground floor and one on the first floor, none of which retain any glazing. All have timber lintels and stone sills, although the eastern ground floor window is now without a sill. There is also a small slit window at the eastern end of the ground floor and a flue pipe, presumably for a stove on the ground floor which has since been removed. The wheelpit lies at the east end of the mill, originally 1.5m wide and at least *c*. 2.1m deep, of random stone construction with later brick walling inserted on either side to support the turbine mounting.

4.7.1 The east elevation provides some evidence of structural and mechanical changes to the mill. The ground floor contains the wheelpit, which has at some time been reduced in length by the construction of the reservoir retaining wall for the later addition of a turbine, replacing the waterwheel. The turbine reservoir is revetted in random stone standing to a height of up to 6.5m. The axletree window survives, consisting of an irregular doorway 1.8 x 0.8m with a stone lintel, evidently enlarged when the turbine was installed. A small drain in the lower south side of the elevation runs from the pit-wheel

pit (see below). The upper half of the elevation is largely of lap-board construction, within which are three windows, all with timber frames. The upper, second floor window is centrally placed, with two first-floor windows abutting the north and south walls respectively.

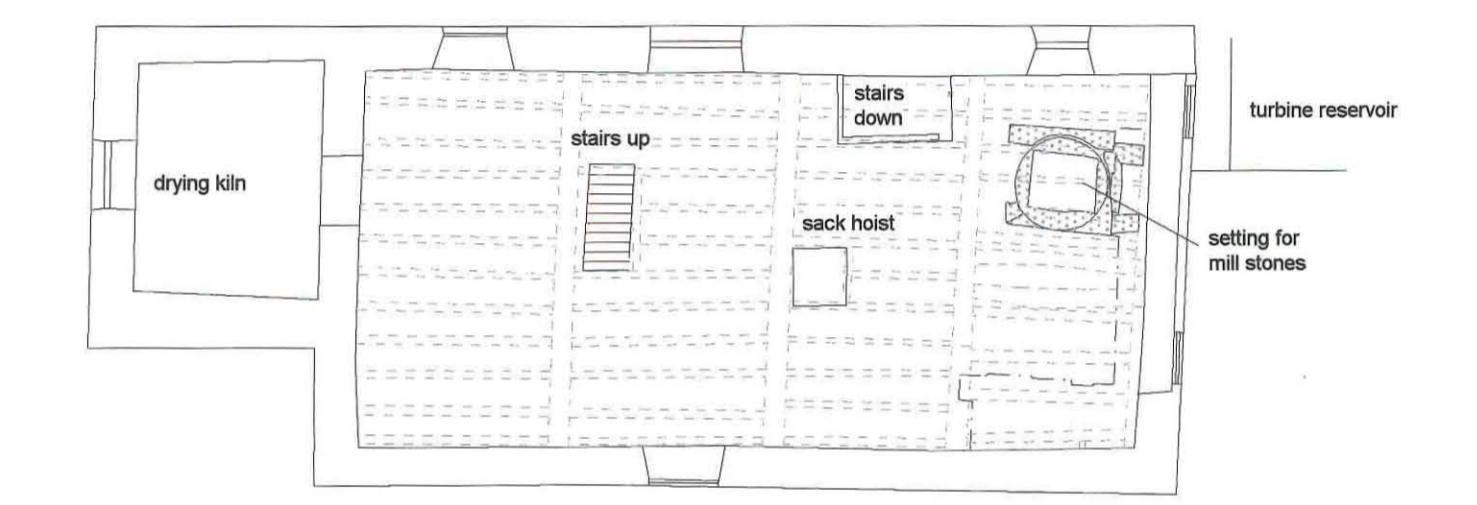
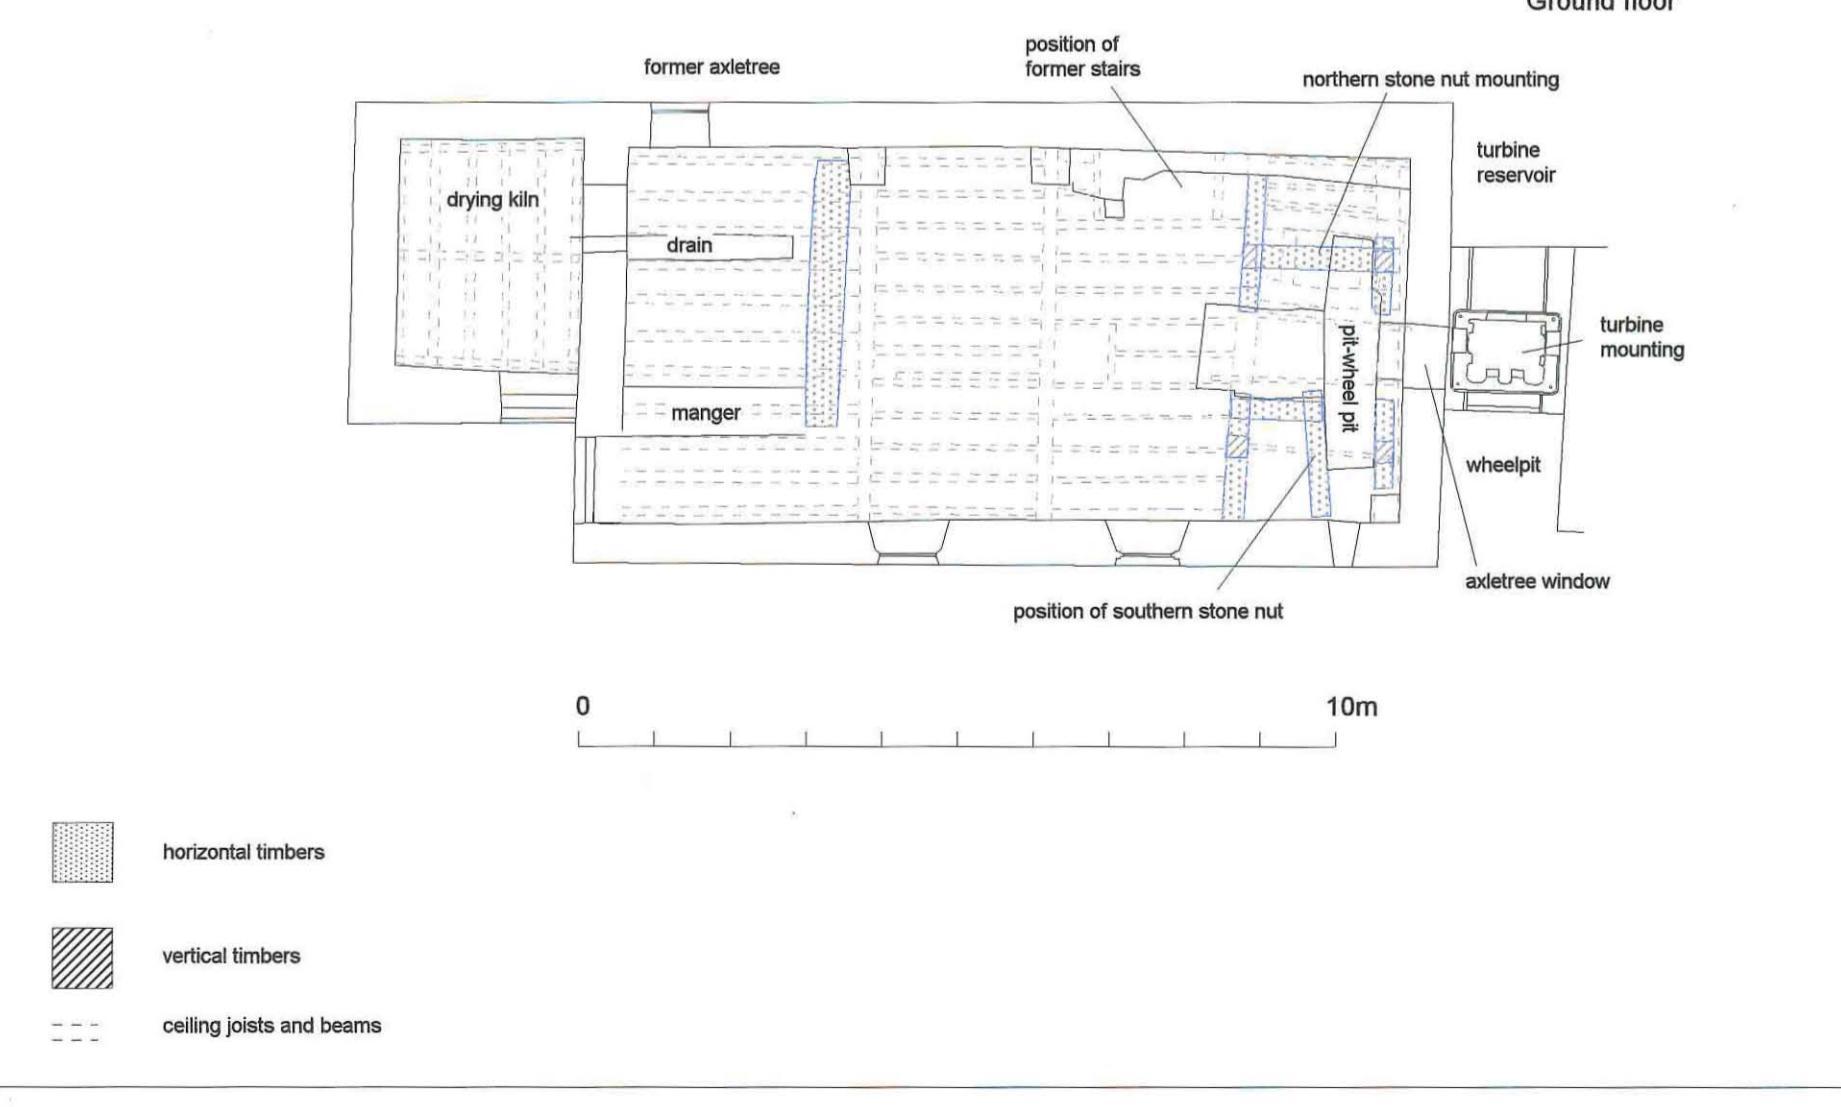
- 4.8.1 The ground floor retains a number of original features although the milling machinery has been removed. At the east end a number of structural features survive relating to the original layout of the milling machinery, including the pit-wheel pit and timber supports and mountings for two pairs of stones. When the waterwheel was in situ, the power would have been transferred into the mill via the axletree, a substantial timber shaft forming the axle for the waterwheel, which entered the mill via the axletree window. The axletree survives, although it has been moved (see below), measuring 3.5 in length and 0.45m diameter. The axletree connected to a vertically bevelled gear wheel on the interior, known as the pit wheel, which revolved within a small wheelpit cut into the floor of the mill. The small drain visible in the east elevation removed any water which may have entered the mill via the axletree window. A system of gears would then have transferred power to the mill stones on the floor above. A bevelled pinion known as the wallower transferred power from the pit-wheel to the vertical main shaft which would have extended through to the top of the first floor. Attached to the main shaft was a large horizontal gear wheel called the spur wheel which in turn drove the pinions, or stone nuts, which turned the millstones directly above (Davies 1997, 90 and 102).

- 4.8.2 The surviving timbers indicate that the mill originally had two pairs of stones, probably one for grinding flour and the other for animal feed. The northern pair survived in situ until recently. Two large upright timbers supported a horizontal timber, which has now fallen partly into the pit-wheel pit, on which the stone nut would have been mounted (plate 7). The west end of the timber was attached to an iron support to raise or lower the upper stone. The timbers supporting the stones survive in situ. The supports for the southern pair of stones have been removed, although the vertical timbers survive (plate 8).

- 4.8.4 A flight of stairs along the north wall originally led to the first floor, although they no longer survive.
- 4.8.5 The west end of the mill, together with the drying kiln, has been modified for use as a cattle byre, the original flagstone floor having been removed and replaced with concrete, including a manger and drain. The former axletree has been used to form the east side of the byre (plate 9). A number of iron bolts are visible in the drying kiln wall which presumably supported the drying floor at first floor level. A fragment of a clay tile now outside the mill suggests that the drying floor was originally composed of perforated tiles. There is now no evidence relating to the firing of the kiln.

- 4.9.1 The first floor, or 'stone' floor, originally had two pairs of stones, as noted above, although there is now nothing surviving at this level which relates to the southern pair of stones. The setting for the northern pair survives, although the stones themselves have been removed (plate 10). The trap doors for the sack hoist survive, as do the open stairs leading to the second floor. The stair leading to the ground floor have been removed although the opening remains together with the hand rail around two sides.
- 4.9.2 The drying kiln, which has been refloored, is open to the roof and retains the ventilator set centrally on the ridge of the roof.

4.10.1The second floor is open to the roof and is divided into four bays by three roof trusses. The access is via an open wooden staircase from the first floor. The sack hoist, which was supported between two trusses (plate 4), has been removed recently, although the trap doors survive.

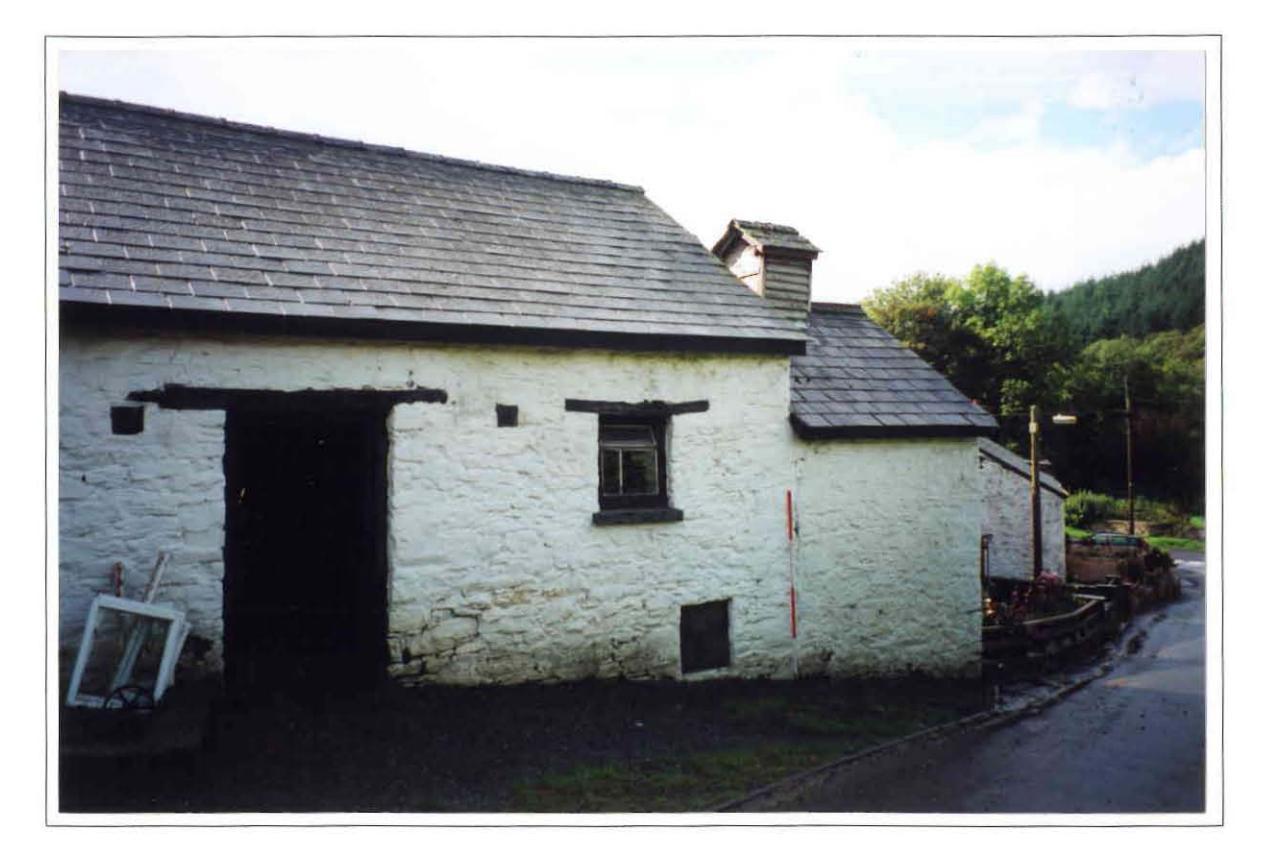
Plate 1 North elevation including drying kiln. Photo CPAT 1001.3
