The Old Mill, Pont Faen, Brecon, Powys ARCHAEOLOGICAL BUILDING SURVEY

CPAT Report No 396

N W Jones October 2000

Report for Mr J Parsons

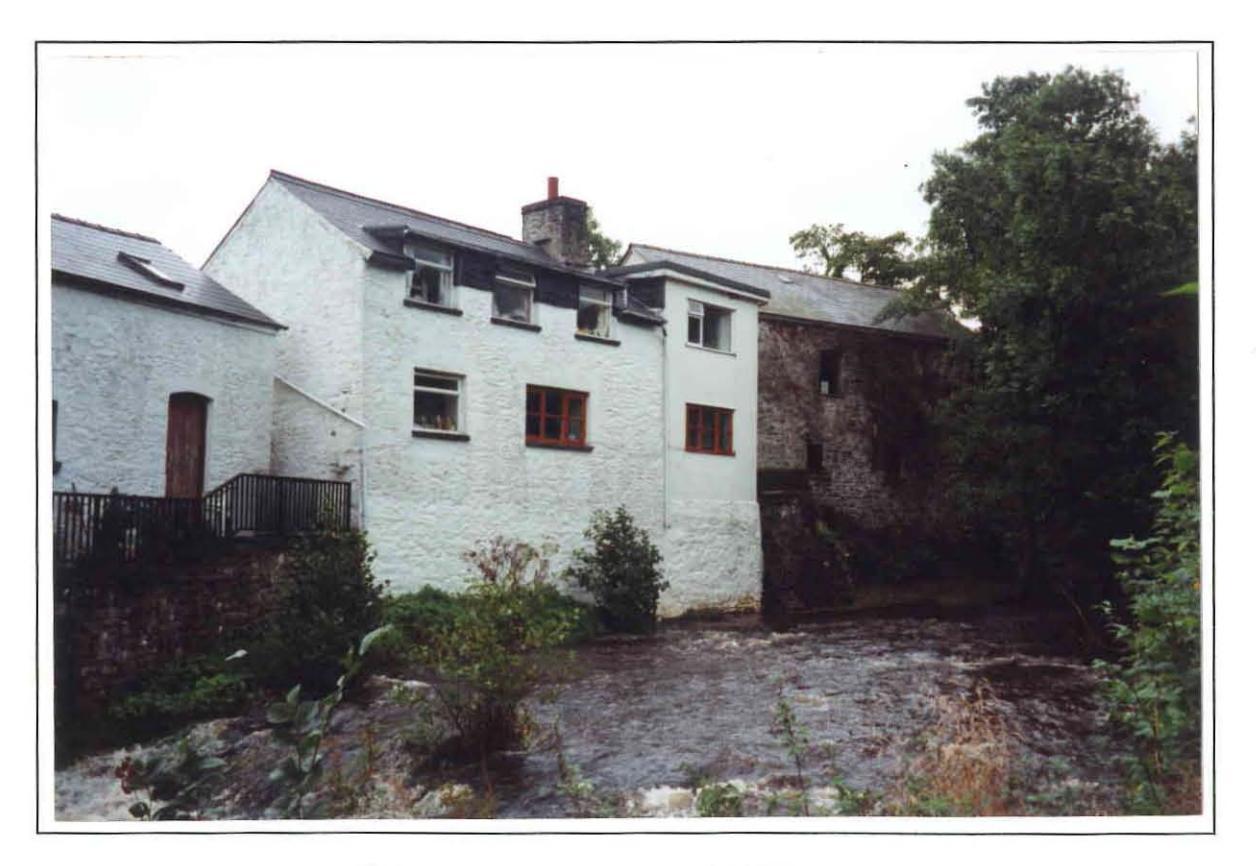
Plate 2 View of Mill and Mill house from SW. Photo CPAT 1001.24

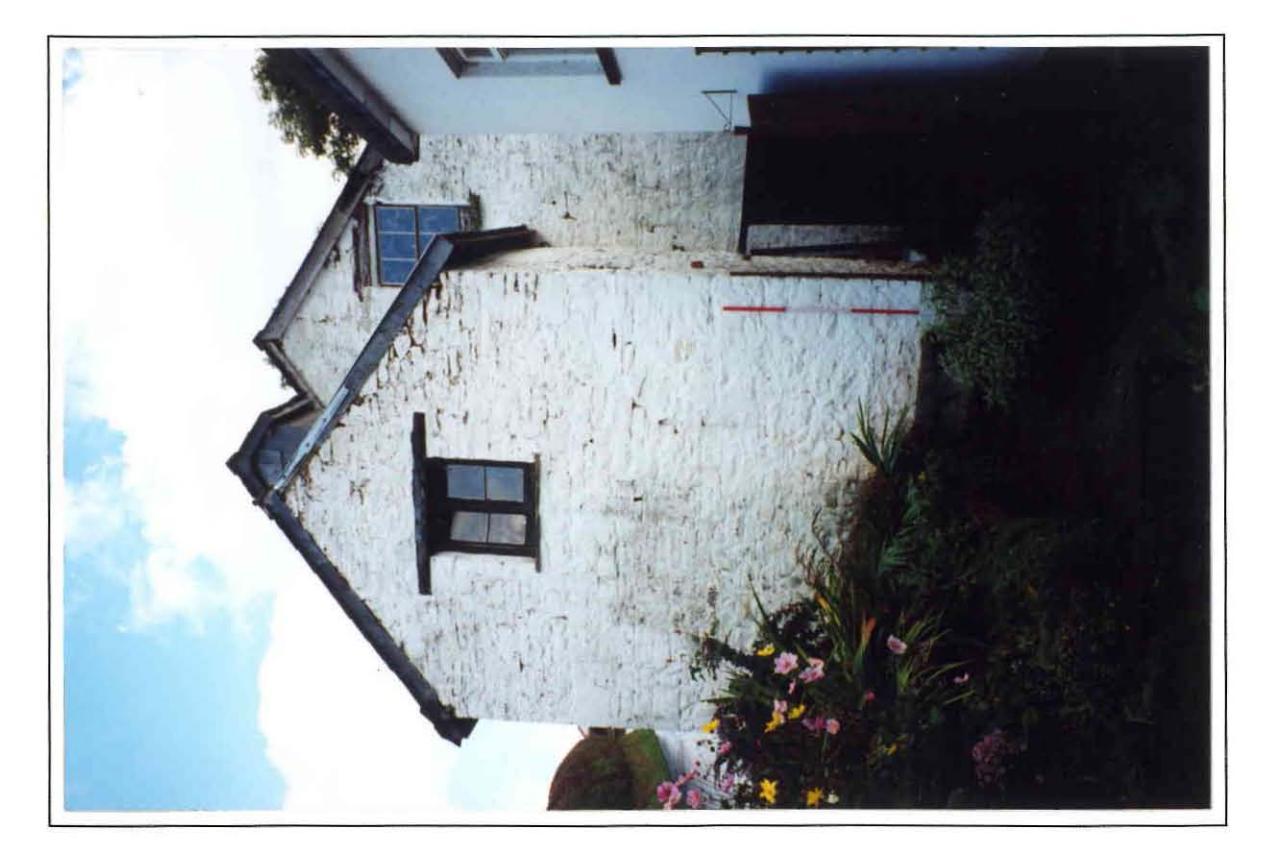
4.5.1 The west elevation shows the drying kiln with a simple window at first-floor level with a timber lintel and stone sill. The main mill building has an entrance on the ground floor consisting of a simple wooden door and frame with timber lintel. There is a single window at second-floor level, offset slightly to the south, consisting of a wooden frame with timber lintel and stone sill. The offset position of the window reflects the position of the drying kiln, suggesting that either it is a later insert, or that both the window and the kiln were part of the original construction, even though the kiln has clearly been built separately from the main building.

Plate 3 West elevation showing drying kiln. Photo CPAT 1001.6

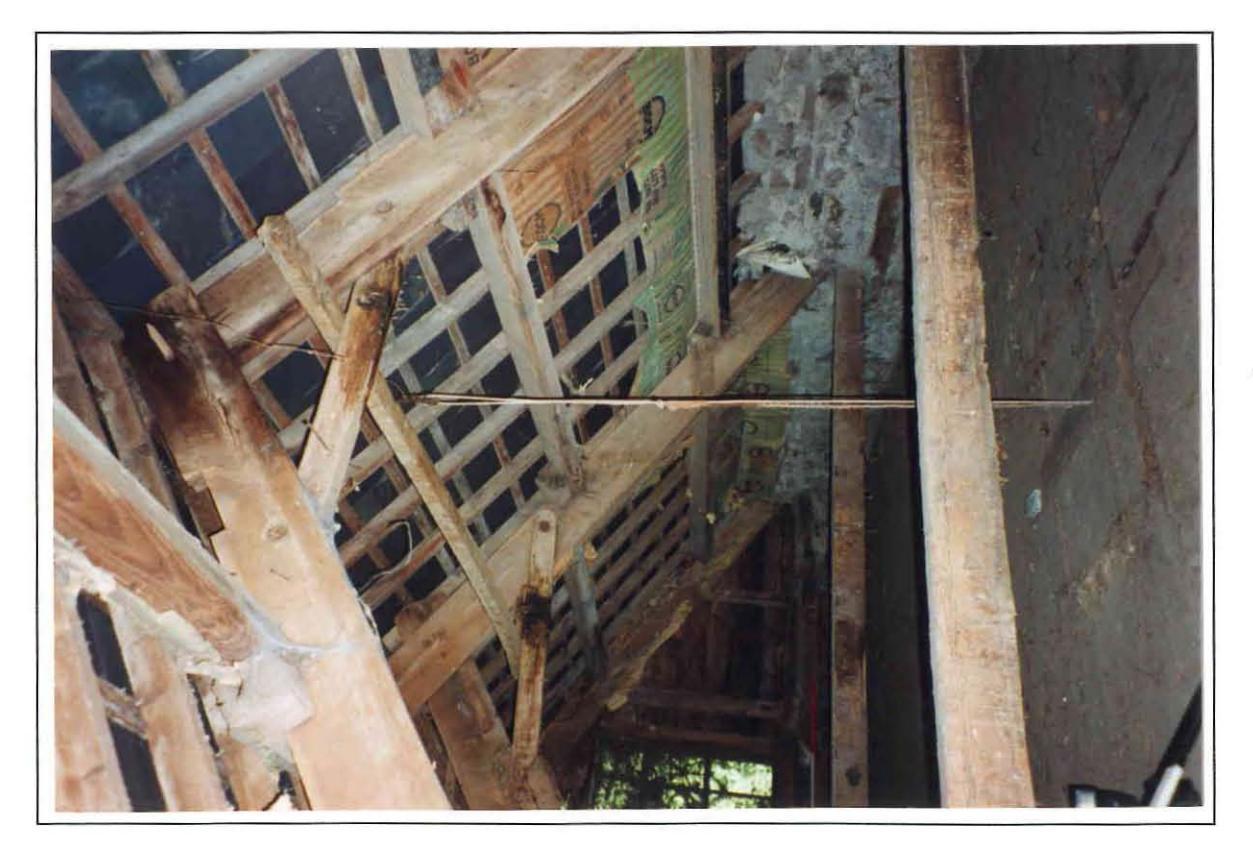
4.10.1The second floor is open to the roof and is divided into four bays by three roof trusses. The access is via an open wooden staircase from the first floor. The sack hoist, which was supported between two trusses (plate 4), has been removed recently, although the trap doors survive.

Plate 4 Second floor interior showing sack hoist. Photo CPAT 1001.10

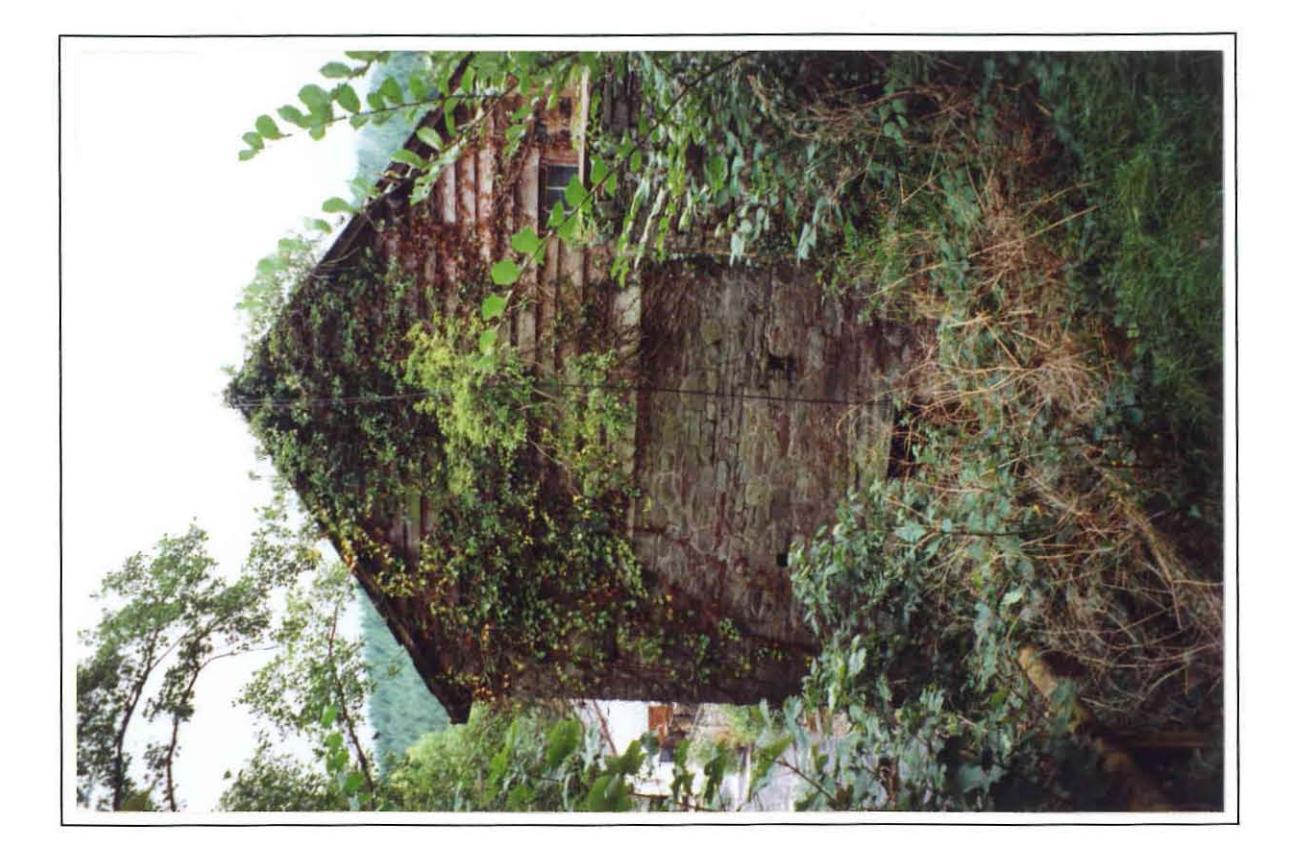
4.7.1 The east elevation provides some evidence of structural and mechanical changes to the mill. The ground floor contains the wheelpit, which has at some time been reduced in length by the construction of the reservoir retaining wall for the later addition of a turbine, replacing the waterwheel. The turbine reservoir is revetted in random stone standing to a height of up to 6.5m. The axletree window survives, consisting of an irregular doorway 1.8 x 0.8m with a stone lintel, evidently enlarged when the turbine was installed. A small drain in the lower south side of the elevation runs from the pit-wheel

Plate 5 East elevation. Photo CPAT 1001.28

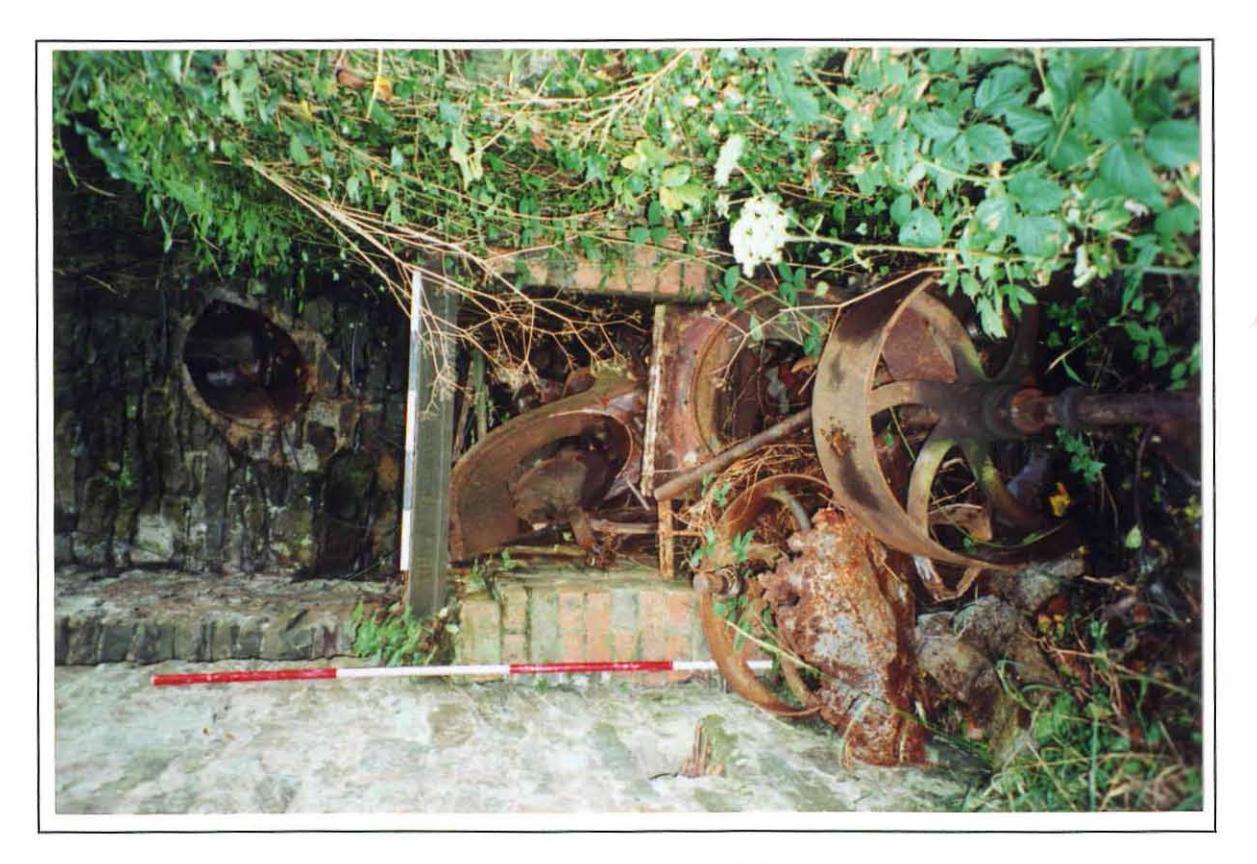
- 4.8.3 The remains of the turbine now lie in the wheelpit (plate 6). The turbine mounting survives in situ supported on two brick walls constructed on either side of the wheelpit. The mounting bears the makers name: Joseph J. Armfield & Co Ltd, Engineers, Ringwood.

Plate 6 Remains of turbine and wheelpit. Photo CPAT 1001.29

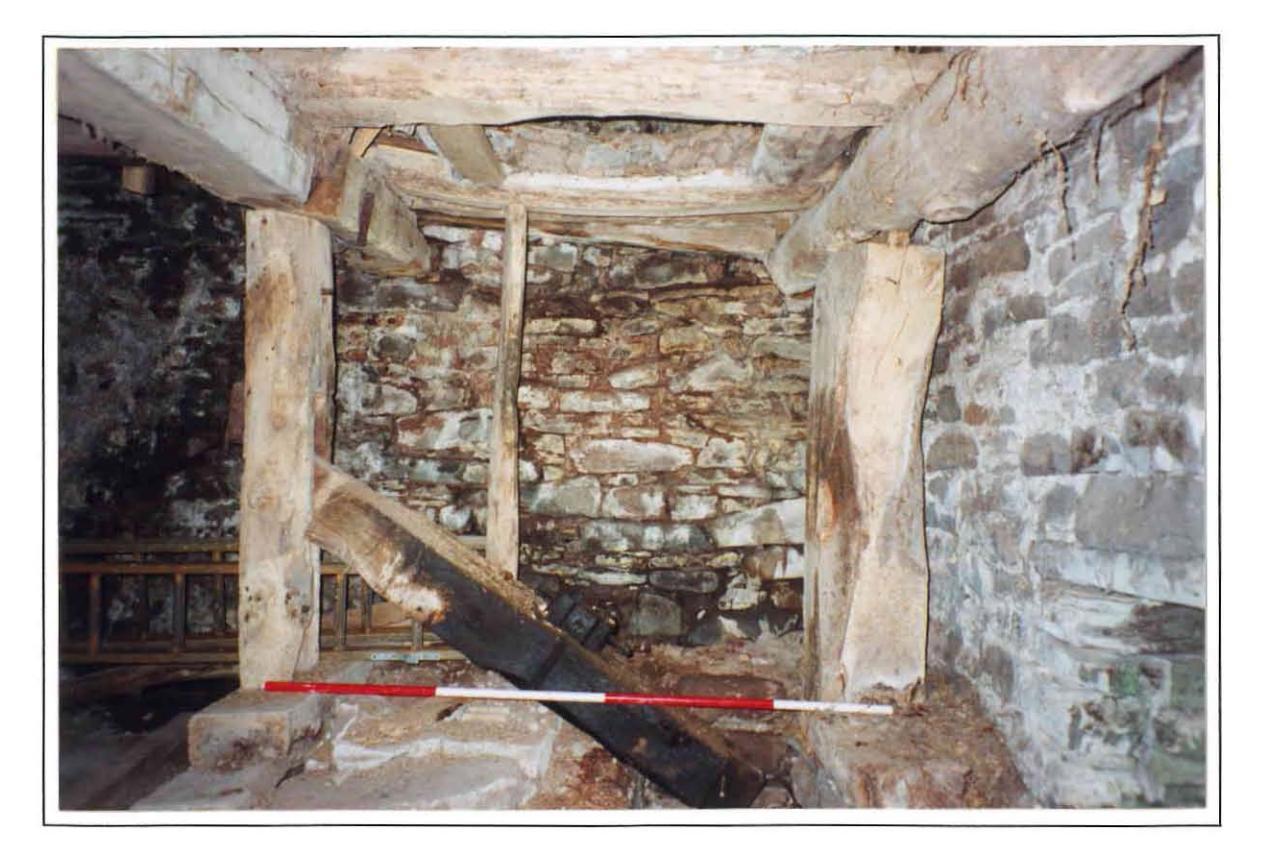
- 4.8.2 The surviving timbers indicate that the mill originally had two pairs of stones, probably one for grinding flour and the other for animal feed. The northern pair survived in situ until recently. Two large upright timbers supported a horizontal timber, which has now fallen partly into the pit-wheel pit, on which the stone nut would have been mounted (plate 7). The west end of the timber was attached to an iron support to raise or lower the upper stone. The timbers supporting the stones survive in situ. The supports for the southern pair of stones have been removed, although the vertical timbers survive (plate 8).

Plate 7 Stone nut mounting for northern millstones. Photo CPAT 1001.35

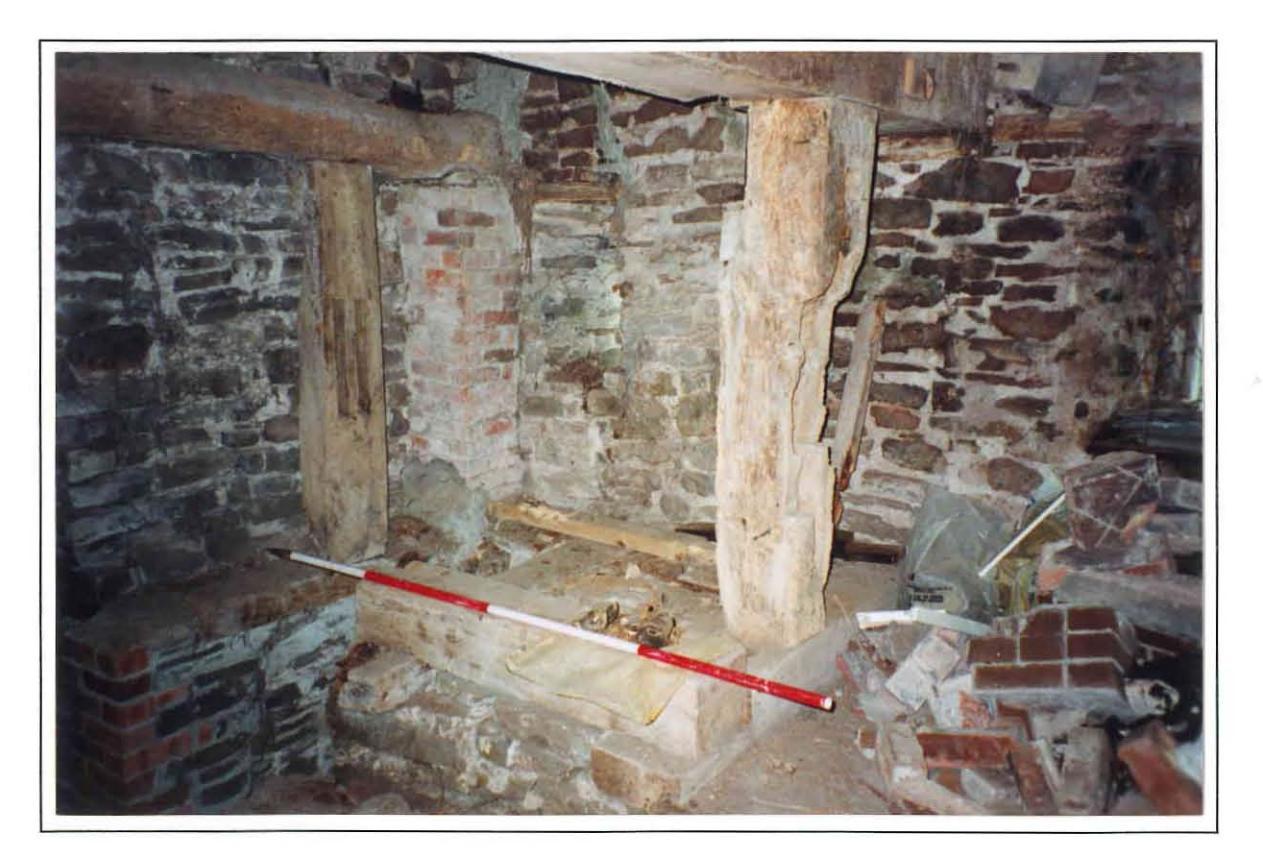
Plate 8 Position of former stone nut mounting for southern millstones. Photo CPAT 1001.33

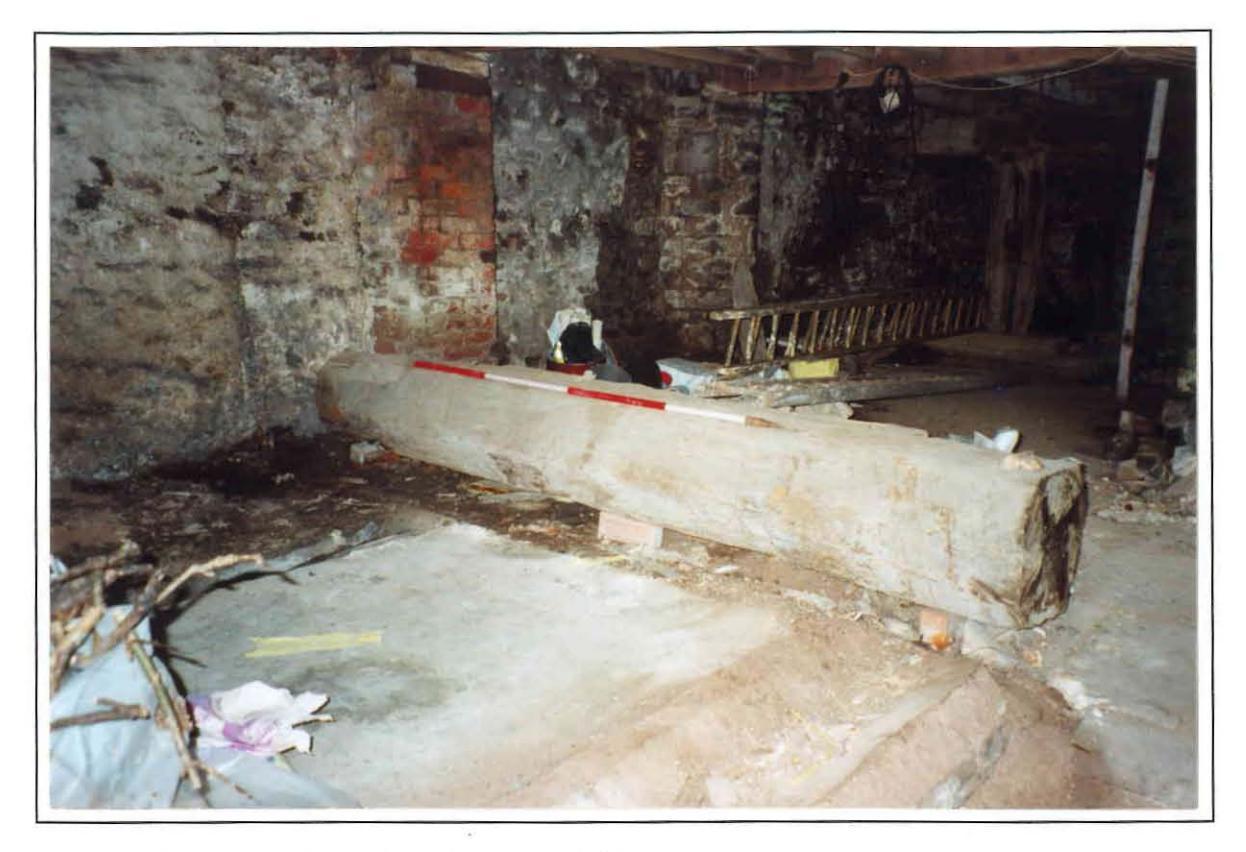
Plate 9 Former axle tree. Photo CPAT 1001.36

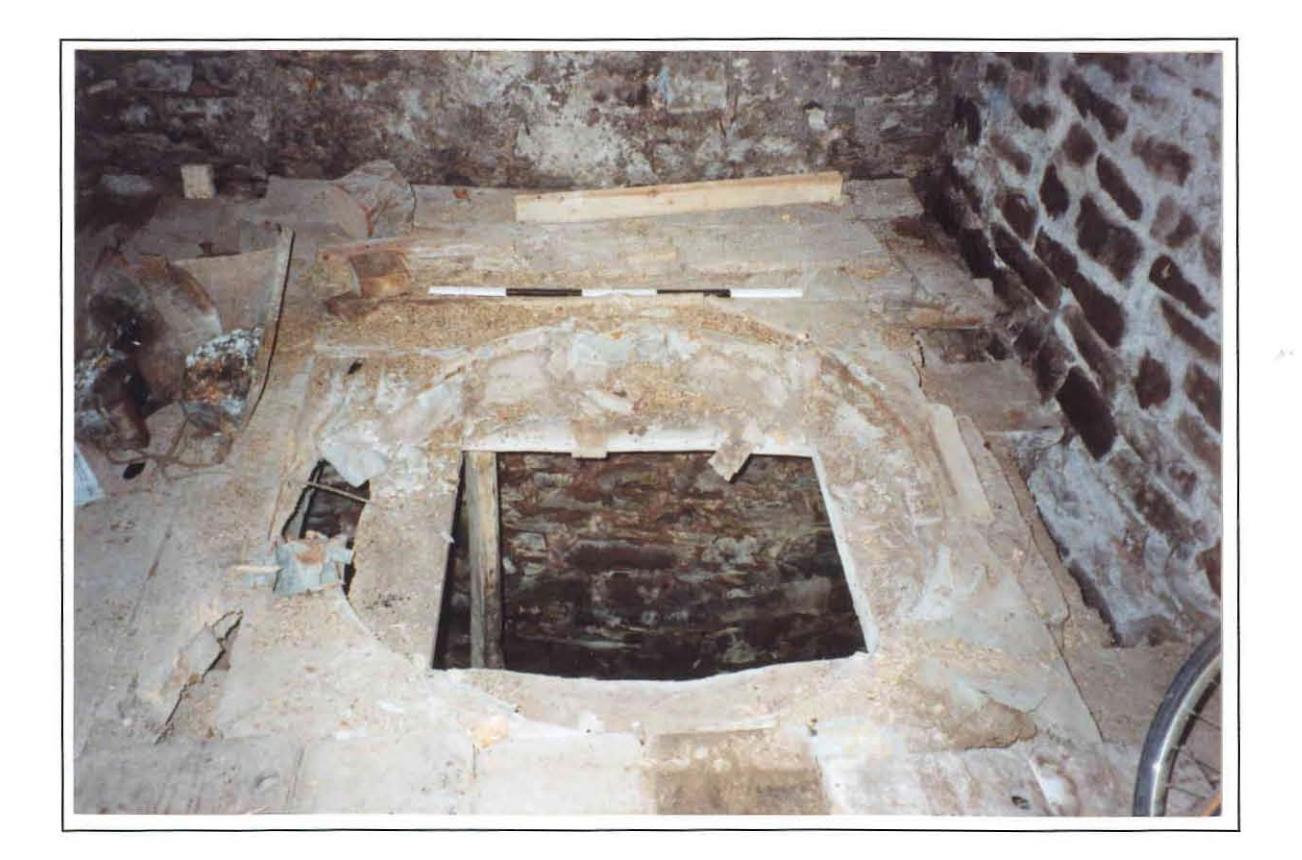
- 4.9.1 The first floor, or 'stone' floor, originally had two pairs of stones, as noted above, although there is now nothing surviving at this level which relates to the southern pair of stones. The setting for the northern pair survives, although the stones themselves have been removed (plate 10). The trap doors for the sack hoist survive, as do the open stairs leading to the second floor. The stair leading to the ground floor have been removed although the opening remains together with the hand rail around two sides.
- 4.9.2 The drying kiln, which has been refloored, is open to the roof and retains the ventilator set centrally on the ridge of the roof.

Plate 10 First floor interior: setting for northern millstones. Photo CPAT 1001.12
