# A458 Road Improvements at Nant-y-dugoed, Powys and Gwynedd ARCHAEOLOGICAL WATCHING BRIEF

**CPAT Report No 355**

NW Jones<sup>1</sup>, M Roseveare and A Roseveare<sup>2</sup> April 2000

Report for WS Atkins Heritage

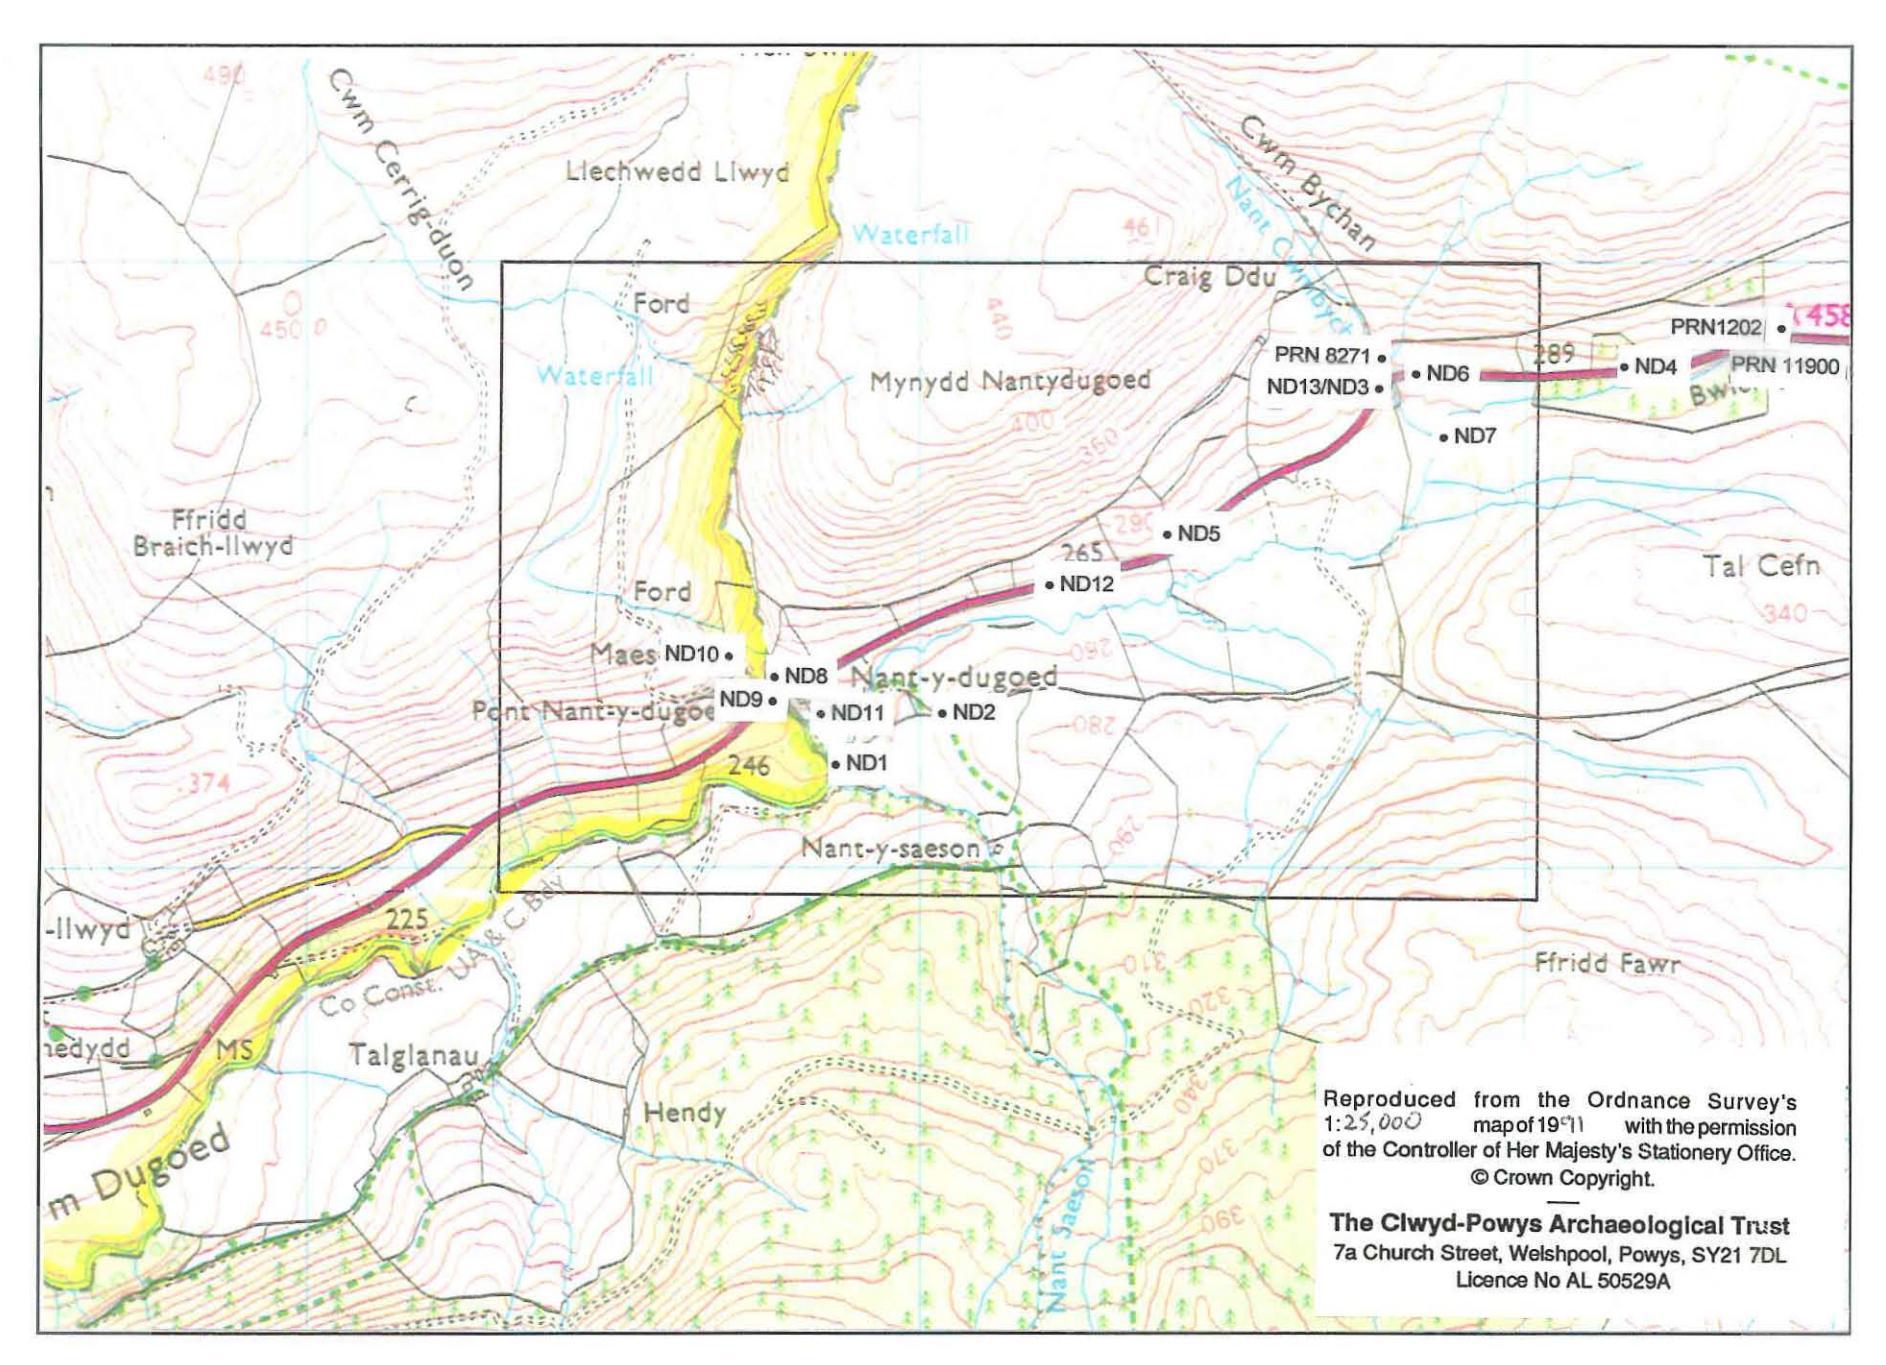
- 1.1 The proposed development involves improvements to the A458(T) trunk road between Shrewsbury and Mallwyd in the vicinity of Nant-y-dugoed Farm. The route corridor for the proposed improvement is approx. 2.5km in length and 0.3km wide between SH 9122 1300 and SH 9353 1387 (Fig. 1).

# 2 LOCATION, TOPOGRAPHY AND GEOLOGY (Fig. 1)

3.1 The known archaeology can be summarised as follows, from east to west (Hankinson 1996; Fig. 1):

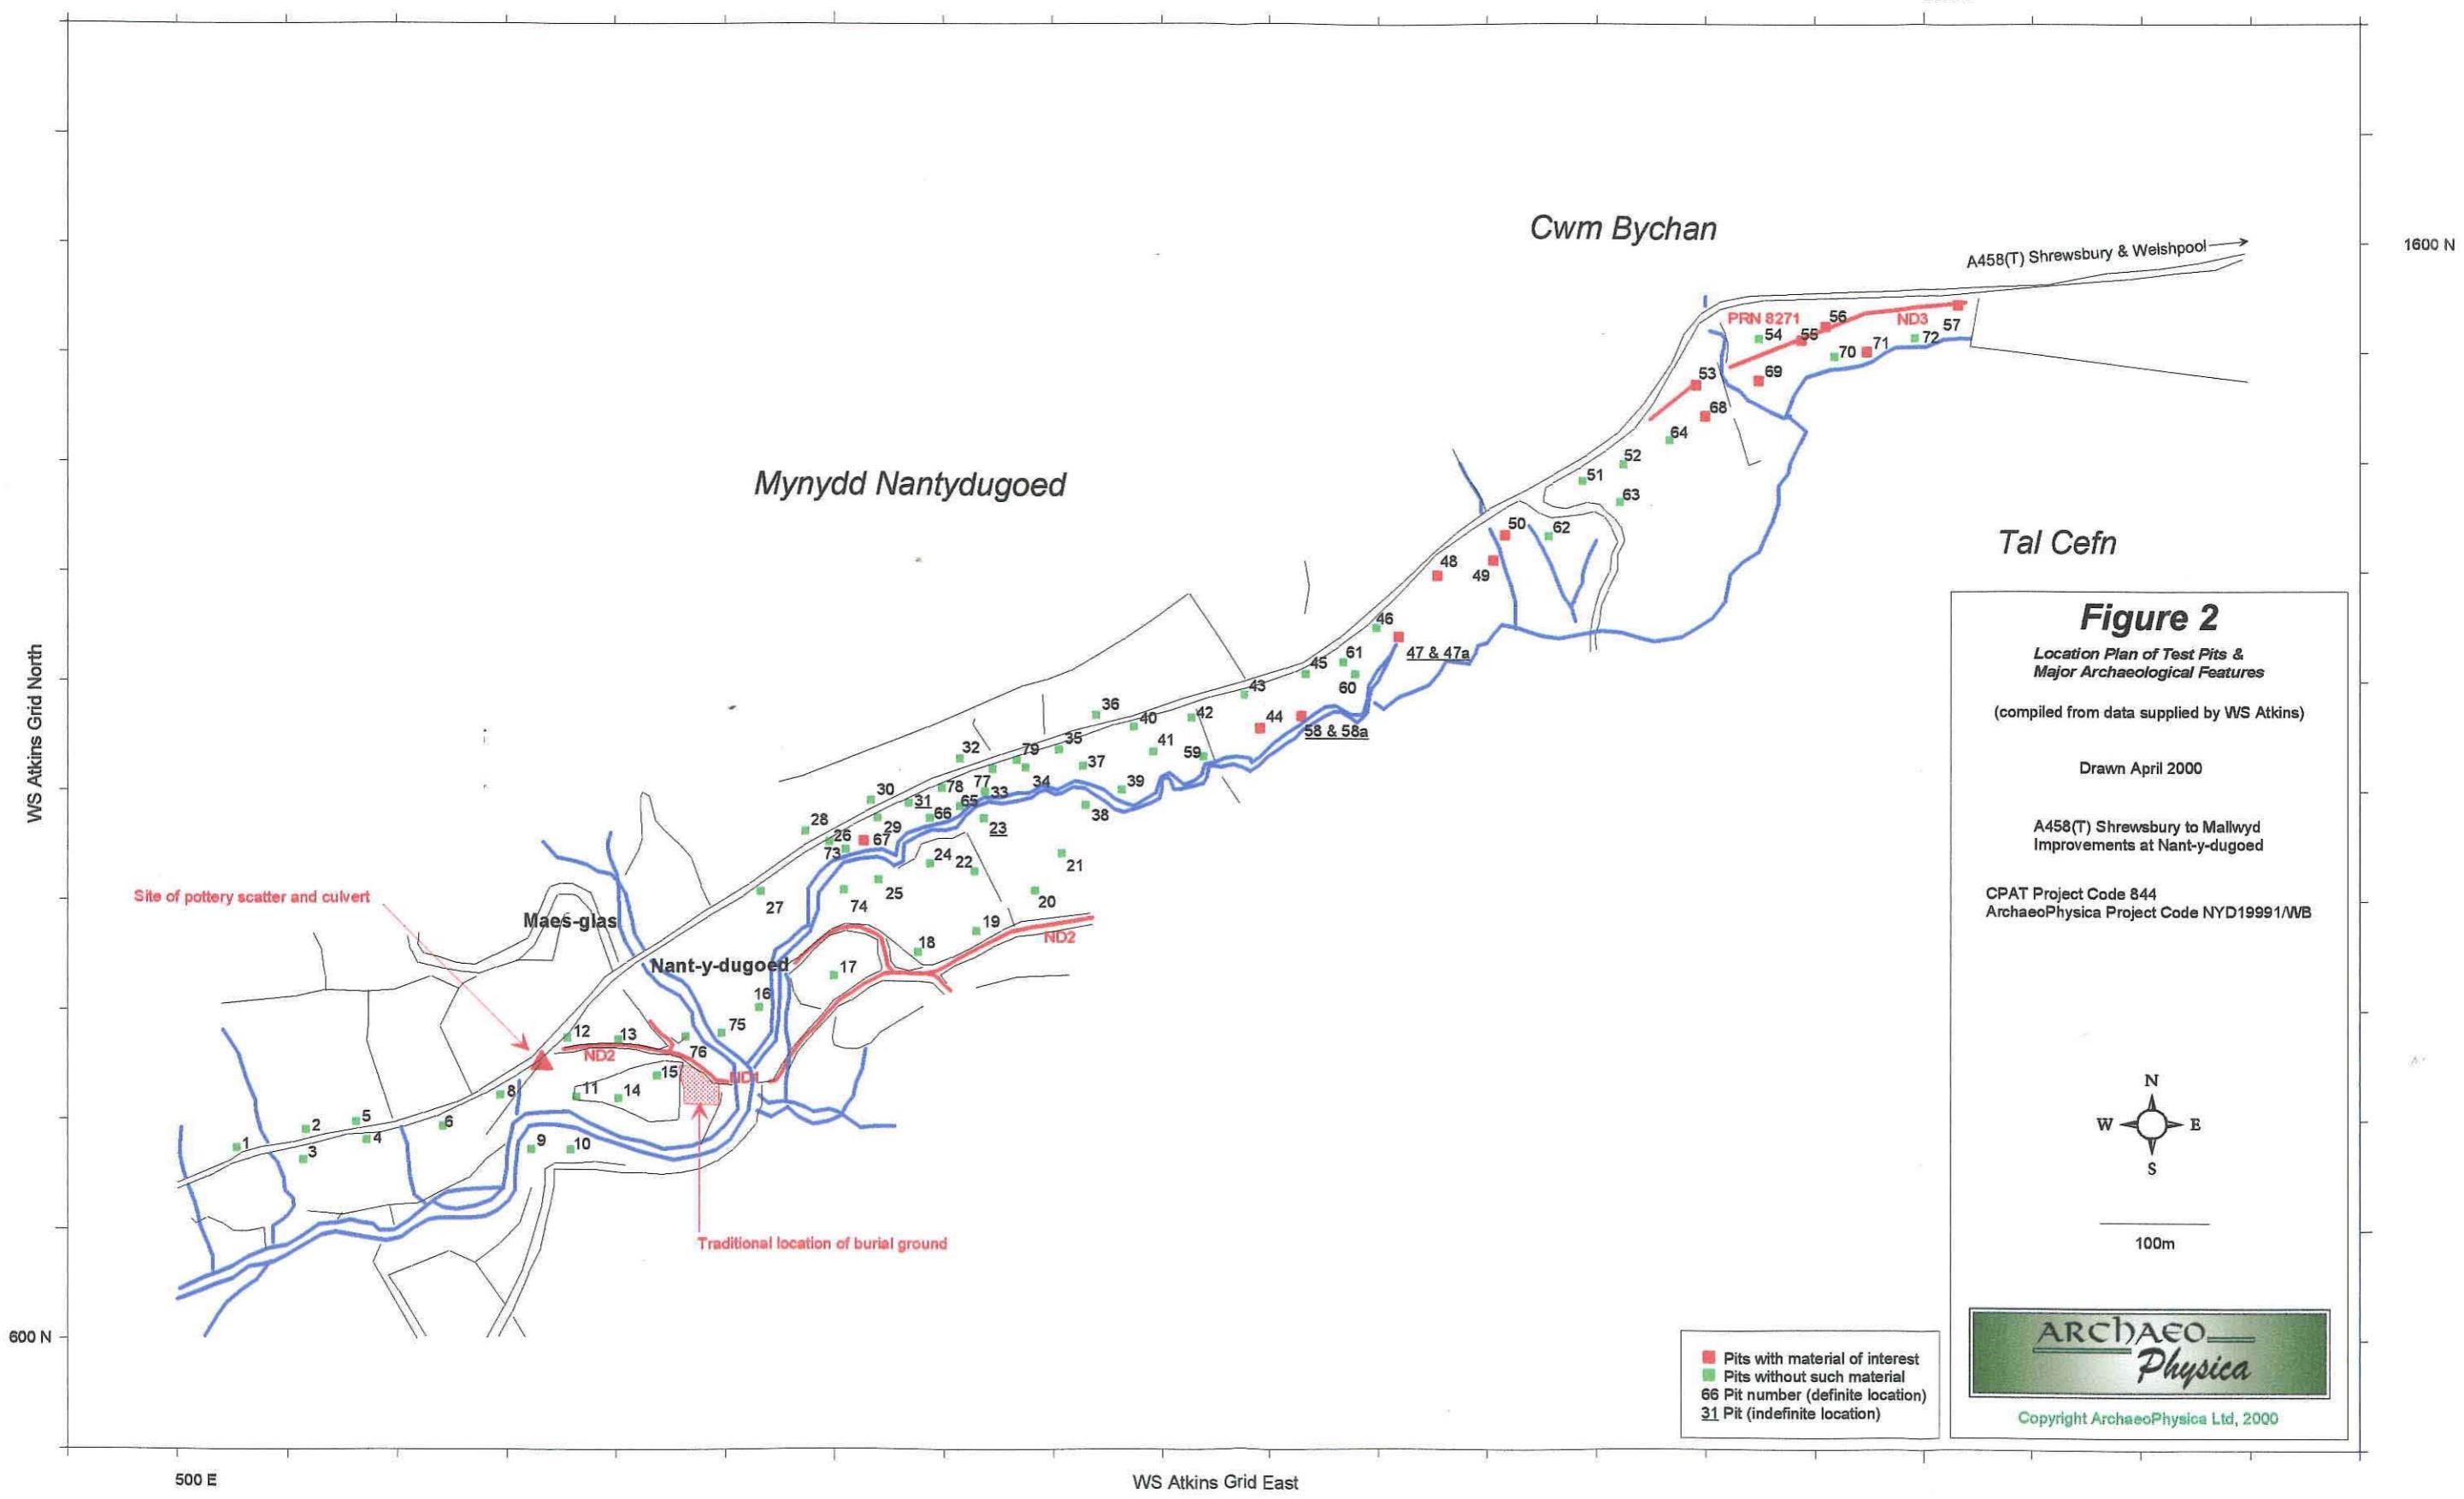
# 4 THE WATCHING BRIEF - AN OVERVIEW (Fig. 2)

# 5 THE WATCHING BRIEF - RESULTS (Fig. 2)
