# St Llyr's Church, Llanyre, Powys ARCHAEOLOGICAL WATCHING BRIEF

**CPAT Report No 382**

W.G.Owen July 2000

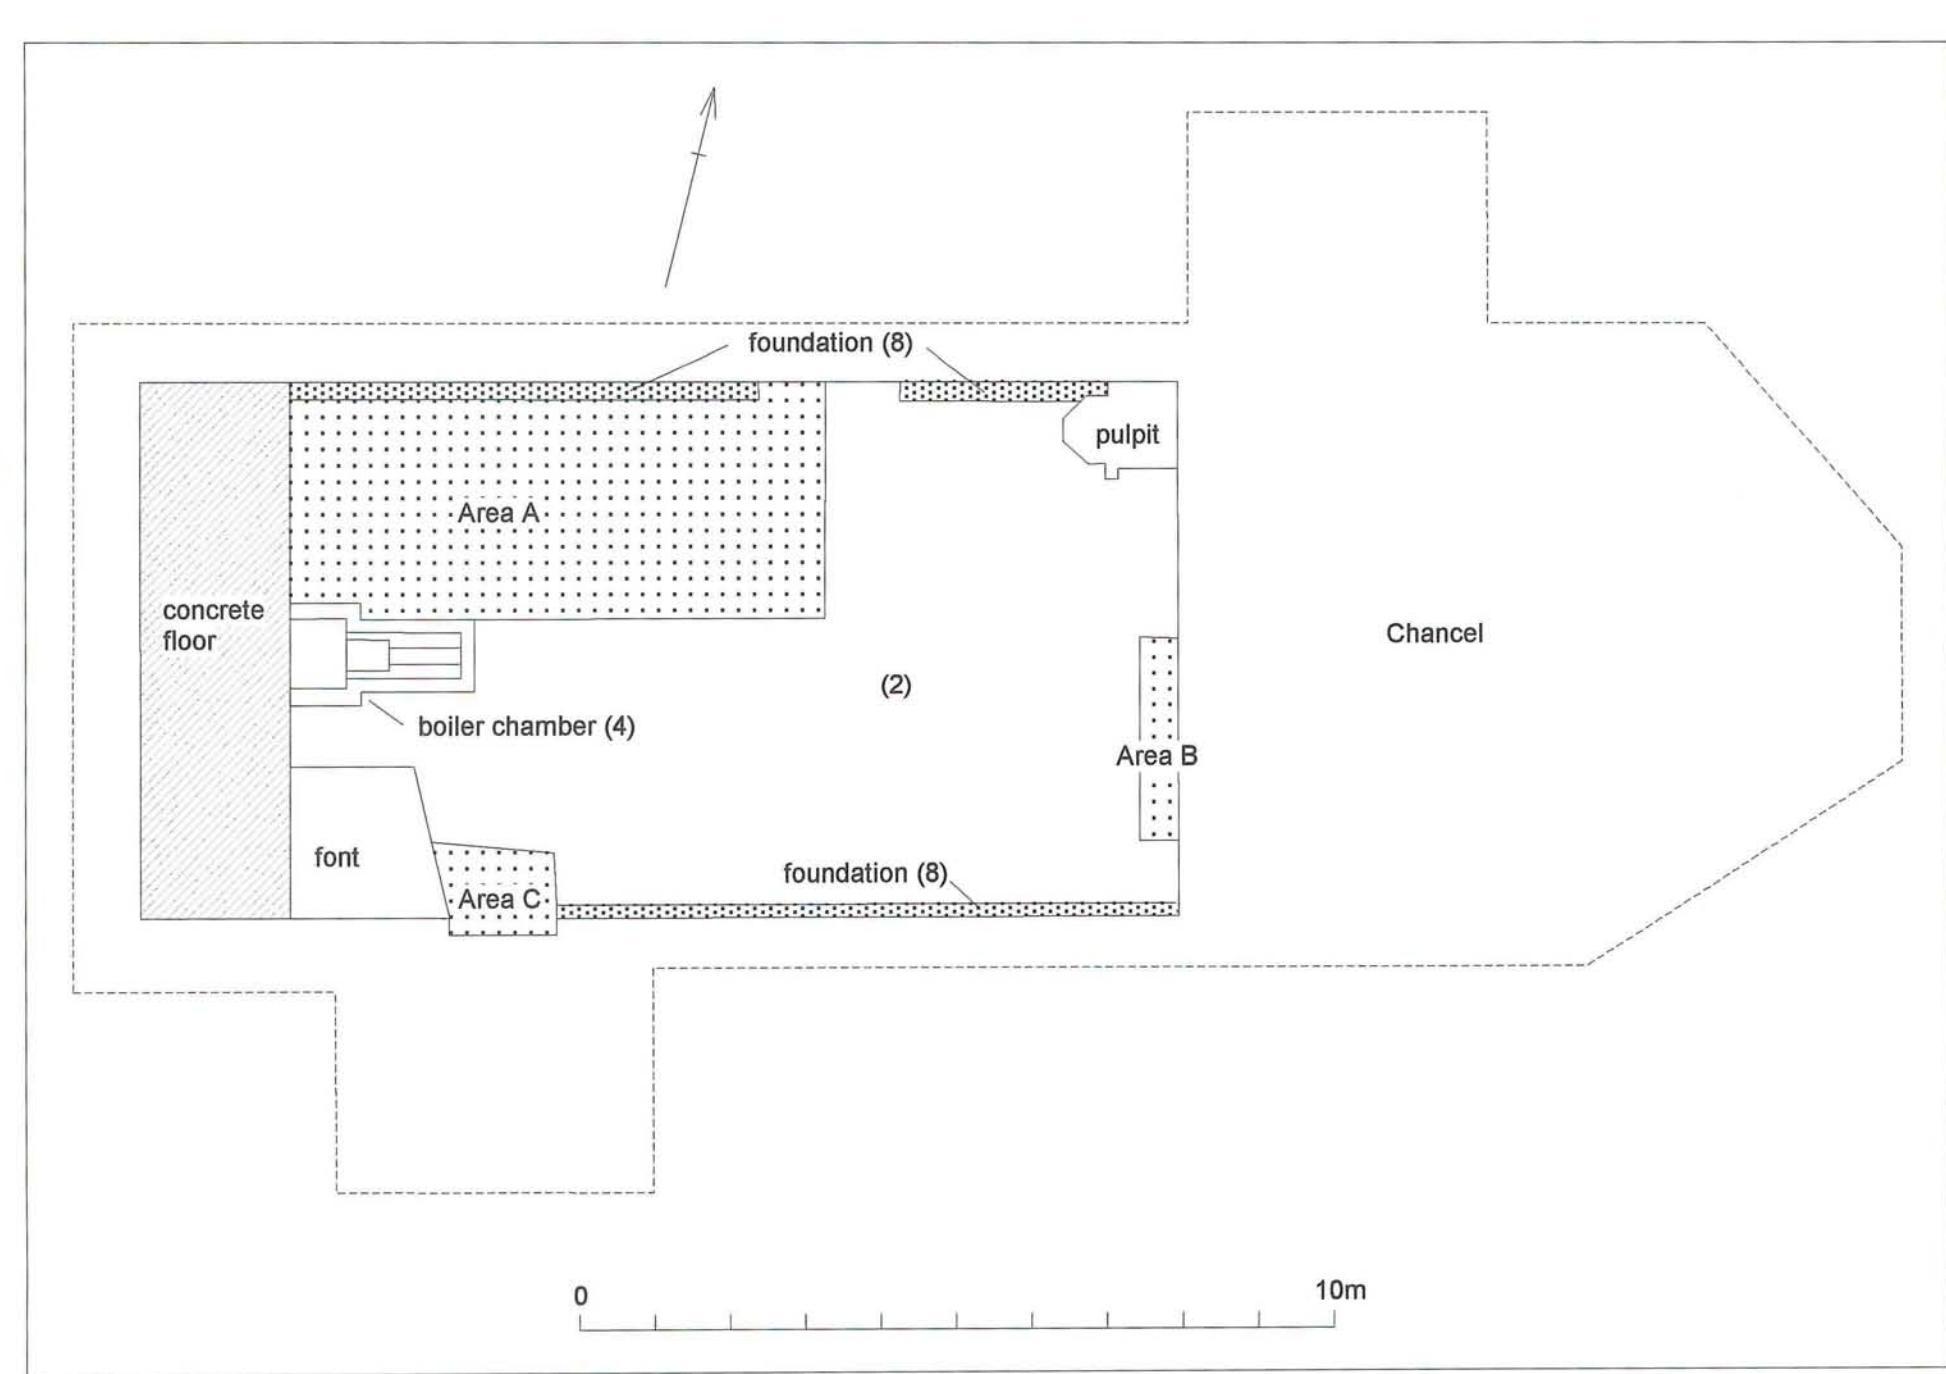
### 4 THE WATCHING BRIEF (Fig. 2)

4.1 The watching brief was carried out on 14th July 2000, immediately after areas of the concrete floor of the nave had been removed. A full drawn, written and photographic record was maintained throughout. Numbers in brackets in the following text refer to individual context numbers in the site archive.

- 4.2 The removal of the concrete floor revealed a rubble sub-base (2) consisting of rounded pebble and angular stone fragments, mortar fragments, and brick and tile fragments contained in a loose grey coloured, granular matrix. To the north and south of this area stone sections of the wall foundations were exposed (8). An area of approximately 21m<sup>2</sup> of this layer adjacent to the north wall (Area A) was lowered by *c*. 0.10m in order that an overall level area was formed. This revealed a continuation of the rubble layer from which no finds were recovered. A small trial pit demonstrated that this layer was 0.35m deep and rested on a buff-yellow clay (3) which may have been the natural subsoil.

- 4.3 Two other smaller areas, areas B and C, adjacent to the chancel and the door respectively, were also lowered but, again, both proved negative.

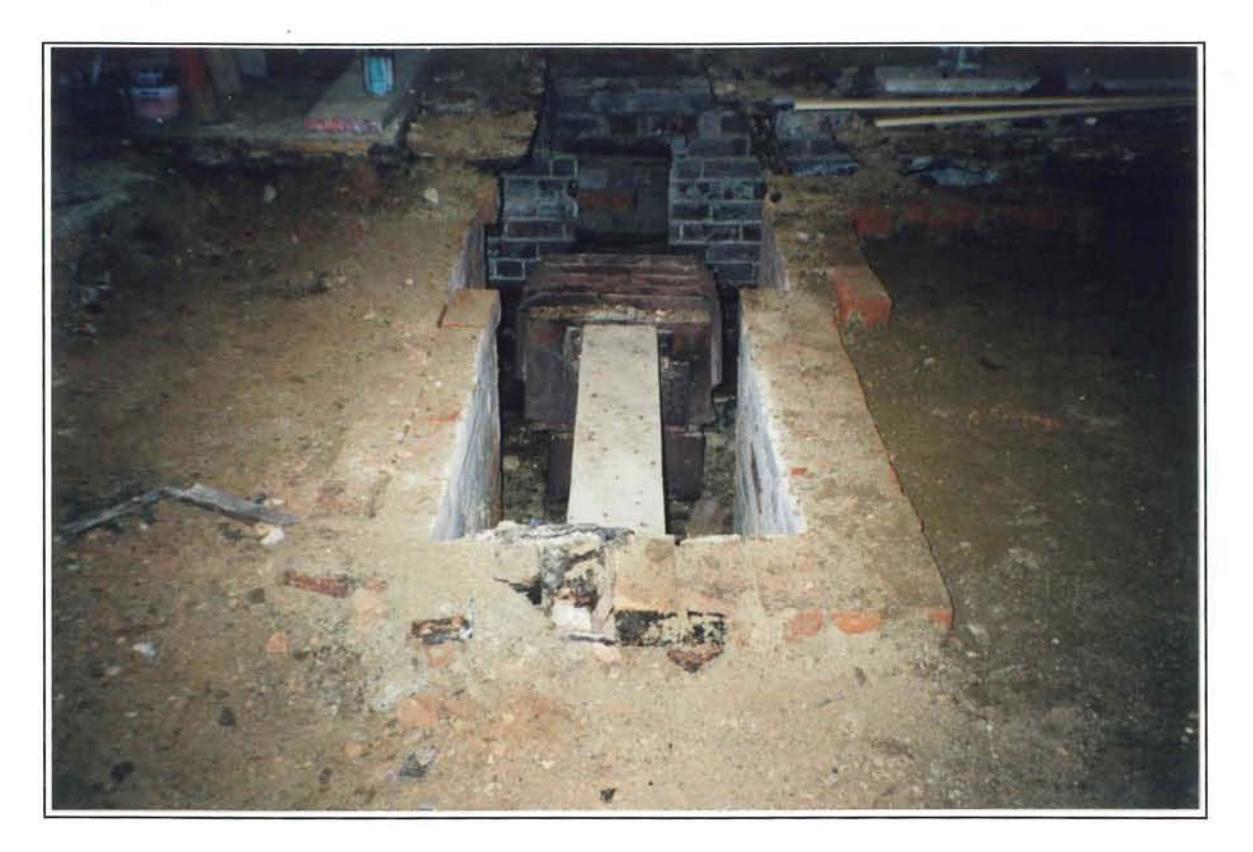
Plate 1 Boiler chamber (4). Photo CPAT 983.09

- 4.2 Adjacent to this area on its southern side, removal of the concrete had exposed a cast iron, coke-fired boiler and ducting (5) which constituted part of the under-floor heating system serving the nave and also the vestry. The boiler was housed in a brick-lined chamber (4; plate 1) 0.9m long, 0.7m wide and 0.9m deep, with a stone slabbed base. Also within this chamber was a wooden chest (6; plate 2) which when lifted out was found to be a chest hollowed out of a single oak trunk. Externally its dimensions were 1.35m long, 0.55m wide, 0.37m high. Only half of the hinged lid, which was in a decayed state, was left. Also recovered was a mortice lock which appeared to be of relatively recent origin, although it may have replaced an older one. The chest was evidently the old parish chest referred to by the Rev. Basil Jones in 1884 which he noted was lodged in the belfry.
