Meifod Sewage Treatment Works and New Rising Main ARCHAEOLOGICAL WATCHING BRIEF

CPAT Report No 461

W G Owen March 2002

Report for Severn Trent Water

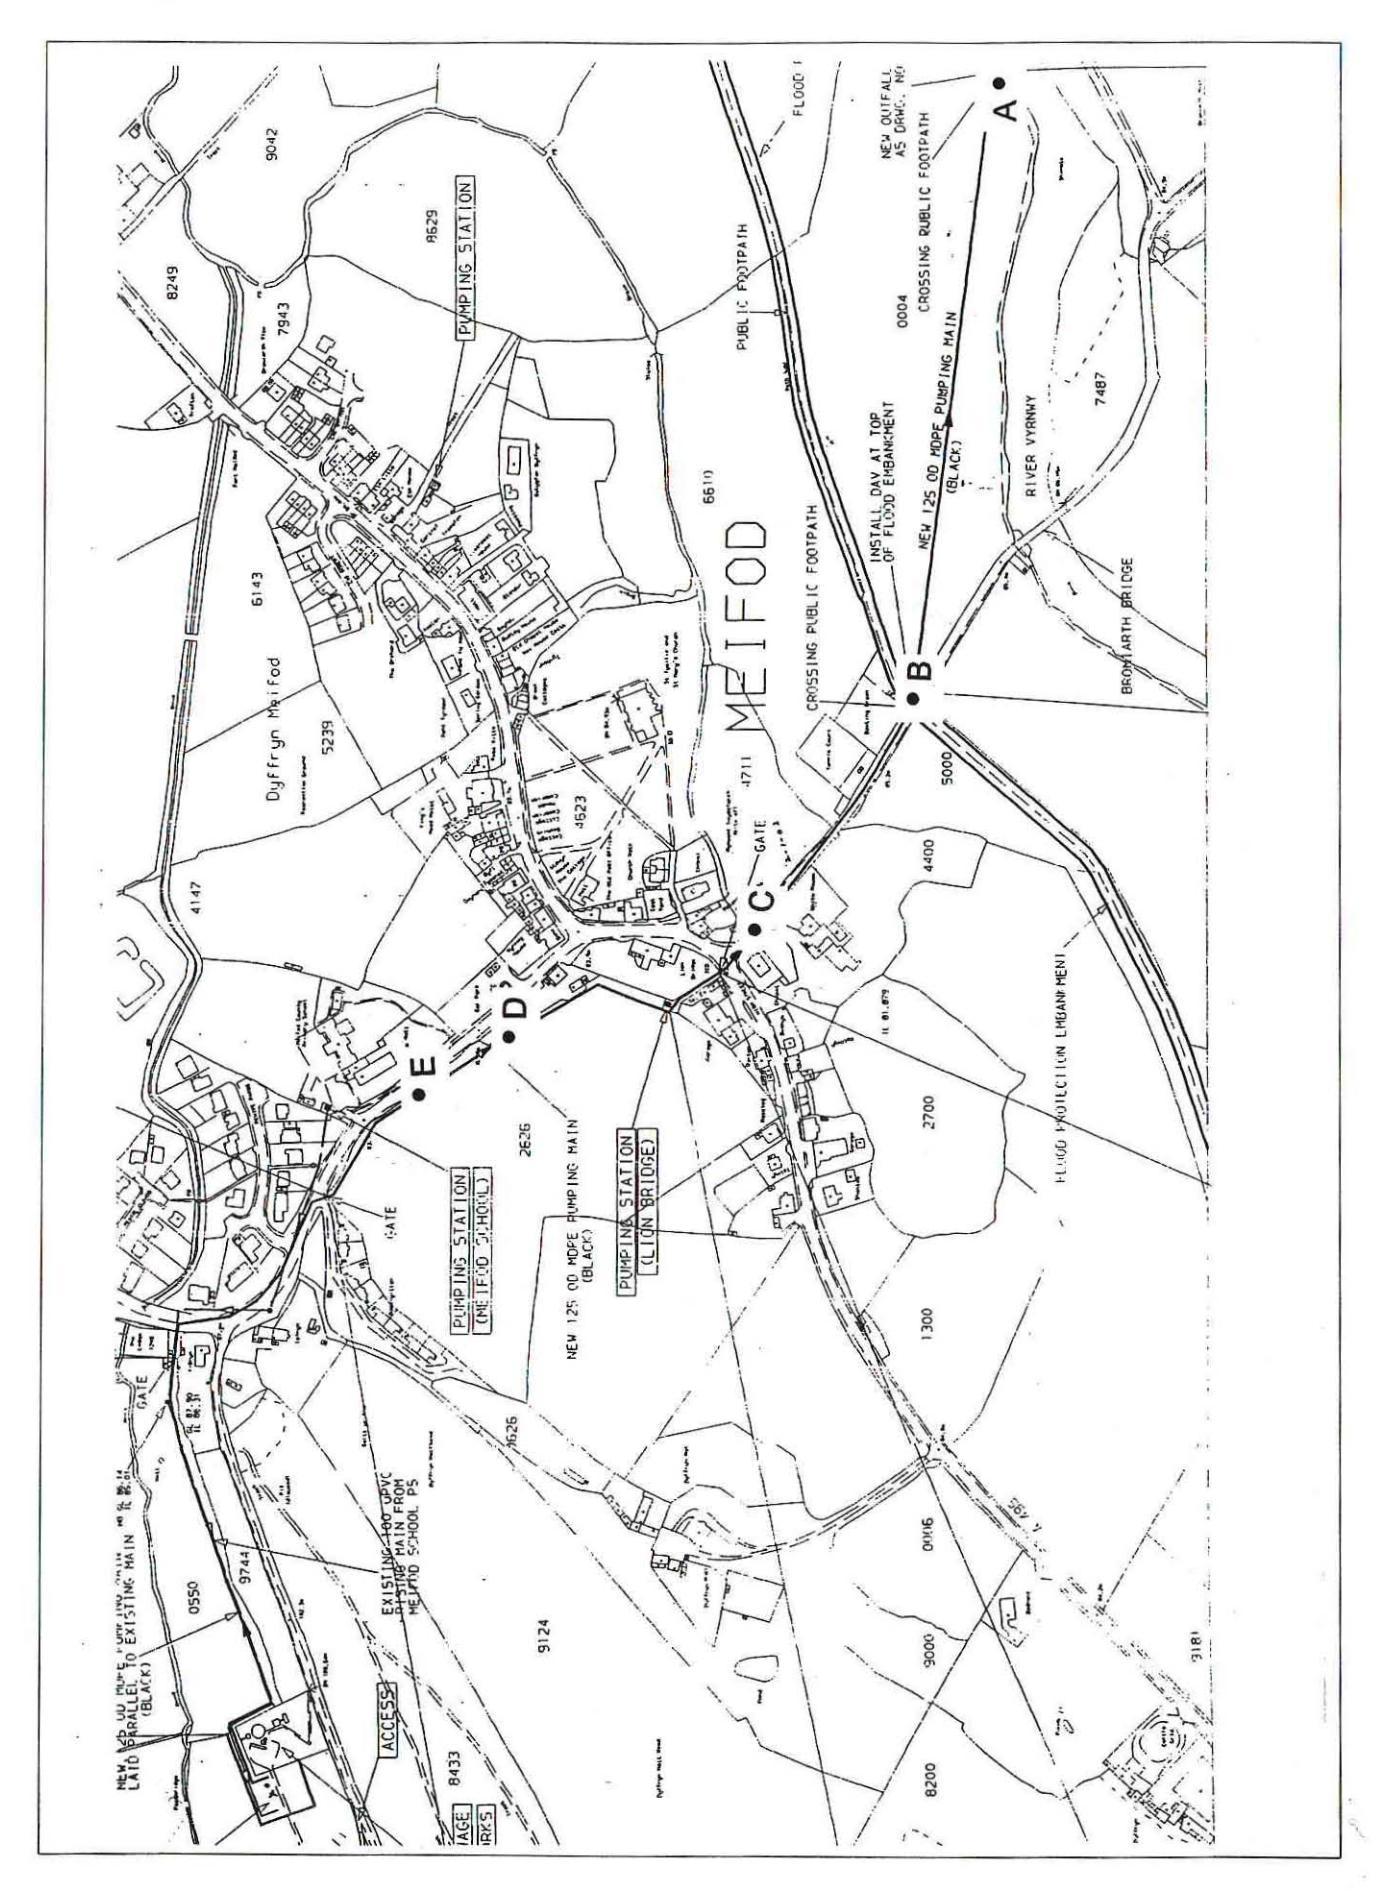
Fig. 1 Pipeline corridor and site location.

- 2.1 The pipeline (Fig. 1) runs for a total of 1.4km, commencing at SJ 15962 12925 on the northern bank of the River Vyrnwy, to the sewage treatment works north-west of Meifod at SJ 14860 13422.
- 2.2 Soils in the area vary from fine silty soils over silts and gravels derived from river alluvium in the valley floodplain, to fine silty and clayey soils derived from drift from Palaeozoic mudstones and siltstones elsewhere (Rudeforth *et al.* 1984).

- 3.3 The section between the proposed new outfall structure close to the northern bank of the river Vymwy (Fig. 1, A; SJ 15962 12925) and the junction of the flood protection embankment and the unclassified road (Fig. 1, B; SJ 15542 13004), yielded no features of archaeological importance. Soils exposed were generally silts and clays above occasional patches of gravel. Apart from brick and field drain fragments, no other artefacts were identified and no deposits indicative of human activity were noted.

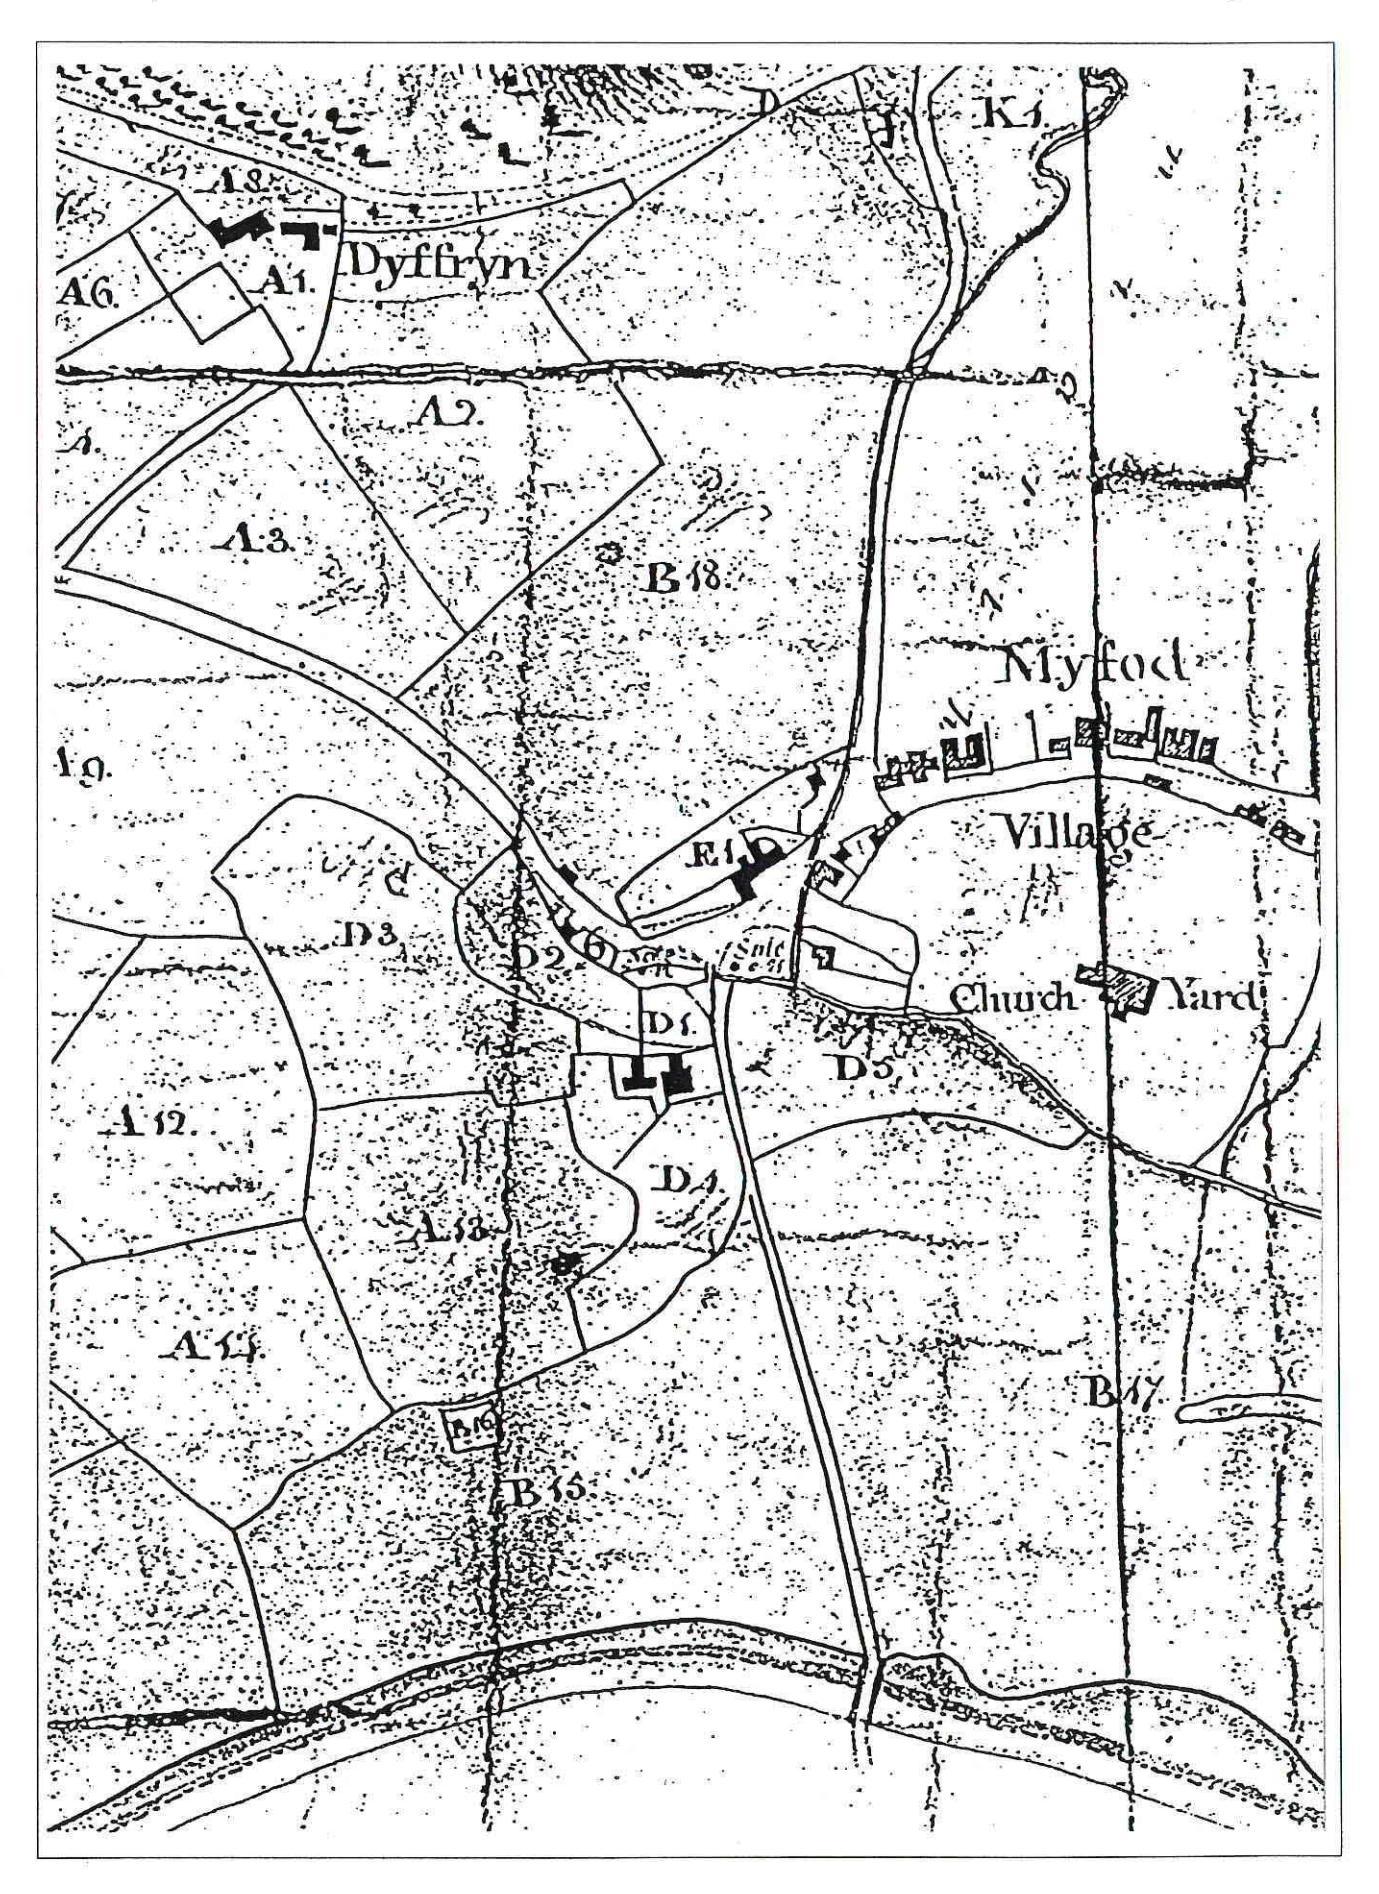
Fig. 2 Extract from the Tithe Survey of Meifod parish 1842

- 3.5 At the south-east edge of Meifod village (Fig. 1, C; SJ 15384 13112) a stone-built, arched bridge was identified below the road surface and reported to CPAT by the contractors. Arrangements were made for this to be recorded and photographed but, unfortunately, for safety reasons the trench at that point had to be backfilled before any record could be made. The bridge and its parapets were reported to be entirely of lime-mortared stone and the section exposed was up to 4.5m wide. It would appear that the bridge had been constructed to carry the road over a drain, visible in the fields to the east, and depicted on the Tithe Survey of 1842 (Fig. 2).

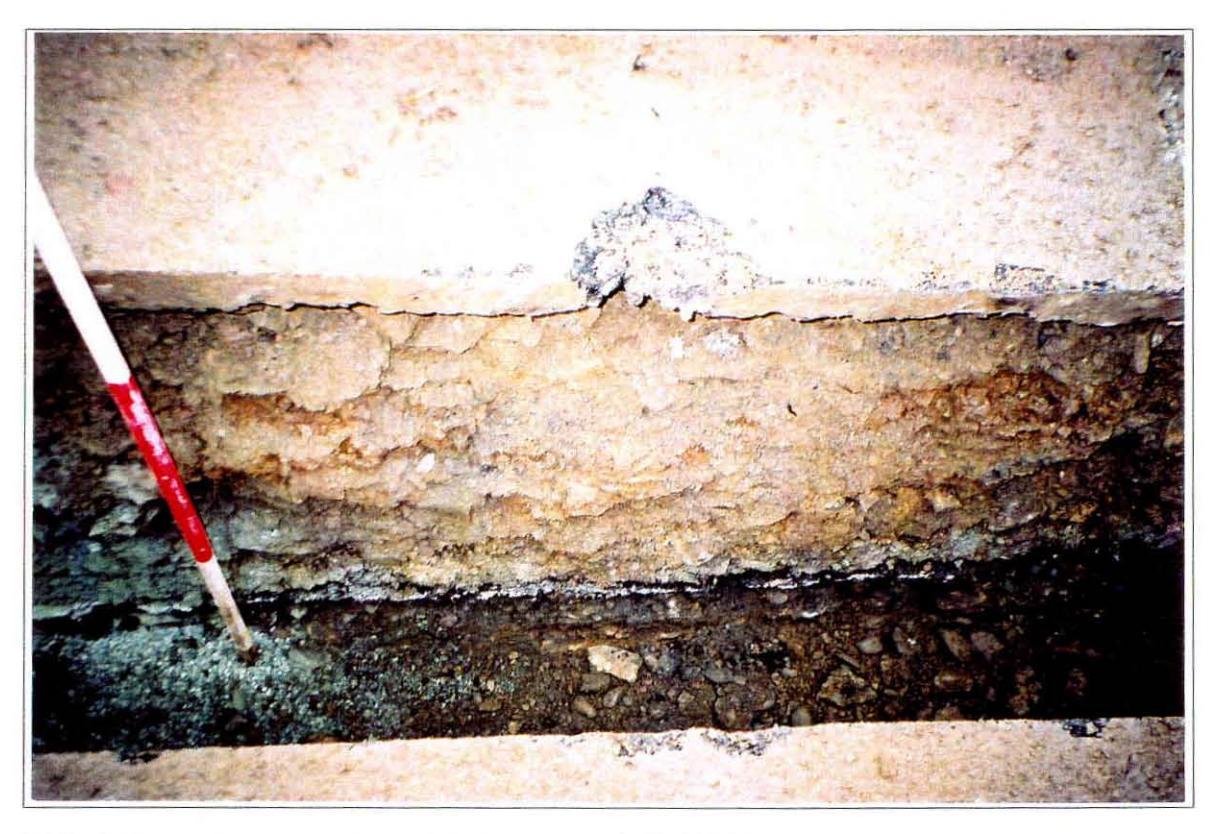
- 3.4 To the north-west of the junction of the embankment and the road, the excavated trench proceeded along the south-western side of the road, the level of which had evidently been raised in association with the flood defences. A section examined at the south-eastern end revealed a former tarmac road surface (pl 1) overlying a clean, grey gravel, which appeared to be a natural deposit. This former road surface re-appeared 60m to the north-west at a point where the modern road levels off. Further to the north-west, the latter and its stone sub-base, overlay undisturbed silty gravels.

Plate 1 Former tarmac road surface (B). Photo CPAT 1151.0

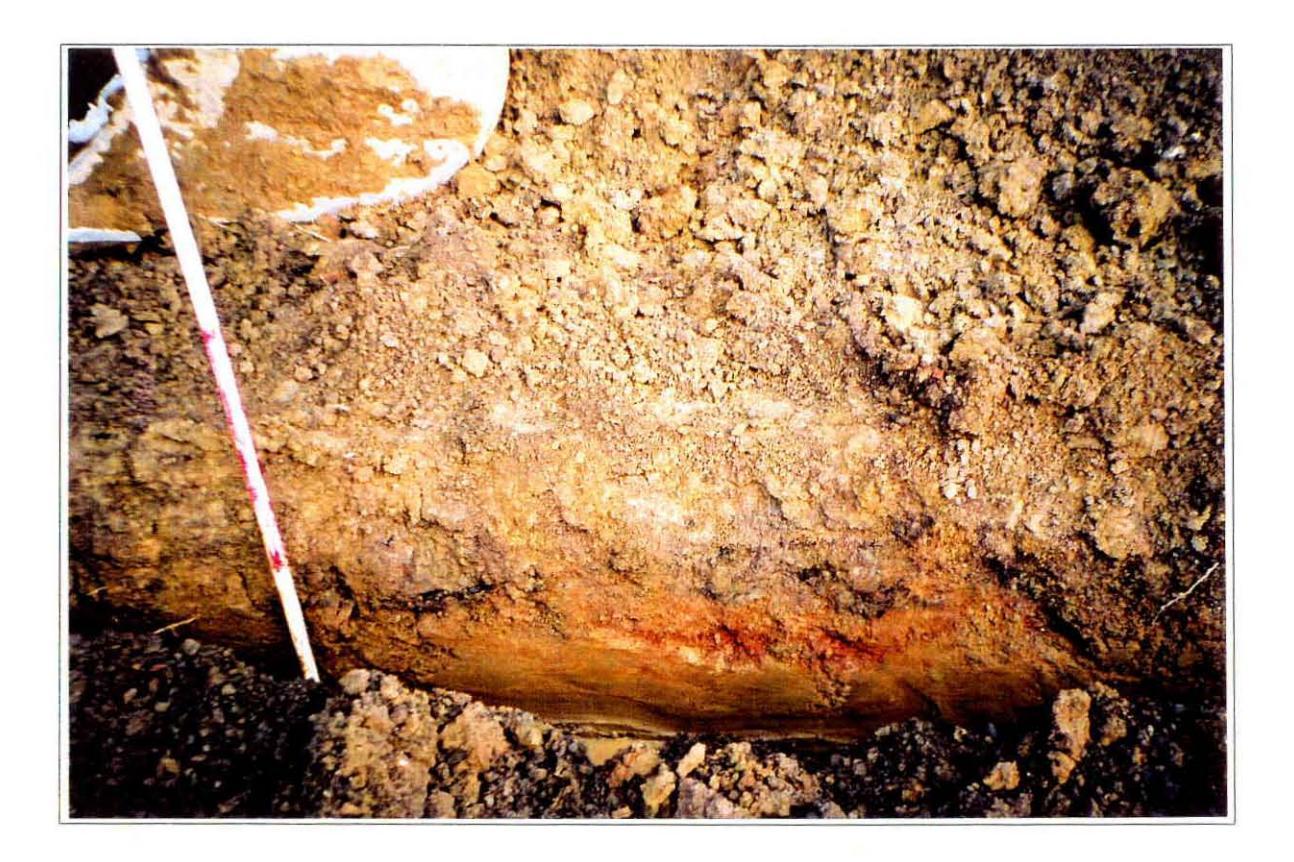
- 3.7 The wayleave corridor and pipe trench ran north-westwards for some 280m along the south-eastern and north-eastern edge of a pasture field (OS no 2626) and parallel to a minor road from SJ 15365 13145 to SJ 15260 13390. Soils excavated below the stripped turf and topsoil consisted of clays and clayey silts above a silty gravel which was generally at a depth close to the base of the trench at 1.1m. A single feature (Fig. 1, D; SJ 15320 13282) was identified along this section, consisting of a layer of burnt clay and charcoal fragments (pl 2), 1.20m long and up to 0.04m thick, which was visible in the clayey silts of the exposed east-facing section of the pipe trench at a depth of 0.35m below the surface. The layer did not extend through to the opposite section of the trench. An existing iron water mains pipe lay adjacent to the layer on its southern side and it appears that the pipe trench for this had cut through the layer. The exposed soils in the wayleave corridor adjacent to this feature were examined but with negative results. This layer appeared to be an *in situ* deposit, although its dating and function are uncertain. No artefacts were recovered from the area.

Plate 2 Layer of burnt material (D). Photo CPAT 1151.9

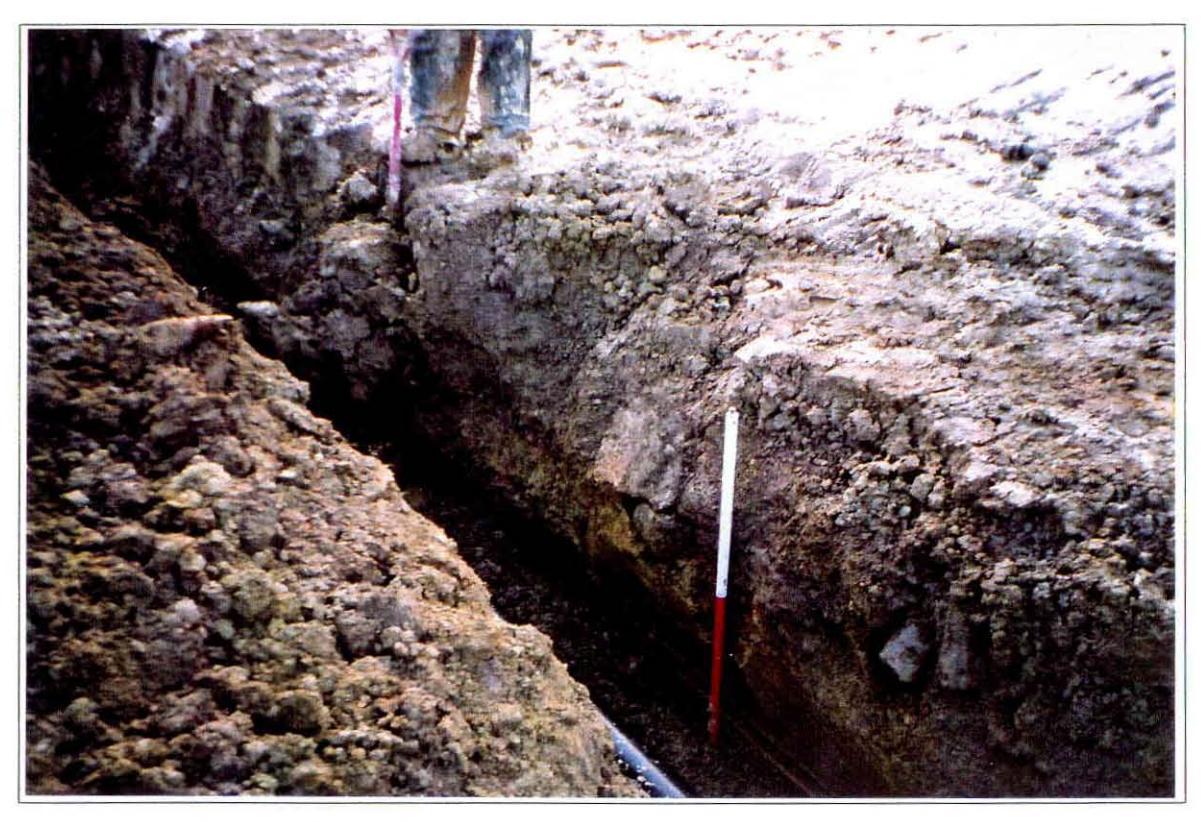
- 3.8 An area of stone (pl 3) was identified within the pipe trench further to the north-west (Fig. 1, E; SJ 15280 13320), extending for *c*. 1.5m and containing a quantity of stone up to 0.26m in diameter, at a depth of up to 0.4m below the surface. The stones appeared to be uncoursed and could not be identified with any certainty as being part of a structure. No artefacts were found that could have been associated with this feature and examination of the wayleave corridor to the west yielded nothing apart from a few randomly scattered flat shale stones.

Plate 3 Area of stone visible within pipe trench at (E). Photo CPAT 1151.11

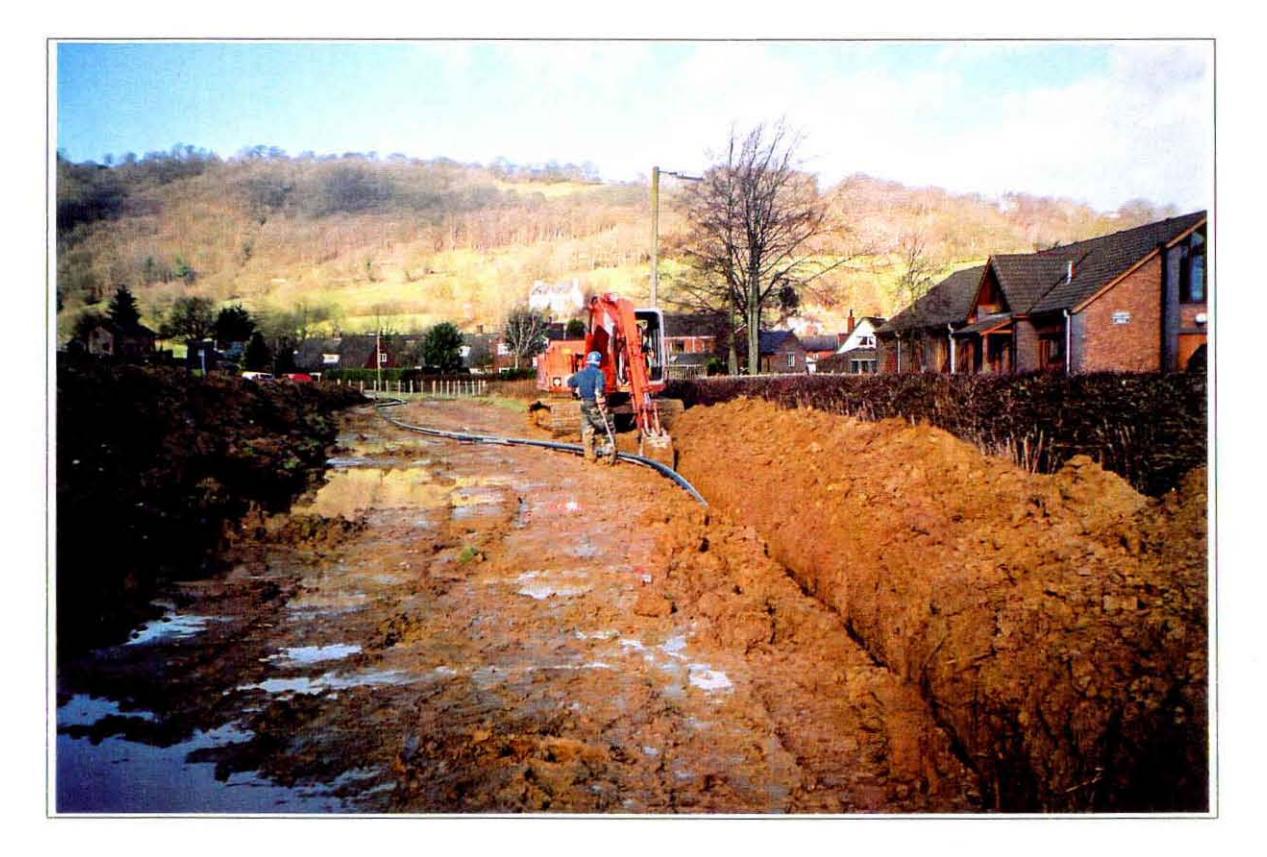
Plate 4 Pipe laying operations near (E). Photo CPAT 1151.10
