# Pennant Mine, Rhuallt, Clwyd ARCHAEOLOGICAL EVALUATION

**CPAT Report No 52**

by WGOwen CPAT RWVernon & JBennett Welsh Mines Preservation Trust

March1993

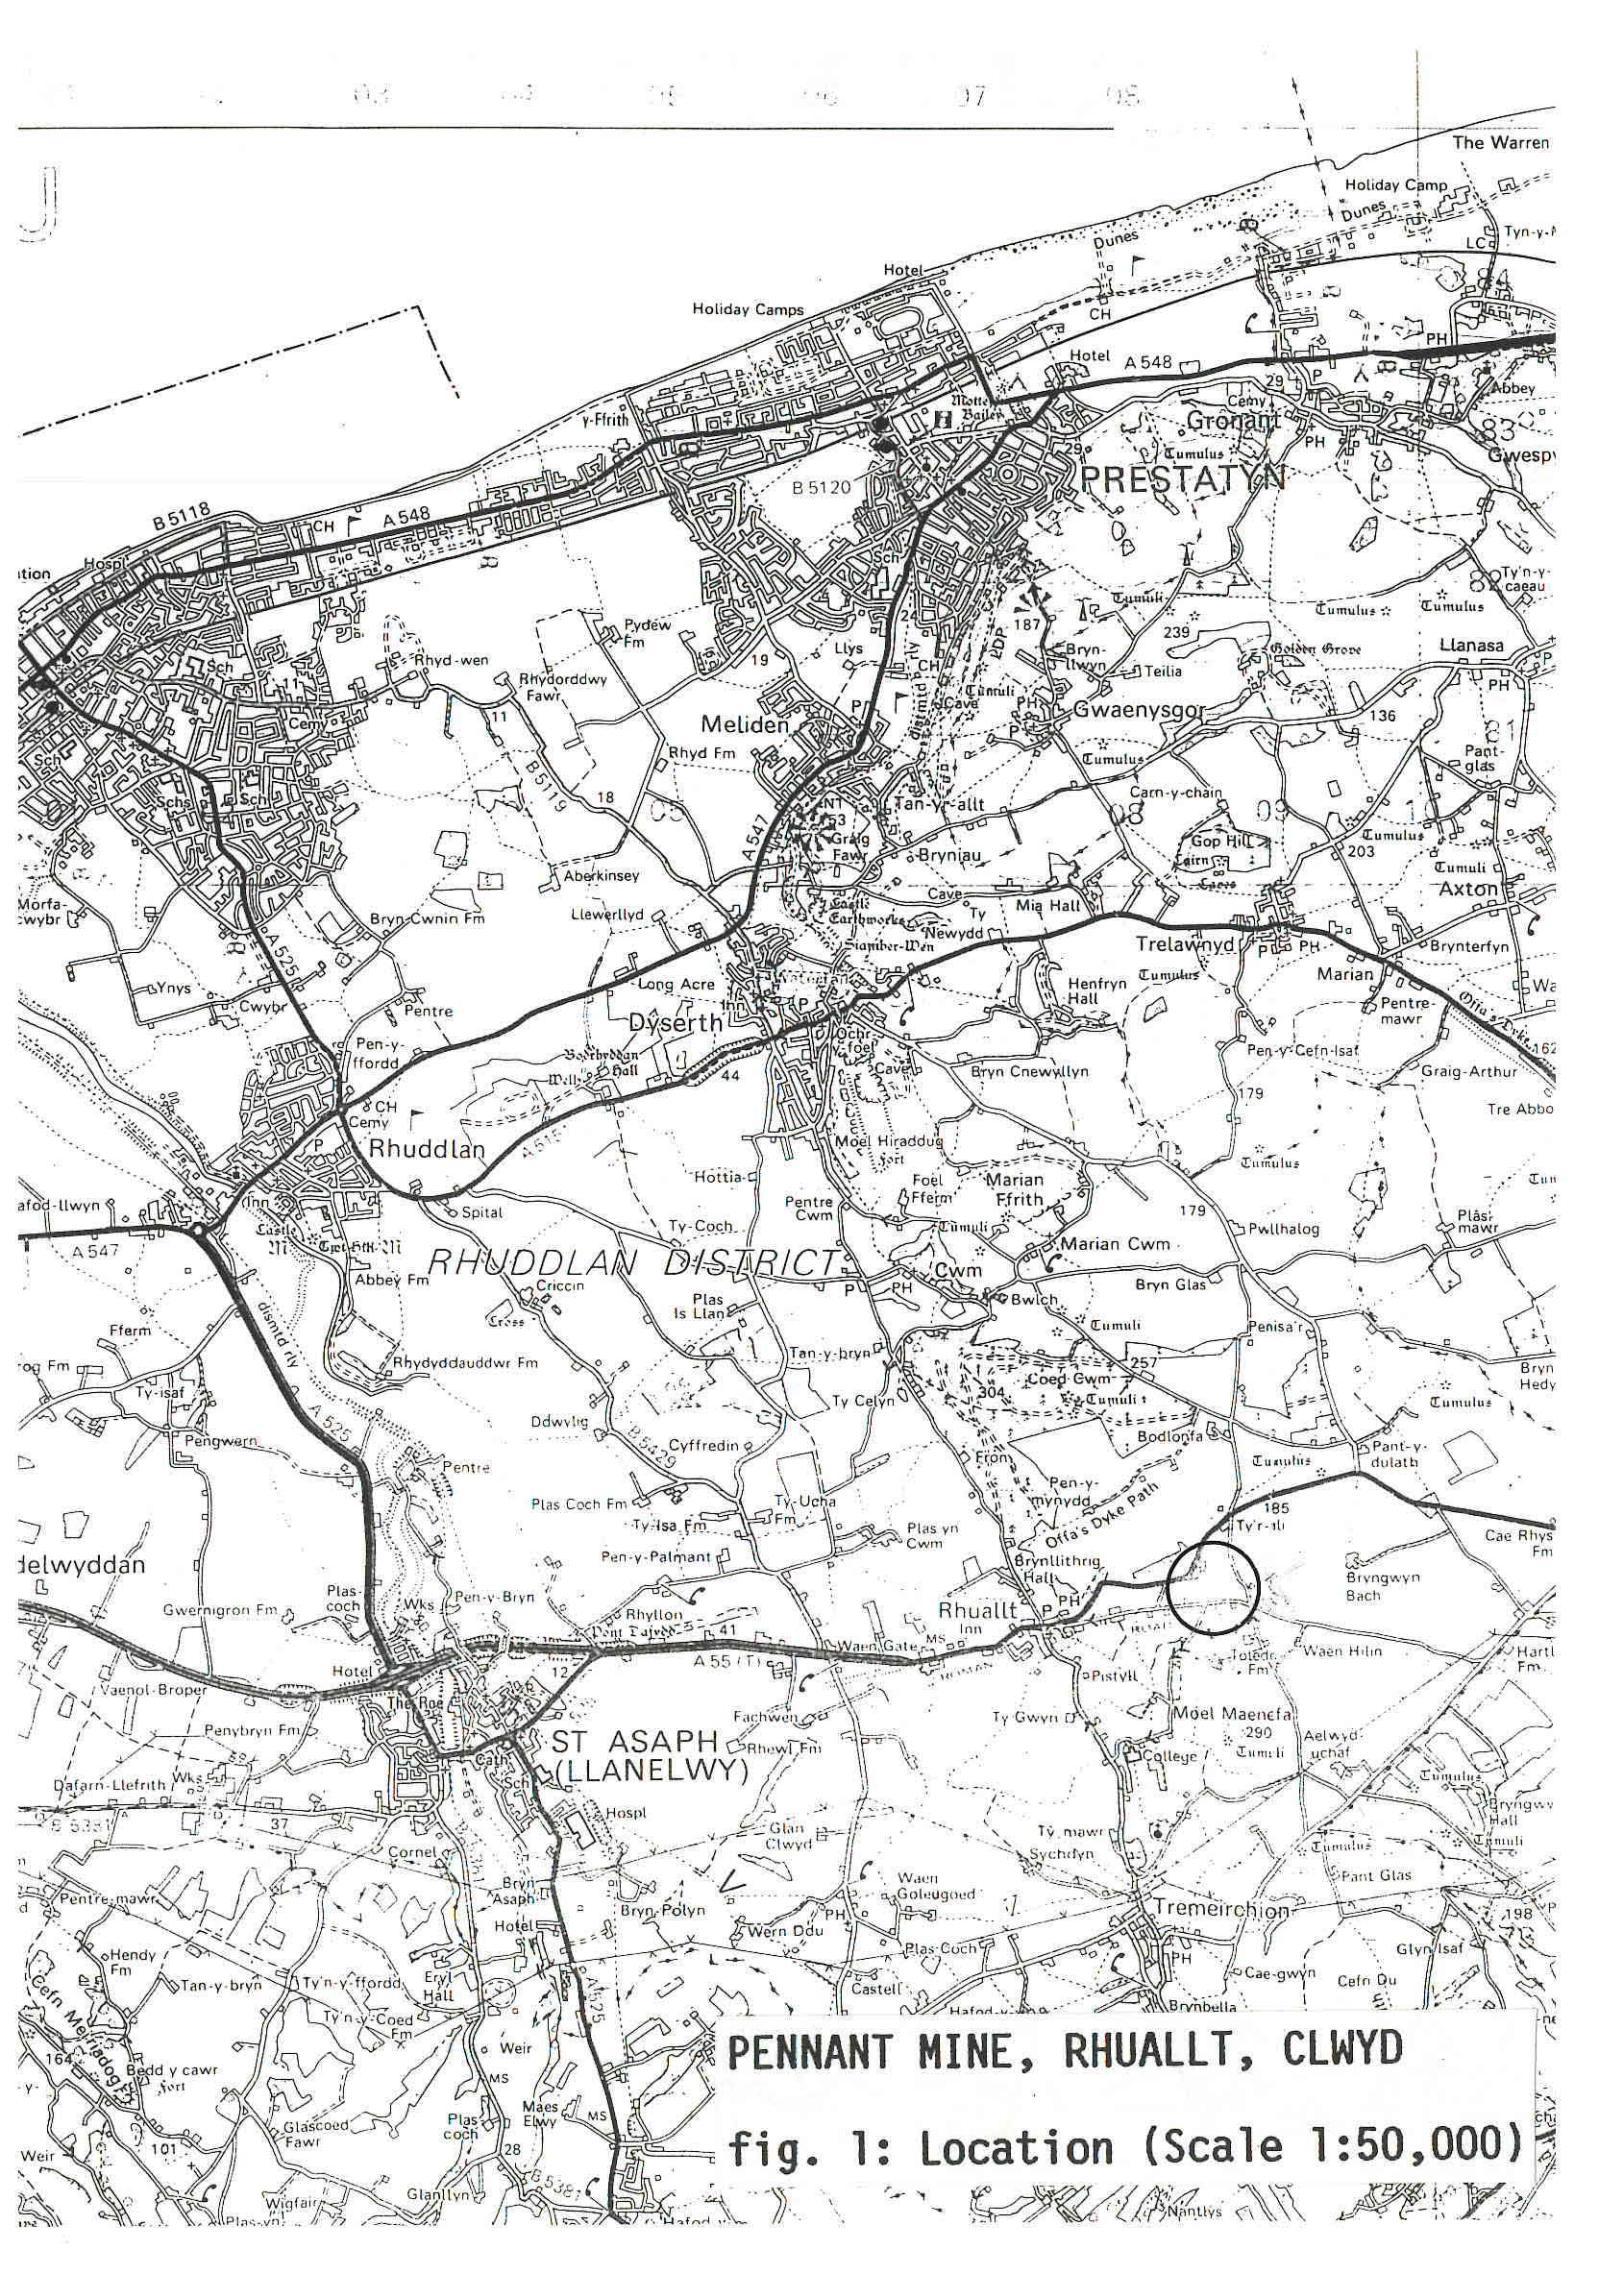
- 2.1 The area affected by the planning application covers an area of approximately 19ha located 1km east of Rhuallt and centred at SJ0860 7530 (Fig 1).
- 2.2 Topographically, the land includes a dry wooded valley which falls gradually from an altitude of 700m OD in the east to 590m OD at the western side. The valley base and lower slopes are occupied by the old mine complex which extend from Pennant View on the side of the A55 road eastwards to a point adjacent to Bryngwyn Mawr Farm, a total distance of approximately 400m. The upper slopes to the north and south above the mine are occupied by pasture fields bounded on their eastern and southern perimeters by unclassified roads.

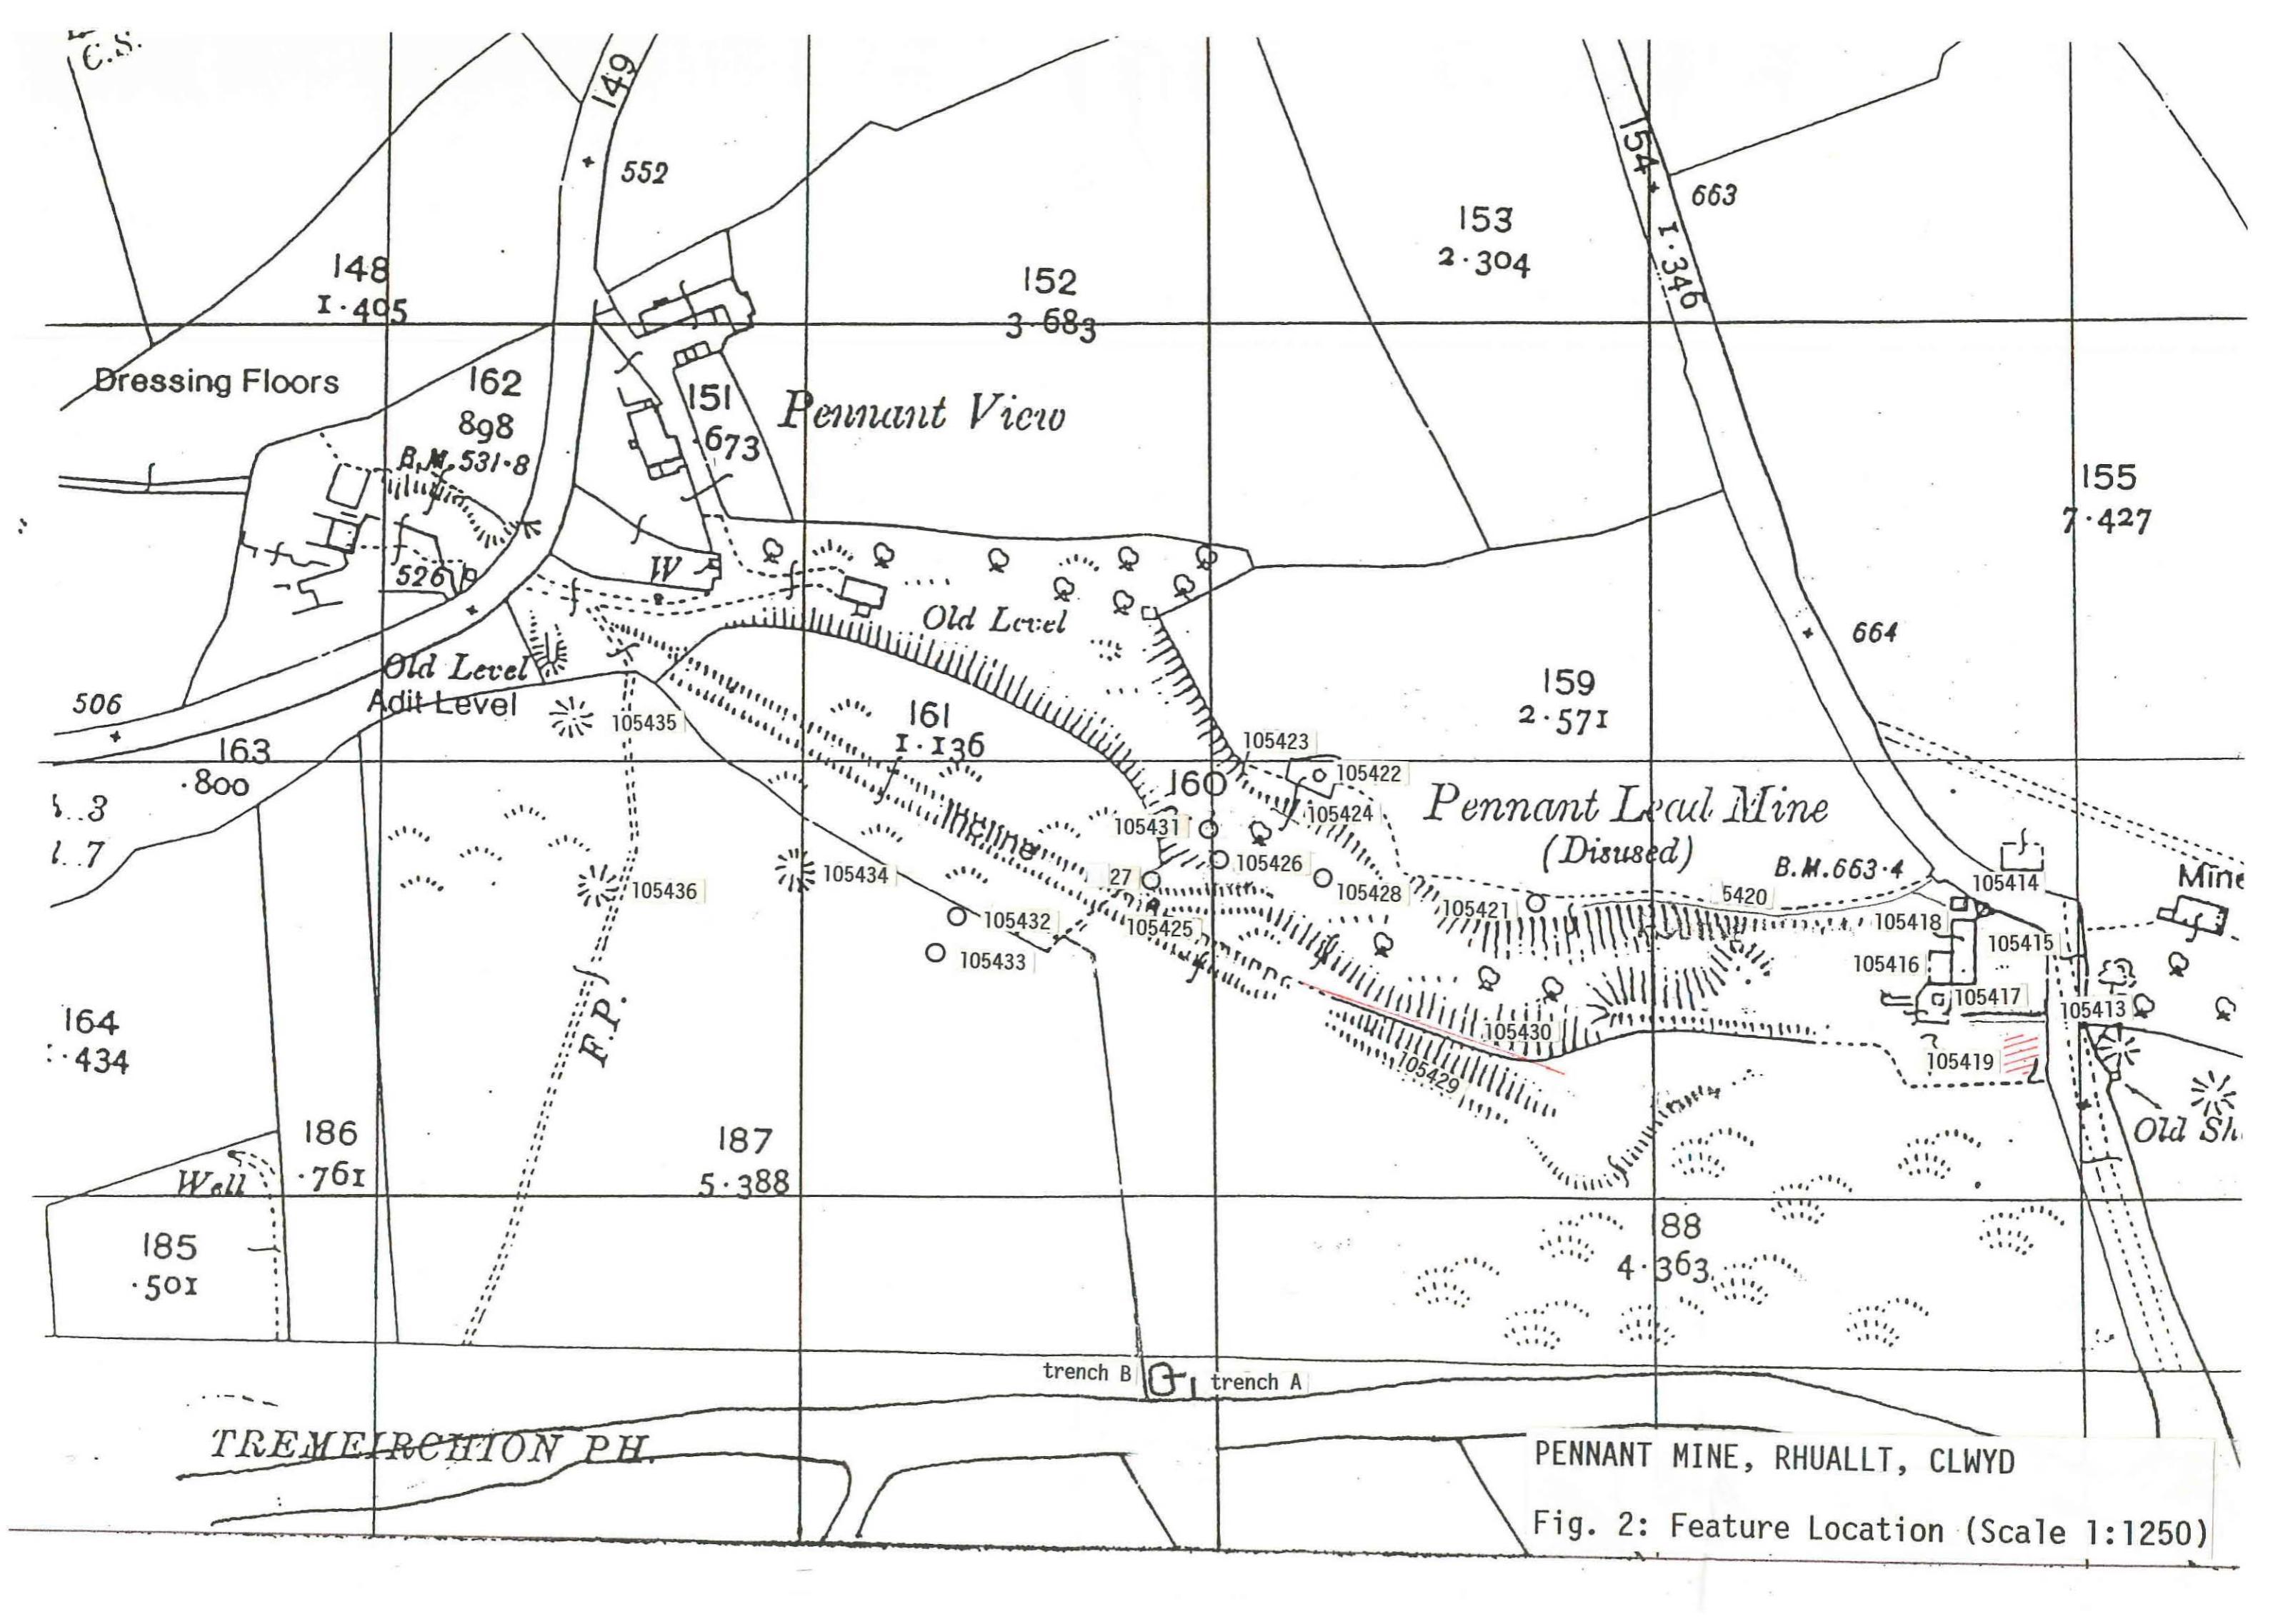
- 4.1 Two trenches were excavated to investigate the possible presence of features of archaeological significance (Fig 2).
- 4.2 Trench A, 5.0m x 1.5m, was located across the possible line of a Roman road at SJ 0859 7526. Ploughsoil was removed mechanically to the level of the undisturbed subsoil and this surface and exposed vertical sections cleaned manually, recorded and photographed. There was no indication of the presence of a buried road surface at any point in the excavated area.
- 4.3 Trench B, 4.5 x 1.5m, was aligned E W across the eastern side of a continuous subrectangular low bank visible on the surface and which enclosed a level area. It had been proposed that this was the site of a small reservoir possibly related to the Pennant mine workings.

## 6 SURVIVING FEATURES OF THE MINE (Fig 2)

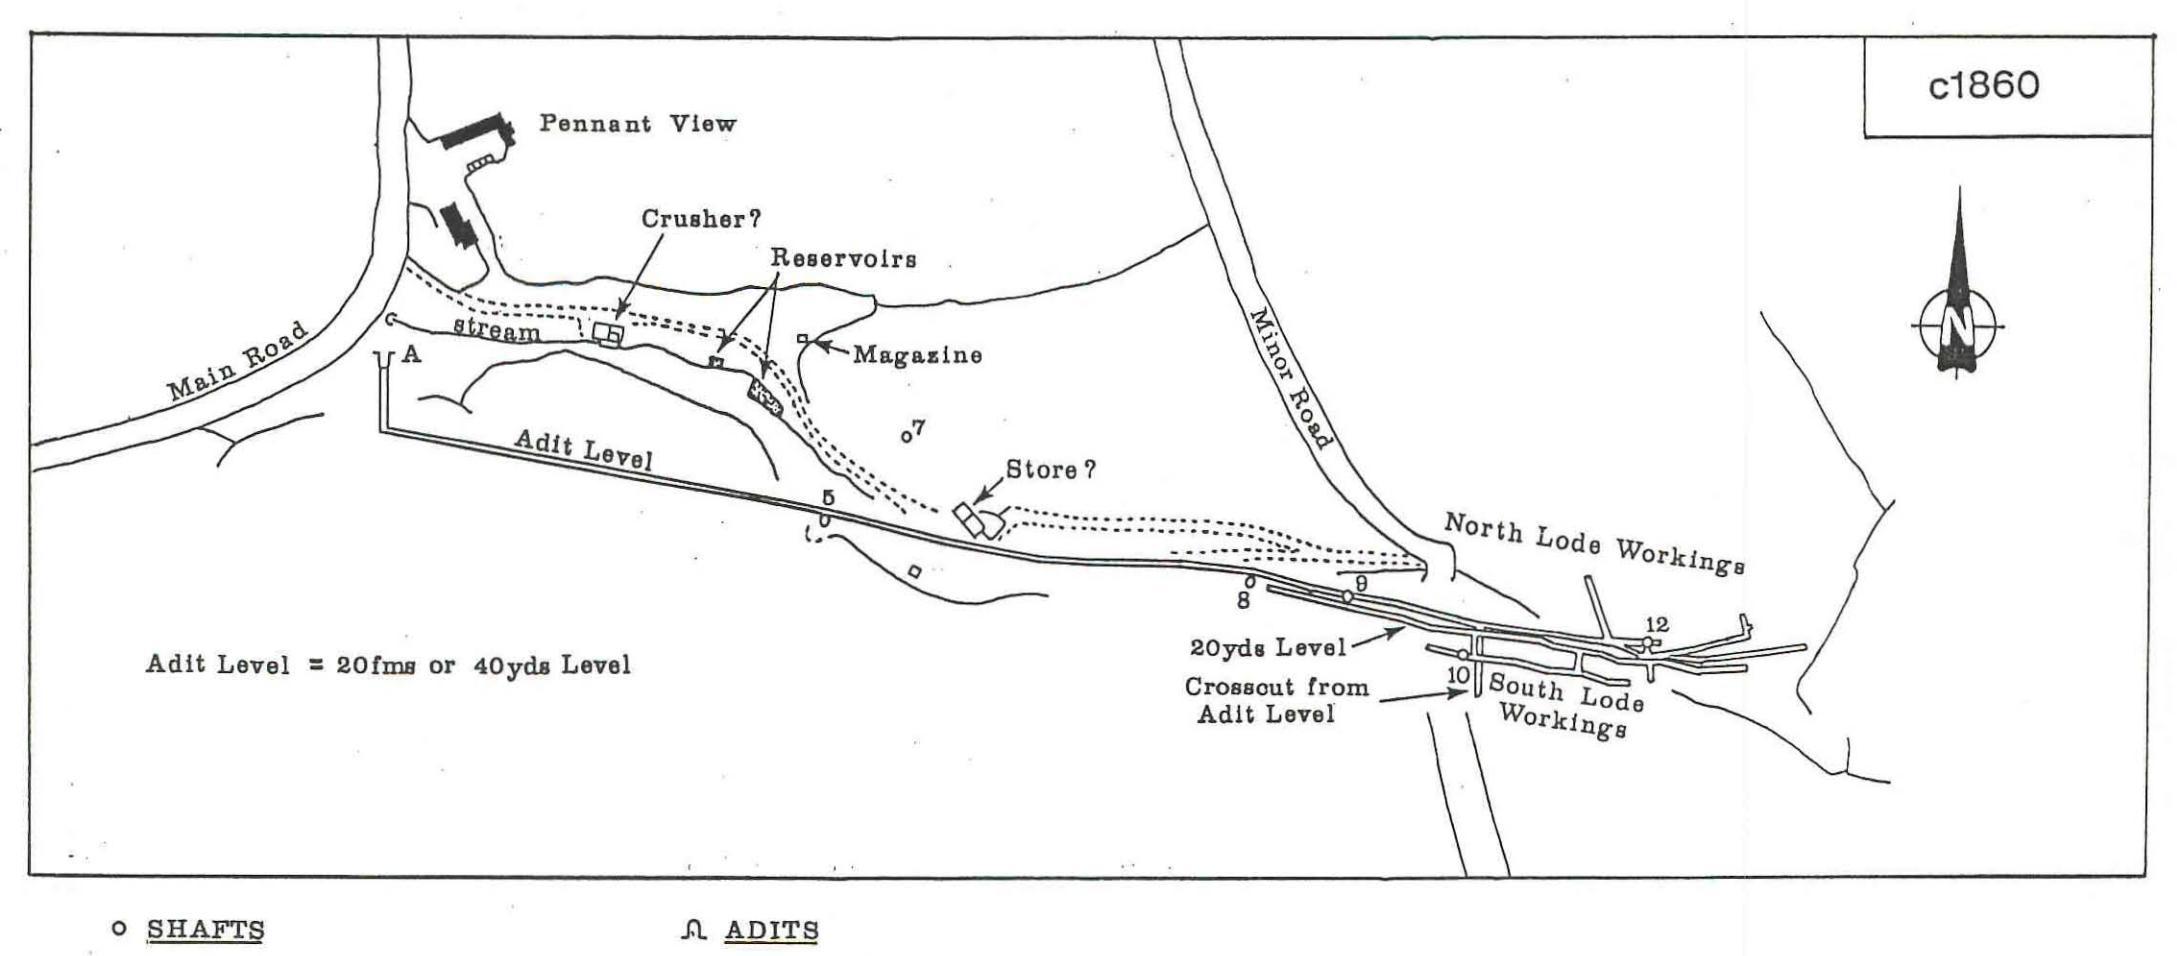
- 5.4 For a period around 1835, the mine is known to have been at a standstill, but with the advent of the Pennant Mine Company in 1859 further development took place. A mine plan of c 1860 (Fig 3), shows six shafts which (with the exception of New Sinking on South Lode) were sunk down to the 40 yard adit level whose portal lies to the south of Pennant View. From west to east these shafts are named Old, Deep, Footway, Old Whim, and East Whim. Several features to the east of the adit level are also shown. At points outside the proposed development area two reservoirs, a possible crusher house and a powder magazine are shown, whilst within the proposed development area another ancillary building, possibly a store, was located.

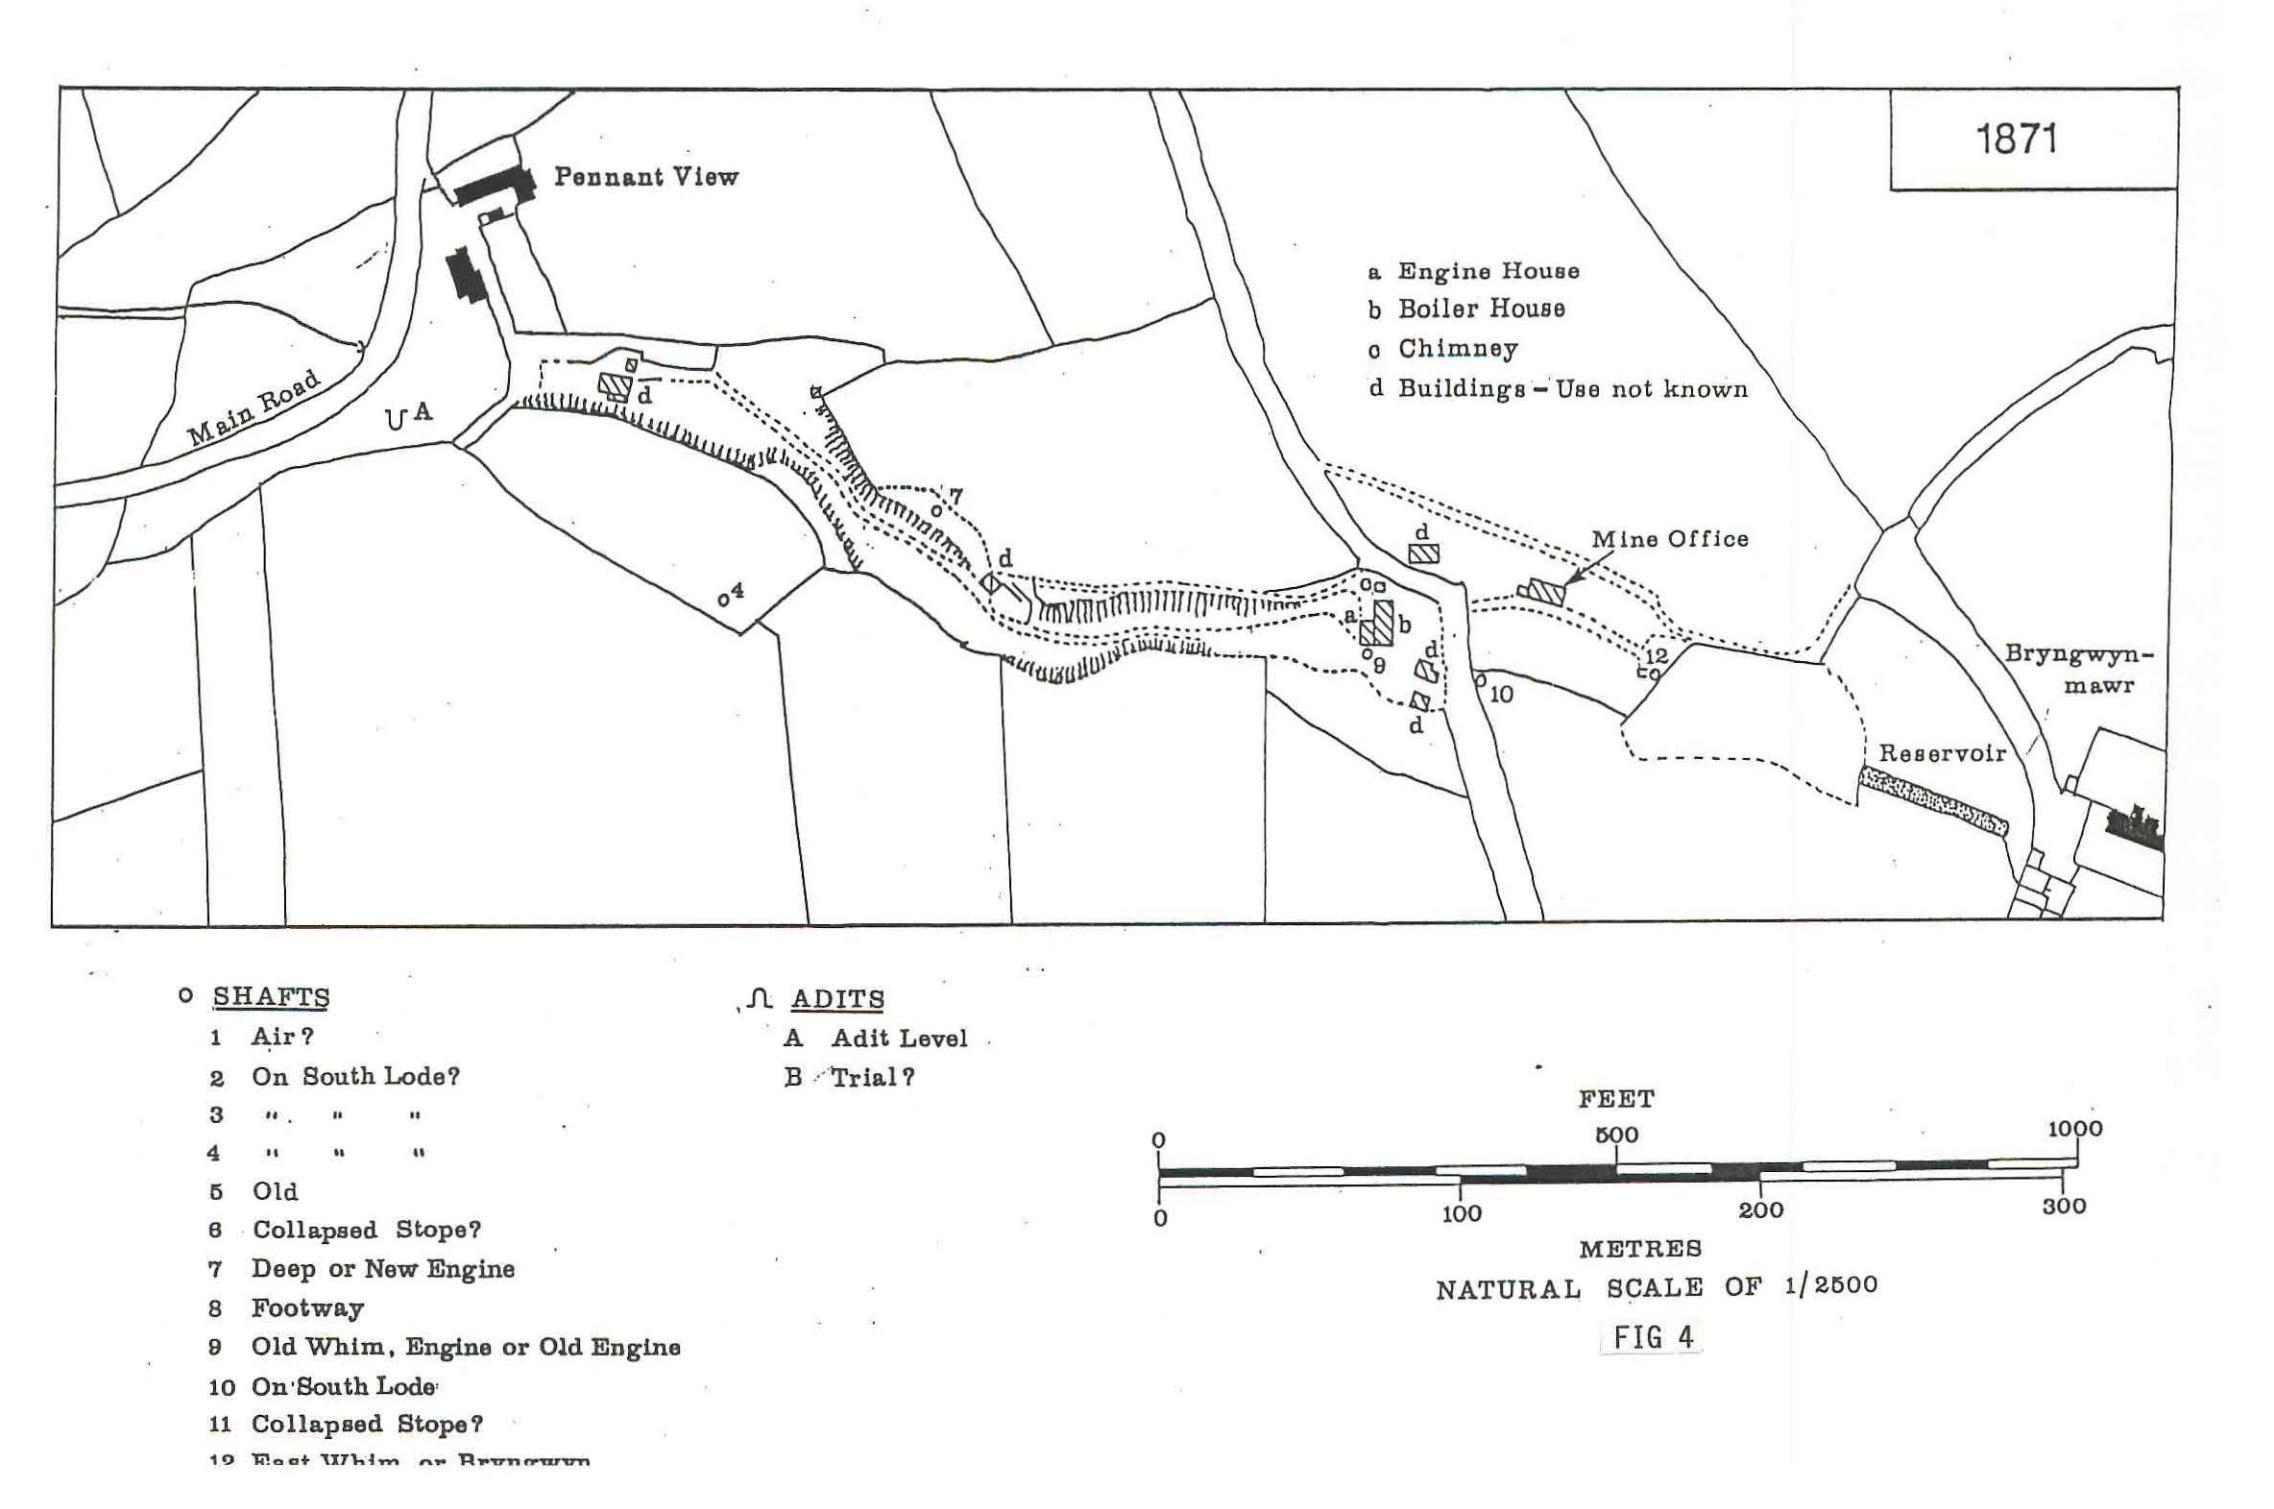
- 5.5 Although no Mine Plan is available for the later 19th century information given in the Mining Journal (published weekly) indicates that by 1871 a pumping engine operating a 30 inch single acting pump was in operation and the Old Whim Shaft had been deepened below the Adit Level to become the main Engine Shaft. The 25 inch Ordnance Survey Map (1st Edition) also shows that an engine house had

been erected by 1871 with adjacent Boiler House and chimney (Fig 4). Two other buildings to the southeast of the Engine House are also shown. The more northerly of the two, whose long axis is aligned with the Engine Shaft, may have housed a 12 HP engine and winding drum. From this complex, ore was carried to dressing floors by self-acting incline.

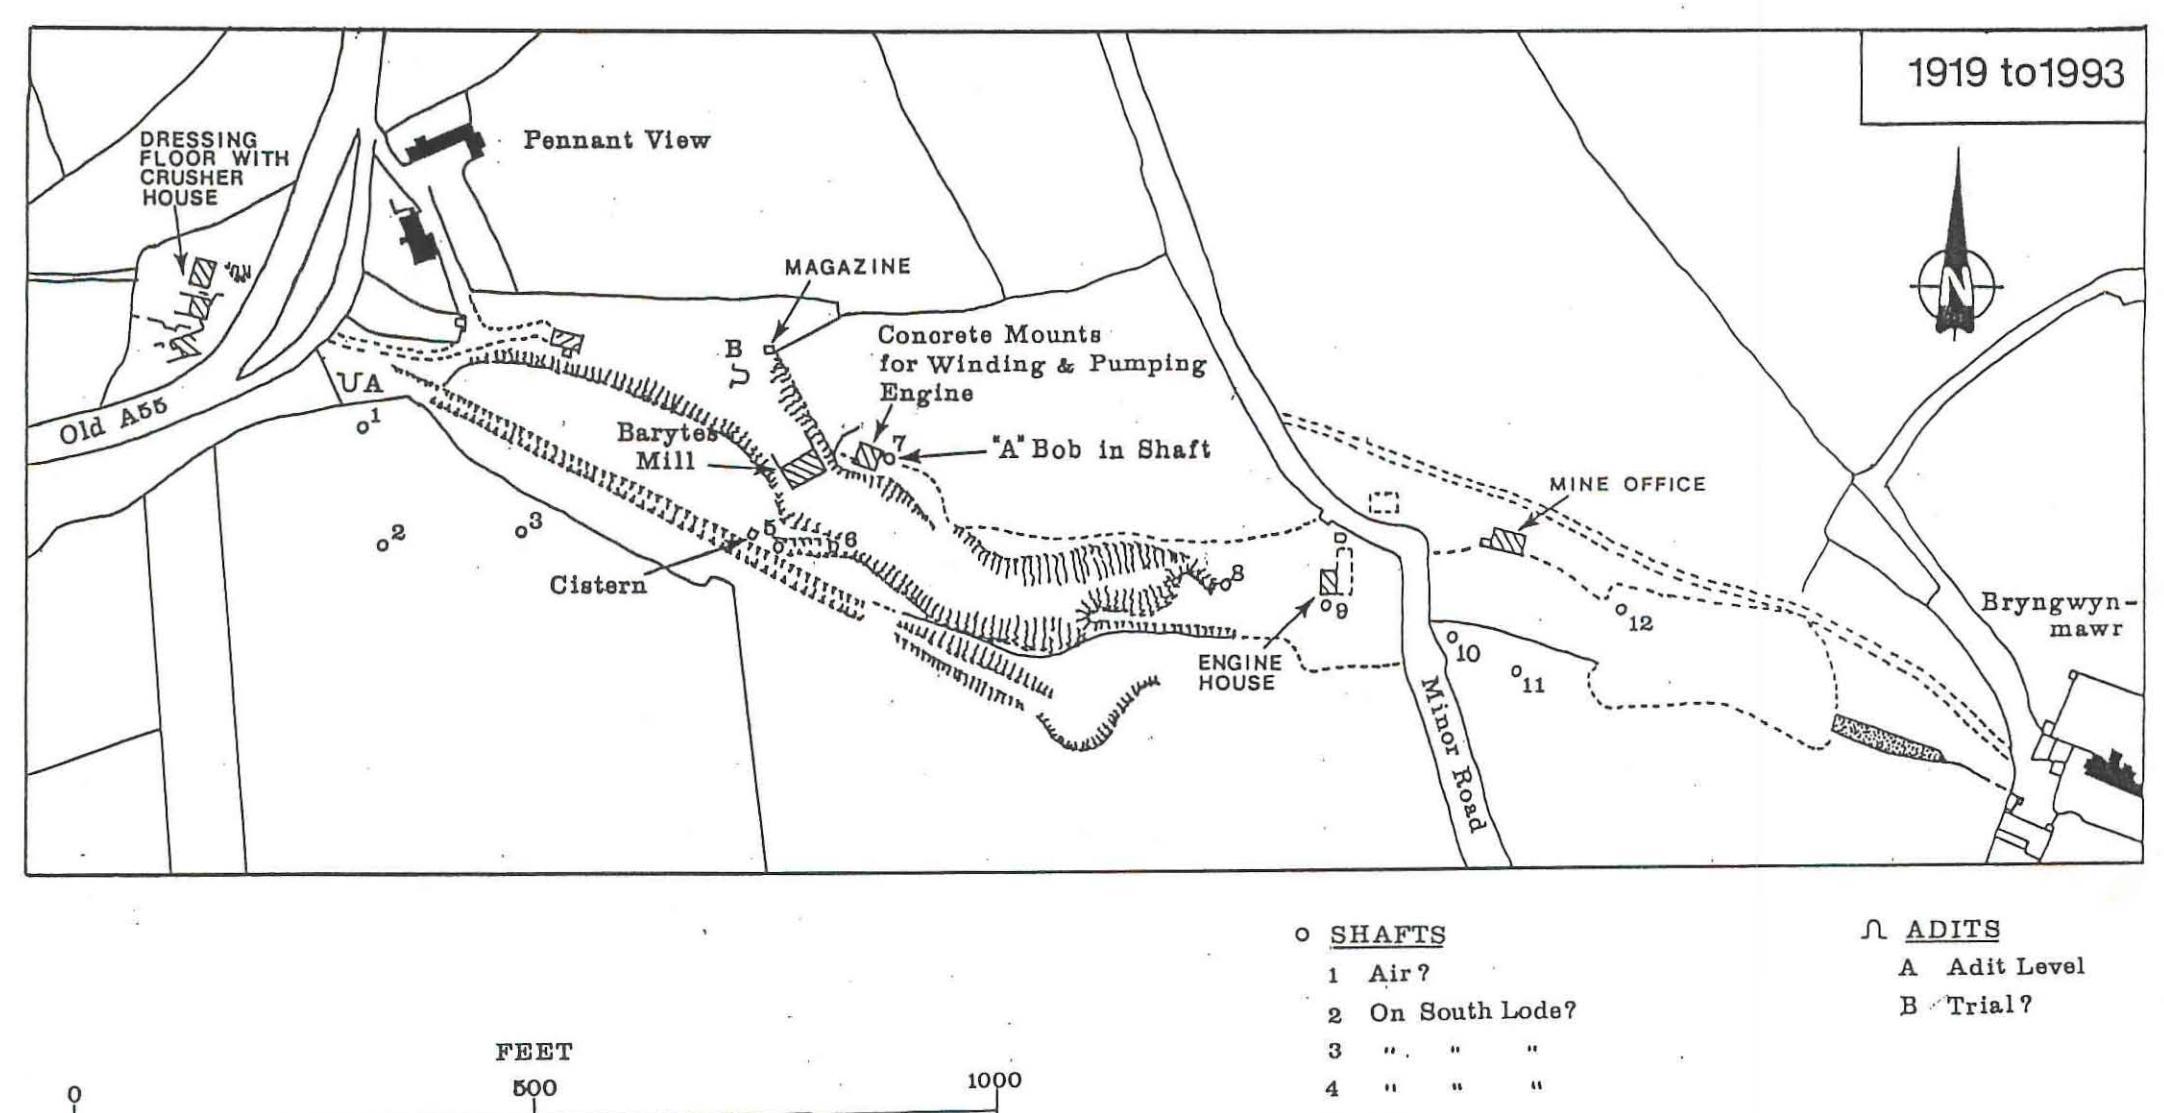
NATURAL SCALE OF 1/2500 FIG 6

- 5 Old
- 6 Collapsed Stope?
- 7 Deep or New Engine

8 Footway

- 9 Old Whim, Engine or Old Engine
- 10 On South Lode
- 11 Collapsed Stope?
