Montgomery Canal, Redwith, Shropshire

ARCHAEOLOGICAL WATCHING BRIEF

CPAT Report No 883

R. Hankinson August 2007

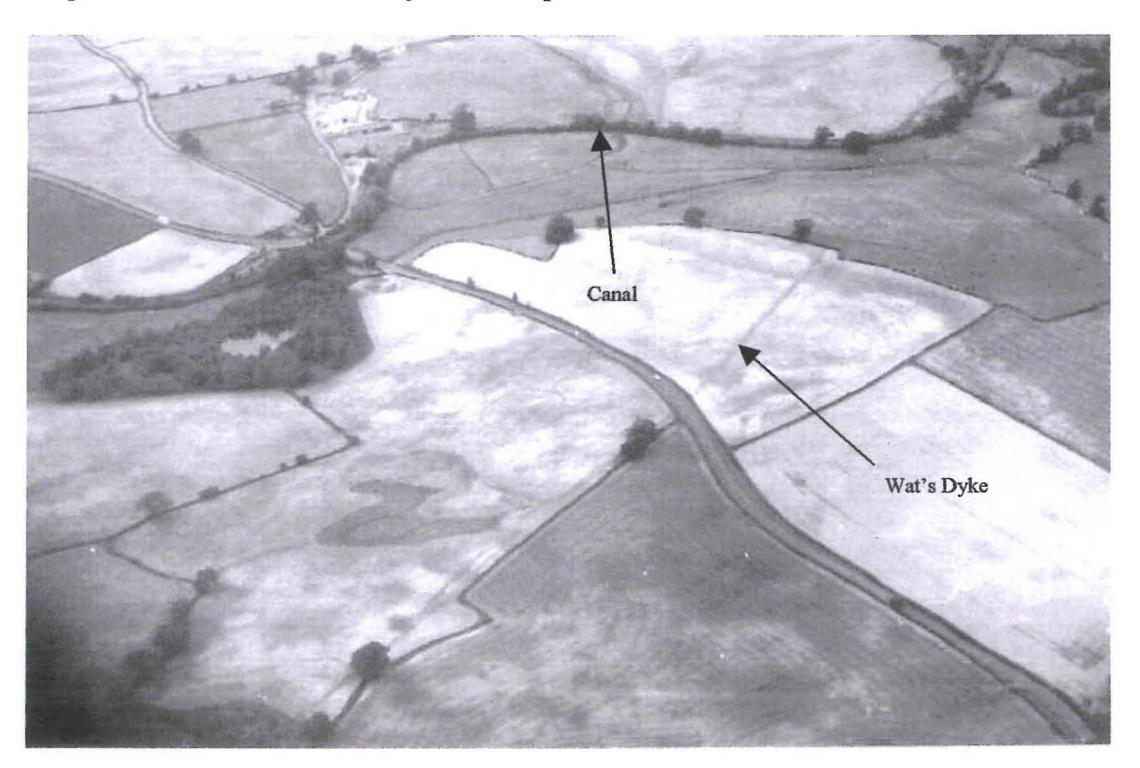
Plate 1 Cropmark evidence of Wat's Dyke, running from bottom left to top right of the photograph, where it meets the course of the canal (Photo CPAT 79-14-29)

- 1.2 Archaeological excavations had been carried out in the area by CPAT in 1996 (Owen 1996), in order to determine whether any evidence of the course of Wat's Dyke, an early medieval earthwork, existed in the immediate vicinity of this section of the canal. Cropmark evidence (see Plate 1) of the alignment of Wat's Dyke revealed that it had been crossed by the canal, but the excavations did not reveal any conclusive evidence of the dyke.

- 4.1 Examination of the aerial photographic evidence (*Plate 1*) confirms that the alignment of Wat's Dyke does coincide with this section of the canal, although the monument is not now readily apparent as an earthwork in this locality, due mainly to past erosion and land improvement.

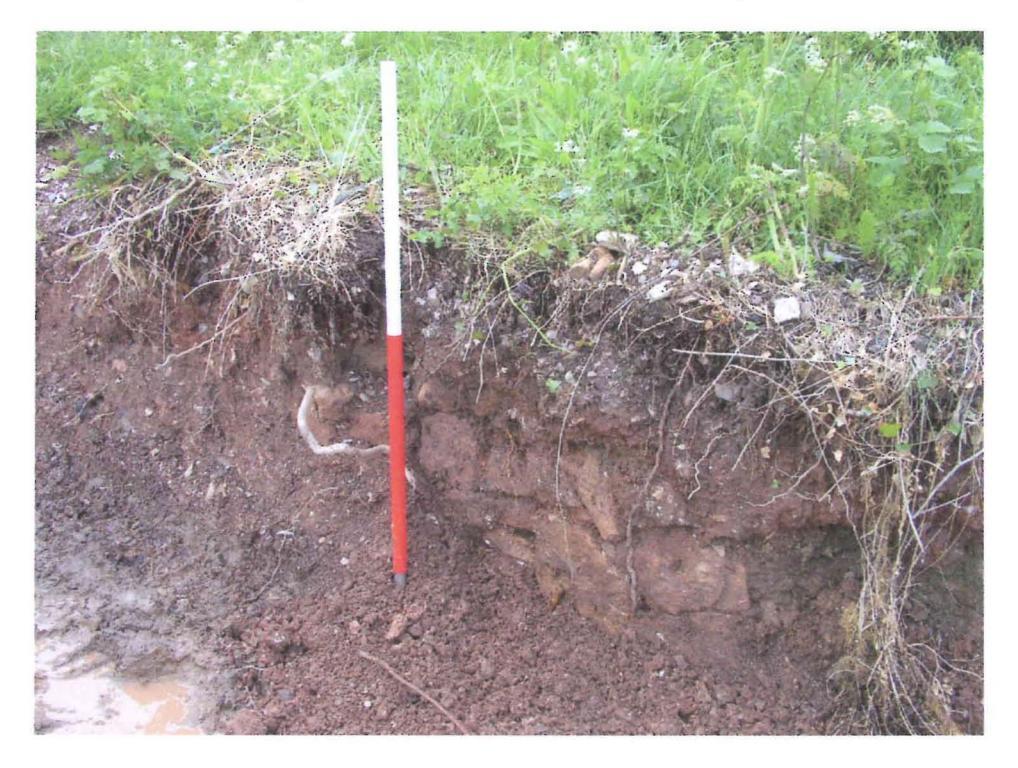
- 3.2 No evidence of Wat's Dyke was revealed in the trench, which crossed both of the putative alignments mentioned by Owen in 1996, but the opportunity was taken to make a brief photographic record of a stone revetment wall which was revealed in the south-eastern bank of the canal (see Plate 2, below). The revetment was probably an original feature which had been installed to protect the canal bank from erosion by wave action.

Plate 2 A section of the limestone rubble revetment wall in the south-eastern bank of the canal (Photo CPAT 2365-001)

- 4.3 Some information was forthcoming on the structure of the canal itself, for a limestone rubble revetment wall had been built into the south-east bank of the canal at the approximate level of the waterline. The wall was probably installed to protect the canal bank from wave erosion, which would have been a significant threat to the integrity of the waterway, given its height of approximately 3m above the adjoining land surface.

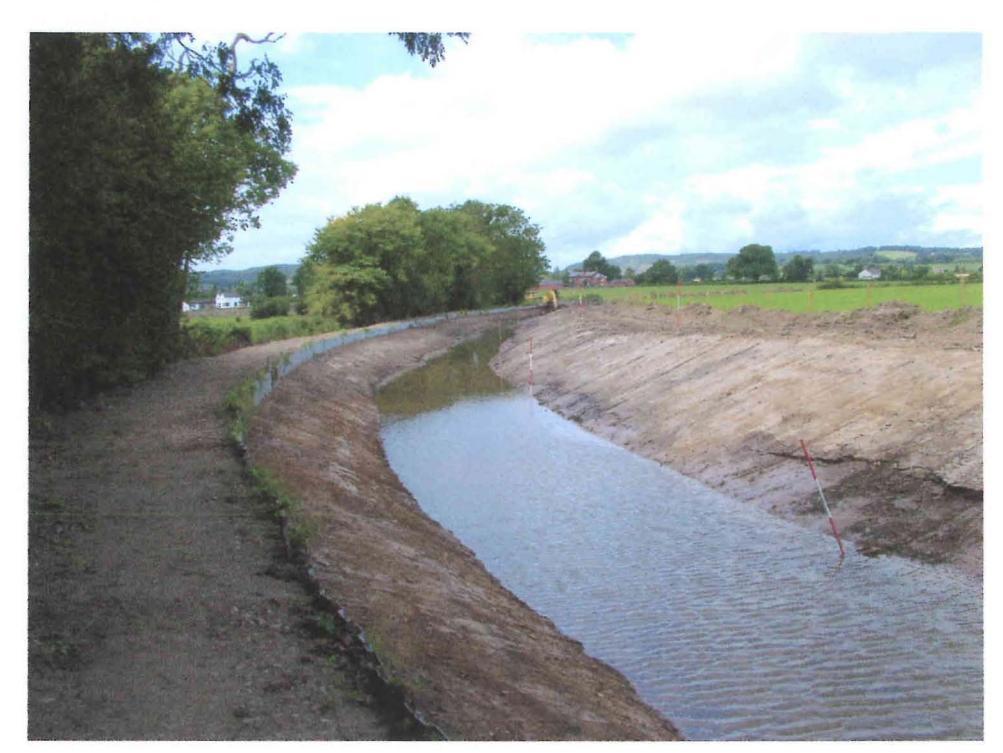
3.3 The second visit examined the machined surface of the base of the canal, which was designed to restore its original profile prior to the installation of a new clay lining. The soils that were revealed were carefully examined for evidence of either the bank or ditch of Wat's Dyke, but neither of these features was apparent. It appeared that the visible deposits were related to the construction of the canal bank and its old clay lining, and that no trace of the earlier earthworks was evident.

Plate 3 The relevant section of the canal, after its profile had been restored (Photo CPAT 2365-005)
