# Island Farm, Bridgend

Archaeological desk-based assessment and ASHIDOHL  
**September 2009**

A report for Davies Landscape Architects  
by Andy Sherman BA

GGAT report no. 2009/069  
Project no.P1352  
National Grid Reference:  
SS 86926 78134

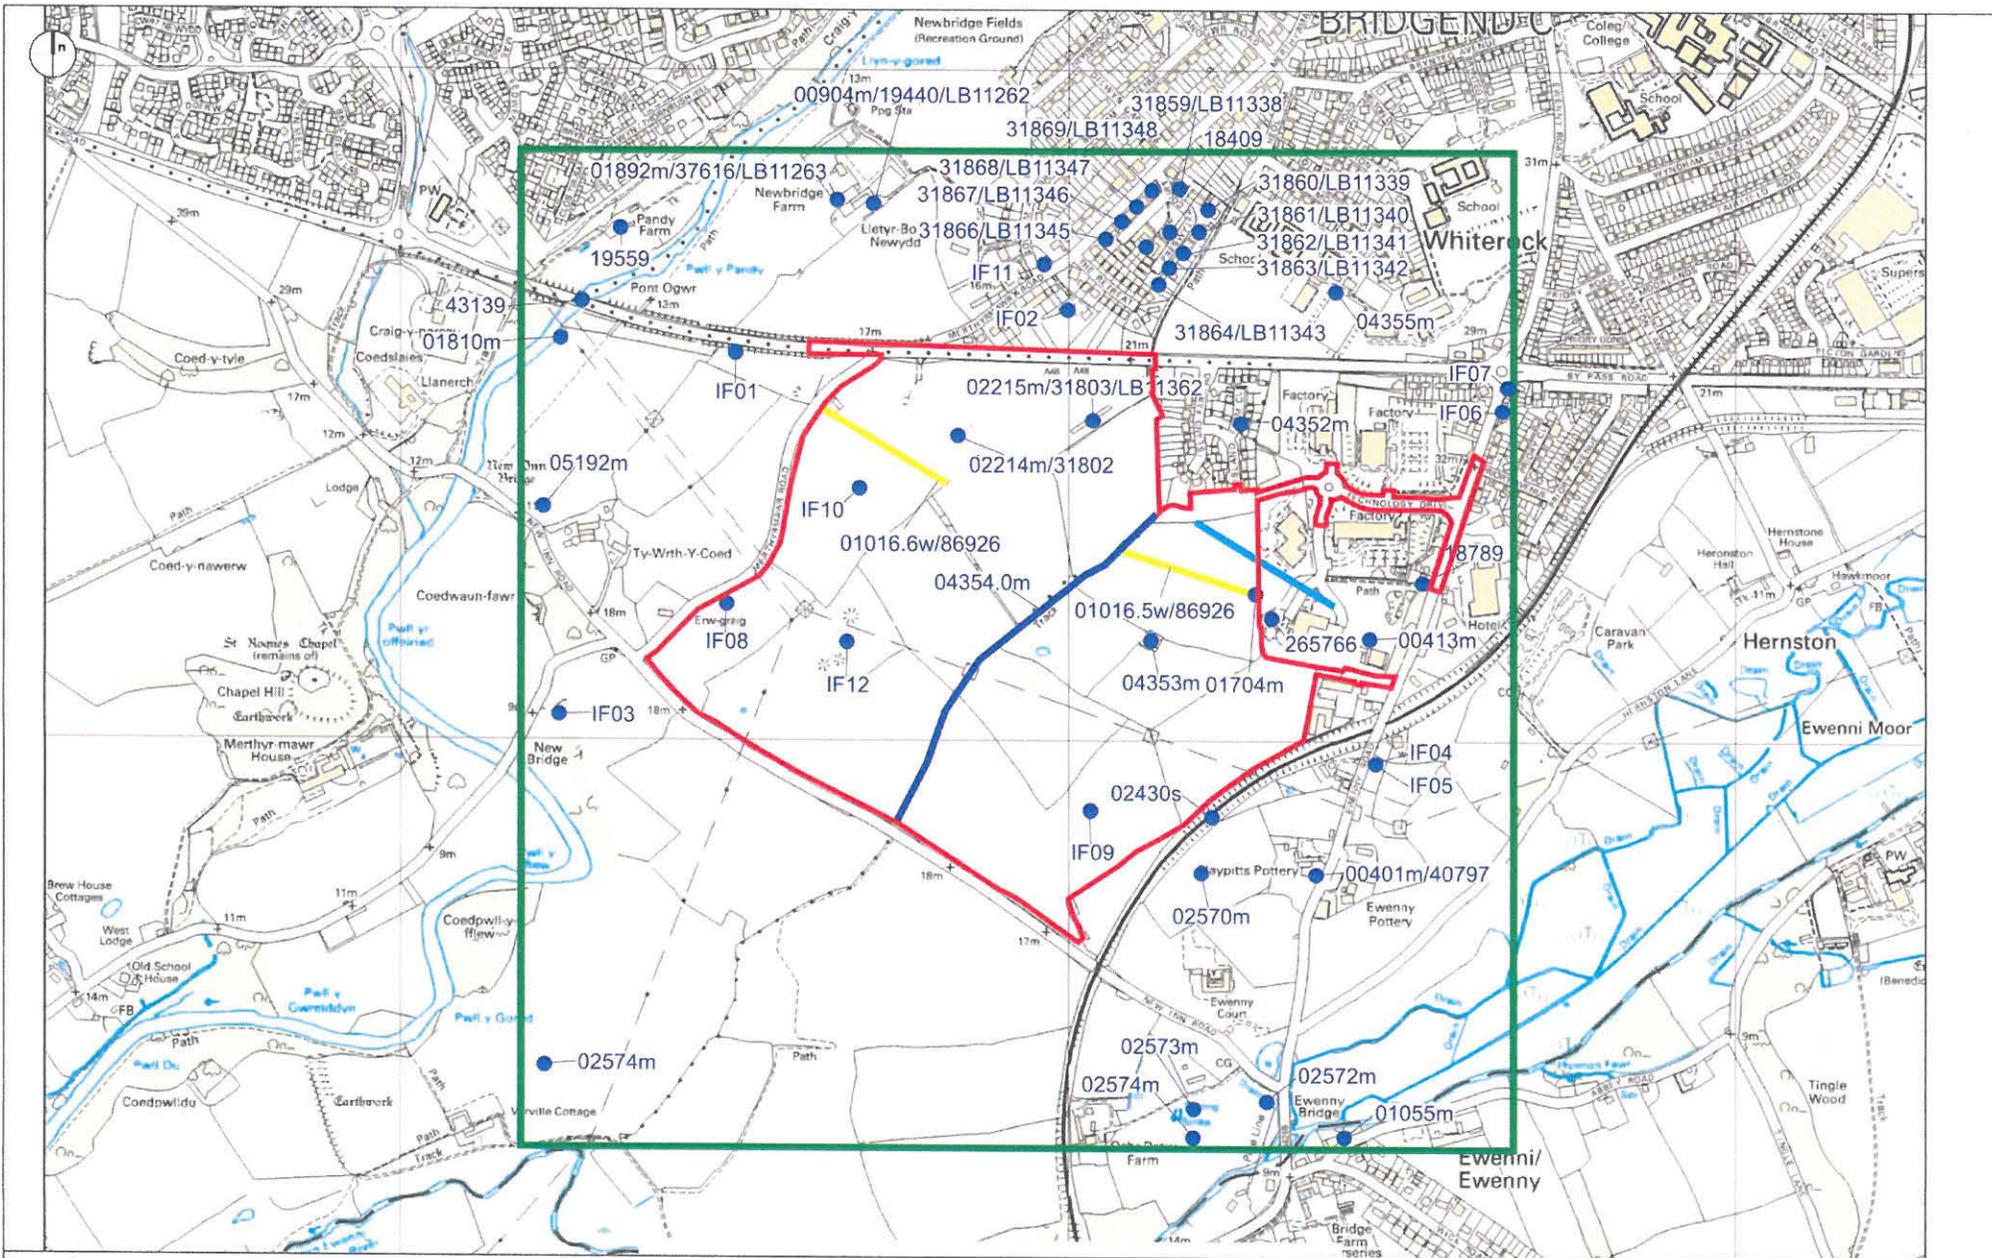
Fig 19

- Application boundary
- Study area
- Heolgam or Crooked Way
- Hedgerow alignment indicating route of Roman road
- Suggested location of agger
- Archaeological interest

Areas of Archaeological Interest

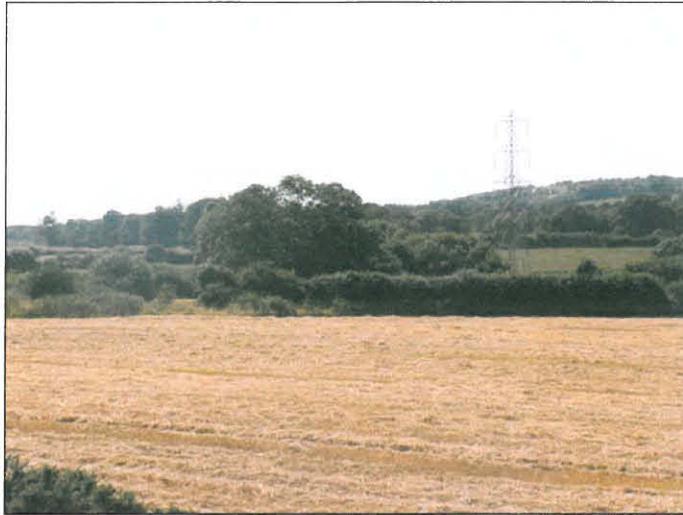
*Plate 1: The southern portion of the development area. View to the northwest.*

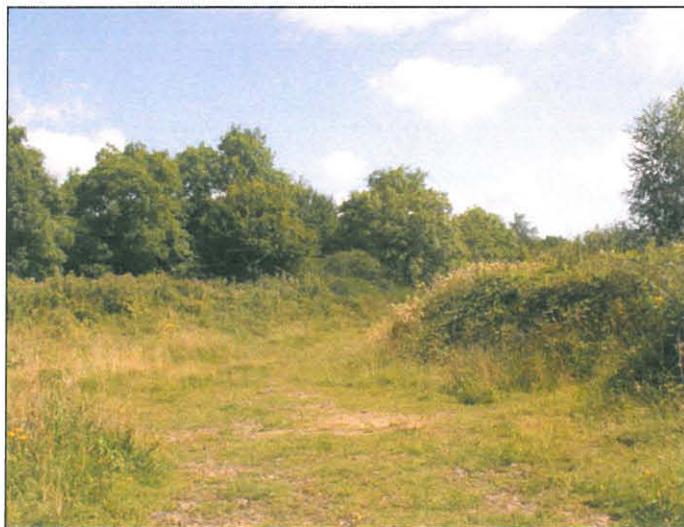
*Plate 2: Site of the Island Farm prisoner of war camp (ID 02214m/31802). View to the east.*

- 8.8.3 The northern section of the proposed development area is occupied by the site of the Island Farm PoW camp (ID 02214m/31802); the site visit conducted for this assessment established that the remains of the PoW camp are more intact than previously thought. As a result it is recommended that a total station survey should be conducted across this site in order to record the locations of the surviving remains. Due to the dense coverage of trees and shrubs across the site it is not currently possible for this survey to be conducted, therefore a programme of vegetation clearance will be necessary before the survey can be achieved.

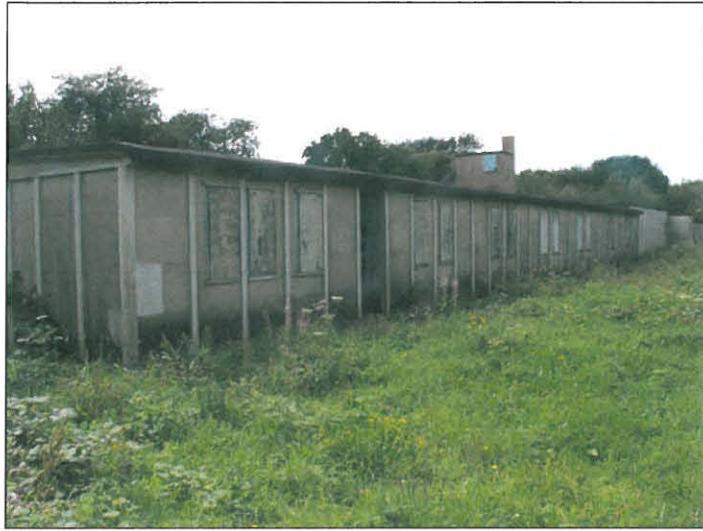
*Plate 3: Northern accommodation wing, Hut 9 (ID 02215m/31803/LB11362).*

*View to the southwest.*

8.6.2 Hut 9 (ID 02215m/31803/LB11362) is located to the north of the area designated as the 'Nature Conservation Area' and a new maintenance road will be constructed off the A48 Bypass road to enable the council to maintain it, therefore the proposed development has been assessed as having a 'beneficial' effect of this site. It should, however, be noted that CCW have concerns with the effects on a population of lesser horseshoe bats currently roosting in Hut 9. A purpose built bat-house will hopefully displace the bats from this sub-optimal habitat and allow the Council to perhaps restore the site as a visitors centre in the future.

effect on this site. Improving the appearance of Hut 9 and providing public interpretation boards describing the historic use of the site and the resulting prison break would enhance the 'beneficial' effect on this monument. It is, however, noted that these further improvements are not practical at the current time due to the presence of a population of lesser horseshoe bats roosting in Hut 9 (see paragraph 8.6.2 above).

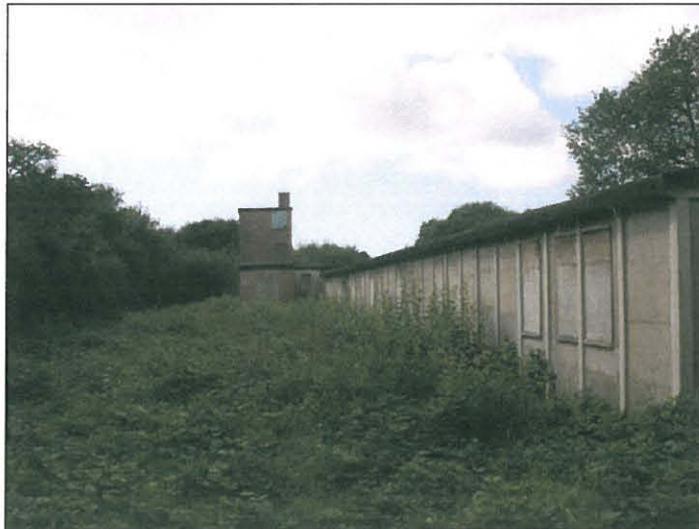
*Plate 4: Central boiler room and water tank, Hunt 9 (ID 02215m/31803/LB11362). View to the northeast.*

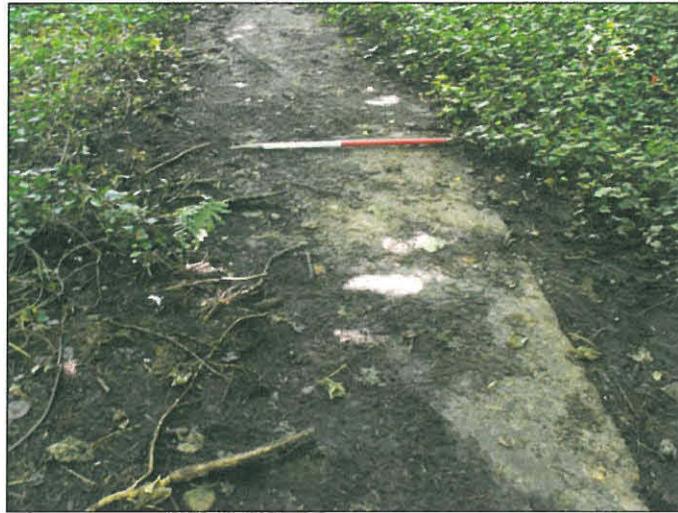
*Plate 5: Concrete path forming part of Island Farm prisoner of war camp (ID 02214m/31802).  
View to the northwest.*

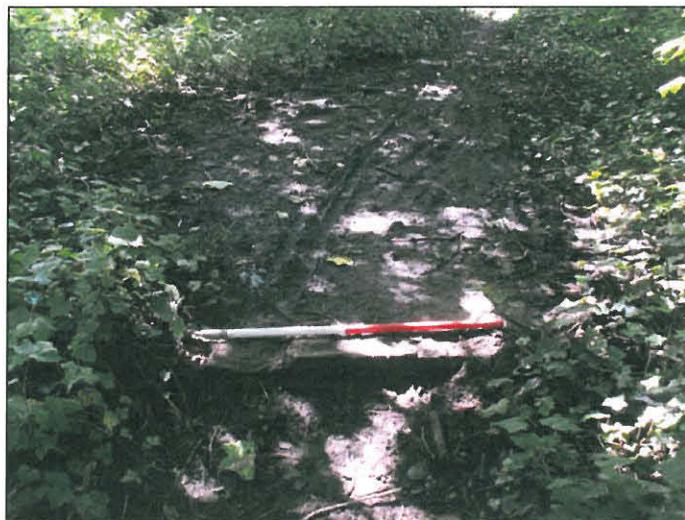
*Plate 6: Brick-built base to prisoner hunt, forming part of Island Farm prisoner of war camp (ID 02214m/31802). View to the east.*

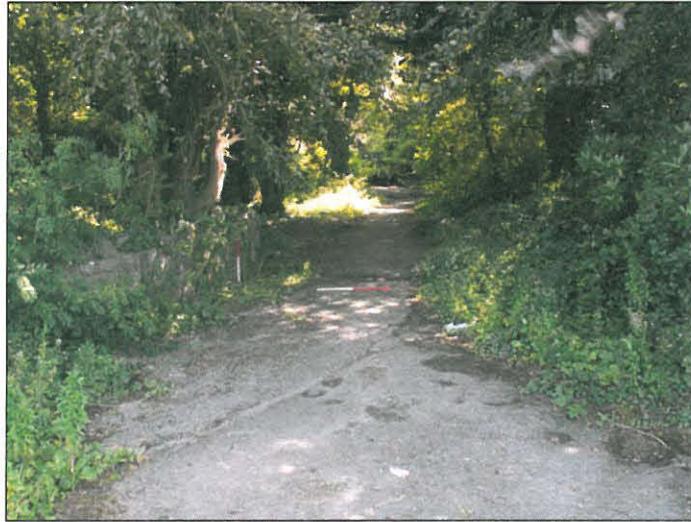
*Plate 7: Tarmac driveway leading to Crossways (ID IF09). View to the east.*

- 8.8.9 It has been assessed that the proposed development will have a 'severe' effect on building IF09; it is therefore recommended that an archaeological watching-brief be conducted during all groundworks in the area of this site.
- 8.8.10 The archaeological works should be carried out to the professional standards laid down by the *Institute for Archaeologists*.

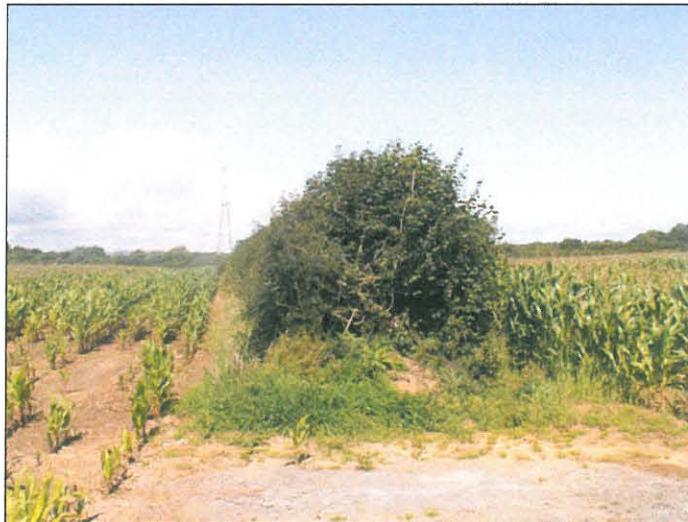
*Plate 8: Hedge marking the route of Trackway (ID 04354.0m). View to the north.*

- 8.8.6 The route of a sunken trackway (ID 04354.0m) of probable medieval date, forming part of the *Heolgam* or the Crooked Way has been identified as running through the proposed development area on a northeast – southwest alignment. The proposed development will have a 'severe' effect upon this trackway. Therefore topographic and photographic surveys to a Level 3 monuments survey as set out in *RCHME's Recording Archaeological Field Monuments* (1999) is recommended in order to preserve this monument in record before it is destroyed.
