**Medieval and Early Post-Medieval
Monastic and Ecclesiastical Sites in East
and North-East Wales**

**The Scheduling Enhancement Programme:
Recommendations**

R J Silvester and R Hankinson

March 2011

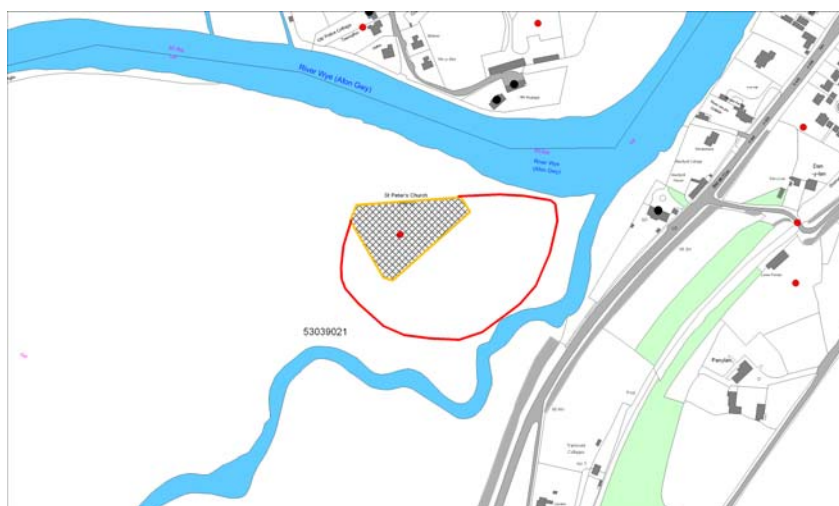
a) above. Recommended enhancement to scheduled area at Glasbury old church, Breconshire. The existing scheduled area is shaded while the area recommended for scheduling is outlined in red. ©Crown Copyright and database right 2011. All rights reserved. Welsh Assembly Government. Licence number 100017916.

The earthworks of the old church at Glasbury were recommended for scheduling in March 2004 (CPAT Report 624). This was followed up and the triangular mound on which the church was placed together with a buffer zone were subsequently scheduled as Br350.

Unfortunately, the associated earthworks of the curvilinear churchyard were overlooked at that time and were not included in the scheduling envelope. We would suggest that this is rectified by enlarging the scheduled area. The churchyard earthwork is an integral part of the site, and as one of the early clas structures which continued in use as a parish church into the post-medieval centuries this is one of the most important sites of its kind in Powys, made all the more rare by the fact that it is now abandoned.

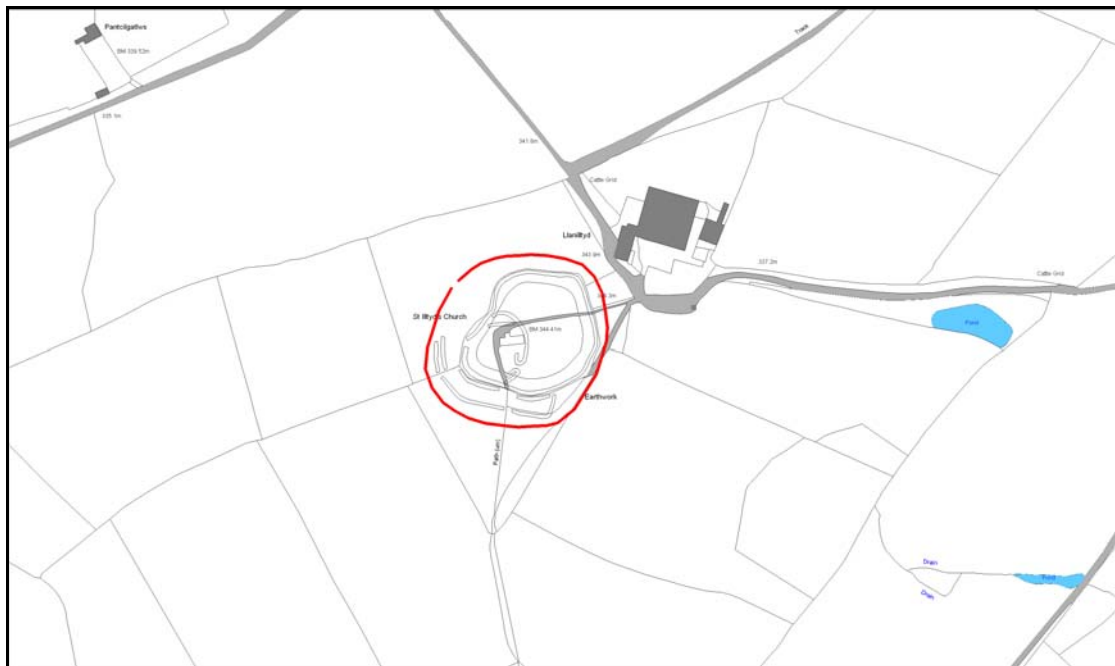
The churchyard at Llanilltyd has always been recognised as a complex earthwork of more than one phase. There is a smaller curvilinear enclosure set into one side of a larger one. The current appearance of these earthworks suggest that the smaller earthwork is earlier and that the larger earthwork diverges from its line to join it. The implication is that the site probably originated as a prehistoric enclosure, and was subsequently adopted as a churchyard.

Recommended scheduling area at Llanilltyd churchyard near Brecon. The area recommended for scheduling is outlined in red. © Crown Copyright and database right 2011. All rights reserved. Welsh Assembly Government. Licence number 100017916.

The earthworks thus have considerable interest and importance, and the writer is at a loss to understand why this site has been consistently overlooked for statutory protection. Of the eight scheduling criteria, it meets six if not seven.

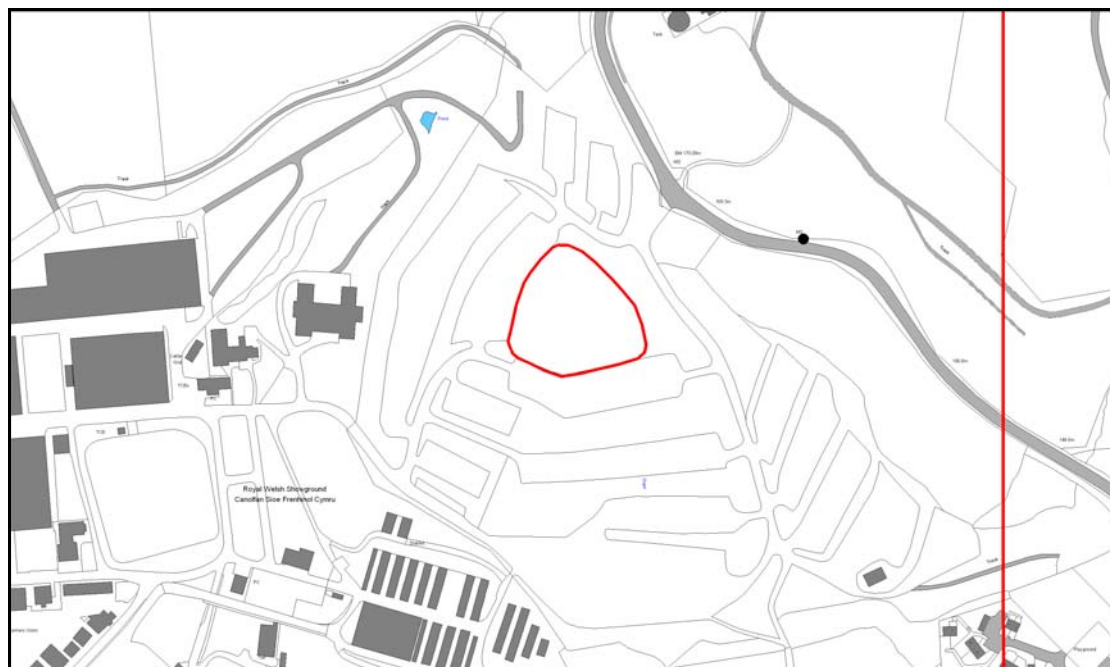
The site occupies a slightly domed knoll (on the east side of the Royal Welsh Showground), though much of it is fairly flat and might even be artificially levelled, albeit with some surface irregularities. The highest point is in the south-east quadrant, perhaps the place for the church? But there is now no visible surface trace of the building. Around the west side of the knoll extending to the south-west is a low scarp bank, with perhaps a hint of an external gully. This appears to be curvilinear. Geophysical survey by ArchaeoPhysica reveals good sub-surface survival of church, churchyard and burials.

Recommended scheduling area at Henllan, Llanelwedd, Powys. The area recommended for scheduling is outlined in red. © Crown Copyright and database right 2011. All rights reserved. Welsh Assembly Government. Licence number 100017916.

Henllan is a rarity in the region - a lost church with good sub-surface preservation, its associated features in place and, at present, a positive attitude on the part of the land owner to avoid any significant intrusion from development.

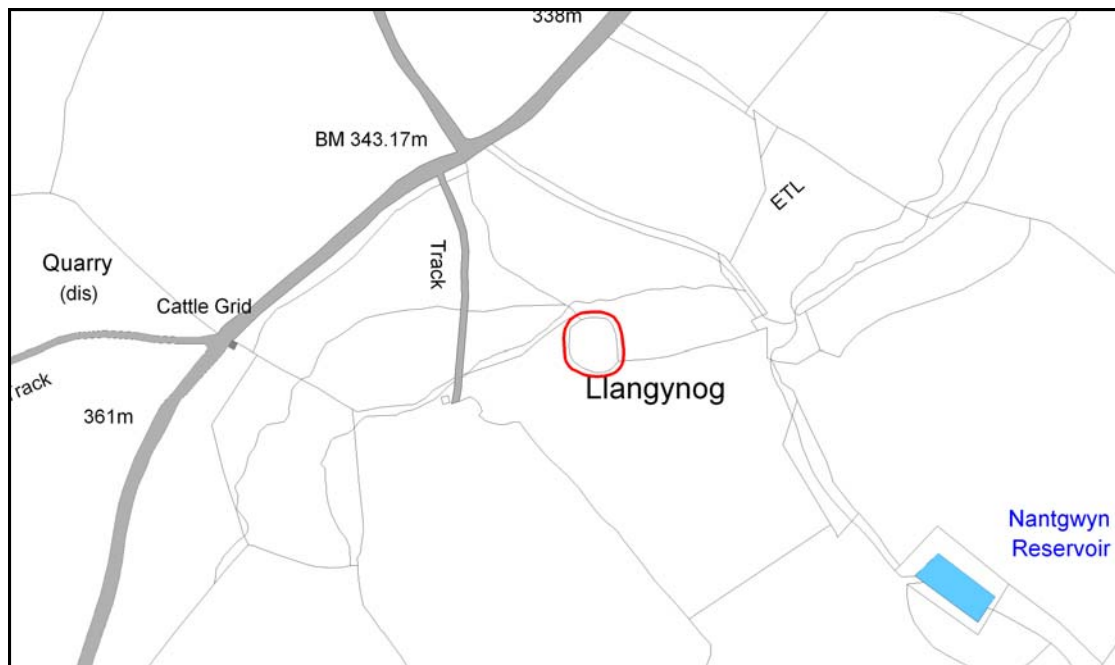
Virtually no visible superstructure from Llangynog church exists, apart from some rubble, but the foundations certainly remain in place. The boundary of the churchyard survives as a grassy earthen bank, fronted in places by a stone revetment and there are also earthwork traces which together indicate the presence of an early curvilinear churchyard here.

Recommended scheduling area at Llangynog, Breconshire. The area recommended for scheduling is outlined in red. © Crown Copyright and database right 2011. All rights reserved. Welsh Assembly Government. Licence number 100017916.
