St David's Church, Newtown

**AN ARCHAEOLOGICAL ASSESSMENT
IN ADVANCE OF REDUNDANCY**

CPAT Report No 815

R J Silvester
September 2006

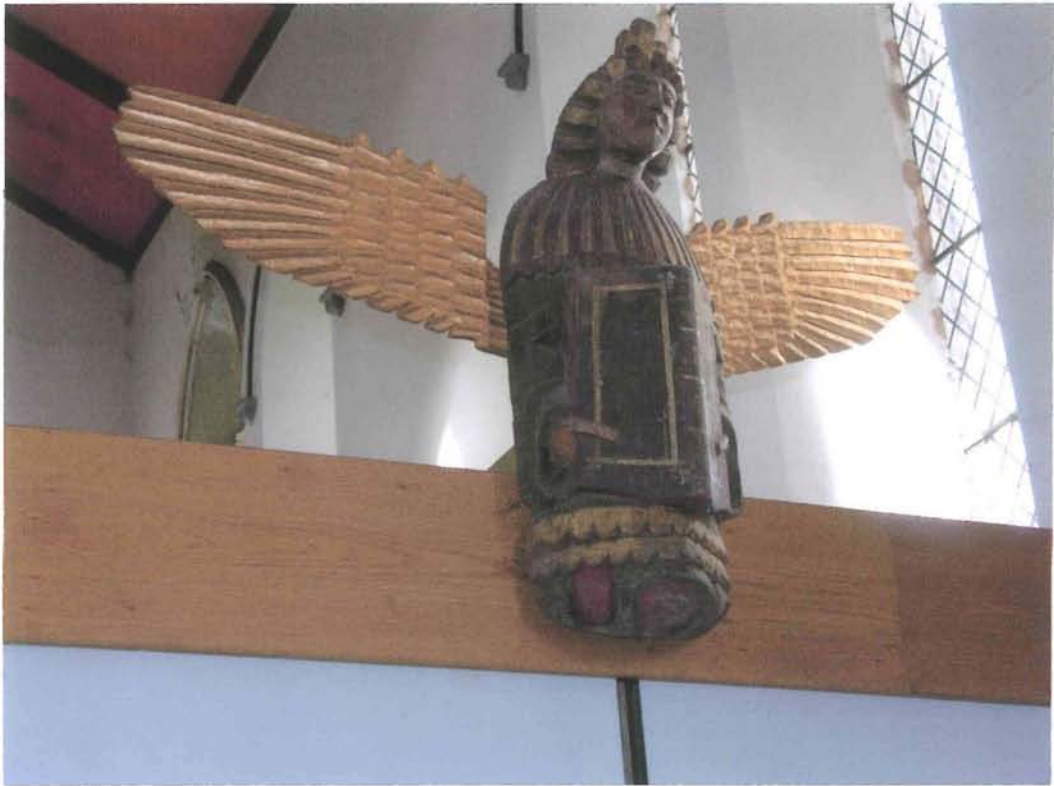
Three gilded and painted *angels*, perhaps terminals from a medieval hammerbeam roof (*cf* *Llanidloes*). Two in the north aisle, one high on the wall at the east end, and the third in the south aisle.

Plate 1: one of three angels from a former hammerbeam roof

- 2. It is imperative that the most important wooden furnishings and fittings be re-located to appropriate repositories. These would include the various sections of the medieval rood screen, the three medieval angels and the two early 17th-century chairs.*

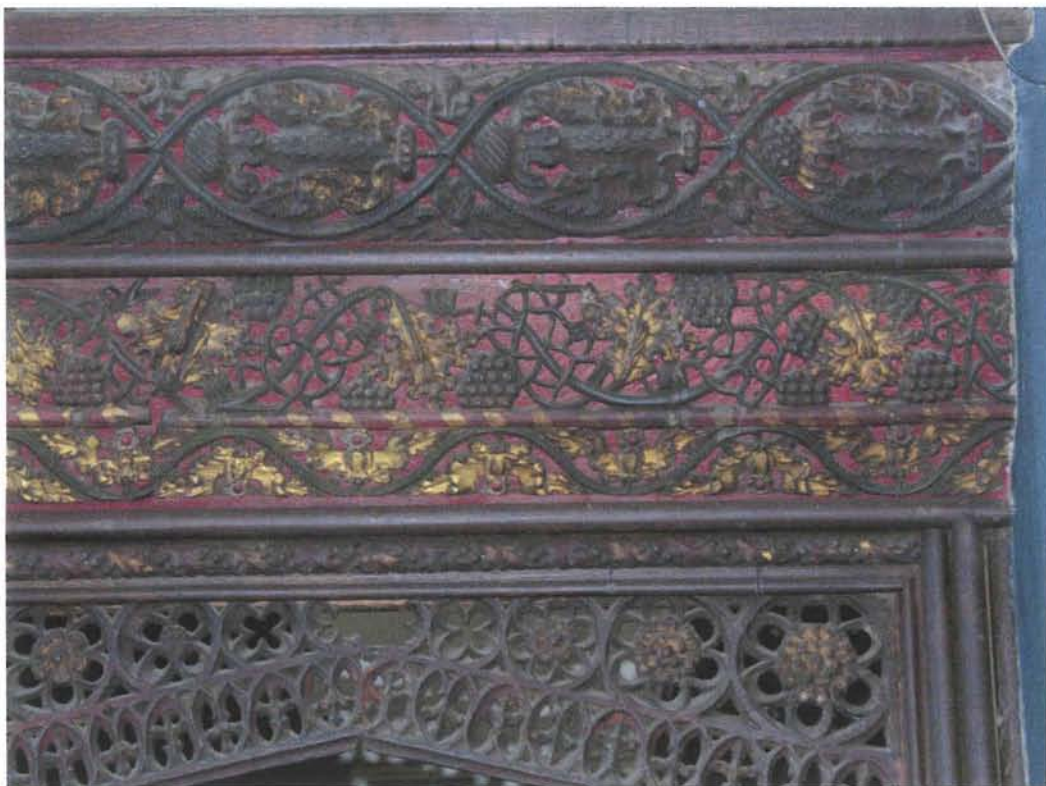
Rood screen. Various parts of the screen from St Mary's have been utilised in St David's. Haslam thought it 'the highest in quality of any of the so-called Newtown School, except perhaps for Llananno' while a recent volume on the screens in the Welsh Marches claims that 'the woodwork is startling in its variety and includes several carved pieces of almost unparalleled finesse'. Some parts retain their original colours, green, red and gold. Part used as a parclose screen – sections approximately 3.5m and 2.5m long – to surround a small chapel at the east end of the north aisle. The hood over the altar in the Lady Chapel also uses parts, and the dado around the sanctuary is fashioned from the screen.

Plate 2: detail from the late medieval screen, formerly in St Mary's church, Newtown

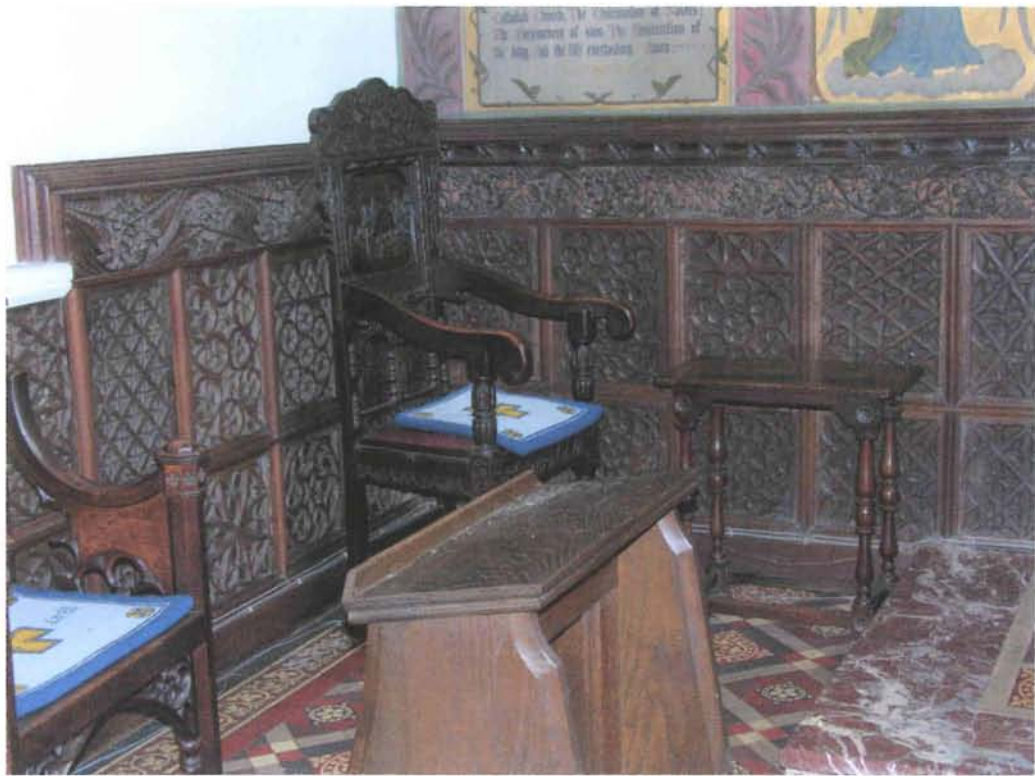
Chairs. A pair, elaborately carved and with highly decorated panels, inscribed with the name Edward Talbot, Earl of Shrewsbury and carrying the date 8 May 1616, assumed to be the date of his succession to the earldom. In the sanctuary.

Plate 3: parts of the former screen used around the sanctuary, together with an early 17th-century chair

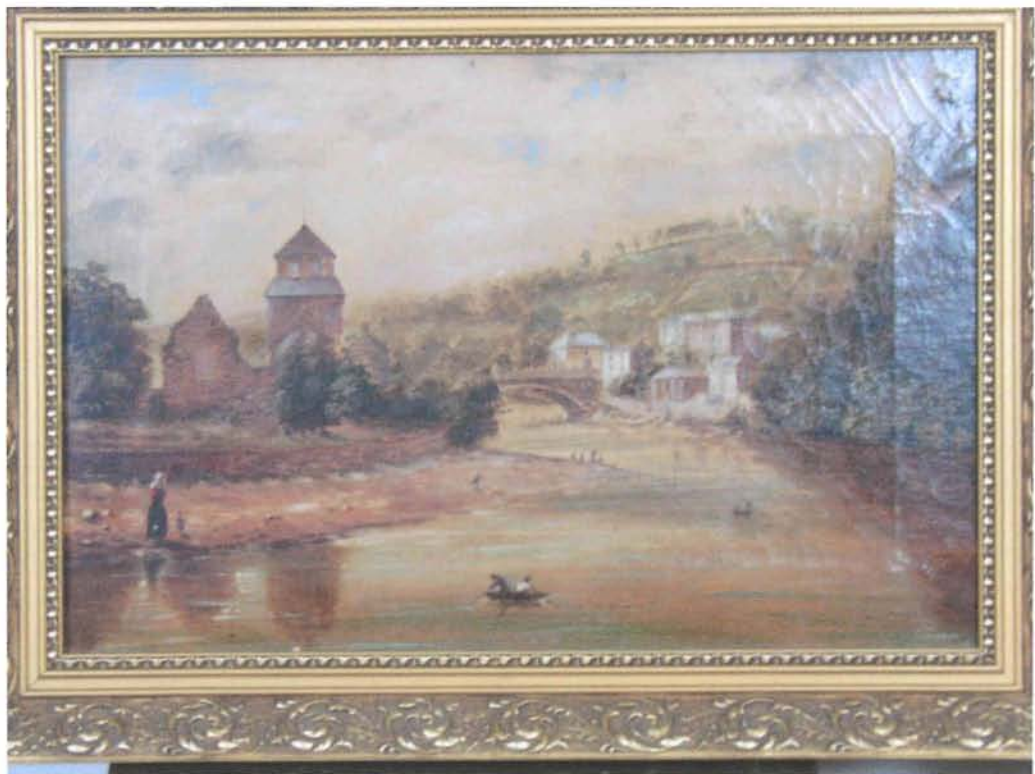
Pair of paintings – 19th-century? - of the Severn, one showing the old church of St Mary's in ruins, the other perhaps looking along the valley in the opposite direction. North aisle meeting area.

Plate 4: painting of old St Mary's church, Newtown

- 6. Advice should be taken on the importance of the Dyer painting and depending on that advice, a decision should be taken as to where it should be re-housed. The painting of the old church may have some local interest. Again advice should be taken. The other paintings do not appear to have great merit, but the writer would claim no expertise in this field.*
