TRE'R CEIRI
CONSERVATION PROJECT
1989 - 90
PART 2: PLATES

REPORT ON THE FIRST SEASON OF THE
TRE'R CEIRI CONSERVATION PROJECT
DECEMBER 1989 - MARCH 1990

S.D. BOYLE

PART 2: PLATES

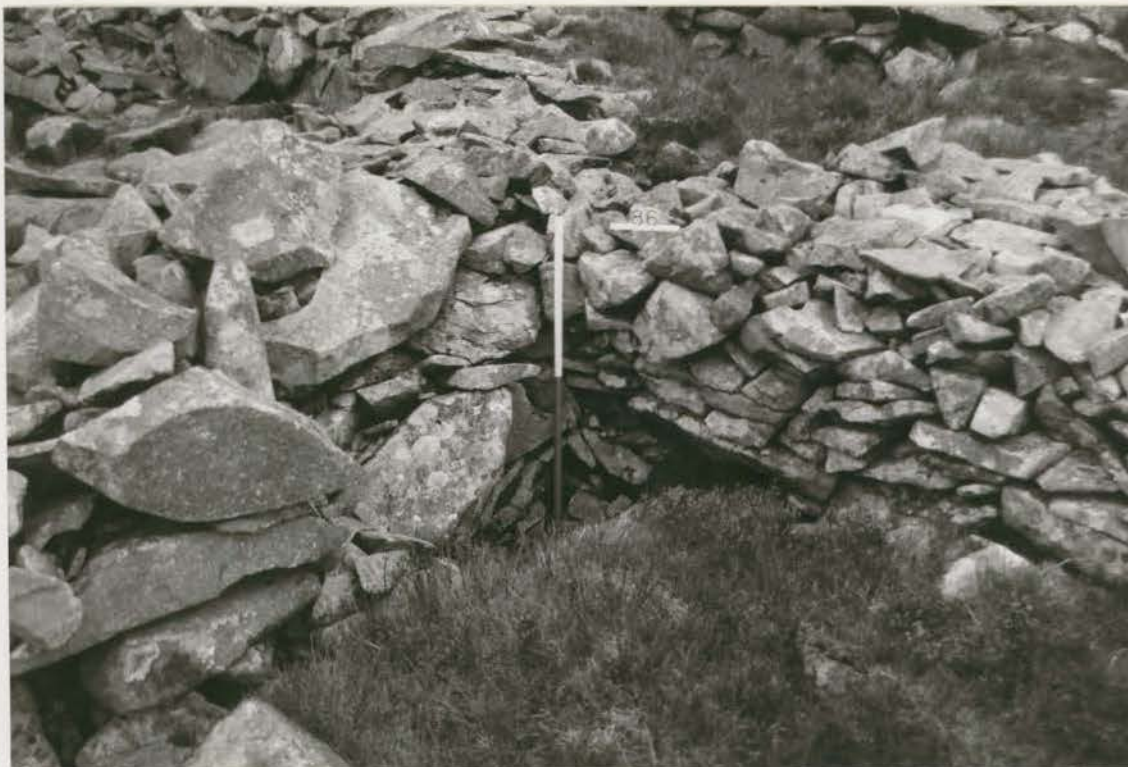
Plate 3. Hut 86: E corner, before conservation (G1022/001/13).

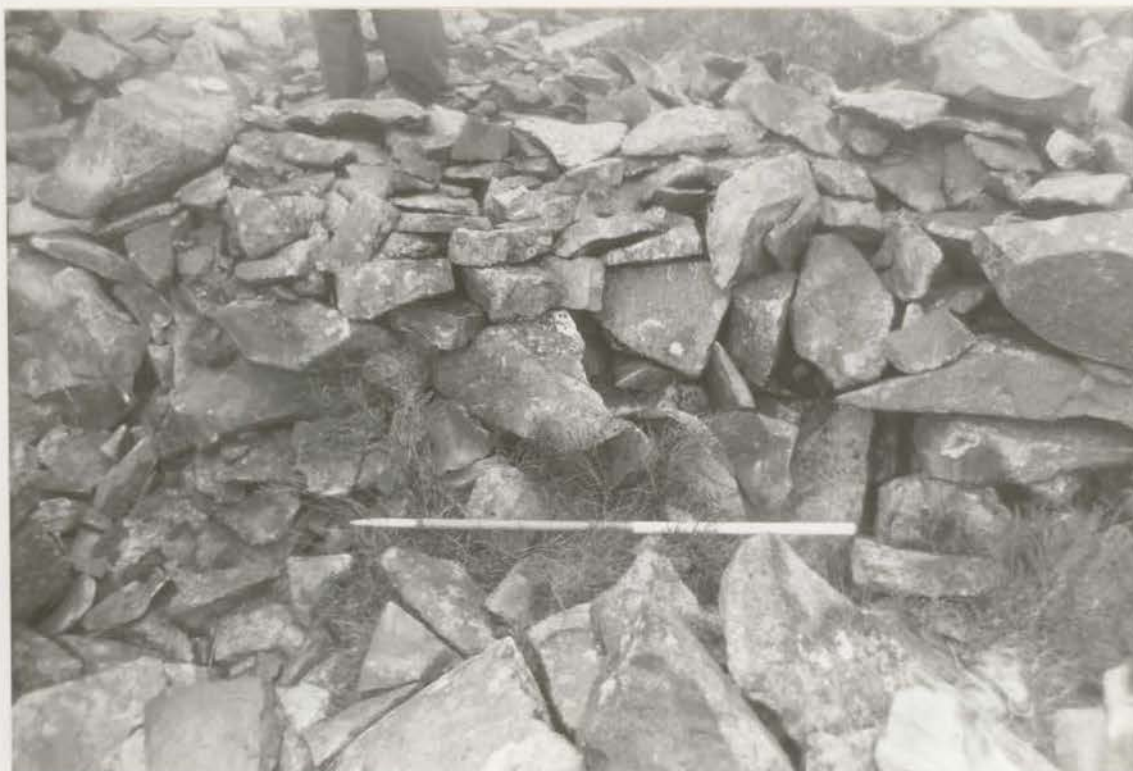
Plate 4. Hut 86: NE wall after clearance of tumbled stones, looking NE (G1022/005/12A).

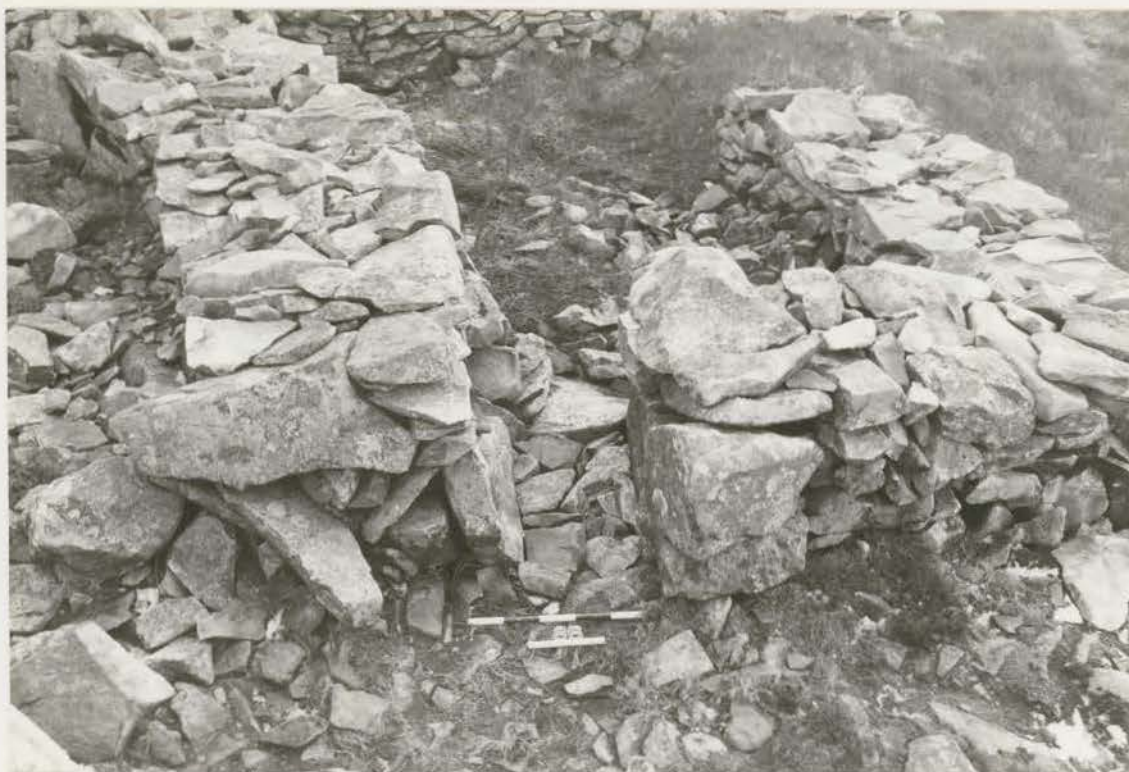
Plate 5. Hut 86: NE wall and entrance restored, looking SE (G1022/022/04A).

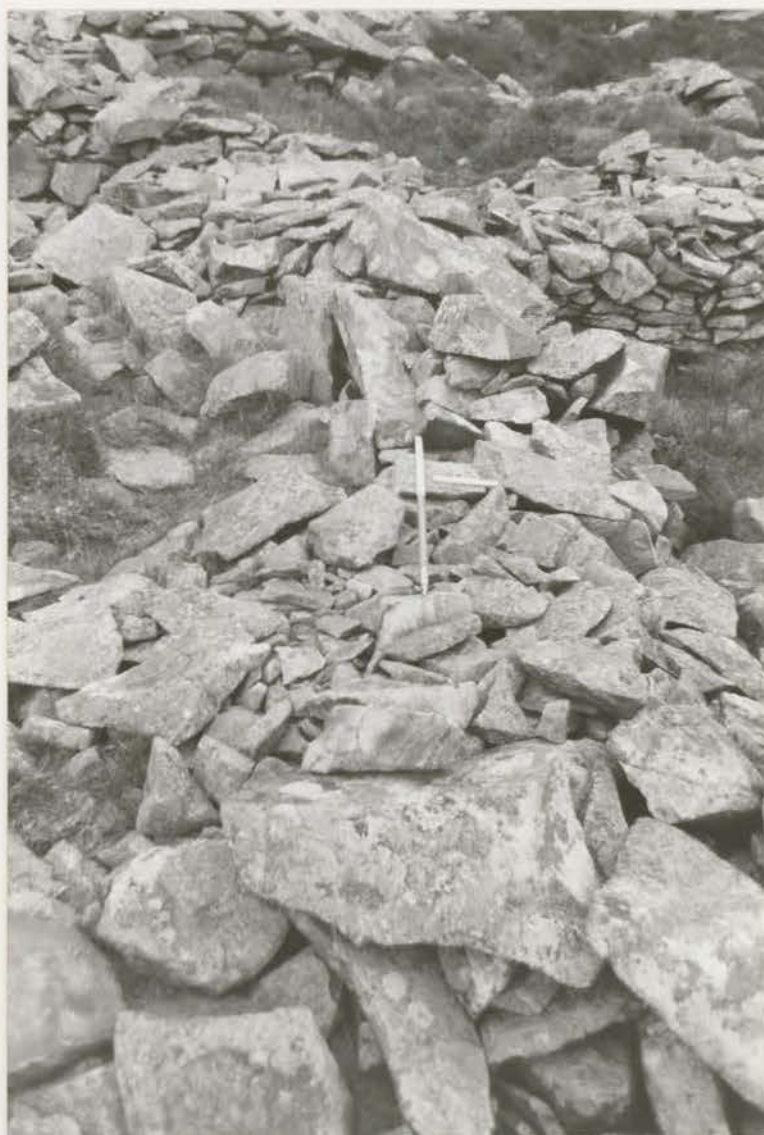
Plate 6. Hut 86: outer face of NE wall before conservation, looking SE (G1022/003/15).

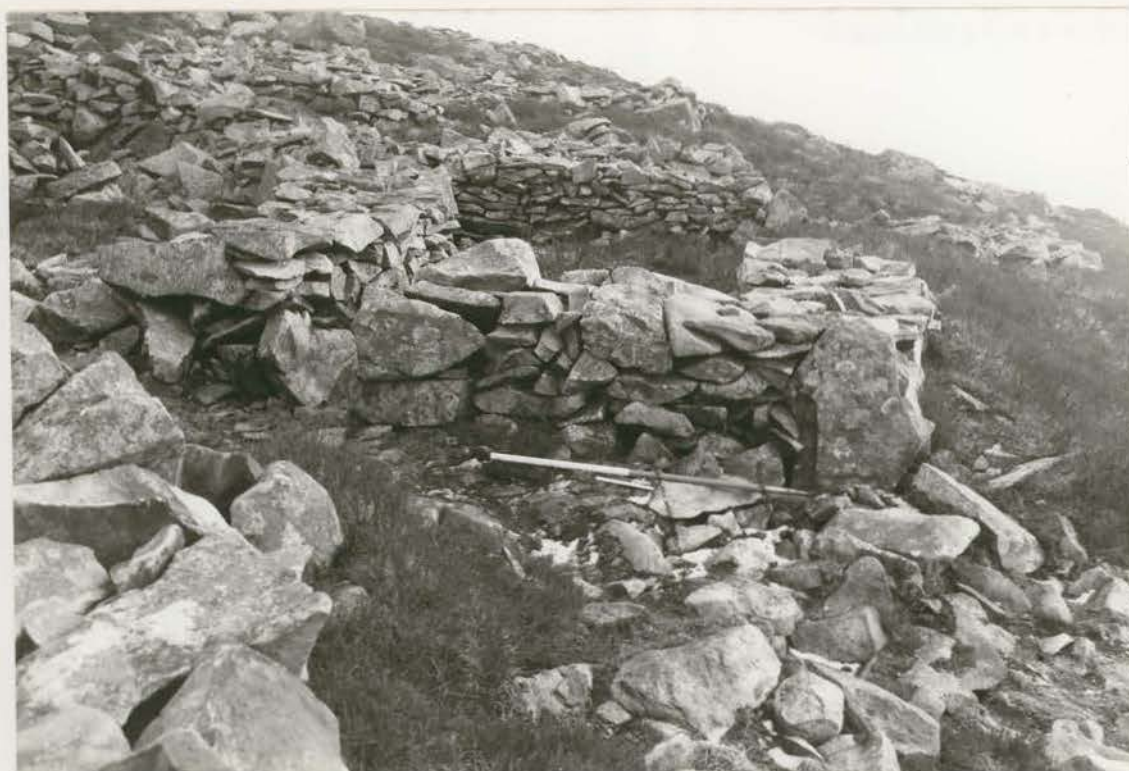
Plate 8. Hut 86 after conservation, looking SE (G1022/022/03A).

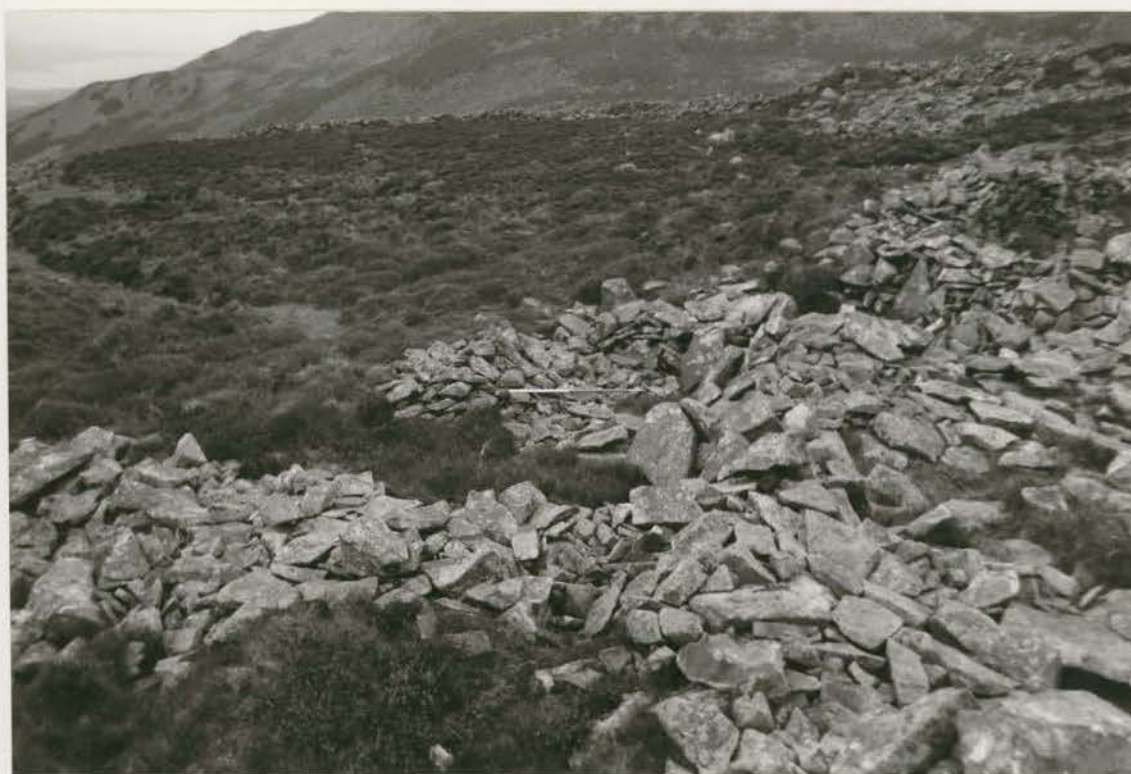
Plate 9. Hut 86 before conservation, looking W (G1022/001/11).

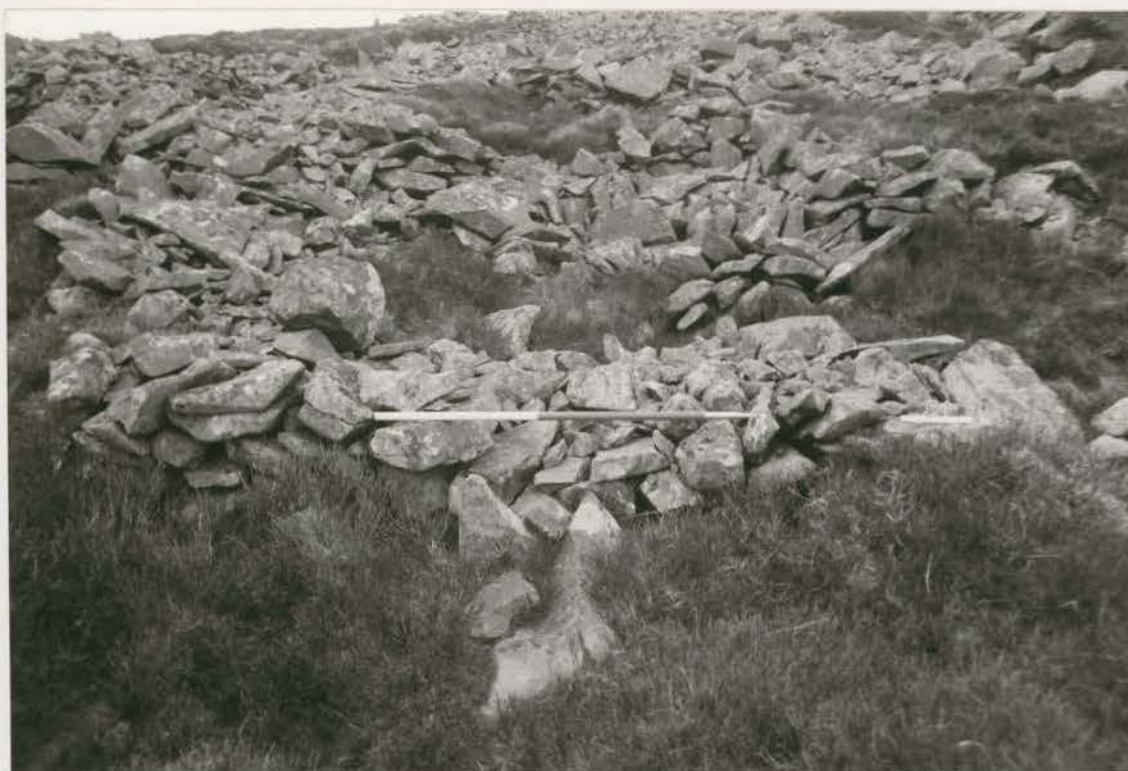
Plate 11. Hut 51 before conservation, looking NE (G1022/001/19).

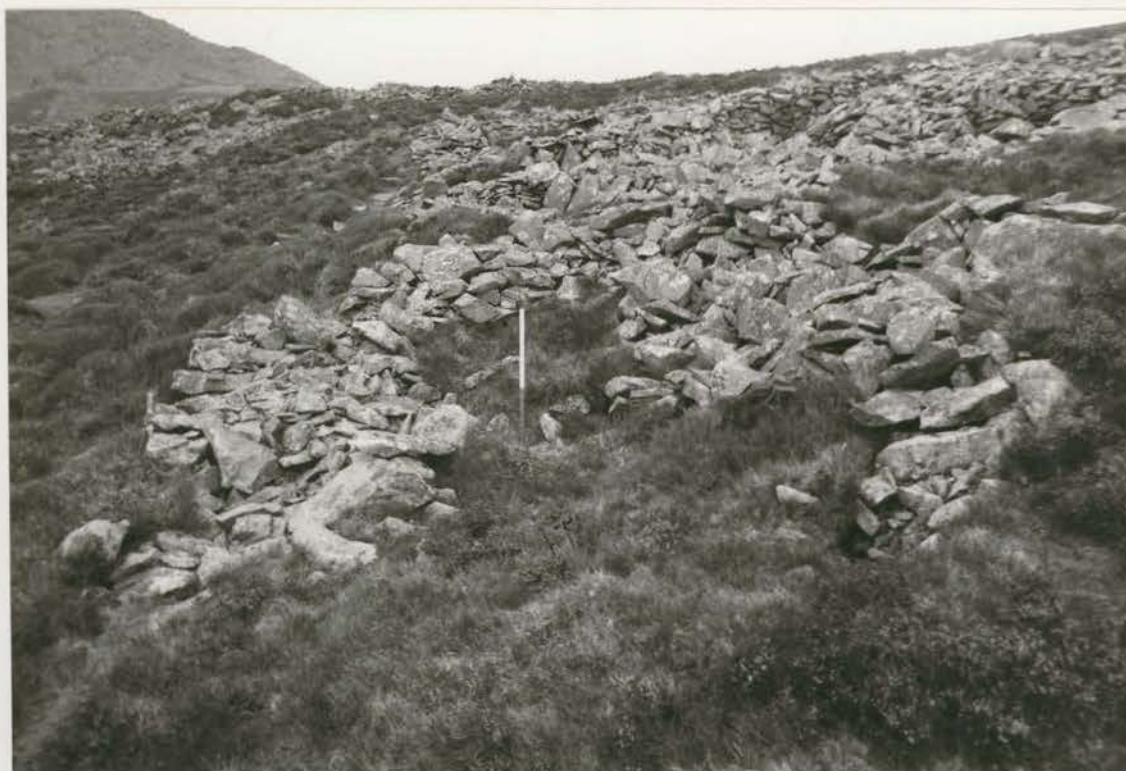
Plate 12. Hut 51 before conservation, looking NW (G1022/001/15).

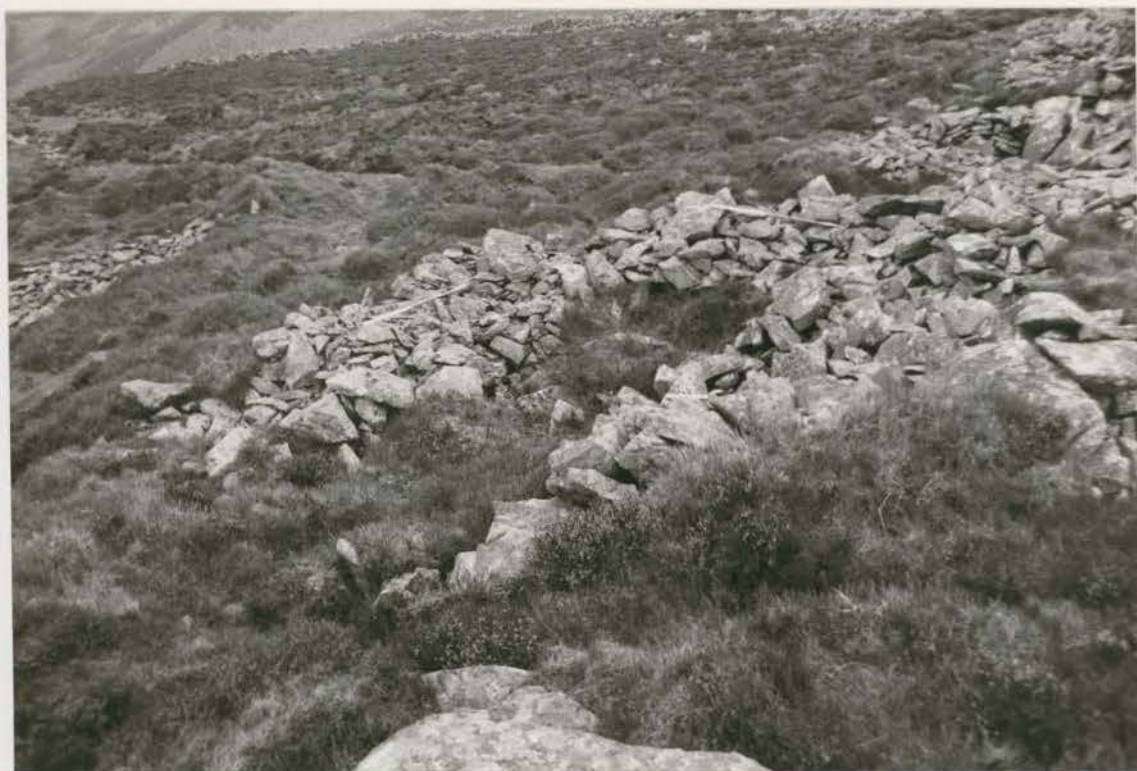
Plate 13. Hut 51 before conservation, looking W (G1022/001/16).

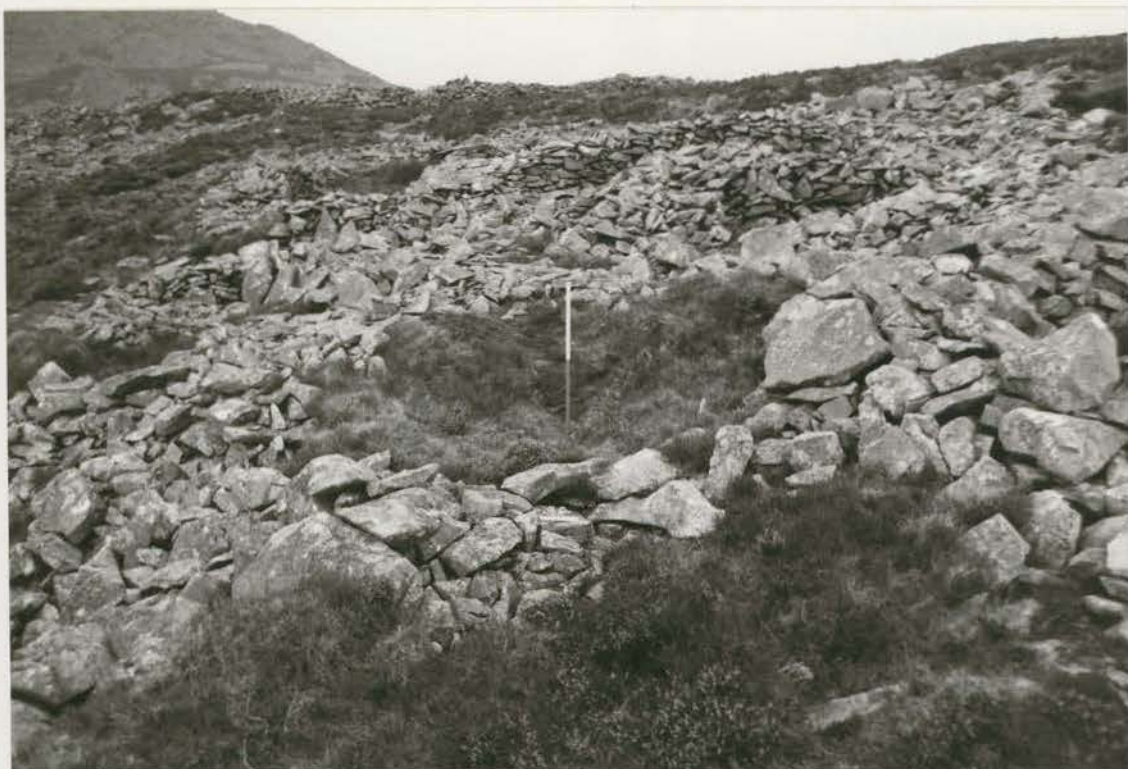
Plate 15. Hut 52 before conservation, looking NW (G1022/001/23)

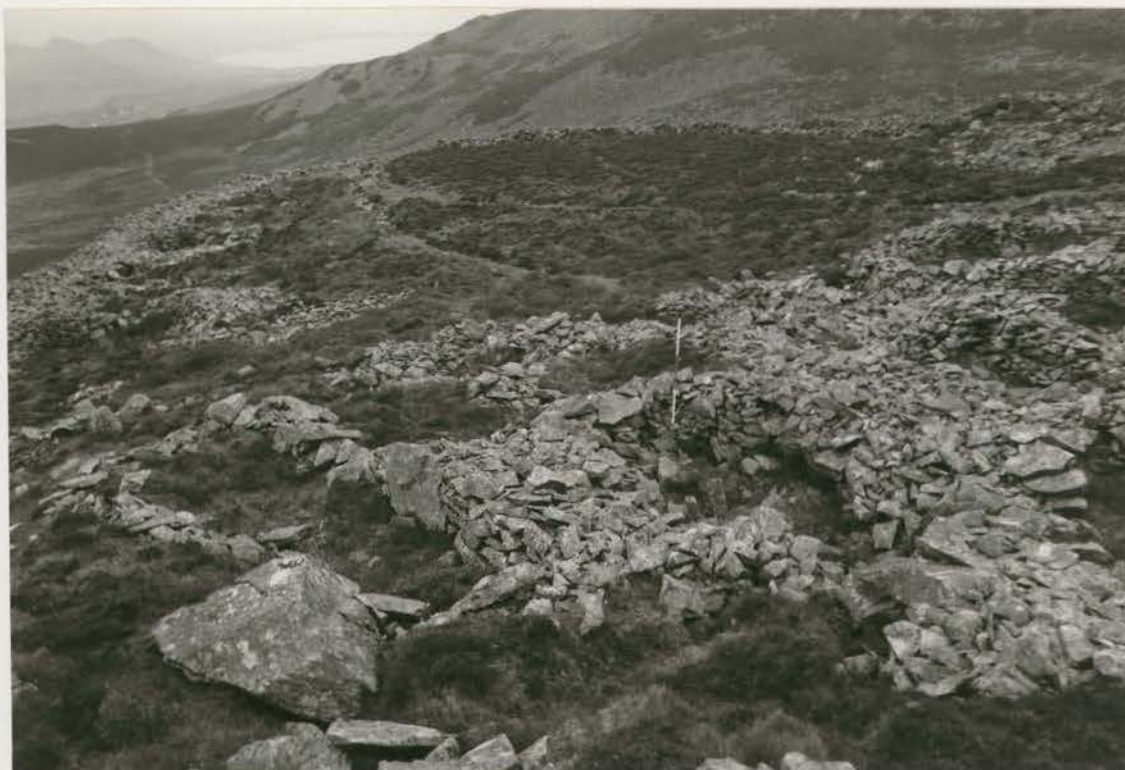
Plate 19. Hut 72 (left of frame) before conservation, looking W
(G1022/001/05).

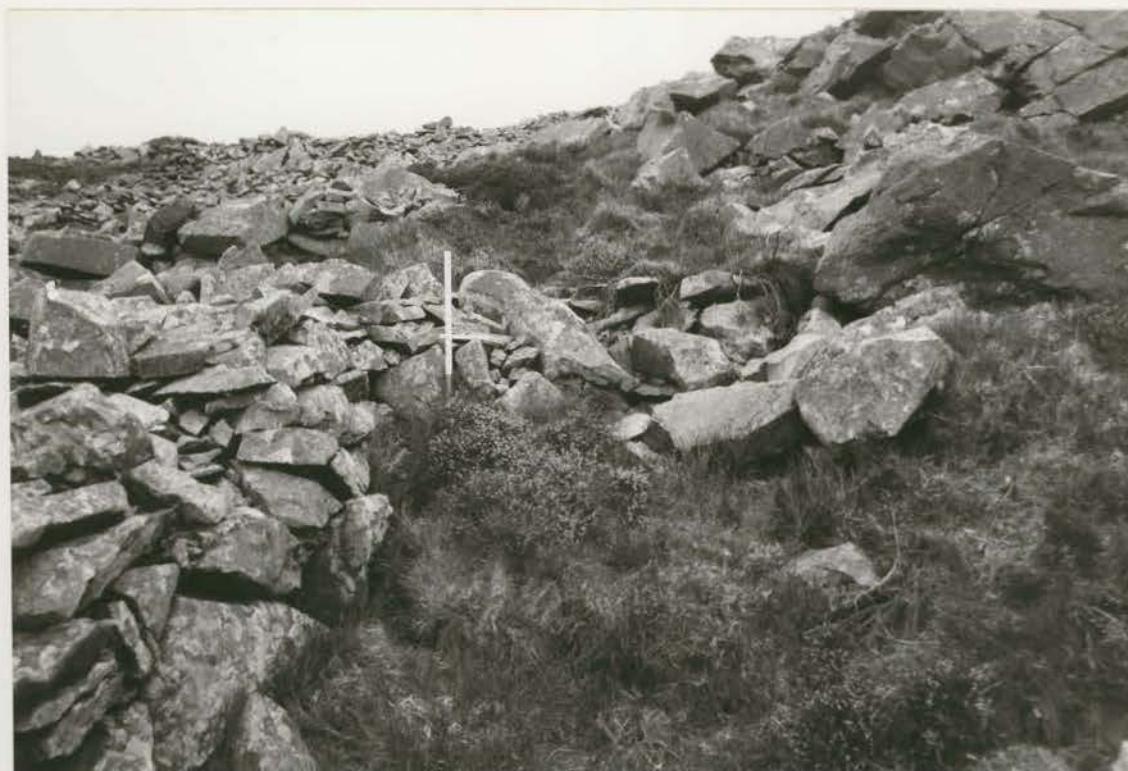
Plate 20. Hut 72: NE wall before conservation, looking NE
(G1022/001/30).

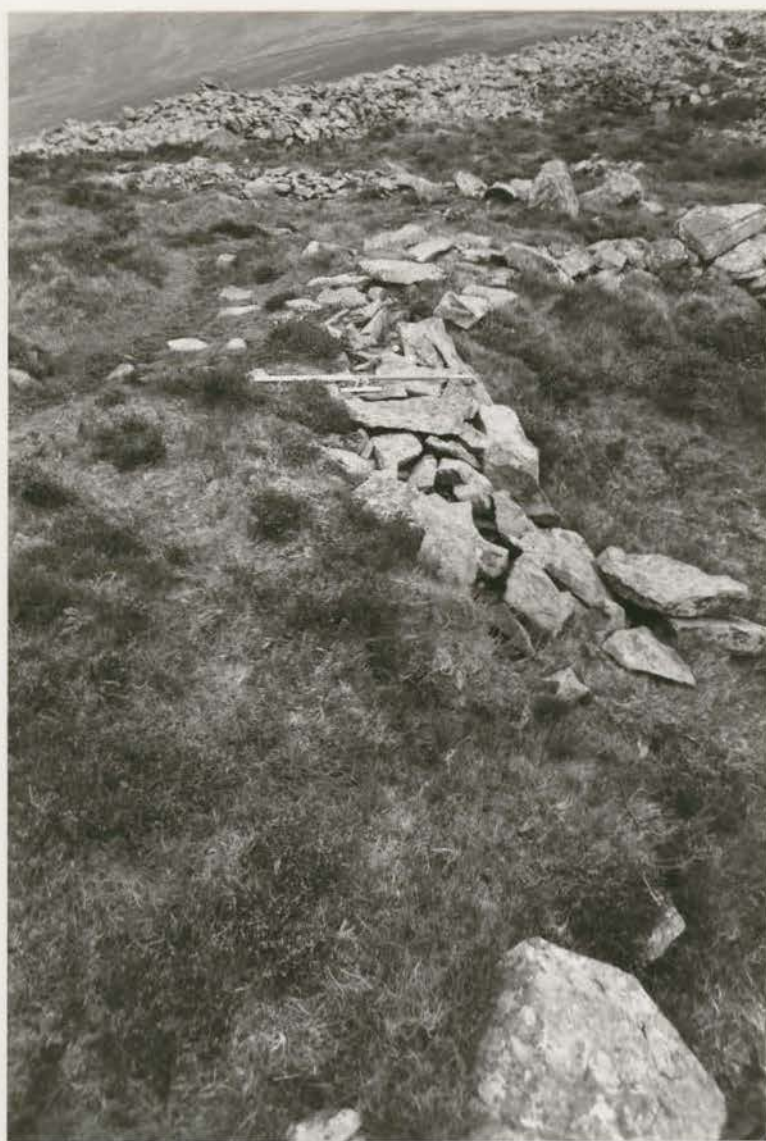
Plate 24. Hut 72: SE wall before conservation,
looking SW (G1022/001/29).

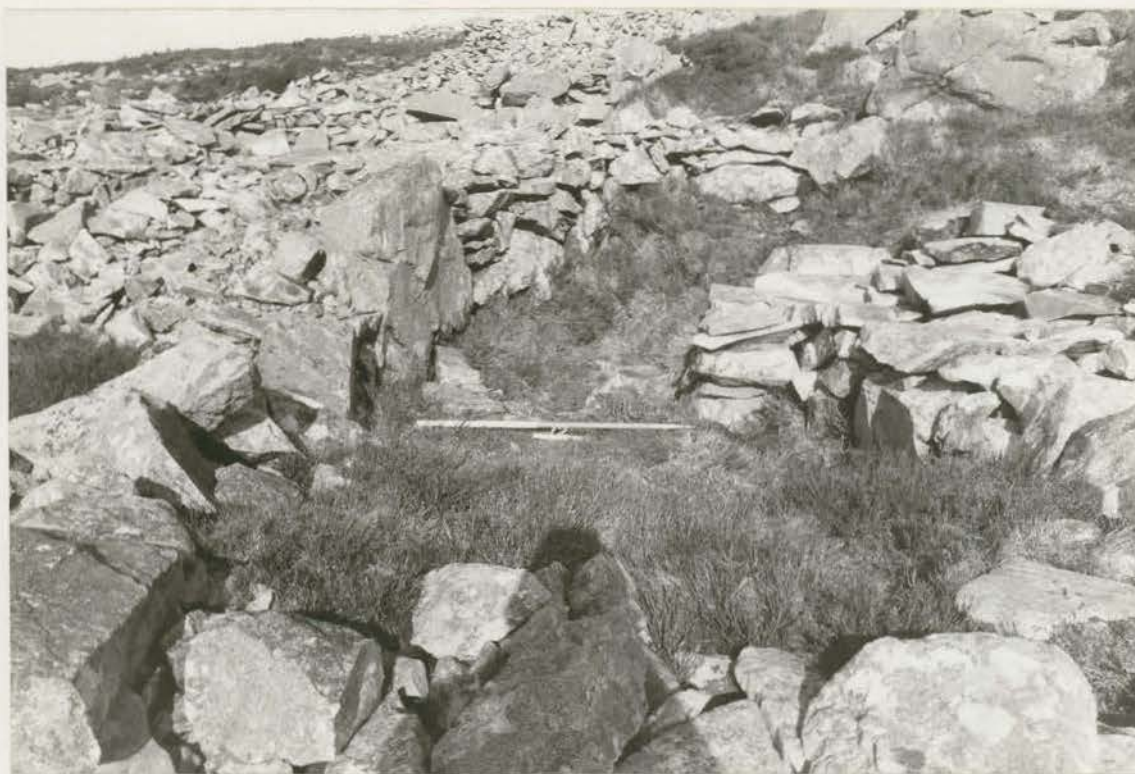
Plate 27. Hut 72 after conservation, looking NE (G1022/022/20A).

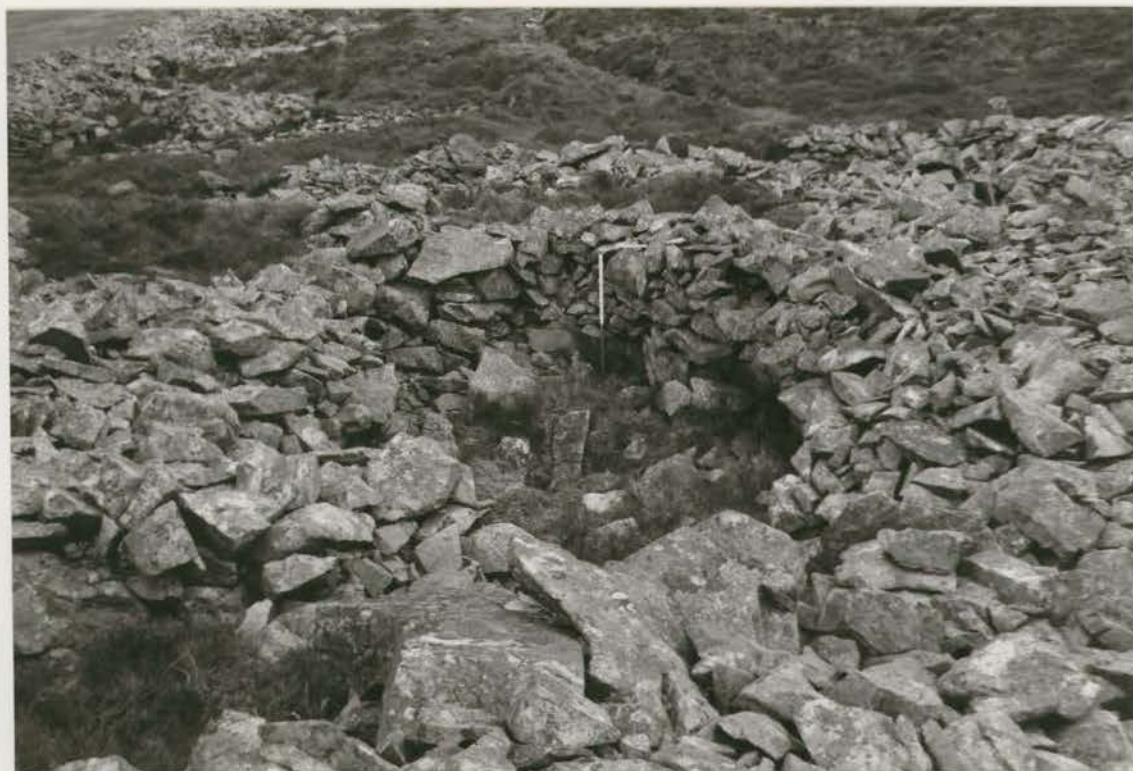
Plate 28. Hut 92 before conservation, looking SW (G1022/001/34).

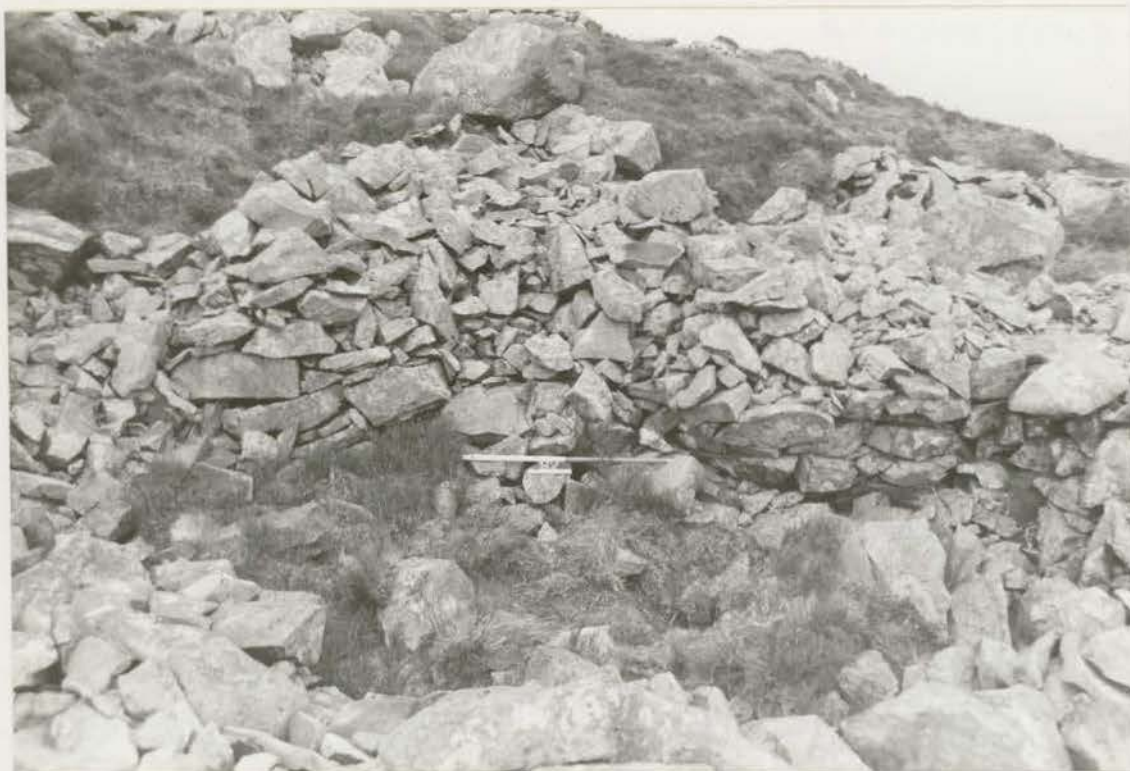
Plate 29. Hut 92: SE wall before conservation, looking SE
(G1022/002/05A).

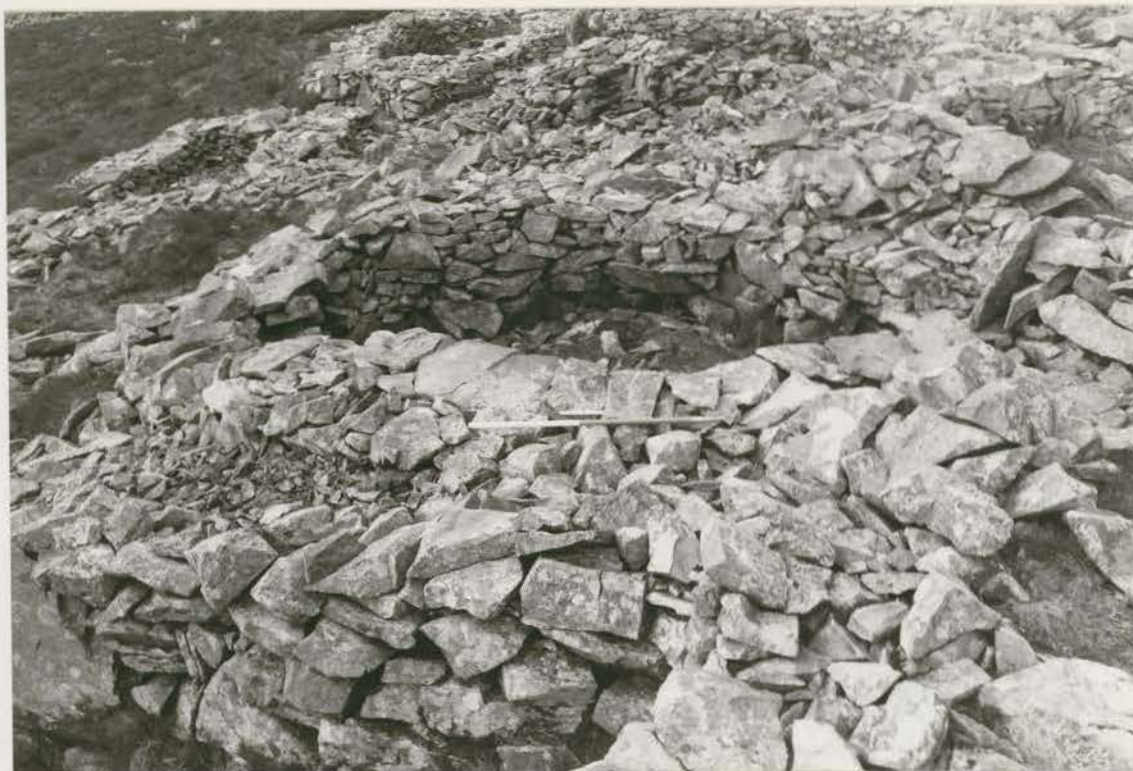
Plate 33. Wall between huts
72 & 92 after conservation,
looking W (G1022/022/17A).

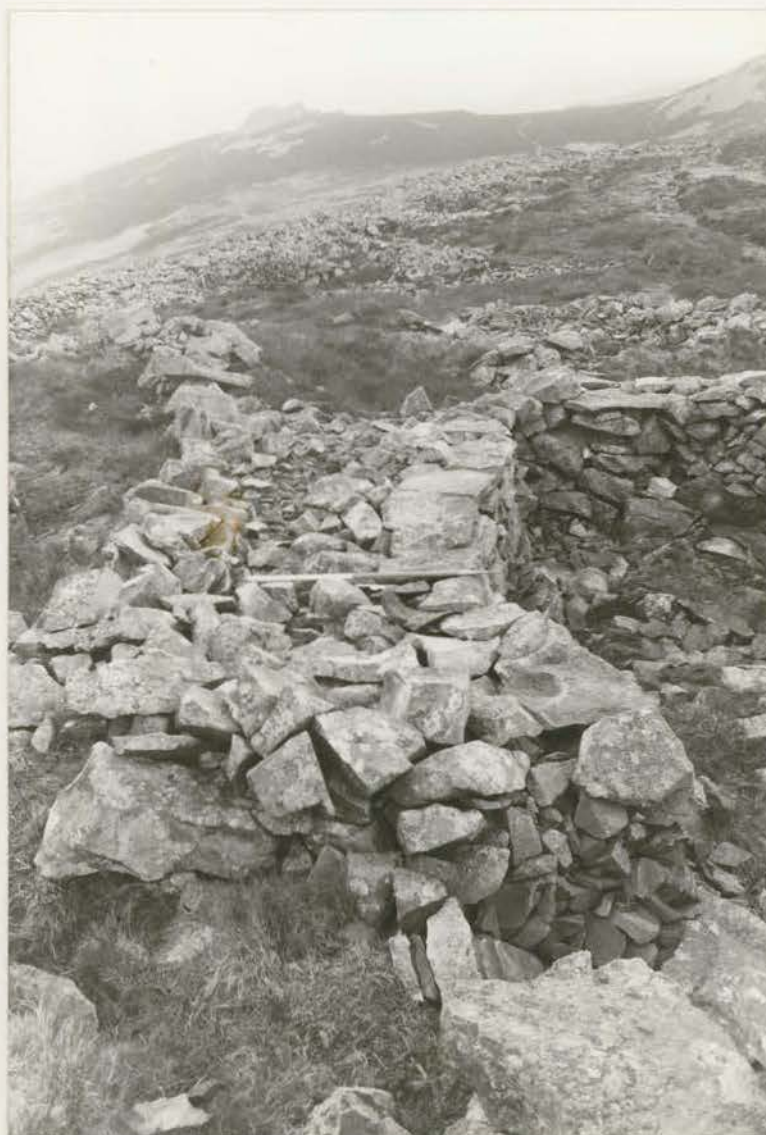
Plate 34. Wall between huts
72 & 92 after conservation,
looking SW (G1022/022/15A).

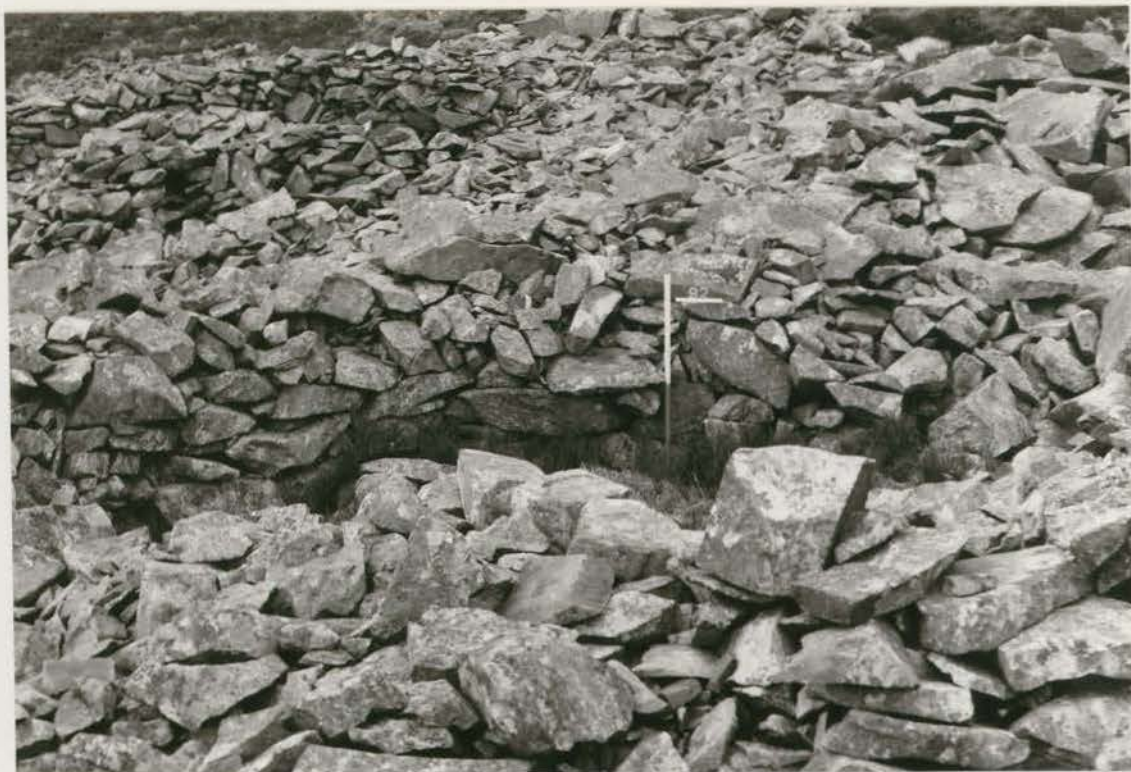
Plate 35. Hut 92: NW wall before conservation, looking NW
(G1022/001/36).

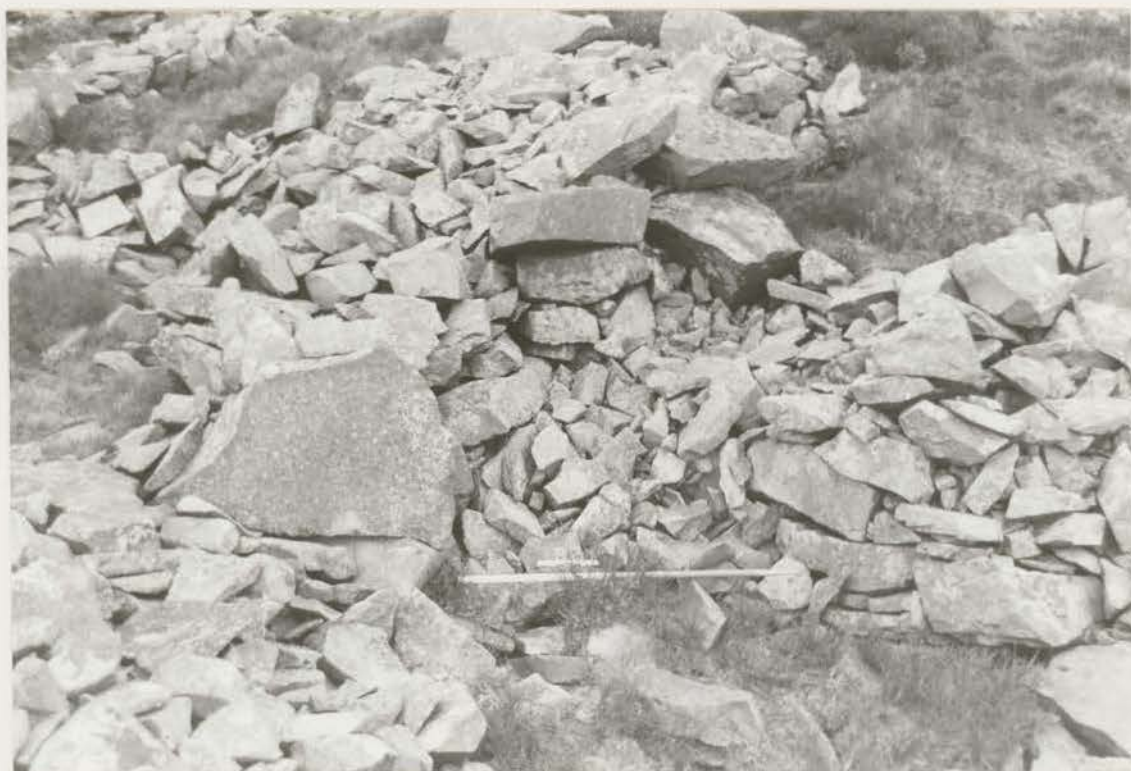
Plate 37. Hut 92: E entrance
before conservation, looking
E (G1022/002/06A).

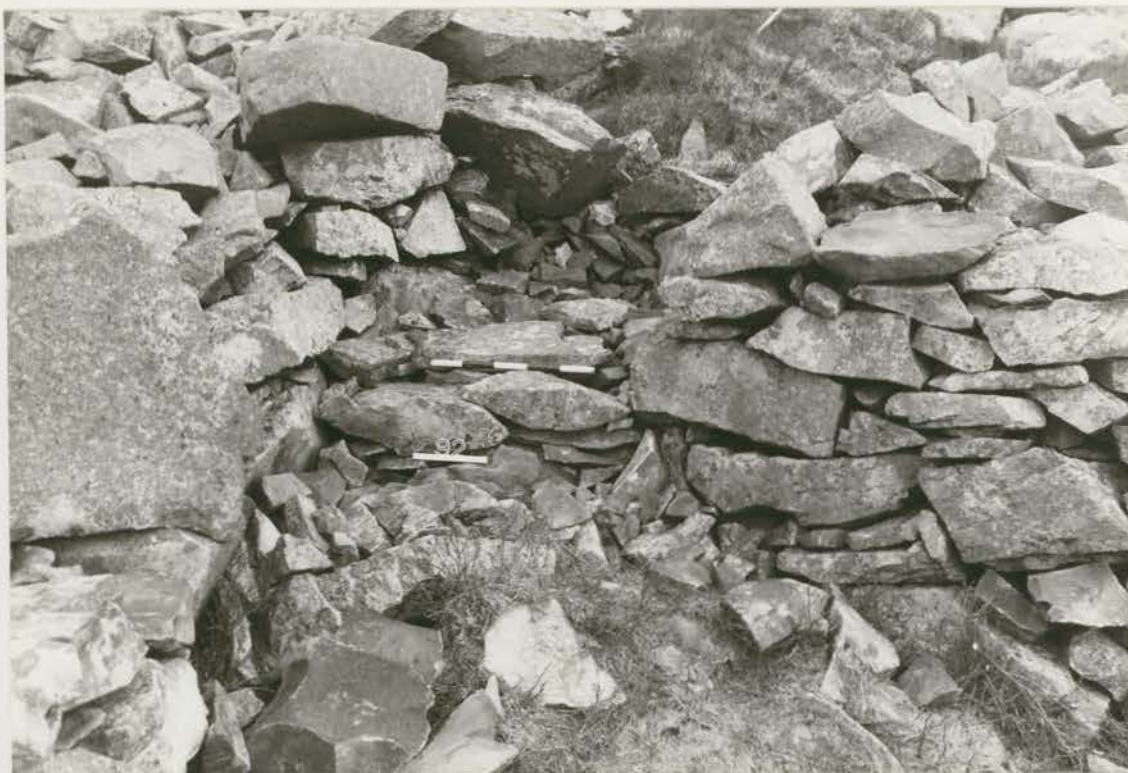
Plate 40. Hut 92. E entrance after conservation, looking E (G1022/021/28).

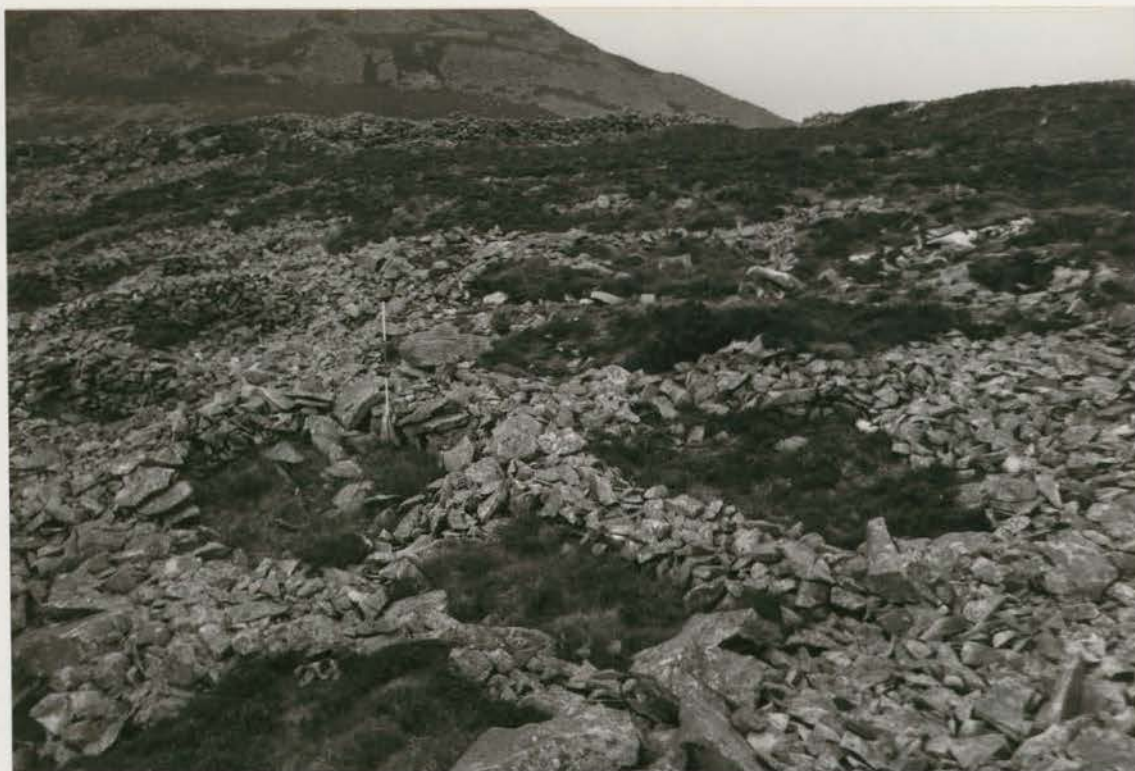
Plate 45. Hut 73 (left of centre) before conservation,
looking NW (G1022/001/07).

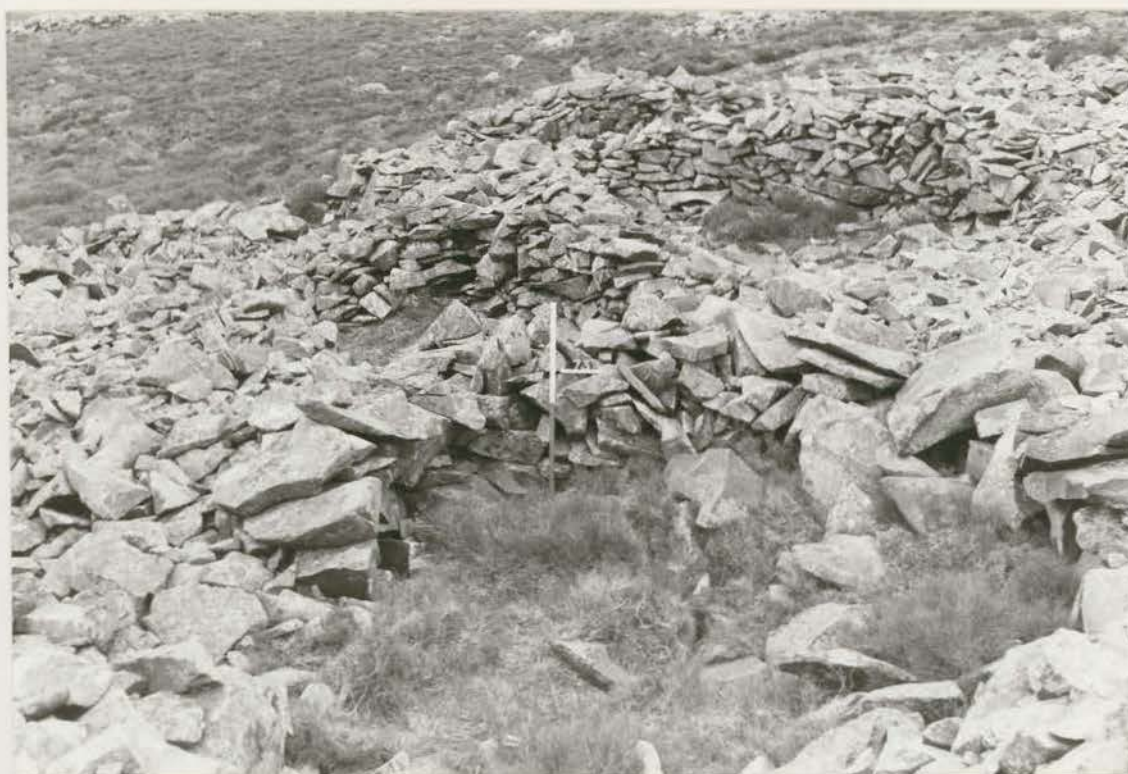
Plate 46. W end of hut 73 before conservation, looking W
(G1022/002/14A).

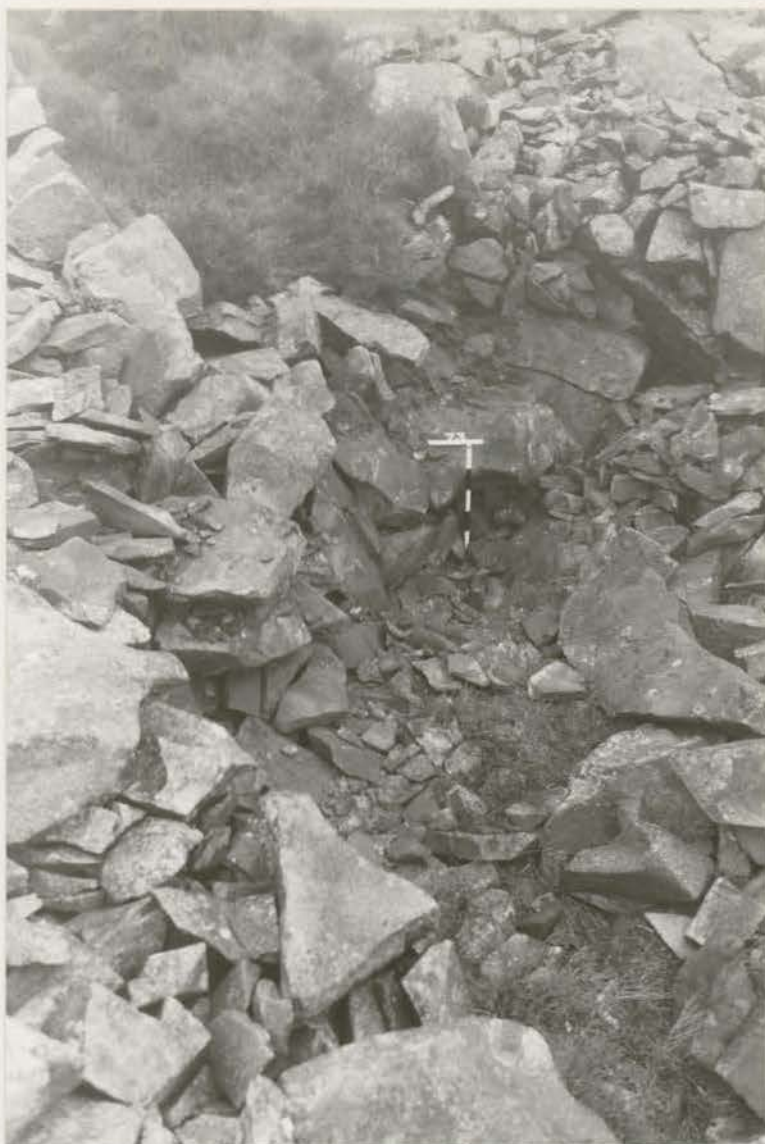
Plate 50. Hut 73: E wall,
tumble removed, with W corner
of hut 74 exposed, looking E
(G1022/006/03).

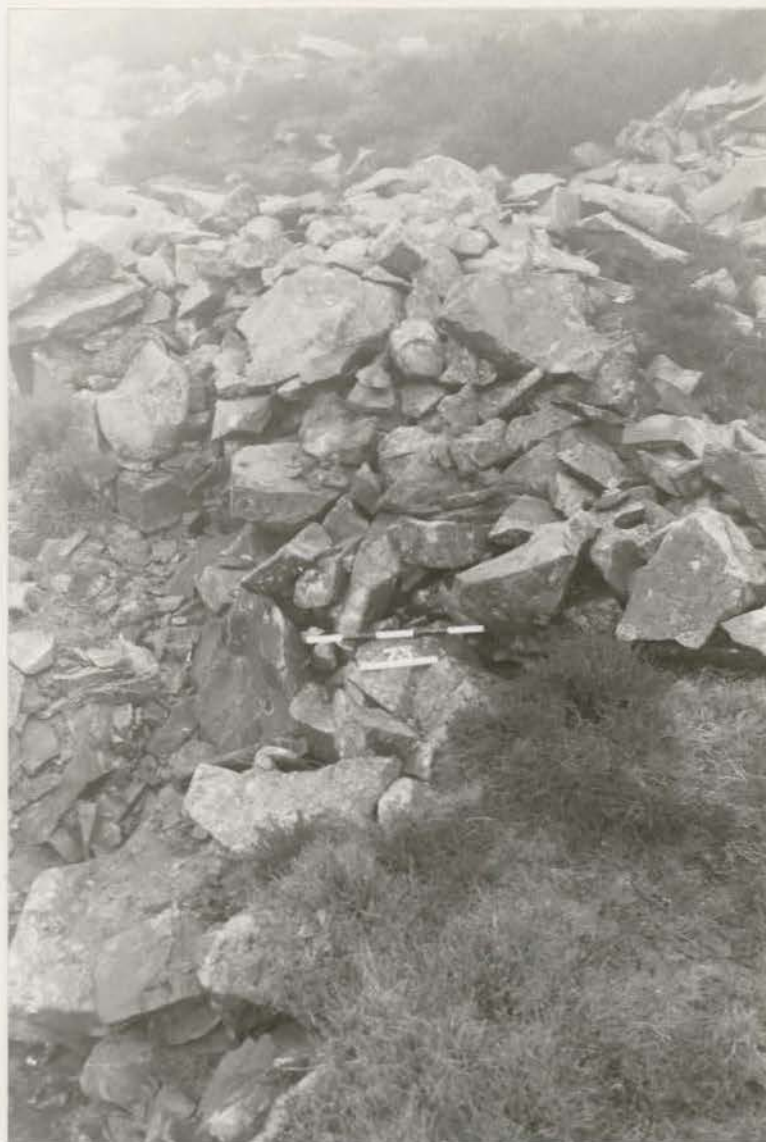
Plate 52. Hut 73: E wall
rebuilt, looking E
(G1022/022/13A).

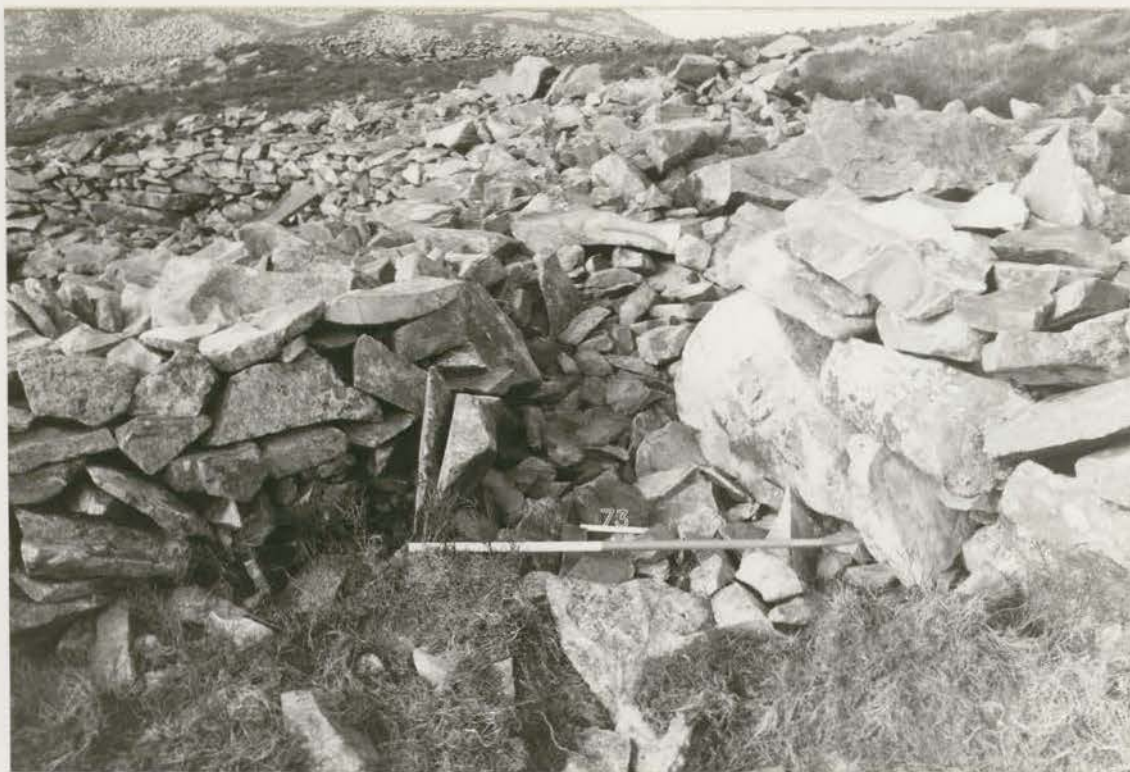
Plate 53. Hut 73: NW entrance re-opened, looking NW (G1022/022/14A).
