TRE'R CEIRI
CONSERVATION PROJECT
1989 - 90
PART 2: PLATES

REPORT ON THE FIRST SEASON OF THE
TRE'R CEIRI CONSERVATION PROJECT
DECEMBER 1989 - MARCH 1990

S.D. BOYLE

PART 2: PLATES

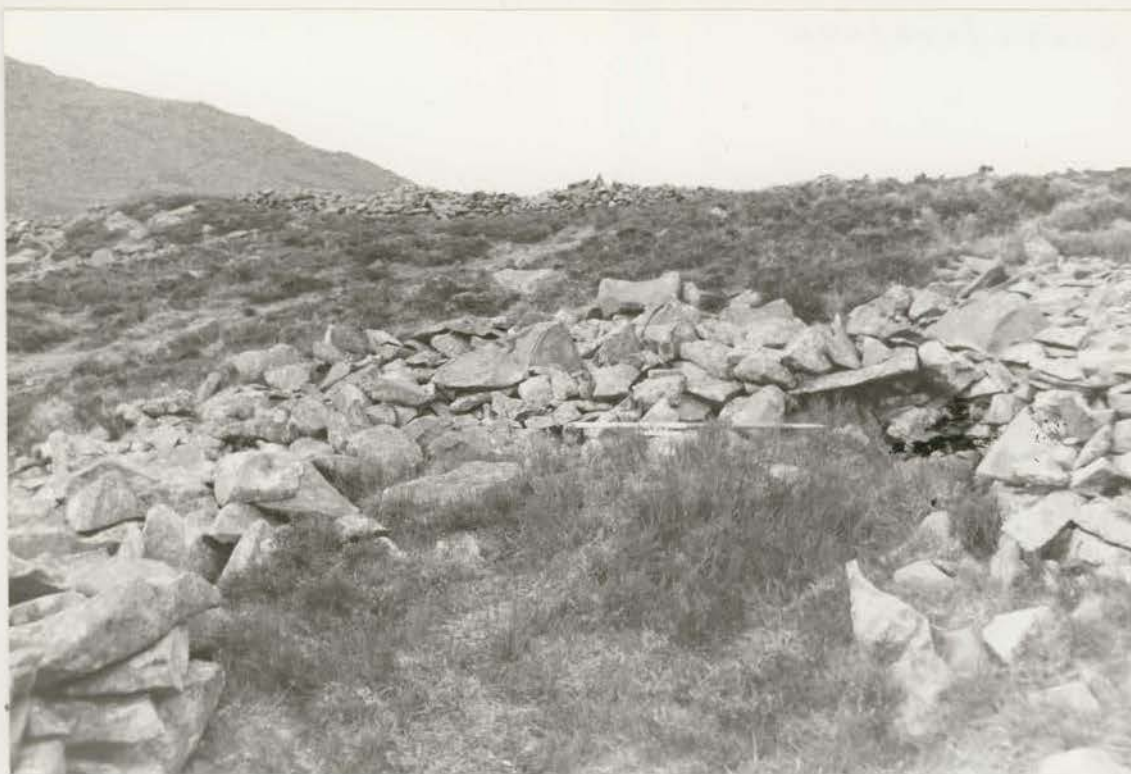
Plate 55. Hut 36: interior and NW wall before conservation,
looking NW (G1022/005/09A).

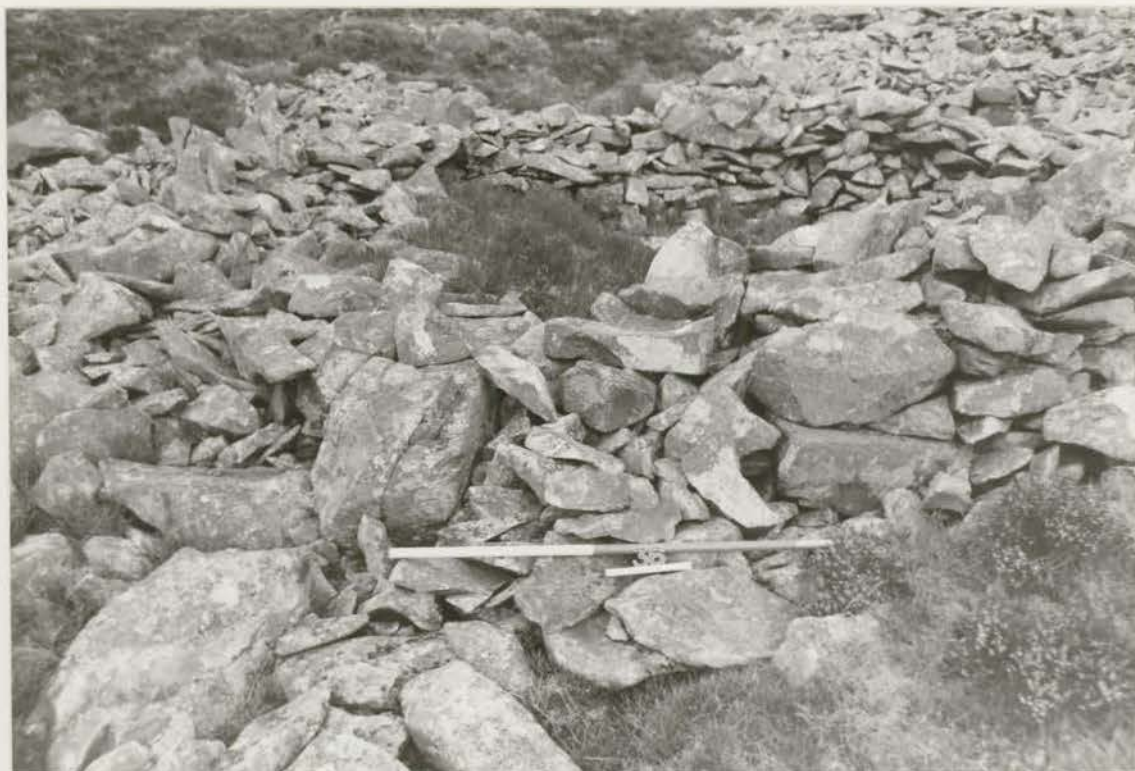
Plate 56. Hut 36: blocked entrance, looking NE (G1022/005/11A).

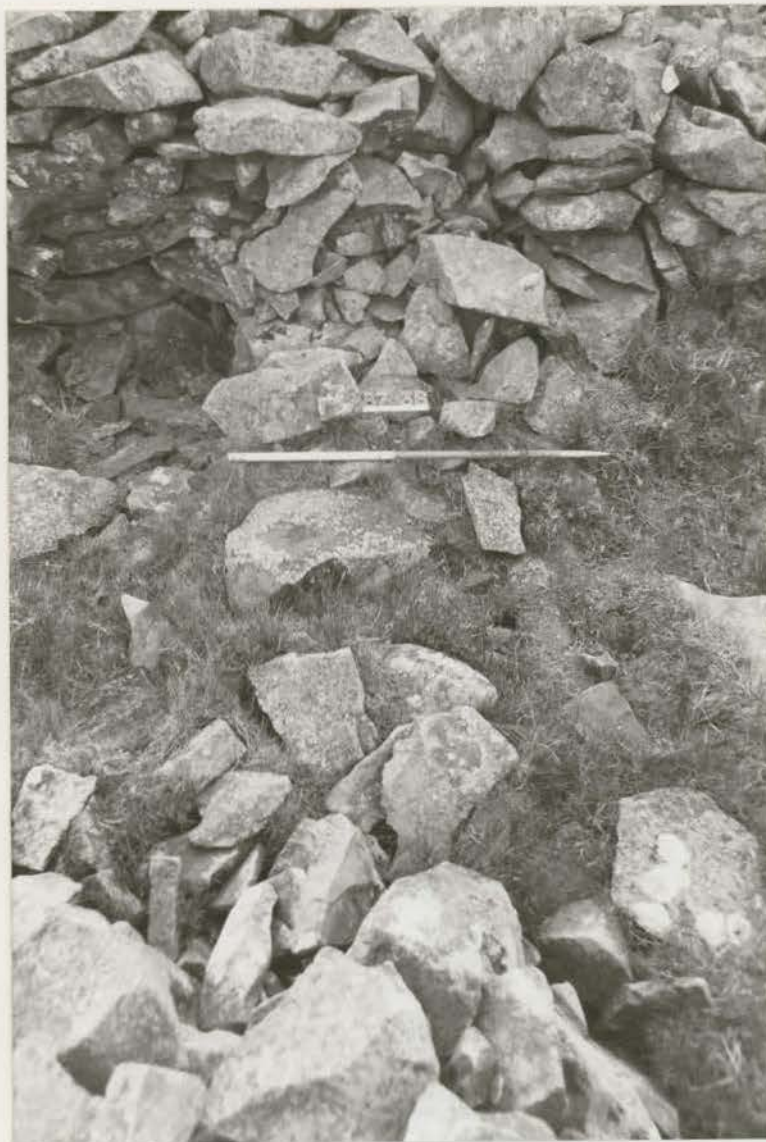
Plate 58. Hut 36: entrance
cleared, looking NE
(G1022/022/12A).

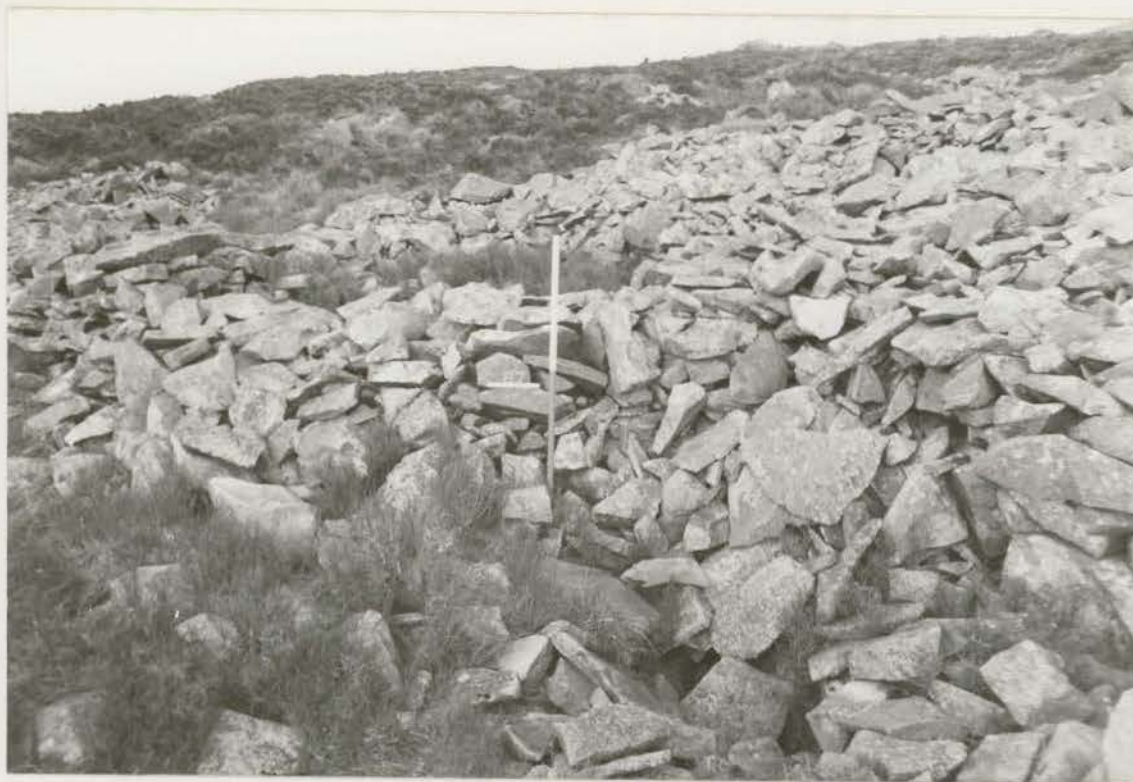
Plate 59. Hut 87: NE wall
before conservation, looking
NE (G1022/004/25).

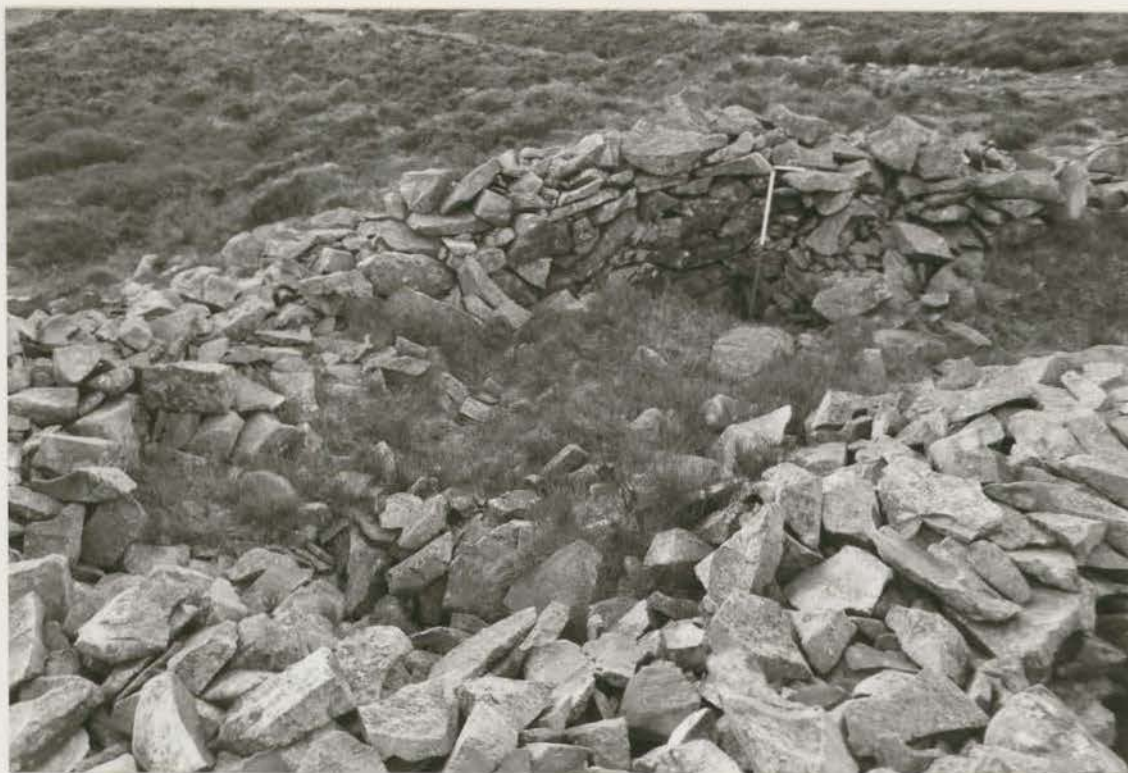
Plate 61. Hut 87: interior and W corner before conservation,
looking W (G1022/004/18).

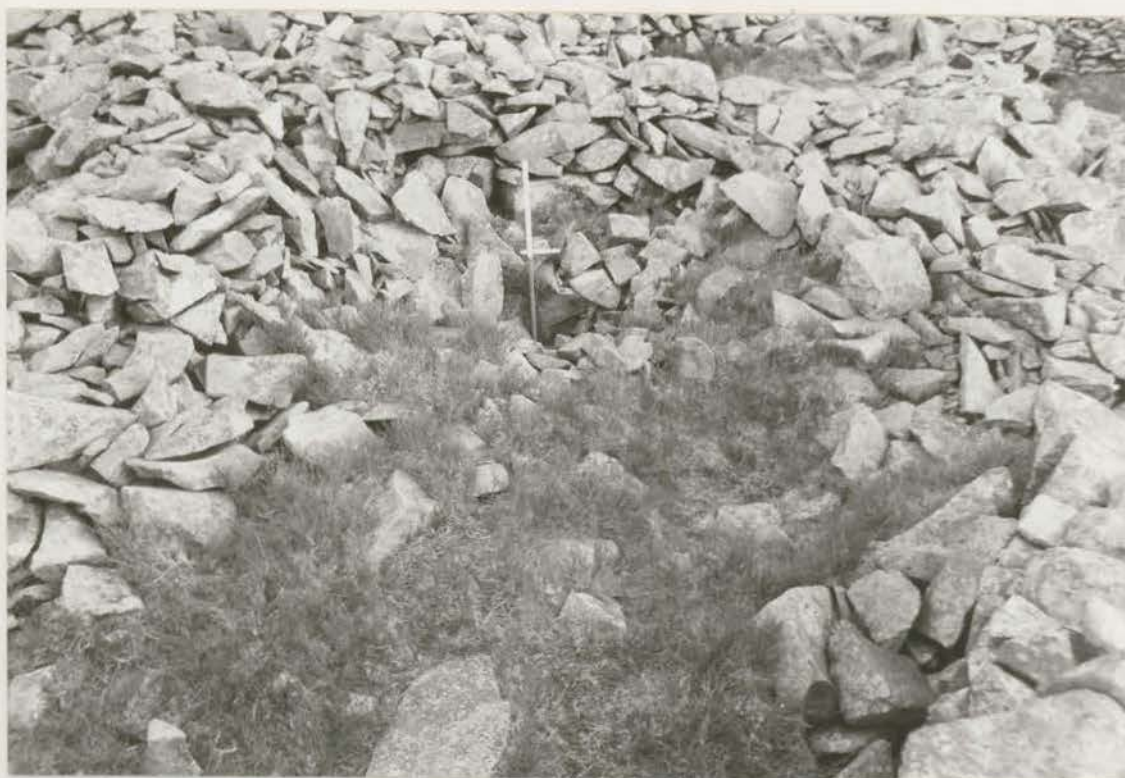
Plate 62. Hut 87: interior and E corner before conservation,
looking E (G1022/004/17).

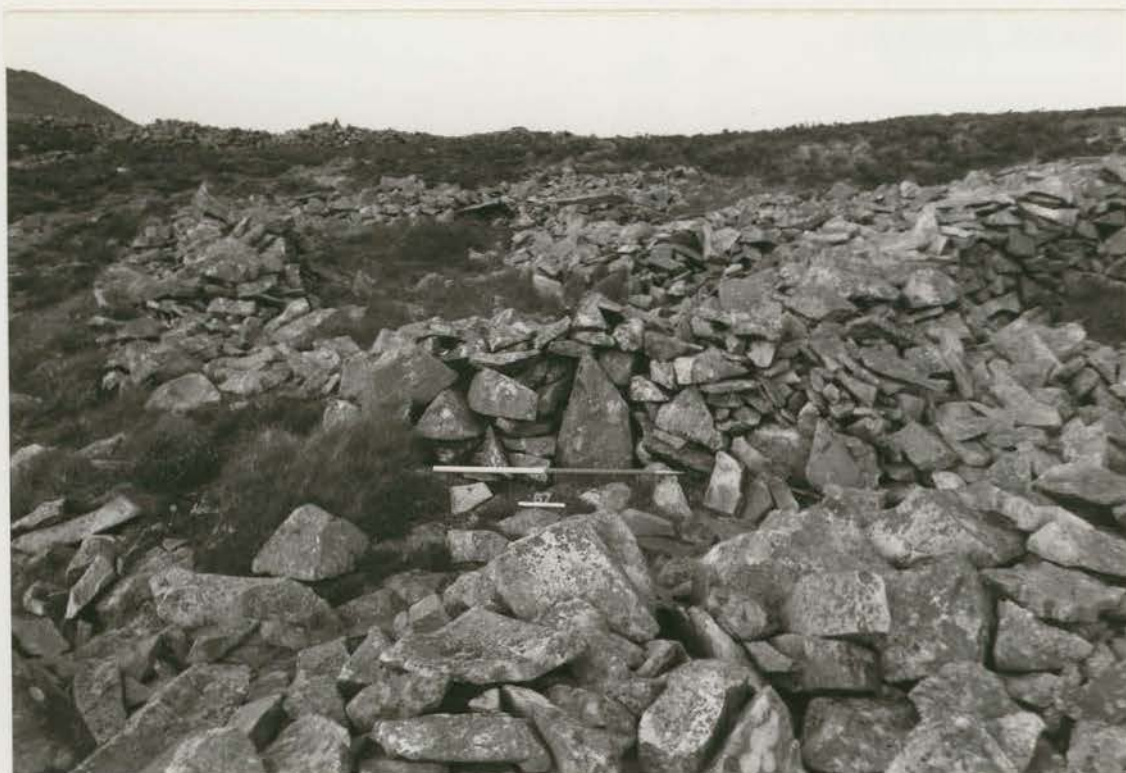
Plate 63. Hut 87: outer face of S wall before conservation,
looking N (G1022/004/16).

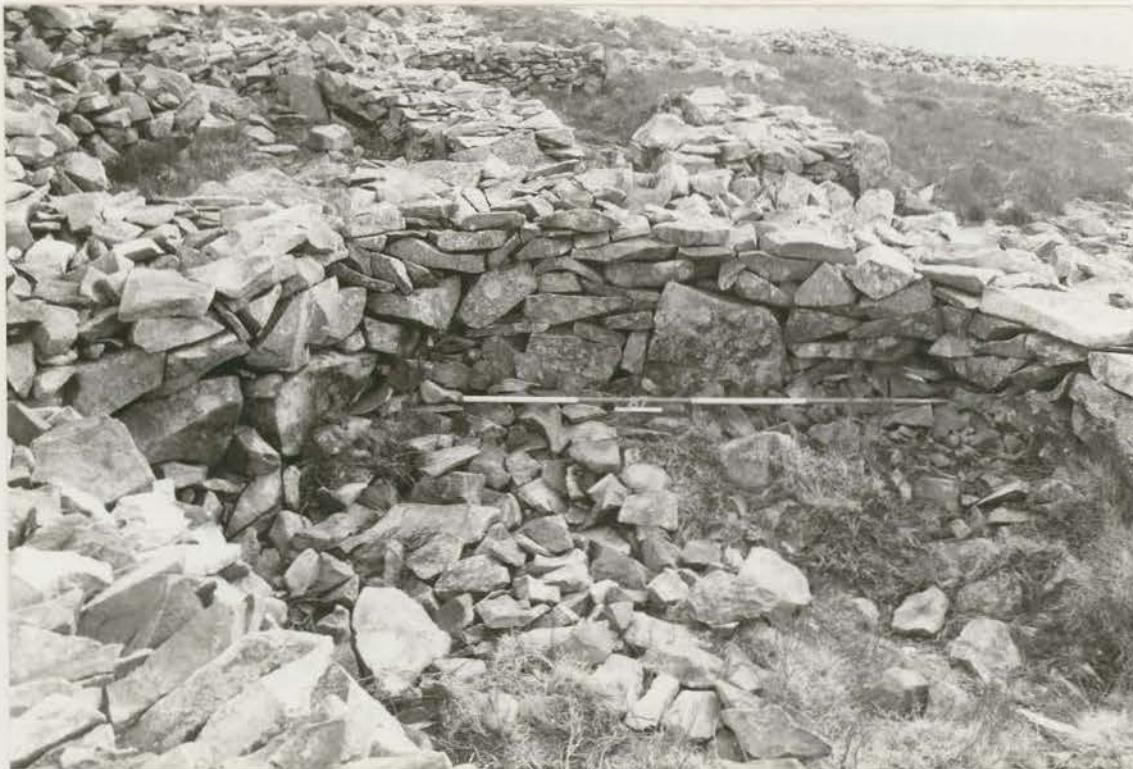
Plate 68. Hut 87: E and S walls after conservation, looking S (G1022/022/10A).

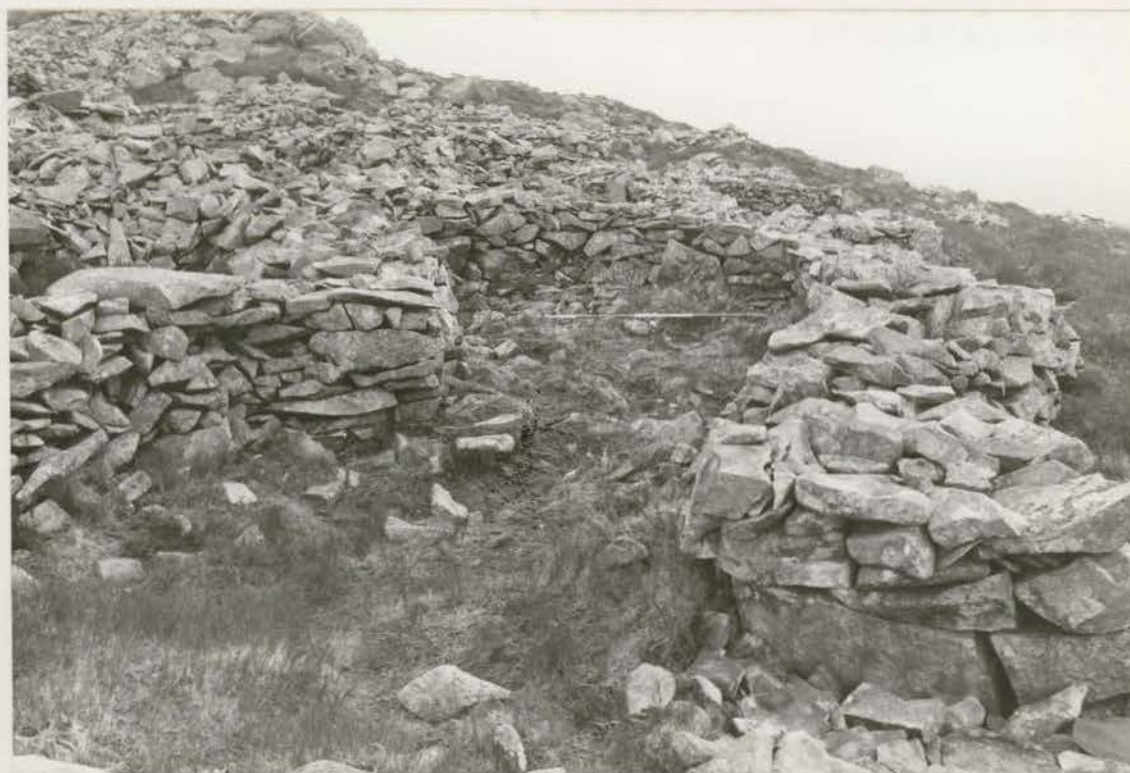
Plate 70. Hut 87 after conservation, looking SE (G1022/022/07A).

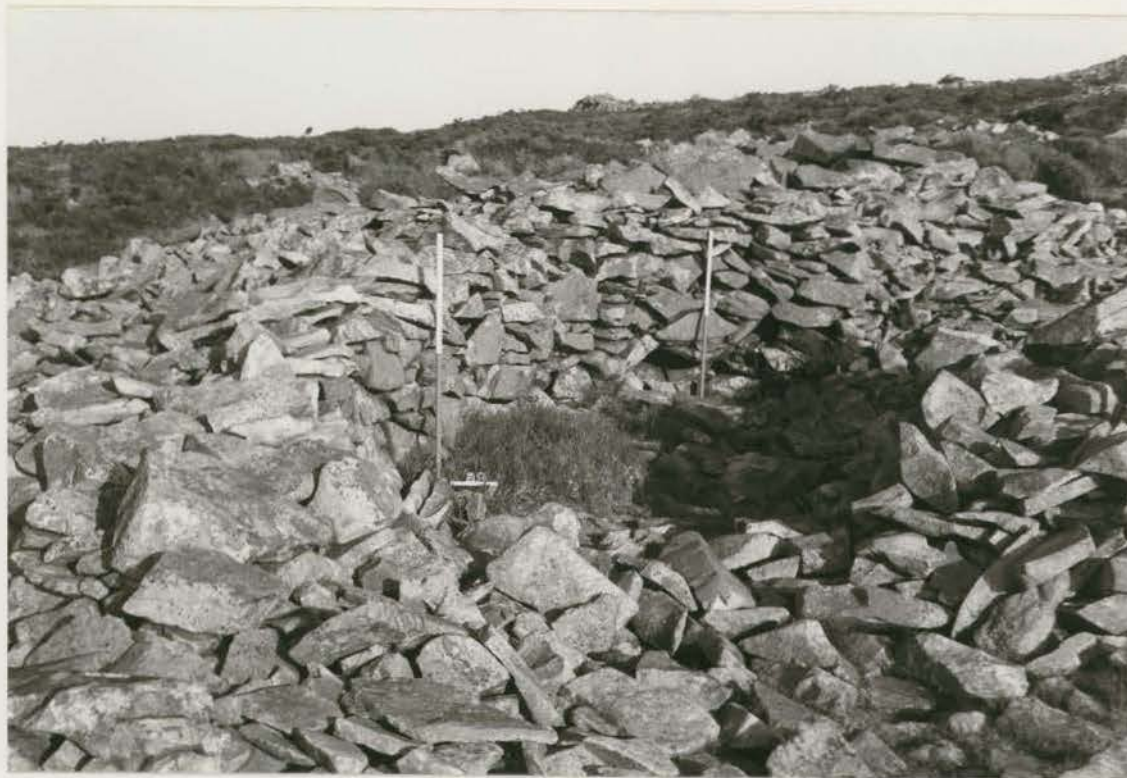
Plate 71. Hut 89: N wall before conservation, looking NE
(G1022/004/07).

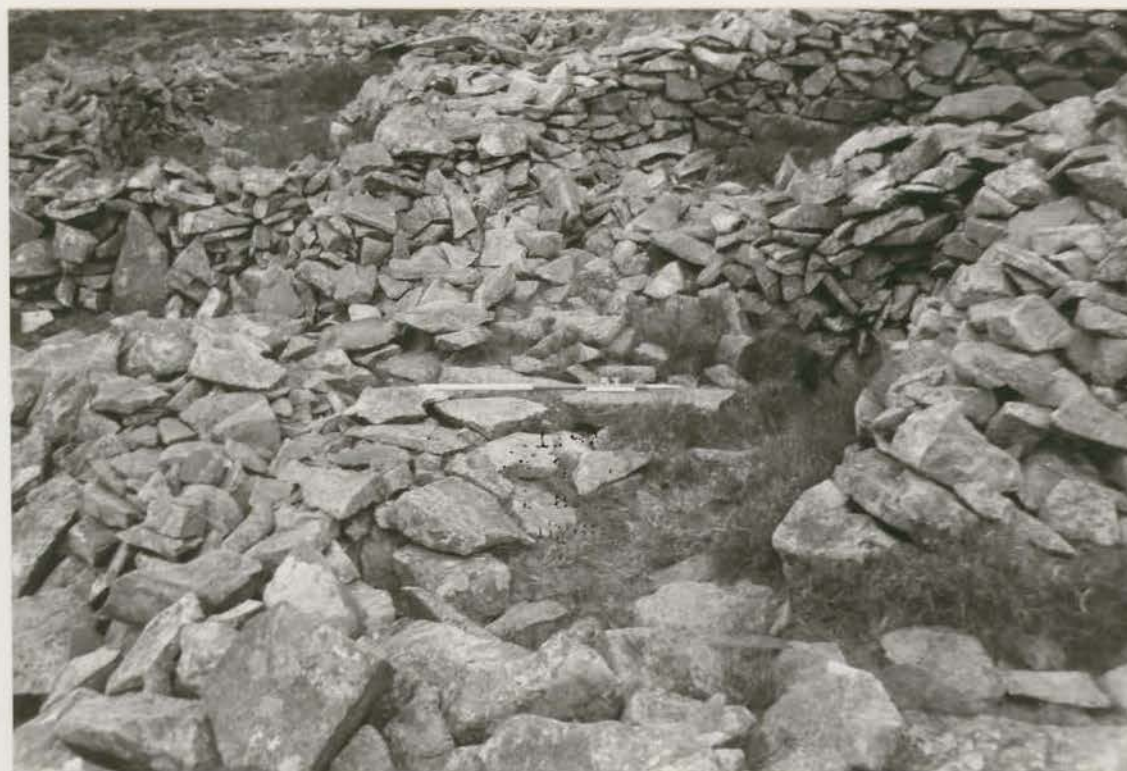
Plate 72. Hut 53: interior and W wall before conservation,
looking NW (G1022/003/12).

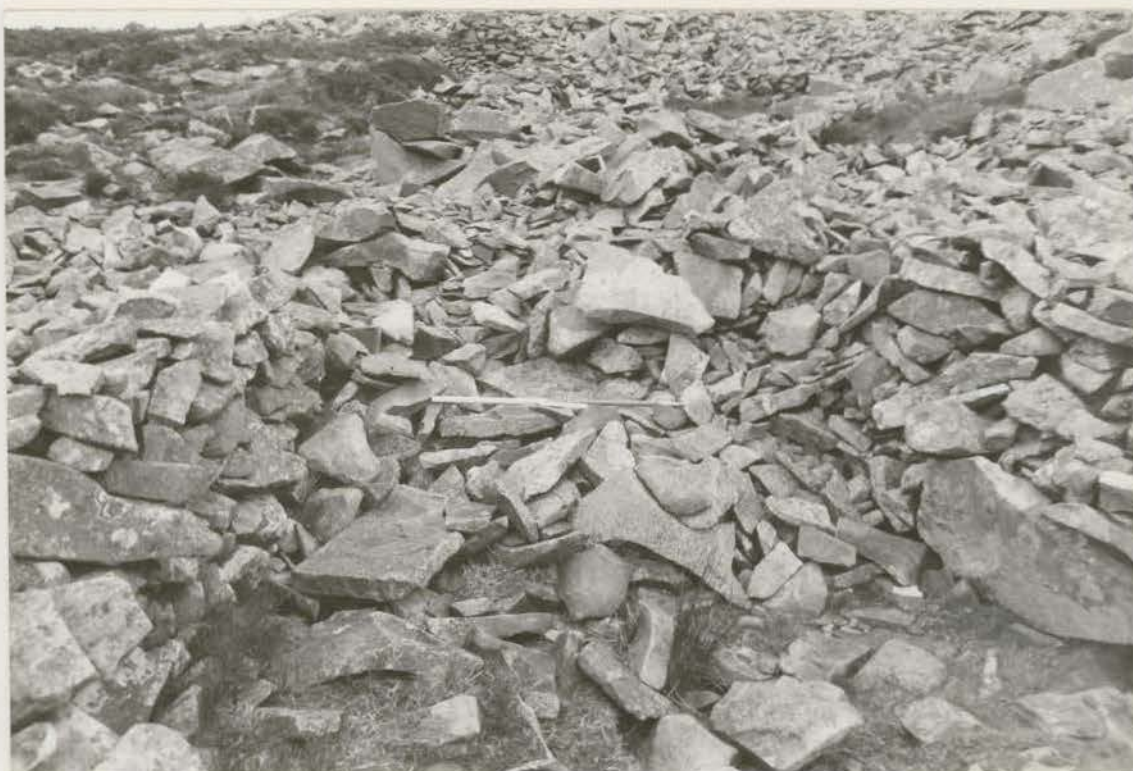
Plate 75. Hut 90: E wall before conservation, looking NE
(G1022/003/03).

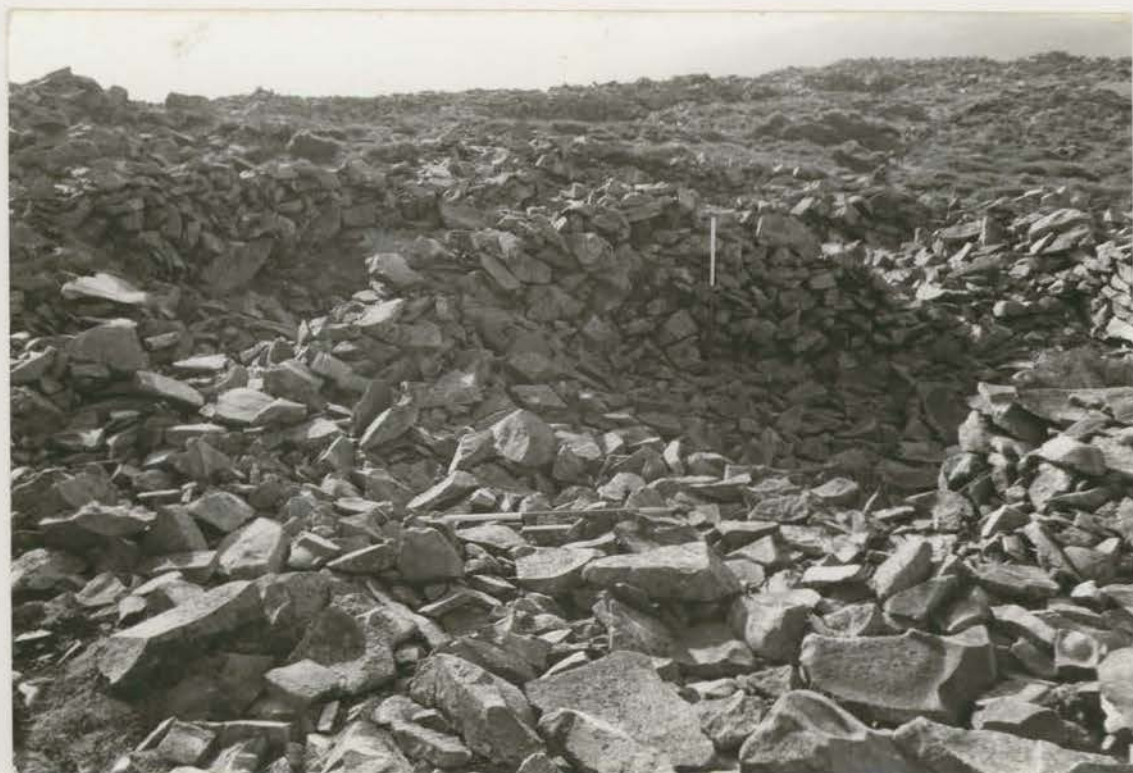
Plate 76. Huts 89 & 90: internal partition before conservation,
looking SE (G1022/004/02).

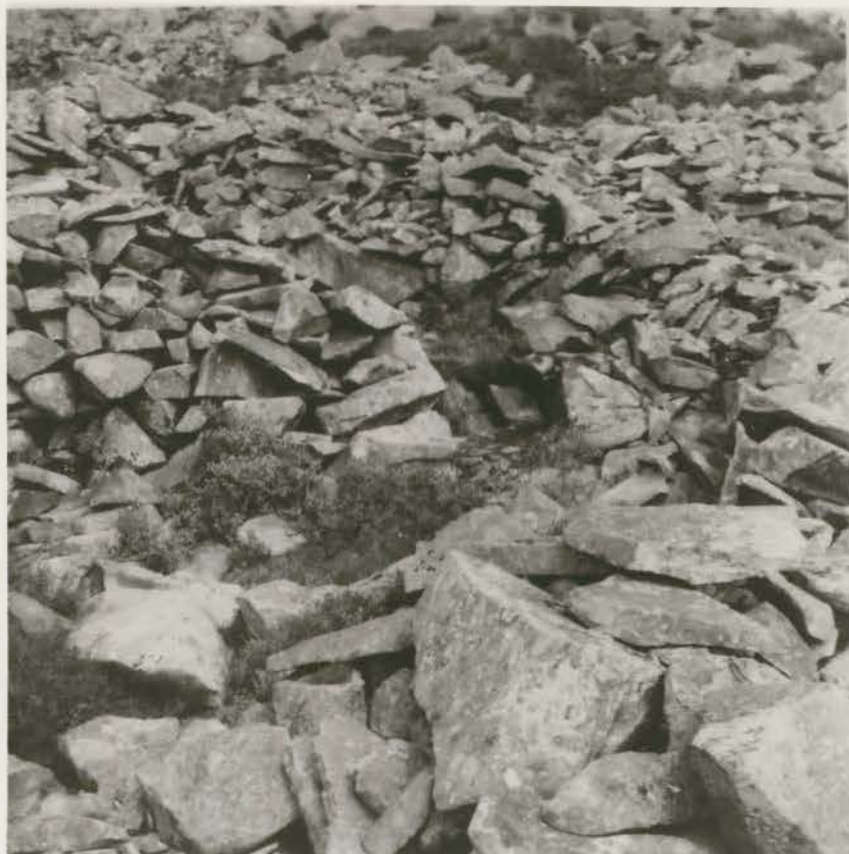
Plate 79. Hut 90:
entrance from hut 53
in 1956, looking E
(RCAHM 890464/6).

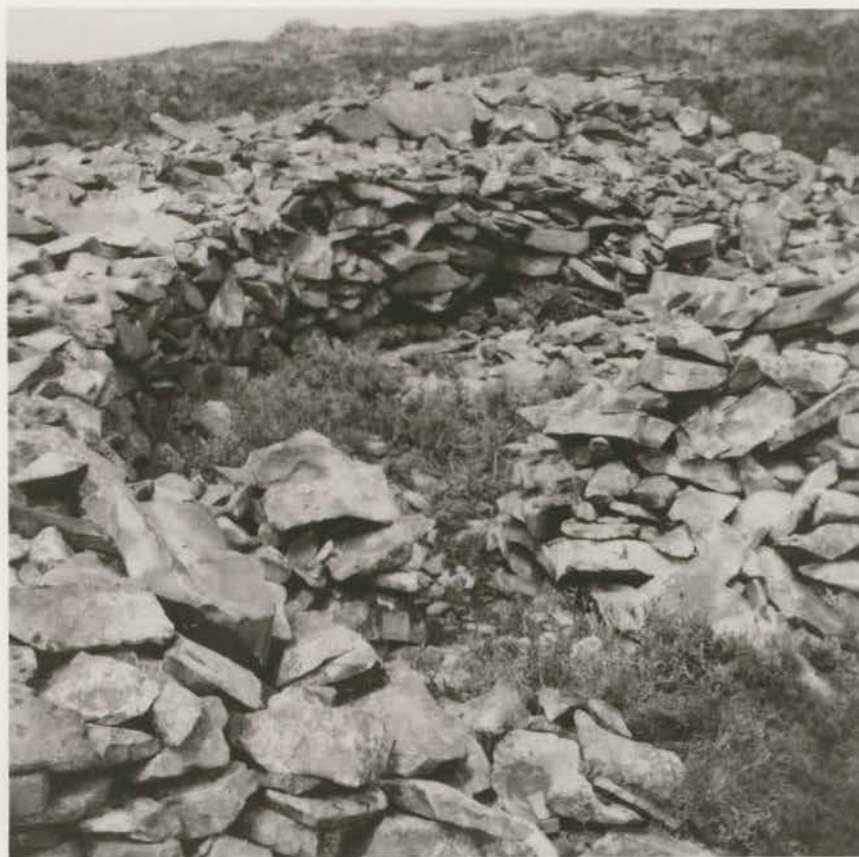
Plate 80. Hut 89:
entrance from hut 53
in 1956, looking N
(RCAHM 890464/8).

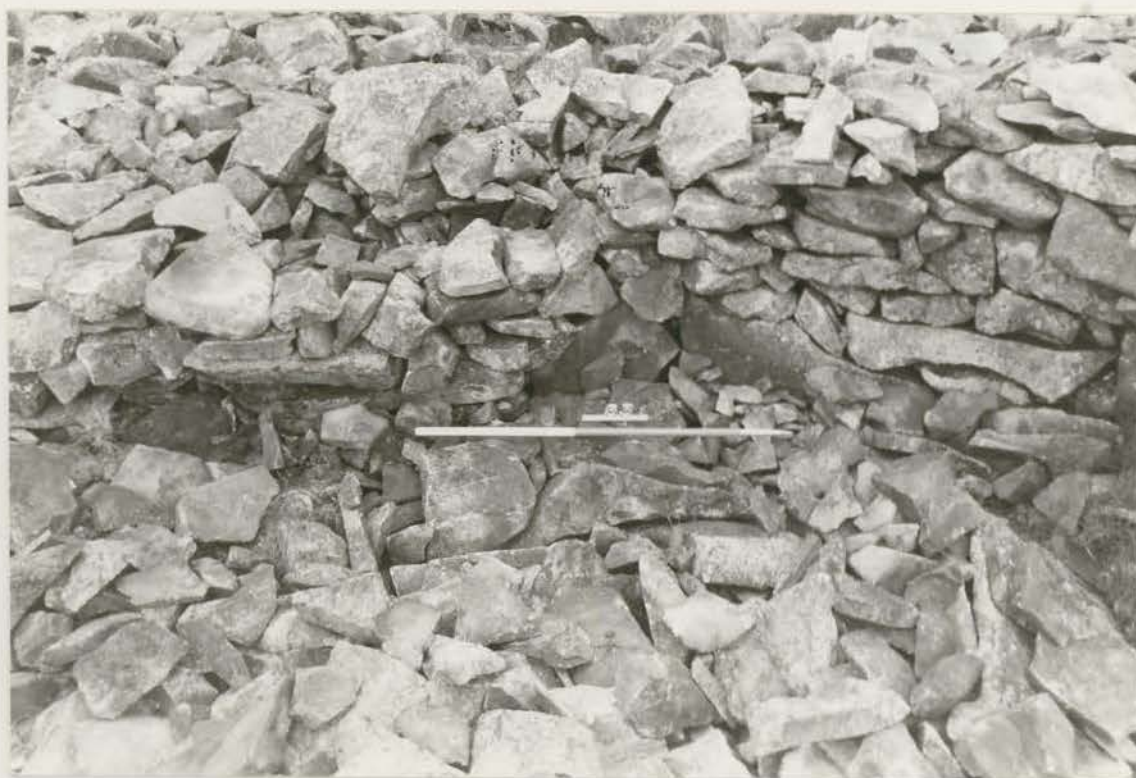
82. Hut 53: foundations of W jamb of doorway to hut 89.
83. Hut 90: base of E wall after removal of collapse.
84. Hut 89: base of NE wall after removal of collapse.

Plate 82. Hut 53: foundations
of W jamb of doorway to hut
89, looking W (G1022/007/15).

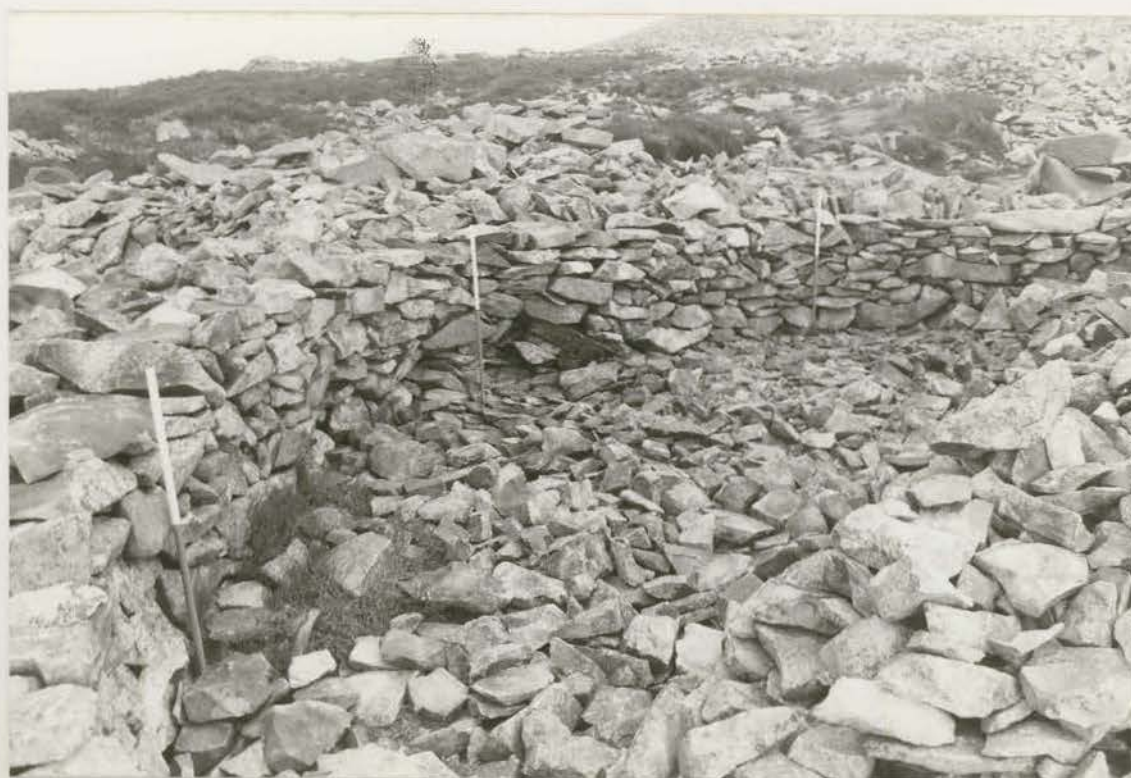
85. Hut 89: foundations of possible cross wall.
86. Hut 89: restored N and NE walls.
87. Hut 90: restored E wall.
88. Huts 89 & 90: restored NE wall.
89. Hut 89: NW wall before conservation.

Plate 86. Hut 89: restored N
and NE walls, looking NE
(G1022/022/31A).

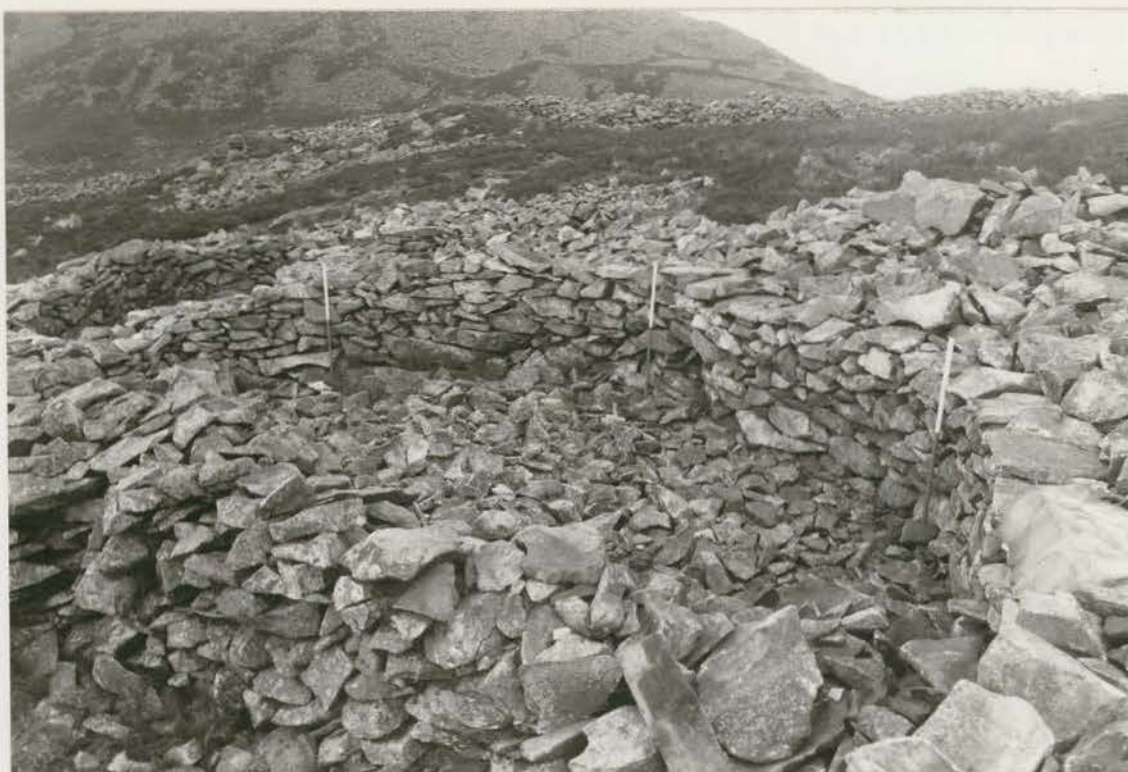
Plate 88. Huts 89 & 90: restored NE wall, looking NE (G1022/022/34A).

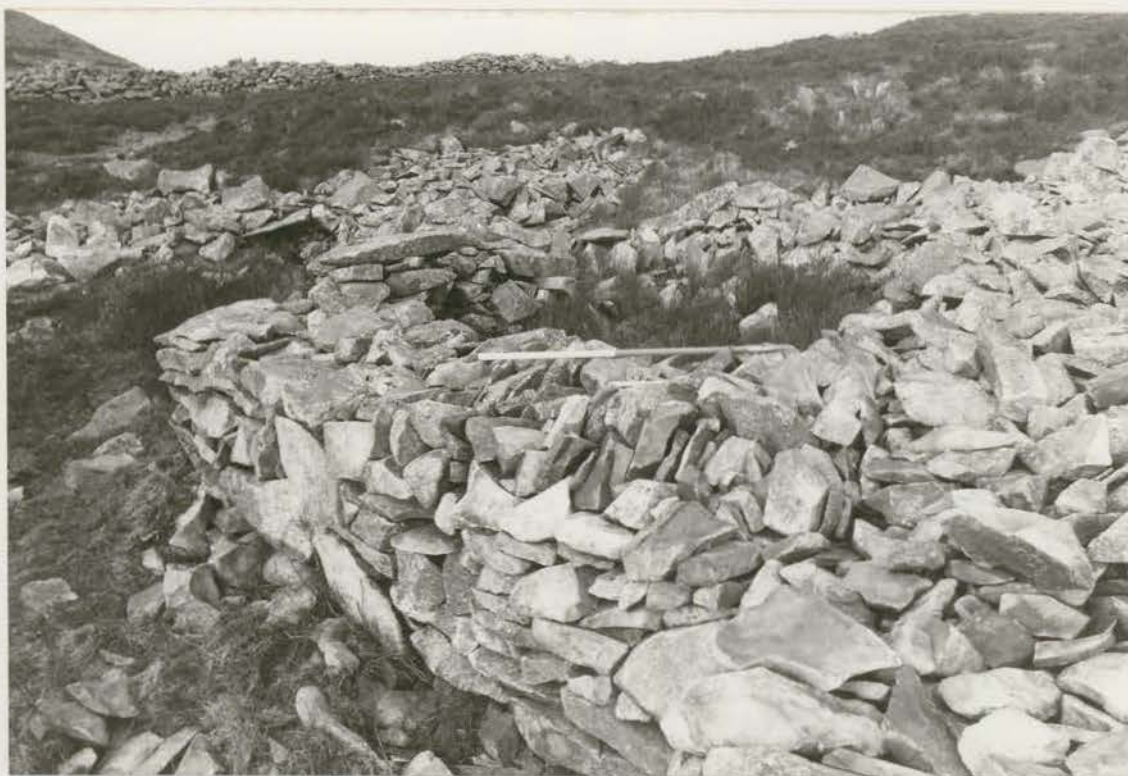
Plate 91. Hut 89: general view after conservation, looking W
(G1022/022/32A).

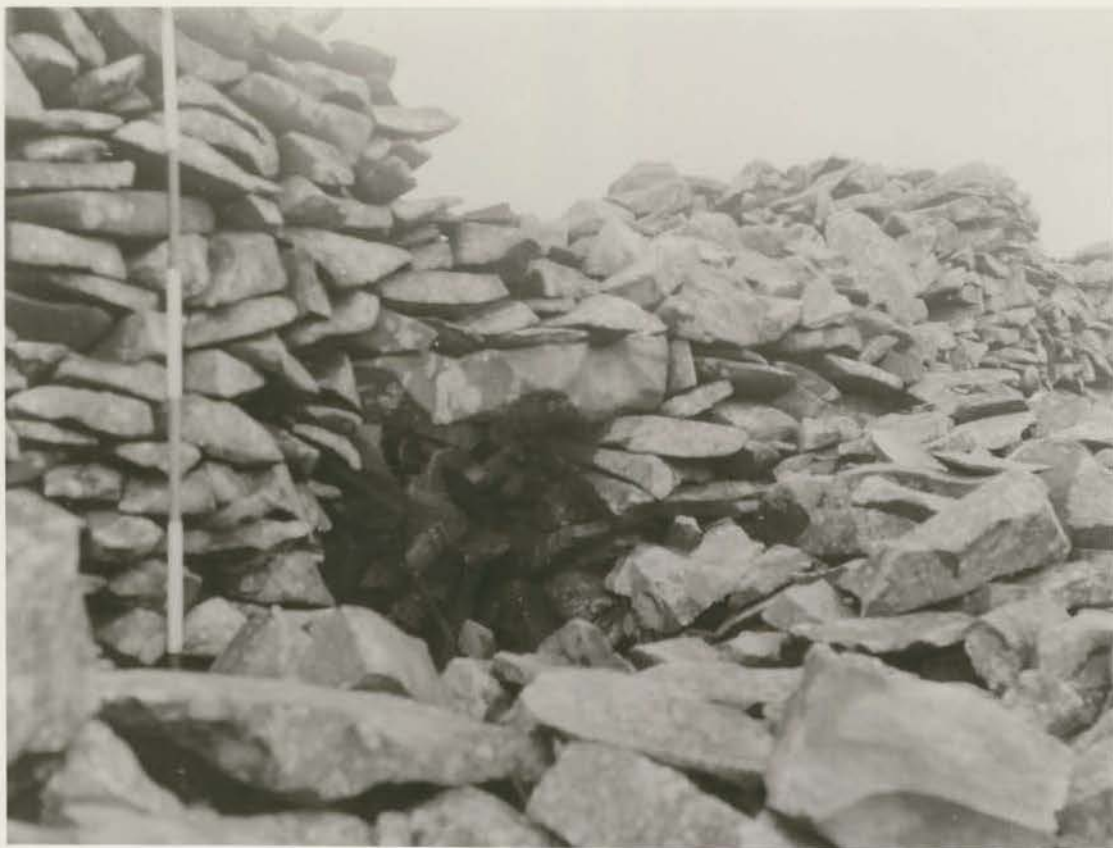
Plate 94. Inner rampart, length D - E, showing changes in construction (G1022/016/31A).

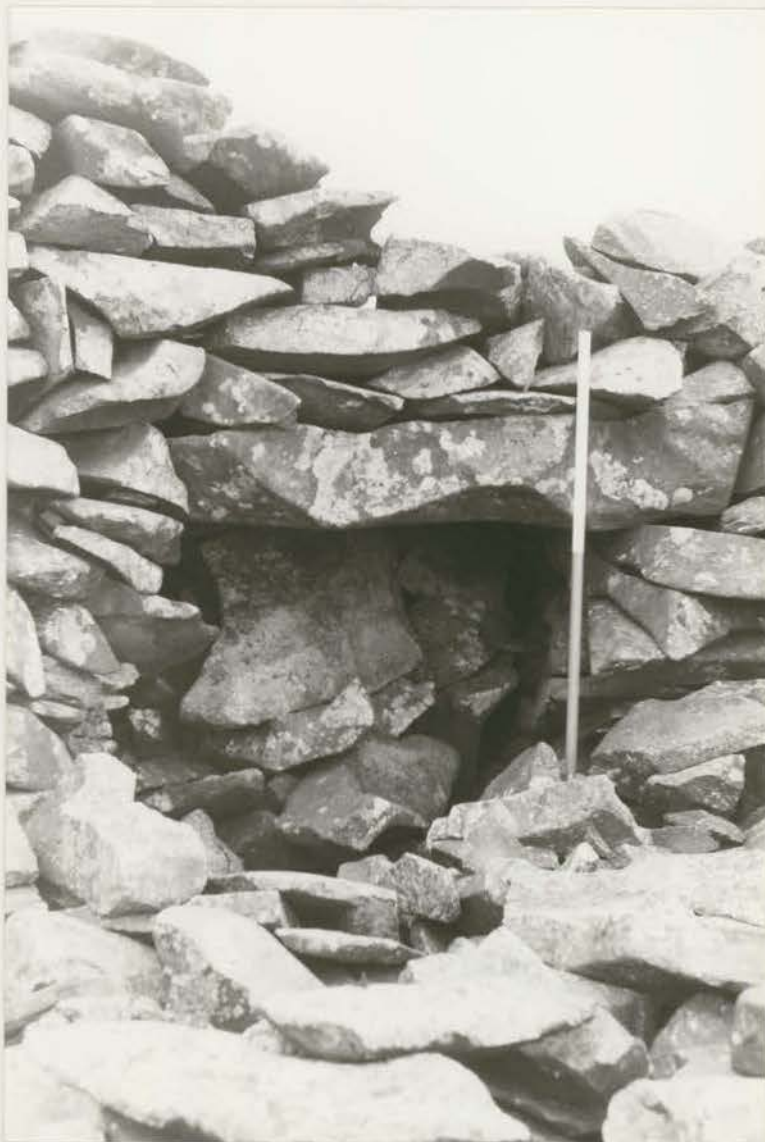
Plate 95. N postern, outer end in 1956, looking SW (RCAHM 890451/6).

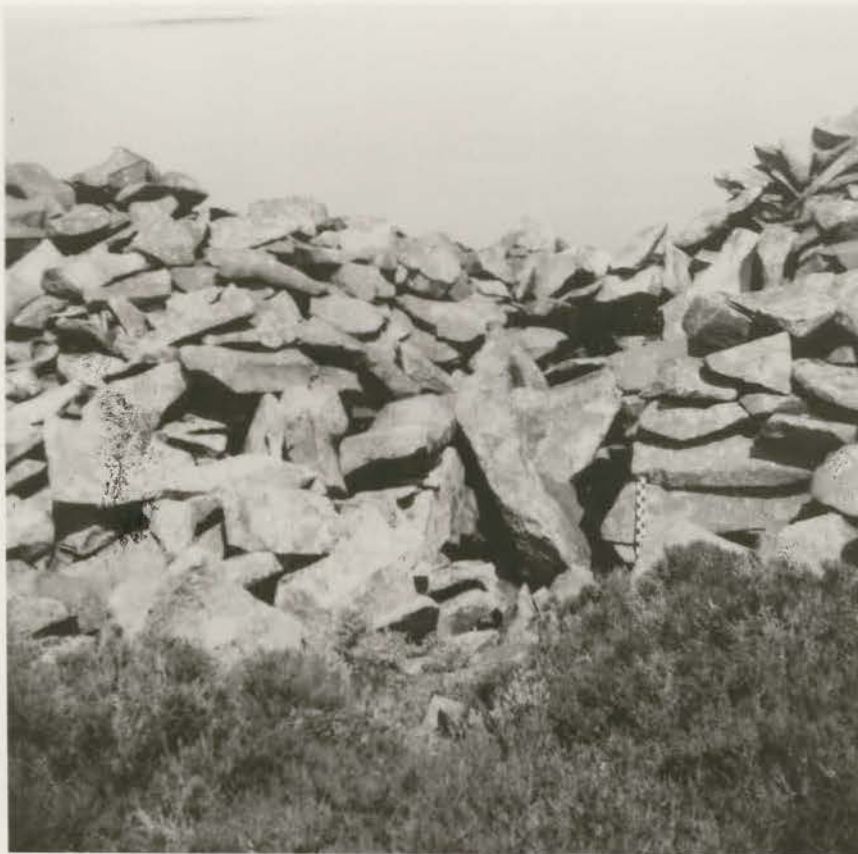
Plate 97. N postern,
inner end in 1956,
looking N
(RCAHM 890466/12).

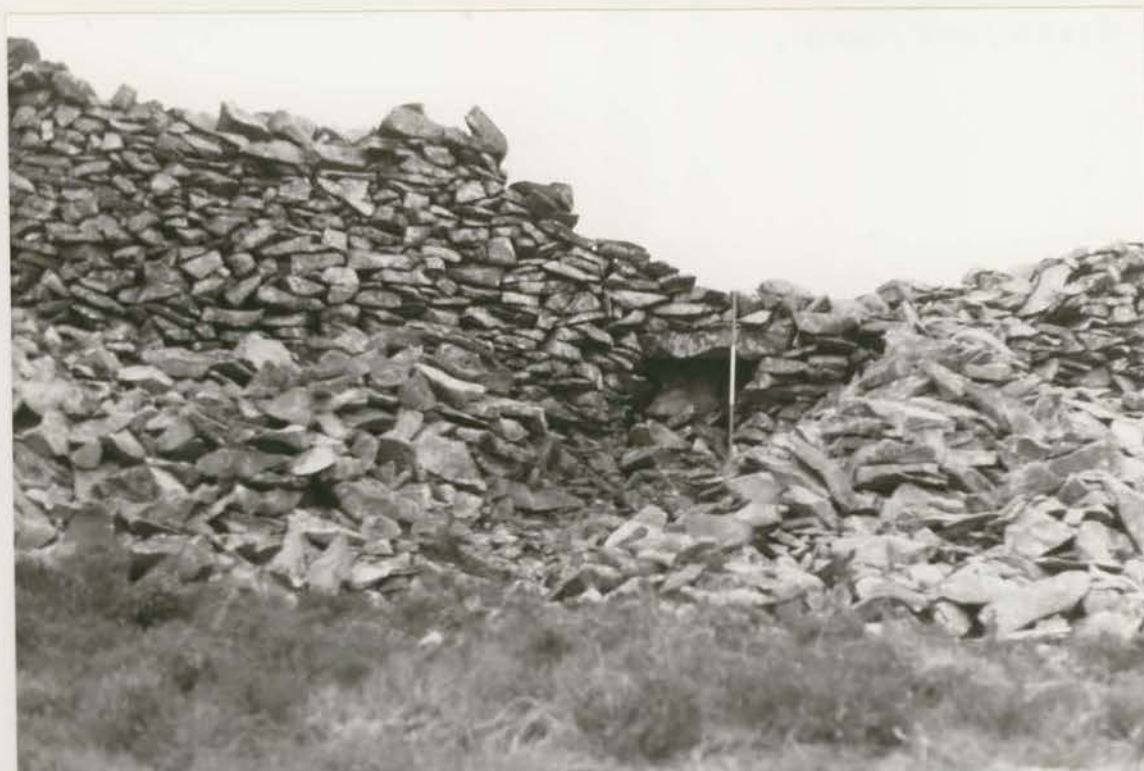
Plate 99. N postern and 'ramp': general view before conservation,
looking NE (G1022/008/14A).

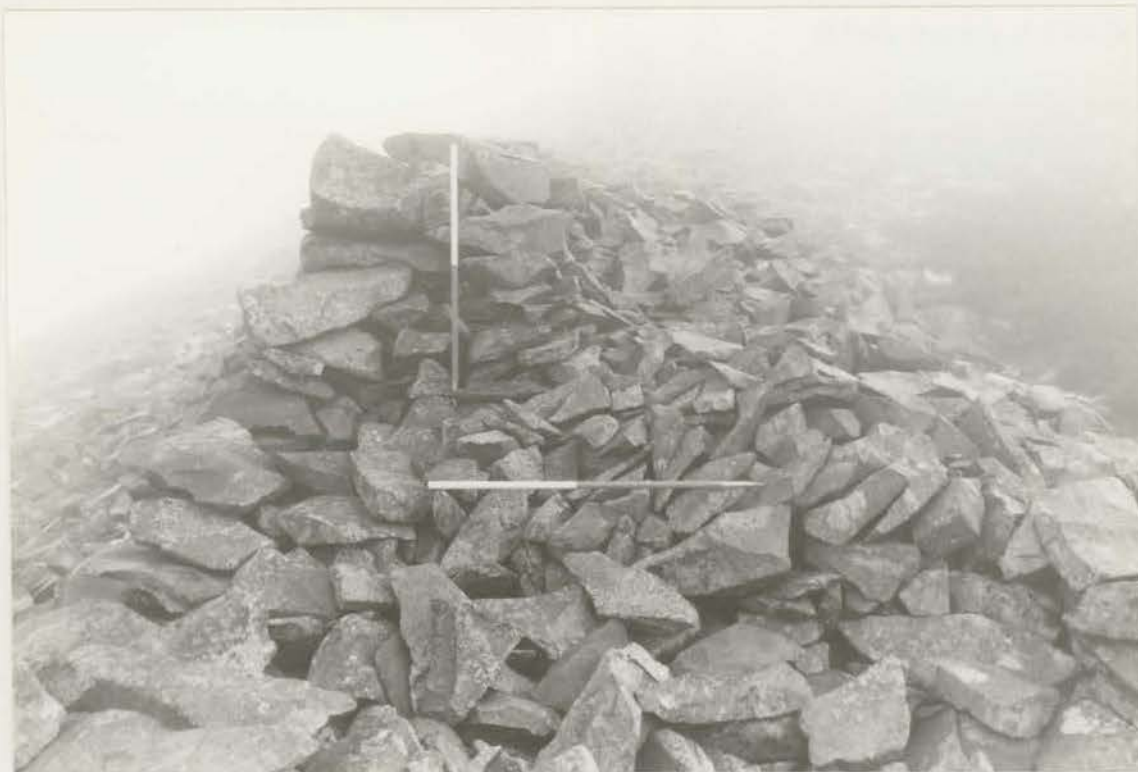
Plate 100. N postern: access cleared in front of passage, looking S
(G1022/008/24A).

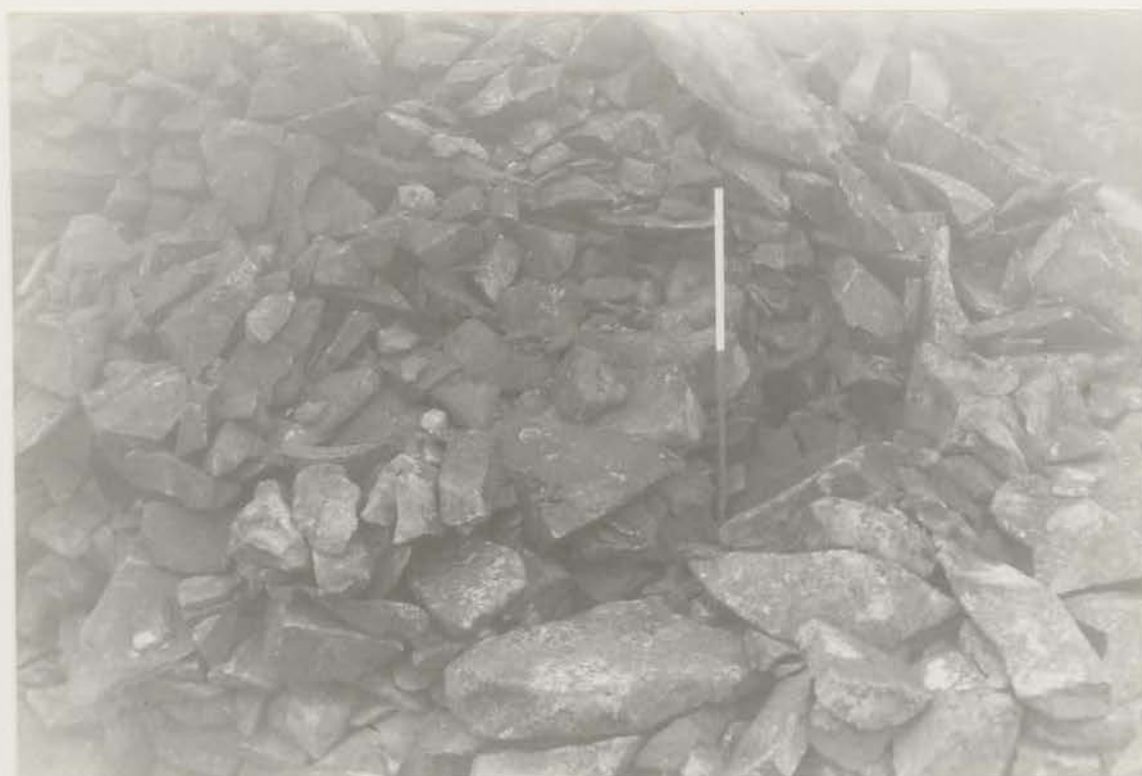
Plate 101. Parapet to E of N postern, looking E (G1022/009/09A).

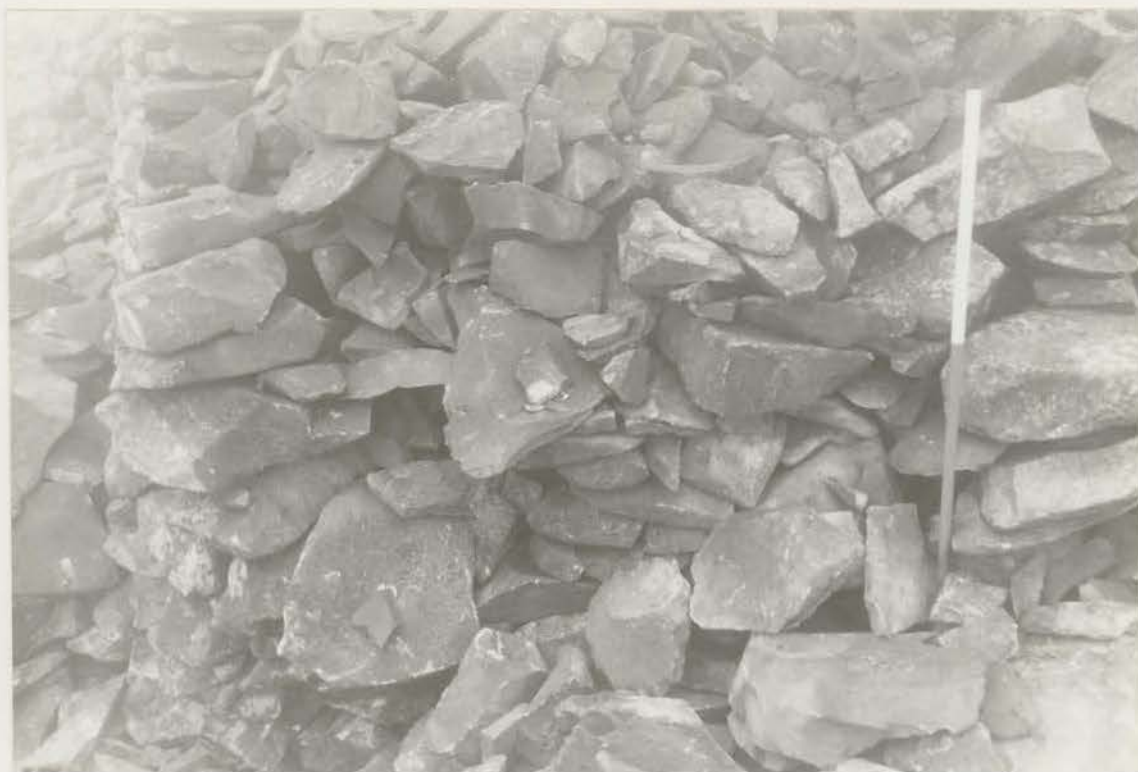
Plate 102. N postern: original inner wall face exposed to E of passage, looking E (G1022/010/12).
