TRE'R CEIRI
CONSERVATION PROJECT
1989 - 90
PART 2: PLATES

REPORT ON THE FIRST SEASON OF THE
TRE'R CEIRI CONSERVATION PROJECT
DECEMBER 1989 - MARCH 1990

S.D. BOYLE

PART 2: PLATES

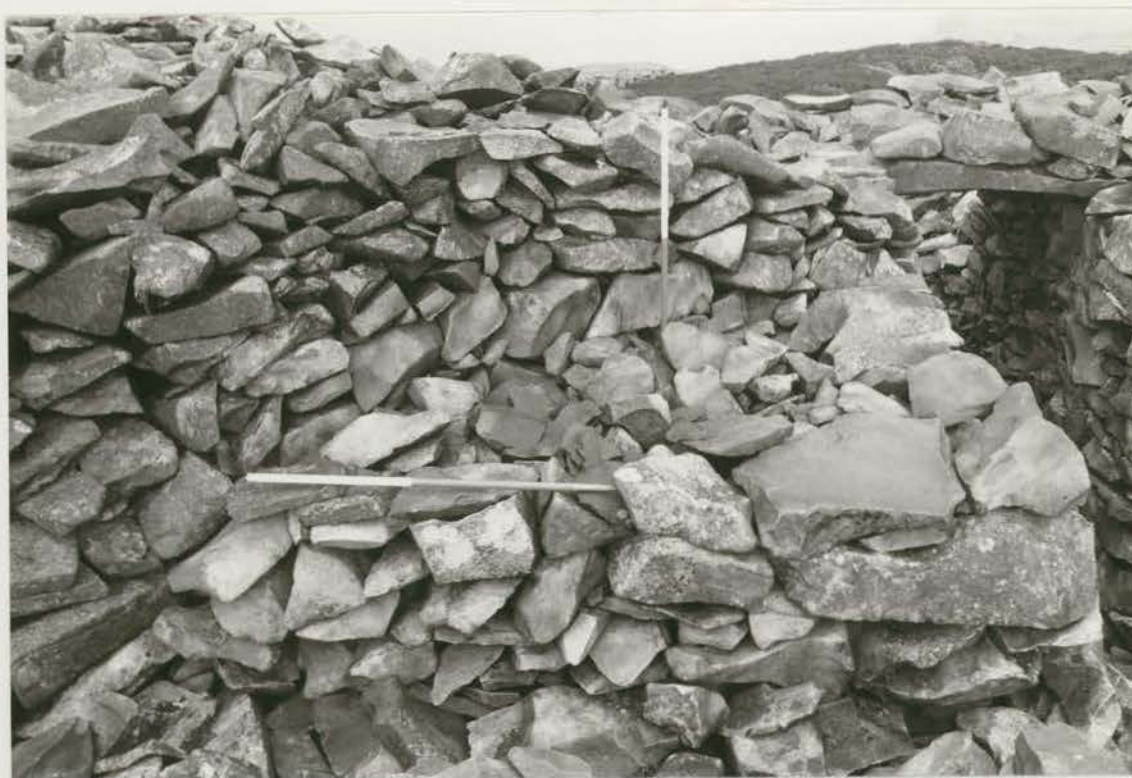
Plate 103. N postern: E side of passage partly cleared, looking E (G1022/010/10).

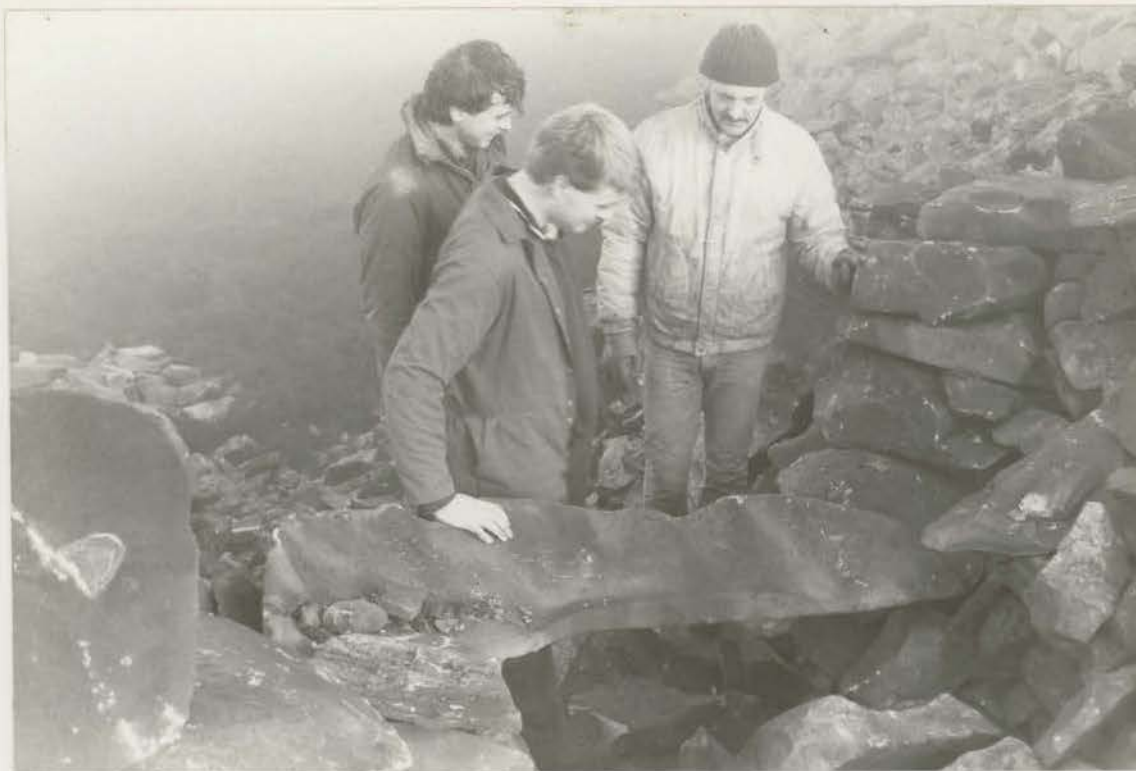
104. N postern: original inner wall face exposed to W of passage.
105. N postern: the outer lintel before removal.
106. The broken lintel.
107. N postern: outer E corner of passage before dismantling.

Plate 104. N postern: original inner wall face exposed to W of passage, looking N (G1022/023/29).

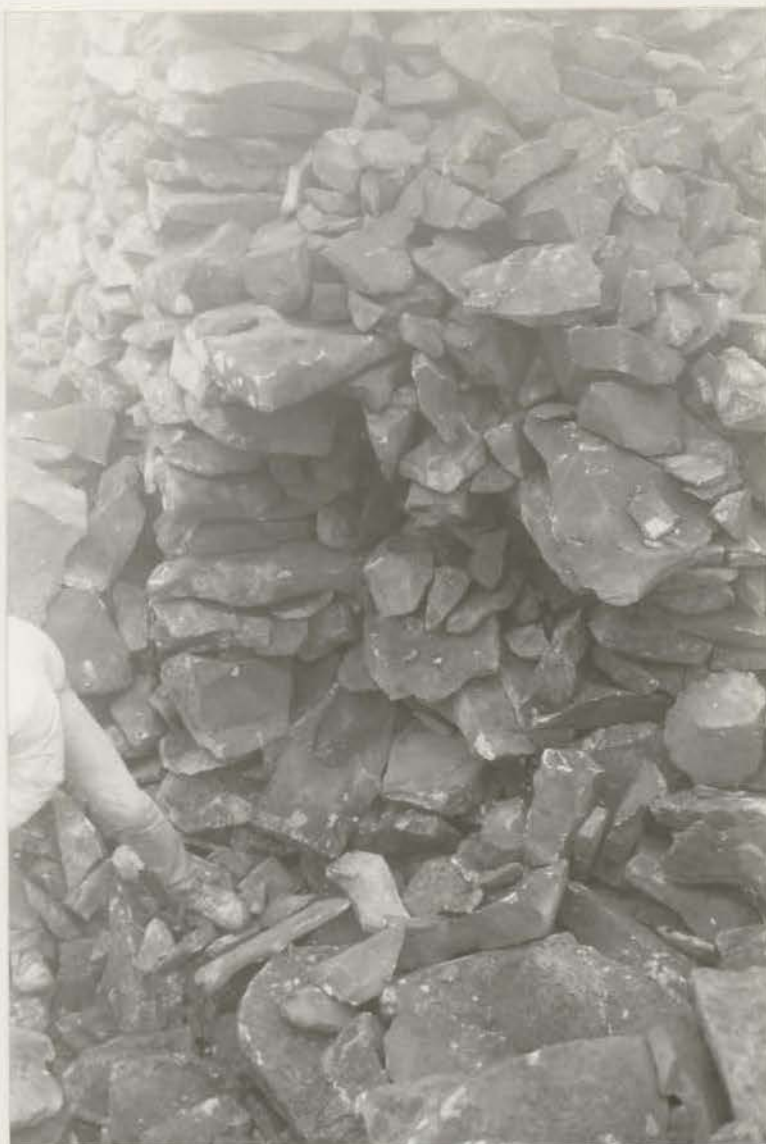
Plate 108. N postern: outer
E corner of passage after
dismantling, looking E
(G1022/010/14).

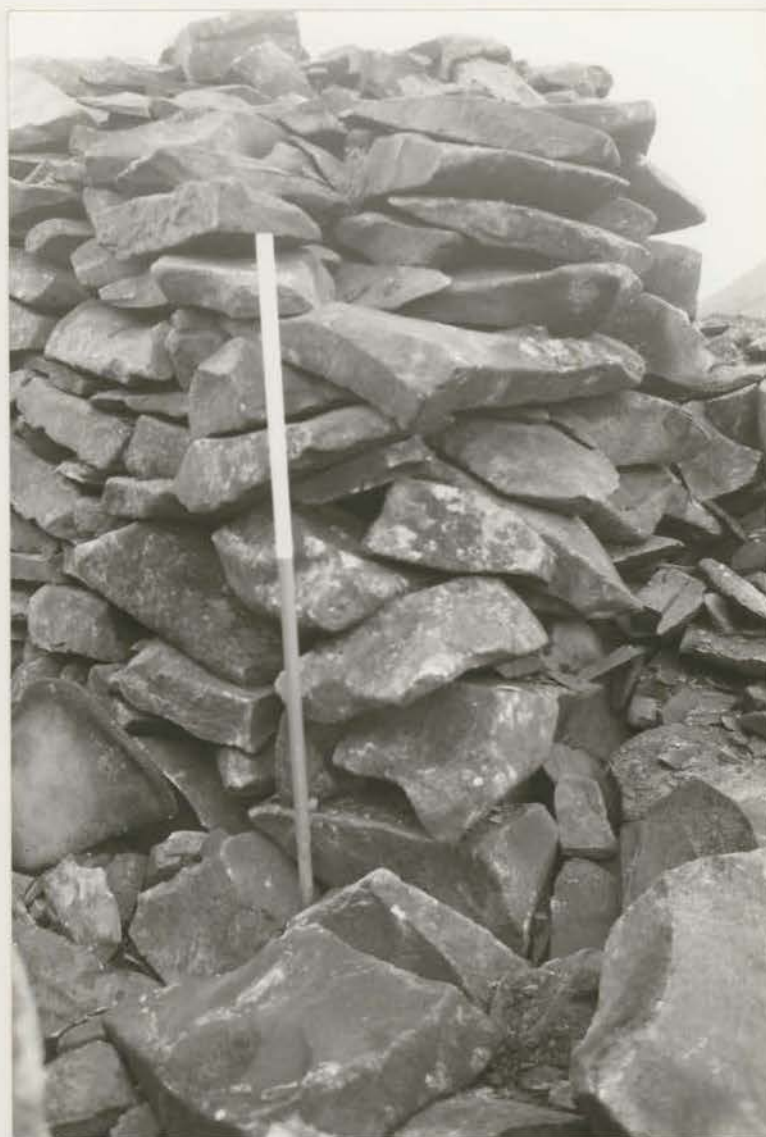
Plate 110. N postern: outer W corner before conservation, looking W (G1022/011/15A).

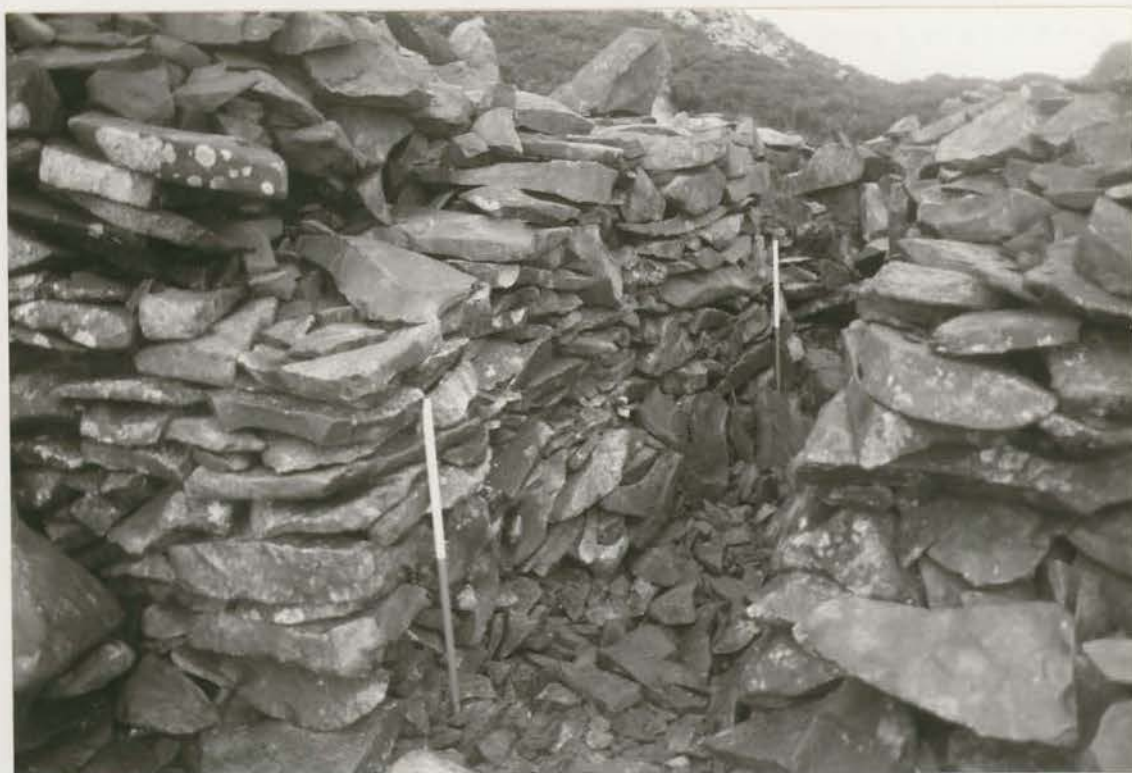
Plate 114. N postern: E side of passage after dismantling, with original inner wall face exposed, looking E (G1022/010/20).

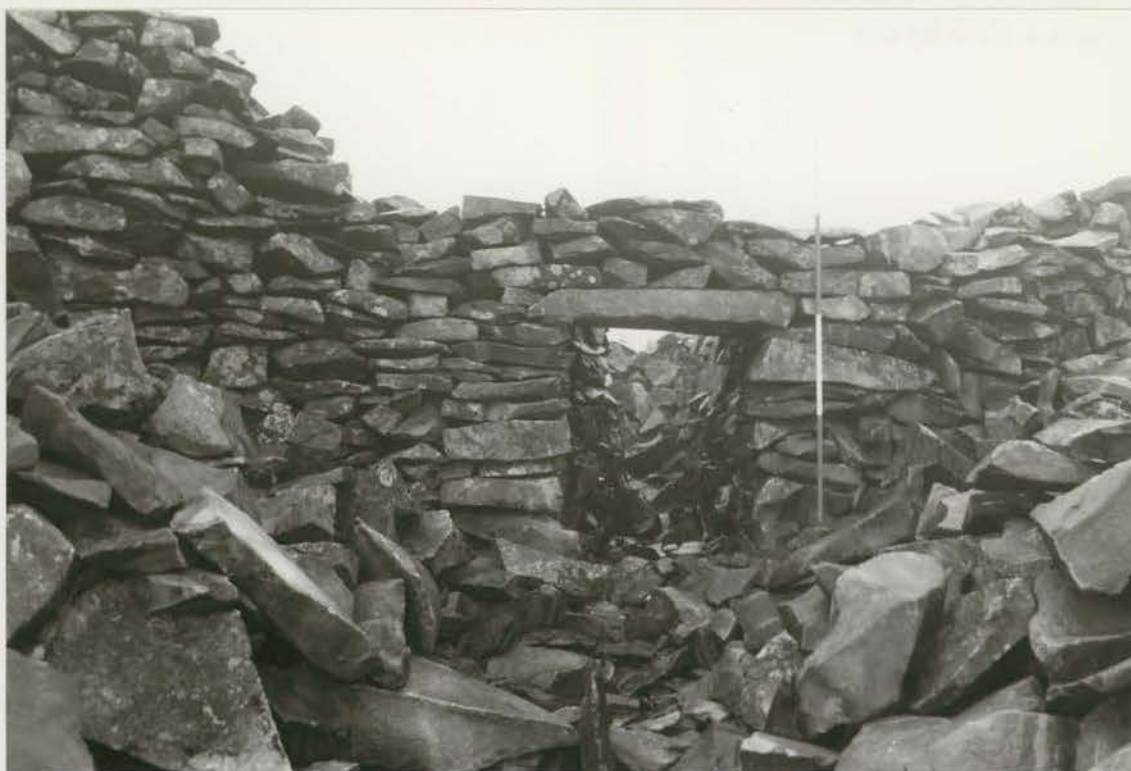
115. N postern: E side of passage after conservation.
116. N postern: W side of passage after conservation.
117. N postern, with replacement lintels.
118. N postern after re-roofing.

Plate 117. N postern, with replacement lintels, looking E (G1022/011/18A).

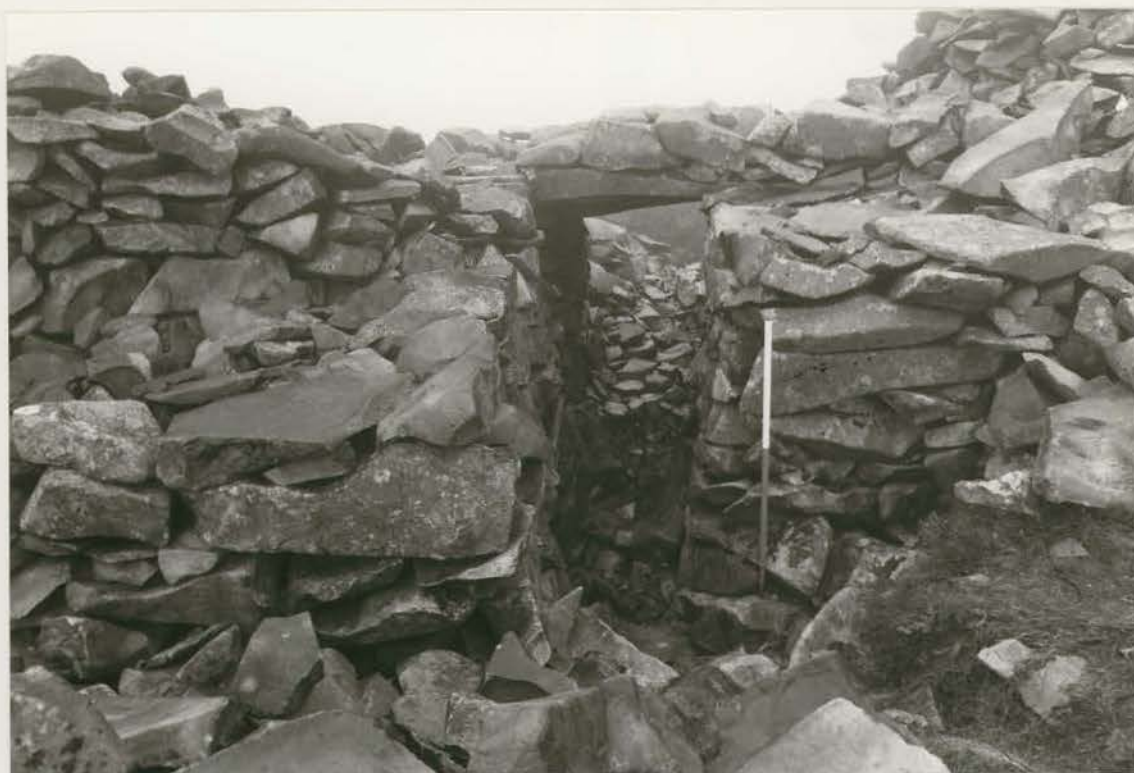
Plate 118. N postern after re-roofing, looking S (G1022/023/26).

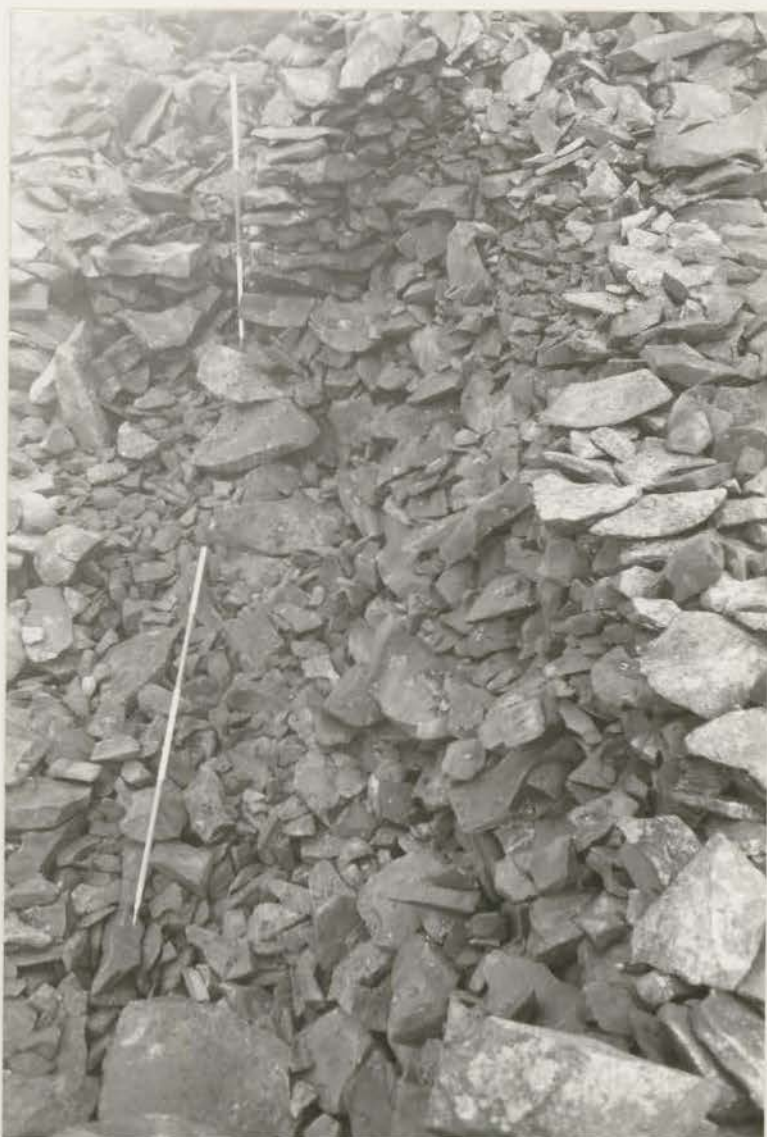
Plate 120. Collapse 'N'
before conservation, looking
S (G1022/008/06A).

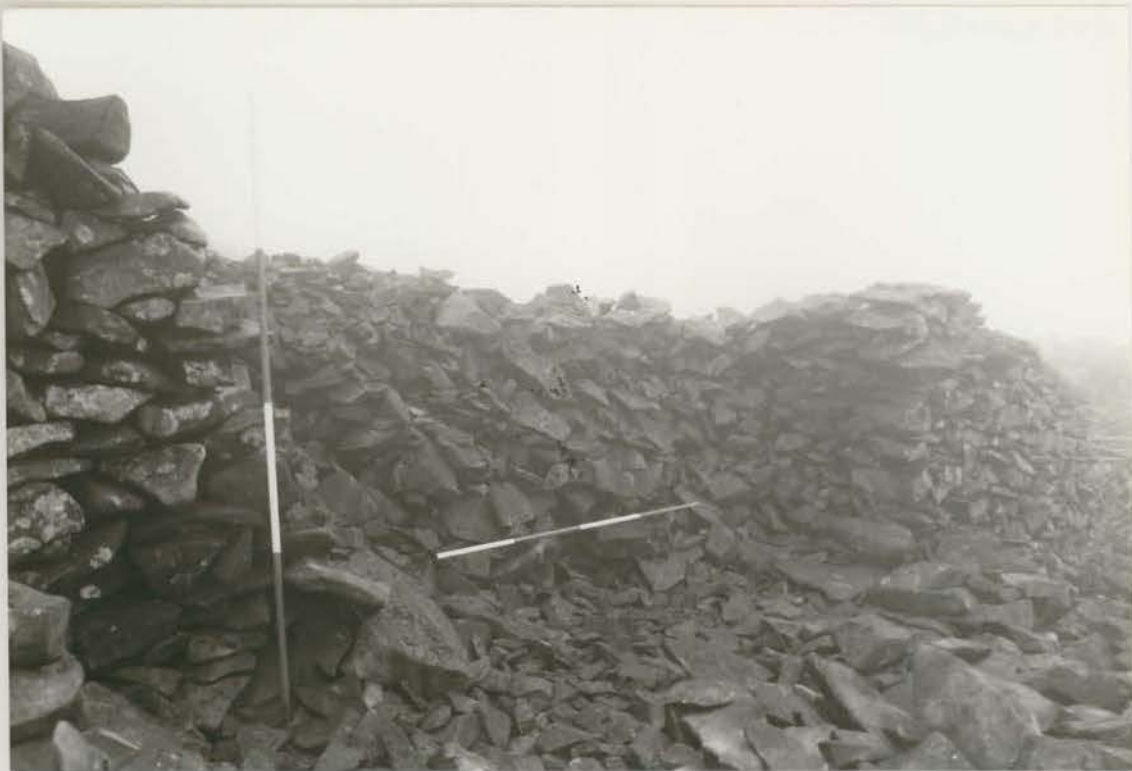
Plate 121. Collapse 'N' after
clearance of tumble, looking
E (G1022/012/09).

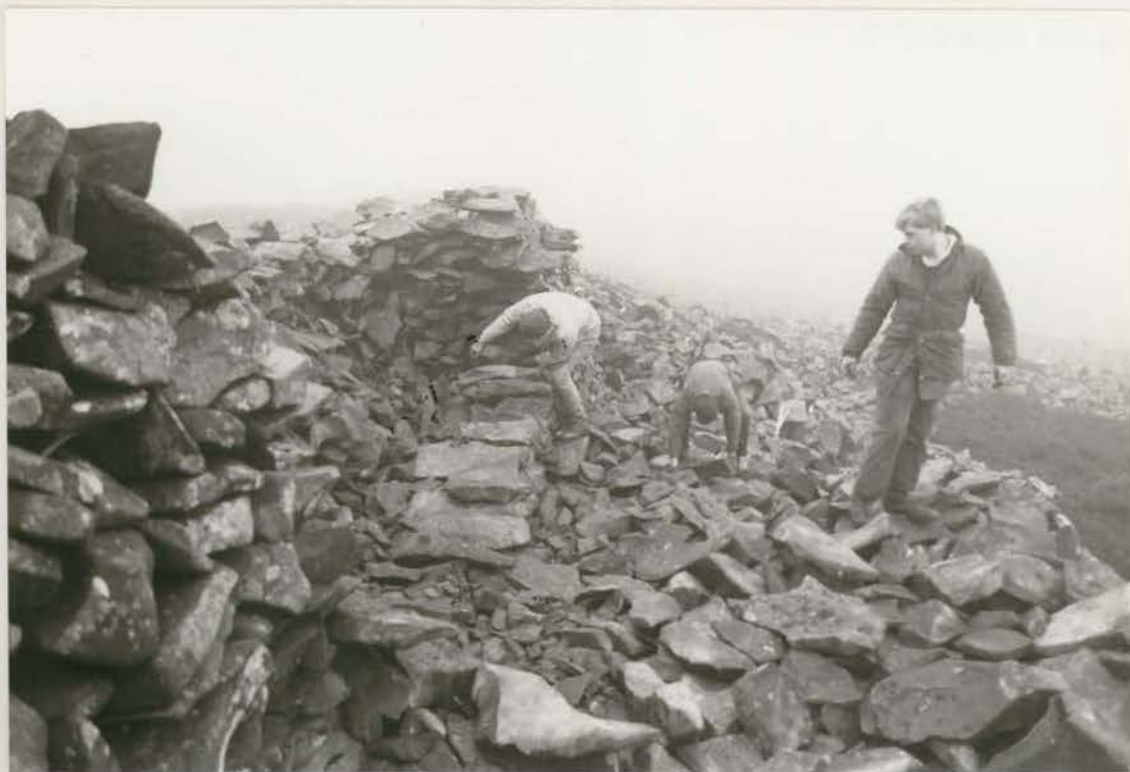
Plate 122. Collapse 'N' after clearance of tumble, looking SW (G1022/012/06).

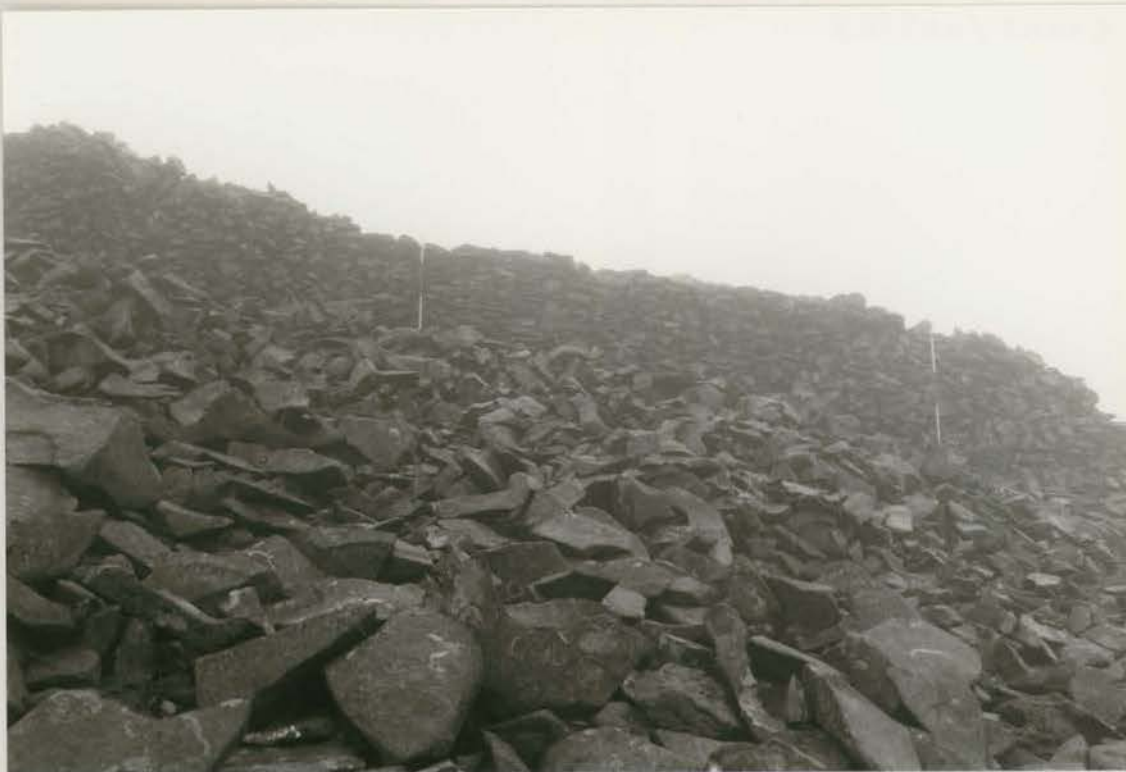
Plate 123. Collapse 'N': wall being refaced, looking W (G1022/012/12).

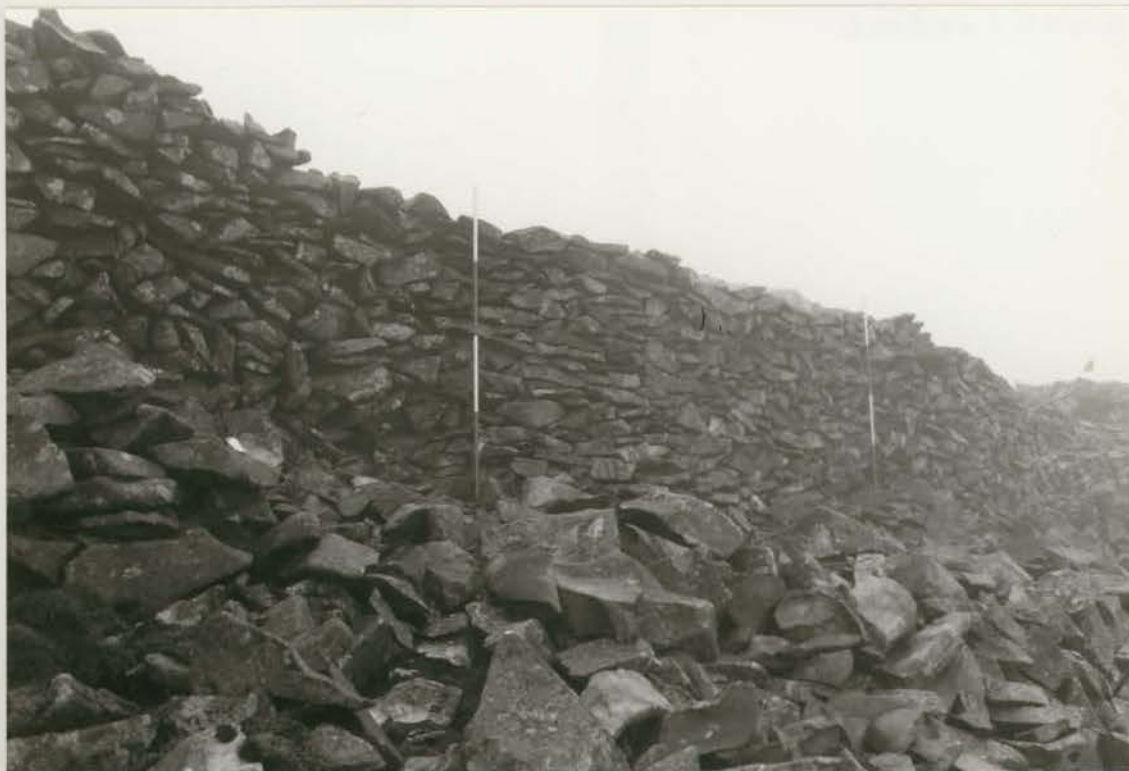
Plate 124. Collapse 'N' after conservation, looking S. Scales
set as in Plate 120. (G1022/023/23).

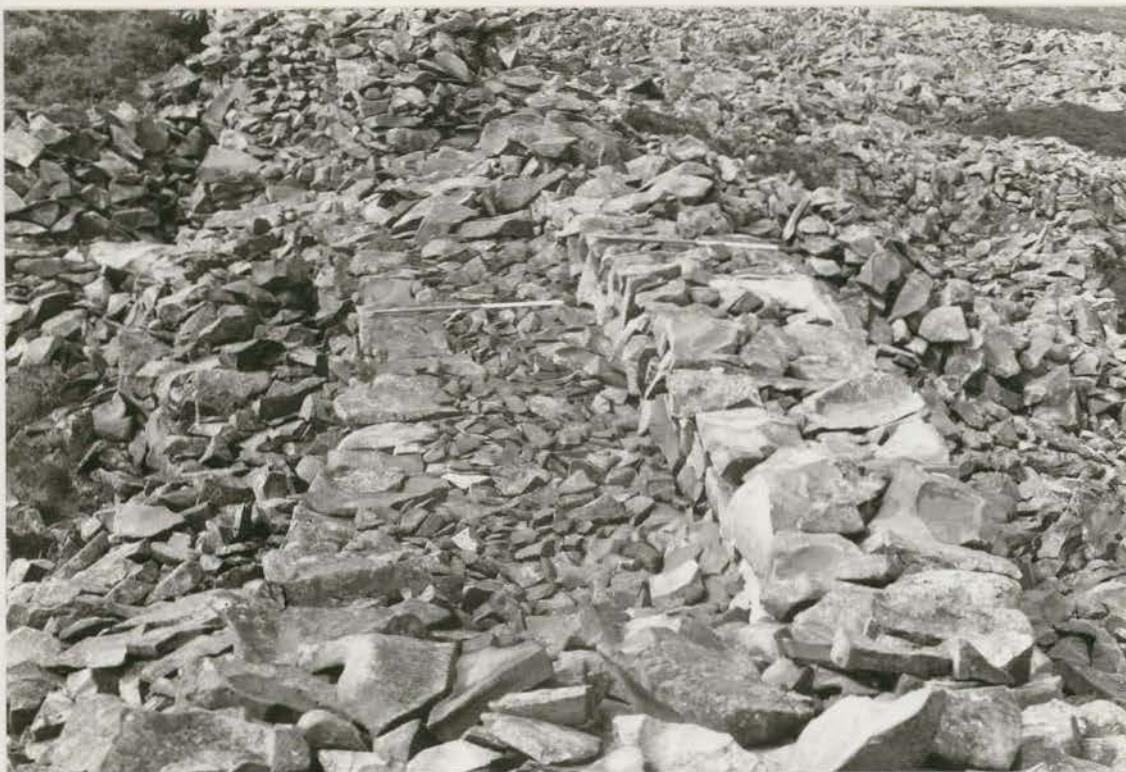
Plate 125. Collapse 'N' after conservation, looking SW (G1022/023/24).

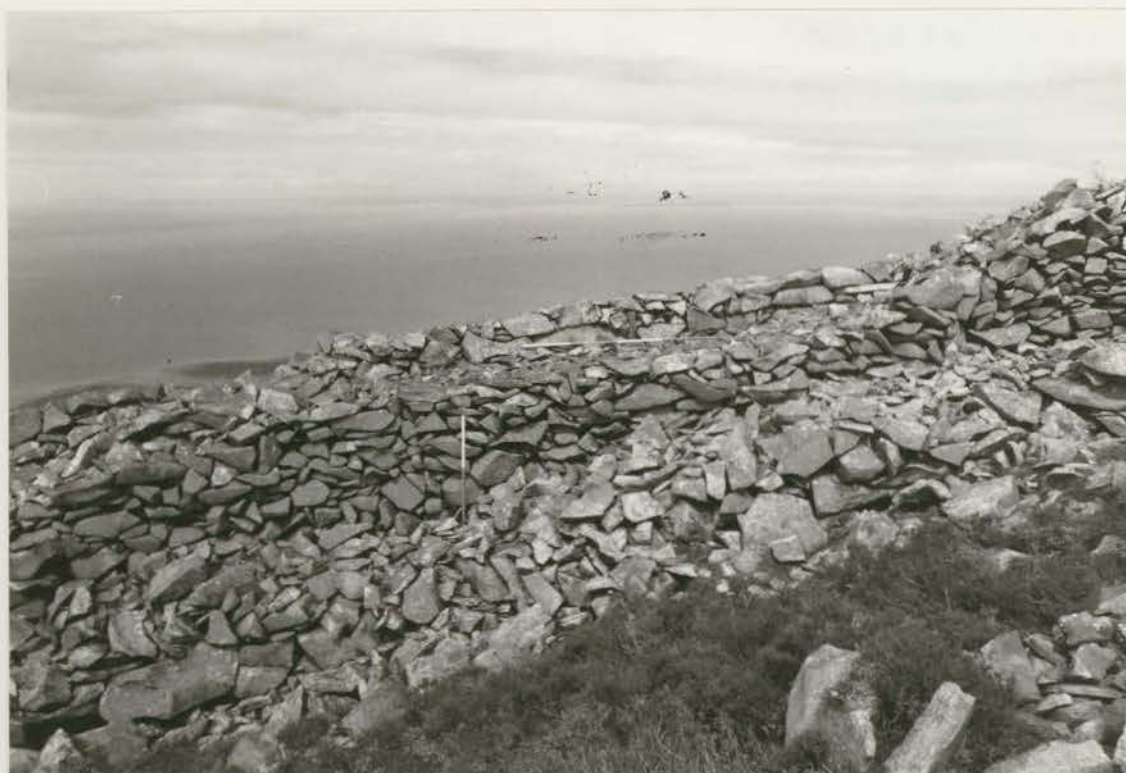
Plate 126. Collapse 'N': top of wall after conservation, with rebuilt parapet, looking W (G1022/023/34).

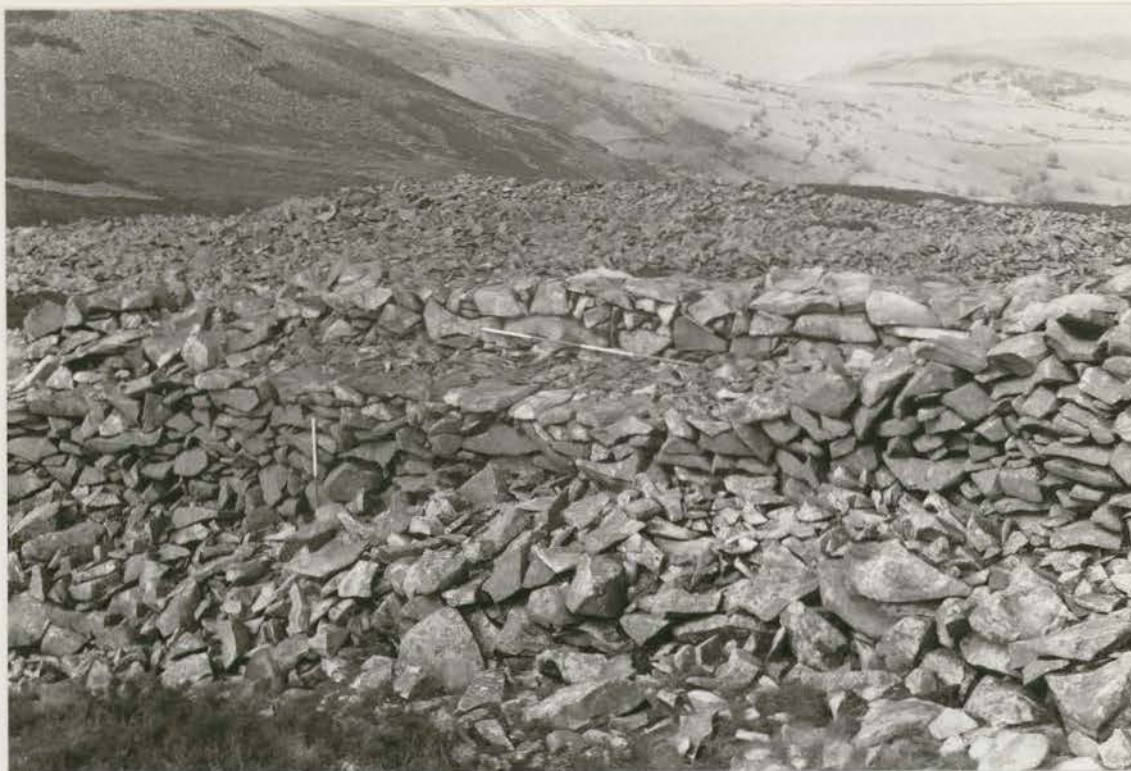
Plate 127. Collapse 'N': inner face after conservation, looking N (G1022/023/35).

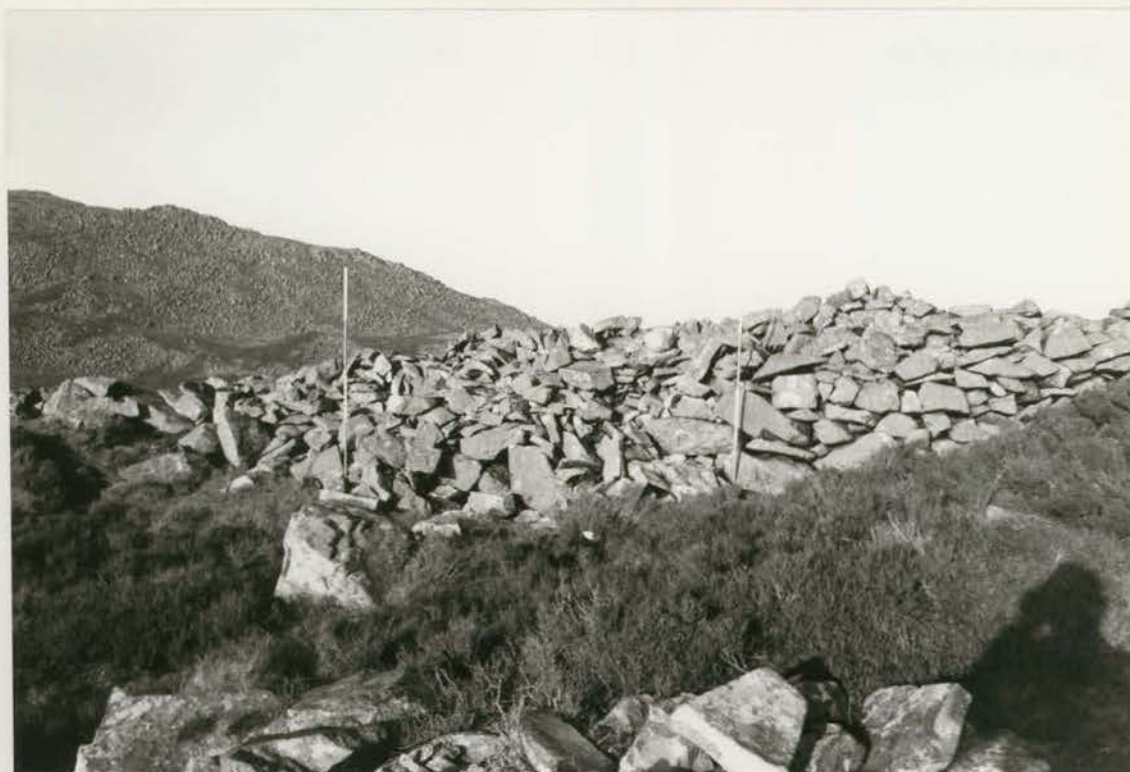
Plate 128. Collapse 'N': inner face after conservation,
looking NW (G1022/023/36).

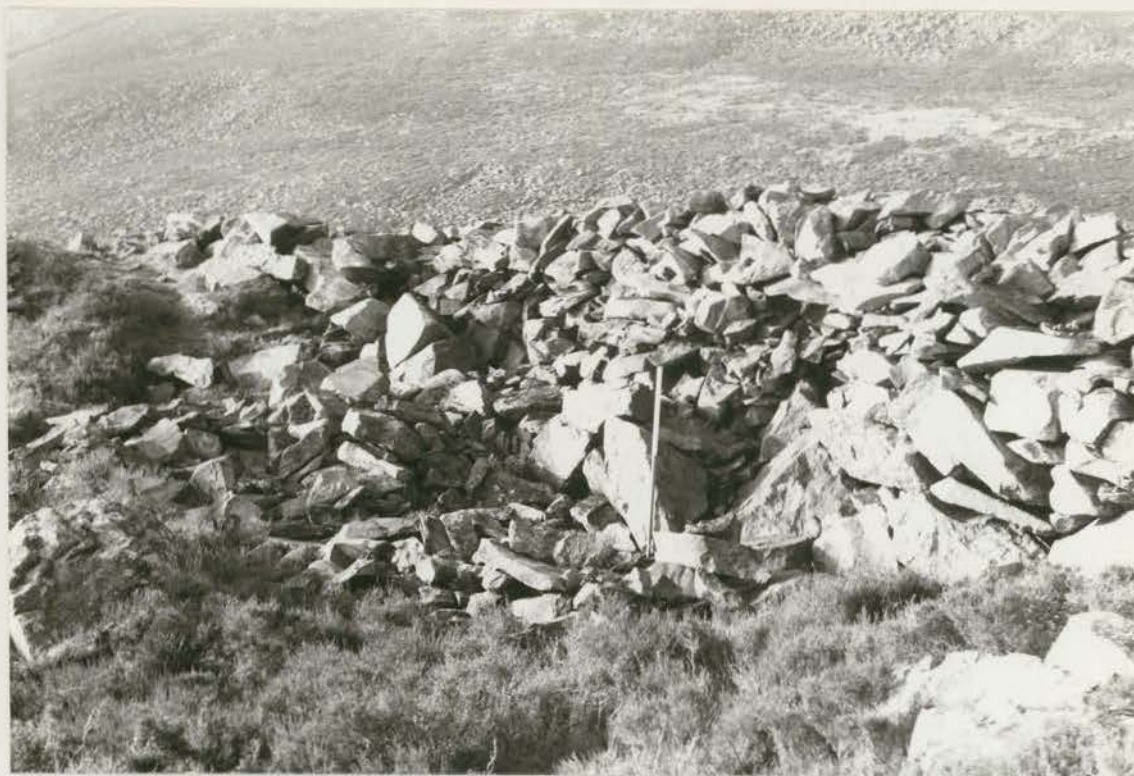
Plate 129. Collapse 'E1' before conservation, looking NW
(G1022/013/12).

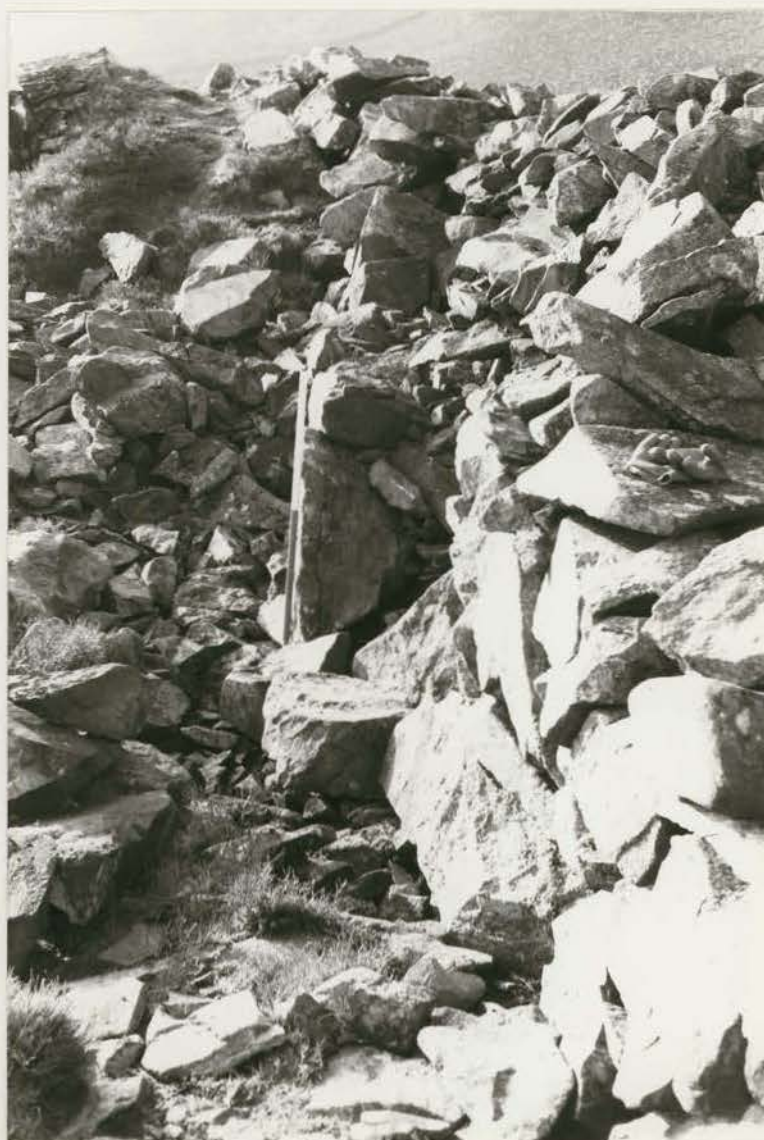
Plate 130. Collapse 'E1'
after removal of tumble,
looking W (G1022/014/18).

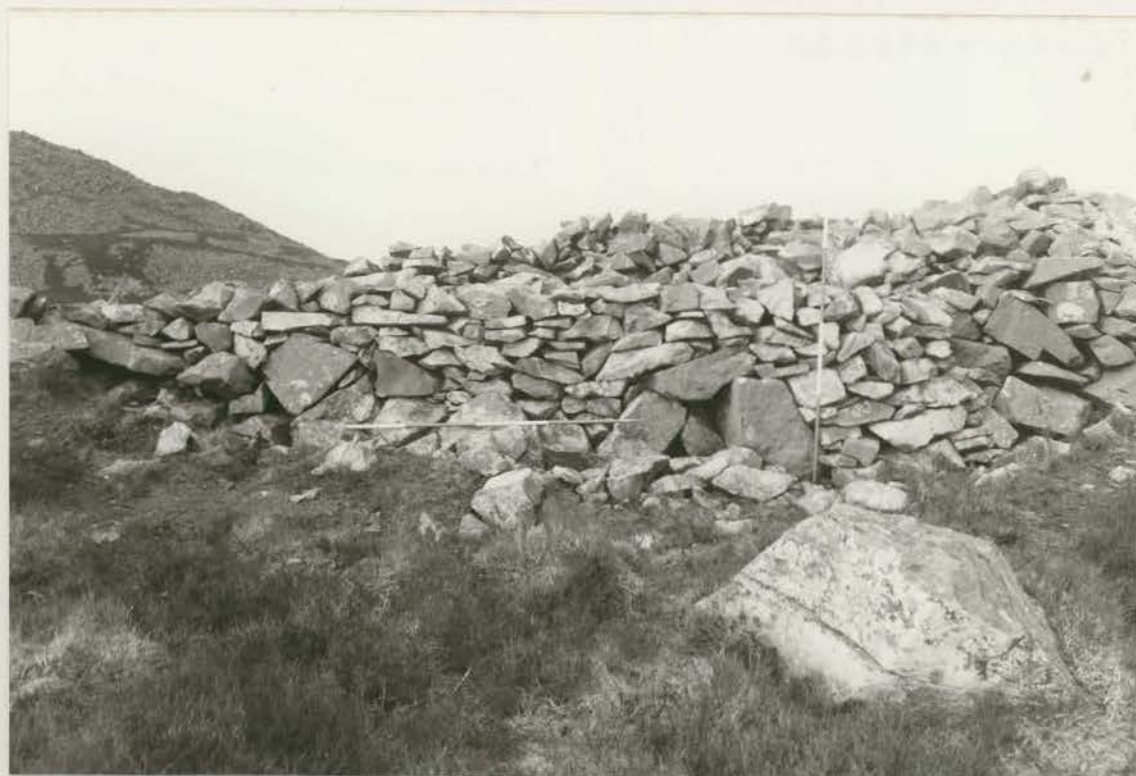
Plate 132. Collapse 'E1'
after conservation, looking
SW (G1022/022/23A).

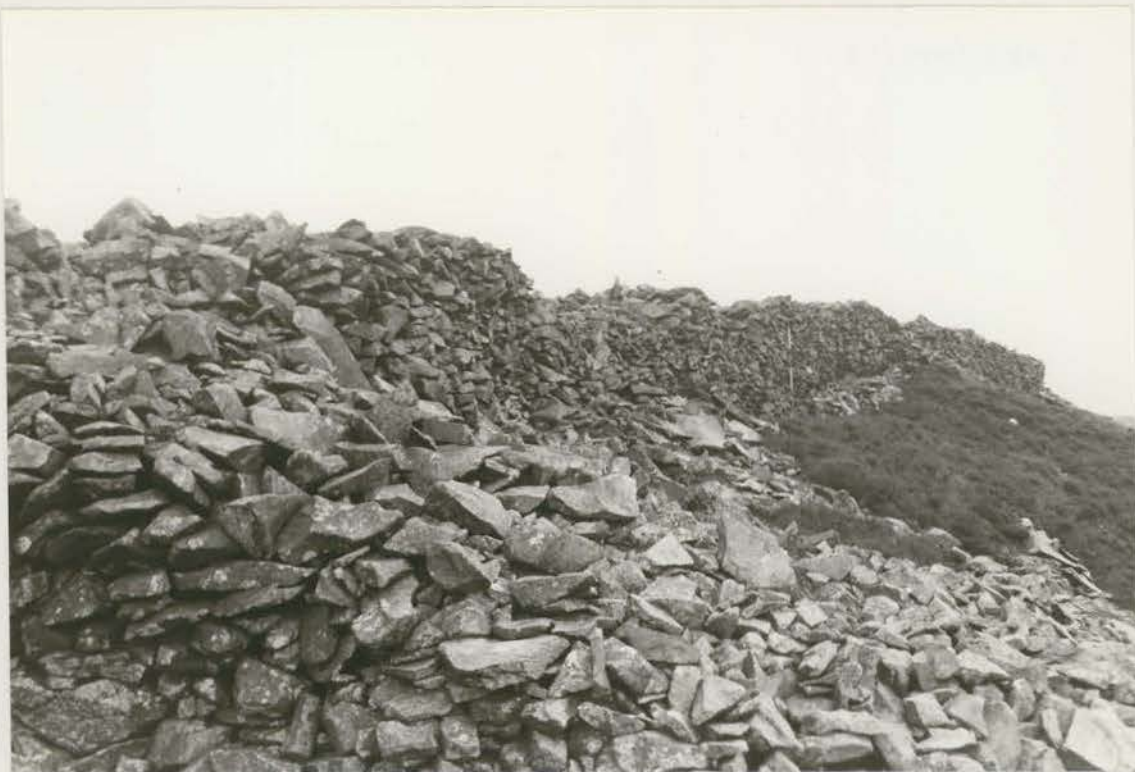
Plate 133. Collapse 'E1'
after conservation, looking
NW (G1022/022/22A).

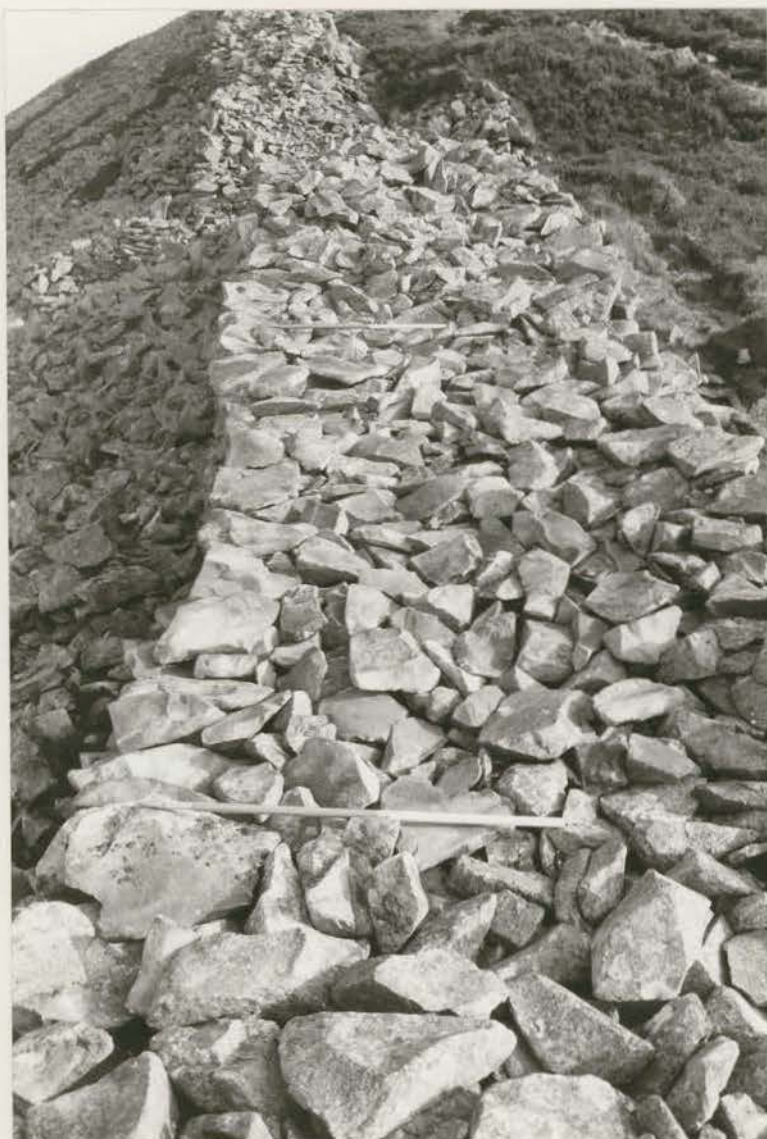
Plate 135. Collapse 'F1' after conservation, looking E (G1022/023/14).
