TRE'R CEIRI
CONSERVATION PROJECT
1990
PART 2: PLATES

REPORT ON THE SECOND SEASON OF THE
TRE'R CEIRI CONSERVATION PROJECT
JUNE - NOVEMBER 1990

S.D. BOYLE

GWYNEDD ARCHAEOLOGICAL TRUST LTD.

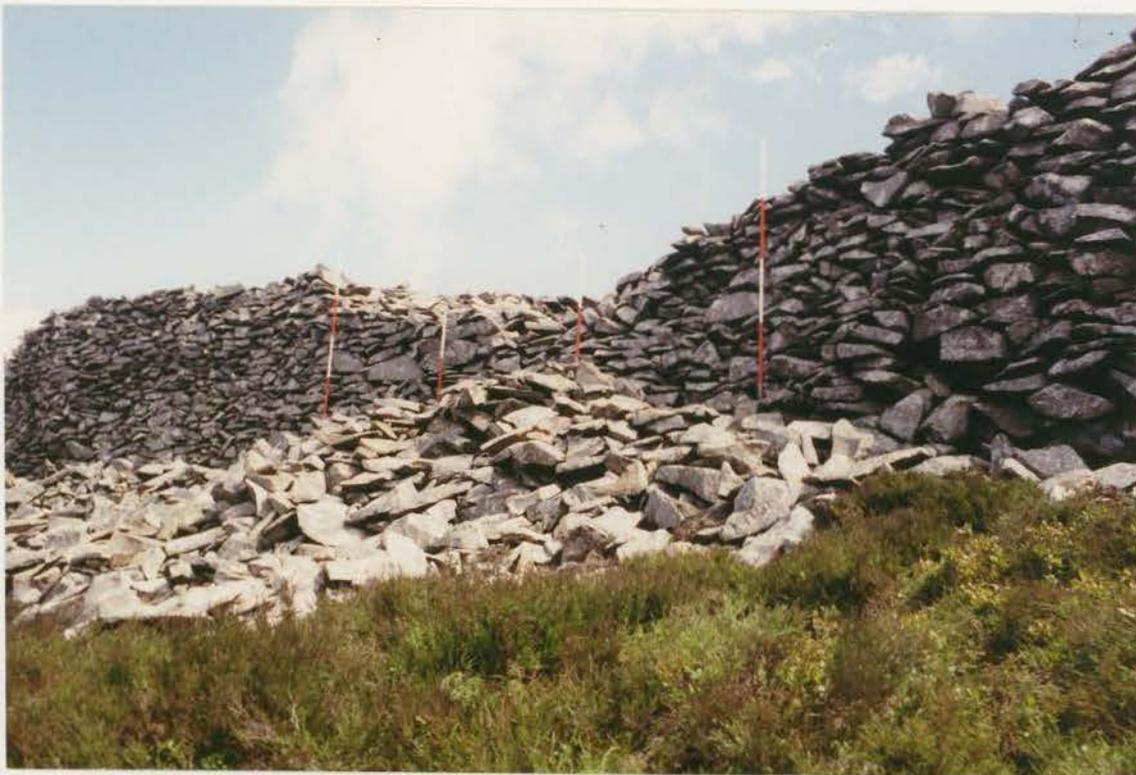
Plate 1. Collapse I: outer face of the wall (G1022/113/06).

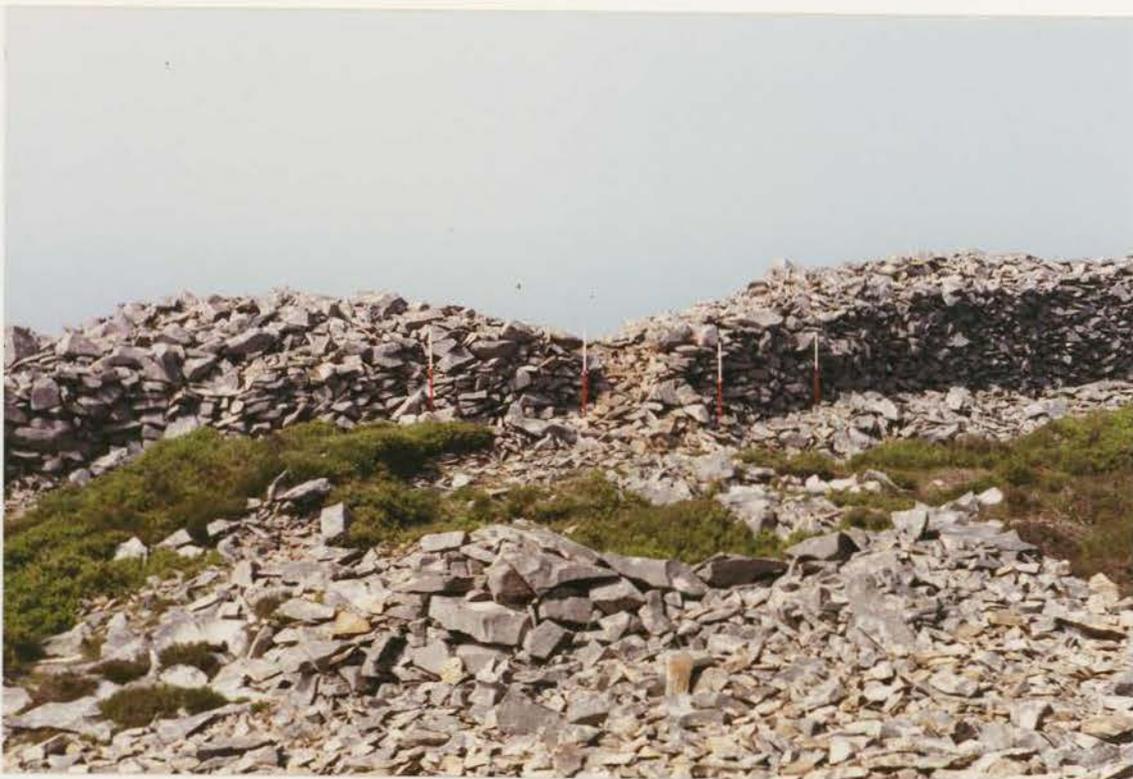
Plate 2. Collapse I: inner face (G1022/110/13A).

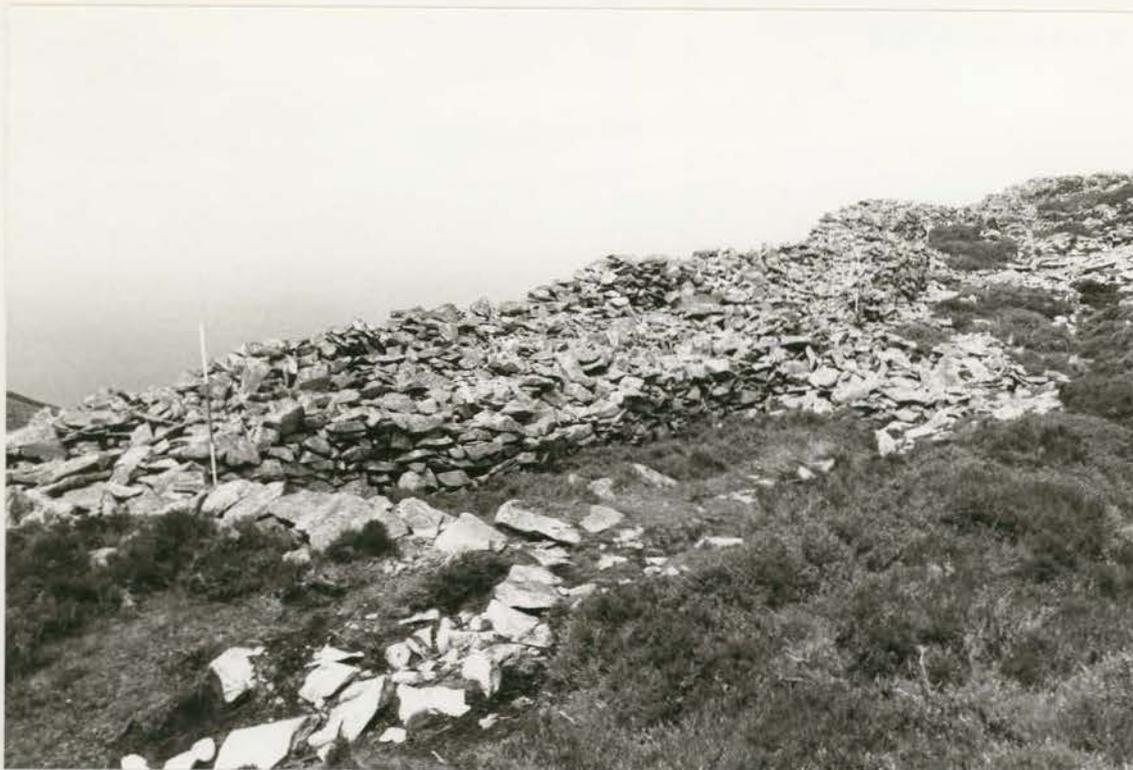
Plate 4. Hut 77 in 1990, with eroded pathway along its SE wall, looking N (G1022/026/16A).

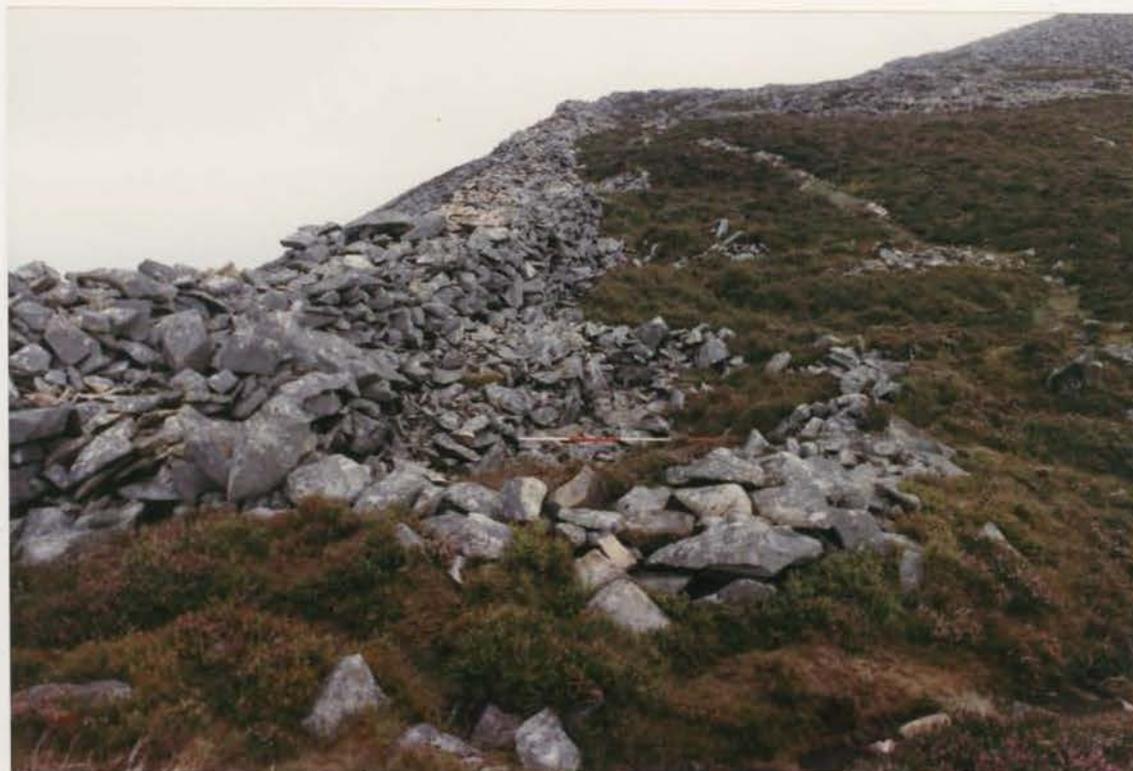
Plate 6. Hut 2: general view before conservation, looking NE
(G1022/114/15).

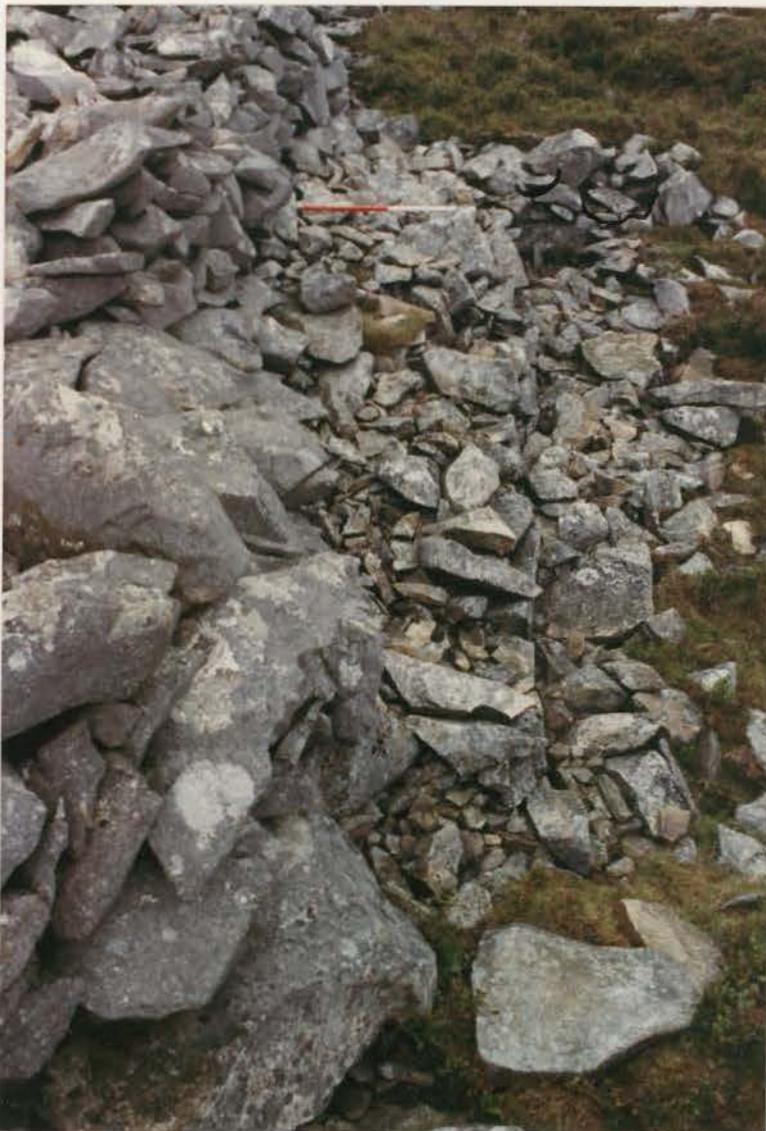
Plate 8. Hut 2: NW wall before conservation, looking NW (G1022/114/20).

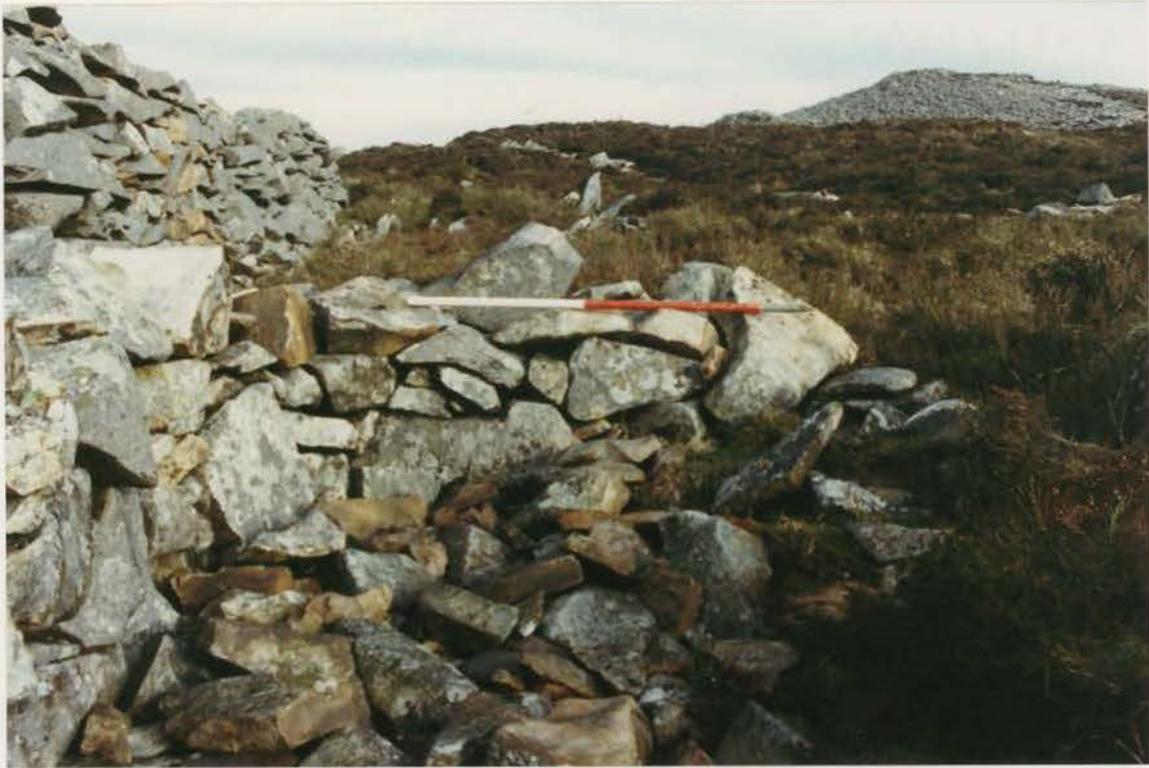
Plate 9. Hut 2: NE wall after conservation, looking NE (G1022/119/21).

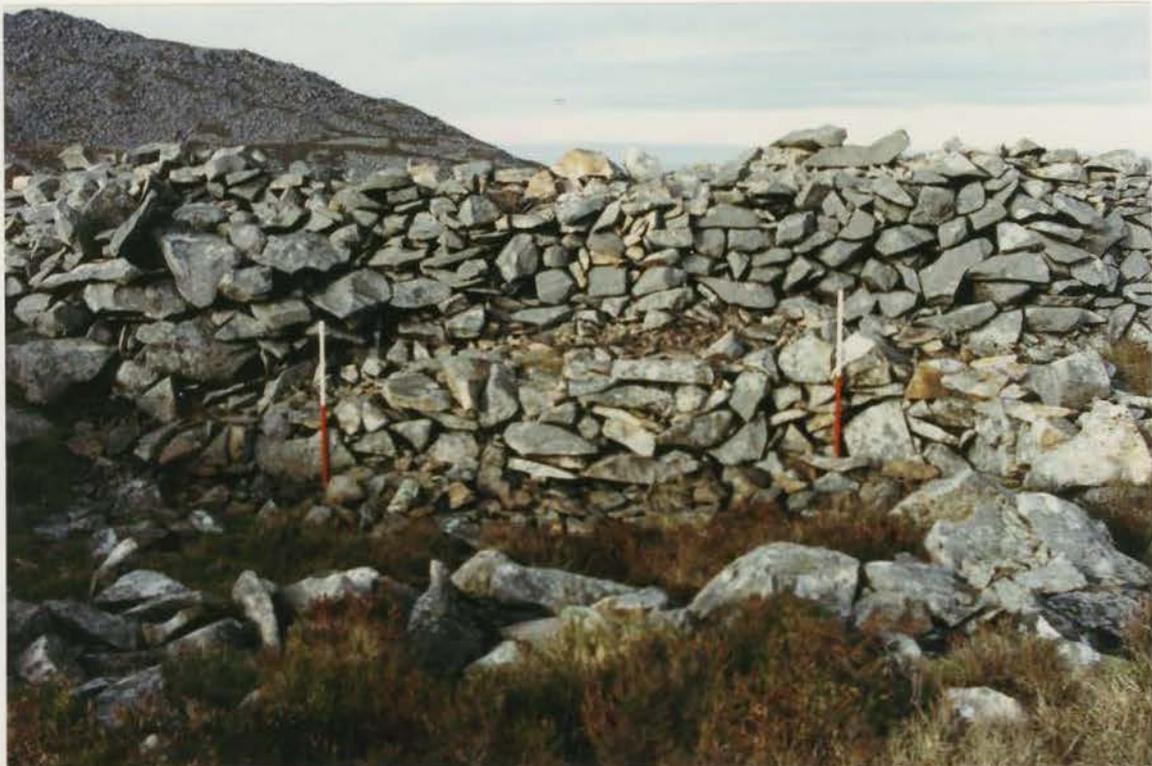
Plate 10. Hut 2: NW wall after conservation, looking NW (G1022/119/18).

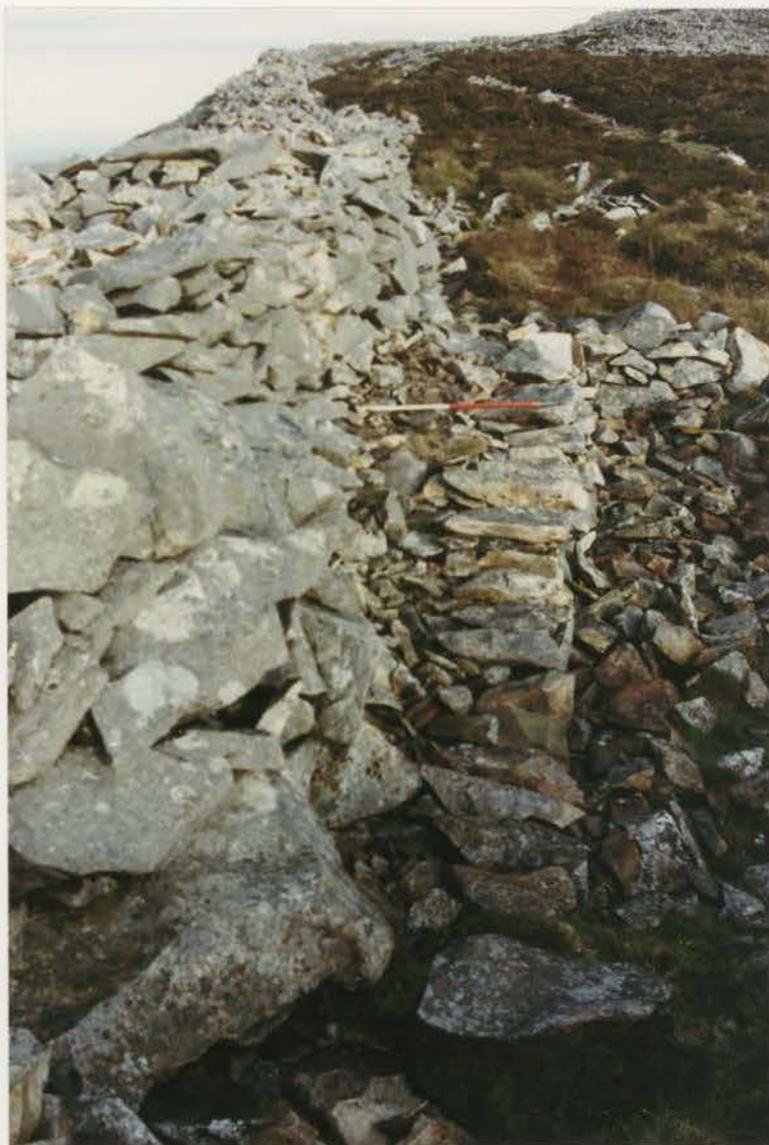
Plate 12. Hut 78: general view before conservation, looking W (G1022/109/05).

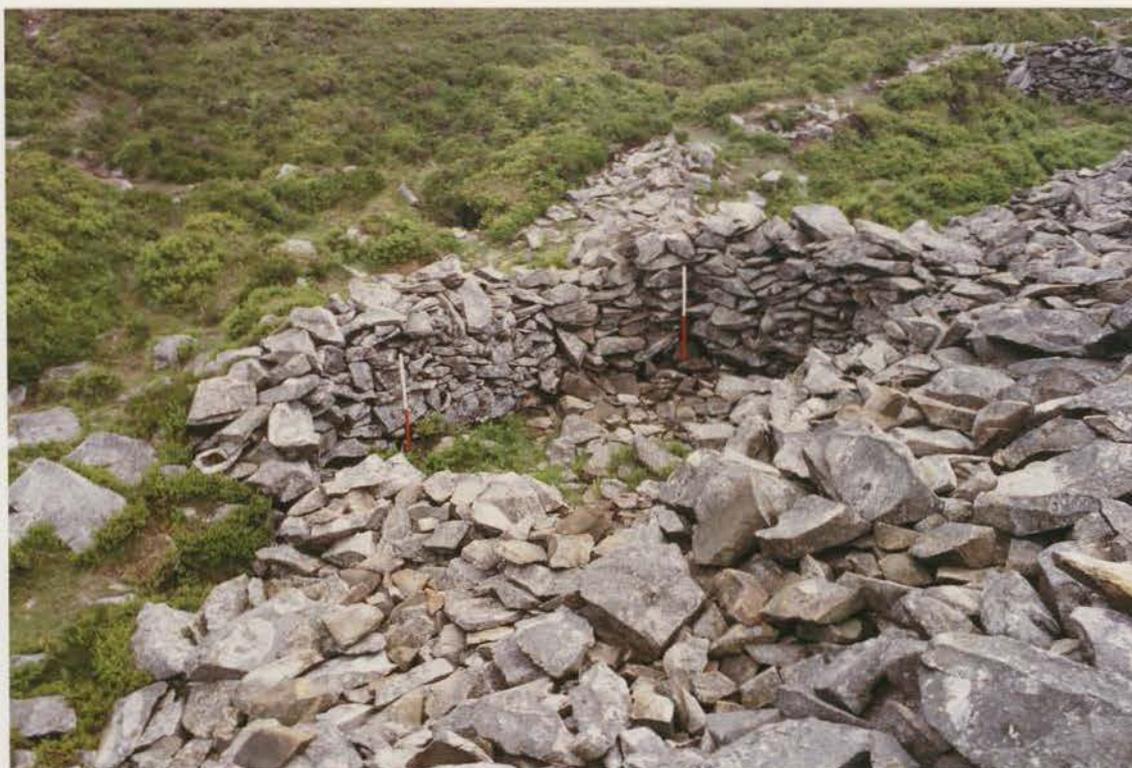
Plate 13. Hut 78: general view before conservation, looking S
(G1022/109/06).

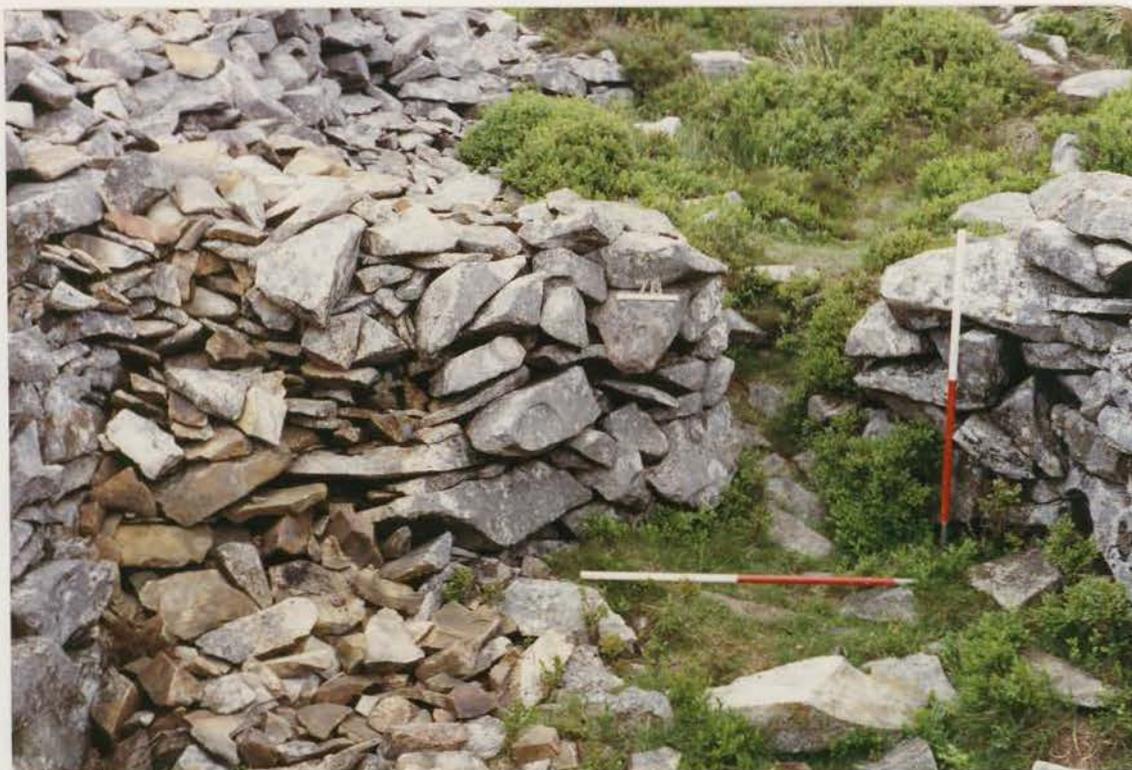
Plate 14. Hut 78: collapsed N corner and hut entrance, looking NE
(G1022/109/11).

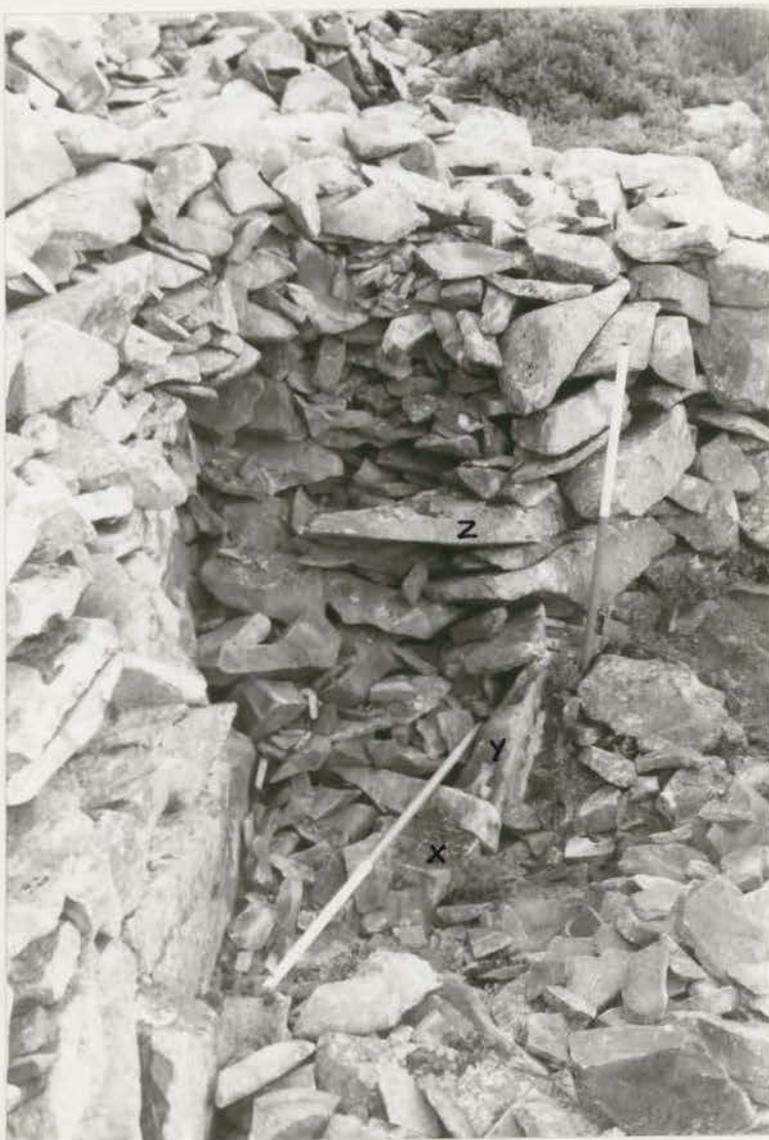
Plate 16. Hut 78: N corner
after removal of rubble,
looking NE (G1022/032/24).

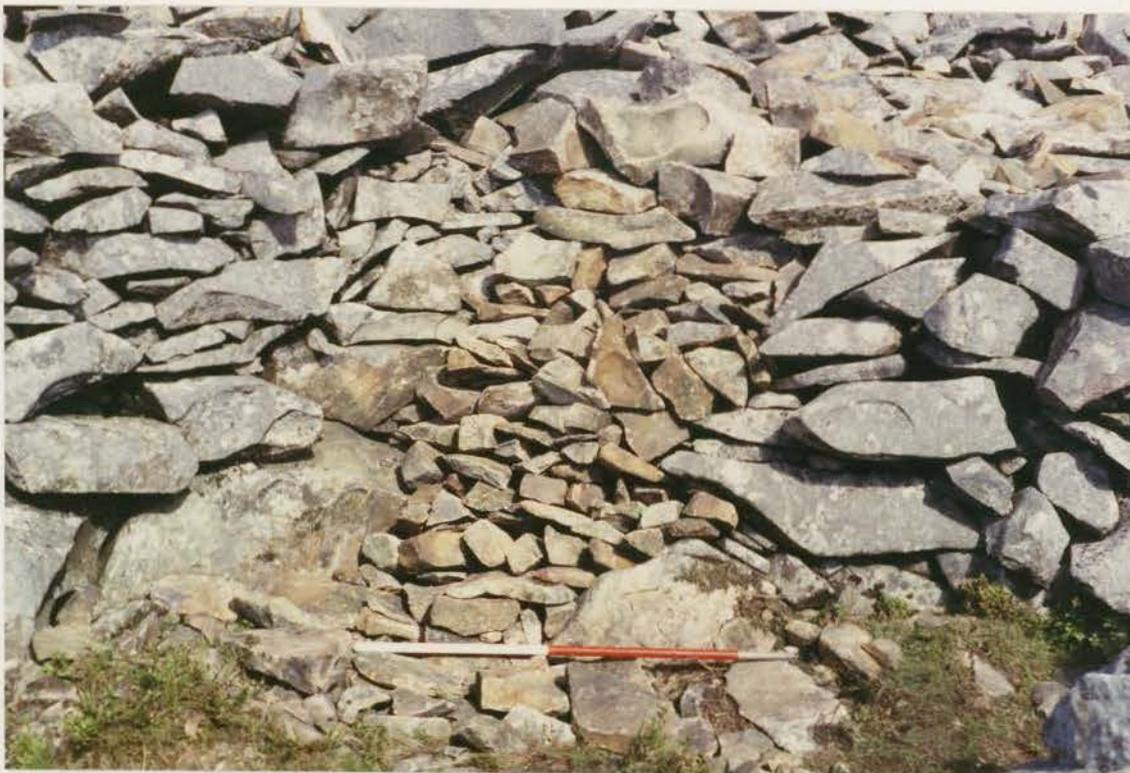
Plate 17. Hut 78: N corner after conservation, looking N
(G1022/113/25)

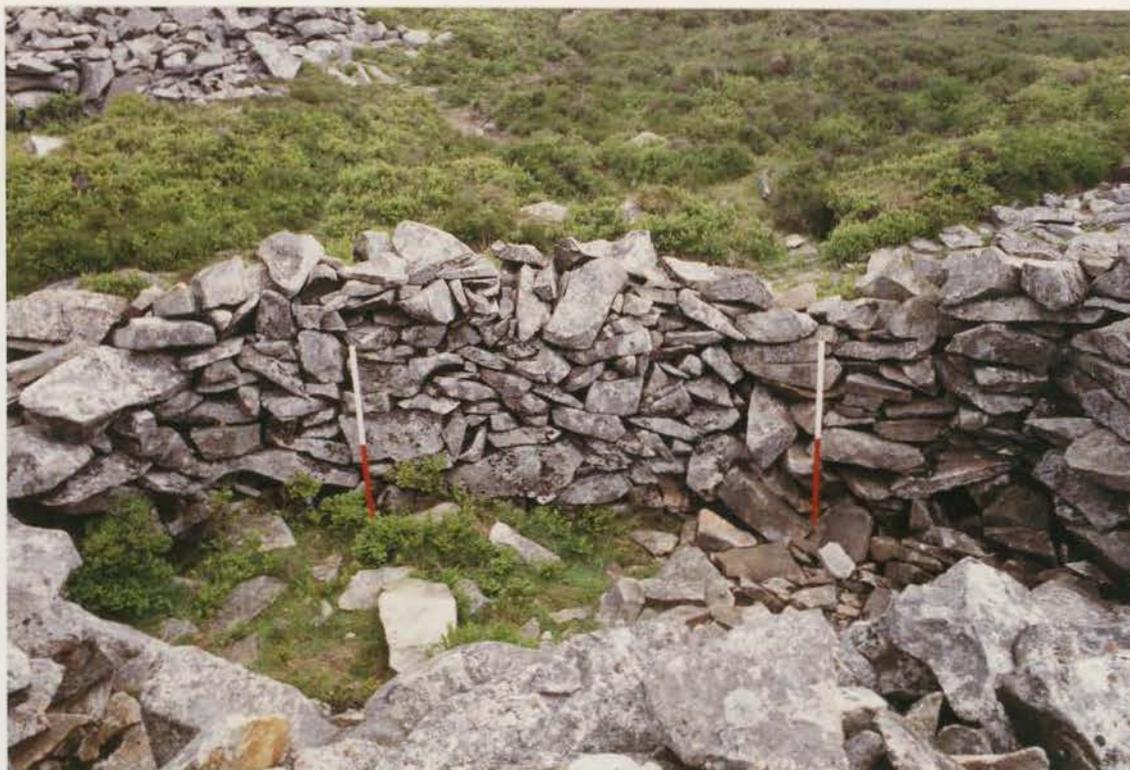
Plate 18. Hut 78: SE wall and S corner before conservation, looking SE
(G1022/109/08).

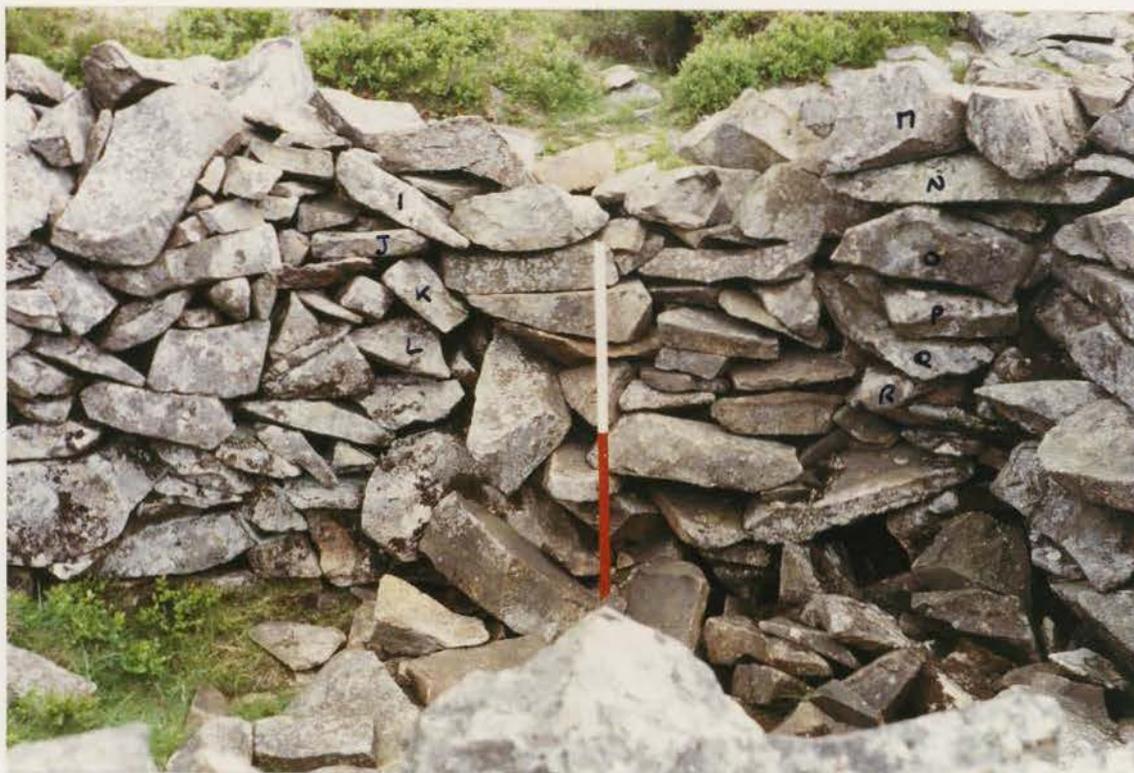
Plate 19. Hut 78: S corner before conservation, looking S (G1022/109/10).

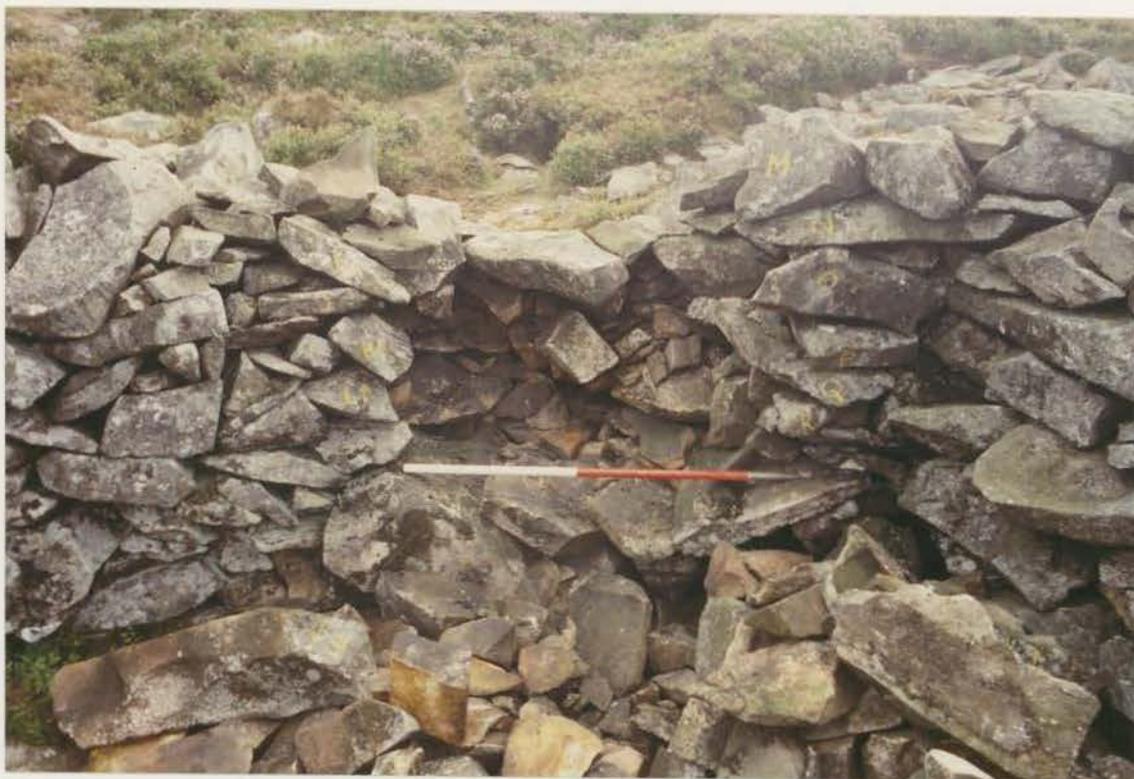
Plate 20. Hut 78: S corner after dismantling of modern rebuild, looking S (G1022/113/23).

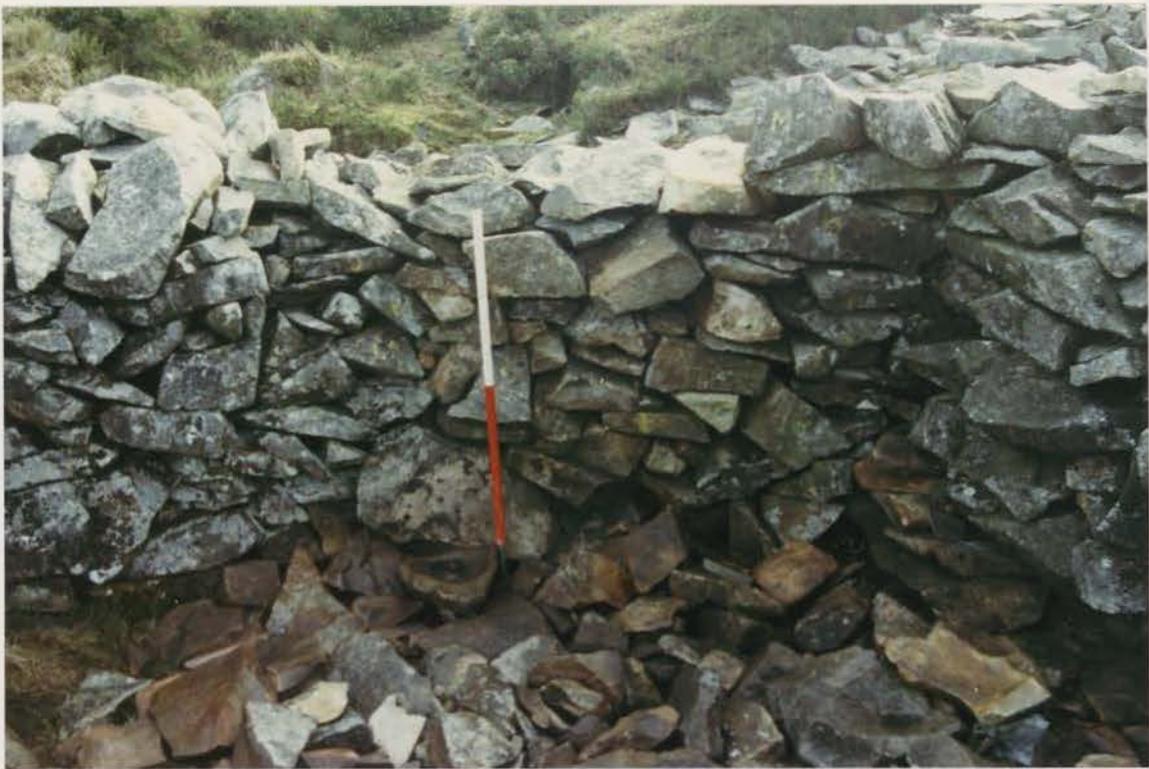
Plate 21. Hut 78: S corner after conservation, looking S
(G1022/119/14).

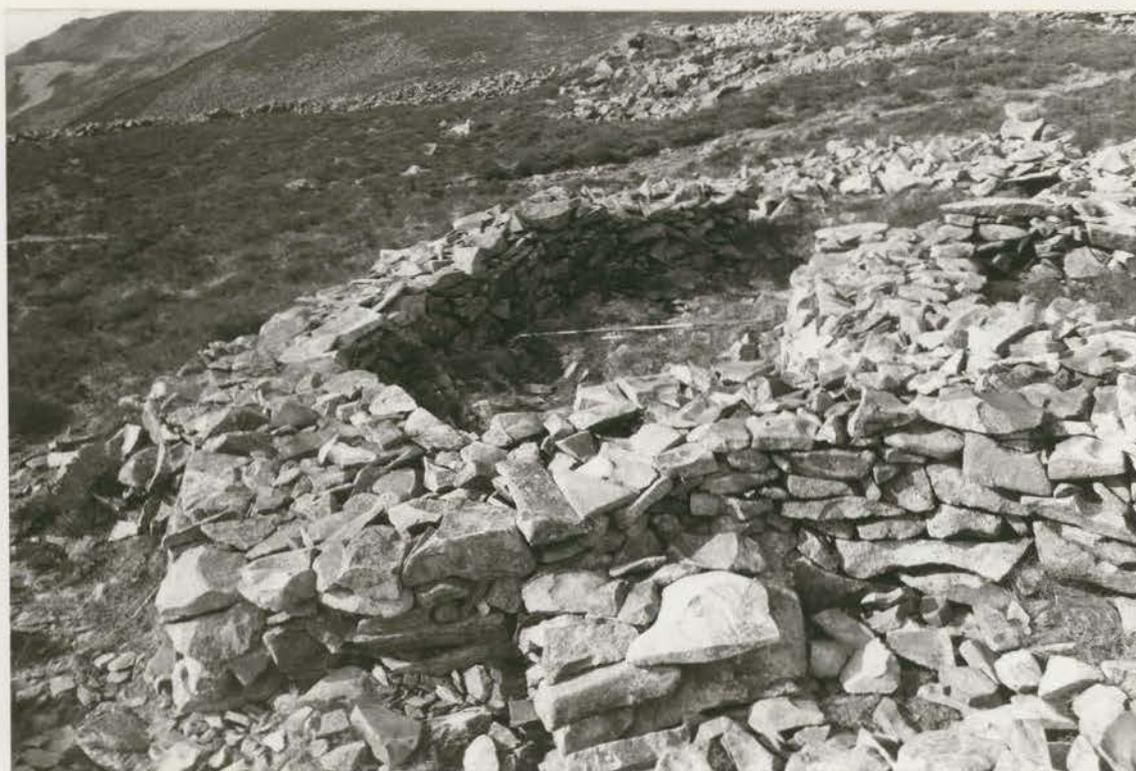
Plate 25. Hut 89: Rebuilt door jamb (bottom centre of frame),
February 1990, looking W (G1022/022/11A).

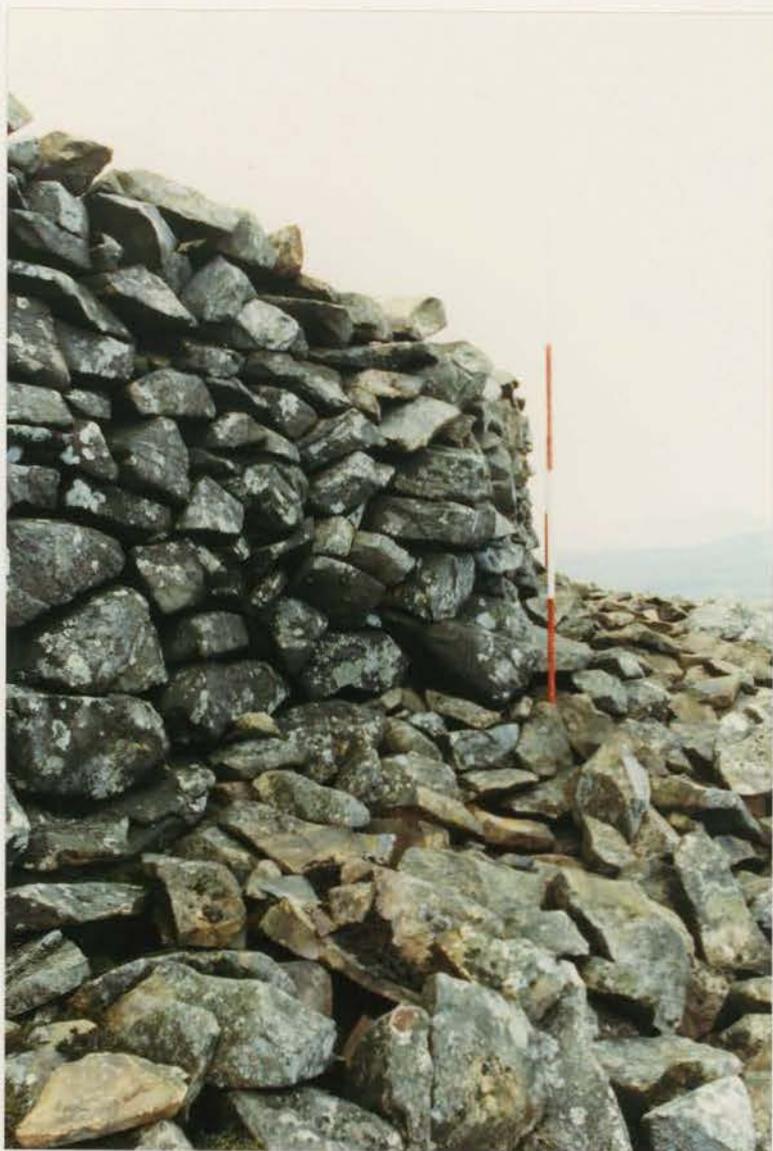
Plate 34. Collapse D after
conservation, looking E
(G1022/118/09).

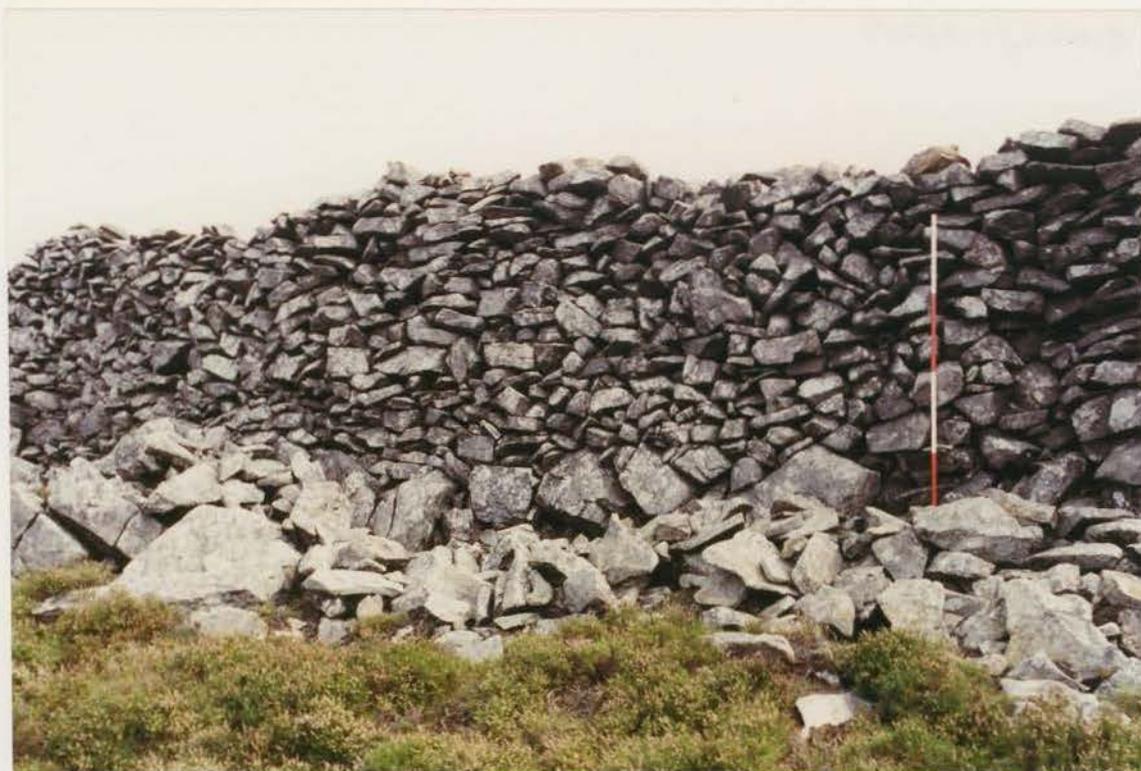
Plate 35. Wall D-E: outer face before conservation, looking E
(G1022/115/29).

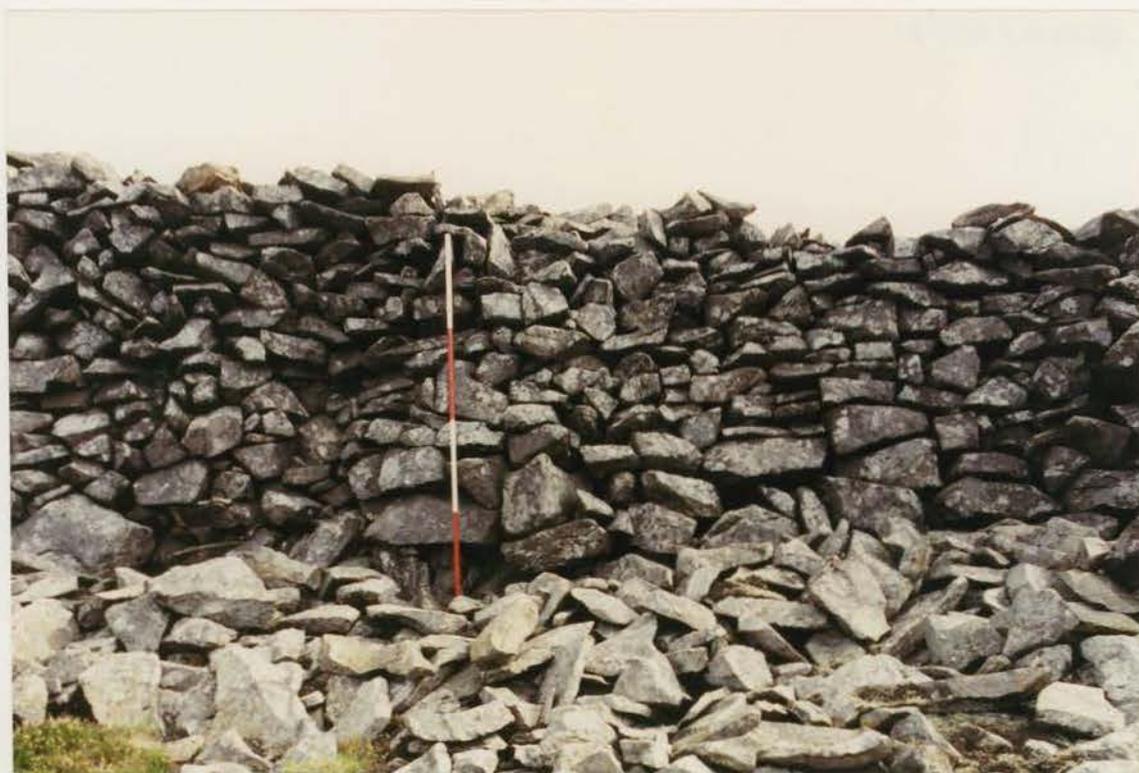
Plate 36. Wall D-E: blocked entrance, looking SE (G1022/15/31).

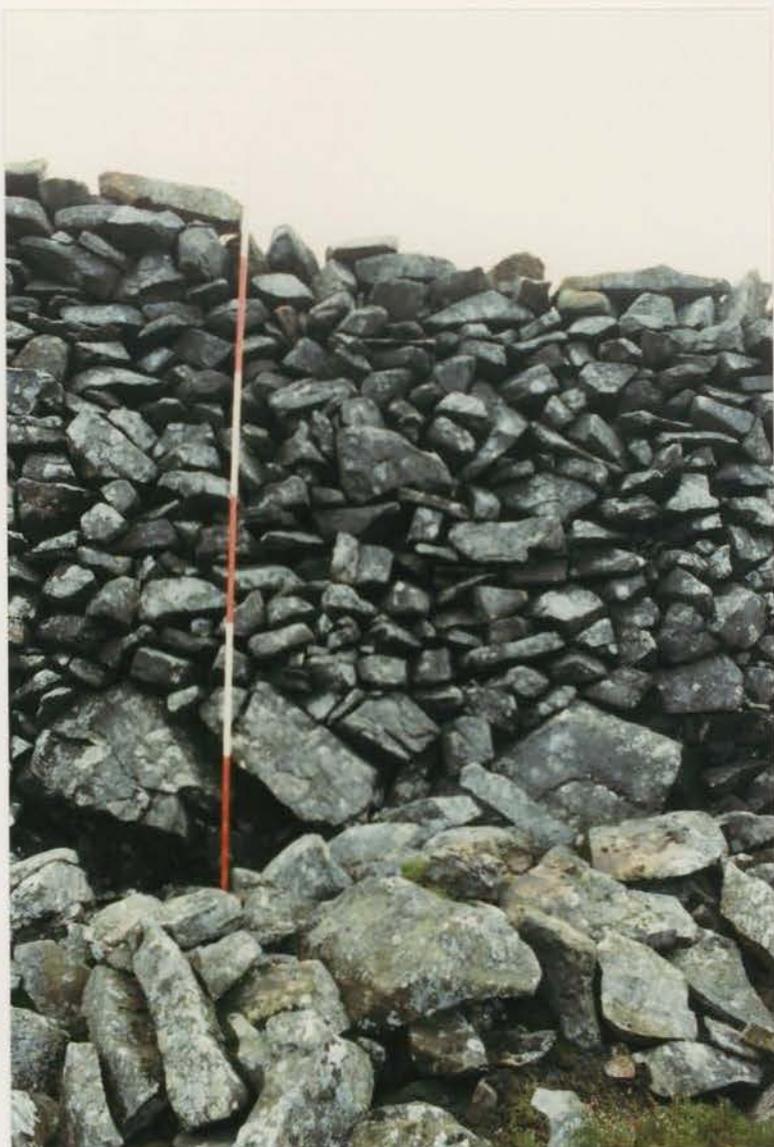
Plate 39. Collapse D2 before
conservation, looking SE
(G1022/115/34).

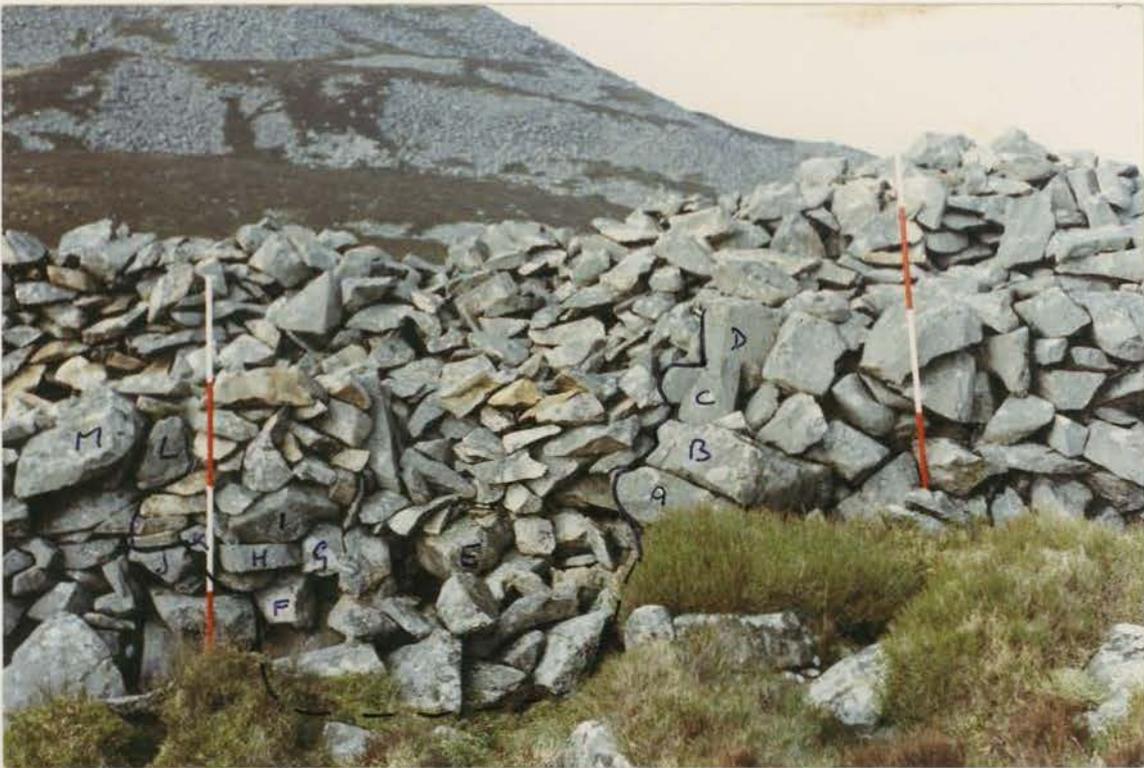
Plate 41. Collapse D3 before conservation, looking NW (G1022/104/12).

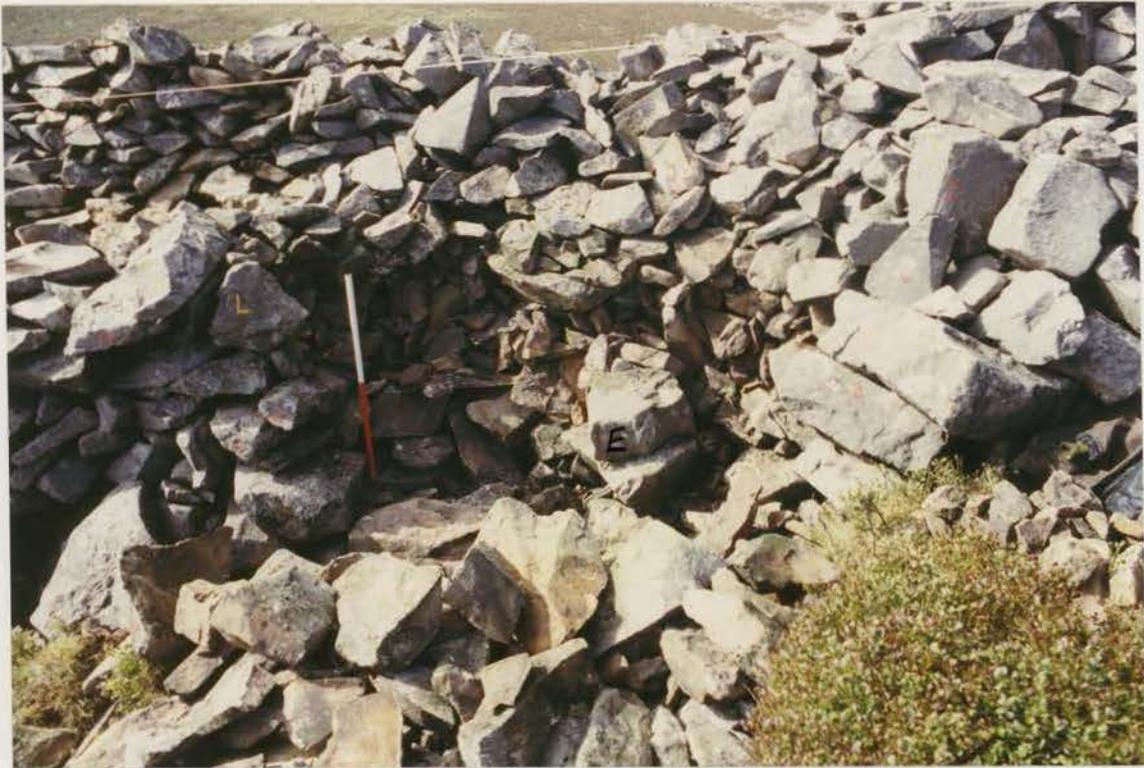
Plate 42. Collapse D3 after clearance of tumble/unstable masonry, looking NW (G1022/115/22).

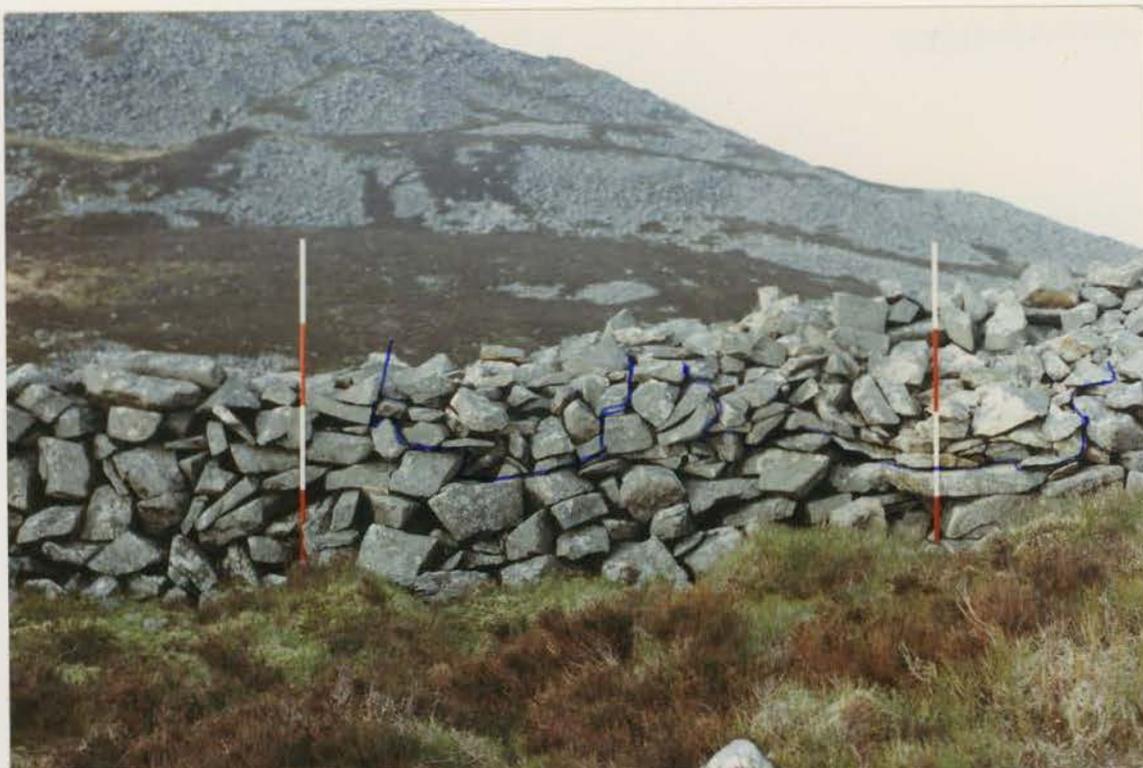
Plate 44. Collapses D4 & D5 before conservation, looking NW. The blocked entrance visible on the outer face would have entered the fort between the two scales. (G1022/104/20).

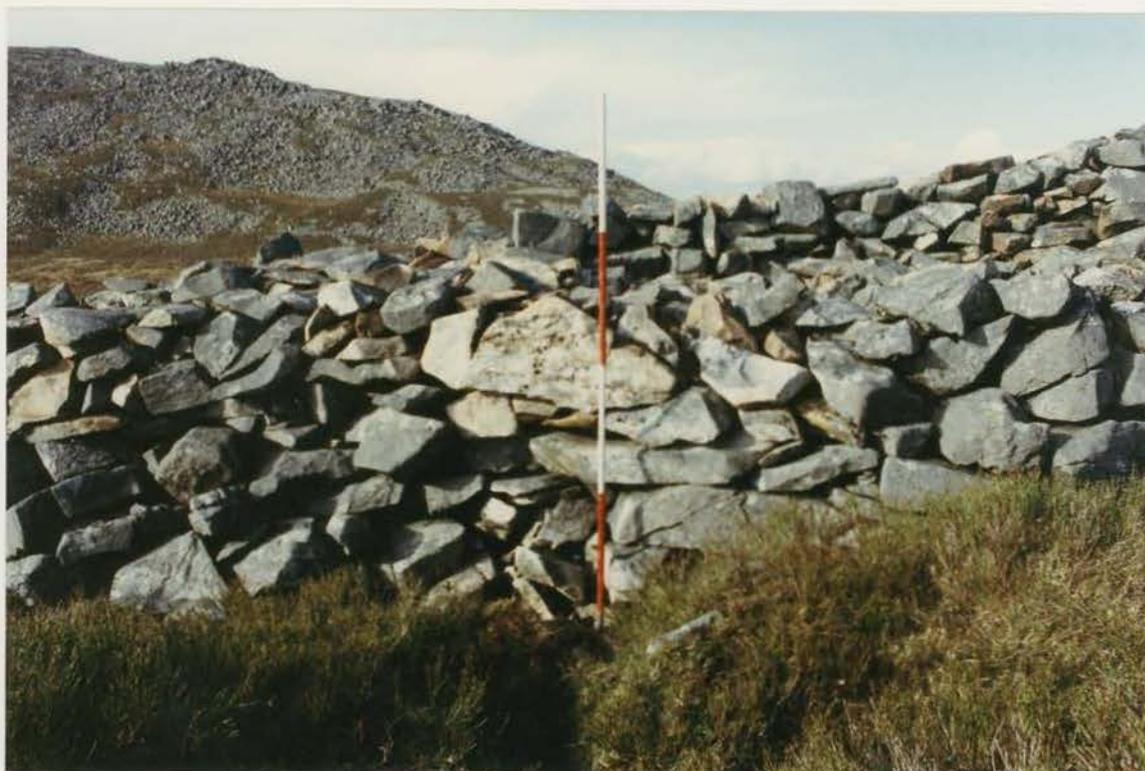
Plate 45. Collapse D4 after conservation, looking NW (G1022/118/35).
