TRE'R CEIRI
CONSERVATION PROJECT
1990
PART 2: PLATES

REPORT ON THE SECOND SEASON OF THE
TRE'R CEIRI CONSERVATION PROJECT
JUNE - NOVEMBER 1990

S.D. BOYLE

GWYNEDD ARCHAEOLOGICAL TRUST LTD.

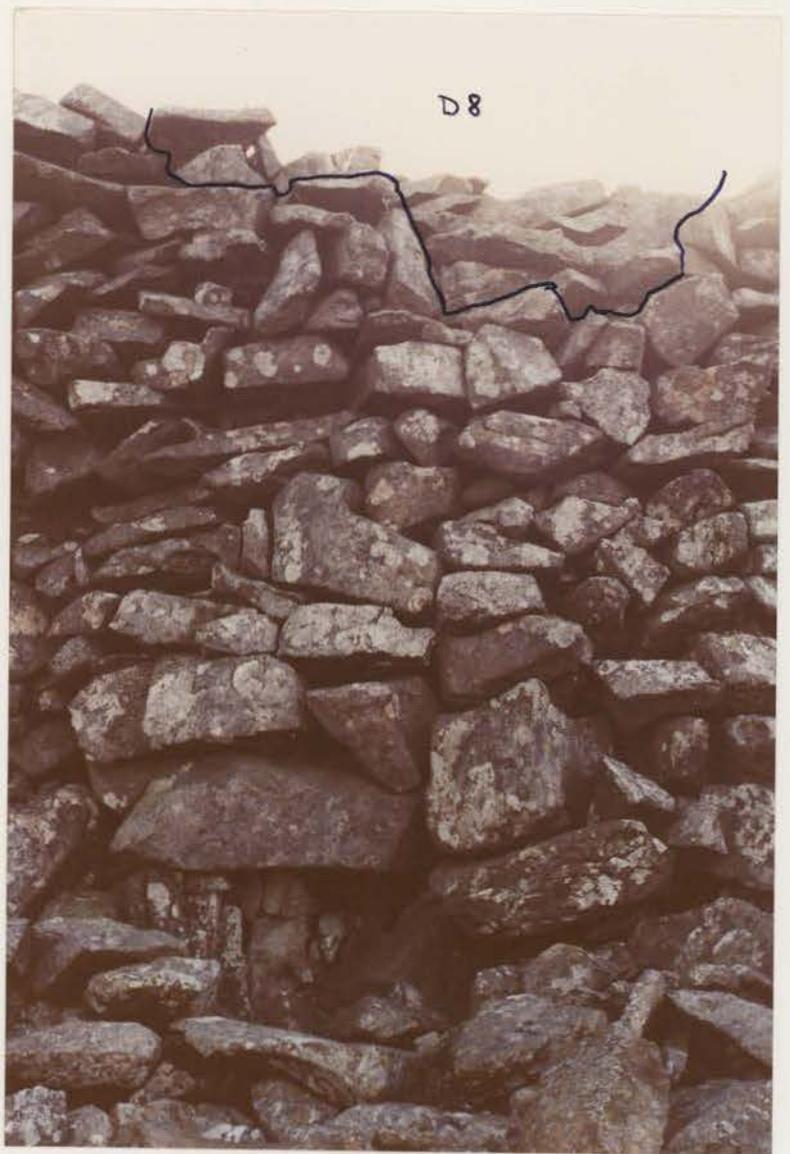
Plate 52. Collapses D8 & D9 after conservation, looking SE (G1022/118/15).

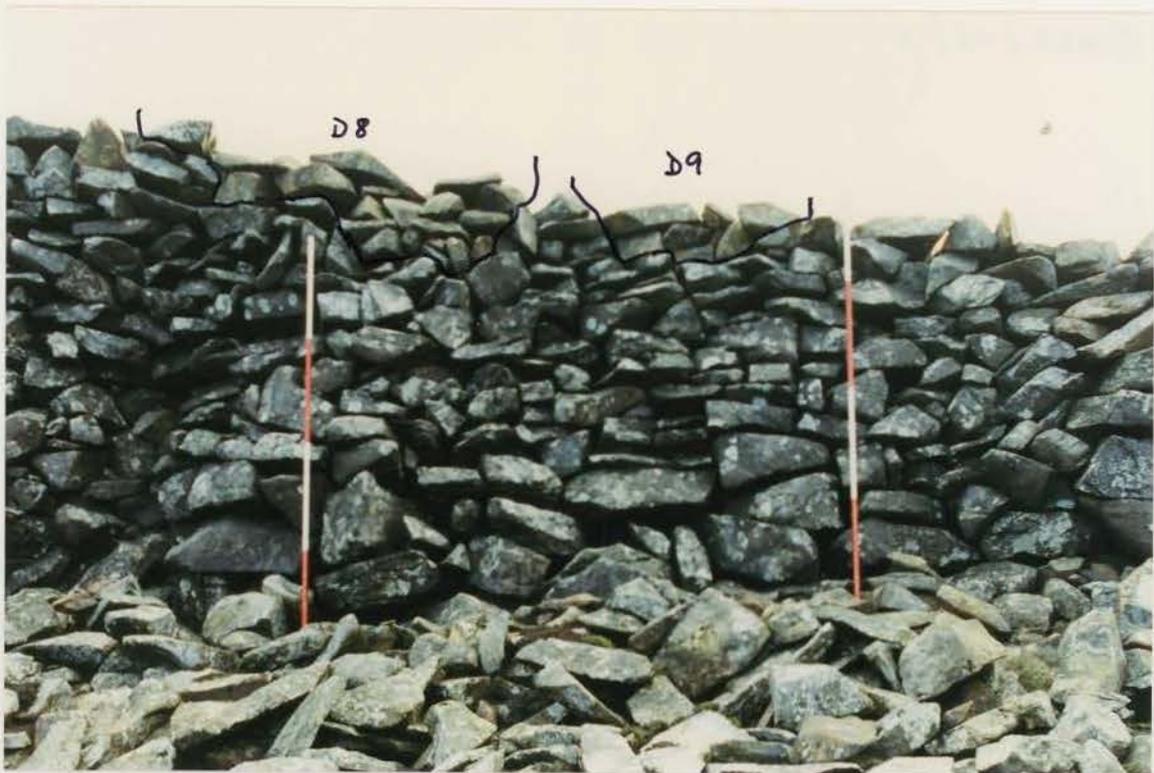
Plate 53. Collapse D9 before conservation, looking SE (G1022/101/31).

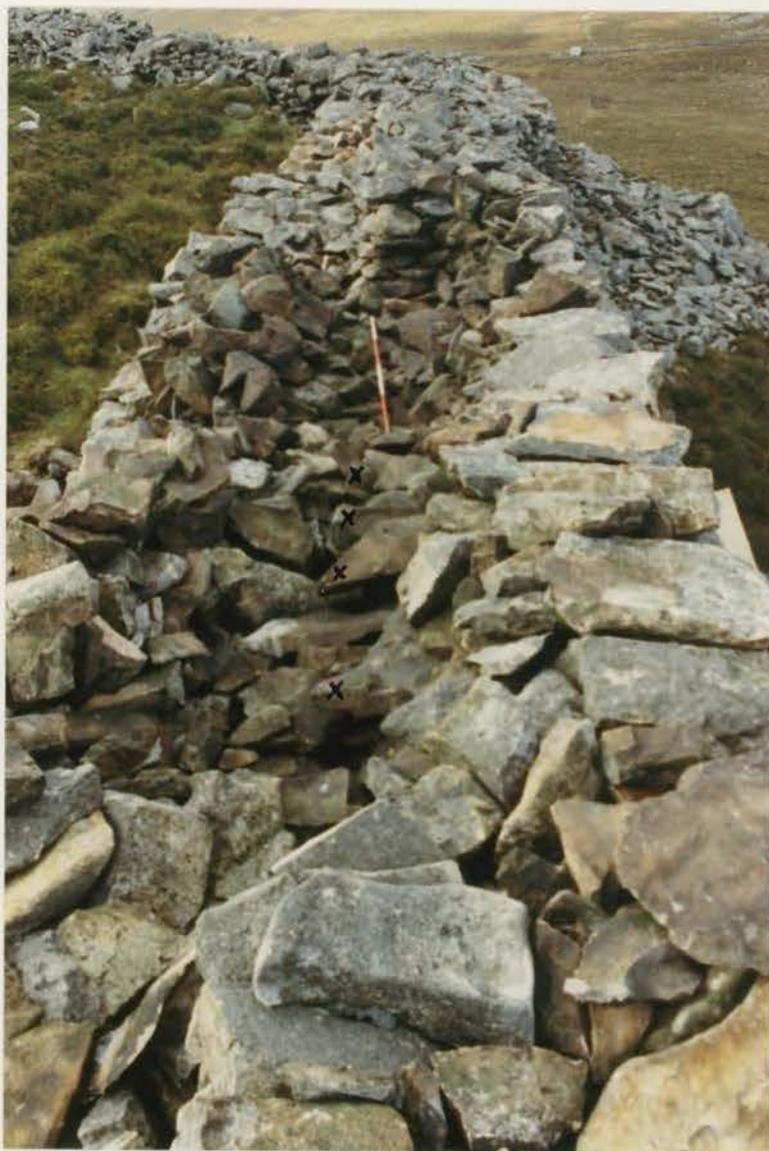
Plate 57. Collapse D10 after conservation, looking NW (G1022/119/03).

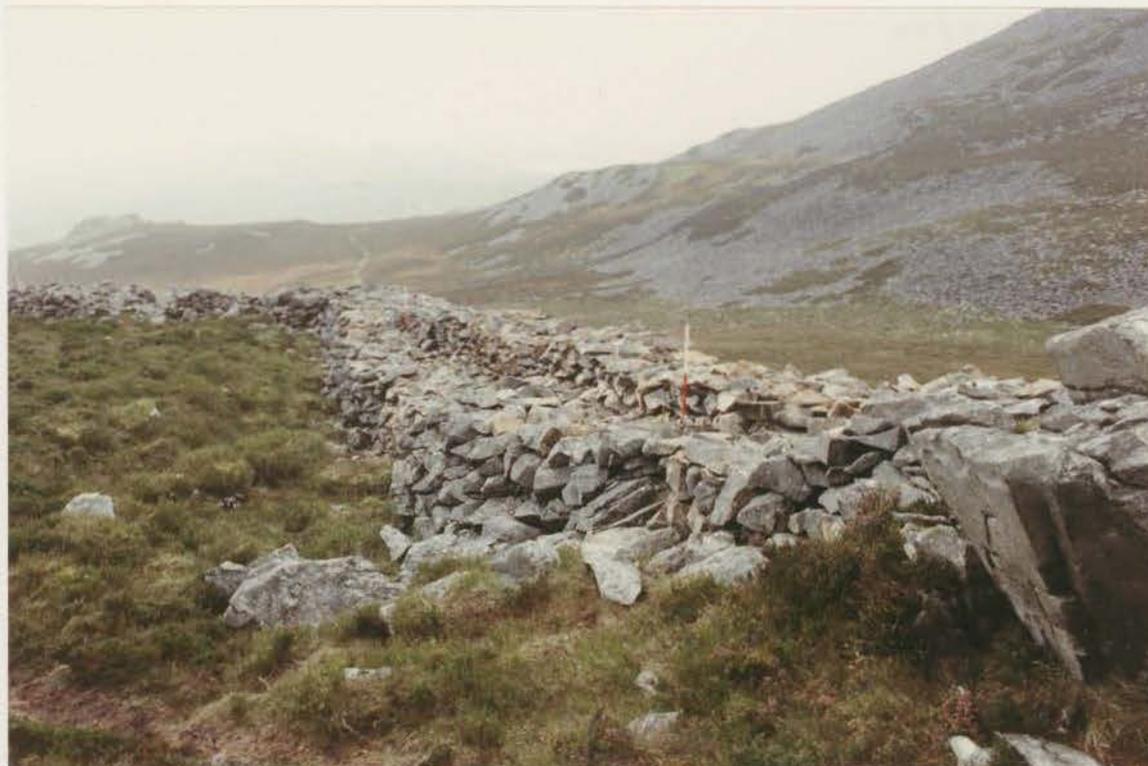
Plate 58. Collapse D10 after conservation, looking SW (G1022/117/30).

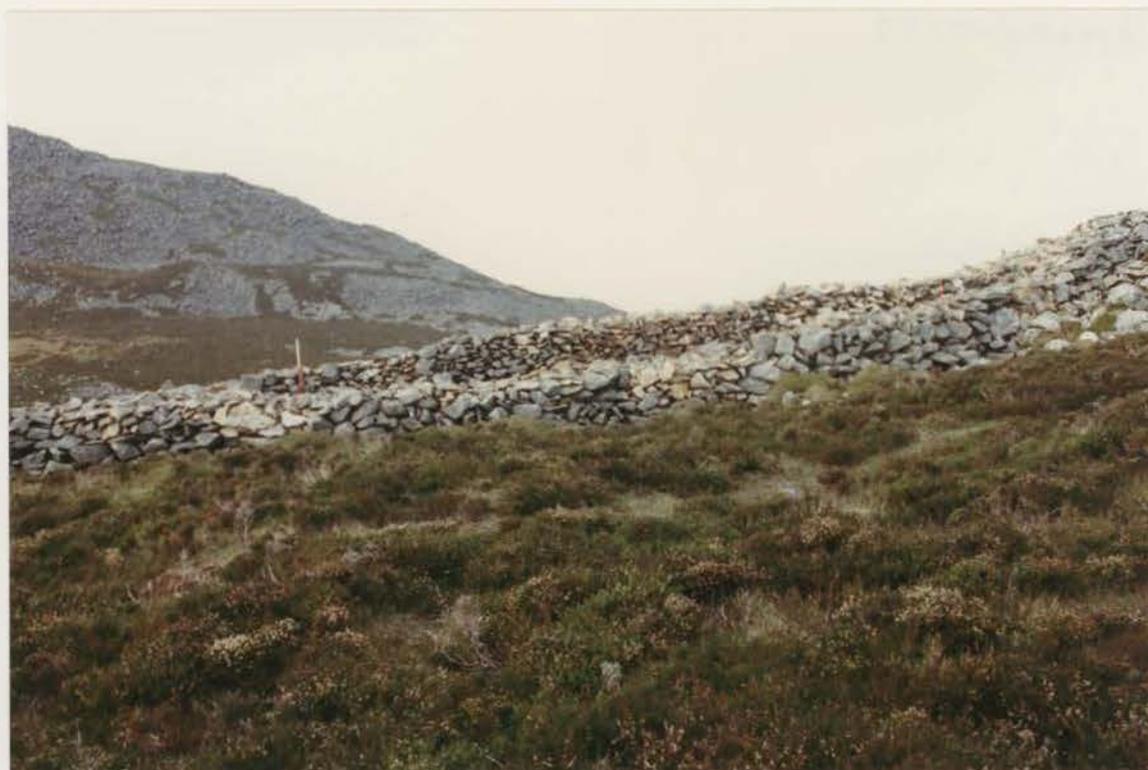
Plate 59. Collapses D10 & D11 after conservation, looking NW
(G1022/117/32).

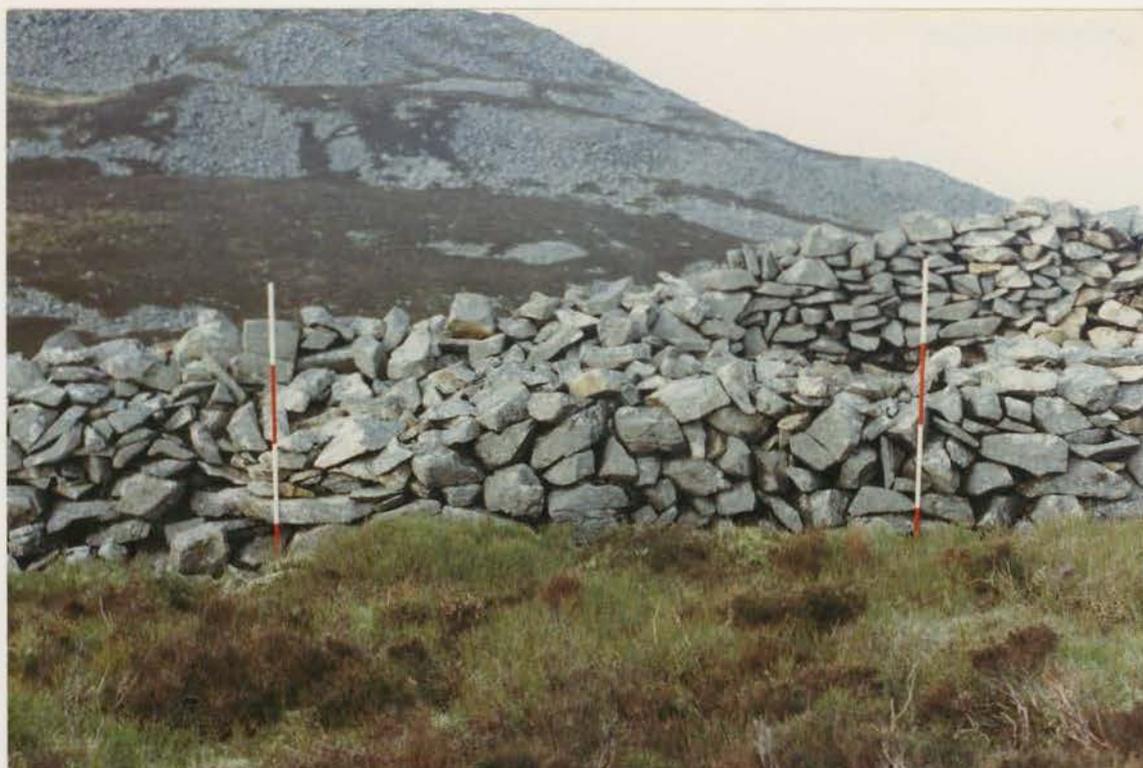
Plate 60. Collapse D11 before conservation, looking NW (G1022/104/19).

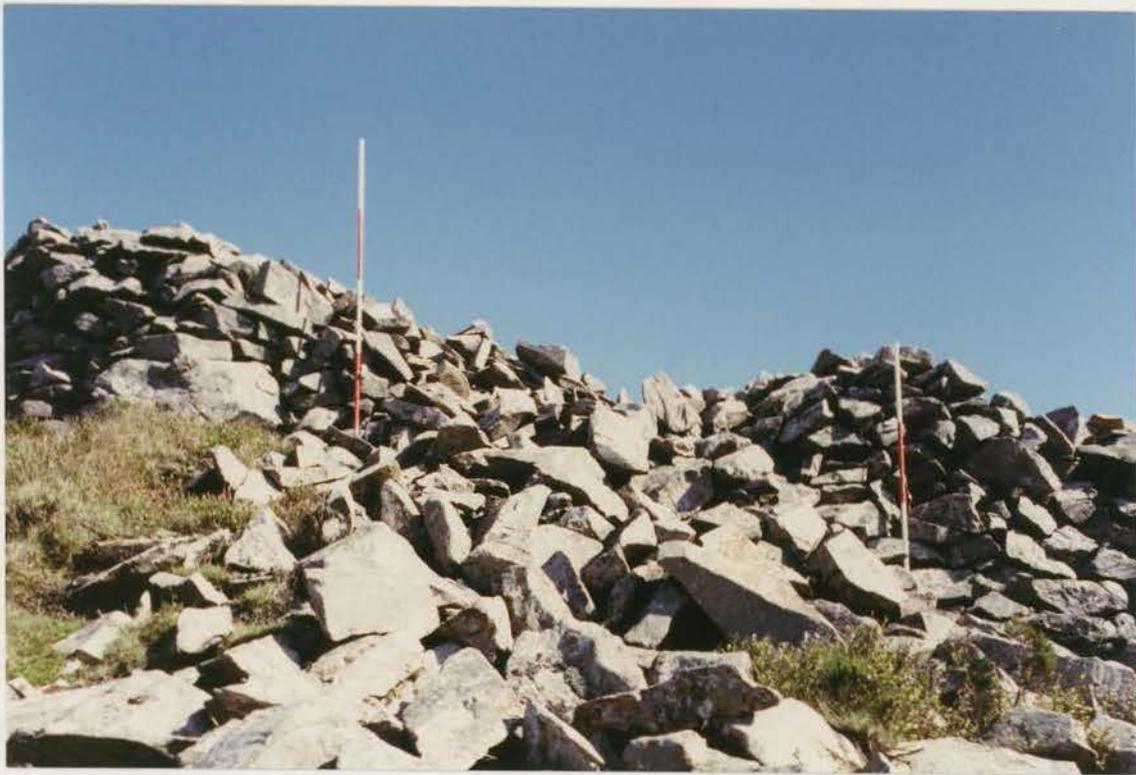
Plate 64. Collapse E before conservation, looking SE (G1022/115/20).

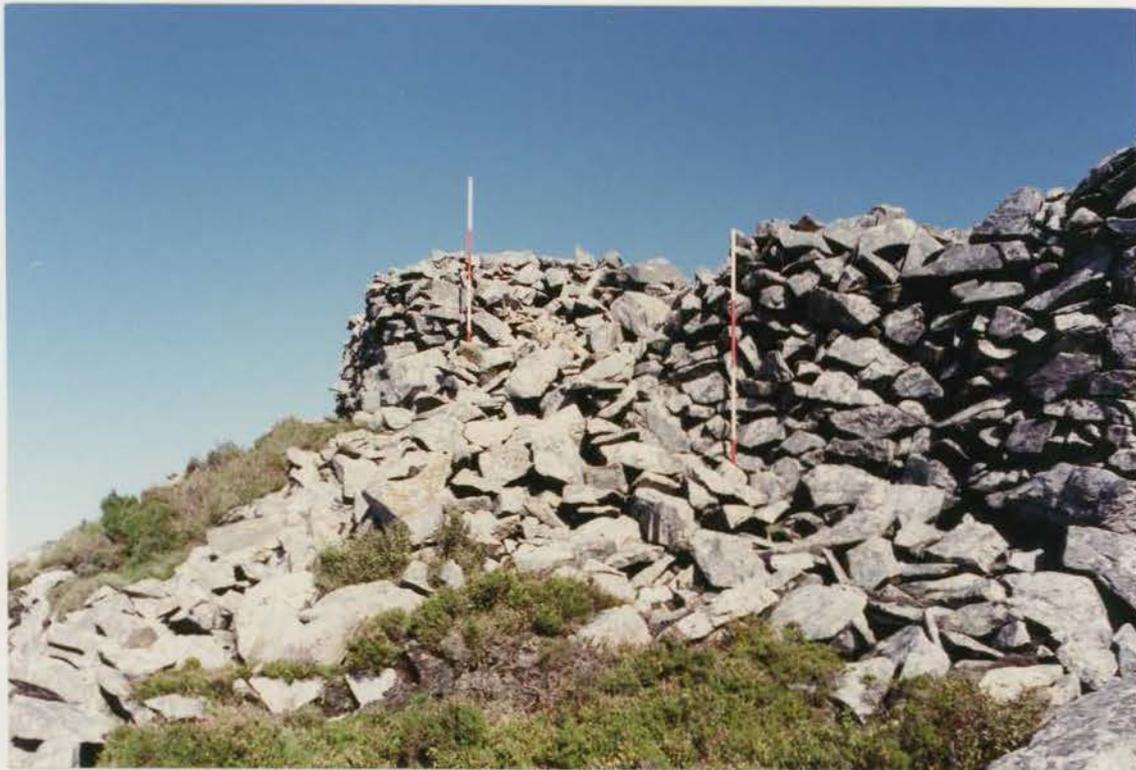
Plate 65. Collapse E before conservation, looking E (G1022/115/21).

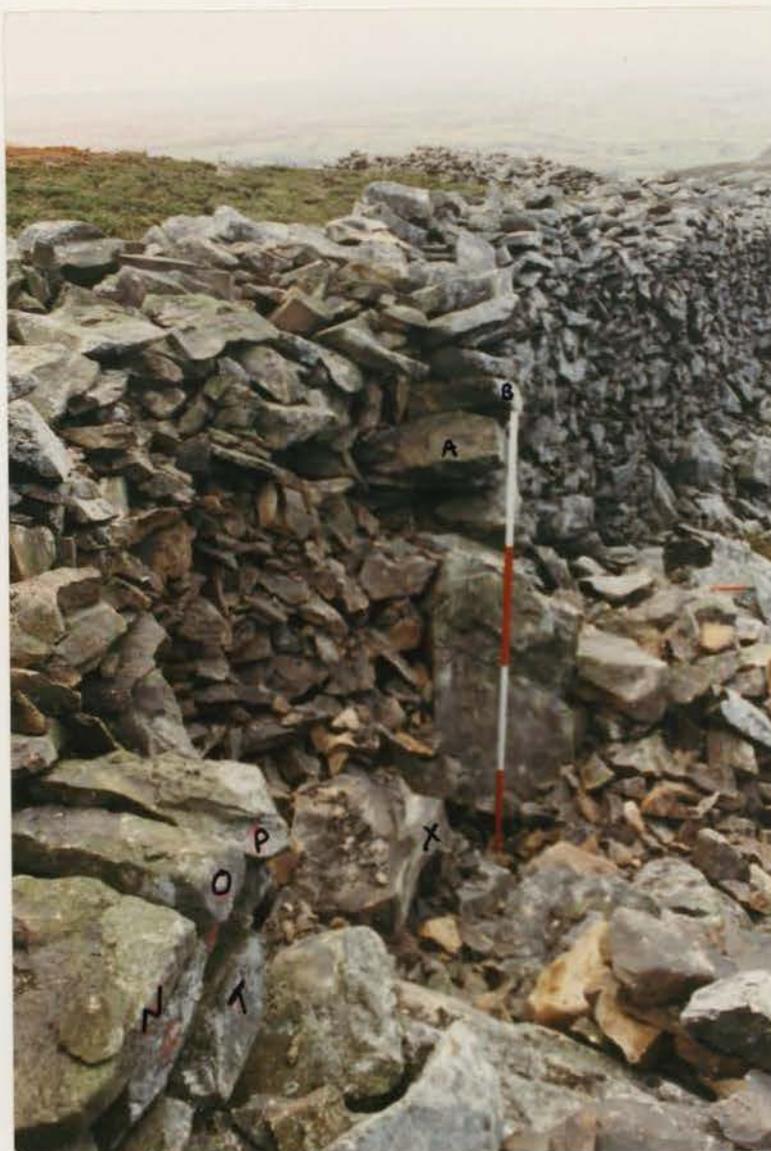
Plate 67. Collapse E after clearance of rubble, looking SE
(G1022/116/05).

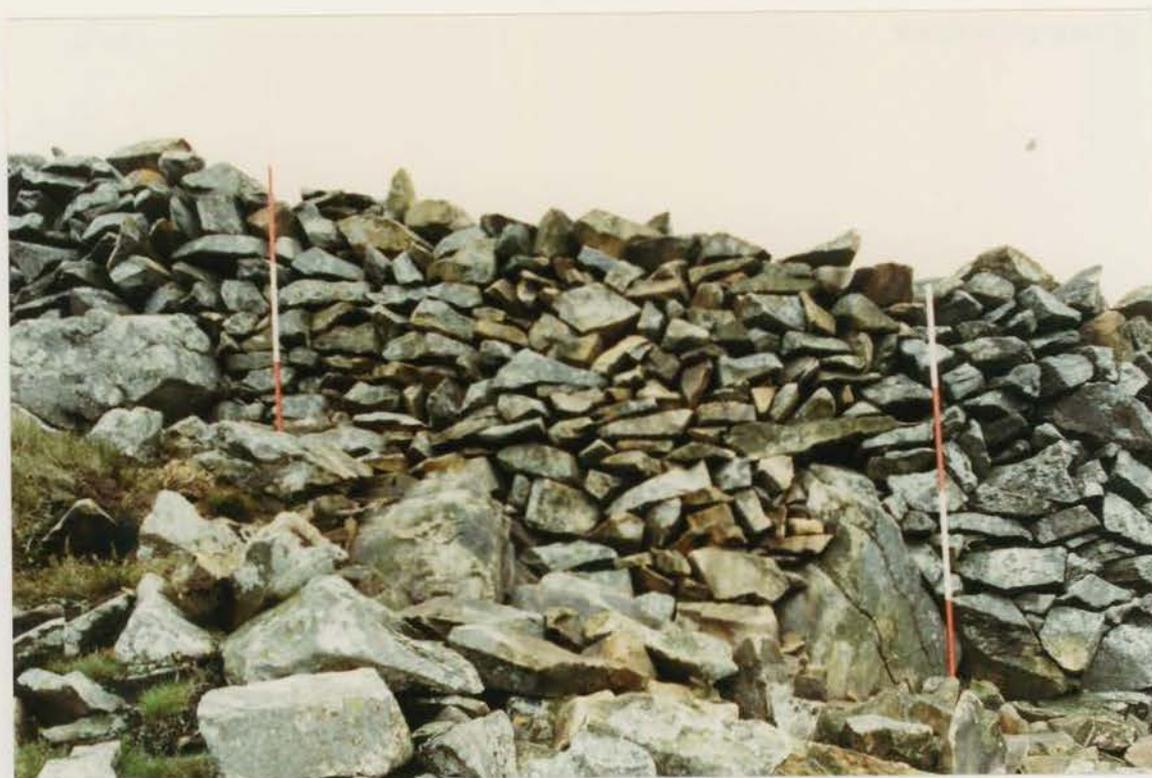
Plate 68. Collapse E after
clearance of rubble, looking
SW (G1022/116/03).

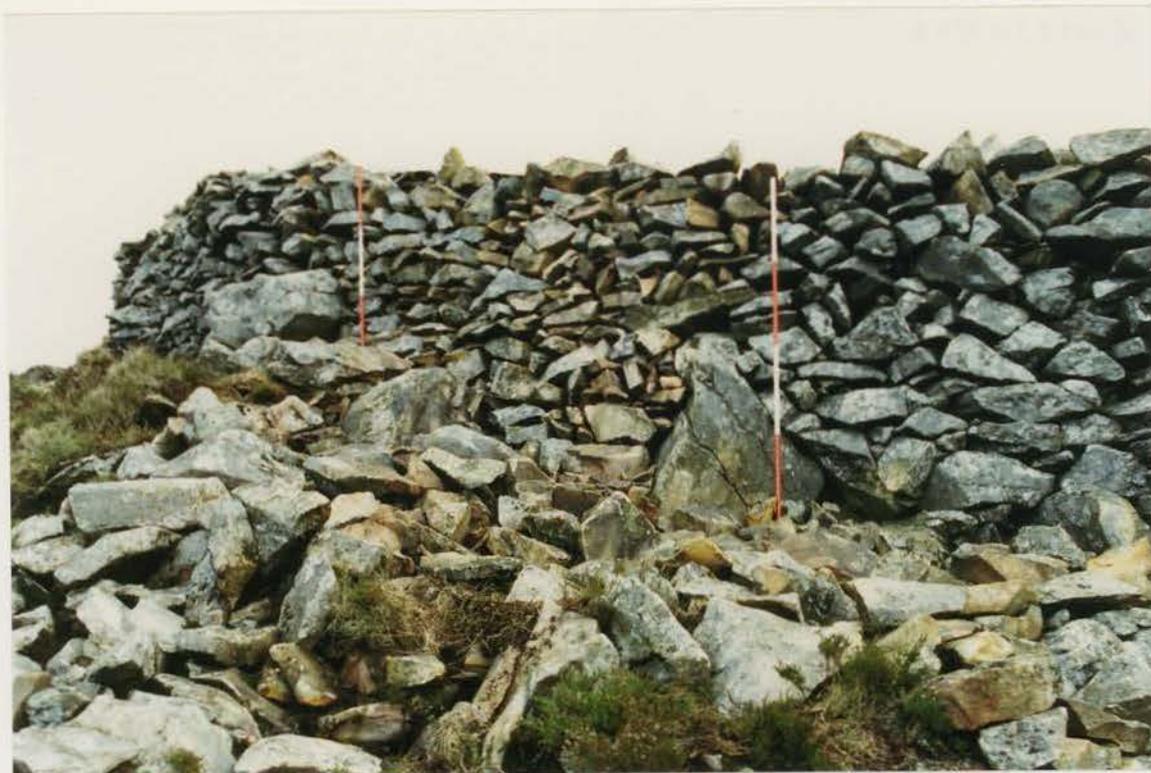
Plate 69. Collapse E after
conservation, looking SE
(G1022/117/07).

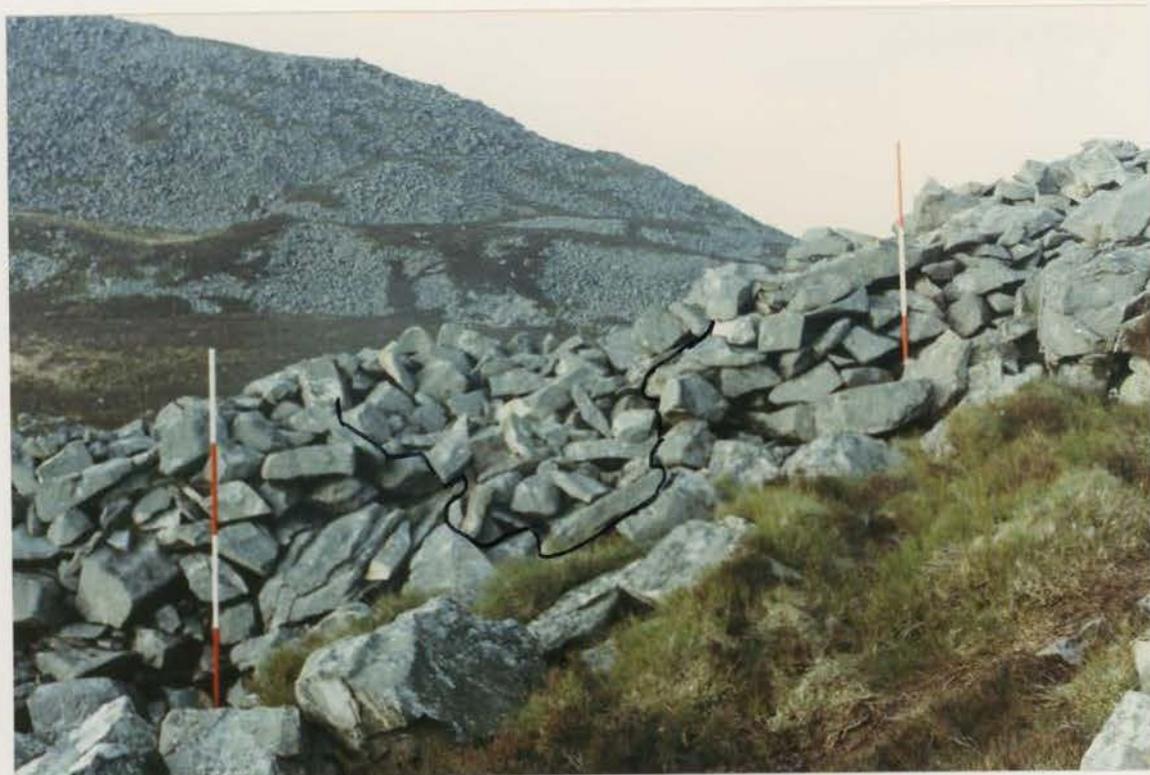
Plate 70. Collapse E after conservation, looking E (G1022/117/06).

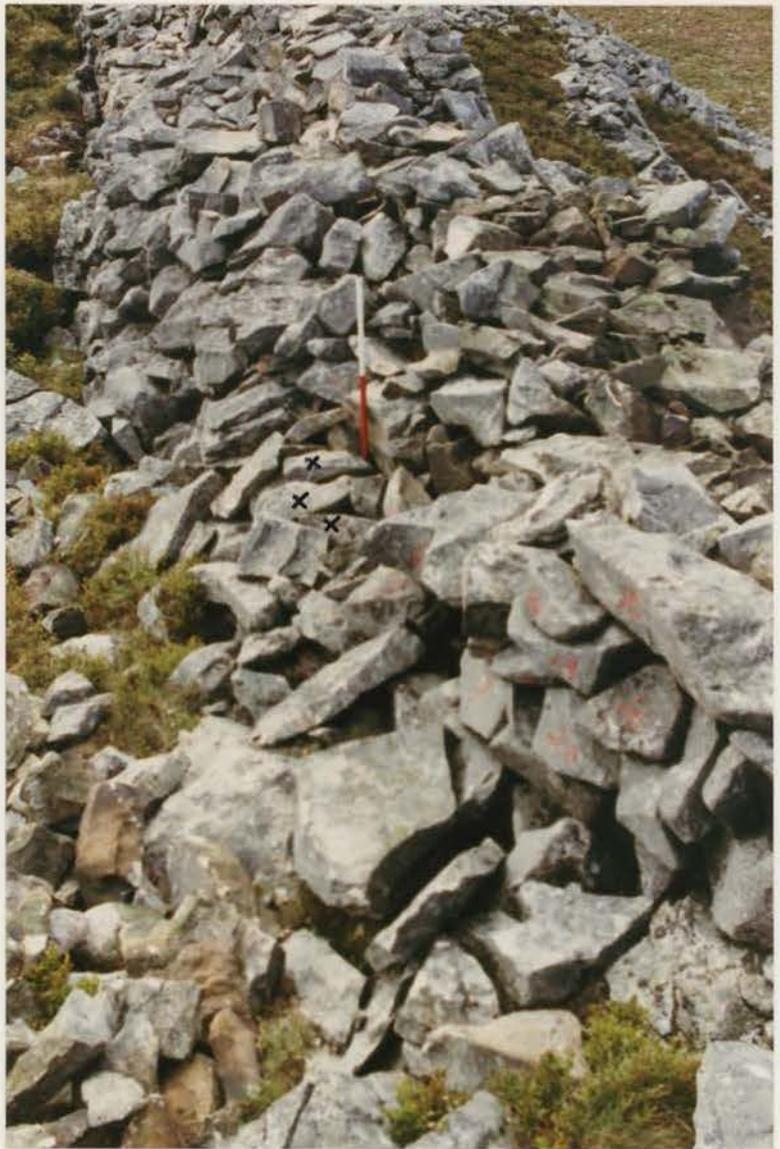
Plate 71. Collapse E (inner face) before conservation, looking NW (G1022/104/03).

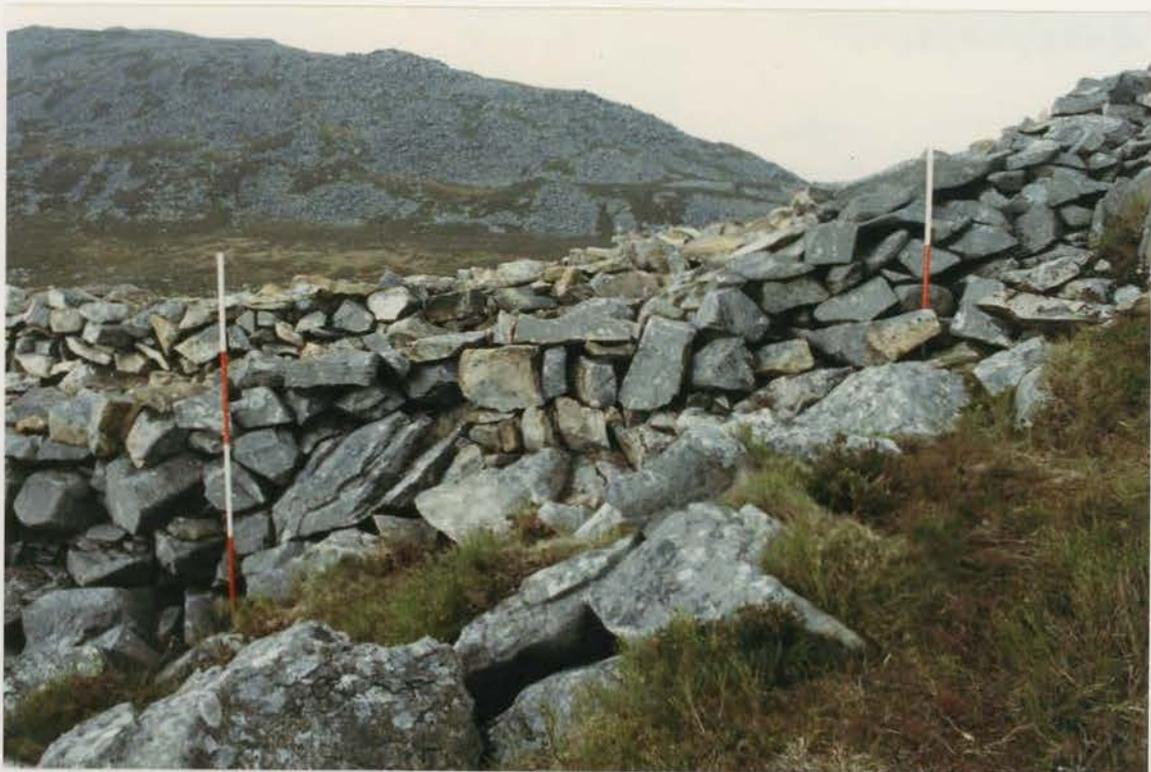
Plate 72. Collapse E (inner face) after clearance of tumble, looking SW (G1022/116/09)

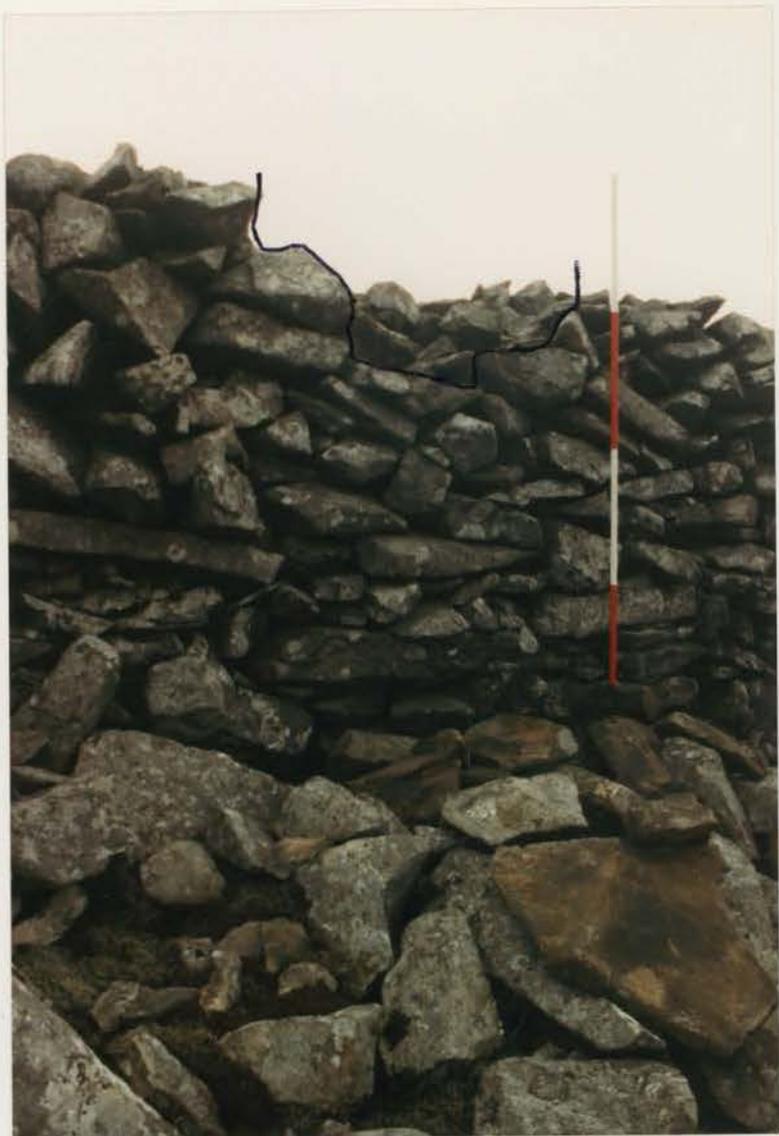
Plate 73. Collapse E (inner face) after conservation, looking NW (G1022/118/31).

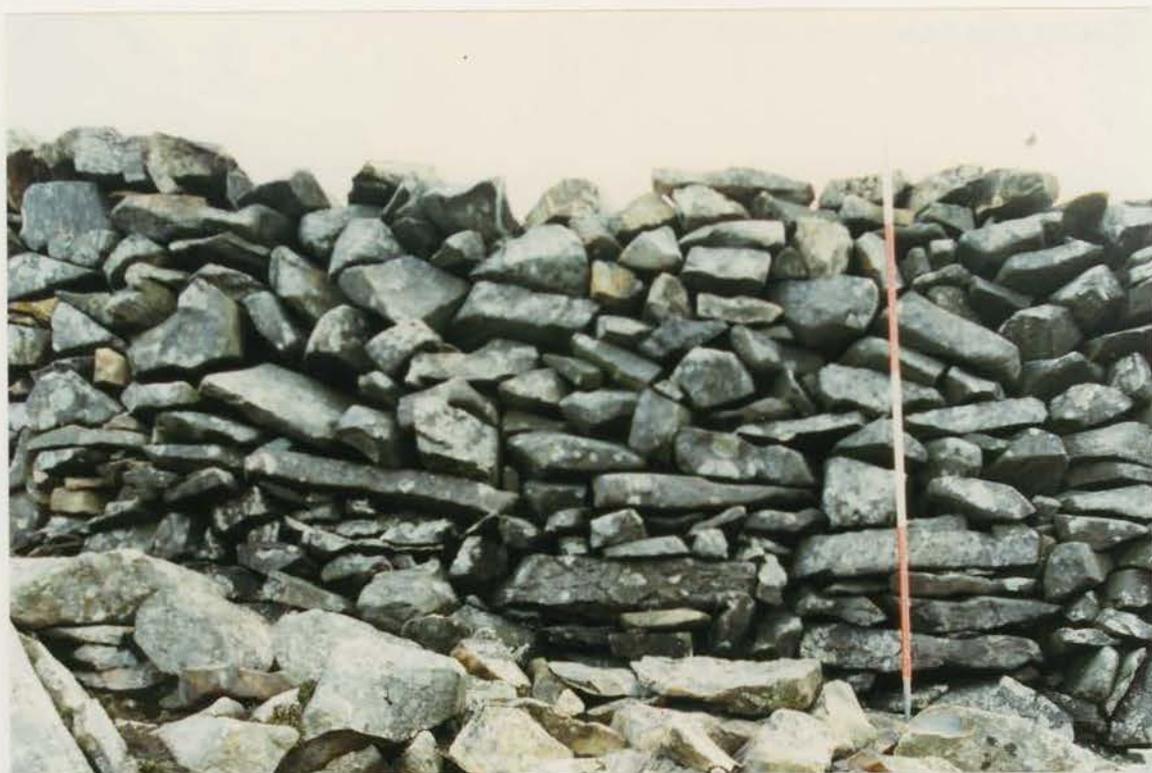
Plate 74. Collapse E2 before conservation, looking S (G1022/114/34).

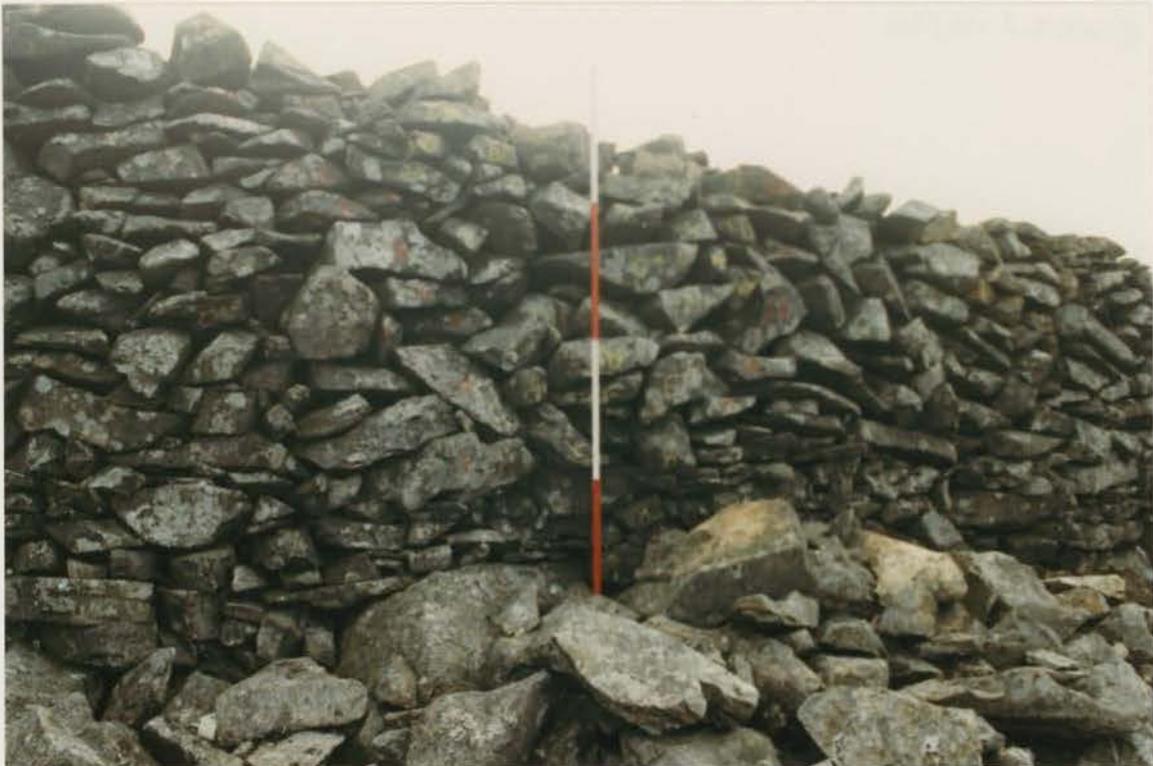
Plate 75. Collapse E2 after conservation, looking SE (G1022/118/26).

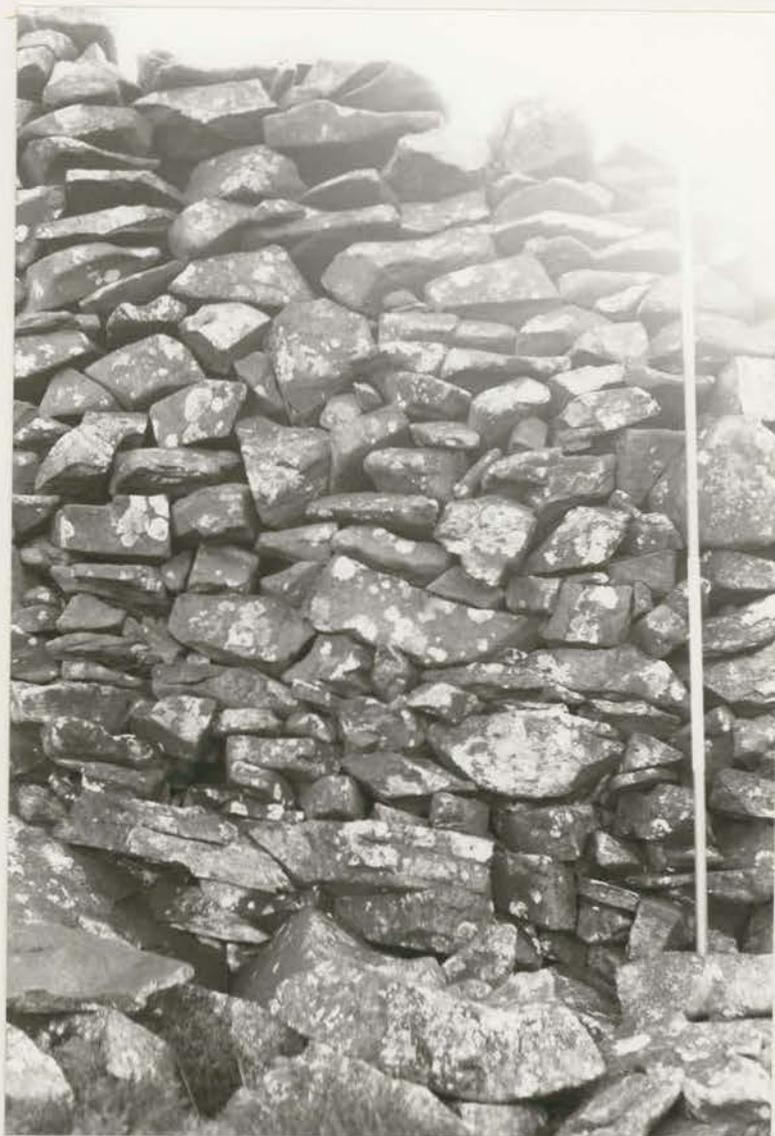
Plate 81. Collapse E4 after conservation, looking SE (G1022/118/06).

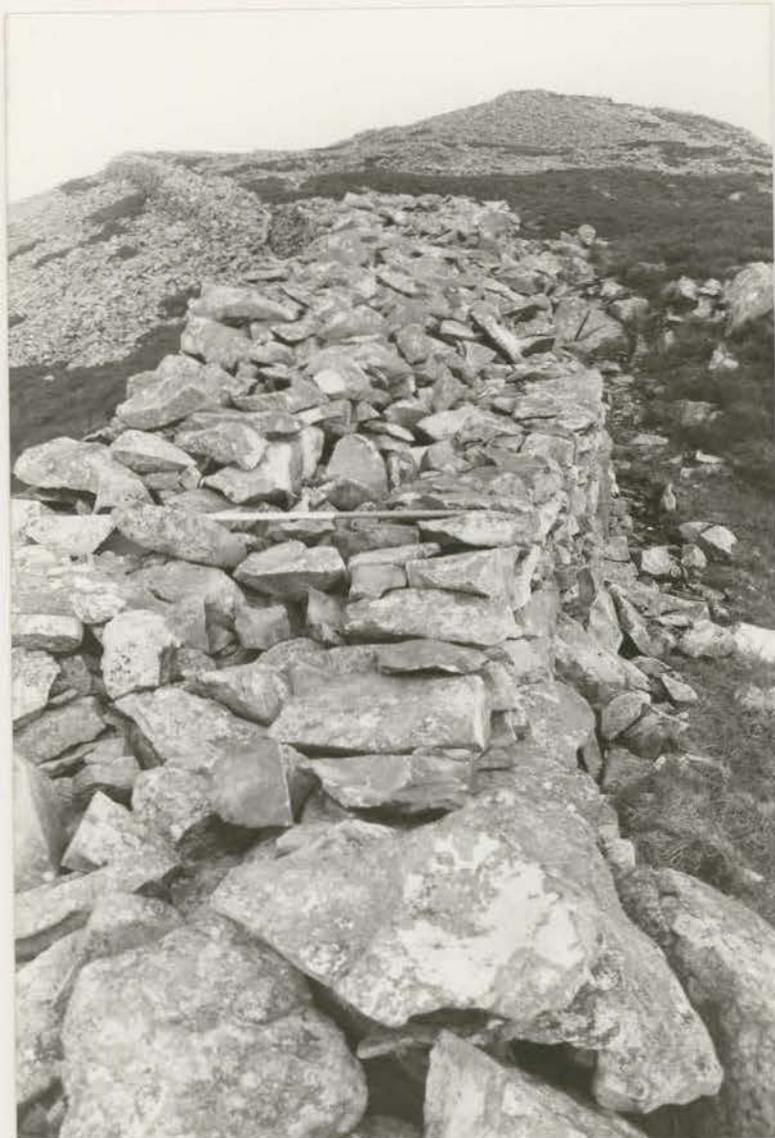
Plate 83. Collapse E5 after conservation,
looking SE (G1022/118/07)

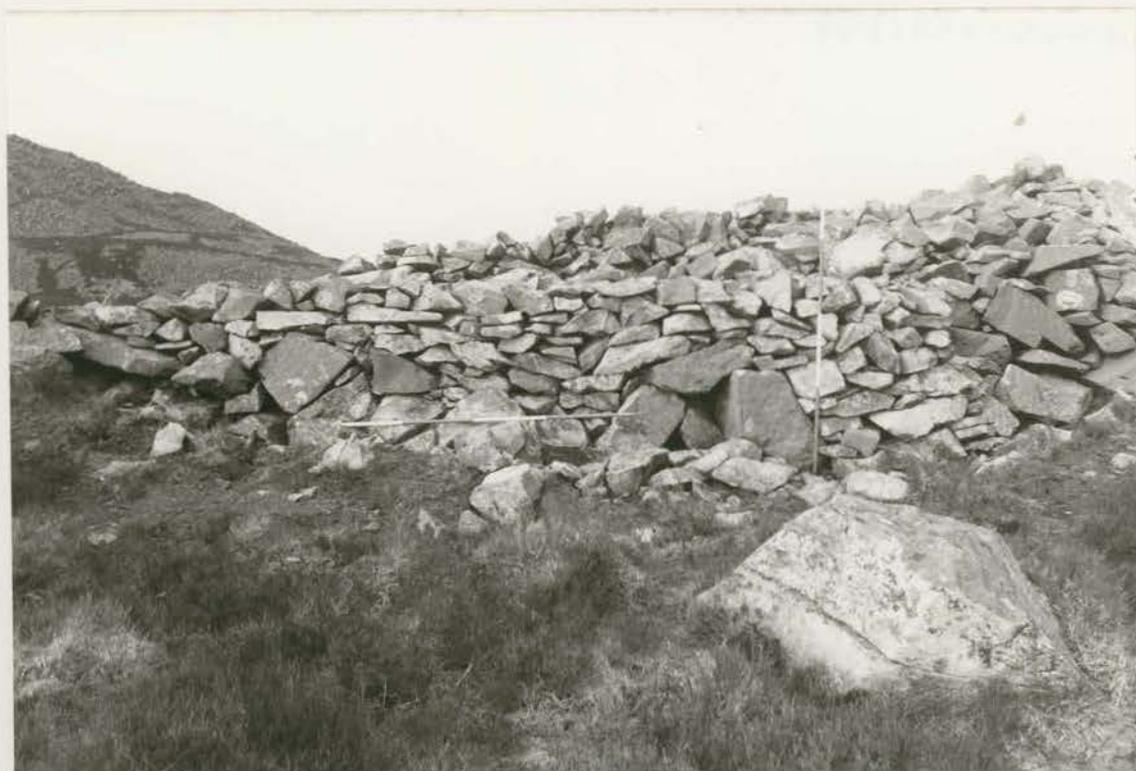
Plate 84. Collapse E6 before conservation, looking NE (G1022/022/24A).

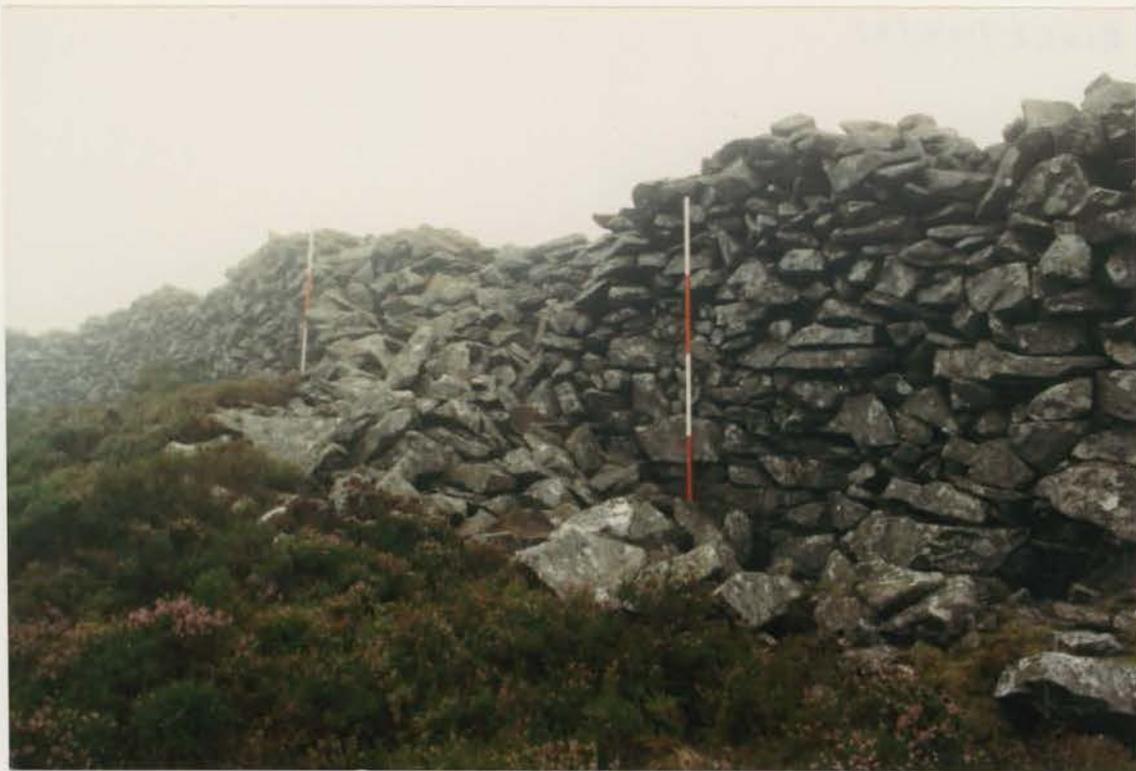
Plate 88. Collapse E6 after conservation, looking N (G1022/117/13).

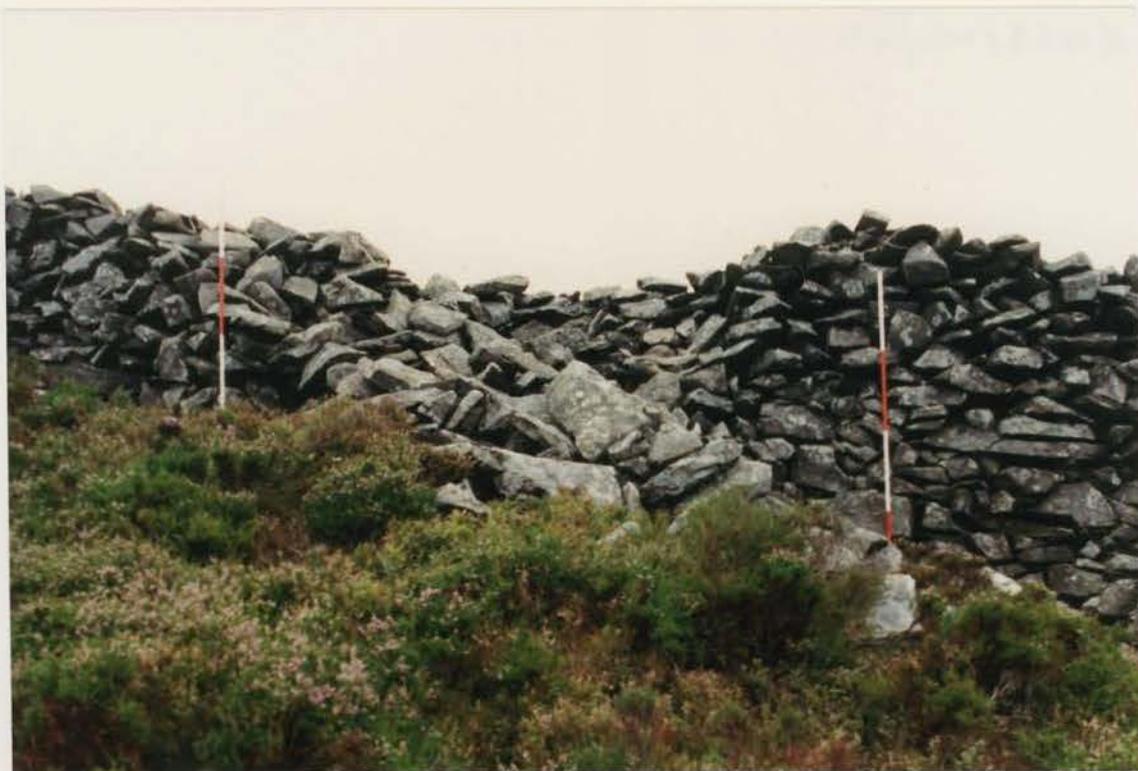
Plate 89. Collapse F before conservation, looking E (G1022/114/21).

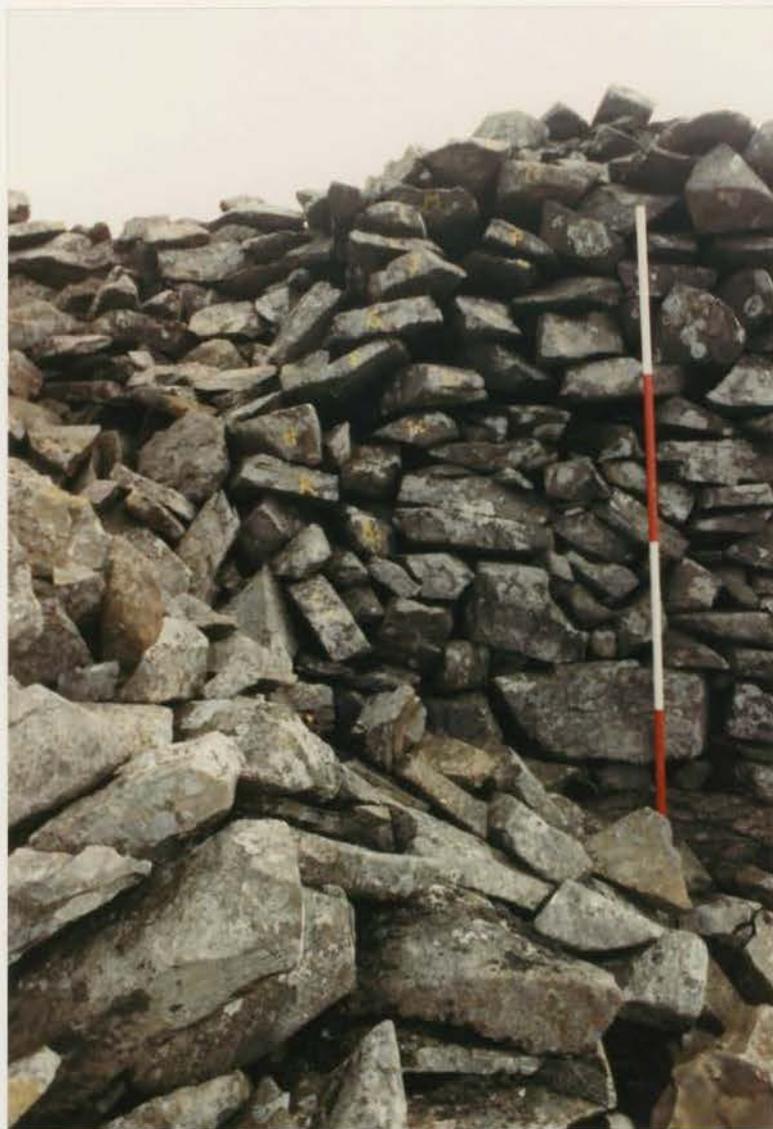
Plate 91. Collapse F: NE edge of collapse
before dismantling, looking SE
(G1022/114/23-24).

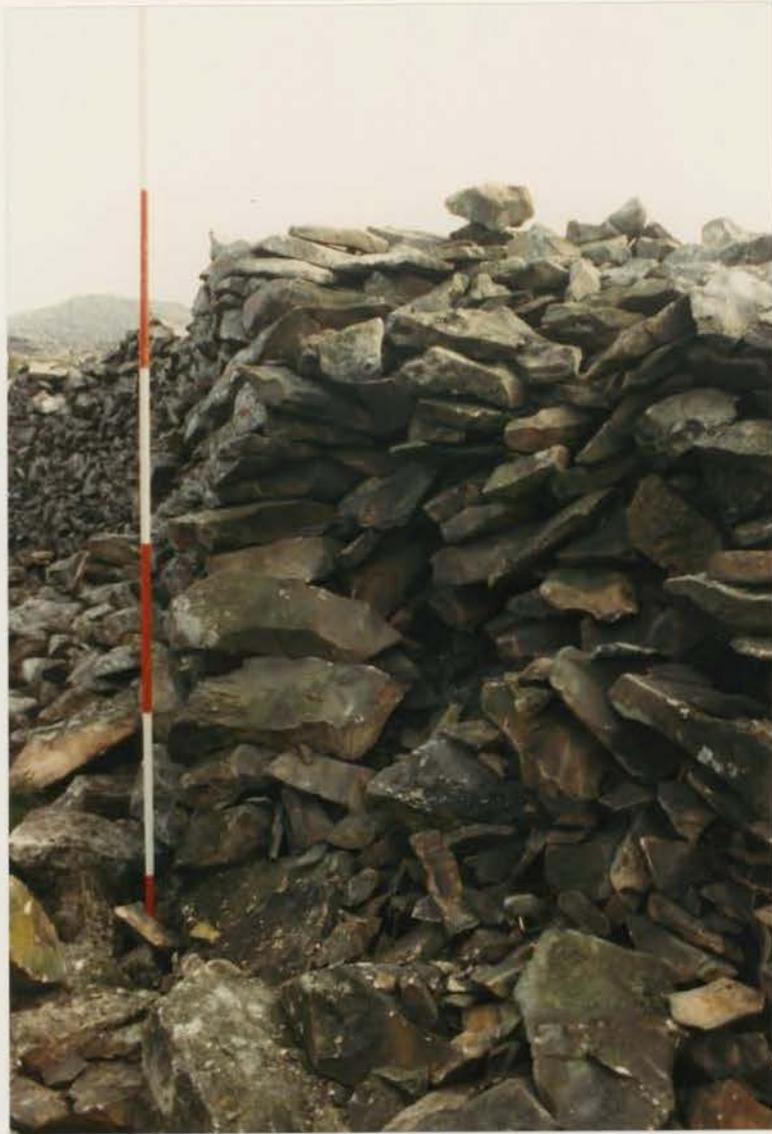
Plate 93. Collapse F: SW-facing section during clearance of rubble (G1022/114/27).

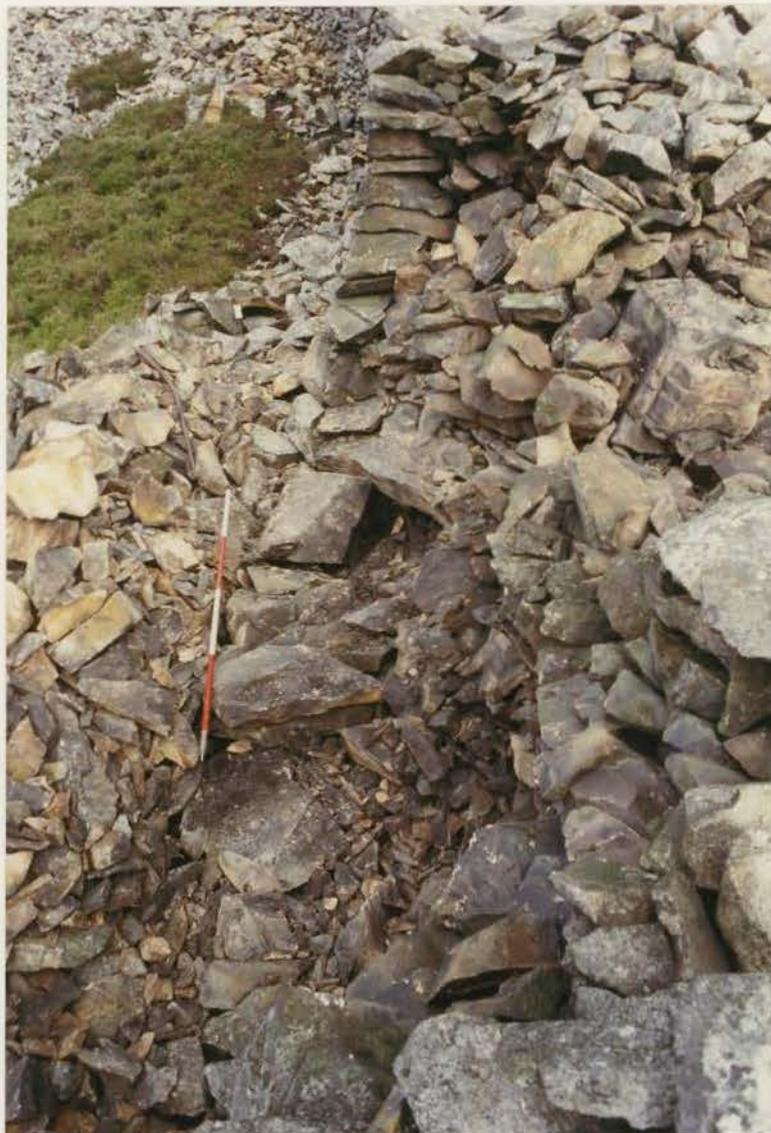
Plate 94. Collapse F: SW-facing section after clearance of rubble (G1022/114/32).
