TRE'R CEIRI
CONSERVATION PROJECT
1990
PART 2: PLATES

REPORT ON THE SECOND SEASON OF THE
TRE'R CEIRI CONSERVATION PROJECT
JUNE - NOVEMBER 1990

S.D. BOYLE

GWYNEDD ARCHAEOLOGICAL TRUST LTD.

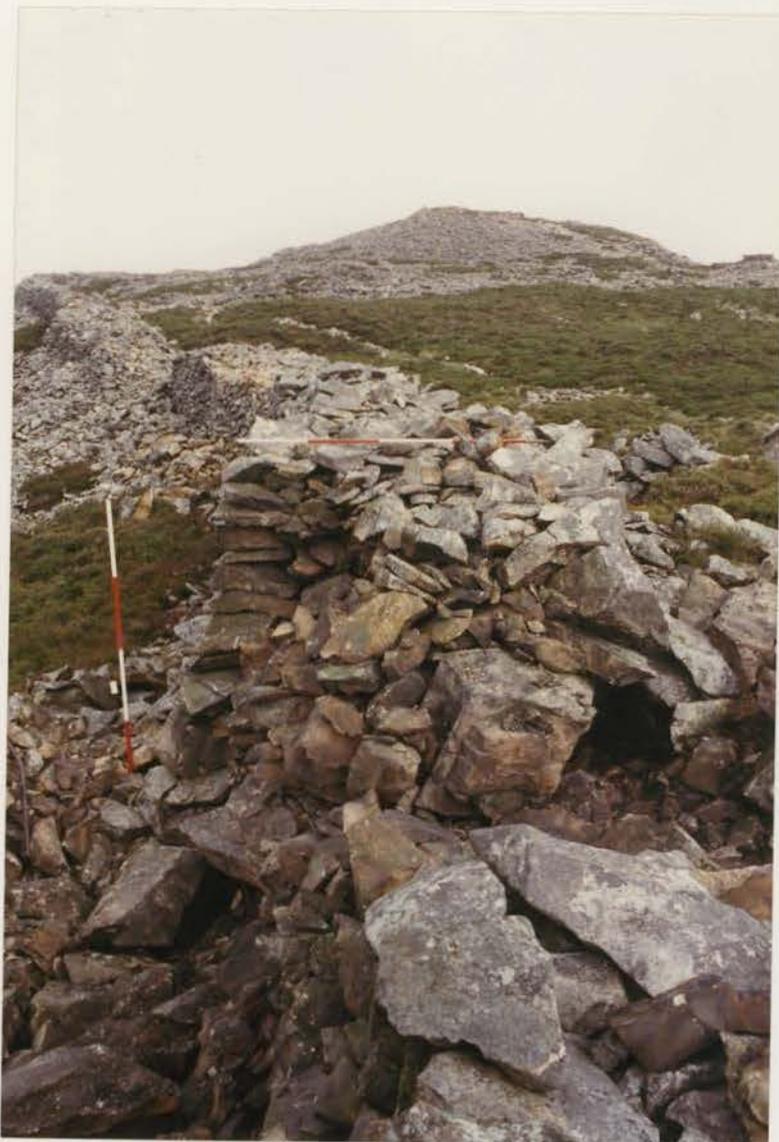
Plate 95. Collapse F after clearance of rubble,
showing surviving basal course of wall face,
looking NE (G1022/115/10).

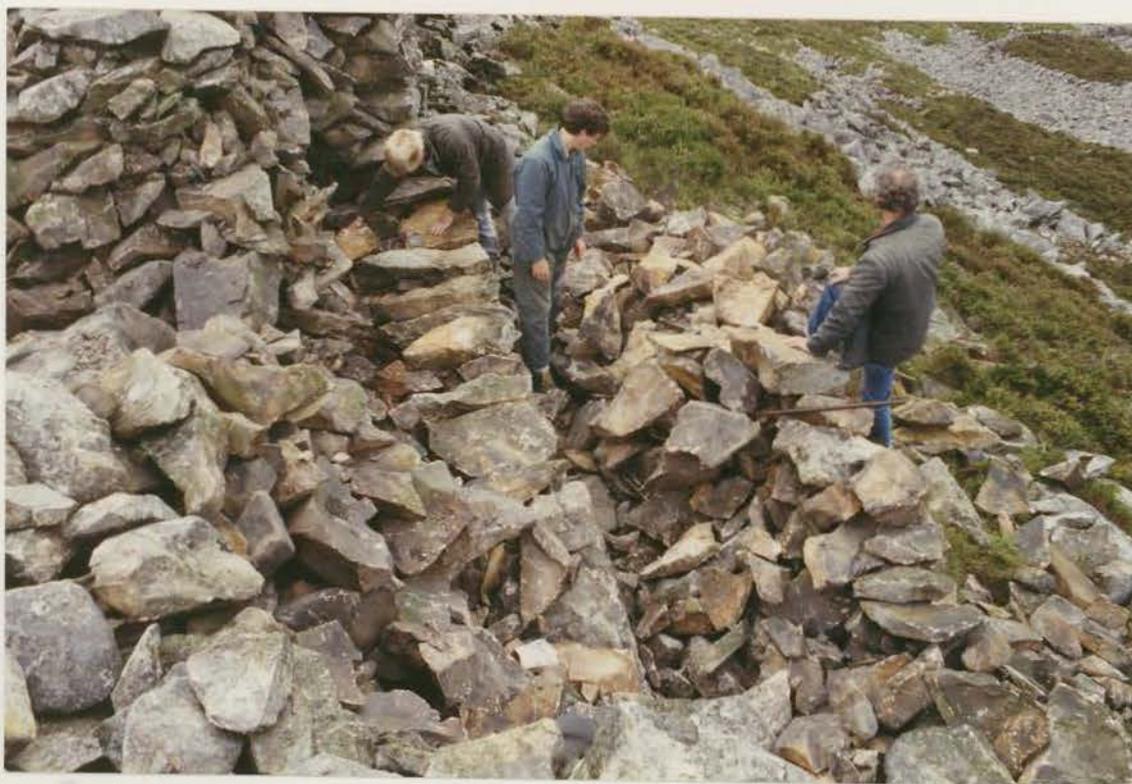
Plate 96. Collapse F after
clearance of rubble, looking
NE (G1022/115/12).

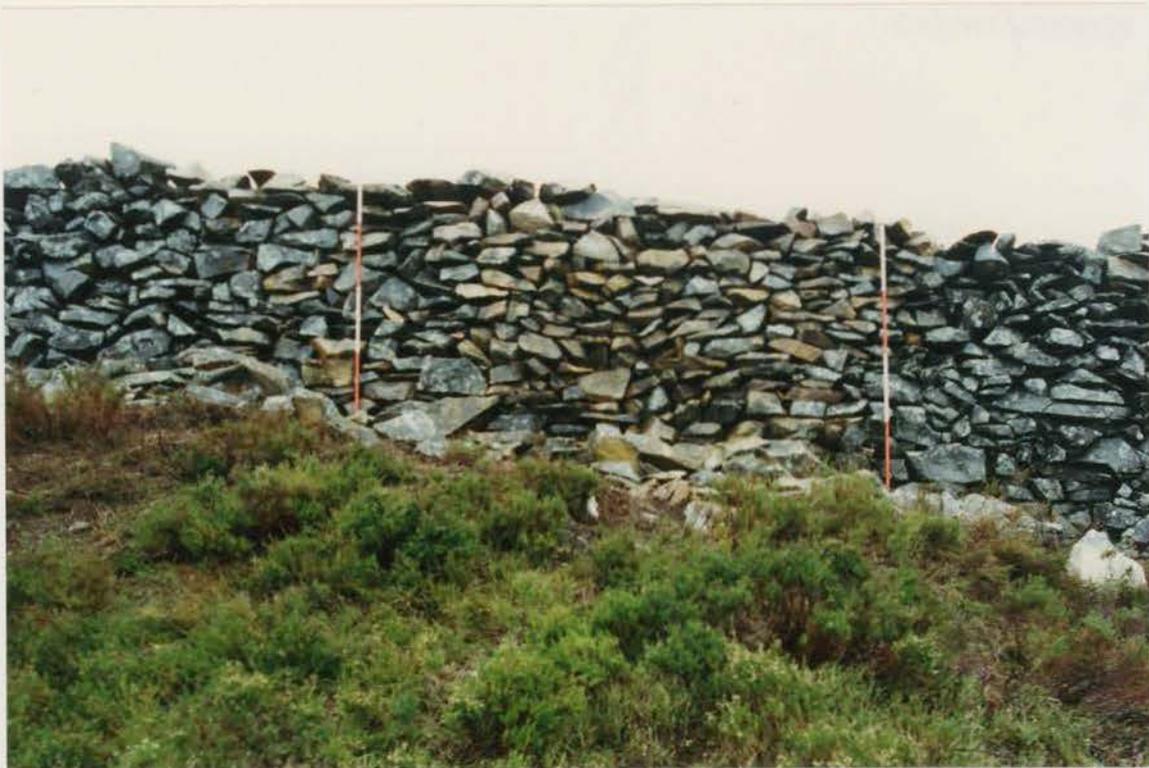
Plate 97. Collapse F:
rebuilding outer face, looking
SW (G1022/115/15).

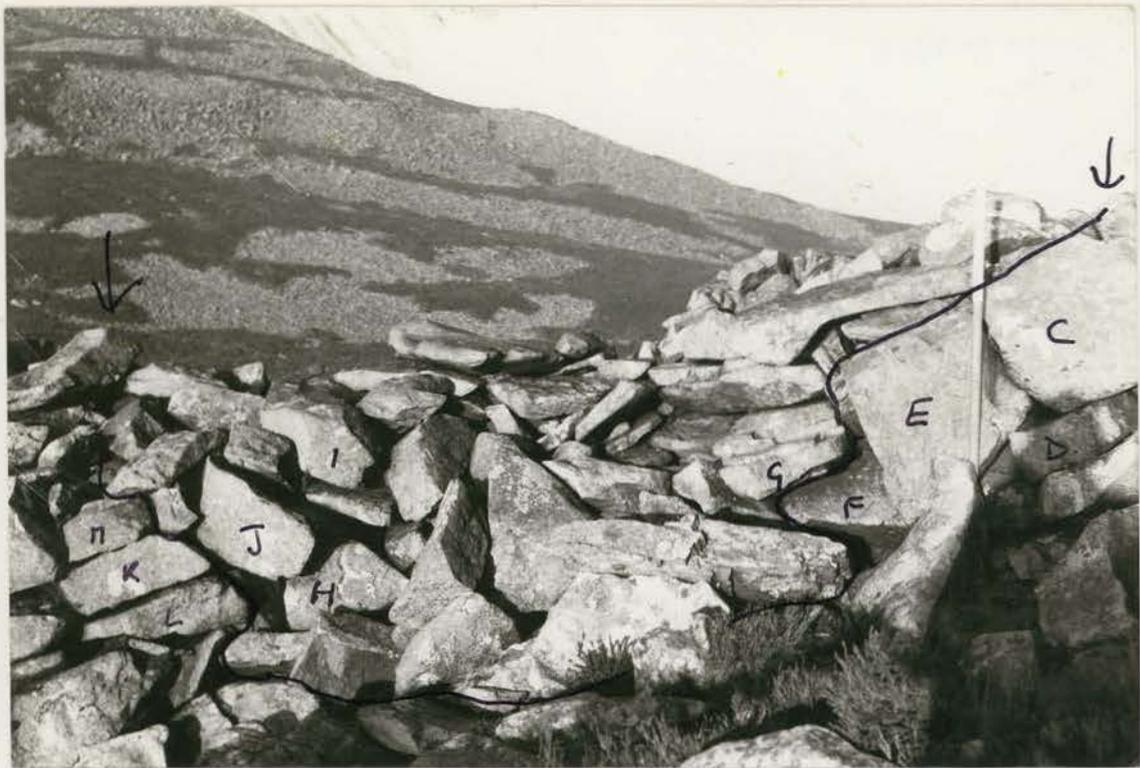
Plate 99. Collapse F after conservation, looking E (G1022/118/05).

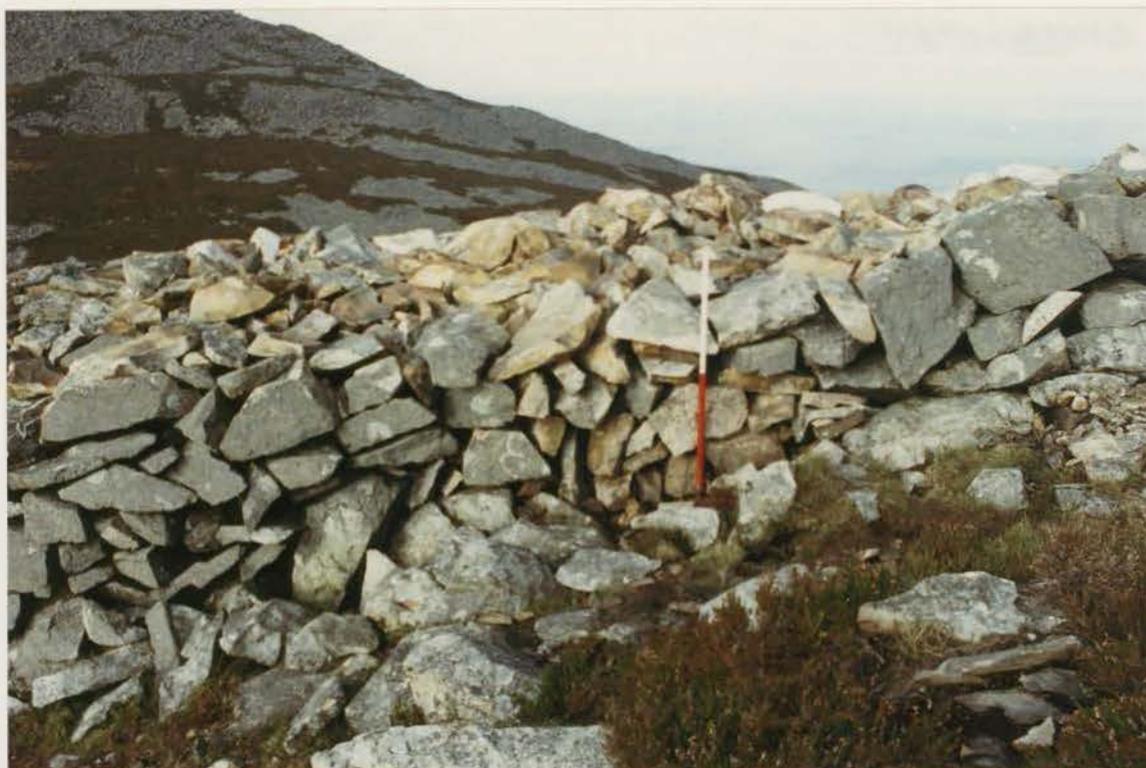
Plate 101. Collapse F (inner face) after clearance of rubble, looking SW (G1022/115/13).

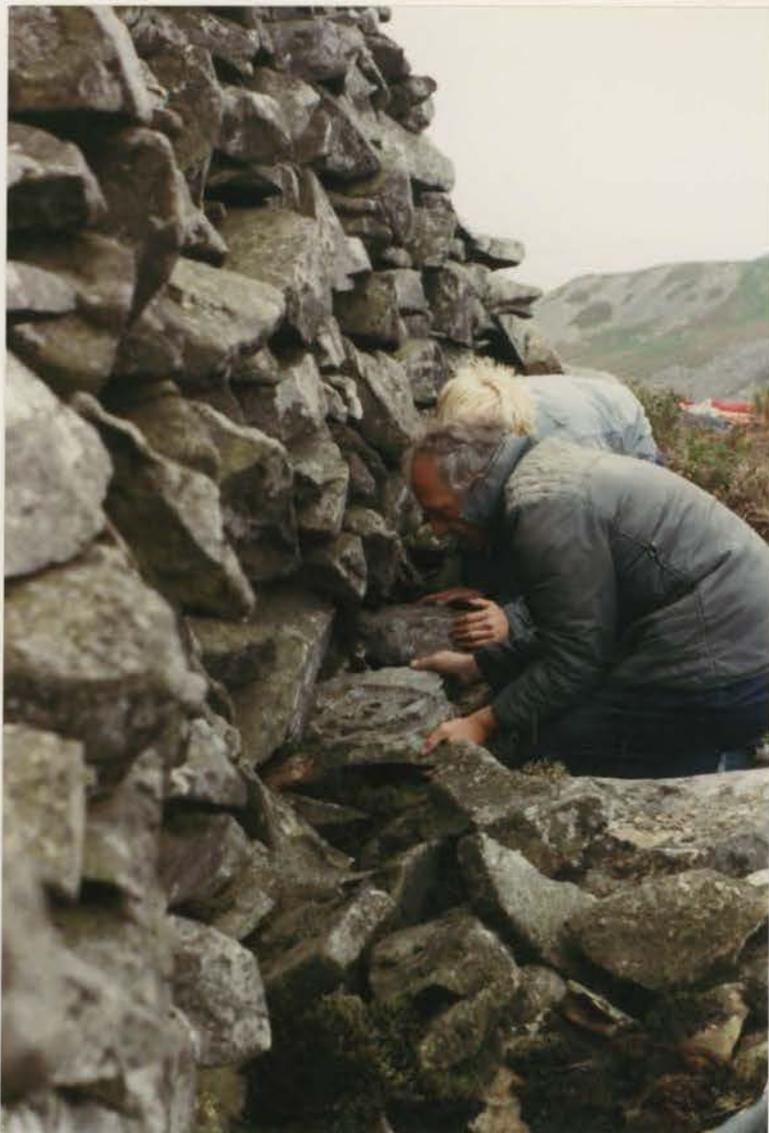
Plate 106. Collapse F3 before
conservation, looking SE
(G1022/014/28).

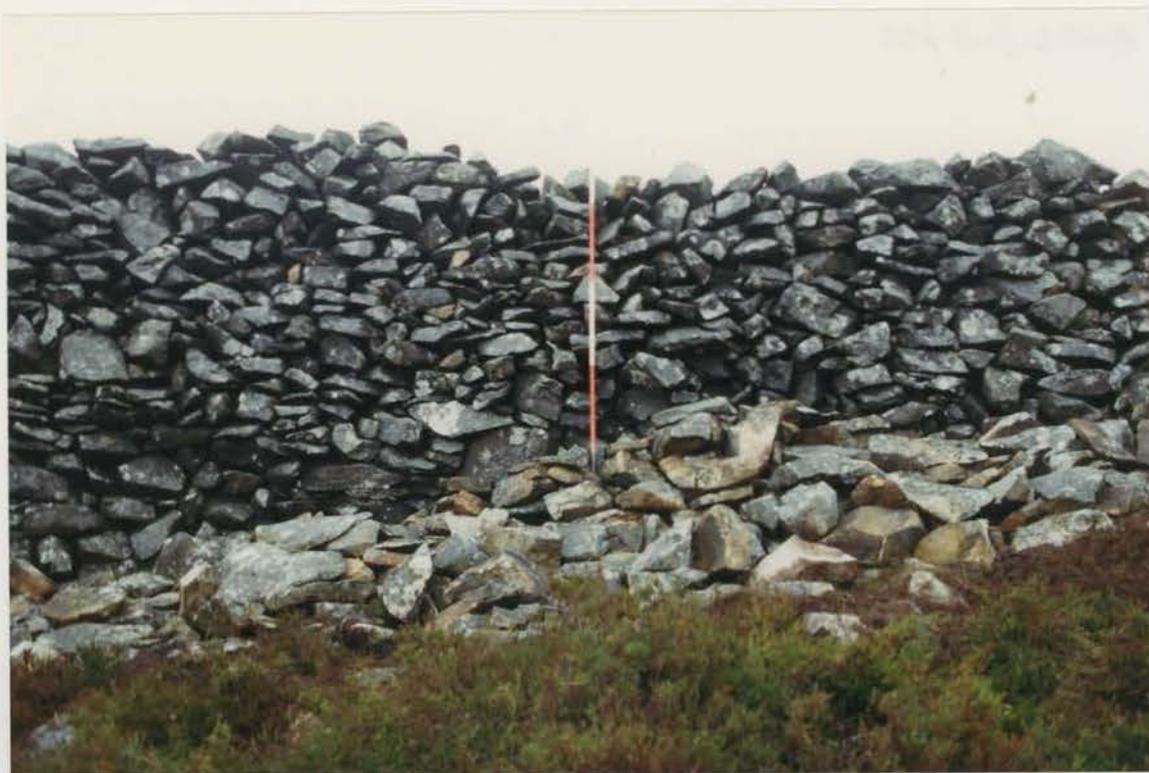
Plate 107. Pinning base of wall at F3 (G1022/114/14).

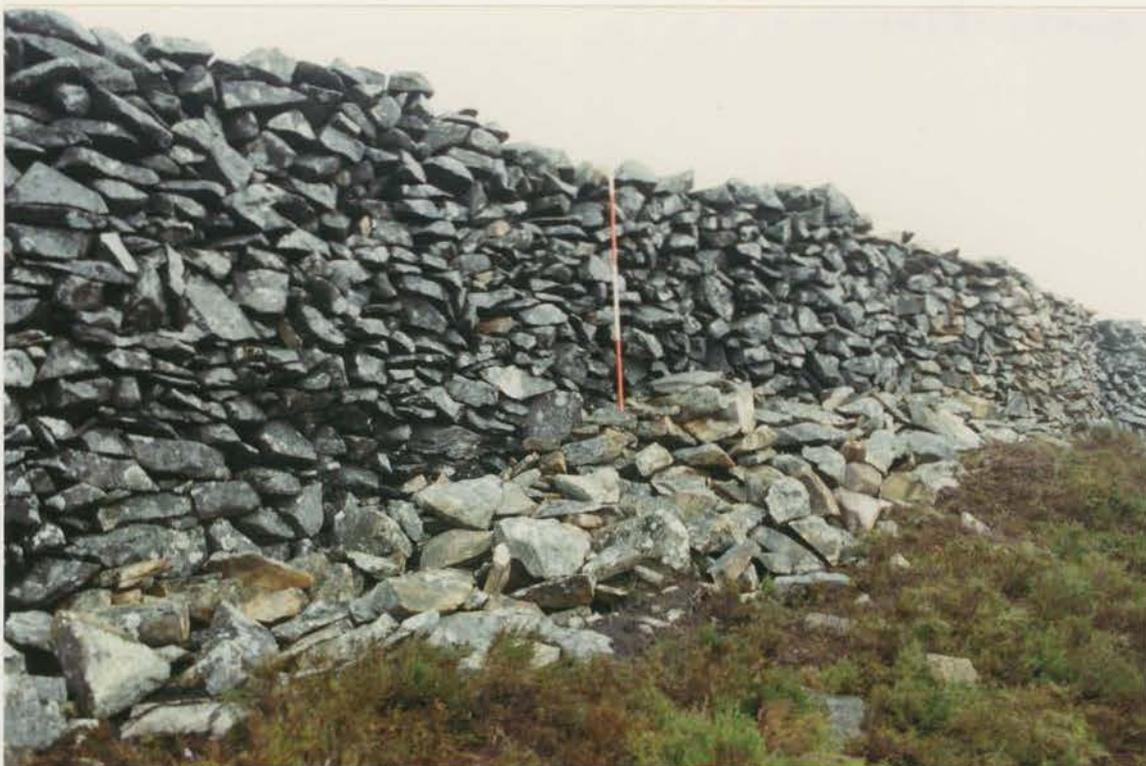
Plate 108. Collapse F3 after conservation, looking SE (G1022/117/35).

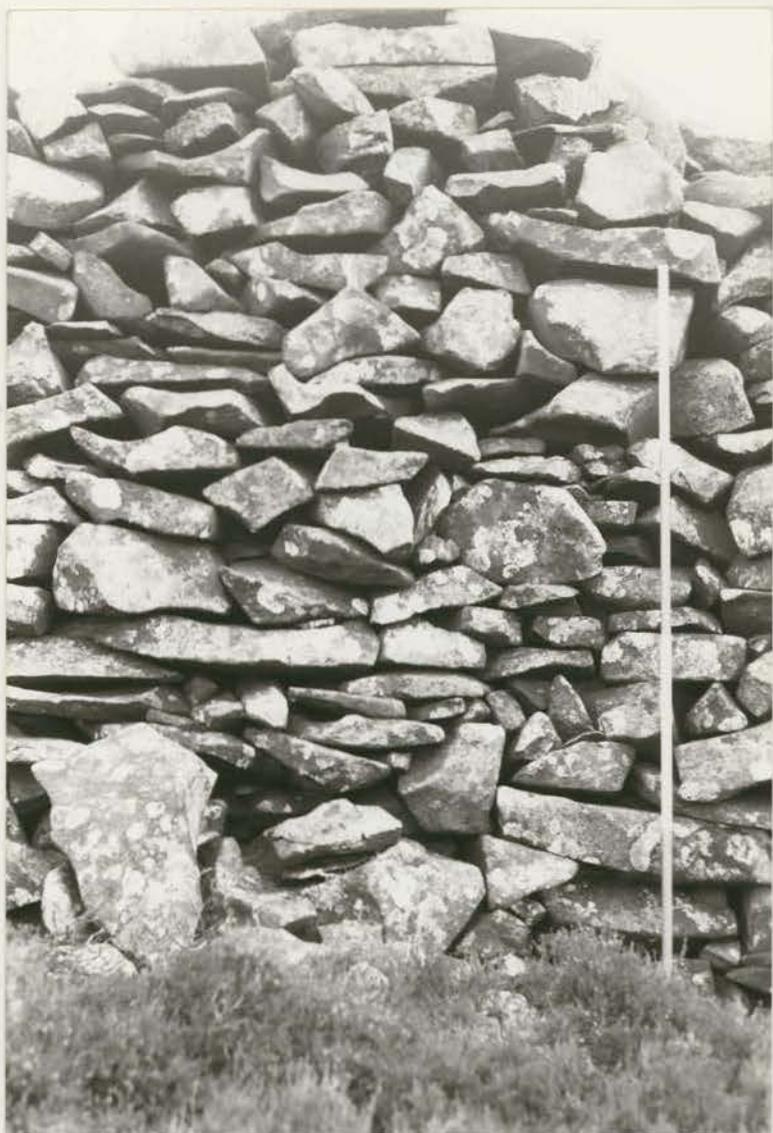
Plate 112. Collapse F4 after conservation, looking NW (G1022/117/09).

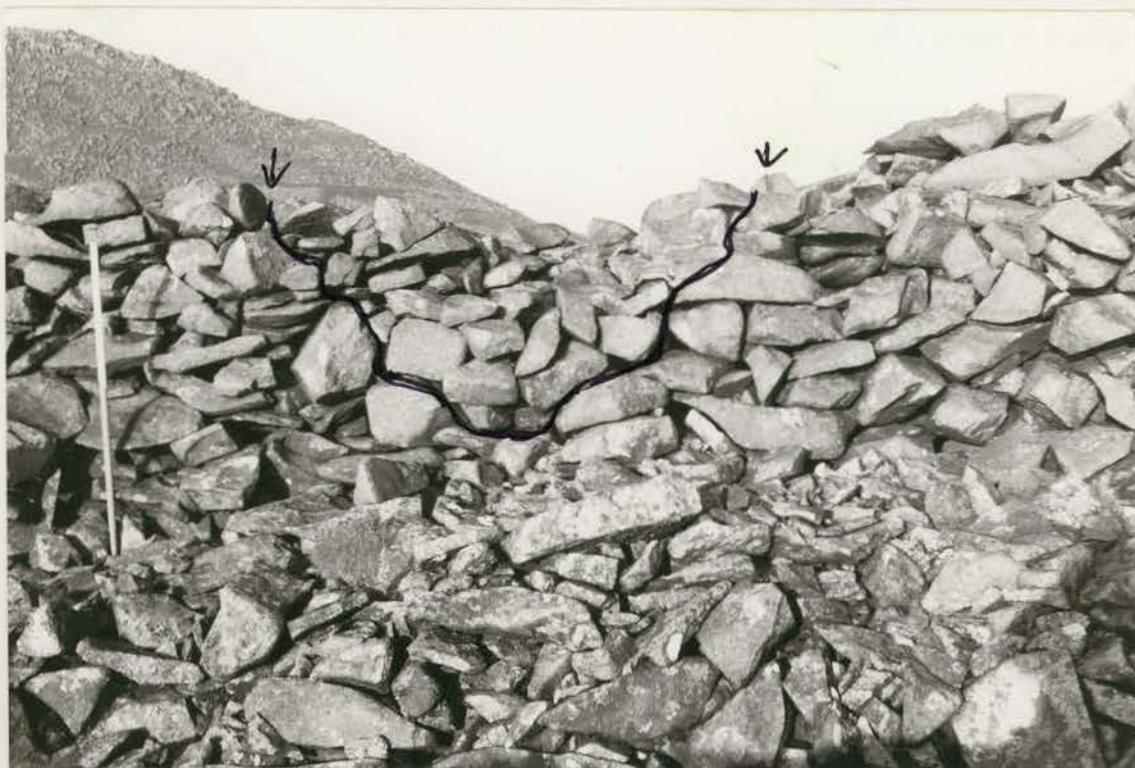
Plate 113. Collapse F5 before conservation, looking SE (G1022/014/34).

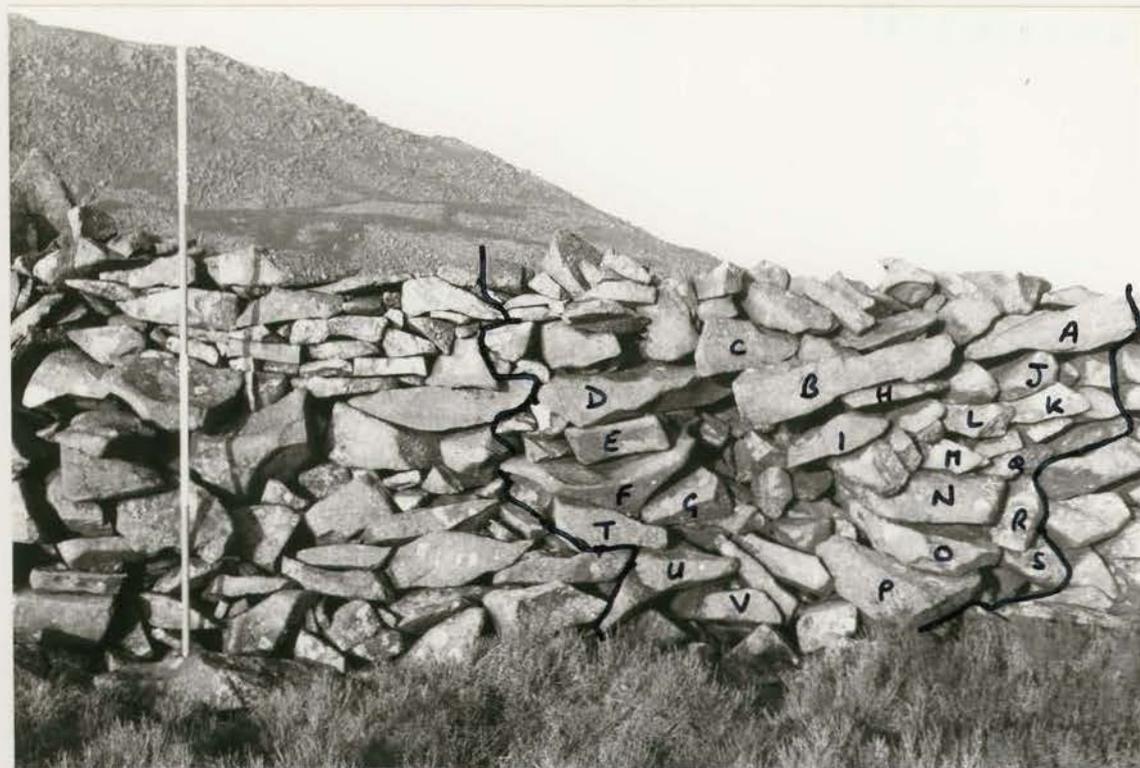
Plate 115. Collapse F6 after conservation, looking NW (G1022/117/08).

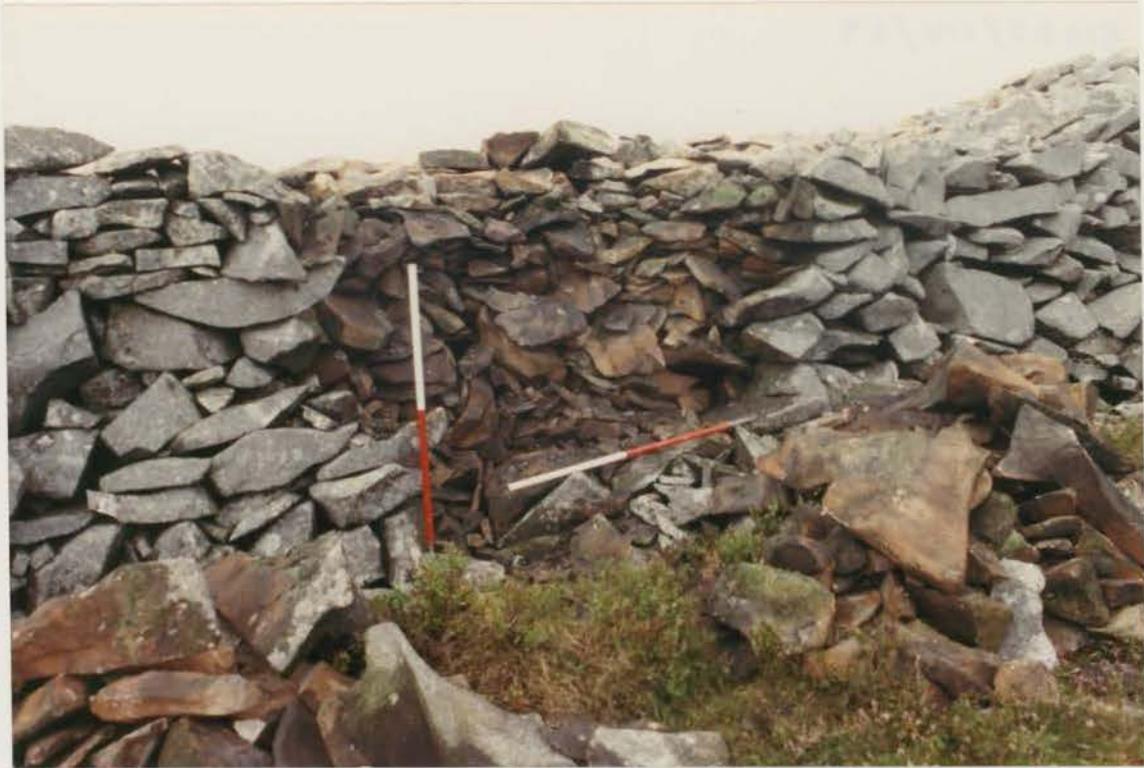
Plate 116. Collapse F7 before conservation, looking NW (G1022/012/29).

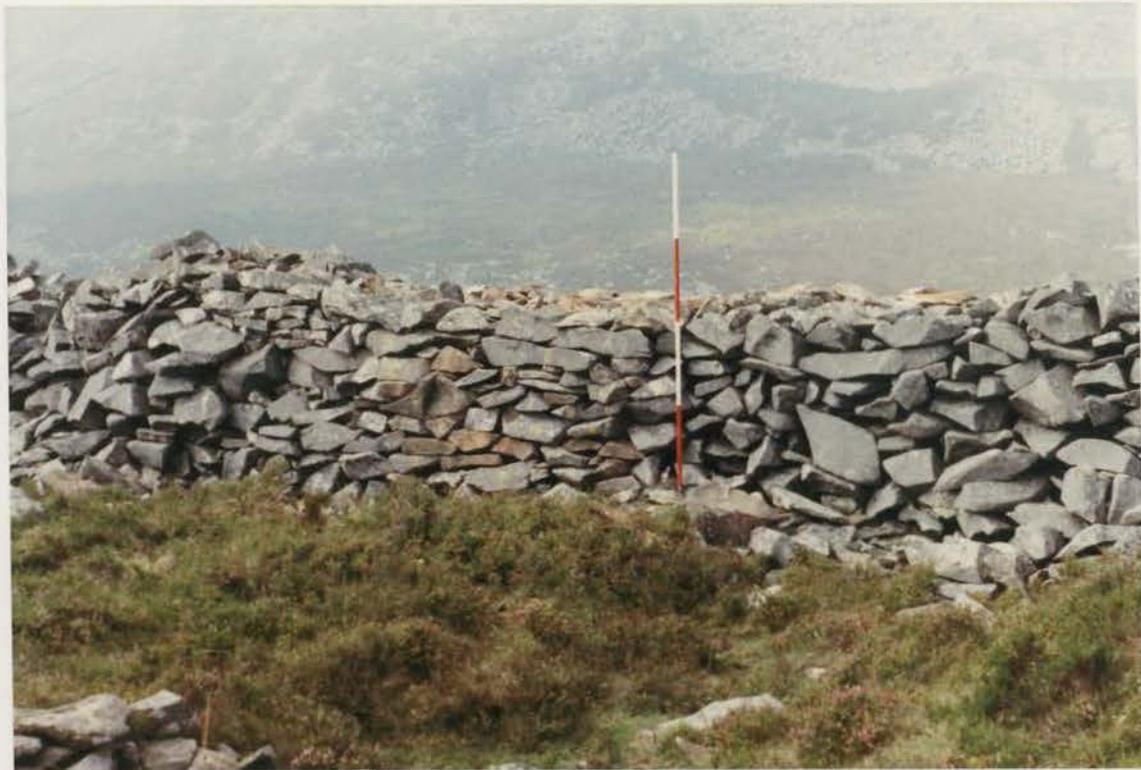
Plate 117. Collapse F7 after clearance of unstable masonry, looking N (G1022/114/29).

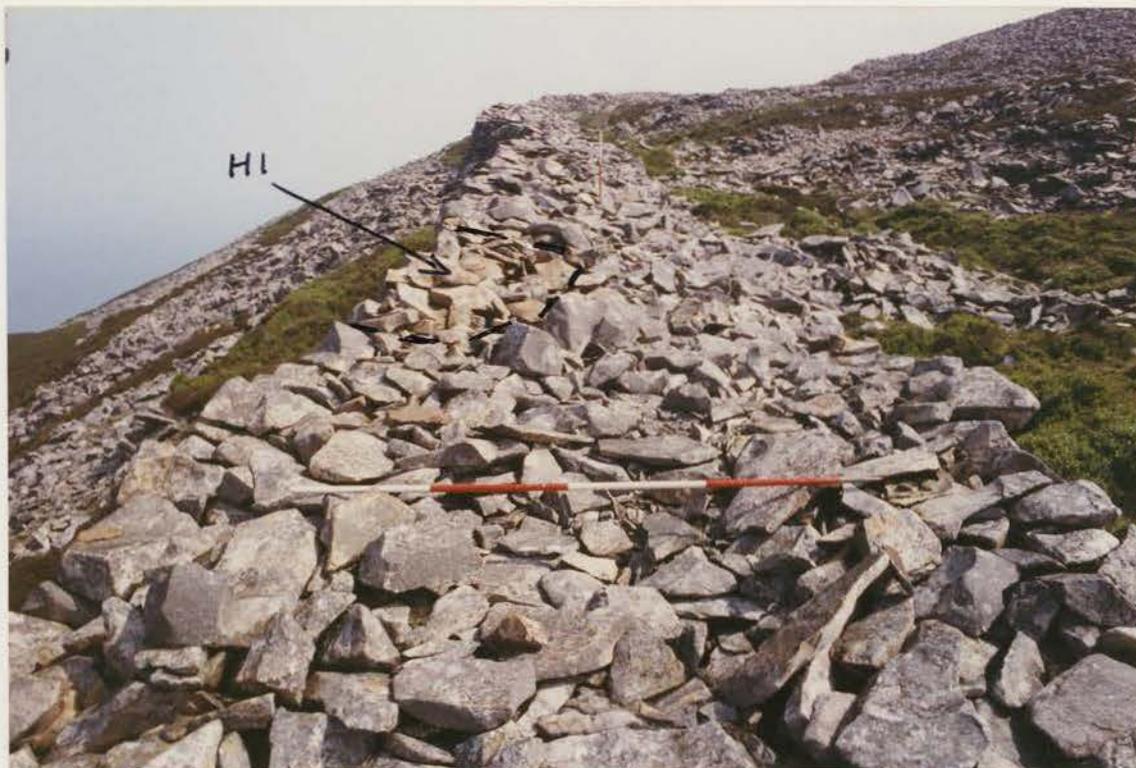
Plate 118. Collapse F7 after conservation, looking W (G1022/114/36).

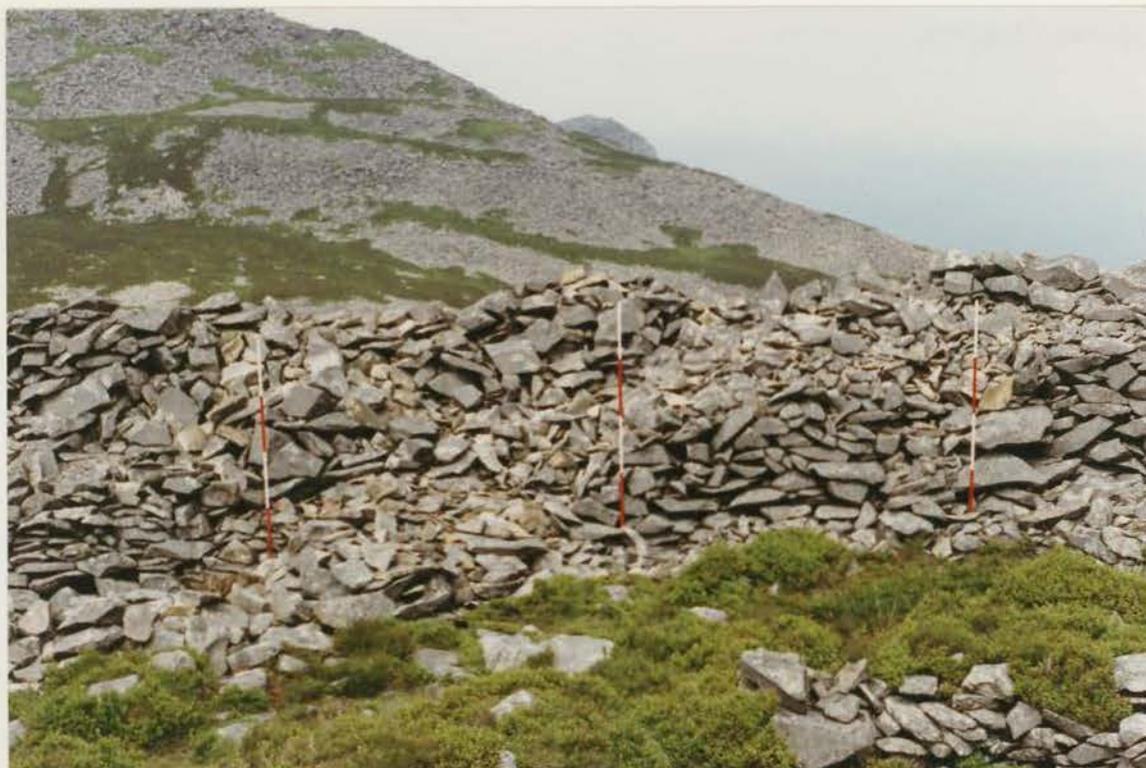
Plate 119. Wall top behind Hut 77 before conservation, with H1 behind the scale, looking NE (G1022/109/27).

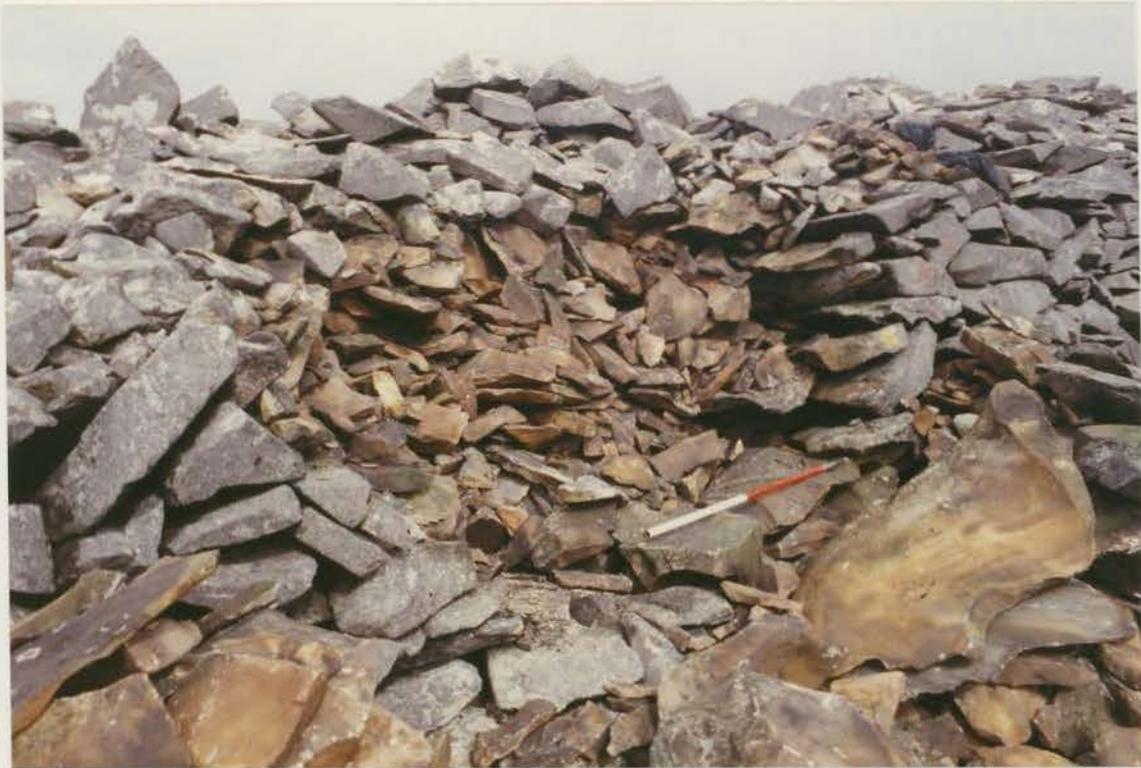
Plate 122. Collapse H3 before conservation, looking NW
(G1022/107/32).

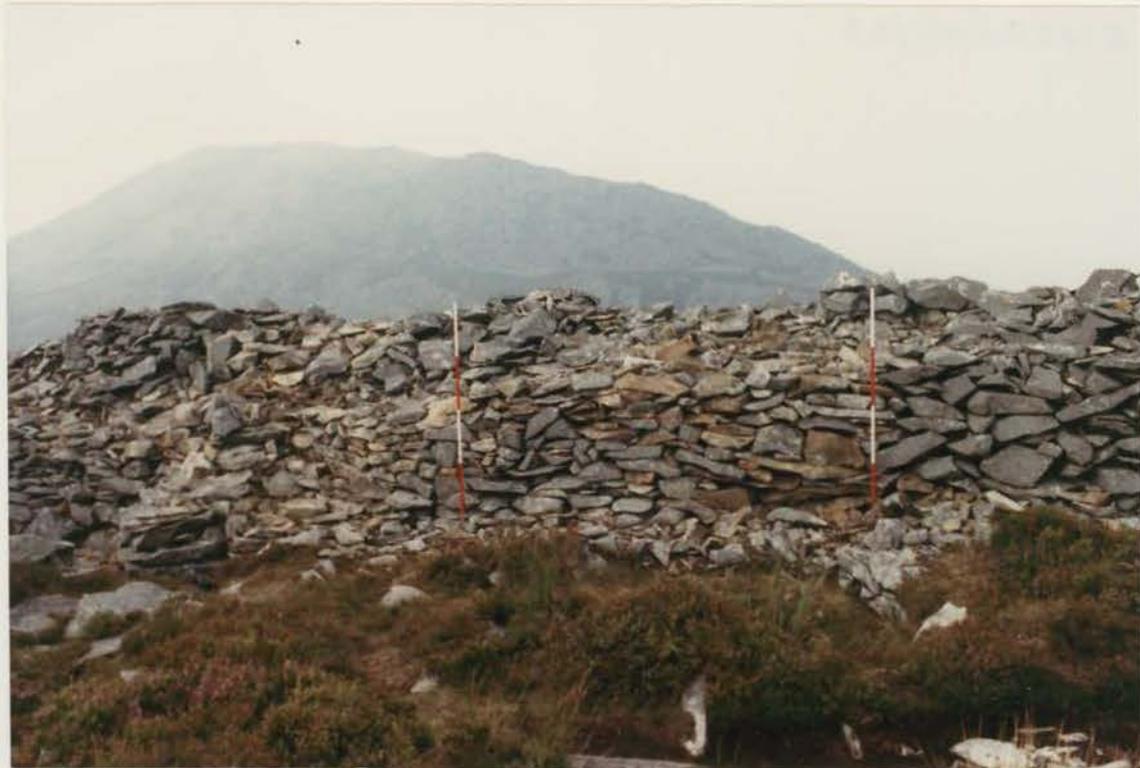
Plate 123. Collapse H3 after removal of unstable masonry, looking N
(G1022/113/31).

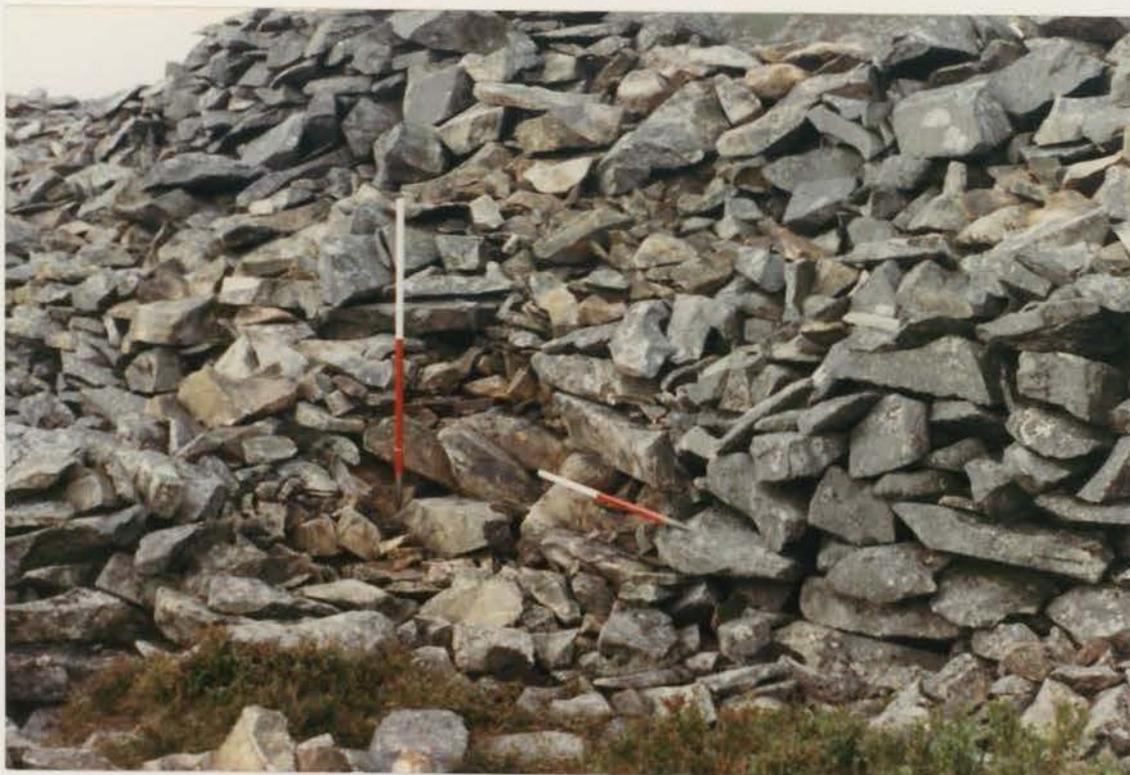
Plate 126. Collapse H4 after clearance of rubble, looking W (G1022/114/06).

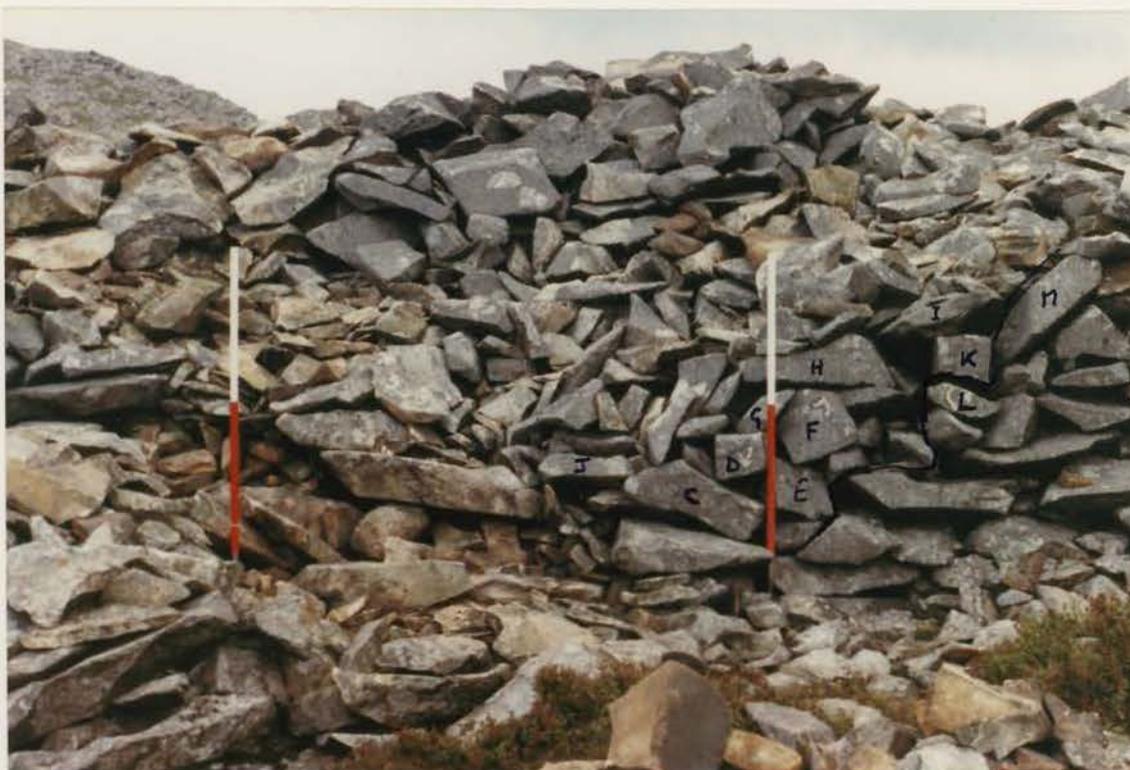
Plate 127. Collapse H4 after clearance of rubble, looking W
(G1022/114/09).

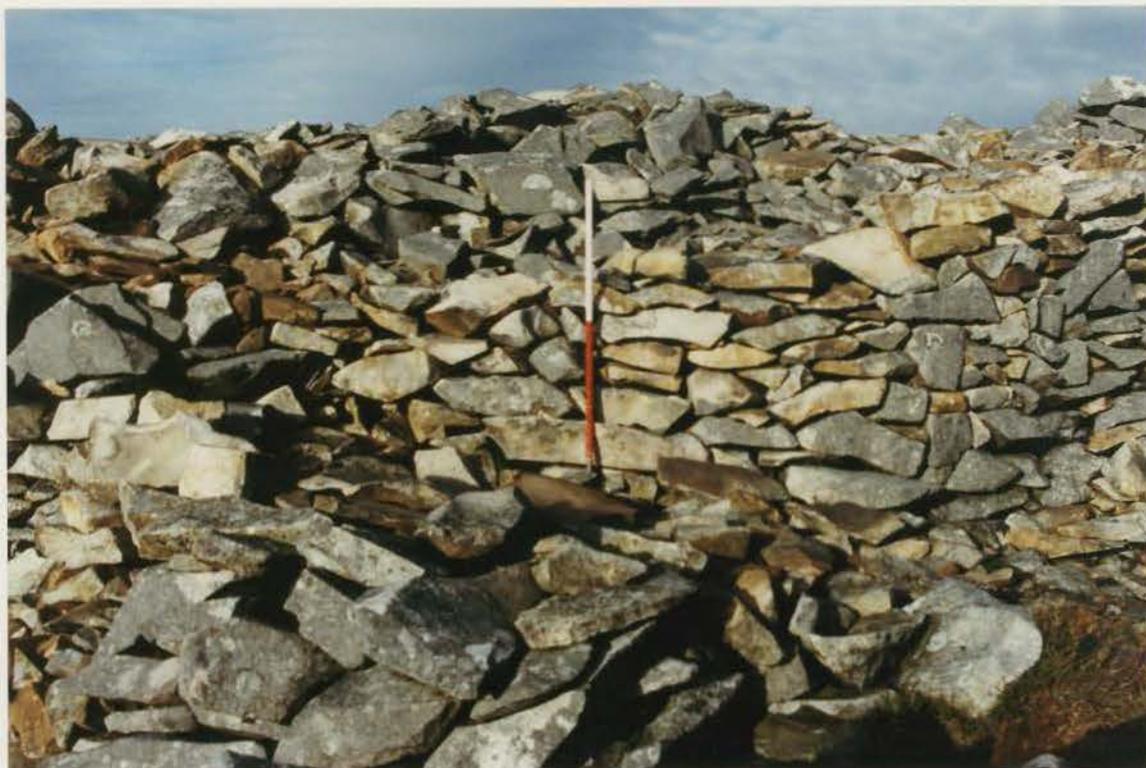
Plate 128. Collapse H4: unstable masonry to NE of collapse before
dismantling, looking NW (G1022/114/08).

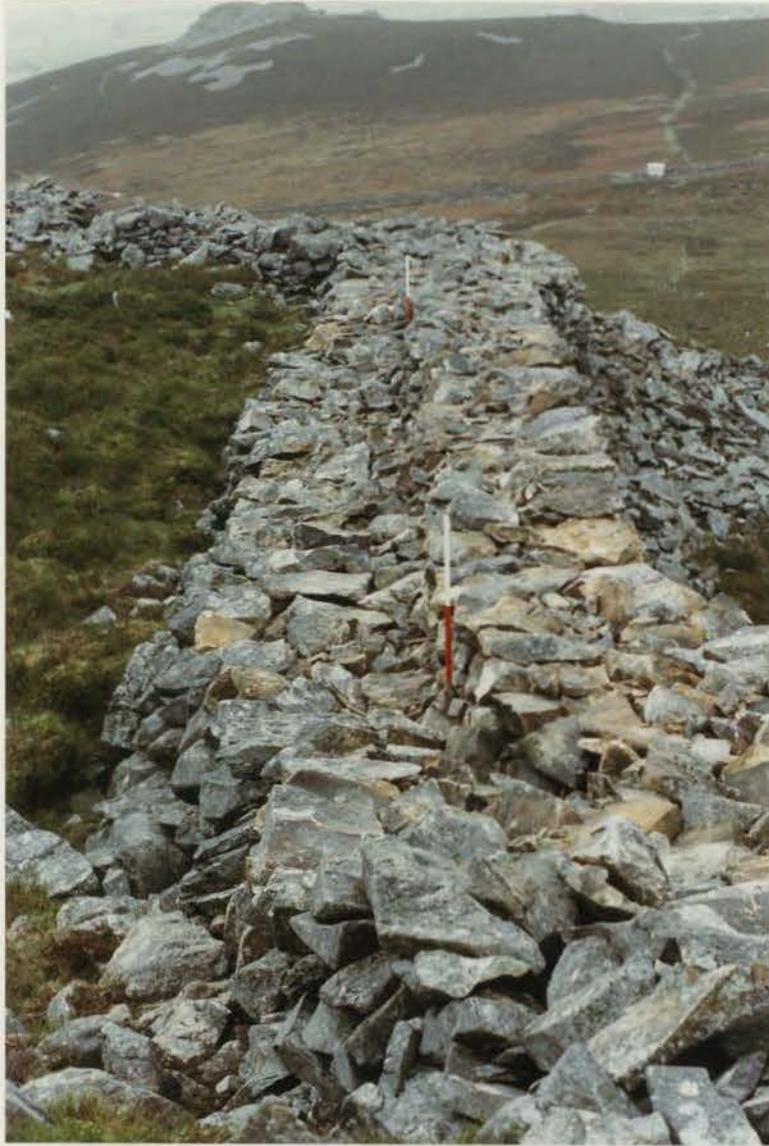
Plate 130. Wall capping between F1 and F7, looking NE (G1022/119/23).
