# THE YORKSHIRE IMPERIAL METALS SITE, SWANSEA

## A SITE APPRAISAL

## ARCHAEOLOGICAL, CONDITION, AND HEALTH AND SAFETY APPRAISALS BUDGET COSTS

NOVEMBER 2002  
REPORT No. 2002/100

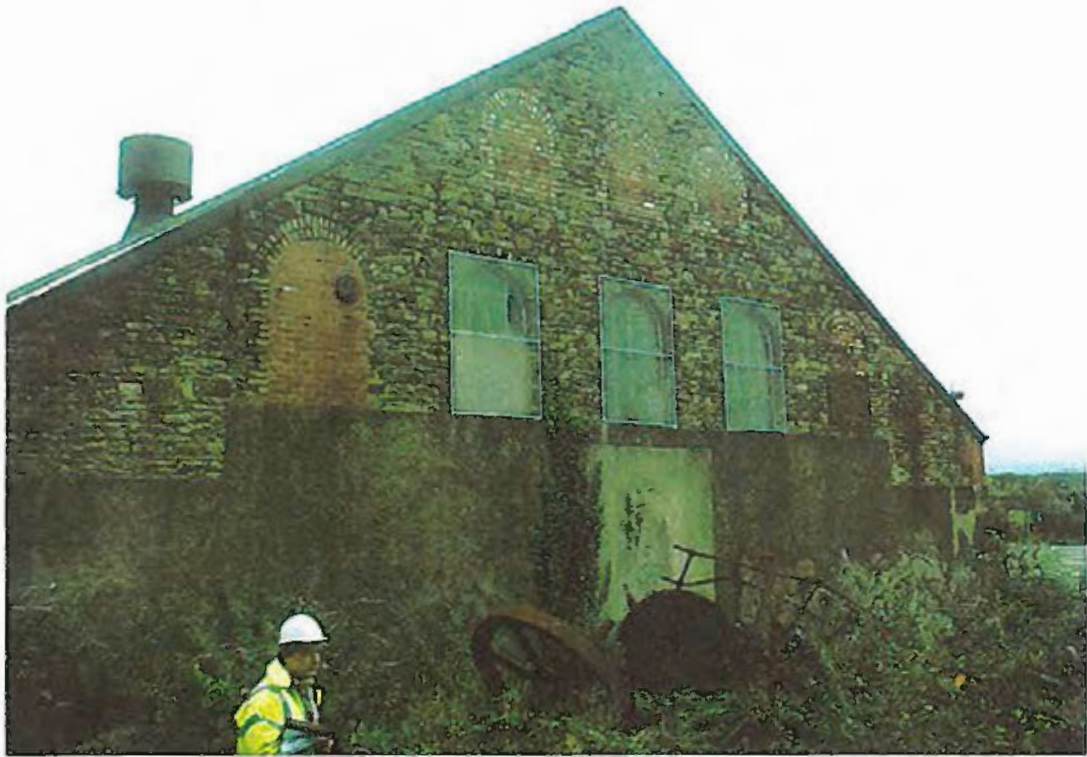
*Photo 1a - Building 10.0 (Museum Stores/rolling mill),  
from the SW showing primary work (c.1830) with contemporary openings*

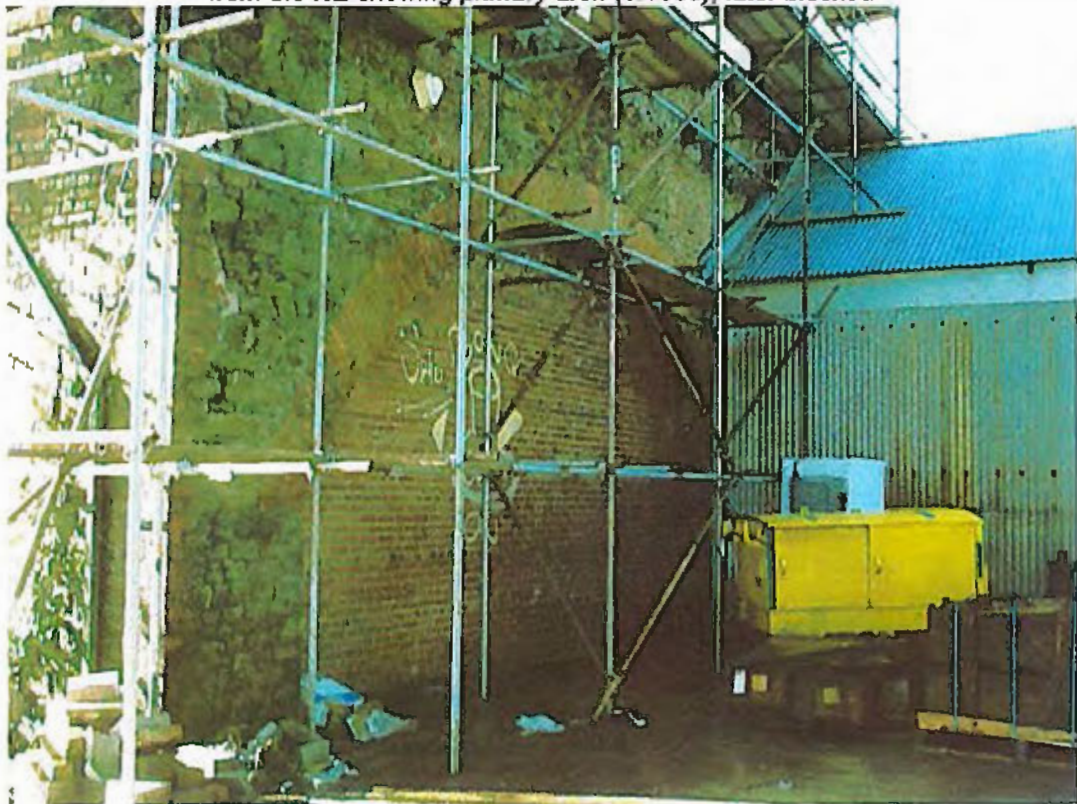
*Photo 1b - Building 10.0, Museum Stores/rolling mill,  
from the NE showing primary arch (c.1830), later blocked*

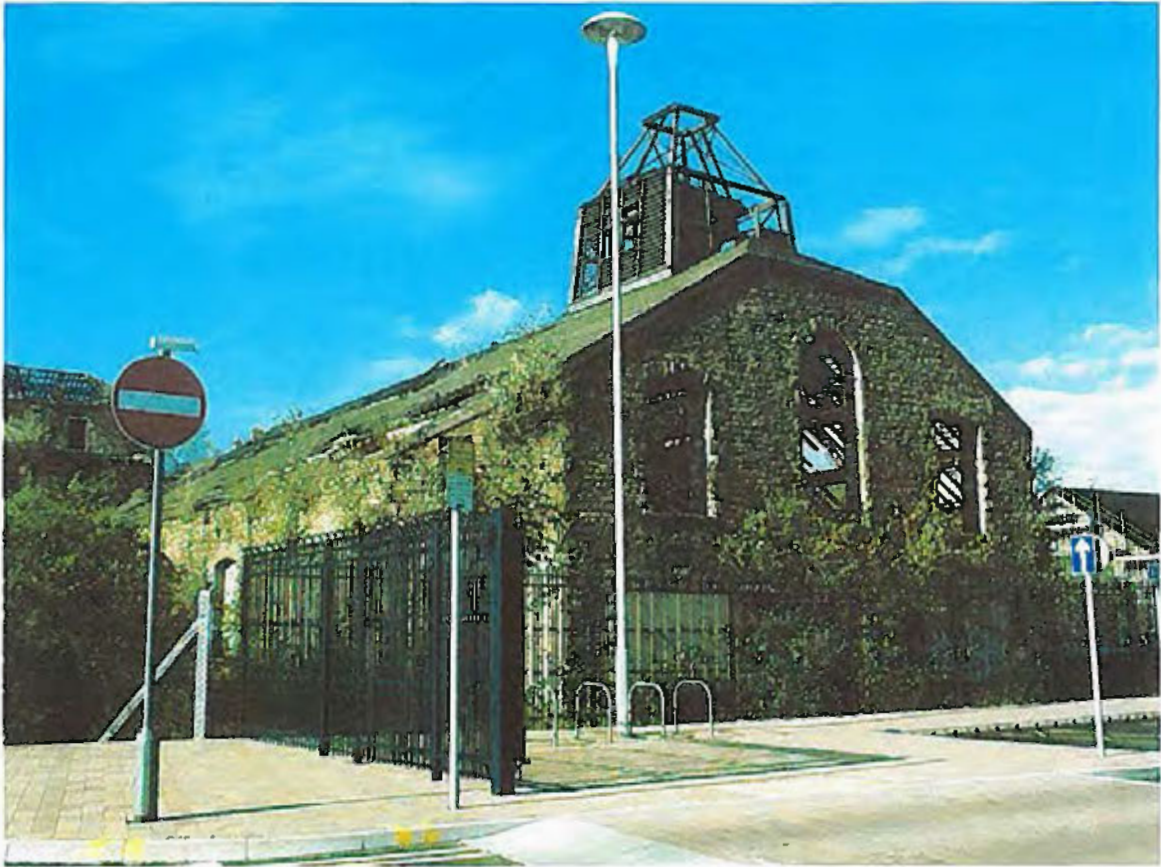
Photo 2 - Building 1.0 (Canteen/power house), from the SE

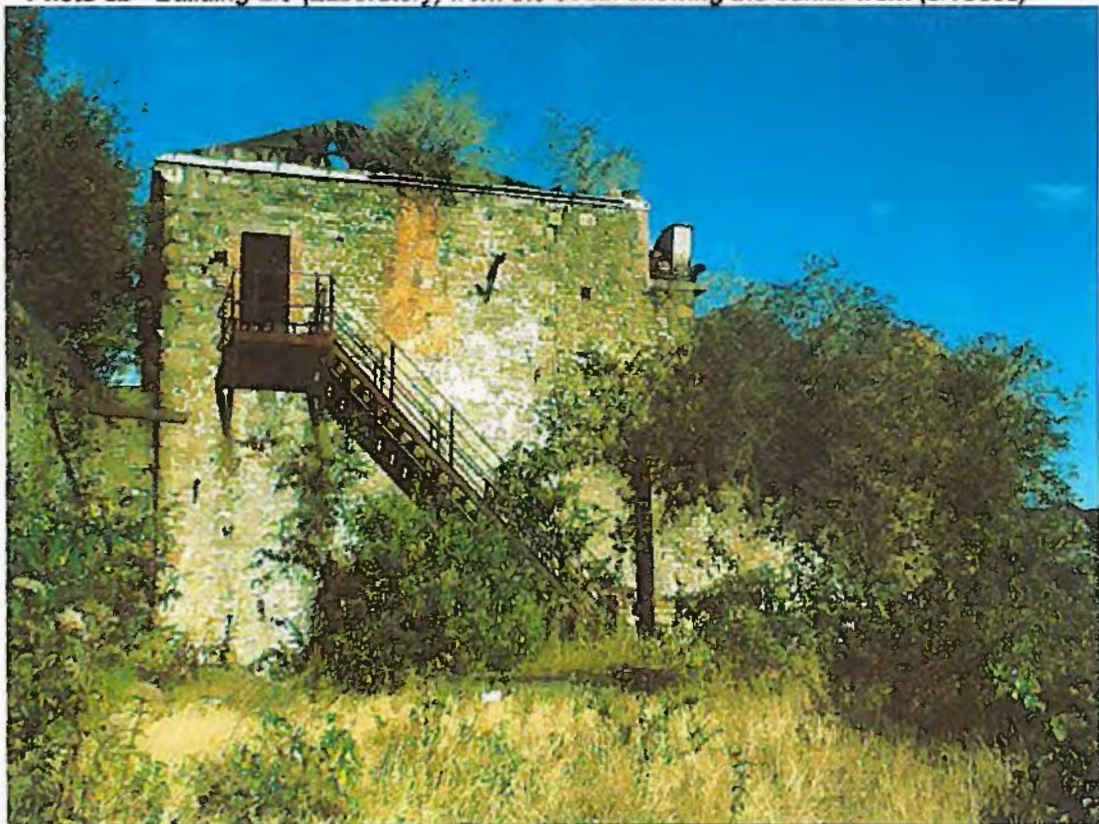
*Photo 3b - Building 2.0 (Laboratory) from the south showing the earlier work (c.1830s)*

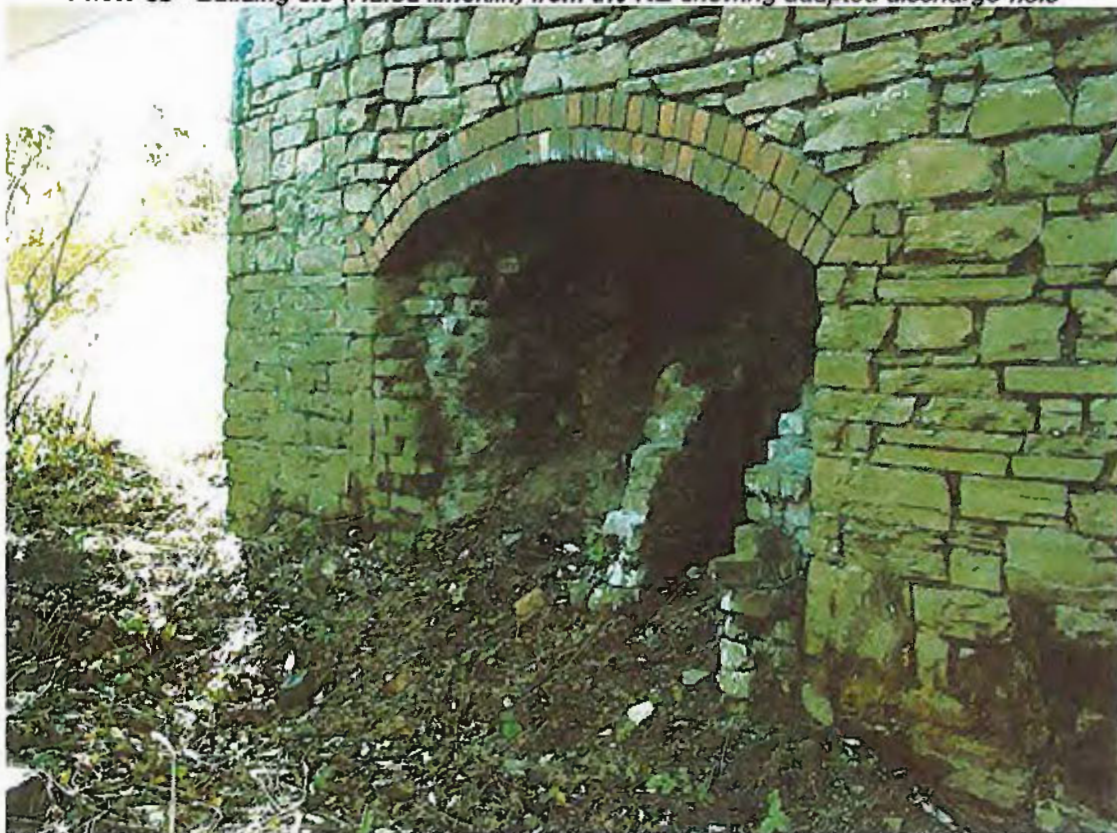
*Photo 6b - Building 5.0 (Hafod limekiln) from the NE showing adapted discharge-hole*

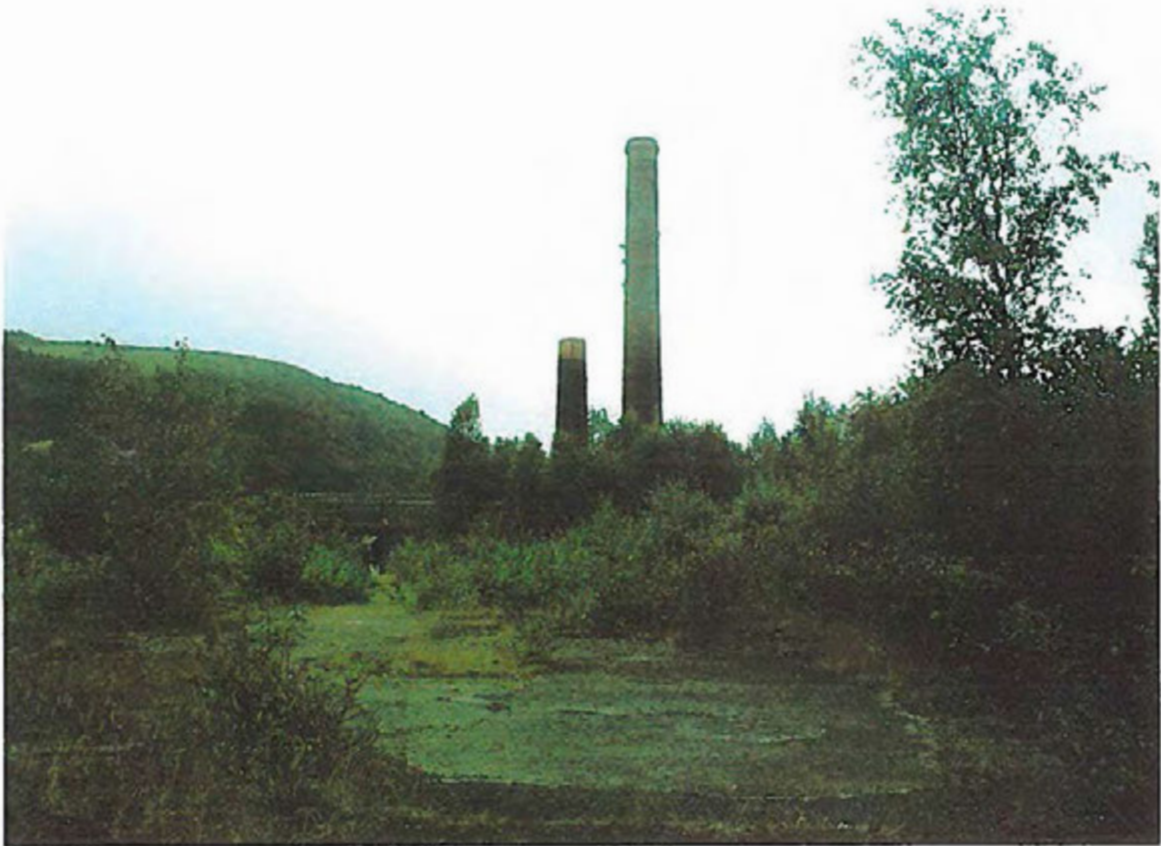
Photo 14e - Area 4C, floor surface of YIM 16 from the north

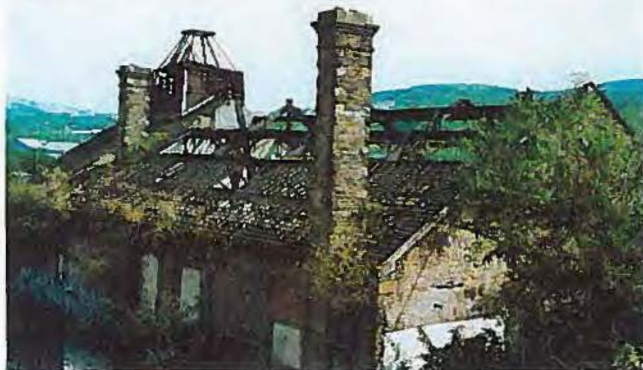
**Below centre:** vegetation growth on the north east corner of the building; intrusive root growth has resulted in the dislodging of masonry.

Walls: cut back vegetation, treat roots with herbicide, temporarily infill and make safe loose or dislodged areas of masonry, mortar cap exposed tops of walls.

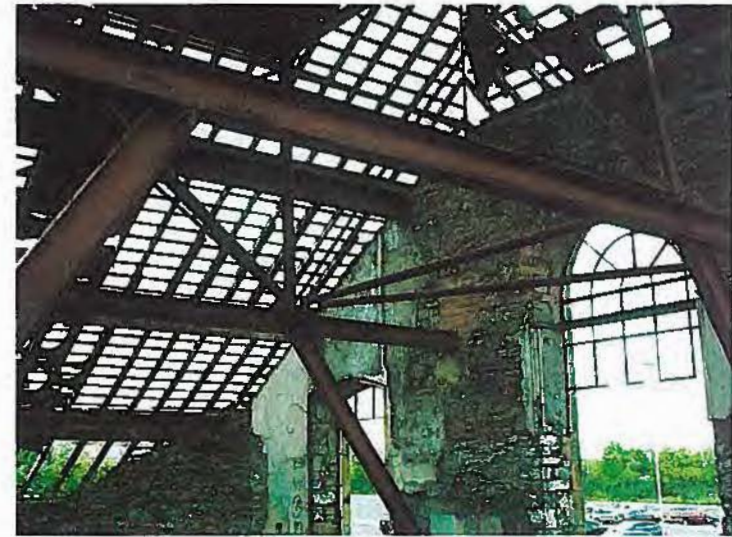
**Below right:** due to the extensive fire damage to the roof timbers over the western portion of the building, temporary ties are required to give restraint to the iron arch braces and supporting columns.

Roof: record remaining timber elements, remove battens, rafters and fascias complete. Remove failed sections of purlins and install temporary scaffold tube ties to provide restraint to remaining elements.

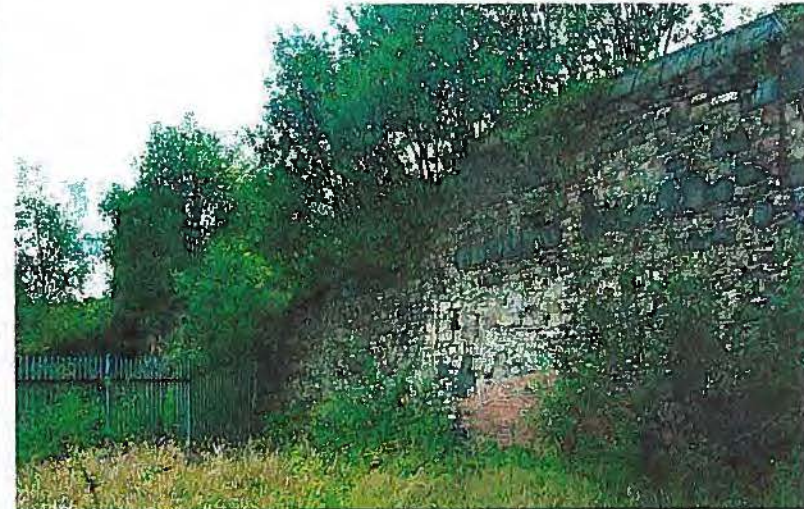
**3.0 Boundary wall of former Morfa Copperworks**

**Above:** east face of the boundary wall at its northern end near the Laboratory building; the wall is constructed of copper slag and rubble stone capped with pointed copper slag coping blocks.  
**Below:** west / canal face of the boundary wall; a wide brick arch near the base of the wall formerly acted as an entrance to one of the canal dock basins.

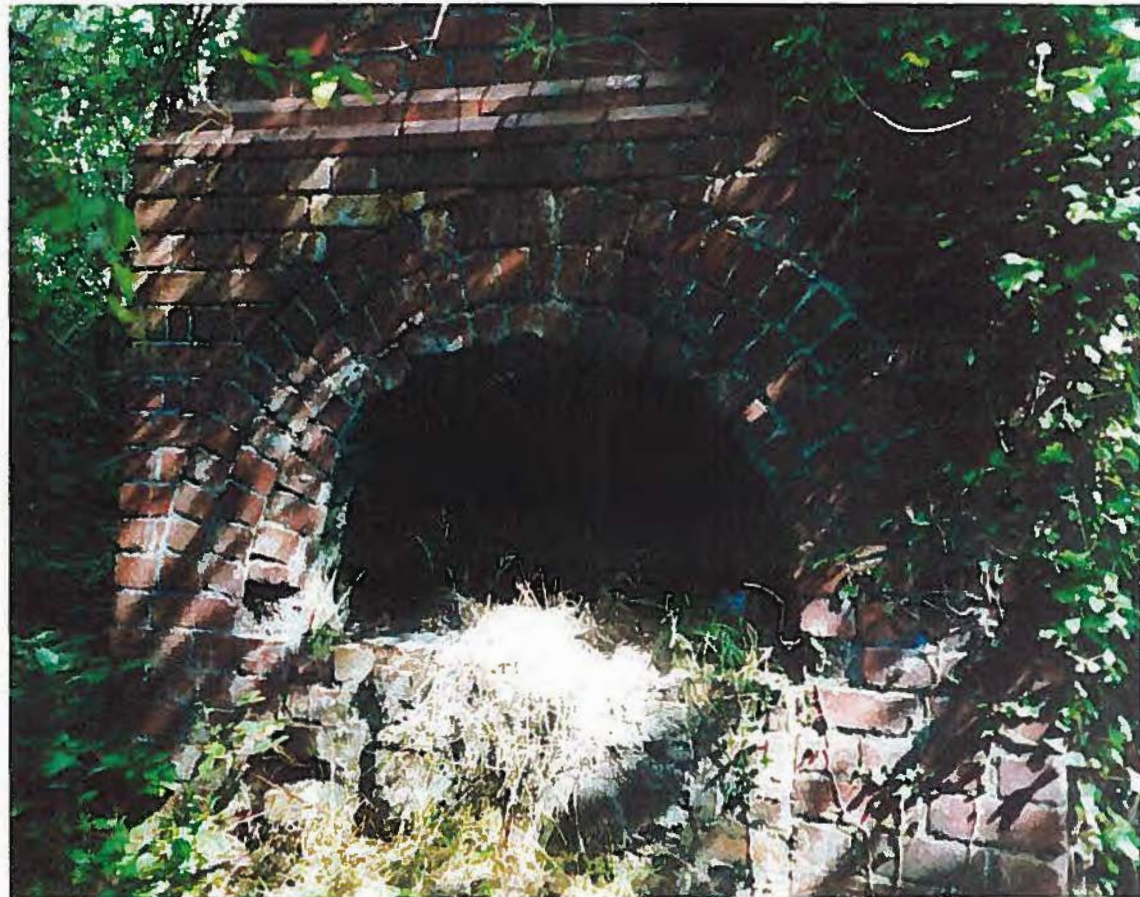
**Right:**  
View of chimney from the north east, the chimney shaft is bound up to mid height with five iron bands.

- Remove vegetation from face of stack.
- Repair, rake out and re-point brickwork generally.
- Inspect, repair / replace / redecorate iron bands
- Repair and secure opening to base of chimney
- Replace lightning protection strap to chimney

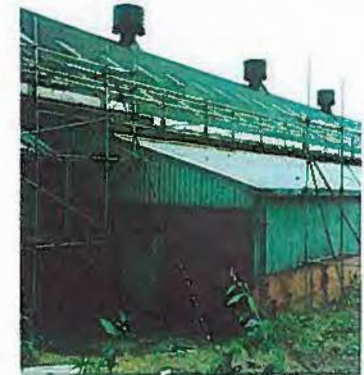
Extensions: lean-to extensions on contain  
offices, workrooms and toilet facilities; bottom  
edge of the metal cladding on east face of north  
extension is rusting through.

**Right lower:**  
modern steel framed profiled  
metal clad extension at the  
north end of the museum  
stores.

Undertake restoration of building to original form.  
Replace cracked and deformed floor slab if  
necessary for further use.  
Replace later extensions with new separate  
structures.

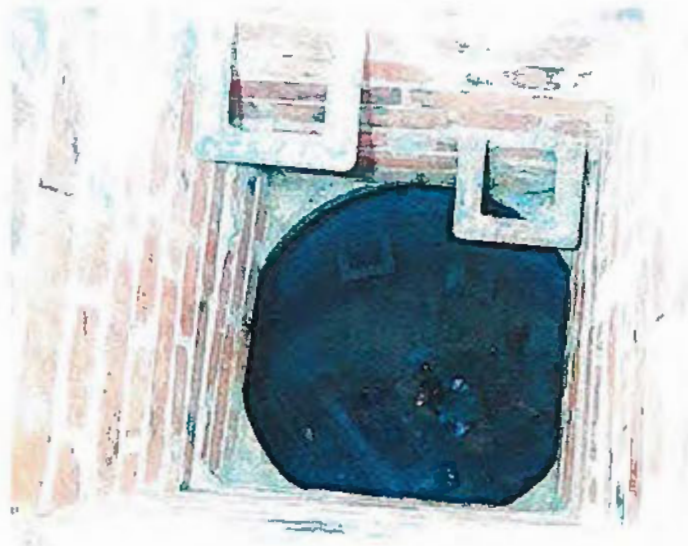
**P11:** Uncovered culvert chamber.

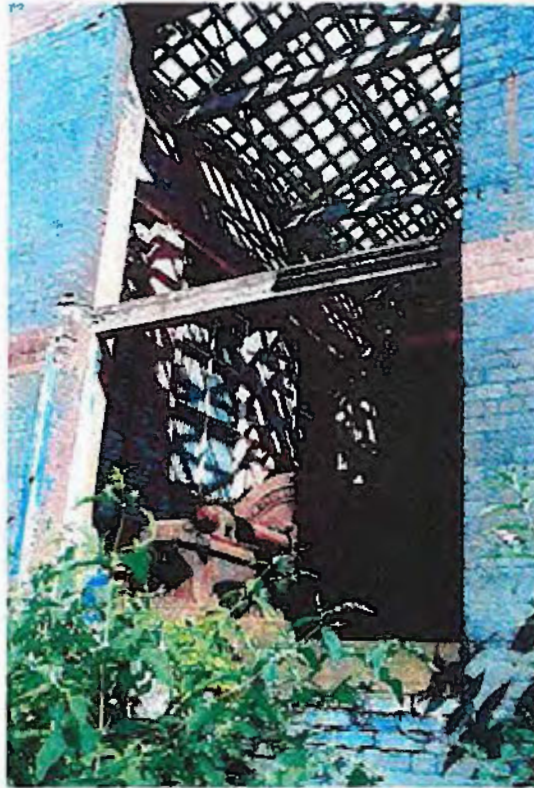
**P29:** Musgrave Engine House. Unprotected drops.
